# National Transportation Safety Board

ERA23FA001

## **AIR TRAFFIC CONTROL**

Group Chair's Factual Report

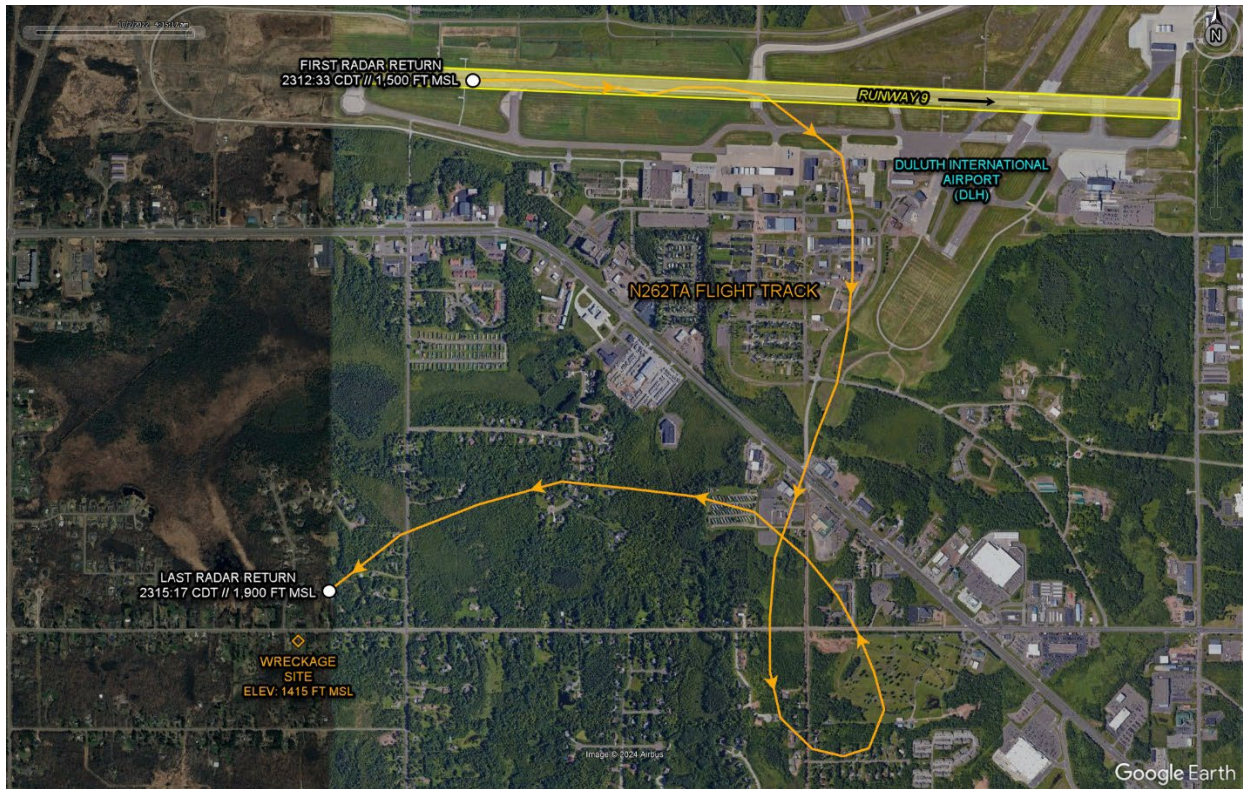
**Figure 1.** Overview of the entire accident flight track overlaid on satellite imagery.

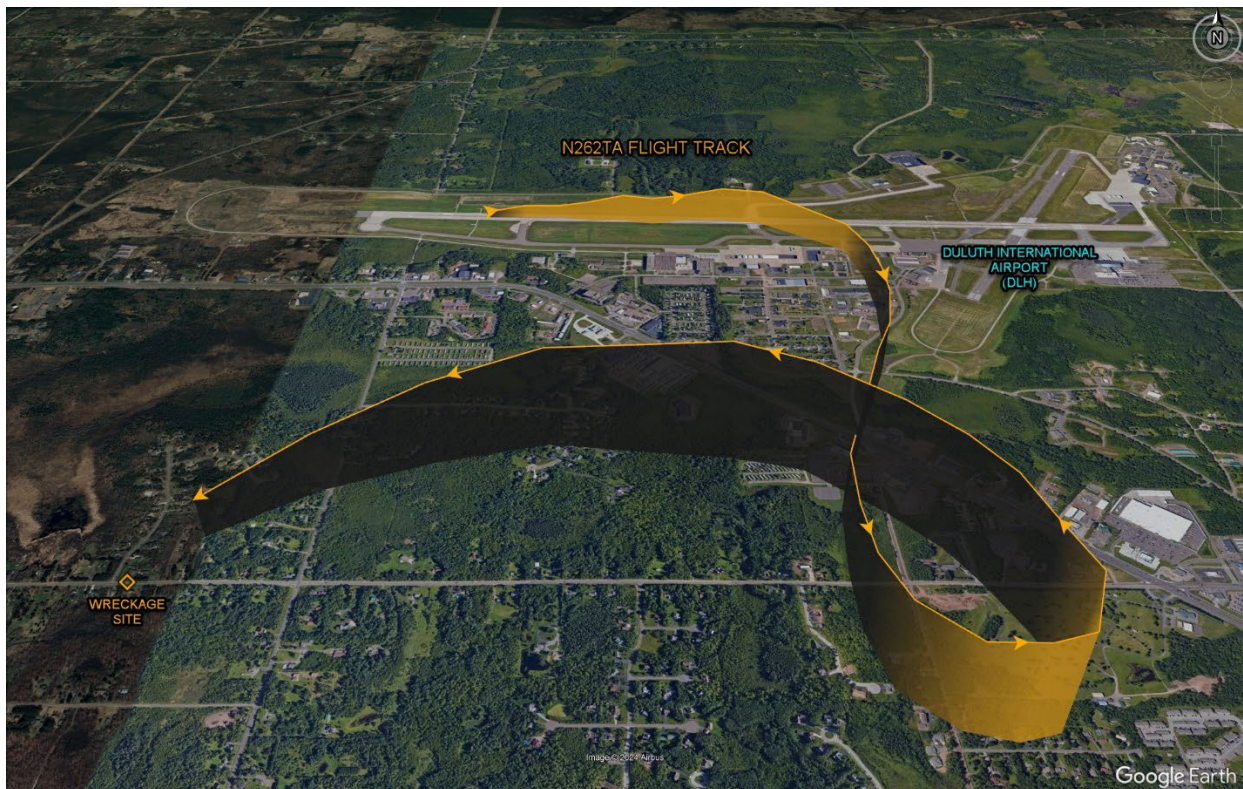
**Figure 2.** Profile view of the entire accident flight track overlaid onto satellite imagery.

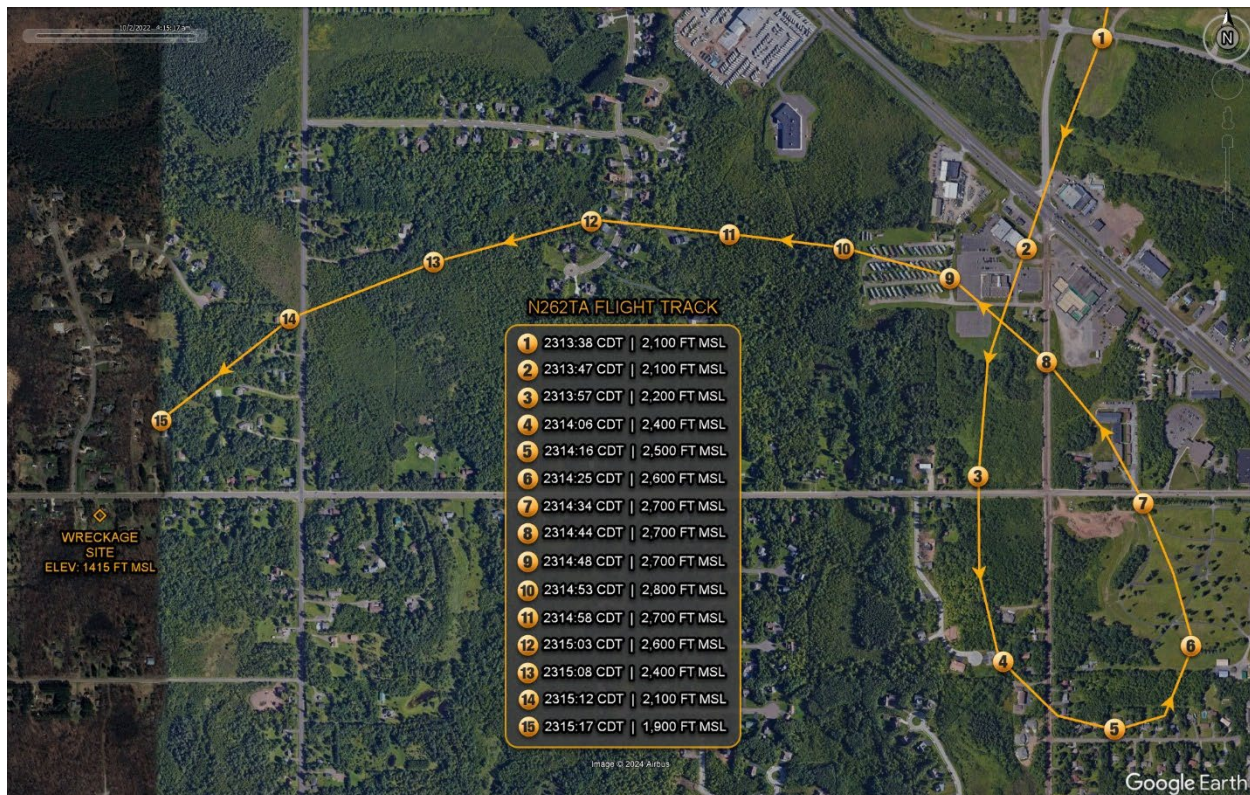
*[According to surveillance data, the airplane continued to climb slowly but then made a left 270-degree turn reaching an altitude of about 2,800 feet and arcing in a counterclockwise direction and beginning to descend.]*

Several seconds later, while the airplane continued to descend in a counterclockwise direction and increasing in ground speed, the radar controller advised N262TA that he observed the aircraft descending and asked the pilot to confirm he was climbing. There was no response. Simultaneously, there was a low altitude (LA)<sup>6</sup> alert observed on the tower display workstation (TDW)<sup>7</sup>.

**Figure 3.** Final portion of the accident flight track with time and altitude information overlaid on satellite imagery.
