# National Transportation Safety Board

## **MATERIALS LABORATORY**

Factual Report 23-064

Location: East Hampton, New York  
Date: October 6, 2022  
Vehicle: Seamax Aircraft M-22, N46PD  
Investigator: Heidi Kemner, AS-ERA

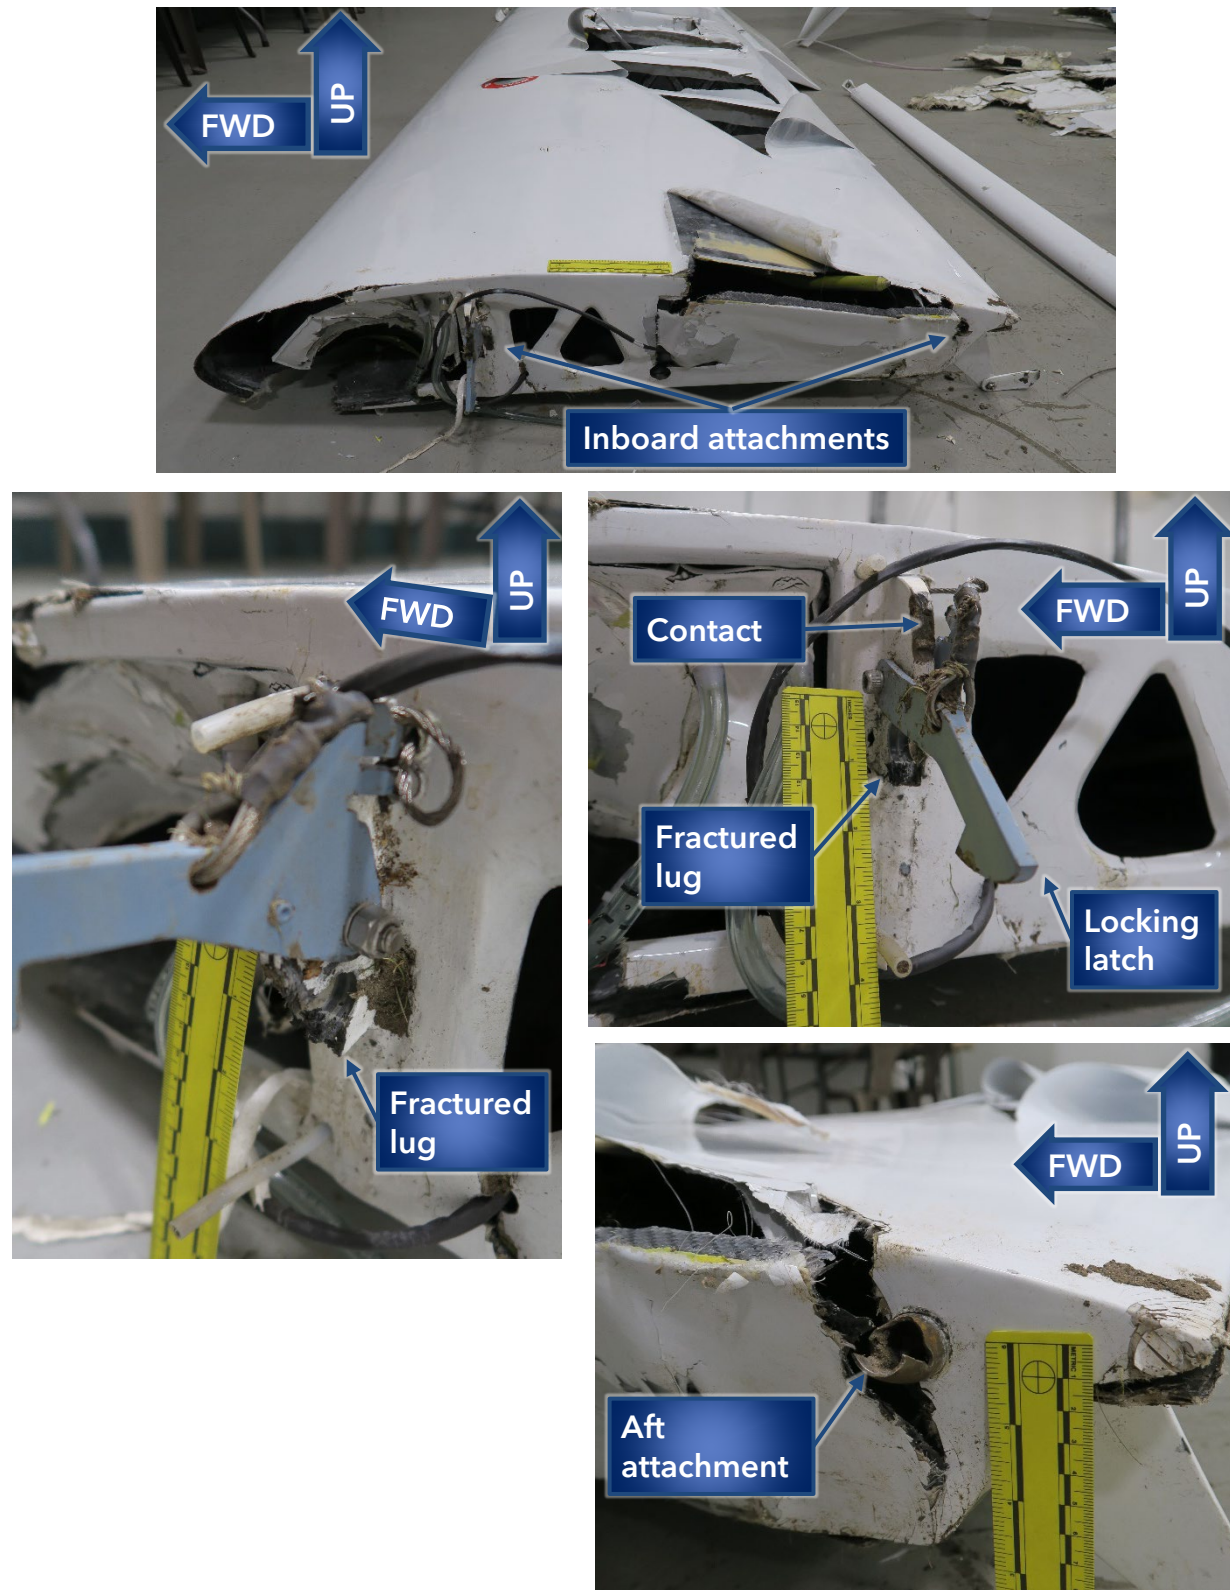
A view of the inboard end of the right wing as examined at an airplane salvage facility is shown in figure 1. The inboard attachments for the wing were fractured at the locations indicated in the upper image in figure 1. At the forward attachment location, the lug, made of composite material, was fractured at the inboard lower quadrant. The area above the lug showed deformation consistent with heavy contact from the wing locking latch. At the aft location, the inboard end of the spar tube was bent upward, and the upper portion was fractured away. The pin holes were elongated, and fractures in the tube intersected the holes for the locking pin at a tangent, features consistent with shearing from the pin attachment.

**Figure 1.** Inboard end of the right wing (upper image) with closer views of the forward (middle left and middle right images) and aft (lower right image) wing to fuselage attachment locations.

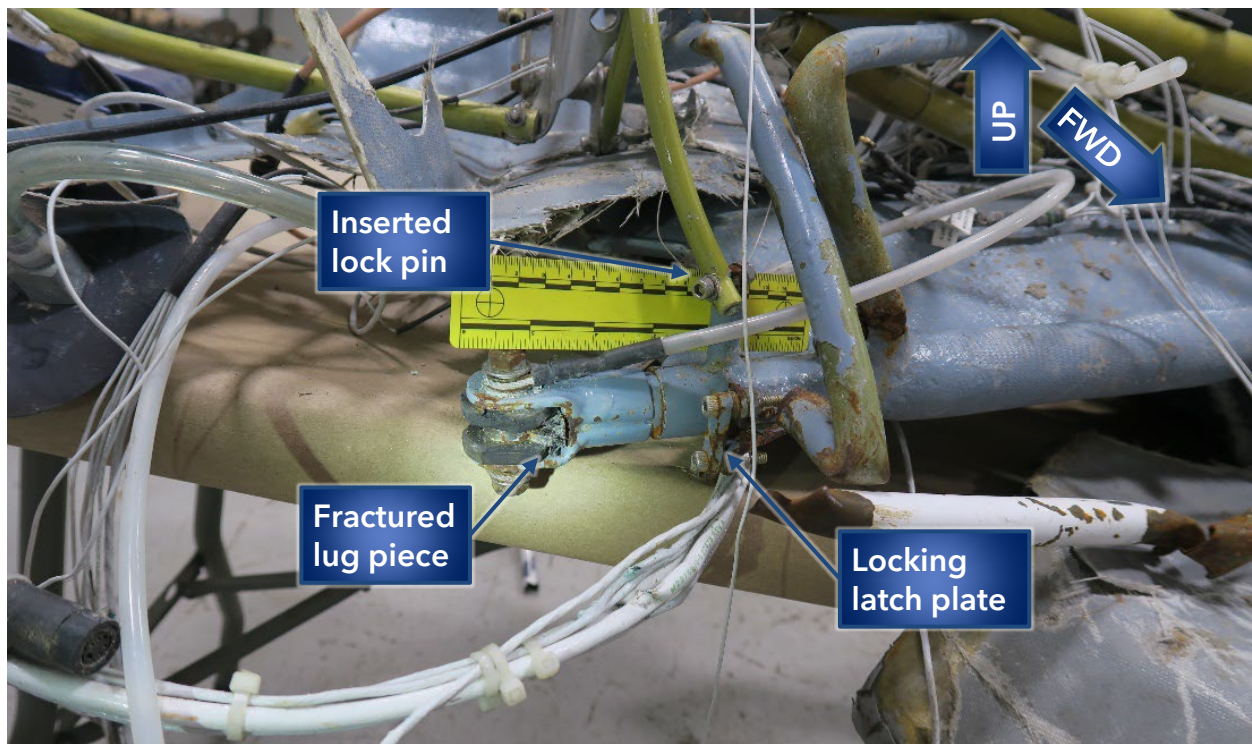
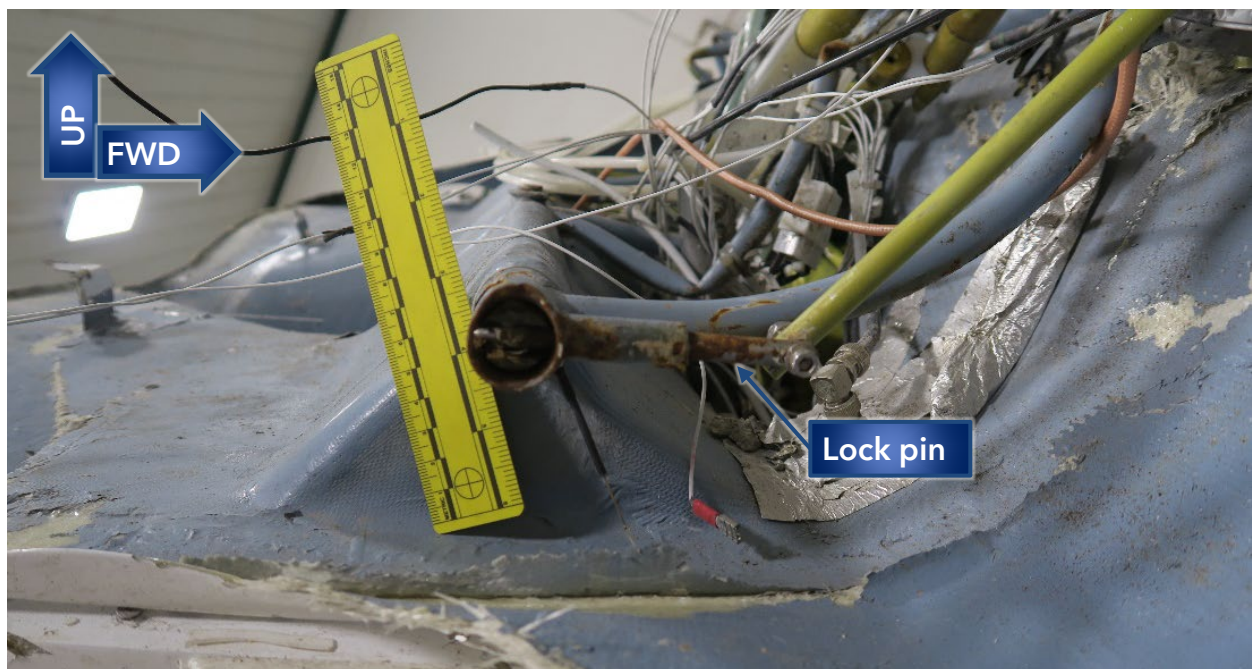
Views of right side of the fuselage at the wing attachment locations are shown in figure 2. The forward end of the wing carrythrough structure was crushed and deformed aft, and the forward transverse tube was rotated clockwise about 90 degrees (as viewed looking inboard) such that the upper side of the tube faced forward. The wing tube that is inserted into the carrythrough structure at the forward attachment location was intact and in place, and a fractured piece of the composite attachment lug was present within the clevis end fitting for the tube. The lock pin that

holds the tube in place was also present and in the locked position. The plate for engaging the locking latch was also intact on the upper side of the carrythrough tube.

At the aft wing attachment location on the right side of the fuselage, the upper half of the outboard end of the carrythrough tube was deformed upward as shown in the lower image in figure 2. The lock pin positioning mechanism was deformed, but the lock pin remained partially engaged in the carrythrough tube.

Overall deformation, witness marks, and fracture patterns for the right wing attachments at the upper side of the fuselage were consistent with the wing bending upward relative to the fuselage with the lock pins and locking latch fully engaged.

**Figure 2.** Right side of the fuselage showing the forward (upper image) and aft (lower image) wing attachment locations. The forward attachment location was displaced aft and rotated clockwise approximately 90 degrees such that the upper side faced forward.

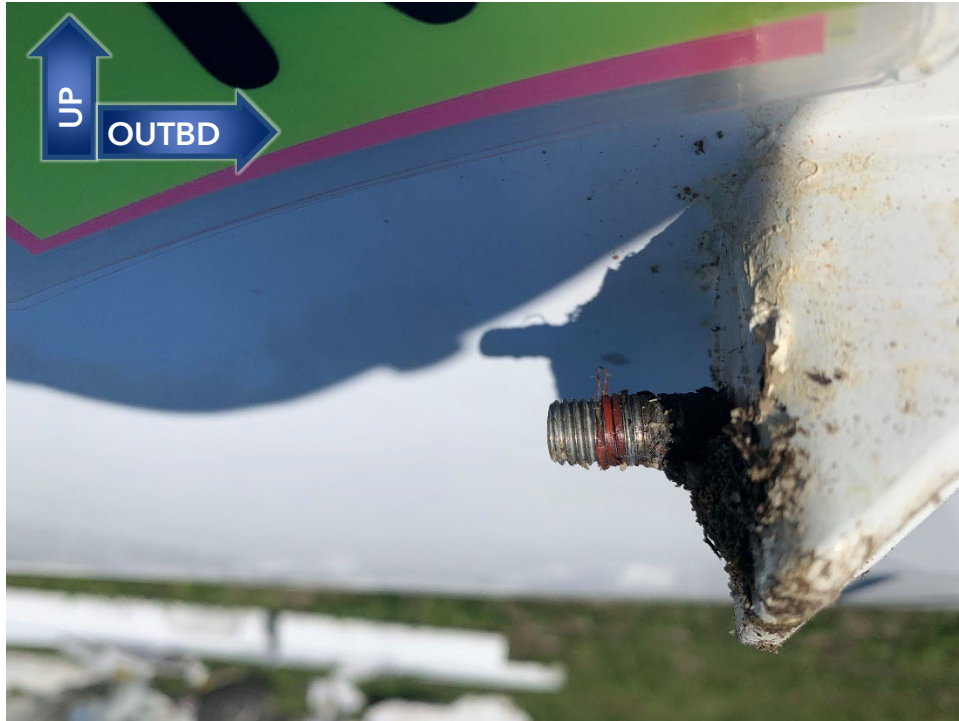
The right wing strut was recovered separated from the right wing and fuselage. The strut had separated at the joint at the outboard attachment location and was fractured at the inboard attachment location. At the outboard attachment location shown in figure 3, the attachment bolt was intact, and remnants of metal threads and the red nonmetallic insert from the self-locking nut were present on the bolt threads. The remainder of the nut and washer on the inboard side of the joint were missing. At the inboard end of the right wing strut, the strut was fractured adjacent to the fuselage attachment location as shown in figure 4. The fracture surfaces were on slant planes with deformation consistent with ductile overstress fracture under bending and torsion loads.

**Figure 3.** Right wing strut outboard attachment location as photographed on scene.

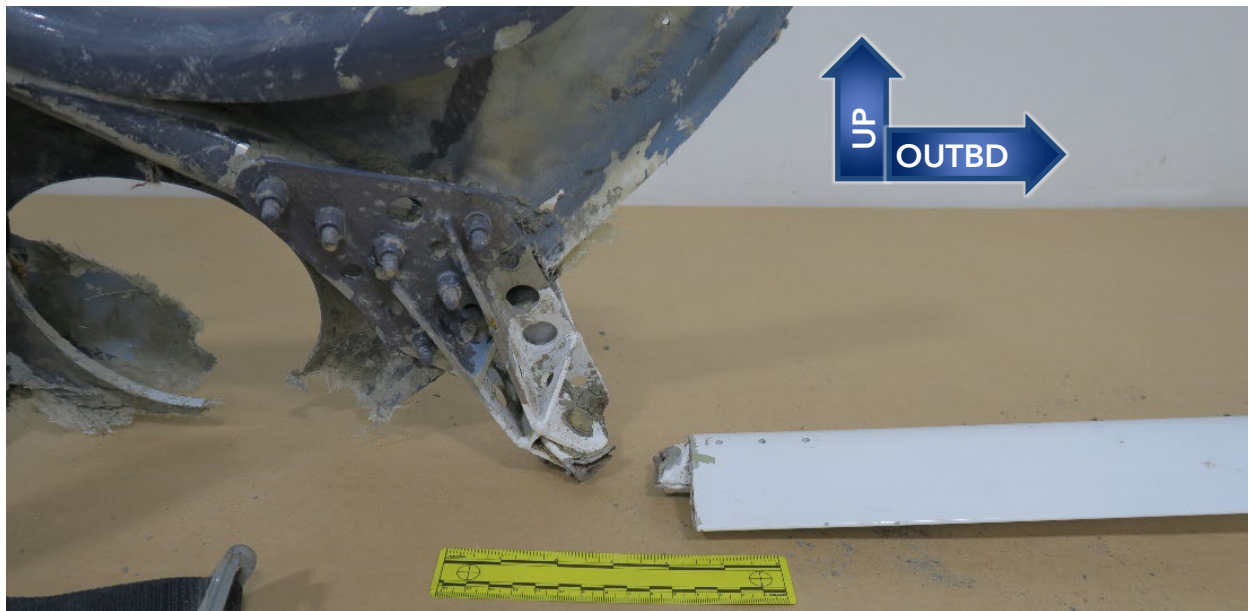
**Figure 4.** Right wing strut inboard attachment location.

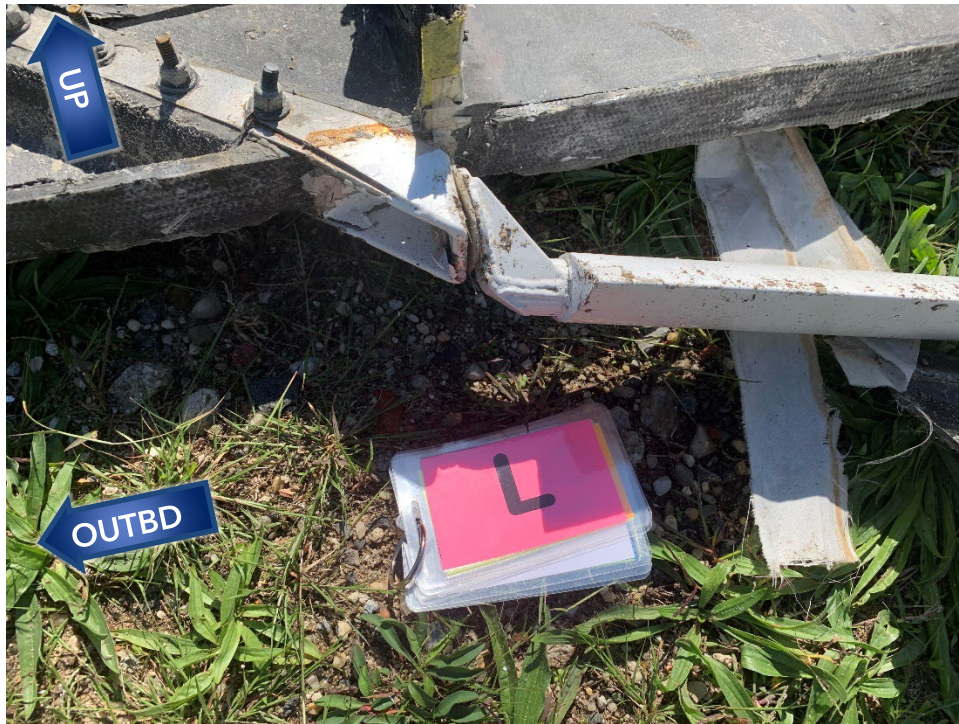
On the left wing, the strut remained intact and connected at both the inboard and outboard joints as shown in figures 5 and 6. The strut attachment hardware consisted of a bolted joint with a self-locking nut with a non-metallic insert. Metal washers were located under the bolt head and the nut clamping face and nonmetallic bushings were located between the faying surfaces of the joint.

**Figure 5.** Left wing strut outboard attachment location as photographed on scene.

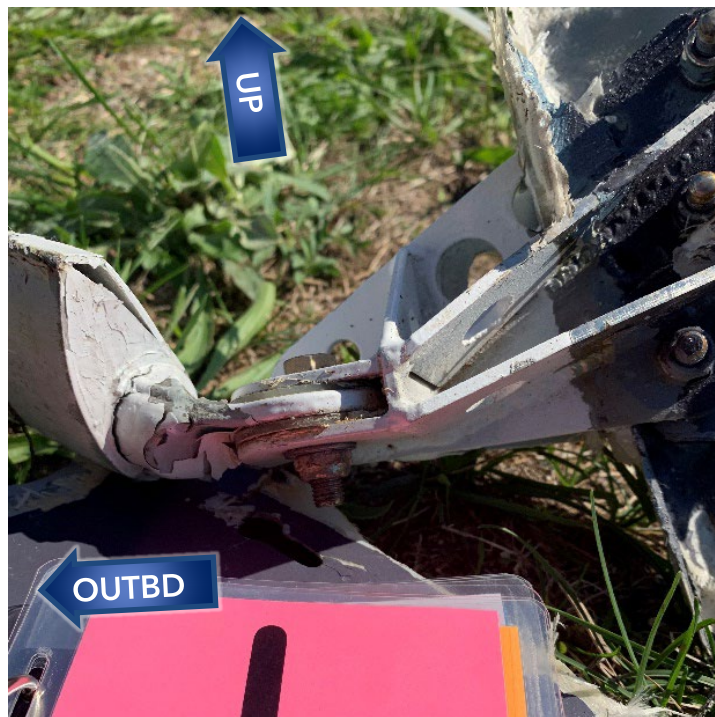
**Figure 6.** Left wing strut inboard attachment location as photographed on scene.

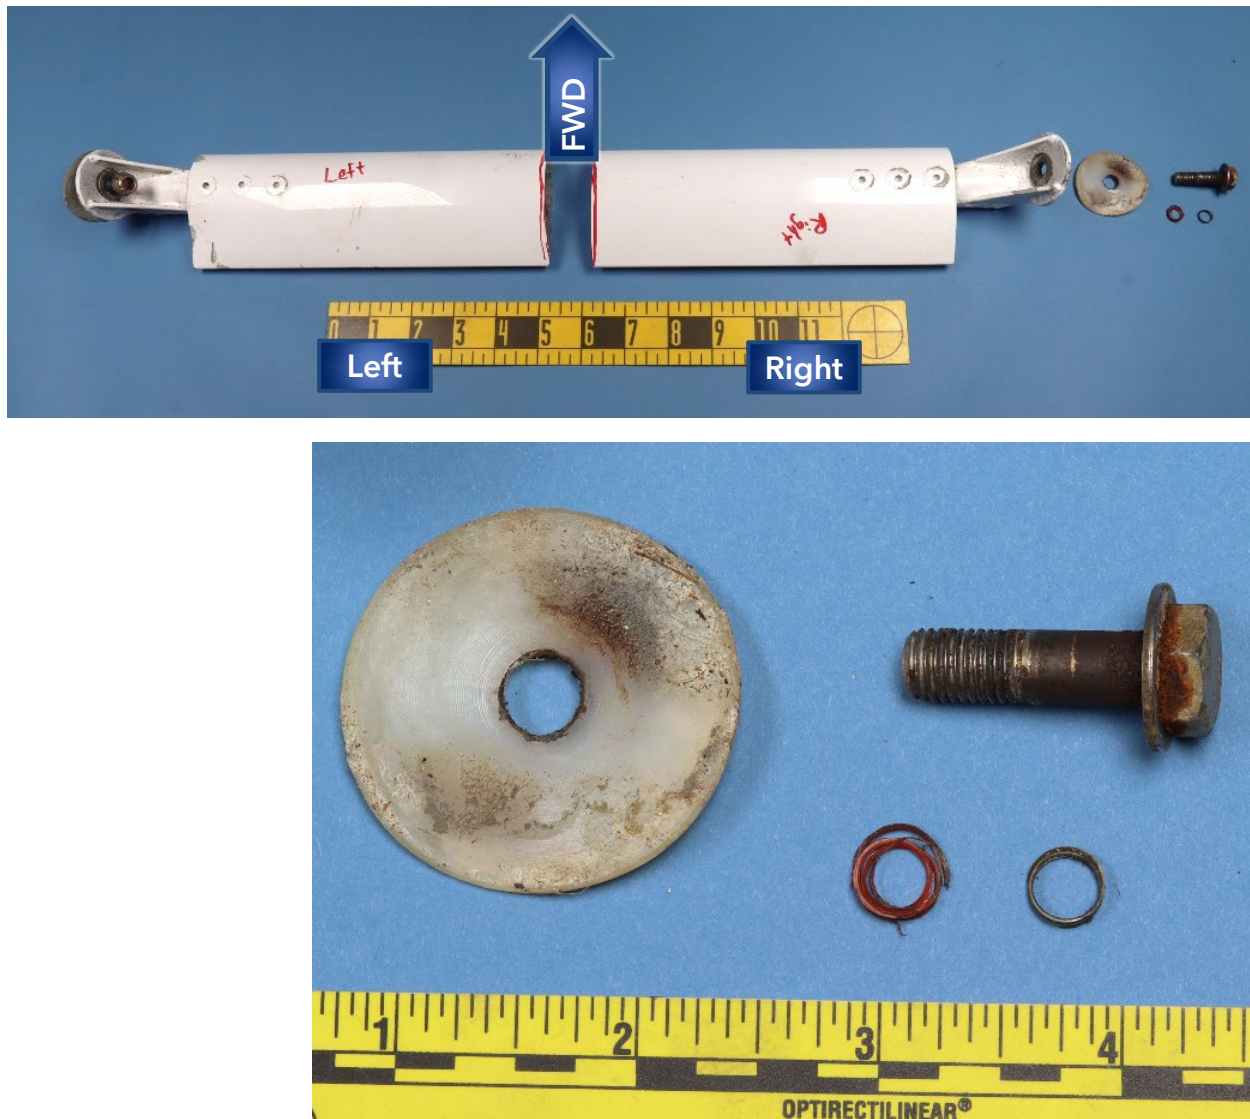
The bolt with the corresponding fractured nut thread and insert pieces (previously removed from the bolt) and the bushing from the outboard attachment for the right wing strut were initially received at the NTSB Materials Laboratory as shown in the lower image in figure 7. Following an additional examination of the wreckage at the salvage facility, the outboard ends of both struts and attachment hardware from the outboard end of the left wing strut were also collected for further examination. The total collection of parts as received at the NTSB Materials Laboratory are shown in the upper image in figure 7.

**Figure 7.** Outboard ends of the left and right wing struts with attachment hardware (upper image), and a closer view of the right wing strut outboard attachment hardware (lower image) as received for examination.

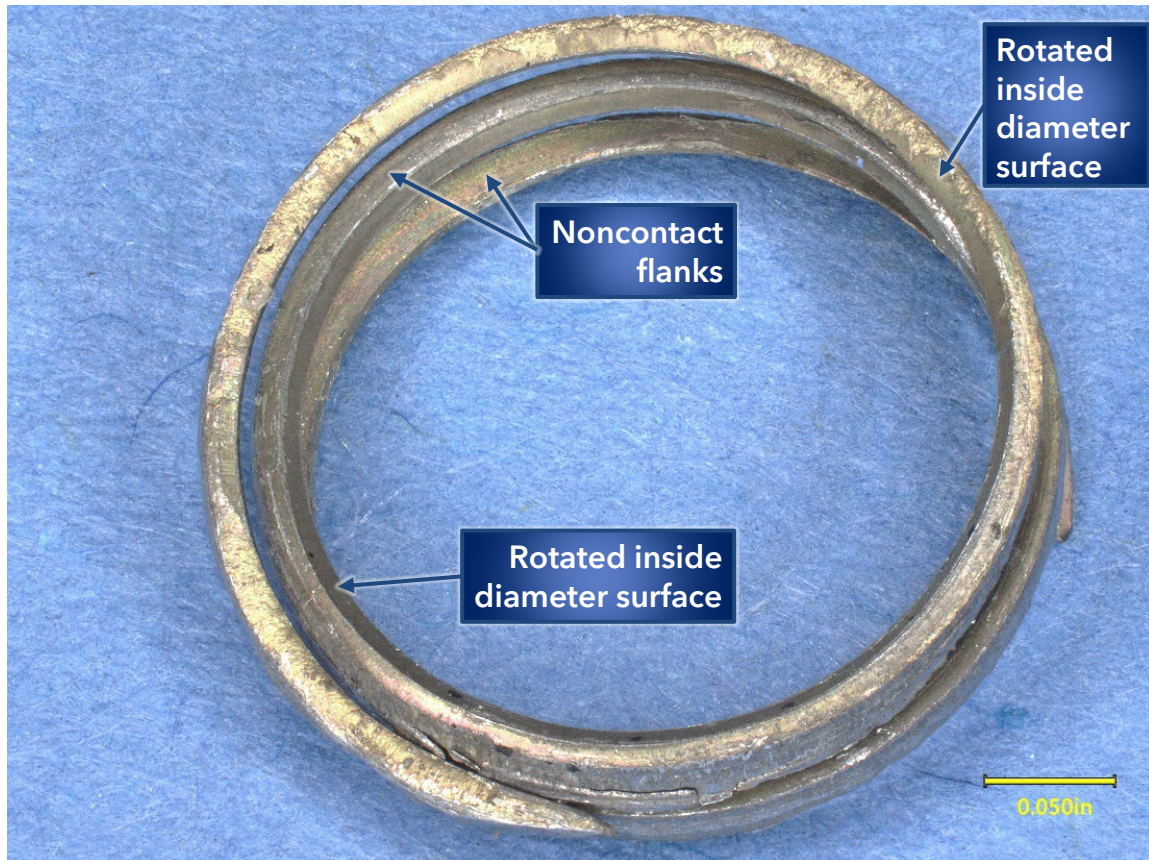
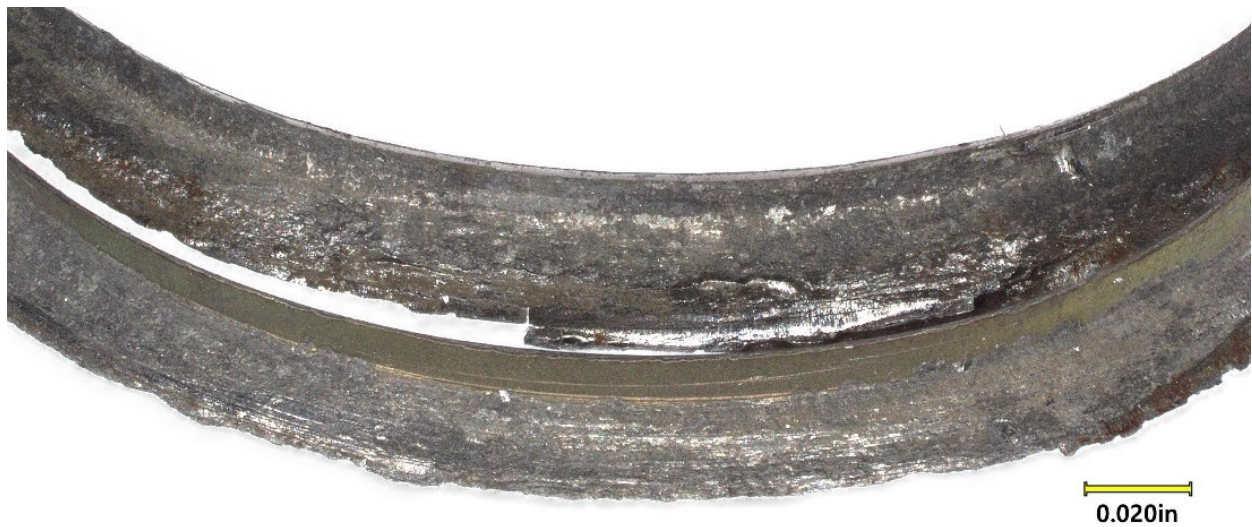
An overall view of the nut thread piece that was removed from the right wing strut outboard attachment bolt is shown in the upper image in figure 8, where the noncontact side of the nut threads is shown. The orientation of the threads relative to contact with the bolt threads was evident by contact patterns on the opposing thread flanks and by deformation in the thread fracture surfaces around the outside circumference. The thread piece consisted of between 2 to 3 threads as shown in figure 8. The threads closest to the clamping face were deformed such that the surface at the inside diameter rotated toward the clamping face. The thread closest to the clamping face had secondary fractures where pieces of the rotated inside diameter surface were fractured away.

A close view of the contact flanks of two of the threads is shown in the lower image in figure 8. The contact faces had a battered appearance with rounded pits and deformed metal shavings, features consistent with repeated contact loading.

**Figure 8.** Fractured threads from the right wing strut outboard attachment nut after cleaning (upper image) as viewed looking at the bolt thread noncontact flanks of the nut threads. The lower image shows a close view of the bolt thread contact flanks on the nut thread piece with rough features consistent with repeated contact loading.

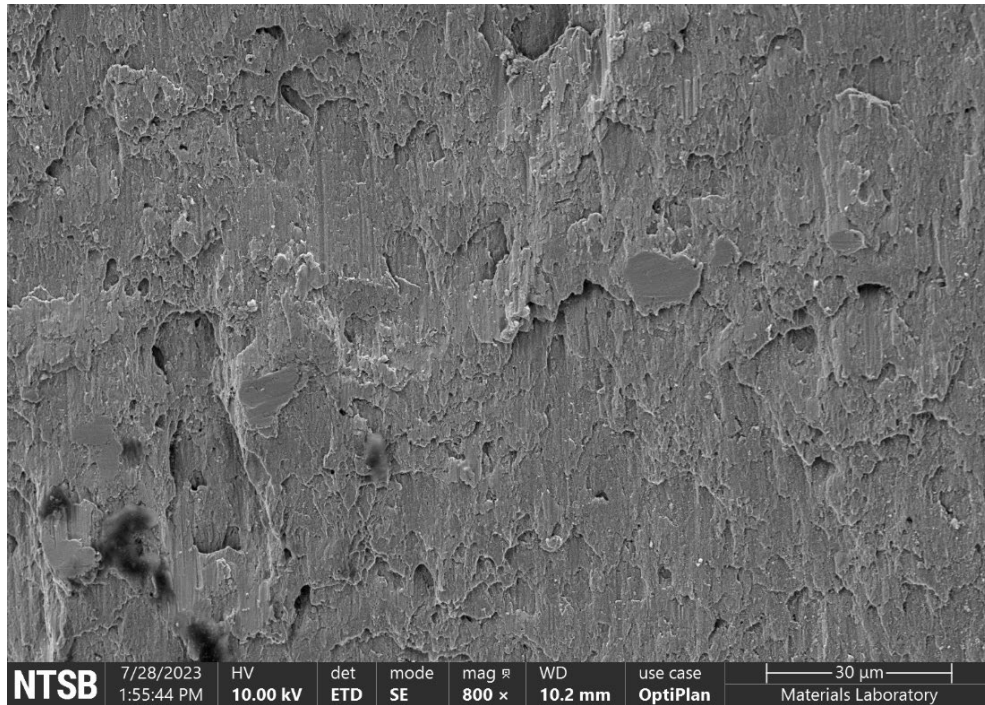
The fracture surfaces around the perimeter were examined using a scanning electron microscope (SEM). The surfaces showed many areas of smearing that obliterated fracture features and other areas where elongated dimple features were observed consistent with ductile overstress fracture in a plane of shear stress. An SEM image of typical fracture features is shown in figure 9.

**Figure 9.** SEM image of typical fracture features for the nut threads showing elongated dimple features consistent with ductile overstress fracture in a plane of shear stress.

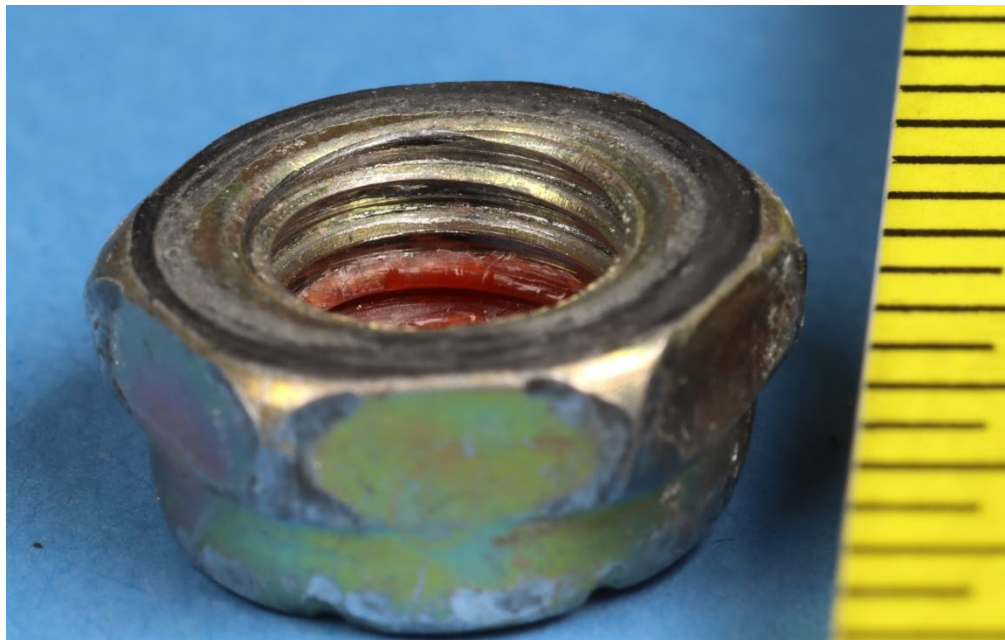
The nut from the left strut outboard attachment location is shown in figure 10. The nut had 2 to 3 threads between the clamping face and the red nonmetallic locking insert. A closer view of the threads is shown in figure 11. The two threads closest to the clamping face were deformed and twisted with the inside diameter face rotated toward the clamping face. The threads were also partially fractured and displaced axially toward the clamping face. The bolt thread contact flanks as viewed from the other end of the nut are shown in figure 12. The contact flanks had a battered appearance with rounded pits and metal shavings consistent with repeated contact loading.

The axial height of the nut as measured using calipers was 0.250 inch, which is the maximum height listed for an AN364-524 nut. The corresponding steel nut with a non-metallic insert, MS21083N5, has a specified height range of 0.235 inch to 0.266 inch.

A flat on one side of the nut was coarse-ground flat while the opposite flat was polished to a 1200-grit finish, and hardness was measured on the polished surface using a Rockwell hardness indenter. The average hardness measured from 3 indentations was 73.0 HR30TW, which corresponds to an estimated tensile strength of 83,000 psi. According to the MS21083 standard, steel nuts should have a minimum yield strength of 70,000 psi.

**Figure 10.** Macro photograph of the nut for the left wing strut outboard attachment showing 2 to 3 threads next to the red insert.

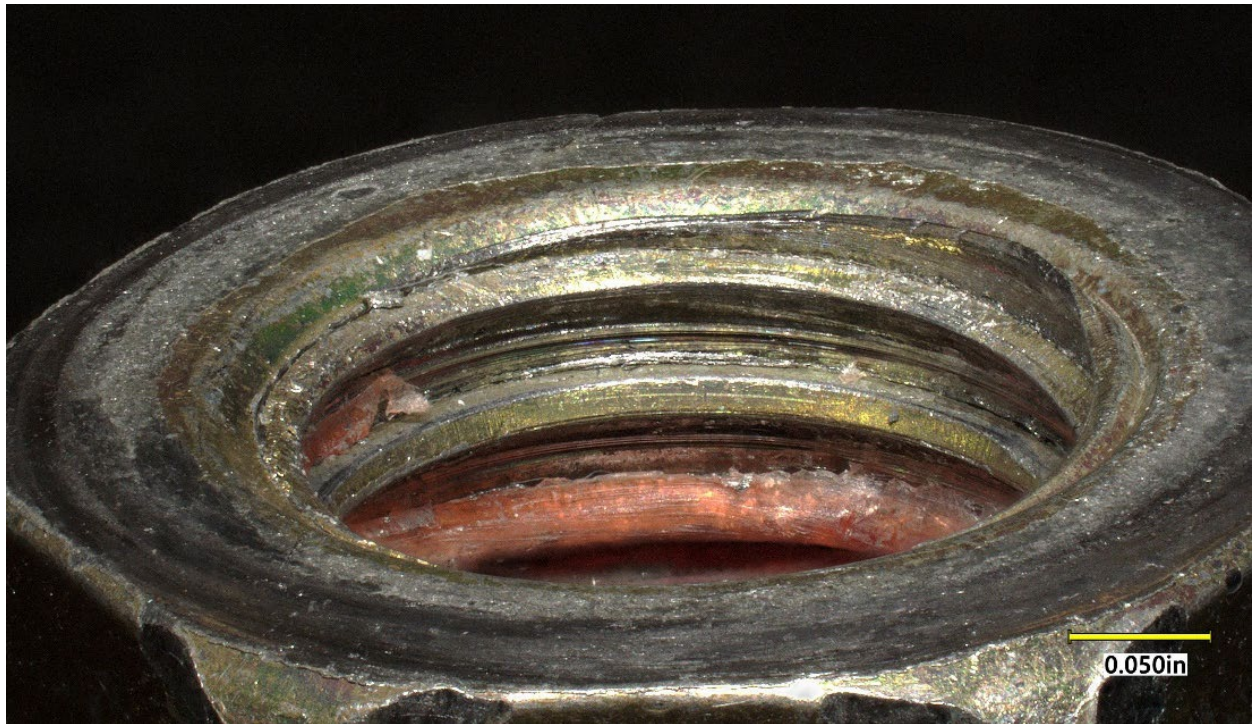
**Figure 11.** Optical image of the nut for the left wing strut outboard attachment location showing rolled, partially fractured, and displaced threads.

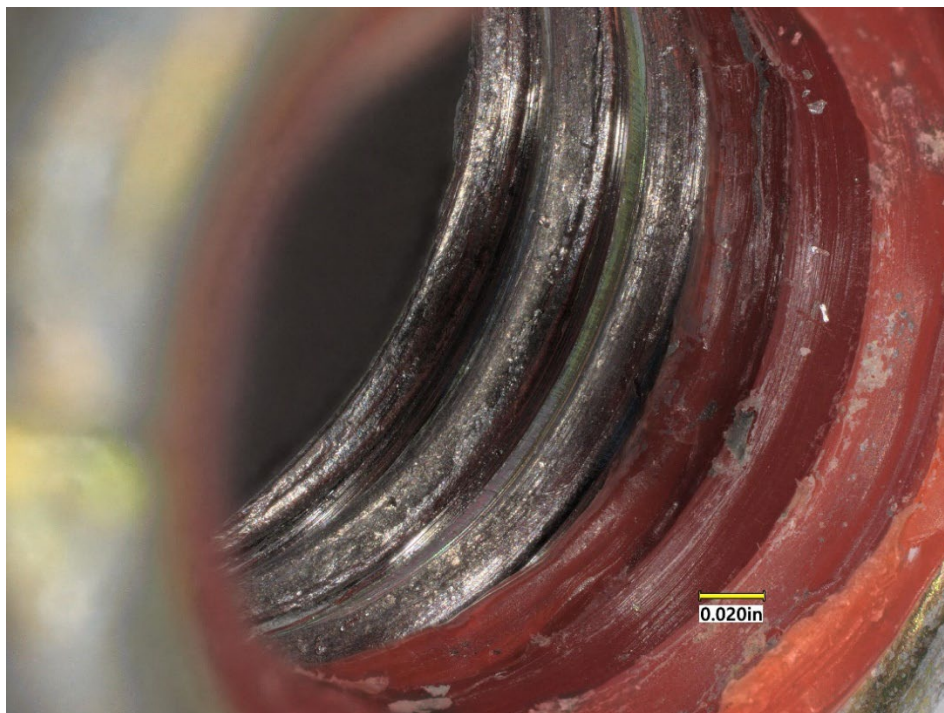
**Figure 12.** Optical image of the nut for the left wing strut outboard attachment location showing rough features on the bolt thread contact flanks consistent with repeated contact loading.
