# National Transportation Safety Board

ERA23FA007

## **WRECKAGE EXAMINATION SUMMARY**

Location: East Hampton, New York  
Date: October 6, 2022  
Time: 1229 EDT  
1629 UTC  
Airplane: Seamax M-22, N46PD

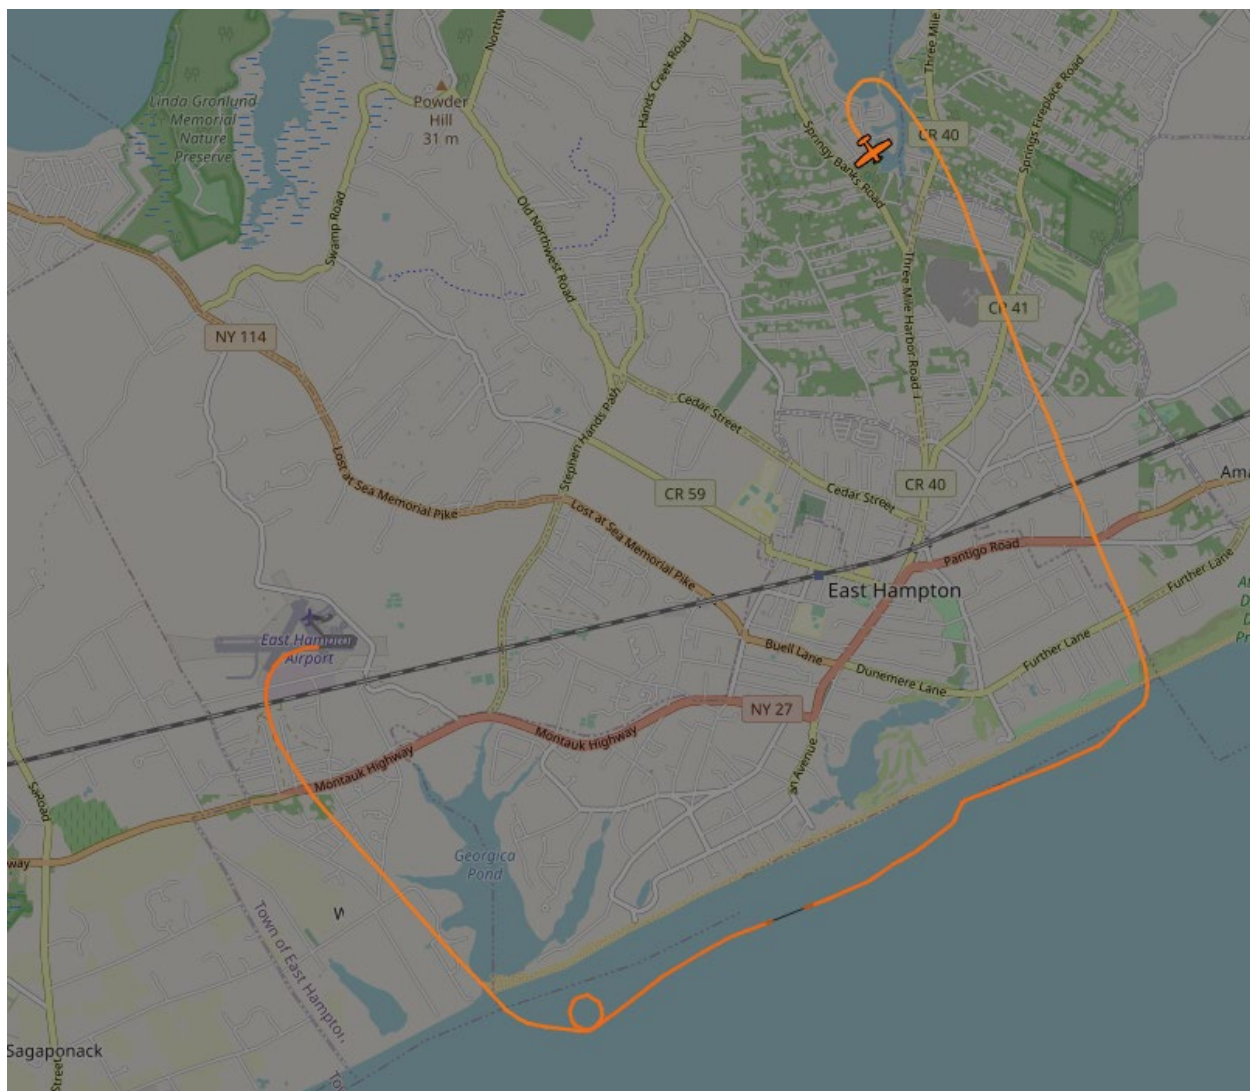
Figure 1 - ADS-B Track - track in orange

According to preliminary ADS-B data, the flight prior to the accident flight occurred on Wednesday, September 30, 2022, which aligns with what the owner of the airplane stated. He flew the airplane on September 30<sup>th</sup>.

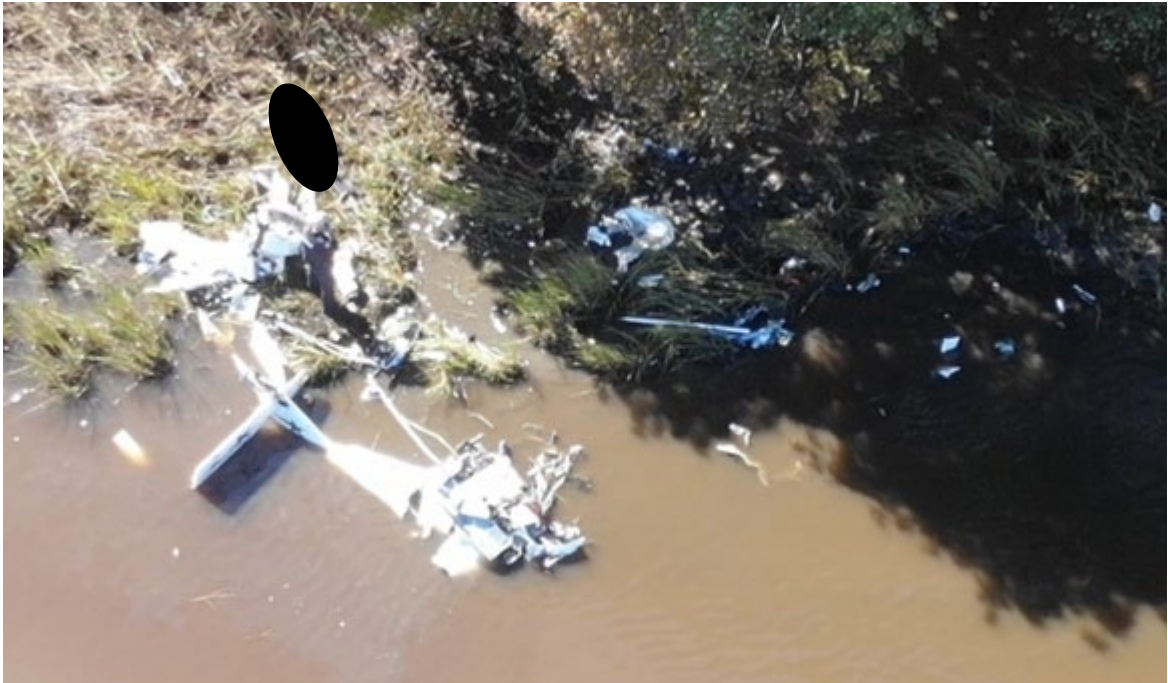
**Figure 2 - Main Accident Site taken from local law enforcement UAS Video.**

The airplane came to rest in about 3-4 feet of water in the Three Mile Harbor. The right wing came to rest in a tree that was about 770 ft from the main wreckage.

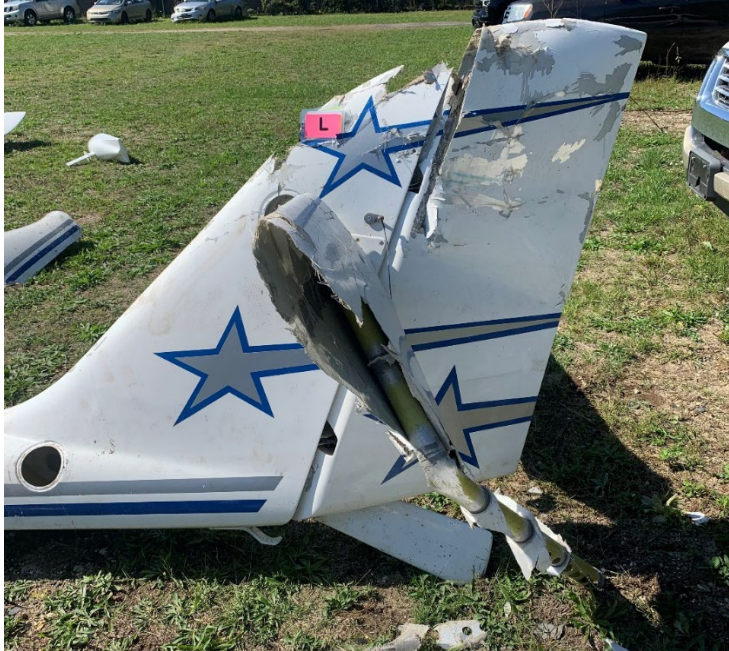
tab remained attached to the outboard section of the left stabilator. The rudder remained attached to the vertical stabilizer and exhibited impact damage. The top section of the vertical stabilizer exhibited impact damage. The beacon remained attached to the vertical stabilizer by wires.

**Figure 3. View of vertical stabilizer and rudder.**

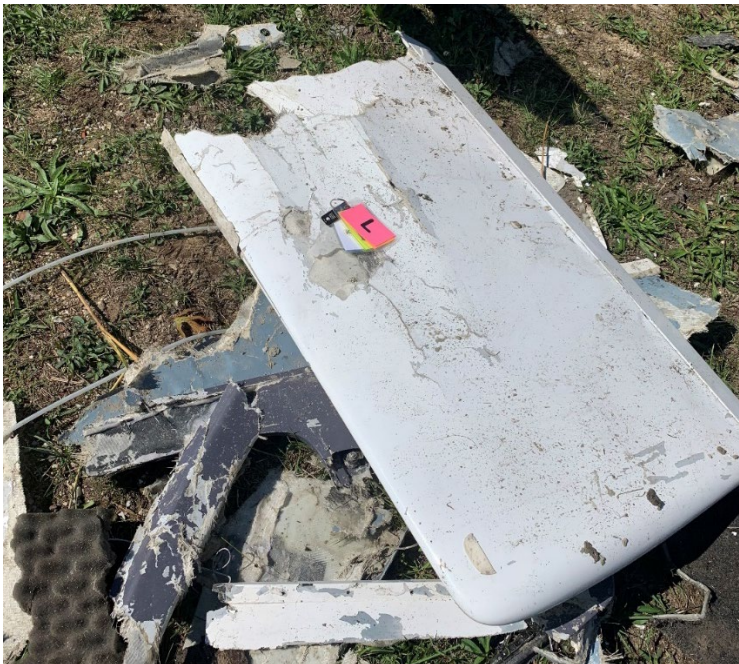
The empennage was impact separated from the fuselage. The right stabilator remained attached to the empennage and exhibited leading edge damage. The right trim tab remained attached to the right stabilator. The inboard section of the left stabilator remained attached to the empennage. The outboard section was impact separated and located in the vicinity of the main wreckage. The left trim

**Figure 4. View of left horizontal stabilizer.**

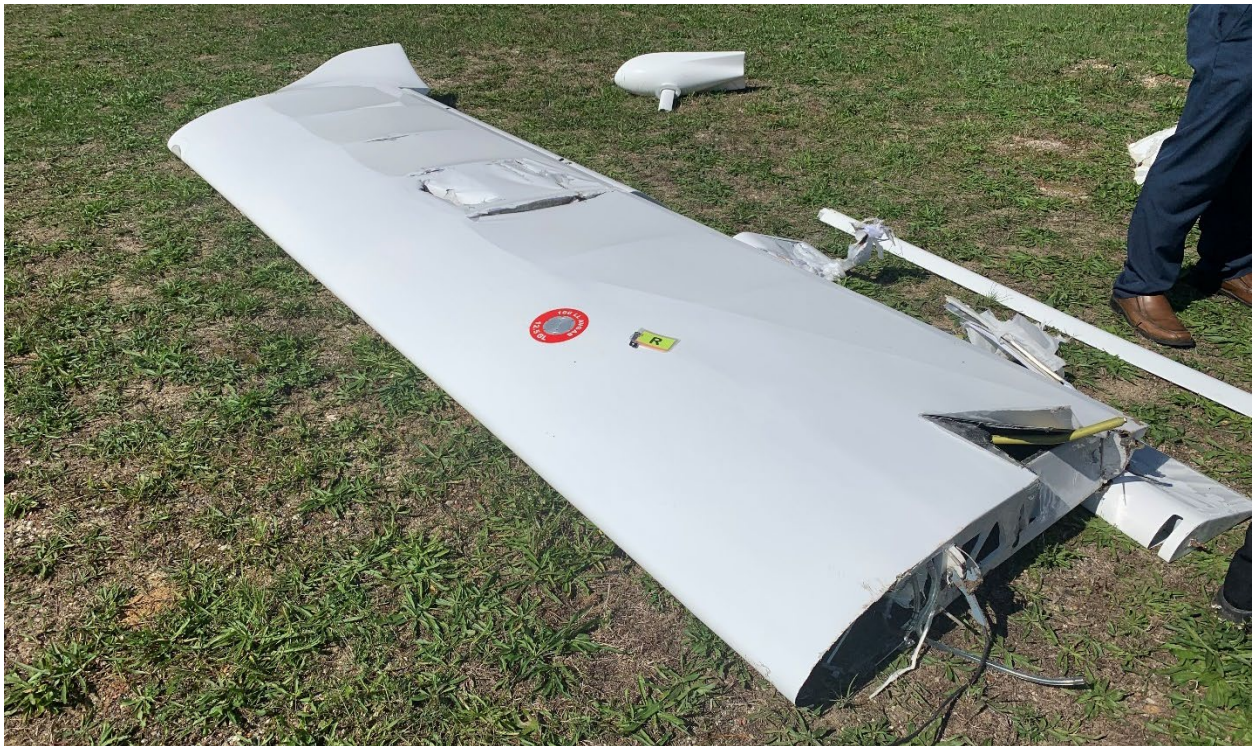
The entire right wing was separated from the main wreckage and located in a tree. The right aileron remained attached to the right wing. The right flap was separated from the right wing and located in the vicinity of the right wing. The right wing strut was separated from the right wing. The bolt attaching the right strut to the right wing remained attached to the right wing and was not fractured. In addition, the bolt threads did not exhibit significant damage.

**Figure 5. View of Top of Right Wing**

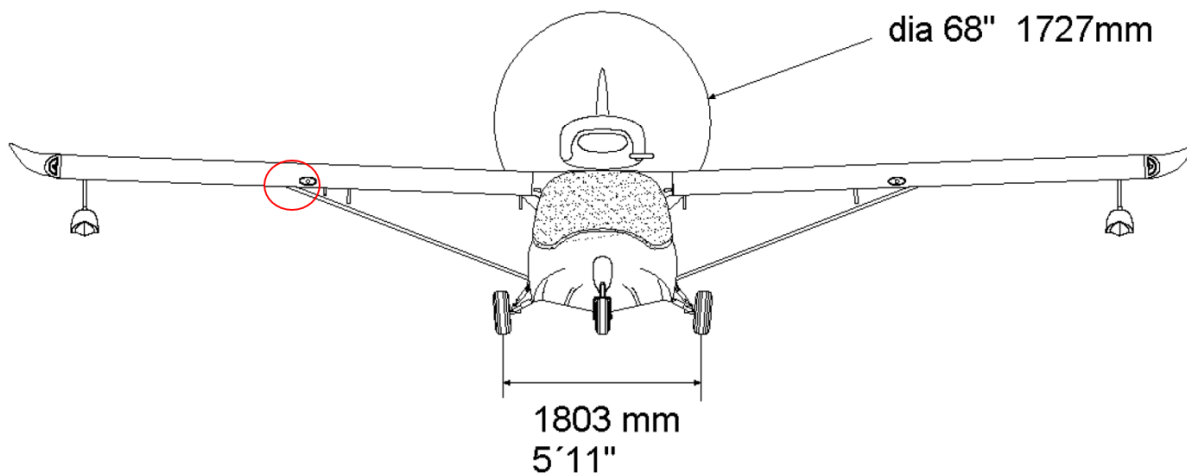
**Figure 6. Front view drawing of airplane. Red circle notes where the bolt remained in place without a nut.**

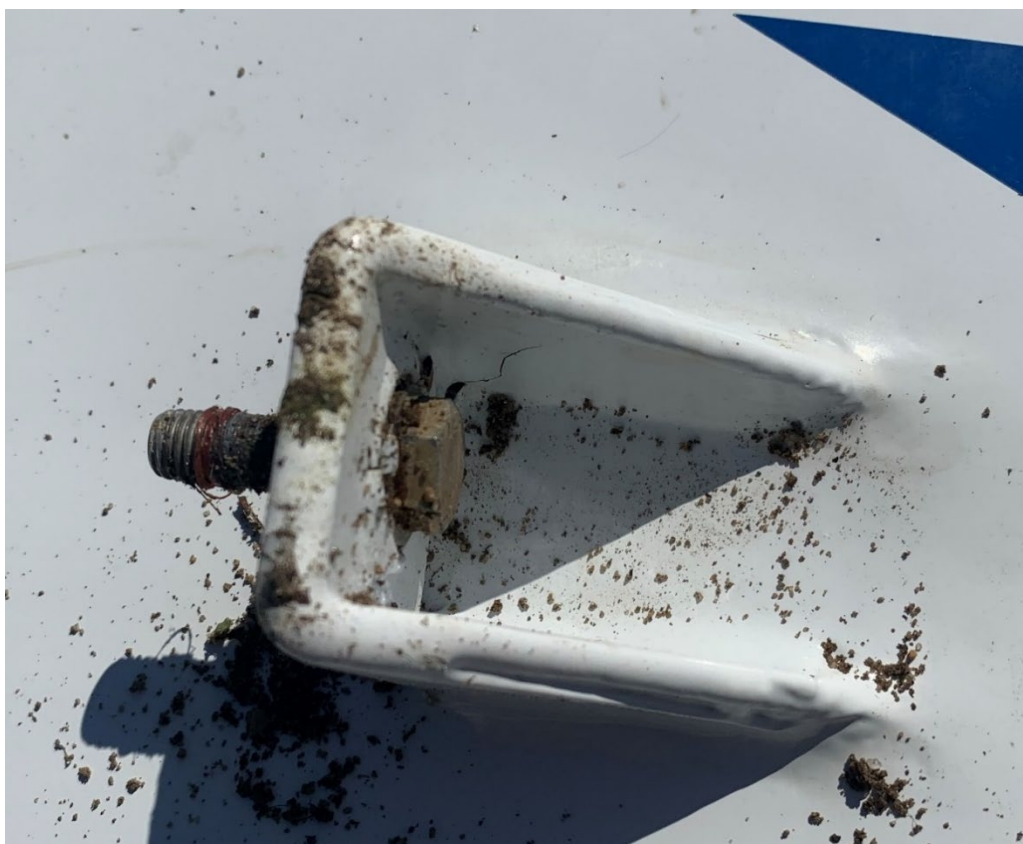
**Figure 7. View of right wing strut attachment bolt as found.**

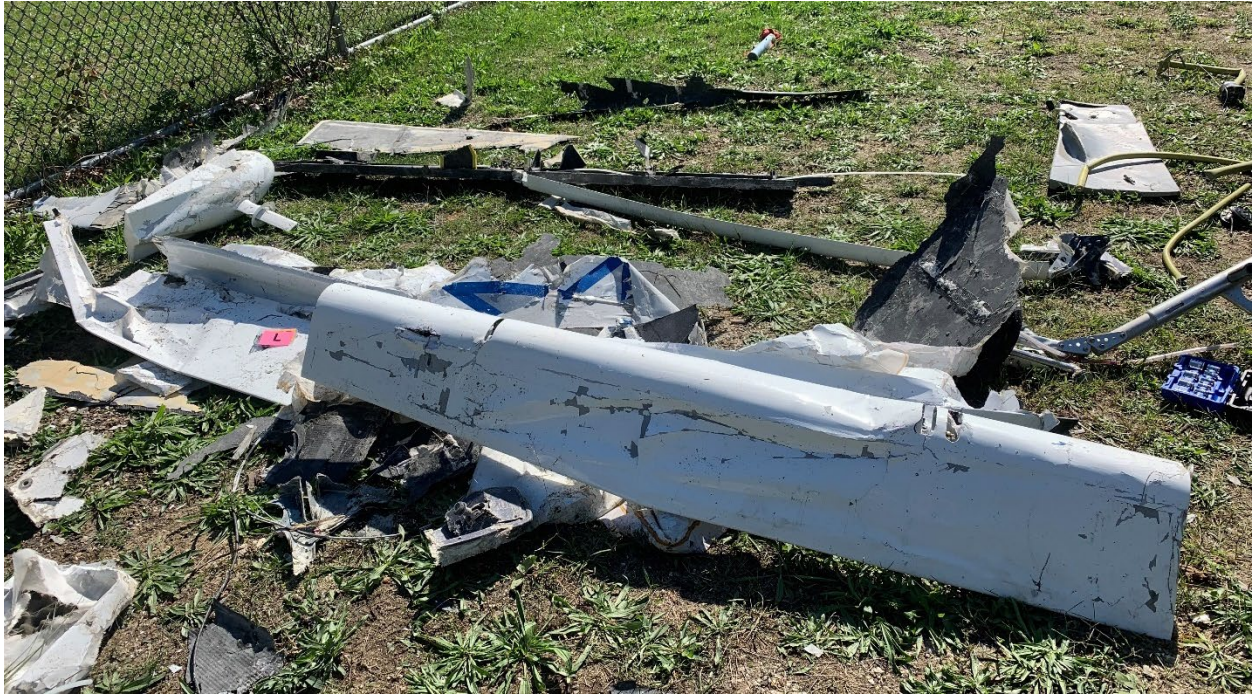
The left wing was impact separated and located in the vicinity of the main wreckage. The left wing was fragmented, but the left aileron, left flap, and left wing tip were located. The left wing strut was impact separated from the wing and the strut attach point bolts remained secure with the nut. The bolt that attached to the wing was removed, examined, and replaced/secured to the strut. The wing strut attachment side to the fuselage remained secured, but the section was pulled/torn away from the fuselage.

**Figure 8. View of Left Wing**

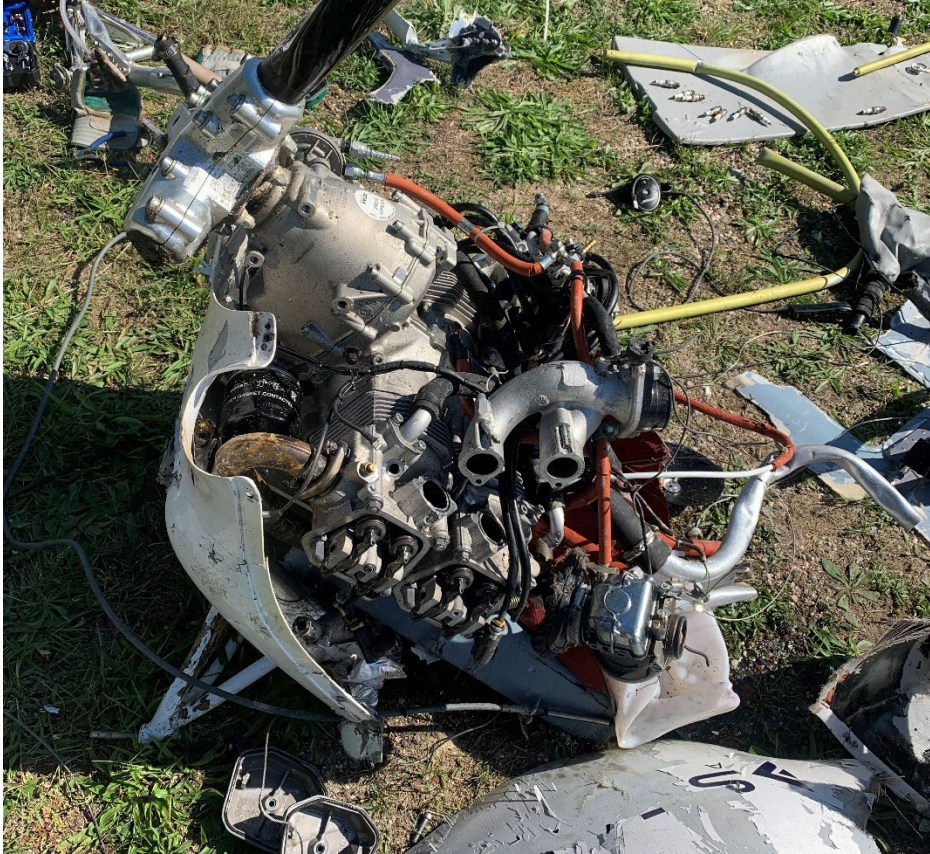
**Figure 9. View of Engine**

The engine was impact separated from the fuselage but remained attached to the engine mounts. There were no holes in the crankcase. All 4 cylinders remained attached to the engine. The carburetors were impact separated from the engine but remained attached through fuel lines. The Both carburetor butterflies could be operated by hand. The spark plugs were removed and examined. All were light grey in color and exhibited minimal wear. The rocker box covers were removed and there were no anomalies noted with the rocker arms or valve springs.

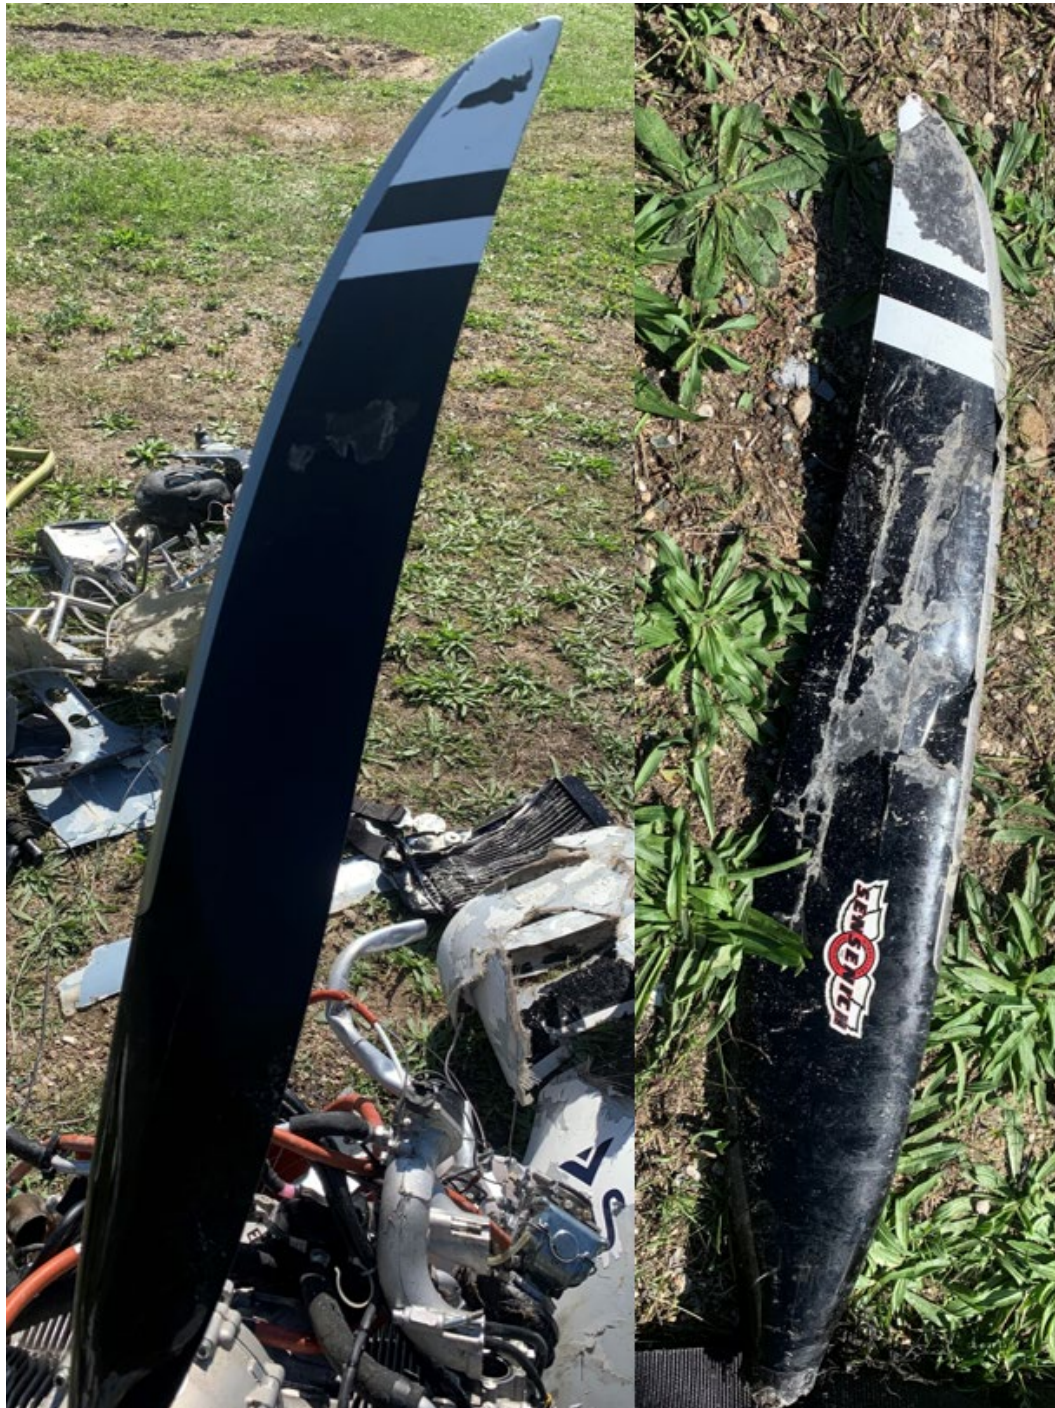
The propeller remained attached to the engine. One propeller blade remained attached to the propeller hub. It exhibited chordwise scratching and leading-edge gouging. Another blade was separated from the propeller hub, but was located in

the vicinity of the main wreckage. It exhibited chordwise scratching. The other propeller blade was not recovered.

**Figure 10. Propeller Blades**
