# National Transportation Safety Board

ERA23FA023

## **WRECKAGE EXAMINATION**

Aircraft: Amateur Built Aventura II

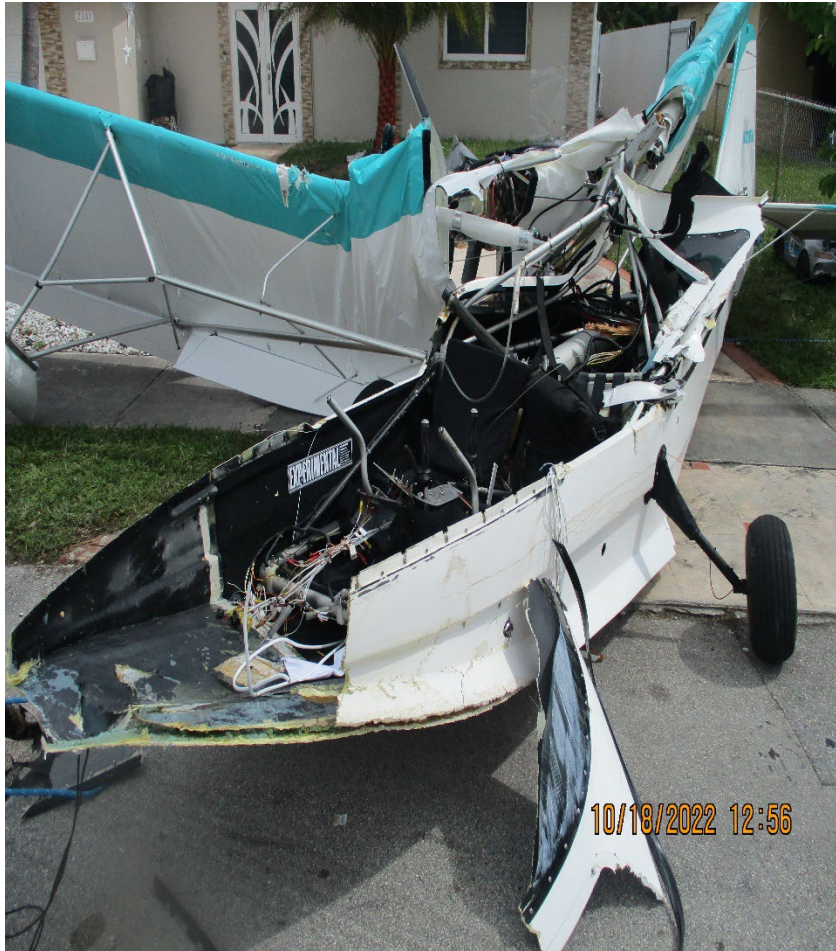
Recovered Aircraft Wreckage

The aircraft came to rest alongside a residential home. The fuselage remained intact, with structural damage observed in the cockpit area. Both wings were separated from the airframe and exhibited impact damage. The engine remained partially attached to the airframe via the engine mounts.
