# National Transportation Safety Board

ERA23FA025

## **MATERIALS LABORATORY**

Factual Report 23-066

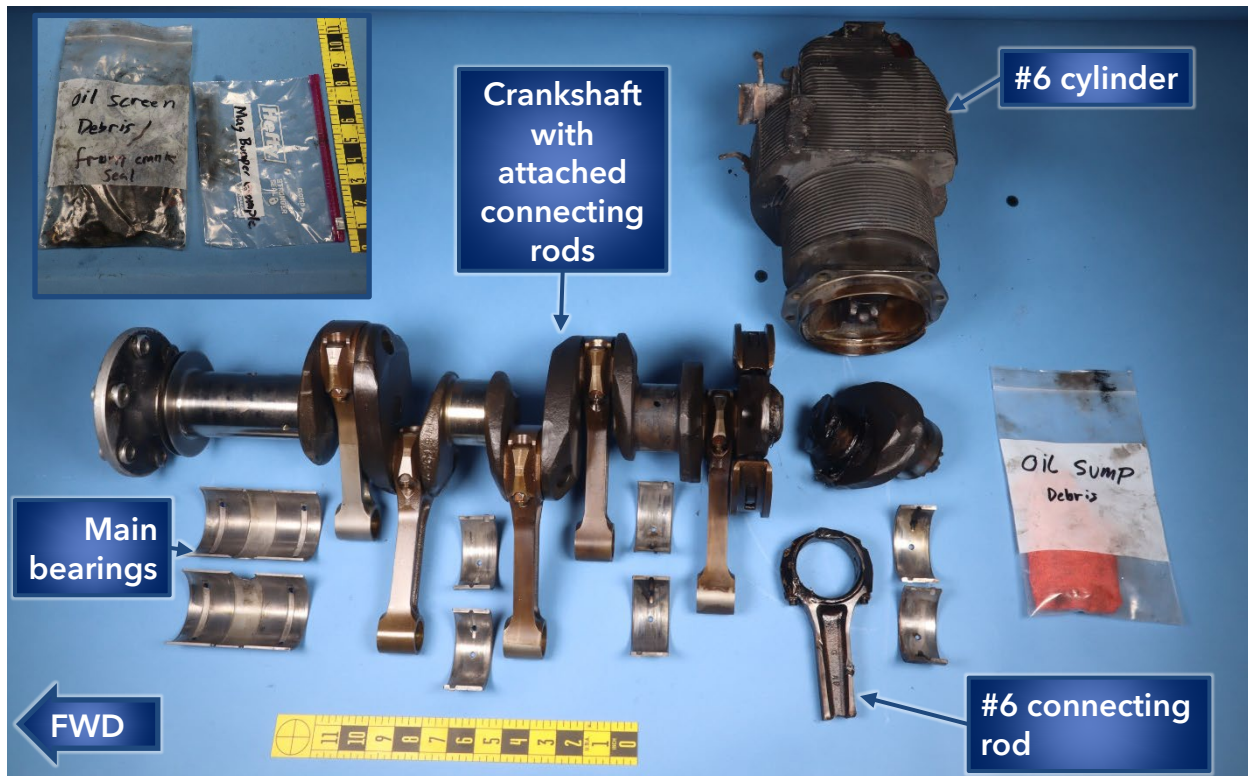
An overall view of the submitted components from the Lycoming Engines model IO-540-K1A5 engine is shown in figure 1. The crankshaft was fractured through the number 6 connecting rod journal adjacent to the forward cheek as shown in figure 2. The number 6 connecting rod was fractured in the beam section near the small end. The big end of the number 6 connecting rod was separated from the crankshaft but remained intact. The remaining connecting rods were intact and were attached to the crankshaft, rotating freely on their respective journals. The

number 6 cylinder assembly was damaged at the barrel skirt, and the number 6 piston assembly was trapped within the cylinder barrel. The submitted components also included the main bearings and bags of assorted debris from the oil sump and the oil screen. A bag containing exemplar magneto bumpers was also included with the bag of oil screen debris as shown in the inset image in figure 1.

**Figure 1.** Overall view of the submitted engine components and bag of oil sump debris with an inset image of the bagged oil screen debris, front seal, and intact magneto bumpers as received.

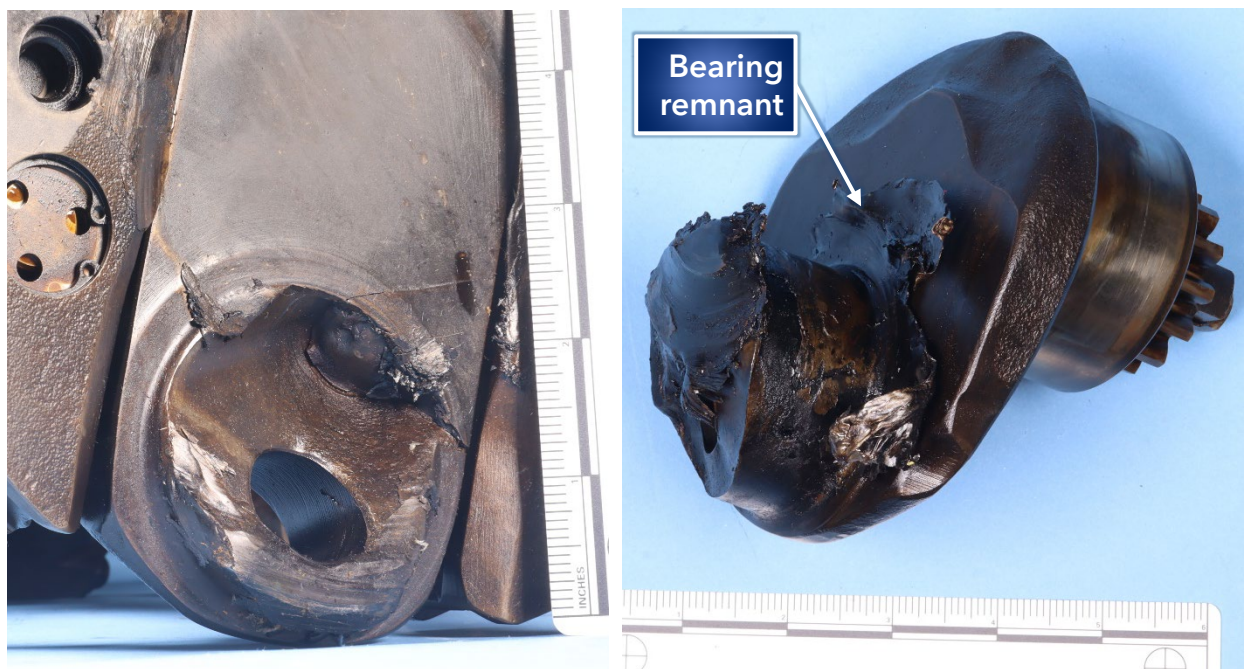
The crankshaft fracture shown in figure 2 was relatively smooth with curving crack arrest lines, features consistent with fatigue. The fracture features emanated from an origin area in the fillet radius between the journal and the cheek at the forward end of the journal. The origin area on the aft side of the fracture was obliterated by post-fracture contact, so additional examination of the fracture surface focused on the forward side of the fracture shown in the left image in figure 2.

**Figure 2.** Mating sides of the crankshaft fracture at the number 6 connecting rod journal forward cheek showing the forward side in the left image and the aft side in the right image.

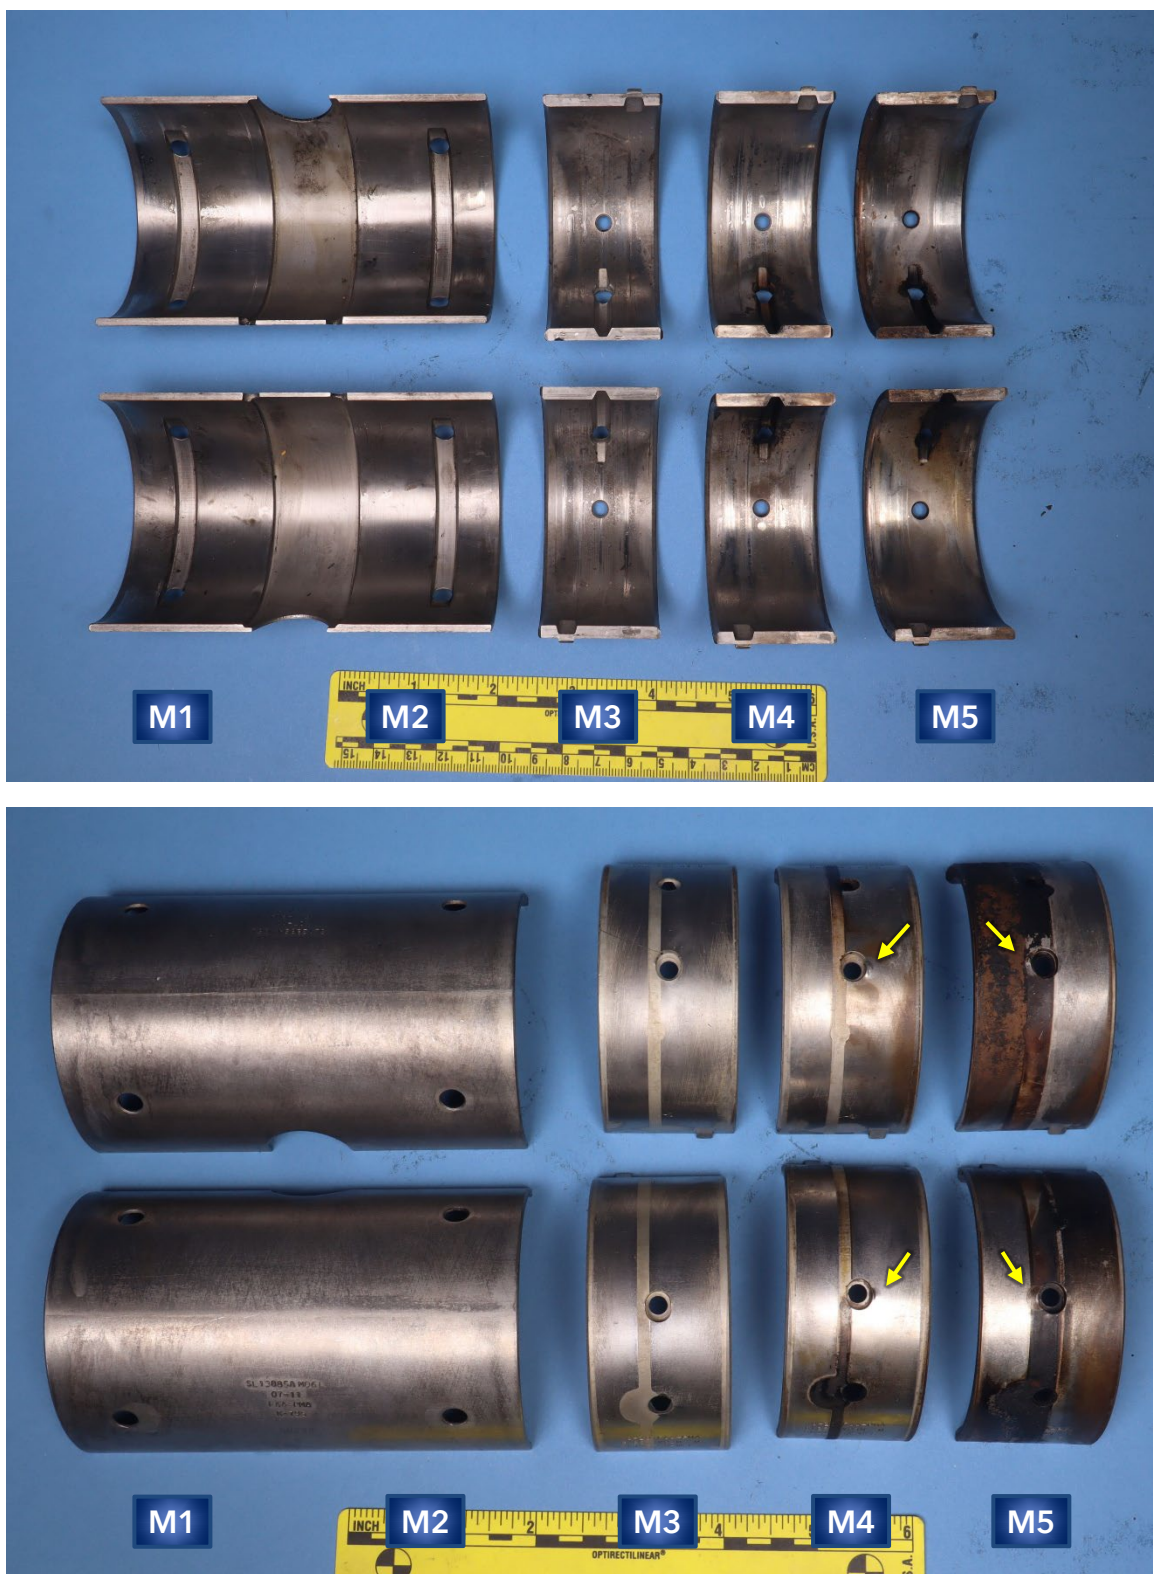
The interior and exterior surfaces of the main bearings are shown in figure 3 labeled M1 through M5. The bearings were marked as Federal Aviation Administration (FAA) parts manufacturer approval (PMA) bearings with a part number that was consistent with the accident engine using a crankshaft with 0.006-inch undersize main journal diameters. The Babbitt material on the interior surfaces of the bearings was intact with isolated debris and circumferential drag marks (comet tails). Coked oil deposits were present on the engine case contact surfaces on the back face of bearing M5 and on the oil channel surfaces on the back face of bearing M4. The edges of the oil channel holes were deformed on bearings M4 and M5 as indicated with arrows in the lower image in figure 3 consistent with contact with corresponding dowels in the engine case. The deformation was located at the aft sides of the holes on bearing M4 and the forward sides of the holes in bearing M5.

**Figure 3.** Views of the main bearing interior (upper image) and exterior (lower image) surfaces. Arrows in the lower image indicates elongation at the edges of the oil supply holes.

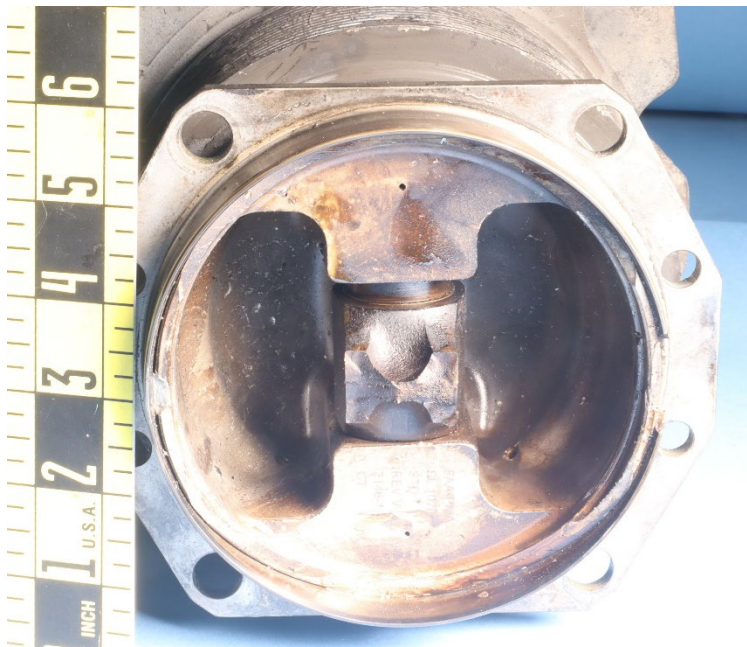
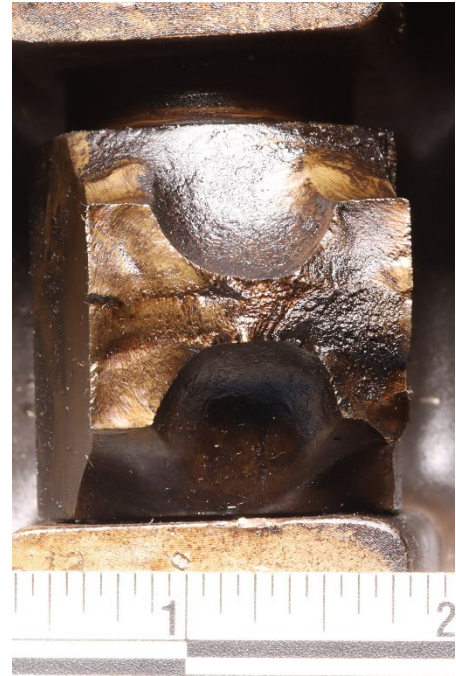
A view of the number 6 piston assembly as received within the cylinder barrel is shown in figure 4. The small end of the fractured number 6 connecting rod was attached to the piston pin, and a closer view of the fracture surface is shown in the right image in figure 4. The fracture surface had smeared features and deformed lips at the edges of the fracture surface consistent with ductile overstress fracture with bending and twisting loads.

**Figure 4.** Lower end of the number 6 cylinder assembly (left image) with a trapped piston assembly and fractured connecting rod. The right image shows a closer view of the fracture surface on the number 6 connecting rod.

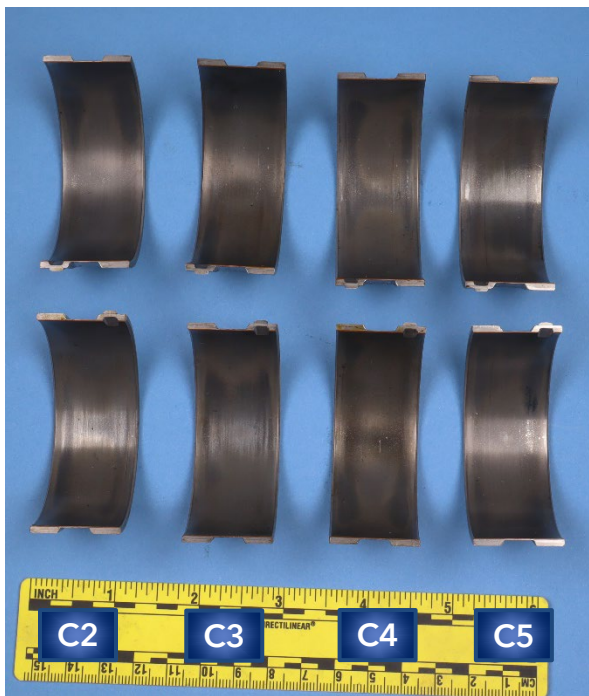
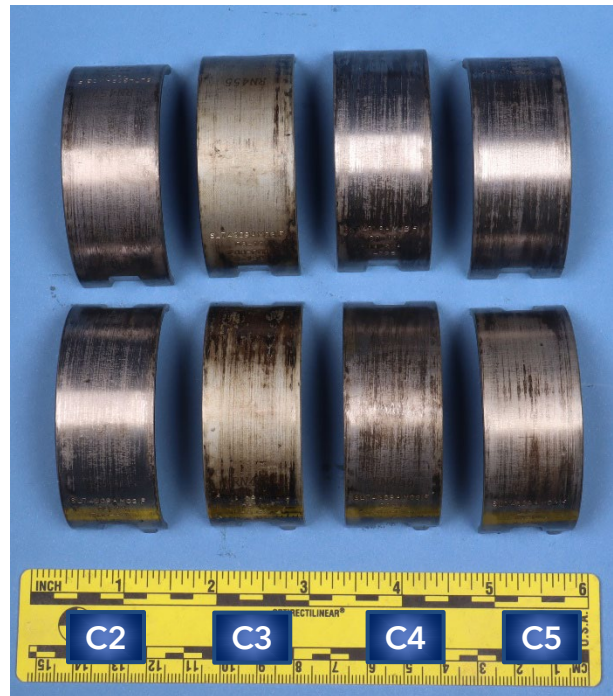
As shown in figure 5, the Babbitt material on the interior surfaces of bearings C2 through C5 was intact with isolated debris and comet trails. The back faces mostly had a shiny appearance consistent with light rub. The anti-rotation tabs on the bearings were intact.

**Figure 5.** Interior (left image) and exterior (right image) surfaces of the number 2 through 5 connecting rod bearings.

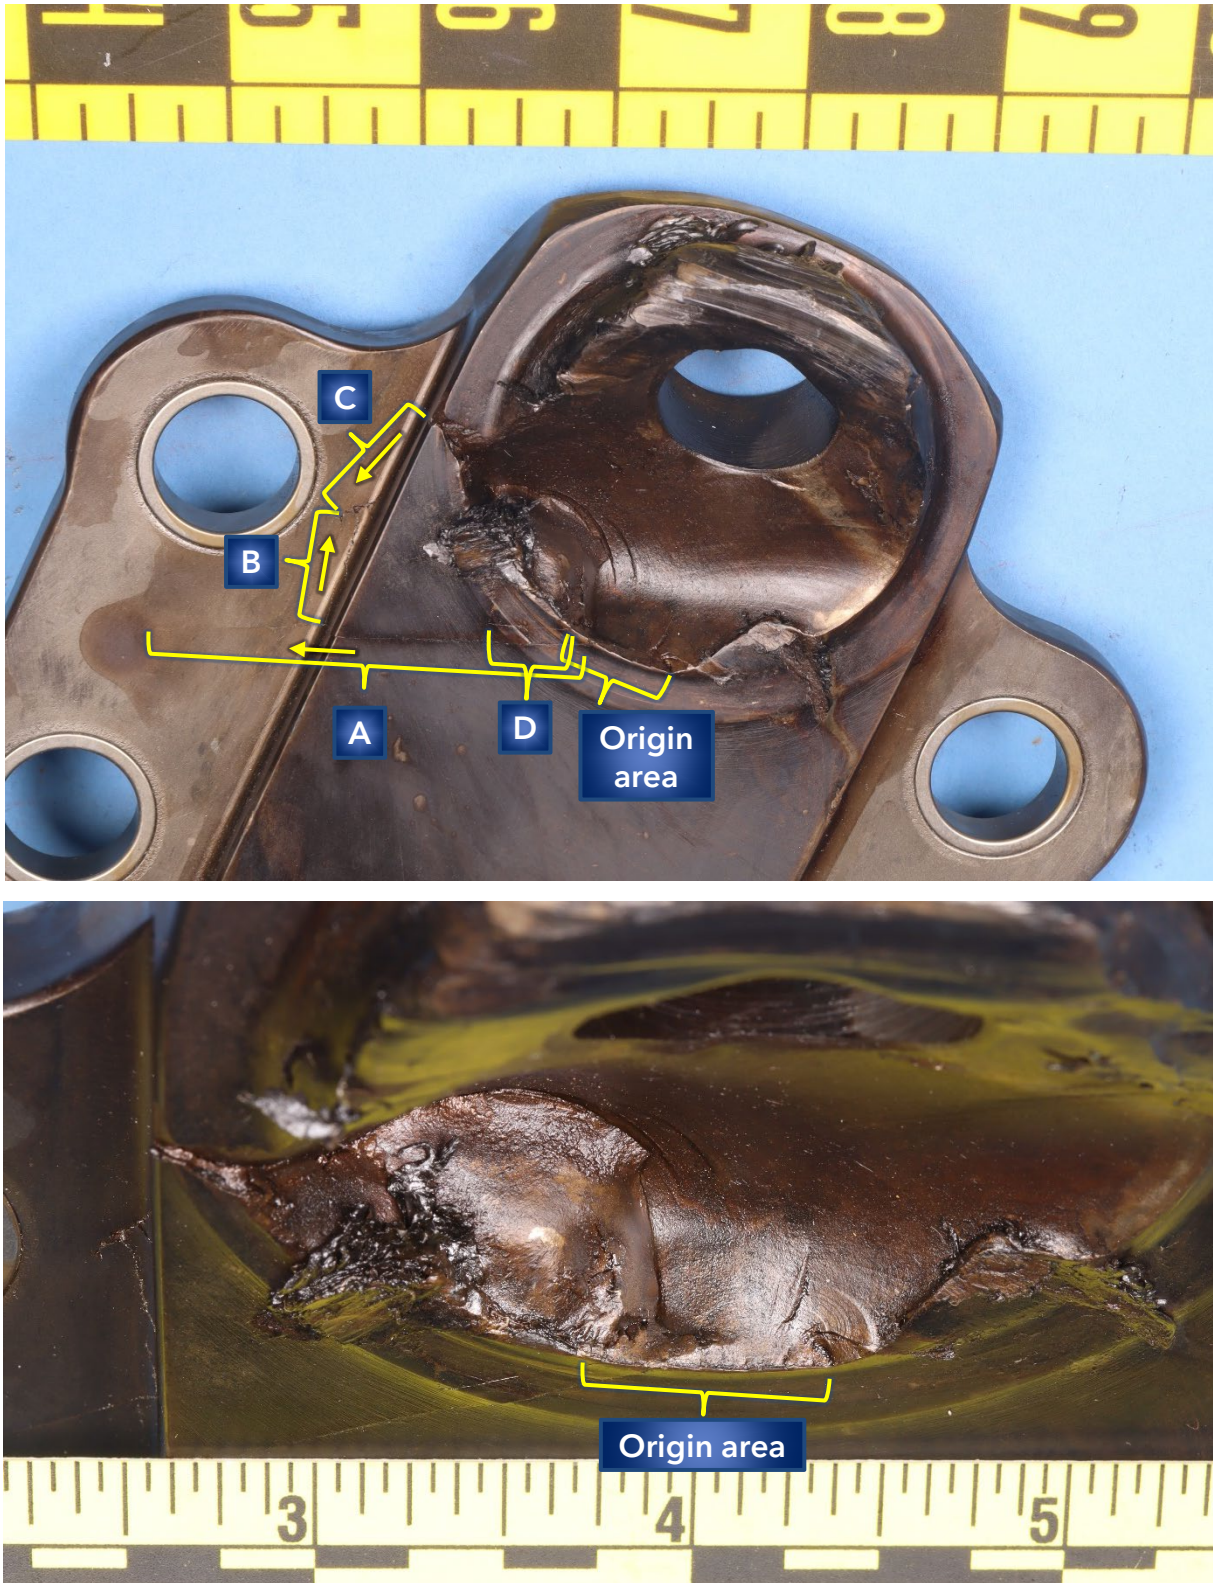
Views of the fracture surface after the initial disassembly, sectioning, and cleaning are shown in figure 6. Brackets in figure 6 indicate the fatigue origin area located in the number 6 connecting rod journal fillet radius near the runout for the cheek. Additional cracks were observed extending from the fracture area into the counterweight attachment ear, and crack locations are indicated with brackets labeled with letters in figure 6.

**Figure 6.** Forward side of the crankshaft fracture showing the origin area. Lettered brackets indicate locations of unopened cracks extending from the origin area, and arrows within the brackets indicate the direction of crack growth.

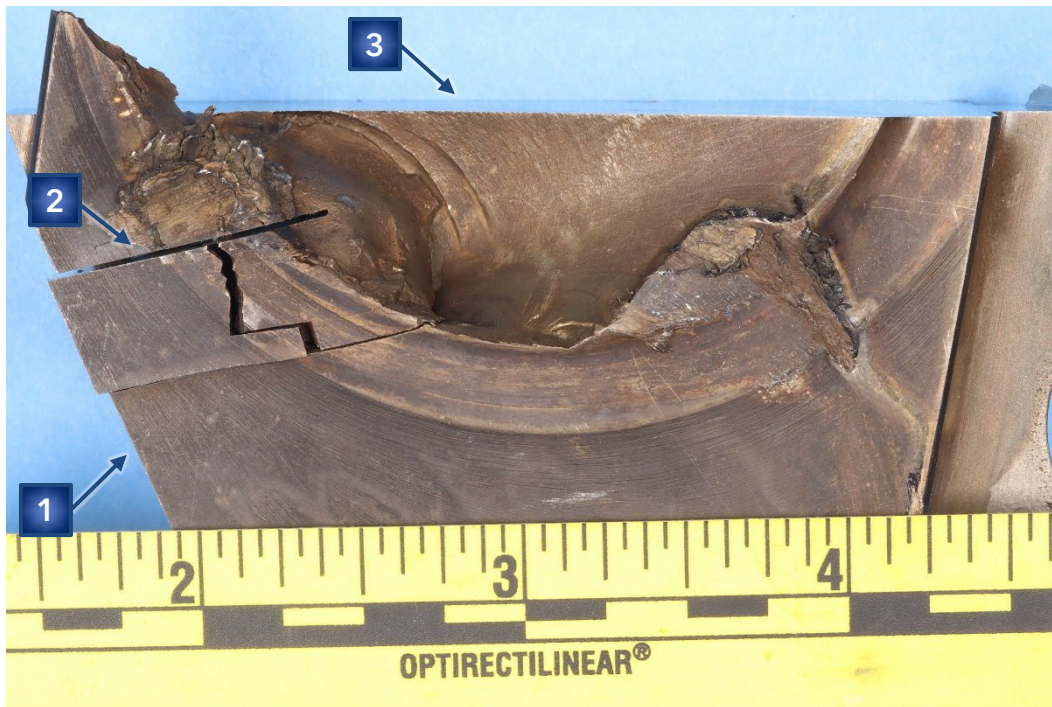
In order to examine the fracture surfaces associated with cracks A through D and to facilitate an SEM examination of the origin area shown in figure 6, the crankshaft piece was sectioned in several locations including the numbered cuts indicated in figure 7. After cut 1 was made through crack A along with a back cut to the tip of crack A (not shown), the exposed portion of crack A showed crack arrest lines that showed the direction of crack growth away from the origin area as indicated with an arrow within bracket A in figure 6. Additionally, the crack path revealed by the cut showed that the portion of crack A penetrating through the thickness of the cheek turned more than 90 degrees and propagated along the path indicated by bracket B.

**Figure 7.** Crankshaft piece showing cuts made to separate unopened cracks and to facilitate SEM exam of the origin area. Numbered arrows point to saw cuts.

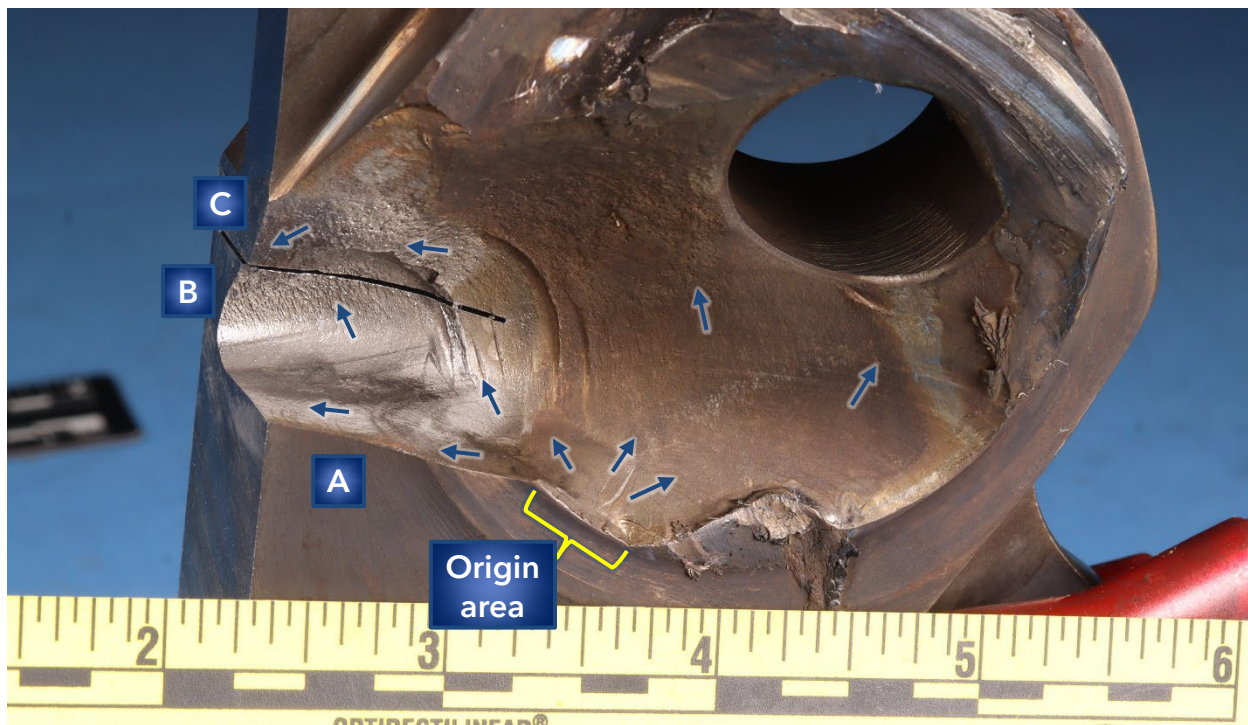
A view of the resulting fracture surface after opening the cracks and ultrasonic cleaning is shown in figure 8. The locations of cracks A, B, and C are indicated in figure 8 for reference. Crack D, a smaller crack parallel to crack A, was contained within the piece that had been removed in the process. Unlabeled arrows in figure 8 indicate local directions of fatigue crack propagation. Fracture features all emanated from the origin area that was originally exposed by the fracture as shown in figures 6 and 8.

**Figure 8.** Optical image of the origin area after separating the unopened cracks and before cutting for the SEM examination. Unlabeled arrows indicate the local directions of fatigue crack propagation.

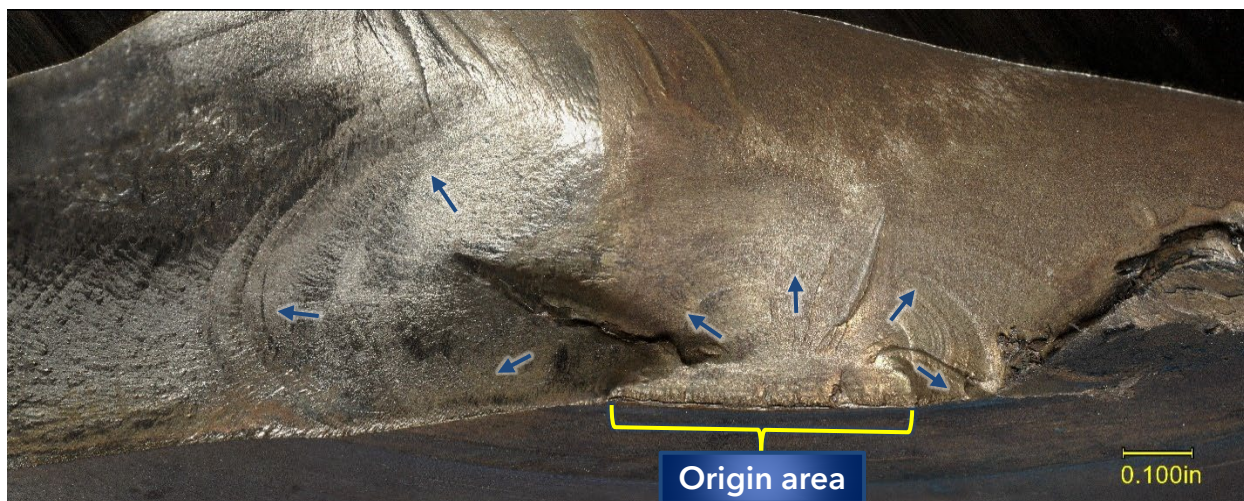
To facilitate closer views of the origin area using an optical microscope and a scanning electron microscope (SEM), cut number 3 (see figure 7) was made through the fracture surface. An optical image of the origin area is shown in figure 9 showing additional detail of fracture features emanating from the indicated origin area.

**Figure 9.** Another optical view of the origin area after separating the unopened cracks. Unlabeled arrows indicate the local directions of fatigue crack propagation.

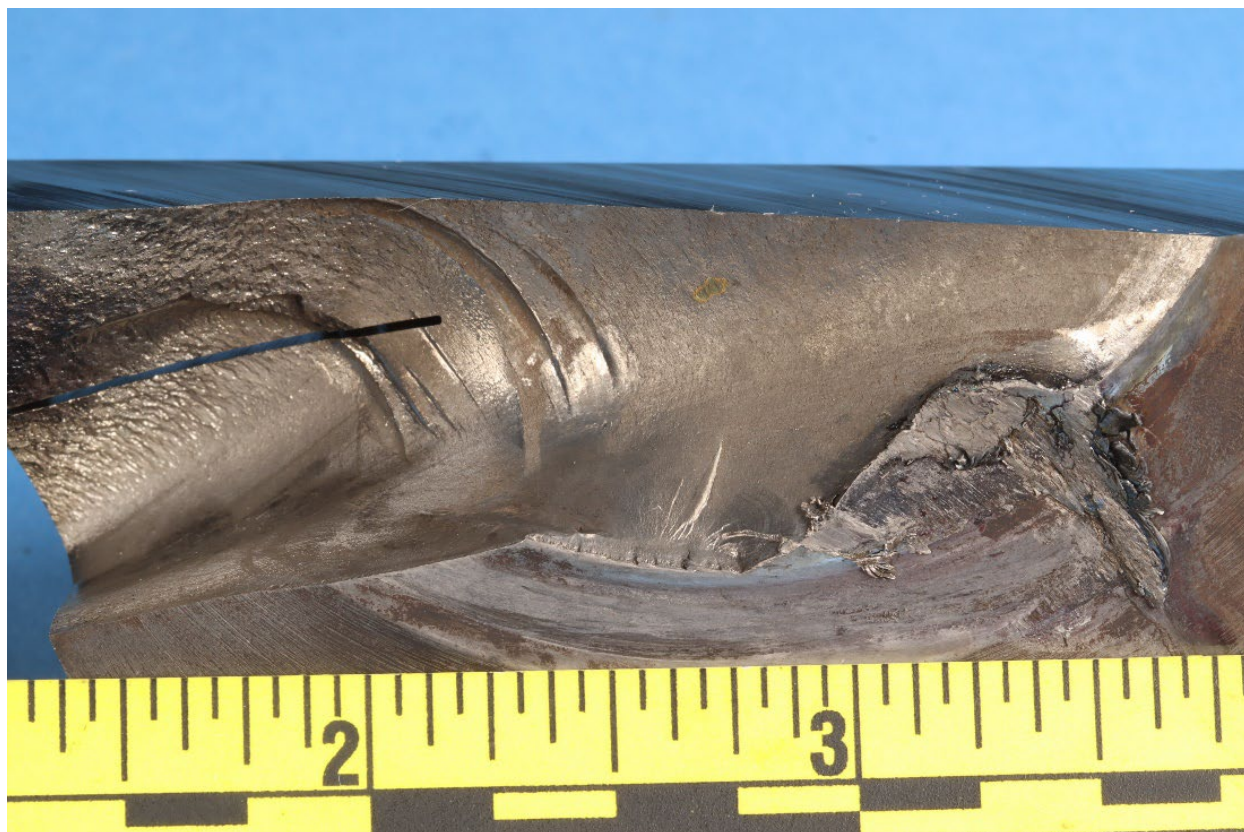
The fracture surface remained lightly oxidized. To assist in an SEM examination of the surface, the piece with the origin area was submerged in Evapo-Rust for a few minutes, and the surfaces were lightly brushed with a soft-bristle brush to remove oxides on the surface. The piece was then rinsed with water followed by ethanol. An overall view of the fracture surface and adjacent cheek after oxide removal is shown in figure 10.

**Figure 10.** View of the origin area after sectioning and cleaning using Evapo-Rust.

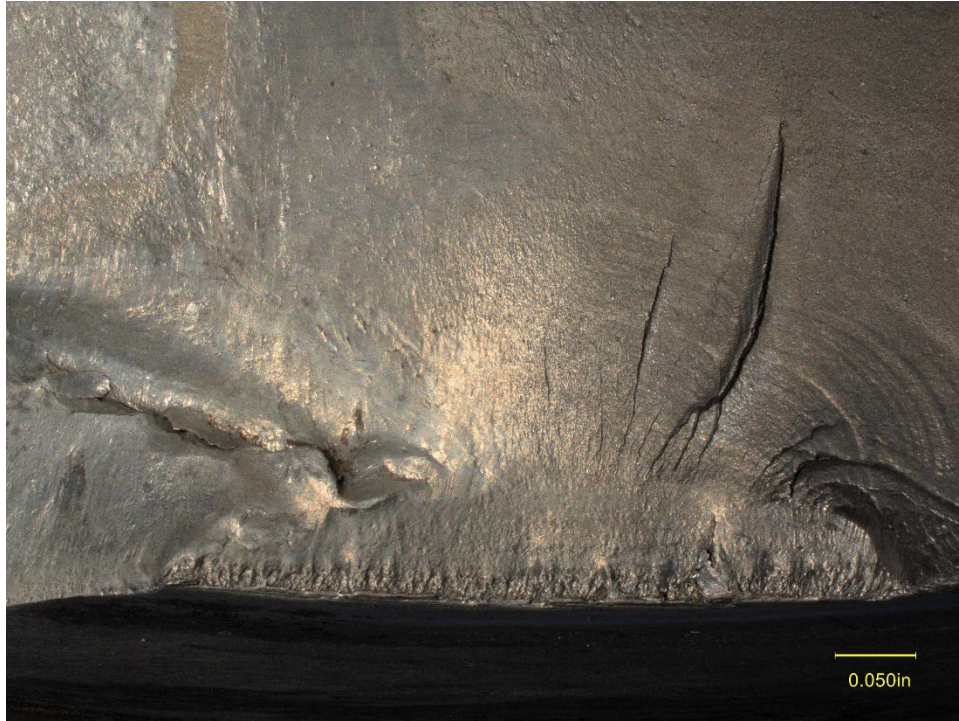
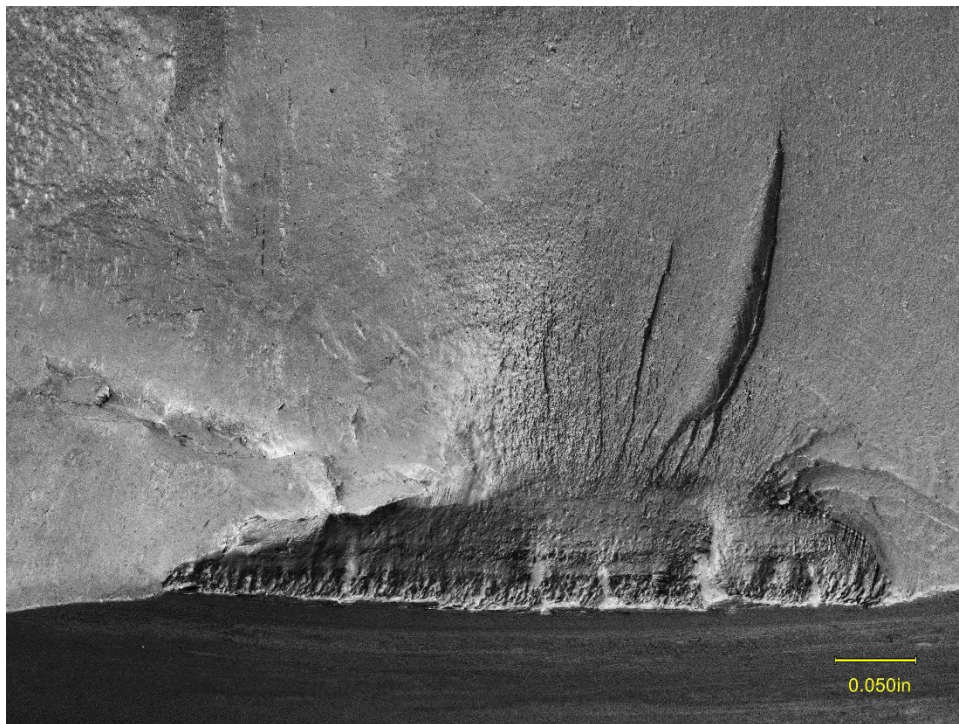
Optical images of the origin area after deoxidation were obtained and processed using a Keyence VHX-7000 optical microscope as shown in figures 11 and 12. In figure 11, the fracture surface was imaged using high dynamic range (HDR) processing to remove reflections and glare on the fracture surface. The image in figure 12 was obtained using the shadow mode to remove color and highlight topographical features. The images show a relatively rough fracture topography near the surface within 0.023 inch of the surface. A fracture region with smoother features was observed extending up to 0.083 inch deep approximately perpendicular to the fillet radius surface. Step features extended radially outward from the boundary of the smoother region and prominent crack arrest marks were observed, features consistent with fatigue crack growth on slightly offset planes emanating from the origin area.

**Figure 11.** Close view of the origin area using a Keyence VHX-7000 in depth-up HDR mode.

**Figure 12.** Optical image of the origin area using a Keyence VHX-7000 in depth-up optical shadow mode.

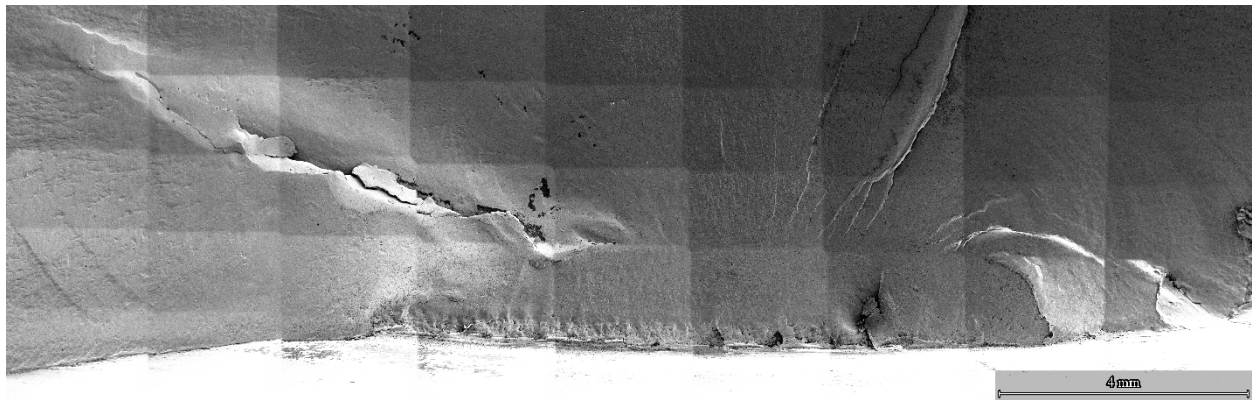
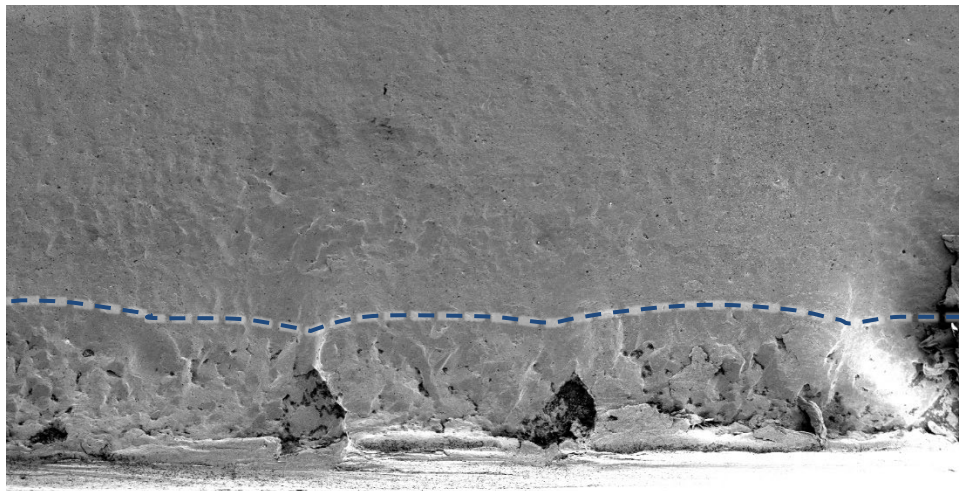
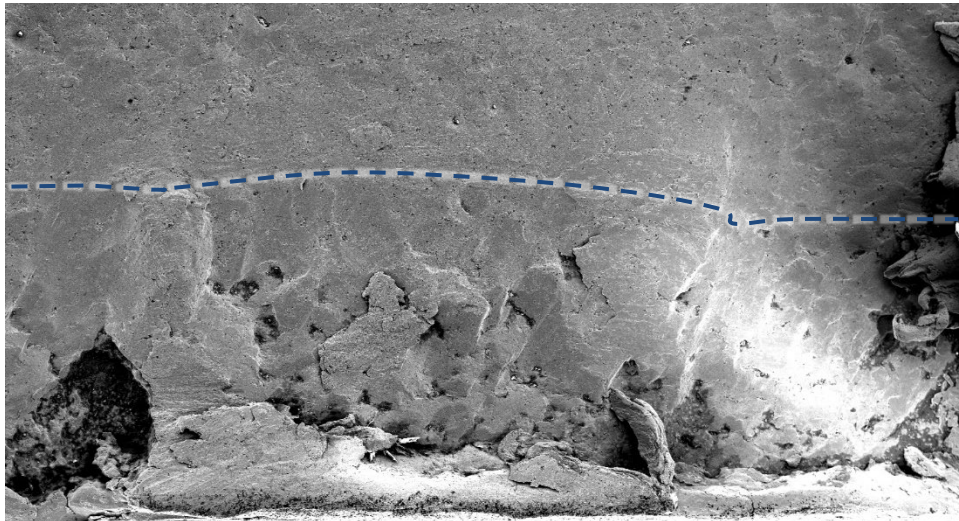
SEM images of the origin area are shown in figure 13. The upper image is a montage of SEM images stitched together to show a wider view, and the lower images show closer views of fracture features next to the surface near the middle of the origin area. Fracture features at the origin area showed mechanical damage from rubbing. However, the relatively rough area at the surface had a granular appearance suggestive of an intergranular fracture.

**Figure 13.** A montage of stitched SEM images of the origin area (upper image) with closer views near the middle of the origin area (middle and lower images).

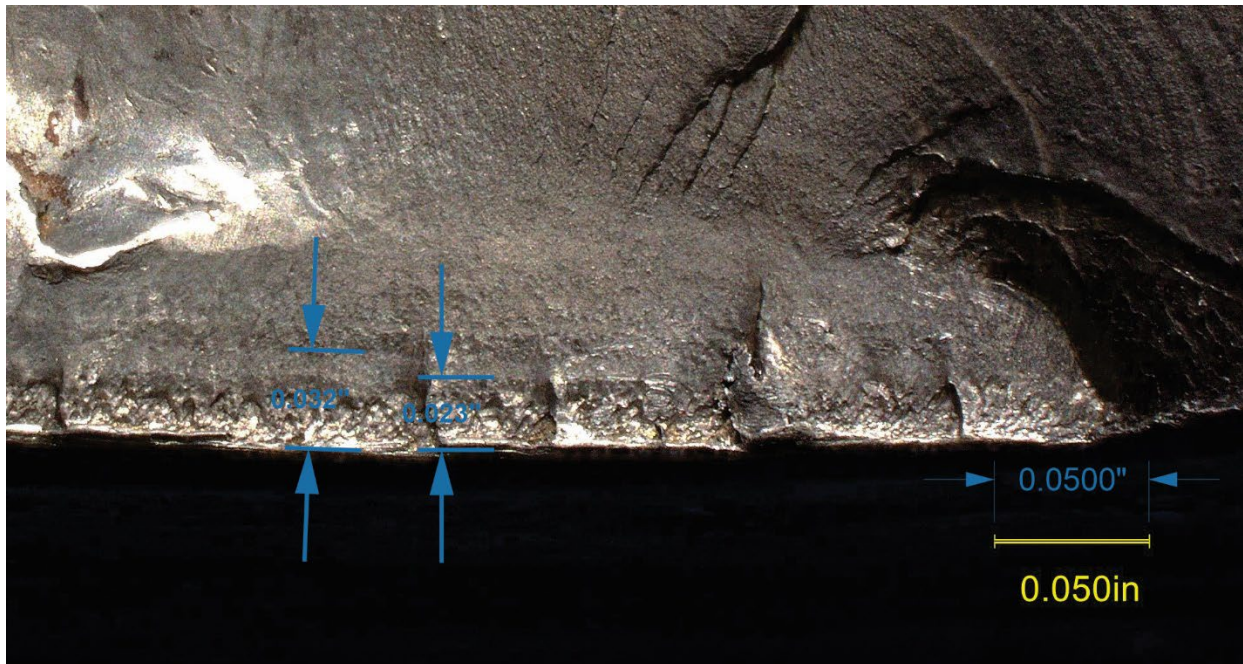
The relatively rough intergranular region near the origin had a curving boundary that had cusps that appeared to coincide with small radial features. The boundary shape and radial features were consistent with multiple origins in a broad origin area located at the fillet radius surface. The intergranular region extended up to 0.023 inch deep as shown in figure 14. Beyond that region, a smoother region with a similar curving boundary was observed up to a depth of 0.032 inch, also indicated in figure 14.

**Figure 14.** Optical image showing regions with different fractographic textures at the origin area with boundaries at depths of 0.023 inch and 0.032 inch as shown.

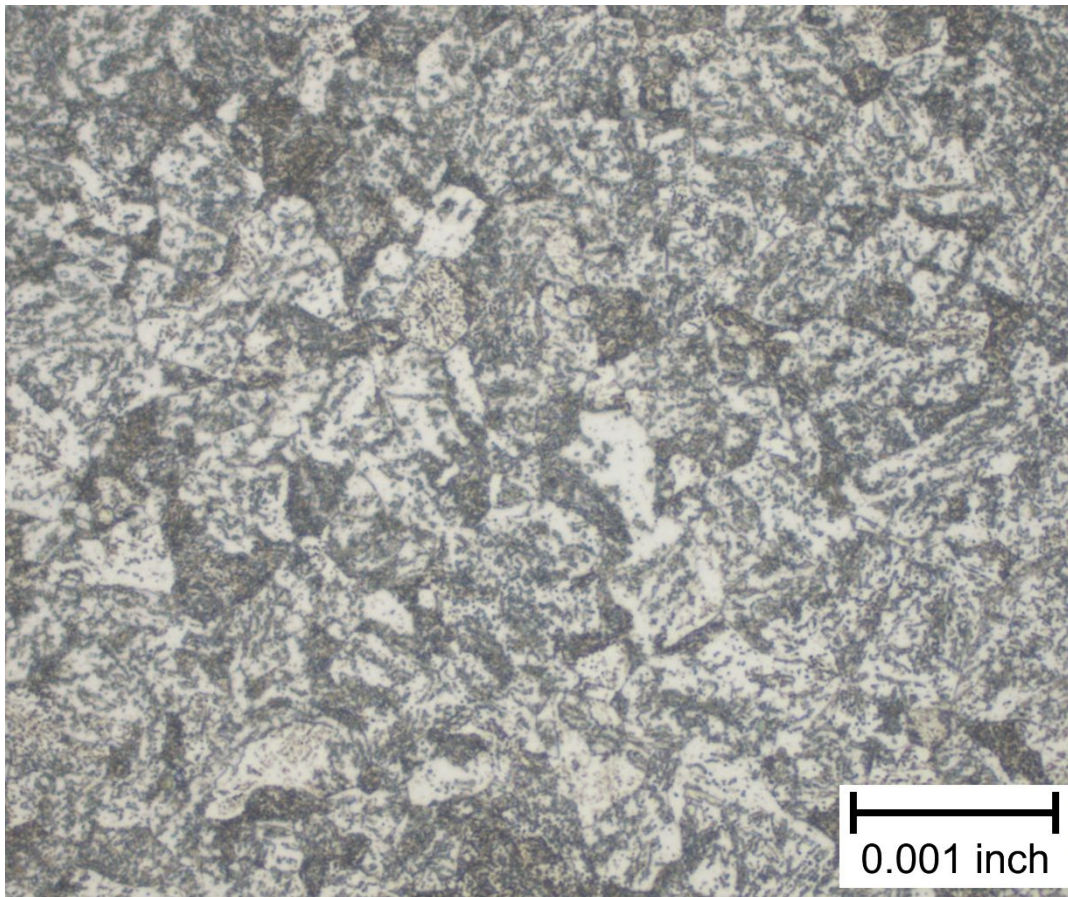
microstructure is shown in figure 16. The typical lath microstructure associated with tempered martensite appeared transformed with spheroidization.

**Figure 16.** Metallographic image of the typical core microstructure observed on the crankshaft cross-section after etching with 2% nital.

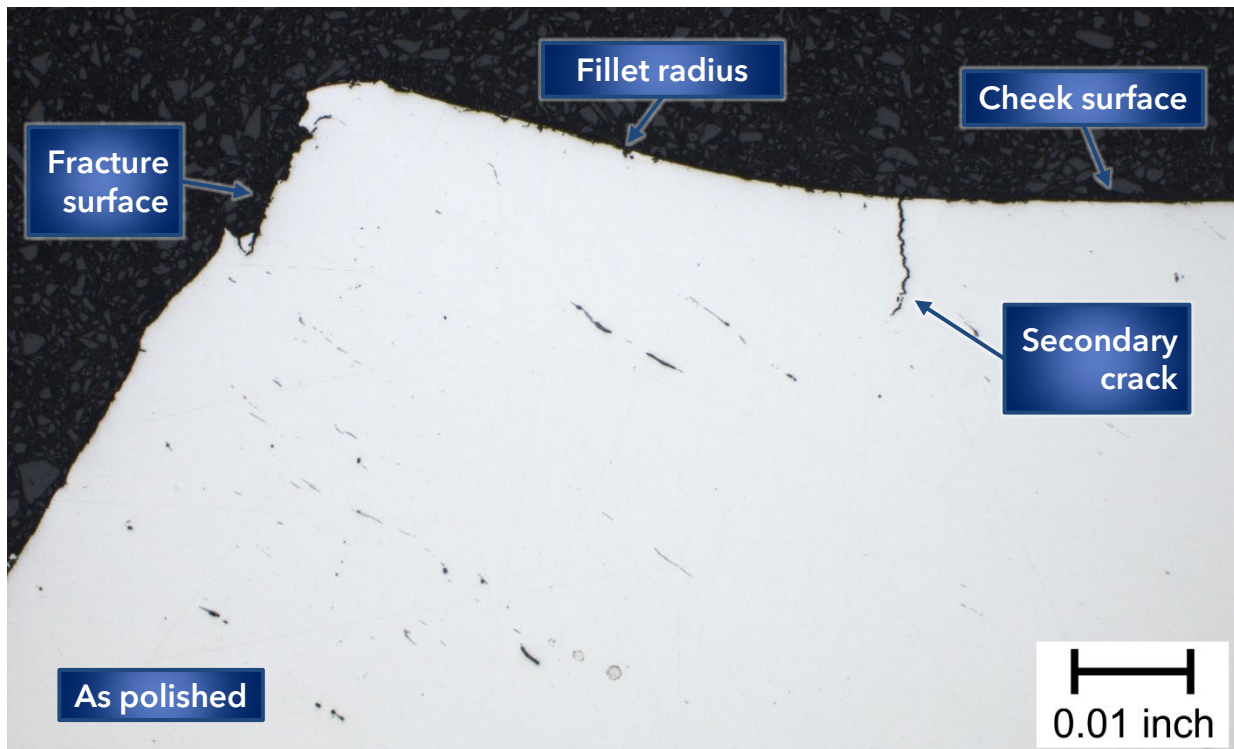
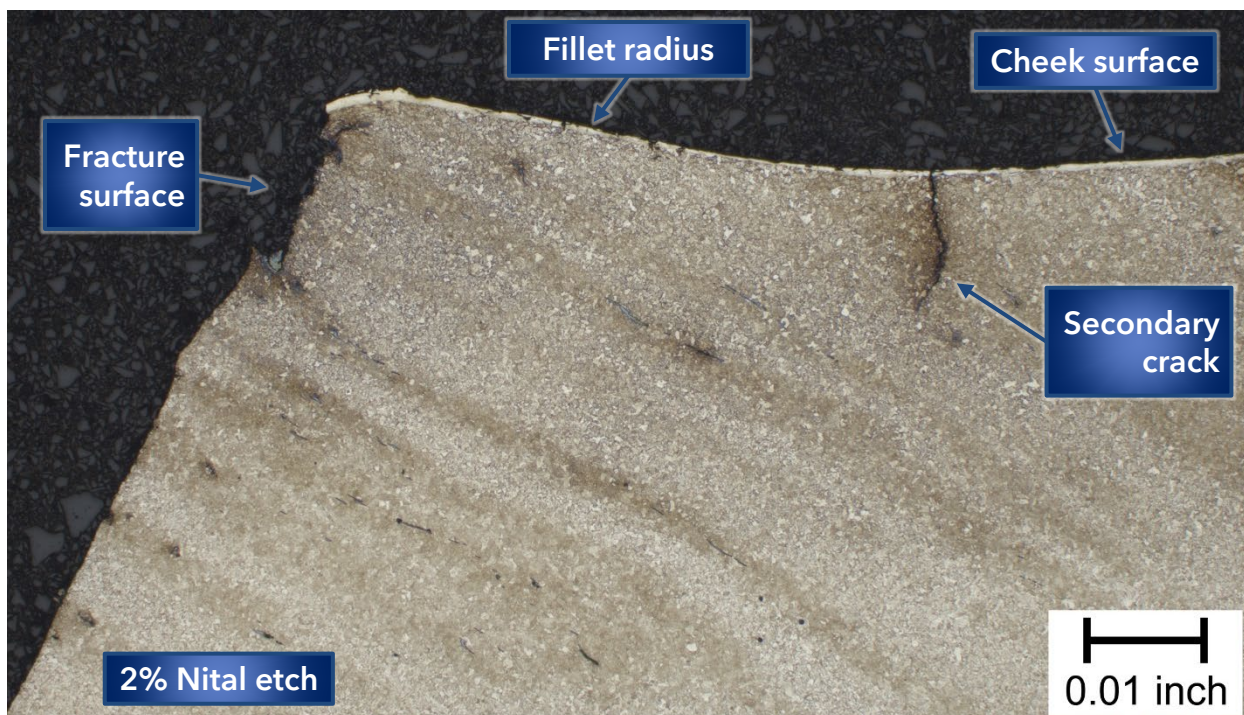
Metallographic images of the polished cross-section at the origin area are shown in figure 17 in the as-polished and etched conditions. The images show the fracture location in the journal radius. A secondary crack was observed at the location of the runout for the journal radius into the cheek. In the etched condition, a white layer was observed at the surface of the cheek and journal radius consistent with nitride hardening. The remainder of the cross-section had a microstructure consistent with tempered martensite.

**Figure 17.** Metallographic images of the cross-section through the fatigue origin area as polished and after etching with 2% nital.

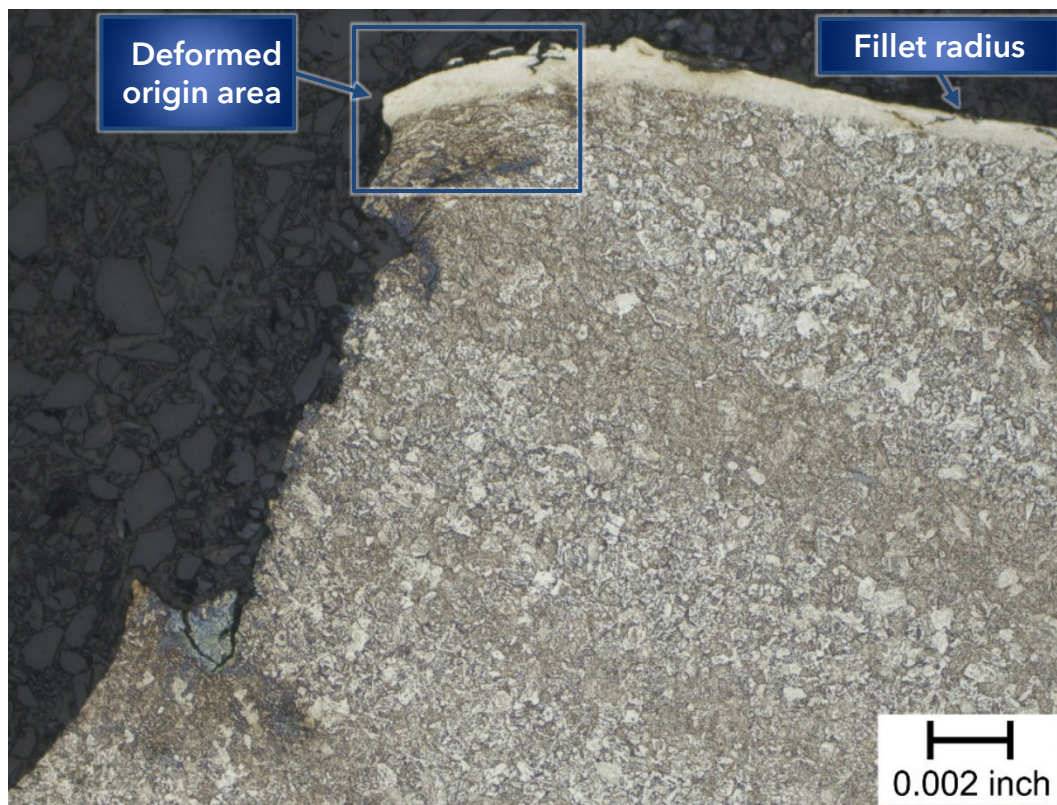
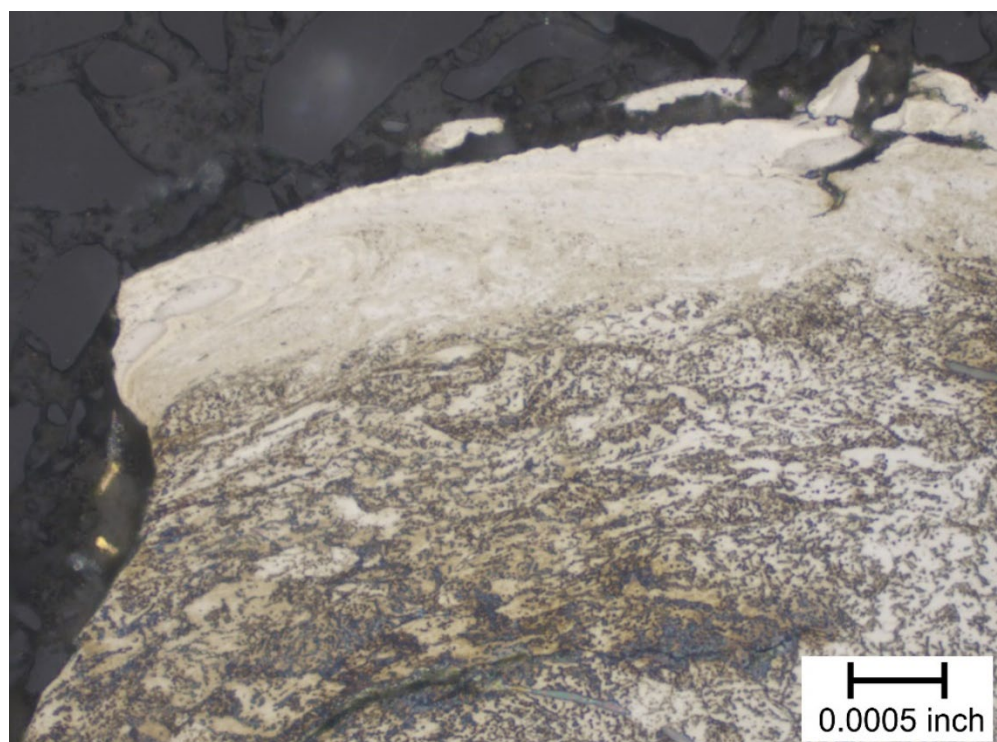
Closer views of the origin area are shown in figure 18. The surface adjacent to the fracture was deformed inward over the fracture surface consistent with post-fracture damage. Additionally, the fracture showed step features at the deformed lip and at a location near the boundary of the surface-hardened region. A closer view of the surface at the location of the secondary crack is shown in figure 19 in the etched condition.

**Figure 18.** Closer views of the fatigue origin area in the metallographic specimen. Etched with 2% nital.

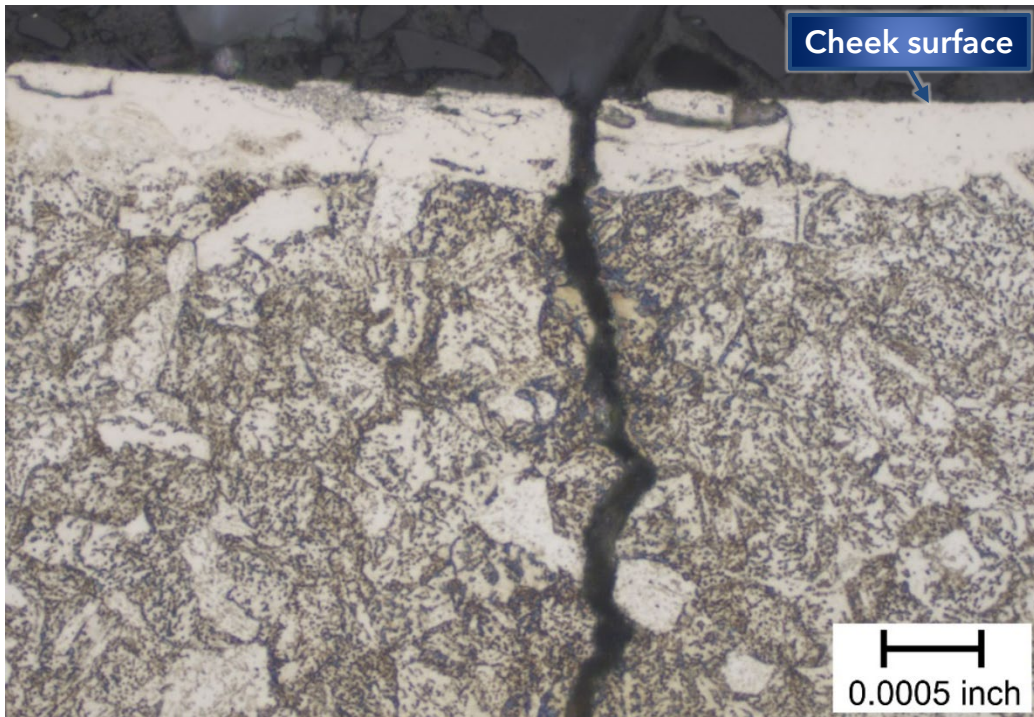
**Figure 19.** Closer view of the secondary crack where it intersected the number 6 journal cheek surface in the metallographic section shown in figure 15. Etched with 2% nital.
