# National Transportation Safety Board

ERA23FA025

## **MATERIALS LABORATORY**

Factual Report 23-066

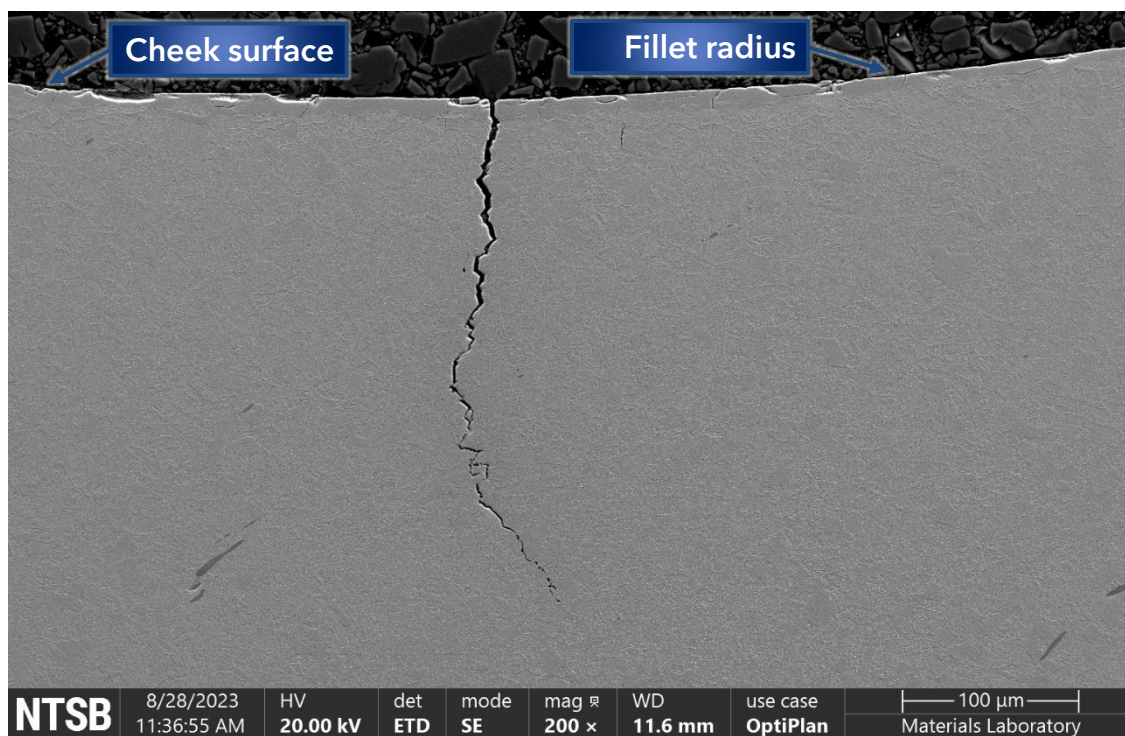
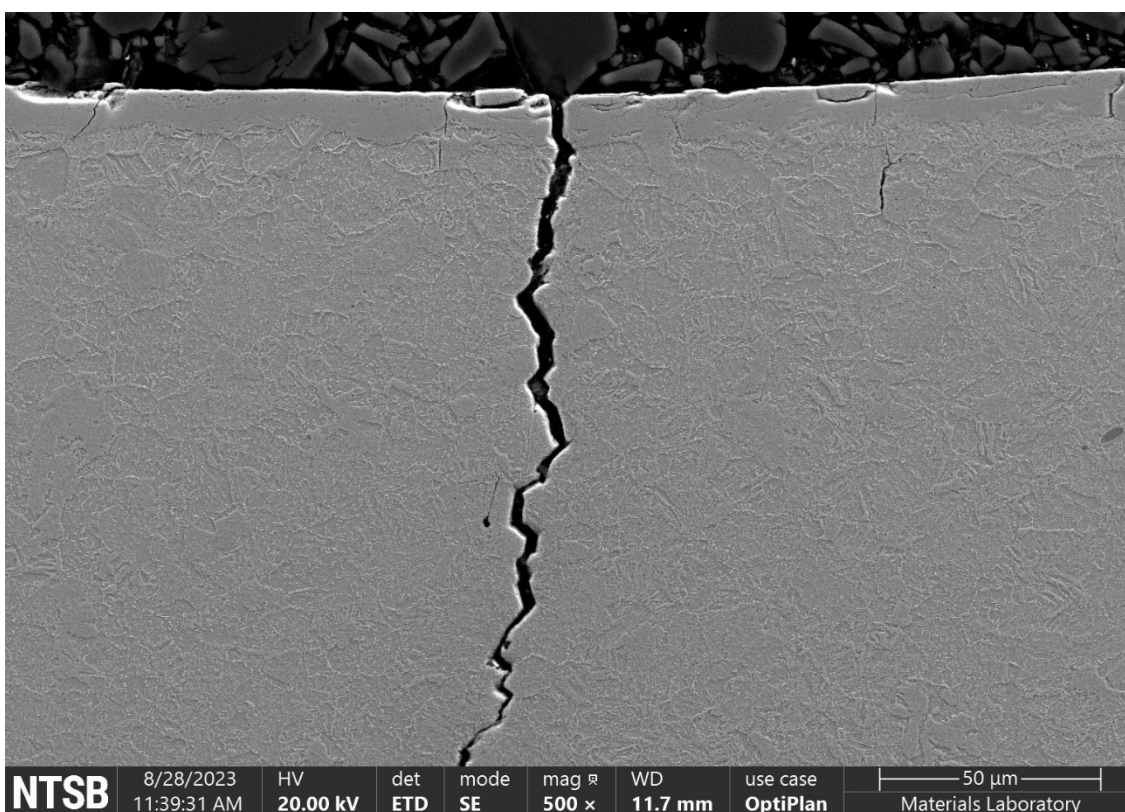
Next, the metallographic mount was sputter coated with a thin layer of a gold/palladium alloy to facilitate an SEM examination of the sample. Note that the SEM images are mirror images of optical images taken with the inverted metallograph as presented in figures 16 through 19. An SEM image of the fatigue origin area is shown in figure 20, and views of the secondary crack are shown in figure 21. Near the surface, both the fracture surface and the secondary crack showed crack paths along prior austenite grain boundaries.

**Figure 21.** SEM images of the secondary crack in the number 6 journal cheek showing an intergranular fracture path. Etched with 2% nital.

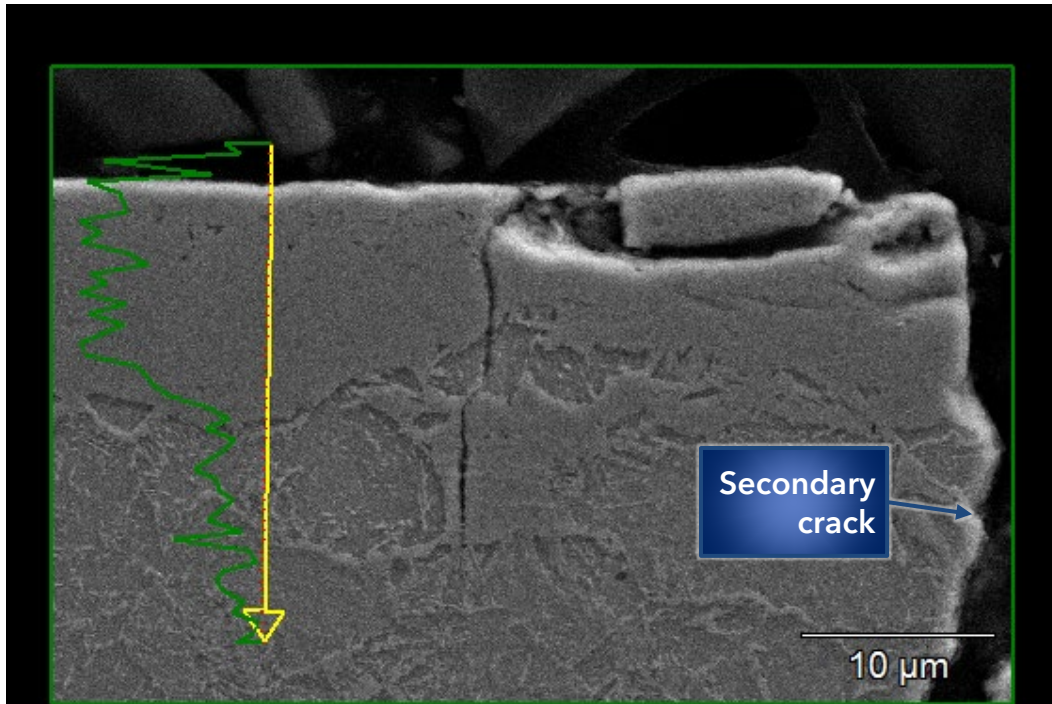
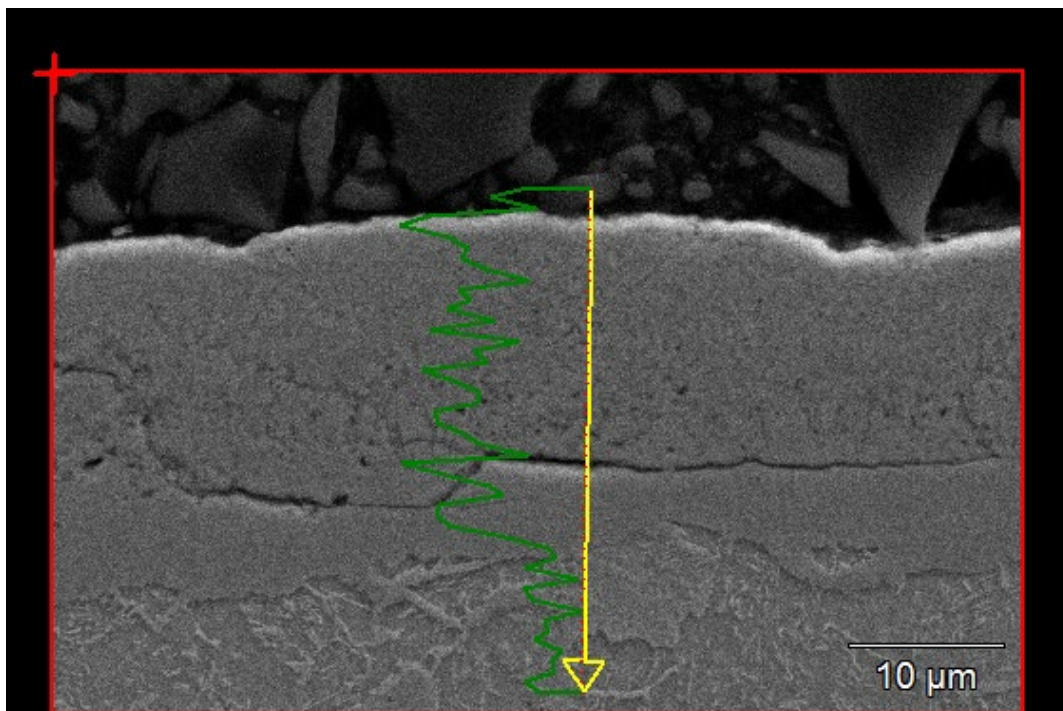
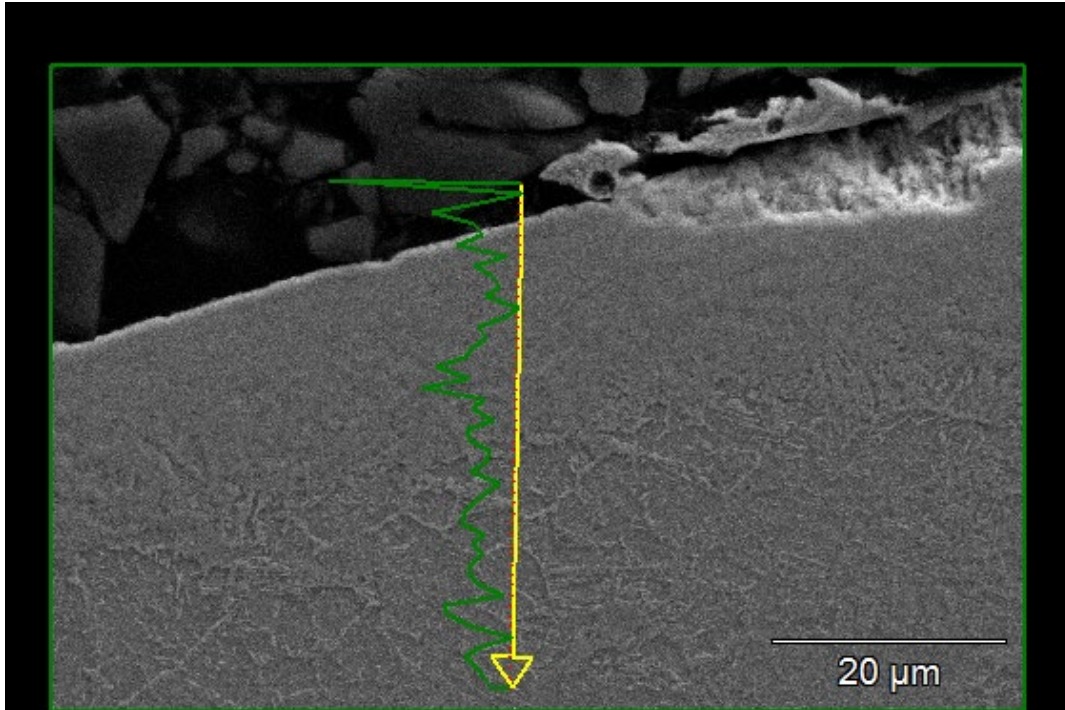
Frictional heating from rubbing damage can produce a layer of untempered martensite that etches white with a nital etch. However, the white layer next to the secondary crack and further away in the cheek showed elevated levels of nitrogen when analyzed using energy dispersive x-ray spectroscopy (EDS), consistent with a nitride layer. EDS line scans through the white layers at these locations showed higher counts associated with the nitrogen peak relative to the underlying material as shown in figures 22 and 23. A similar line scan in the journal radius near the fracture surface as shown in figure 24 did not reveal a similar trend associated with the white layer, but disturbed metal associated with rubbing that can produce untempered martensite also was not observed.

**Figure 22.** Nitrogen concentration profile determined using an EDS line scan at the cheek surface adjacent to the secondary crack. Etched with 2% nital.

**Figure 23.** Nitrogen concentration profile determined using an EDS line scan at the cheek surface away from the potential connecting rod contact area. Etched with 2% nital.

**Figure 24.** Nitrogen concentration profile determined using an EDS line scan at the journal radius near the fracture surface. Etched with 2% nital.

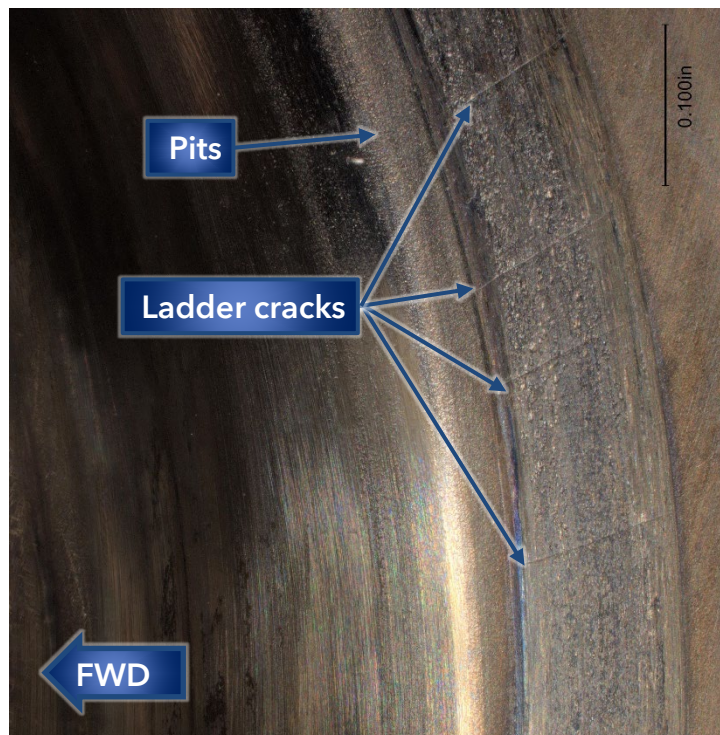
Additional cracks were observed in the number 5 connecting rod journal. On the cheek surface at the aft end of the number 5 connecting rod journal, a series of radially oriented cracks (ladder cracks) were observed in a rubbed area of the cheek that corresponded to sliding contact with the aft side of the number 5 connecting rod assembly. Rub marks from sliding contact with the forward side of the number 5 connecting rod assembly was also observed on the forward cheek, but ladder cracks were not observed in the rubbed area in that case. However, cracks were observed in the fillet radius as indicated in figure 26. The cracks were oriented at an angle

between the circumferential and radial directions and did not appear to be associated with any rubbing damage, scoring, or pits. Small pits were observed in the fillet radius at the aft end of the number 5 connecting rod journal as indicated in figure 25, but no cracks were observed associated with the pits.

**Figure 25.** Number 5 connecting rod journal at the aft cheek showing ladder cracks from sliding contact with the connecting rod assembly and showing small pits in the journal fillet radius.

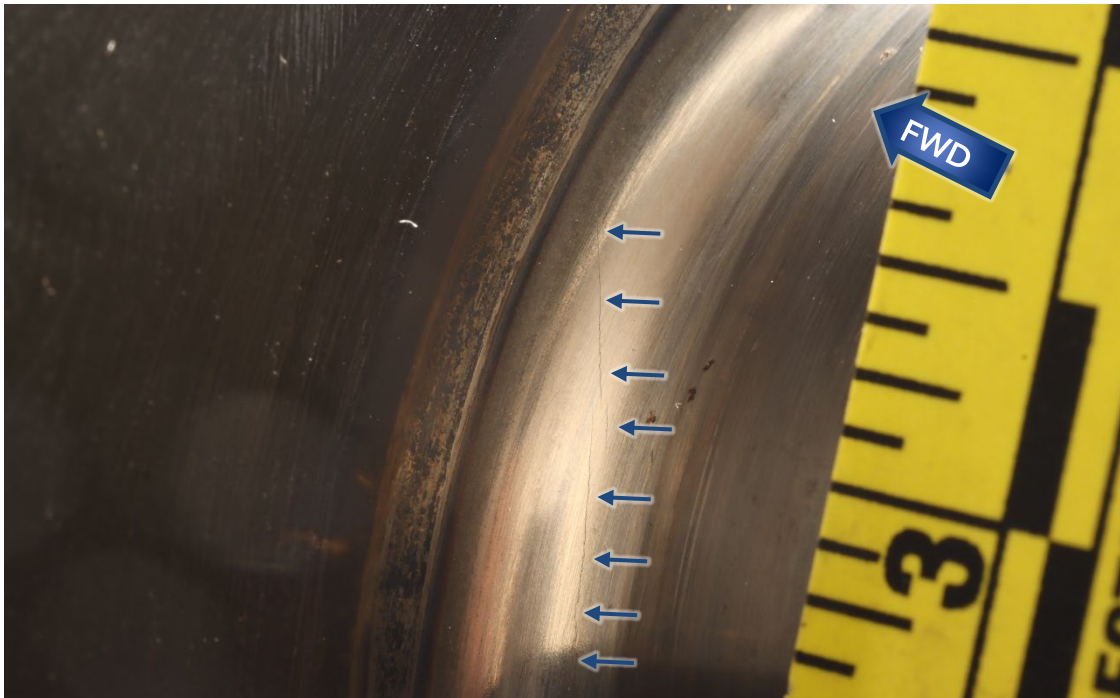
**Figure 26.** Number 5 connecting rod journal at the forward cheek. Unlabeled arrows point to several cracks in the fillet radius.

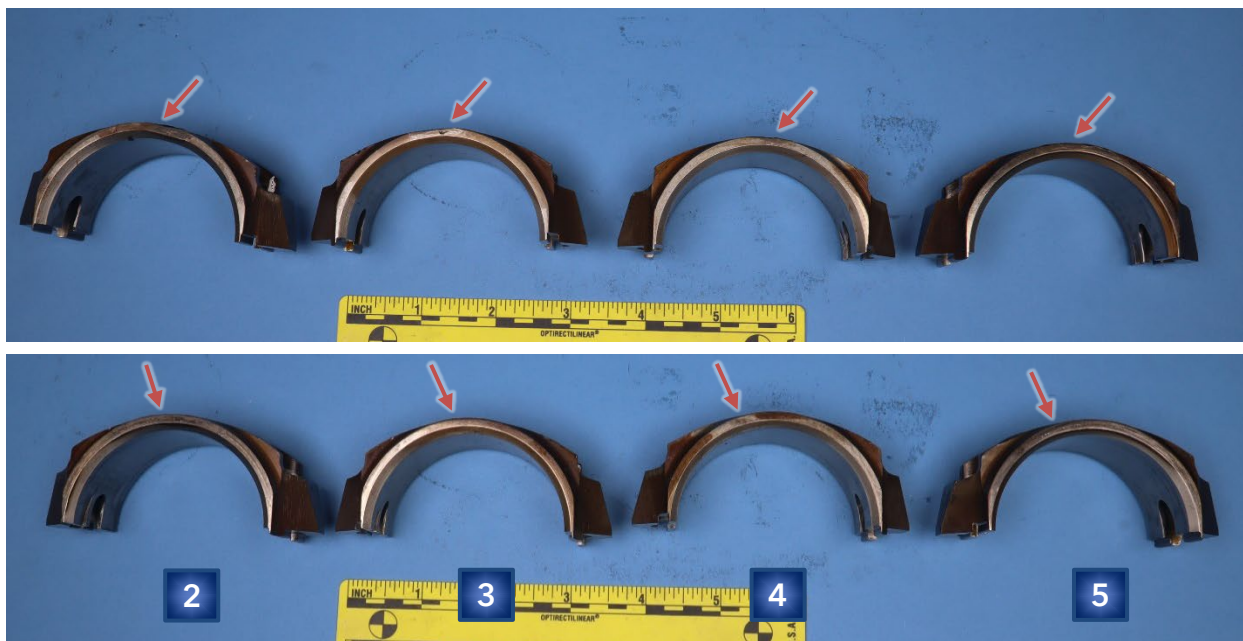
specified maximum value are highlighted in table 2. All caps had a conforming width at the ends of the arcs, but caps from connecting rods 2, 3, and 4 had widths that exceeded the maximum design at the middle of the arc. Although the cap from connecting rod 5 had a conforming dimension at the middle of the cap, it was also the most extensively rubbed and the only connecting rod that was also associated with ladder cracks in the corresponding crankshaft surface.

**Figure 27.** Sides of the connecting rod caps for rod assemblies 2 through 5 showing rubbing contact damage at the middle of the arc.

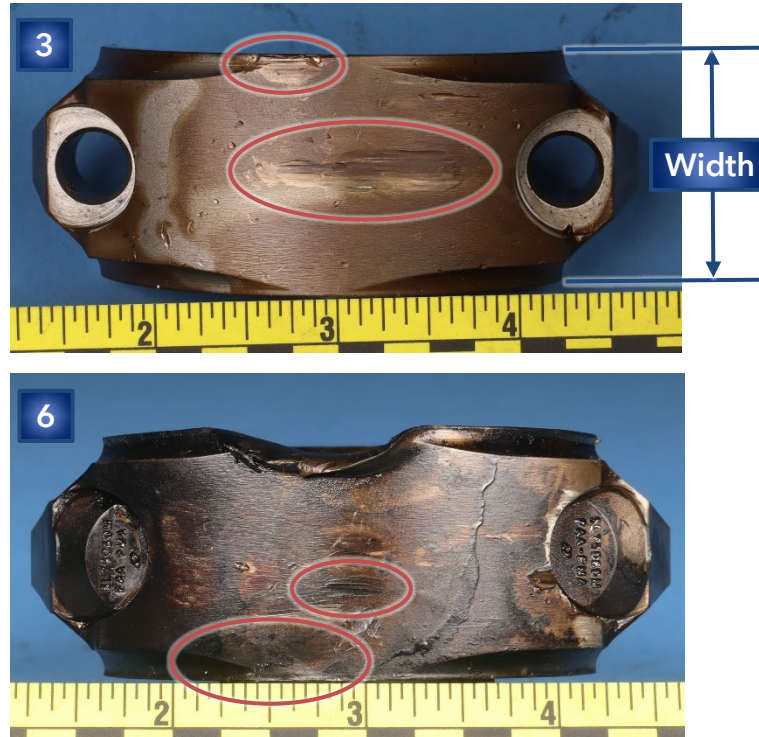
Sliding contact damage was also observed on the outer surfaces of the connecting rod caps. A view of typical damage as observed on the number 3 connecting rod cap is shown in figure 28. Circles indicate sliding contact damage on the outer surface likely associated with contact with the engine case. Although the number 6 connecting rod cap experienced more extensive contact damage, similar areas of sliding contact damage were observed shown circled in figure 29. The damaged areas were stained dark with coked oil, which generally appeared darker in these areas relative to other areas of contact damage.

**Figure 28.** Rub damage on the outer surface of the caps from the number 3 and number 6 connecting rod assemblies.

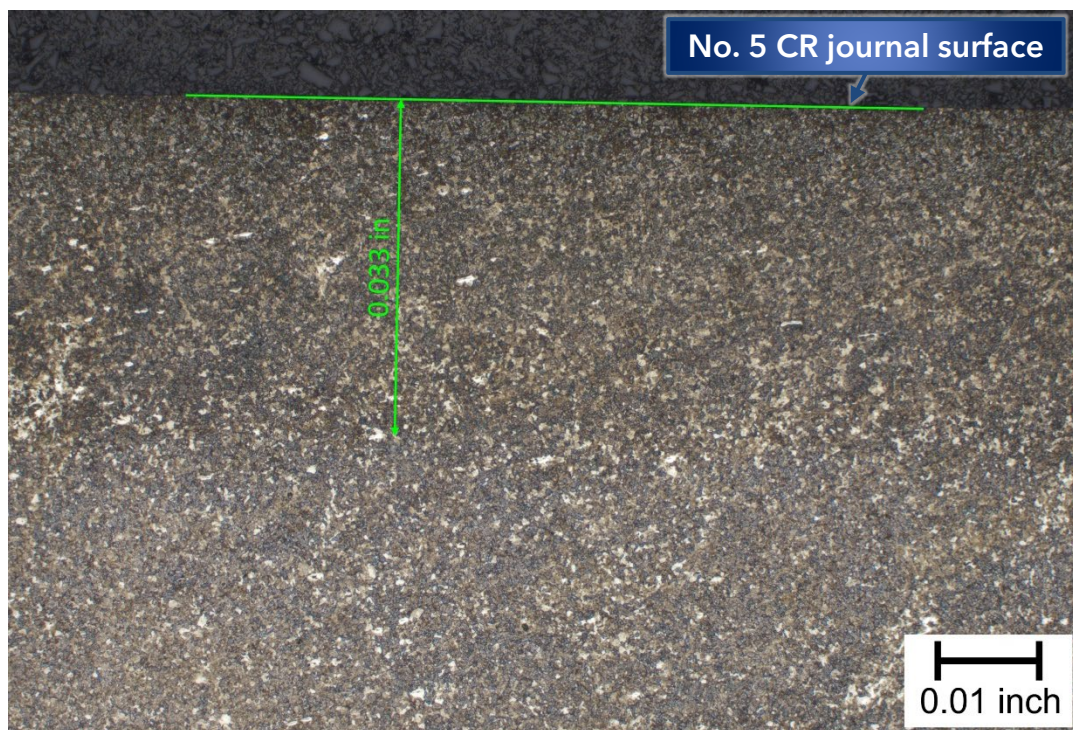
A view of the microstructure near the surface of the number 5 connecting rod journal is shown in figure 30. The sample was etched using Marble's reagent, which produces a darker etch for the nitride case. As shown in figure 30, the case depth as measured optically was 0.033 inch. The case depth as noted in the engineering drawing for the crankshaft was specified to be 0.018 inch to 0.026 inch (or 0.0165 inch to 0.0245 inch for a surface with 0.003 inch removed from the original diameter). However, according to maintenance records for the accident engine, the crankshaft was replaced, and the replacement crankshaft that was installed in the engine at overhaul had been renitrided.

**Figure 30.** Nitride layer thickness at the number 5 connecting rod journal surface measured by optical means. Etched with Marble's reagent.

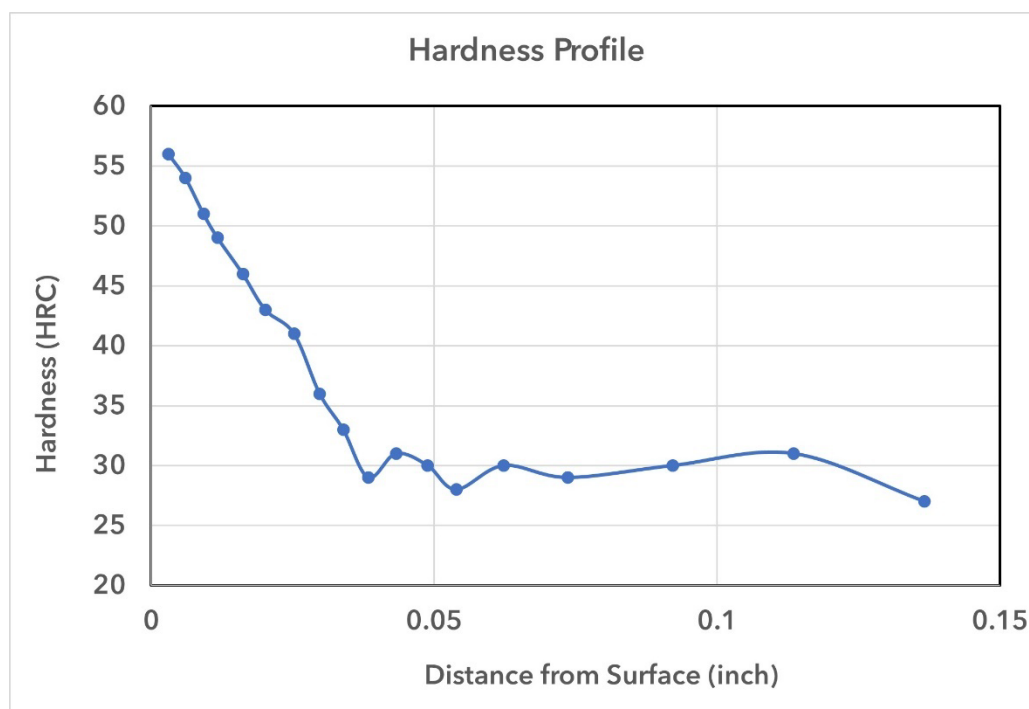
The hardness profile was measured by microindentation at varying depths from the number 5 connecting rod journal surface using a Leco AMH55 hardness tester. The hardness was measured using a Vickers indenter, and the results were reported as converted to the Rockwell C scale. The case hardness profile decreased approximately linearly from 56 HRC at a depth of 0.003 inch to 29 HRC at a depth of 0.038 inch as shown in figure 31. Hardness was also measured in the core using a

Rockwell indenter, and the average hardness measured 29.5 HRC. According to the engineering drawing for the crankshaft, the specified core hardness range is 32 HRC to 37 HRC.

**Figure 31.** Hardness profile measured from the journal surface on the cross-section through the number 5 connecting rod journal.

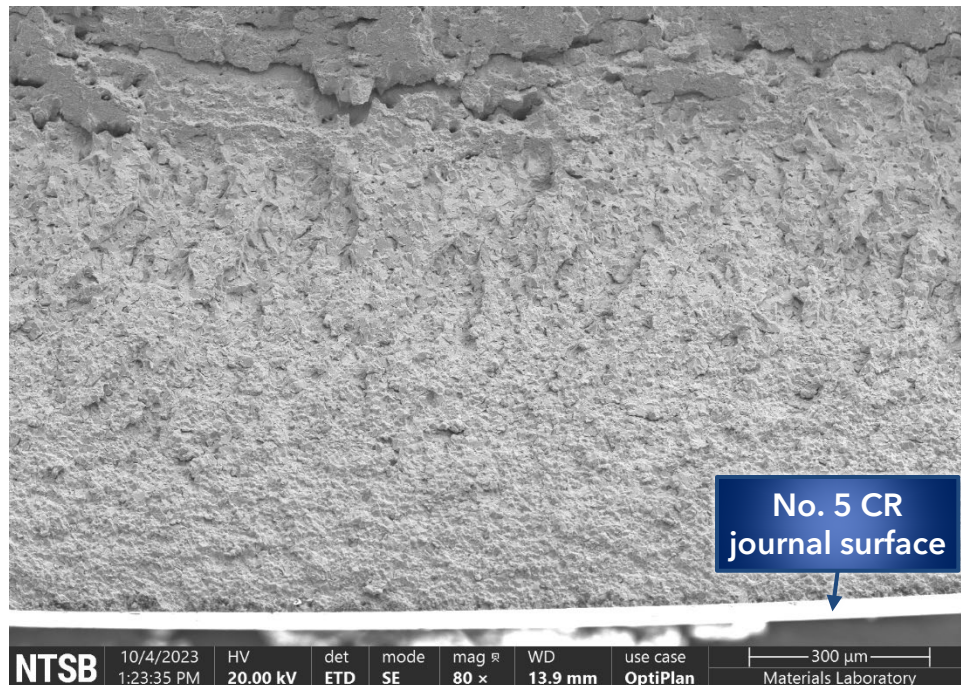
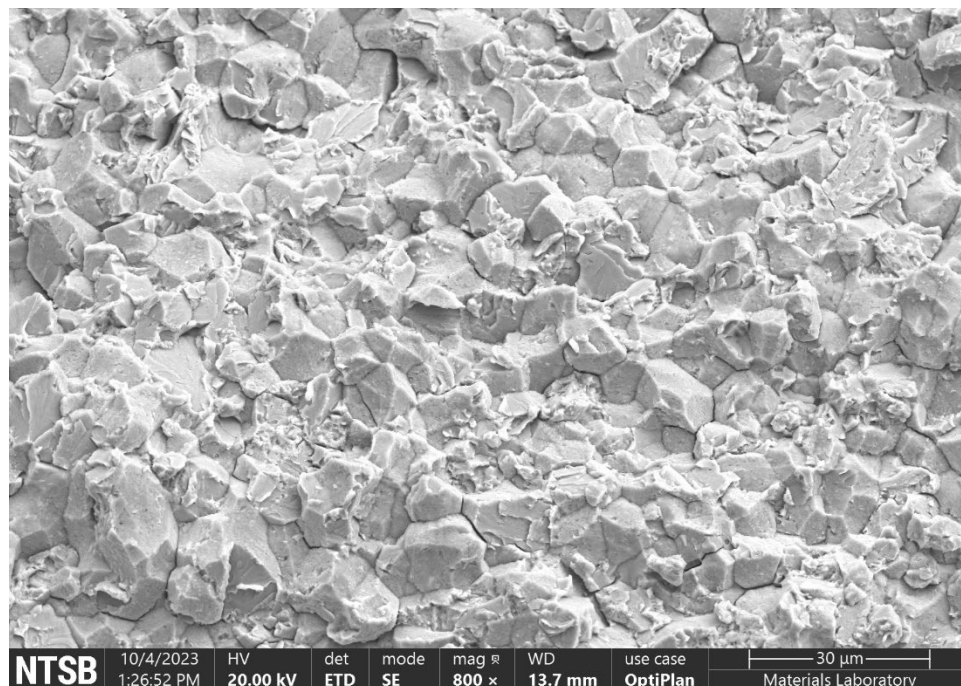
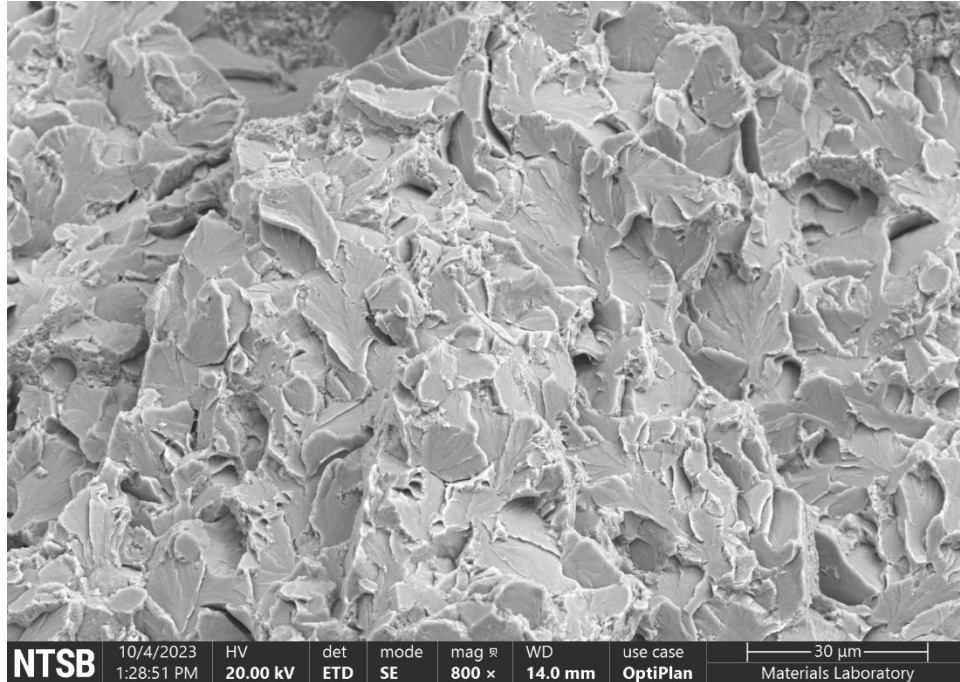
A view of the fracture features near the connecting rod surface as produced by the lab-induced overstress fracture are shown in figure 32. Within approximately 0.015 inches of the surface, the fracture surface had an intergranular fracture features as shown in figure 33. Further from the surface, between 0.015 inches and 0.030 inches deep, the fracture had transgranular cleavage features as shown in figure 34. The remainder of the lab-induced fracture had ductile dimple features.

**Figure 32.** Lab-induced overstress fracture features adjacent to the number 5 connecting rod journal surface.

**Figure 33.** Intergranular fracture features on the lab-induced overstress fracture surface observed within 0.015 inch of the number 5 connecting rod journal surface.

**Figure 34.** Transgranular cleavage fracture features on the lab-induced overstress fracture surface observed between 0.015 inch and 0.030 inch of the number 5 connecting rod journal surface.

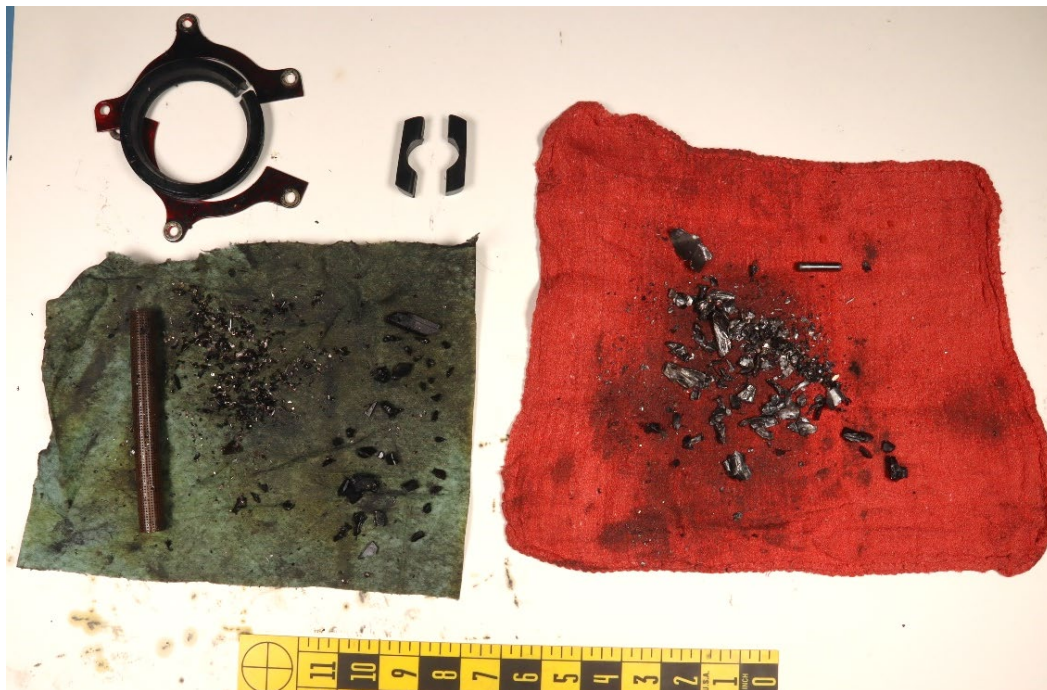
An overall view of debris recovered from the oil screen and sump are shown in figure 35. Material recovered from the sump was mostly consistent with bearing remnants. A dowel pin was included in the sump debris, but a corresponding installation location in the accident engine for a dowel pin of that dimension and configuration could not be determined. Debris from the oil screen included metallic and nonmetallic debris. The nonmetallic debris generally had similar color and surface textures, and the larger pieces had dimensional features that were consistent with a magneto bumper. The forward seal was fractured as shown in figure 35 but was not examined in detail.

**Figure 35.** Oil screen and debris recovered from the oil screen (on the green cloth on the left) and debris recovered from the oil sump (on the red cloth on the right). The front seal and intact magneto bumpers are also shown above the green cloth.
