# National Transportation Safety Board

ERA23FA047

## **G-1000 SD CARD**

Specialist's Factual Report

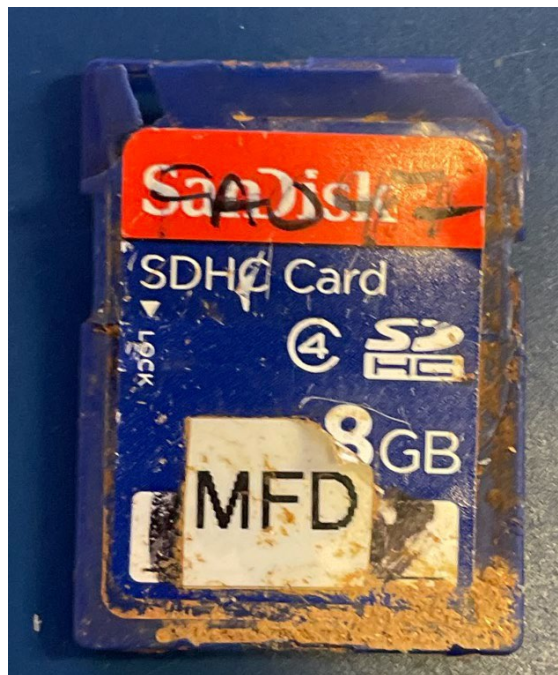
**Figure 1.** SD Card as recovered from the accident site.

The SD Card was damaged in the event. Preliminary X-Ray analysis showed no clear indication of catastrophic damage. But, attempts to power the SD card and read out stored data were unsuccessful. Anomalous heating of the SD Card when under power indicated the presence of an electronic problem not discernable by in-house optical or X-Ray analysis. The SD Card was sent to a university-based failure electronics laboratory for more extensive testing using tools and techniques not available in-house to diagnose the nature of the internal damage. A report was received indicating possible damage, but with inconclusive evidence concerning non-remedial damage to the die.

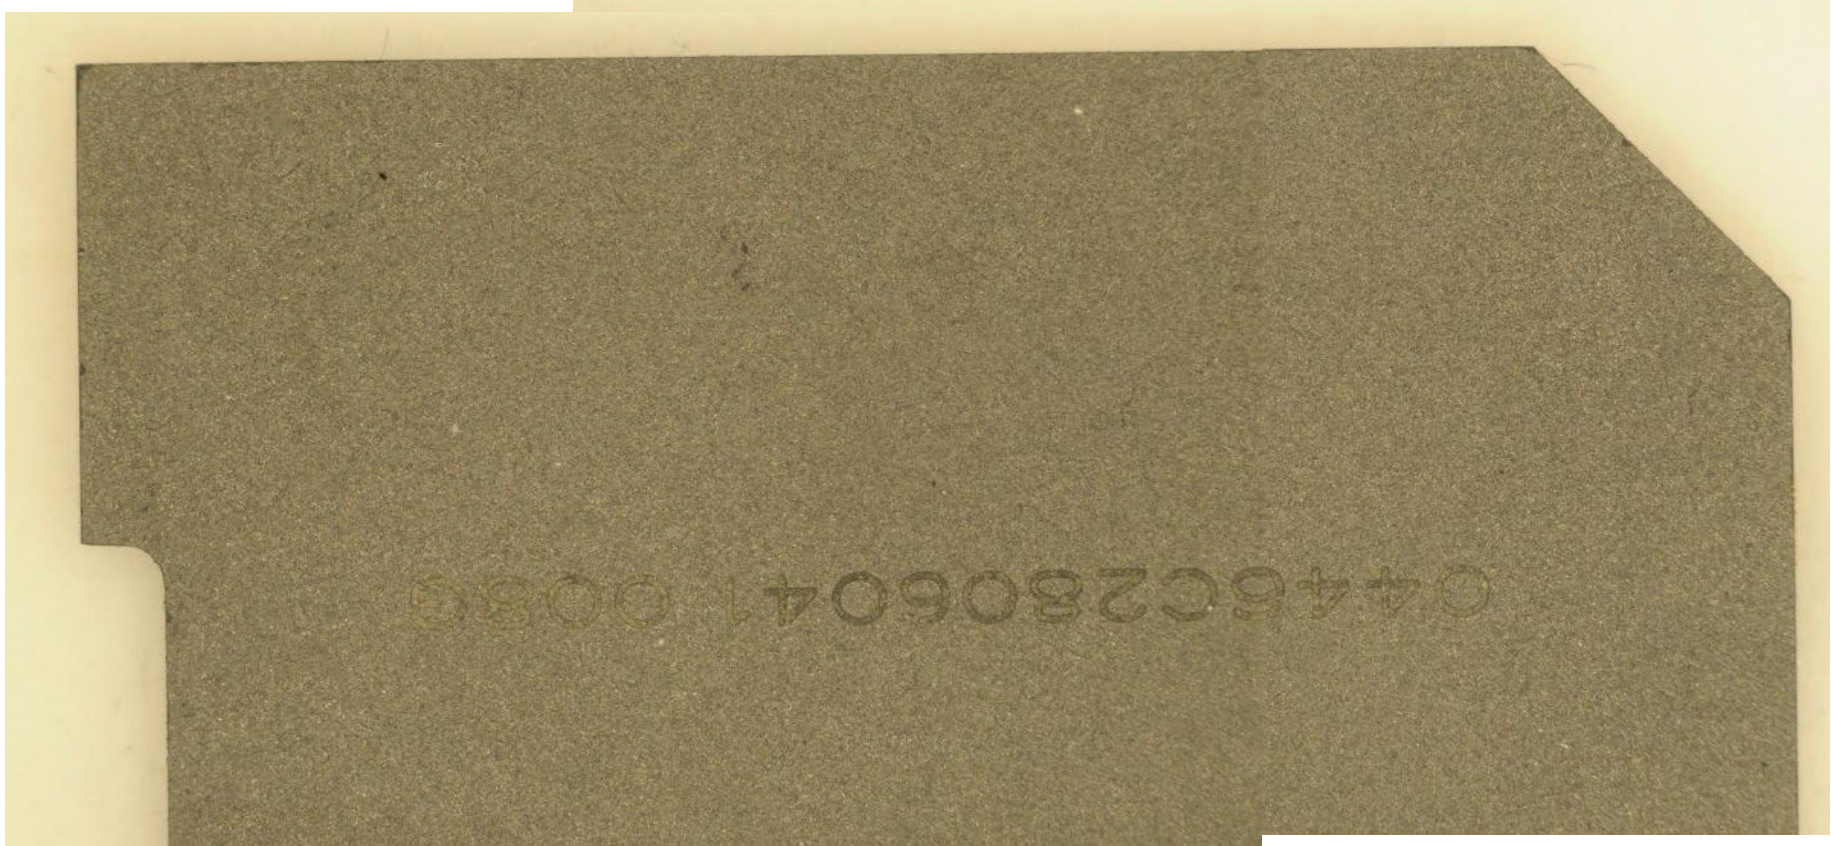
# Gold Contact Edge (Top Side, Stitched Image)

No evidence of thermal or mechanical damage

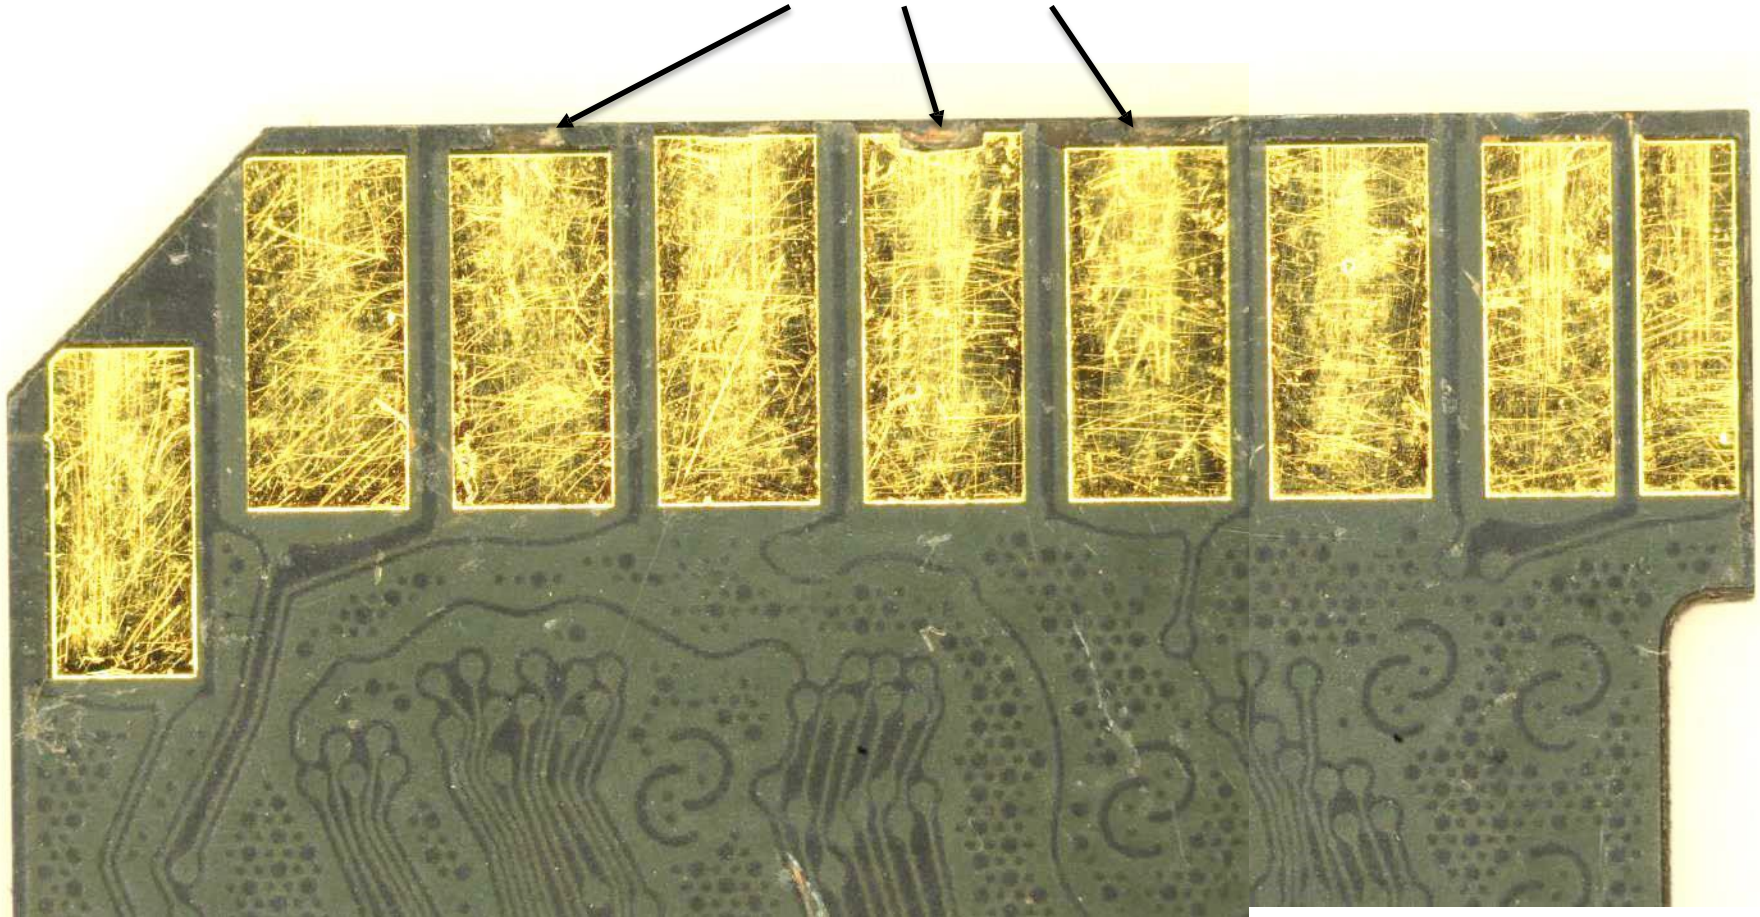
# Gold Contact Edge (Bottom Side, Stitched Image)

Mechanical Damage

- Damage at the edges
- Visible (near surface) circuitry at the interior is intact

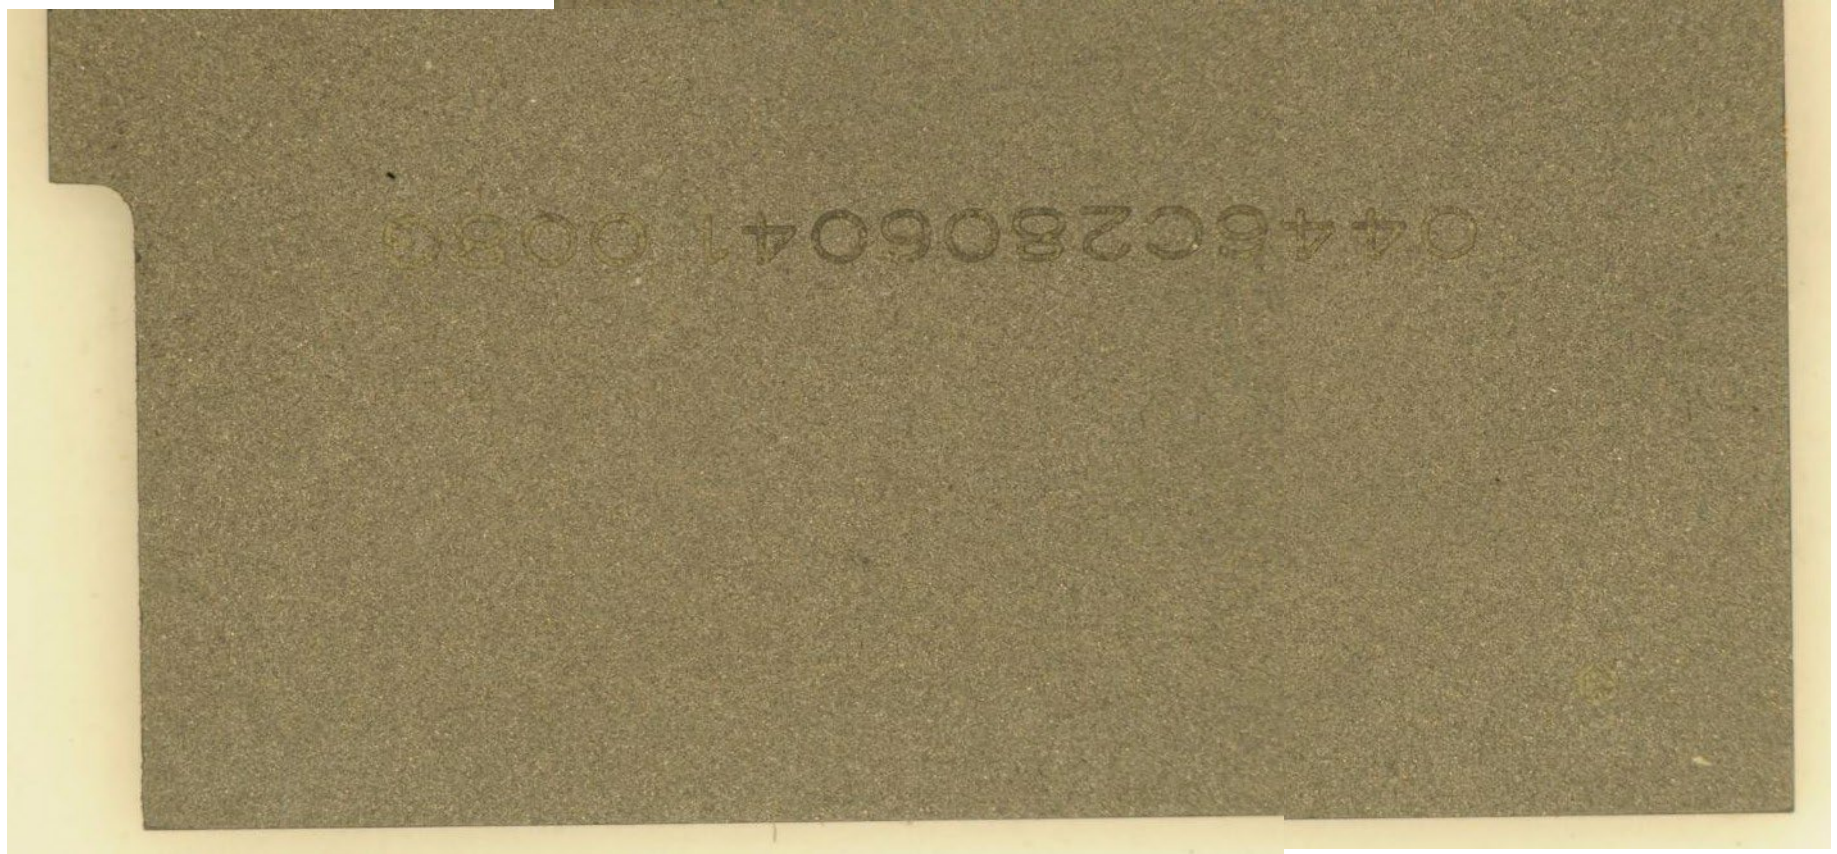
# Back Edge (Top Side, Stitched Image)

No evidence of thermal or mechanical damage

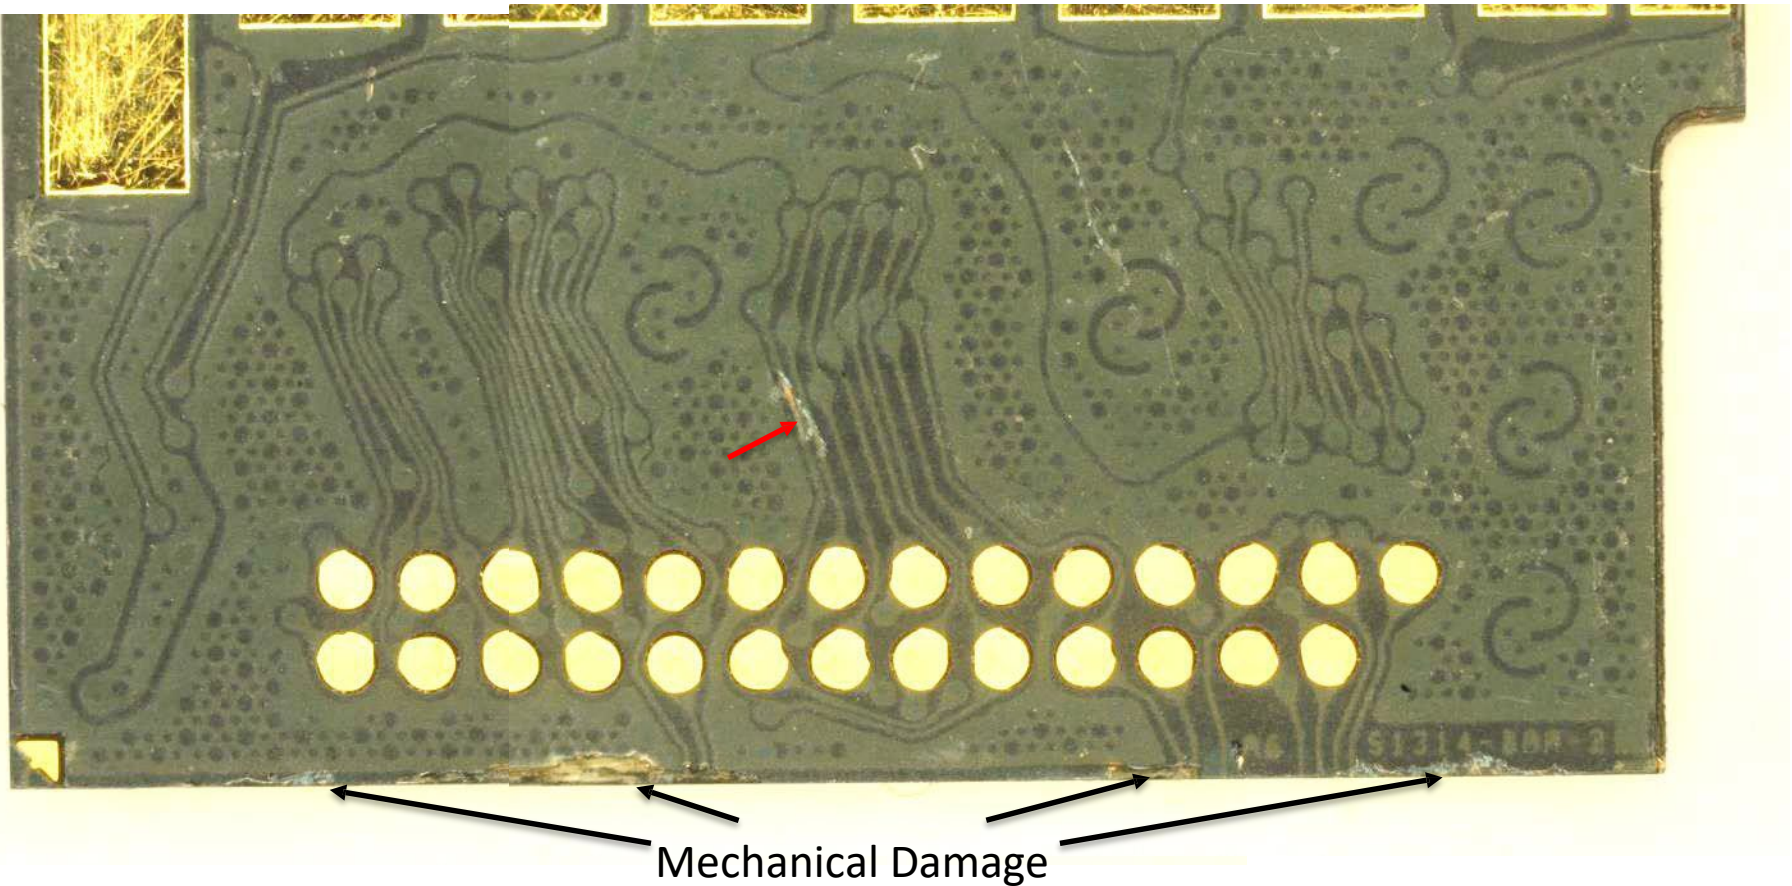
# Back Edge (Bottom Side, Stitched Image)

- Mechanical damage at the edges
- Exposed circuit line in the interior (red arrow) that apparently is still connected
- All other visible (near surface) lines appear to be intact

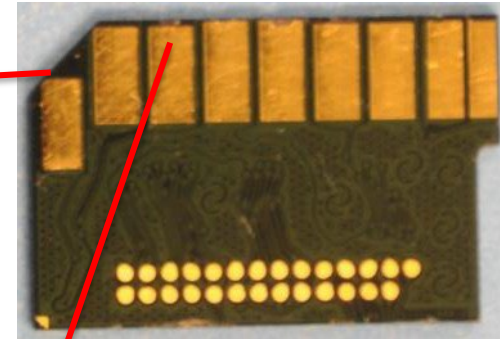
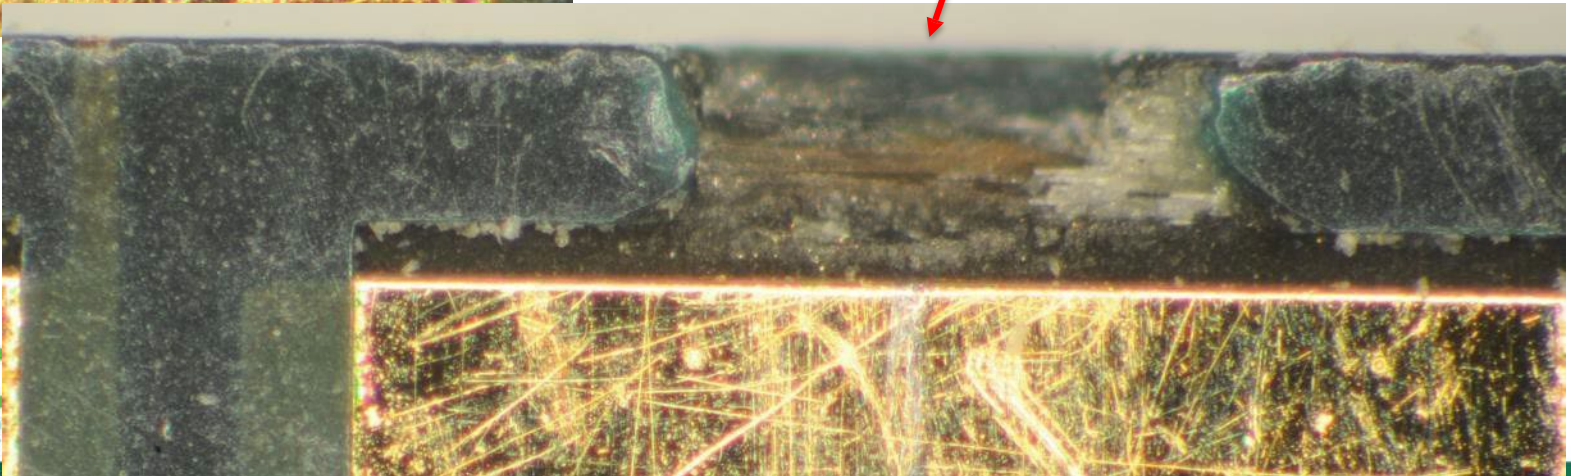
# Higher Mag. View of the Contact Side Peripheral Damage

Laminate crack indicates mechanical stress, but there is no (visible) circuitry here

Damage does not appear to be in an area where there is circuitry

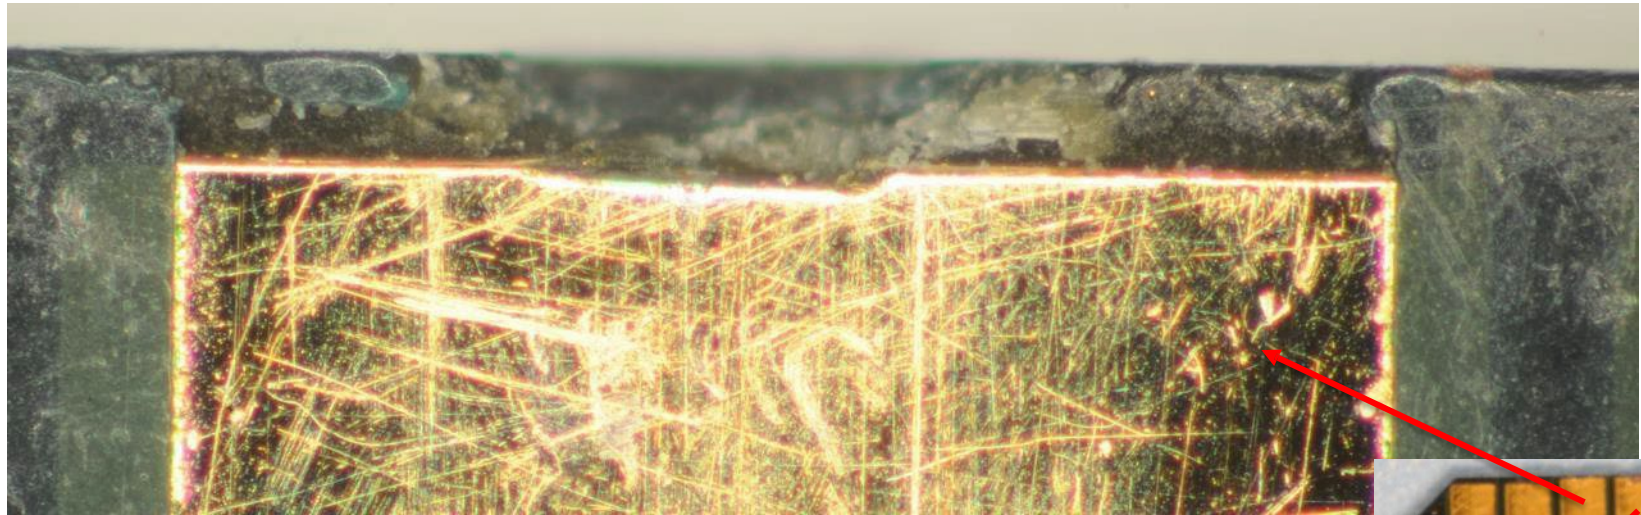
# Higher Mag. View of Contact Side Peripheral Damage

Damage to  
solder mask  
only

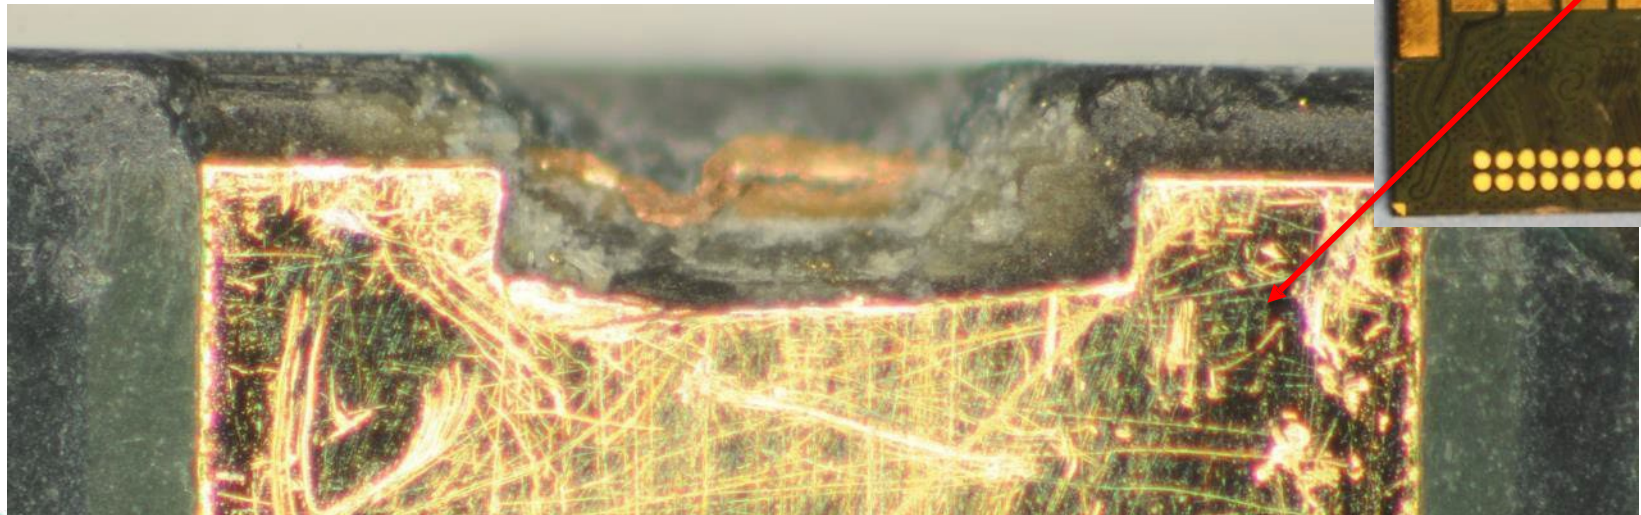
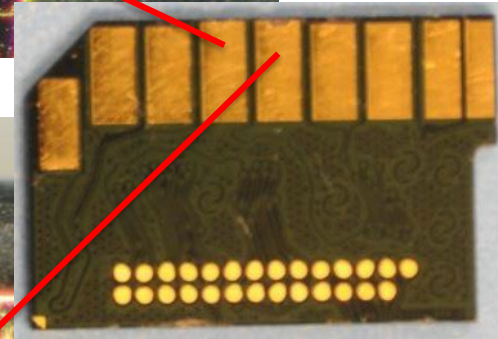
Exposed  
circuit  
line(s);  
possibly a  
short or  
discontinuity

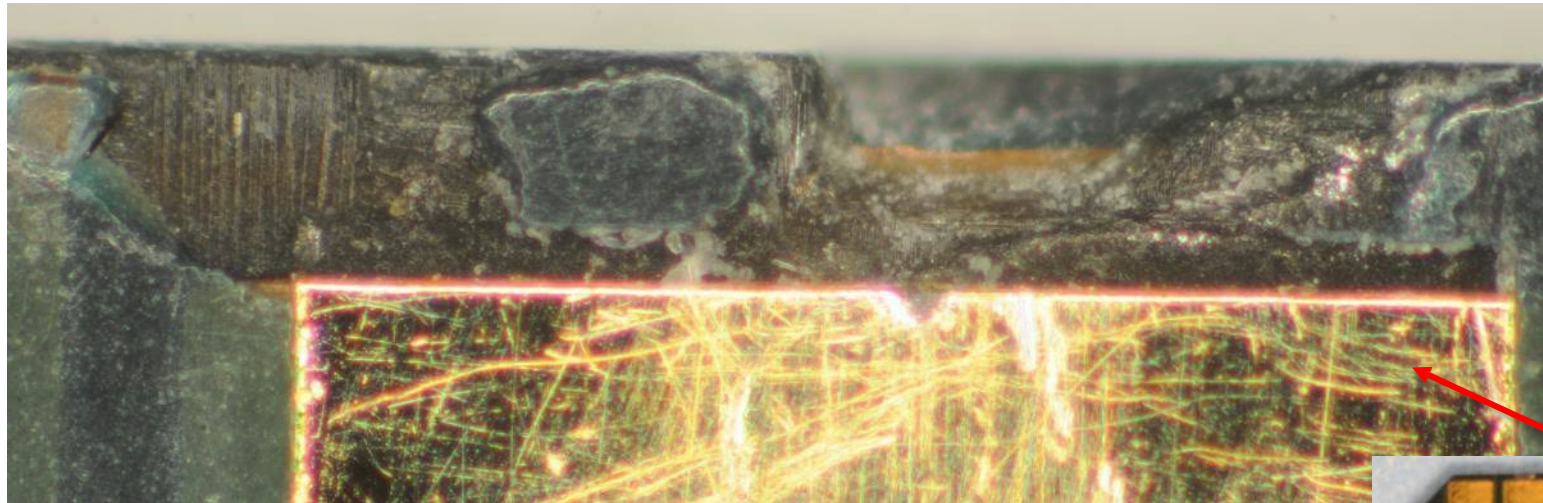
# Higher Mag. View of Contact Side Peripheral Damage

Exposed circuit line, but no evident discontinuity

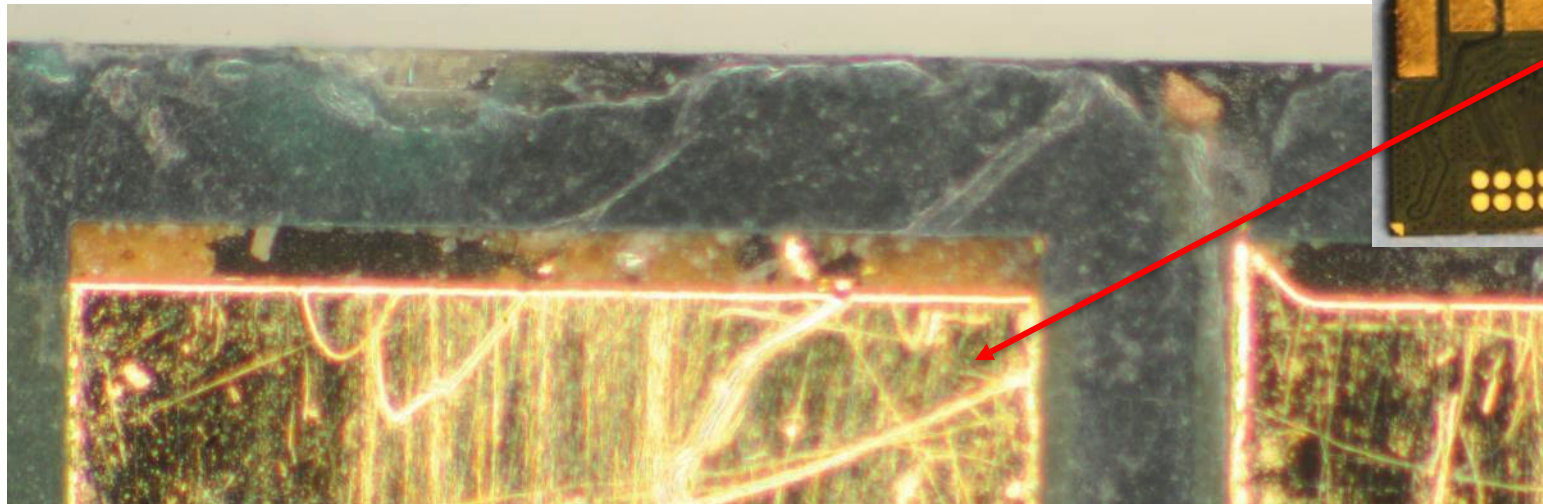
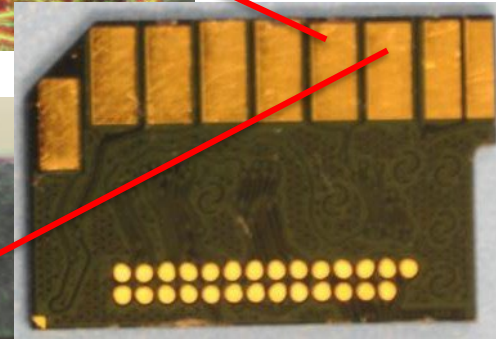
No apparent damage to circuit lines

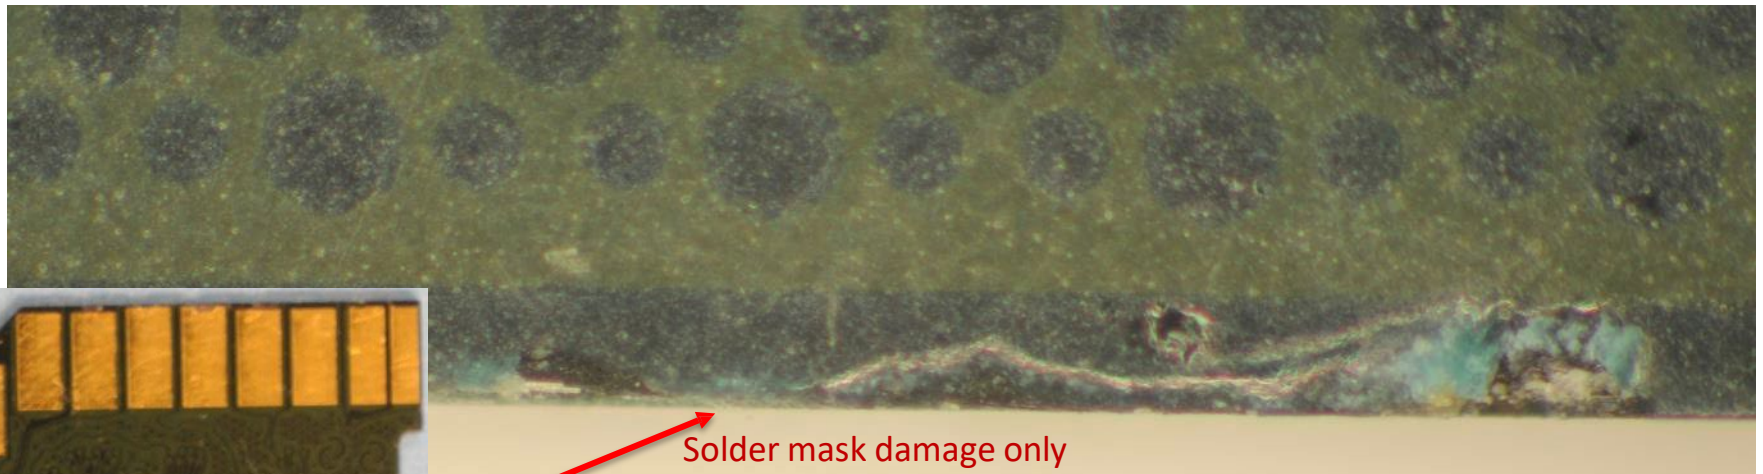
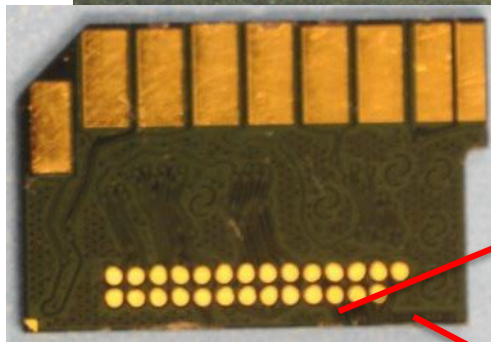
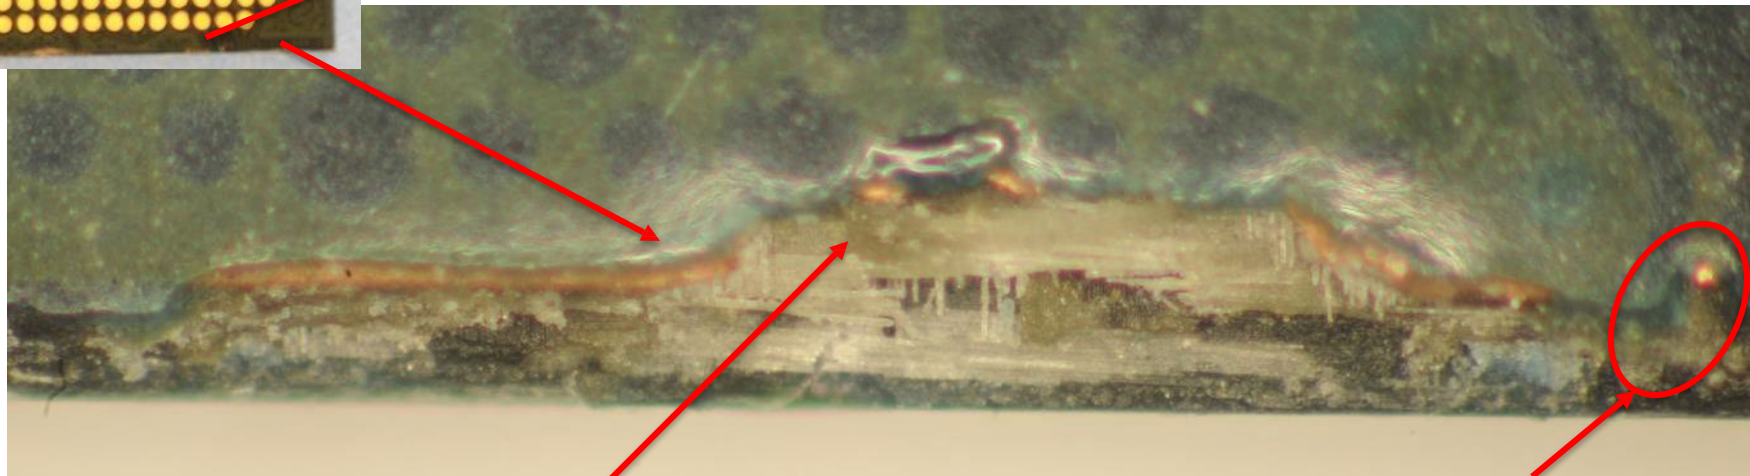
# Higher Mag. View of Back Edge Peripheral Damage

Exposed plating bus bars (yellow arrows), does not affect circuitry

Exposed power (or ground) plane, and exposed plating bus bars, does not affect circuitry

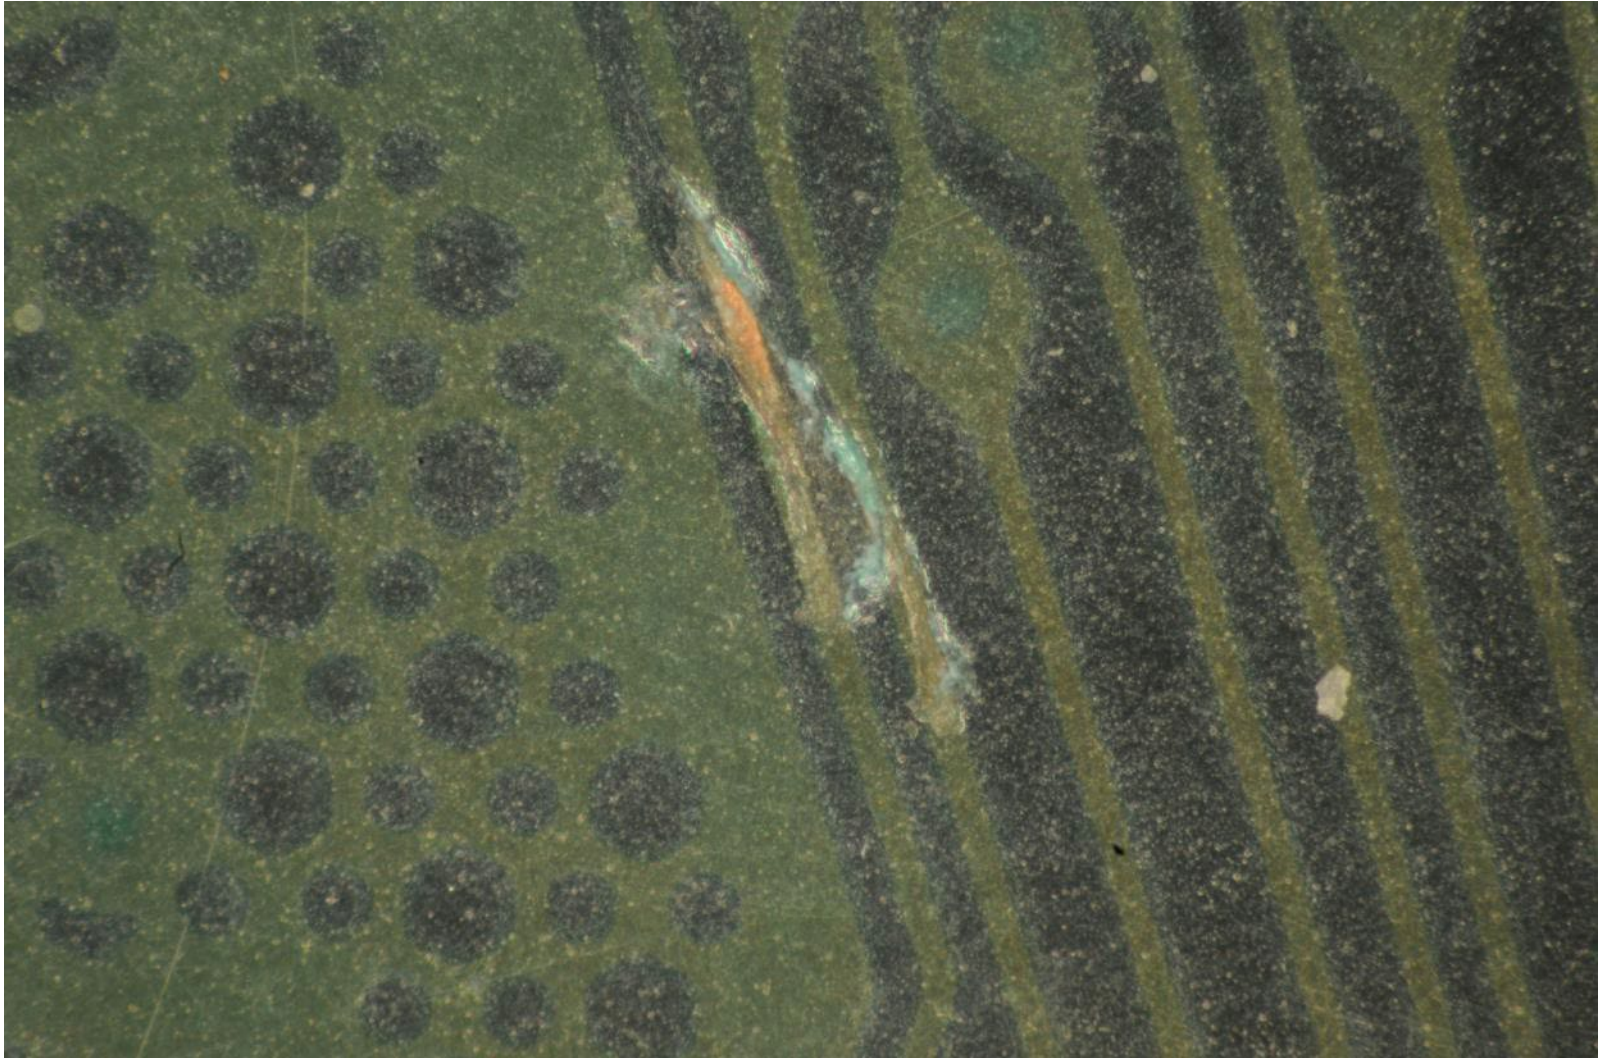
# Zoomed View of Surface Damage on the Interior

Solder mask is scratched, but the circuit line is intact

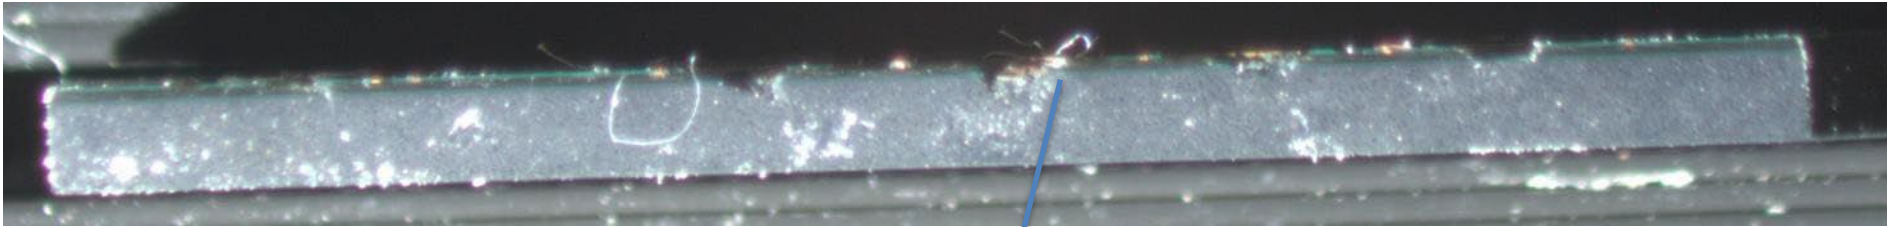
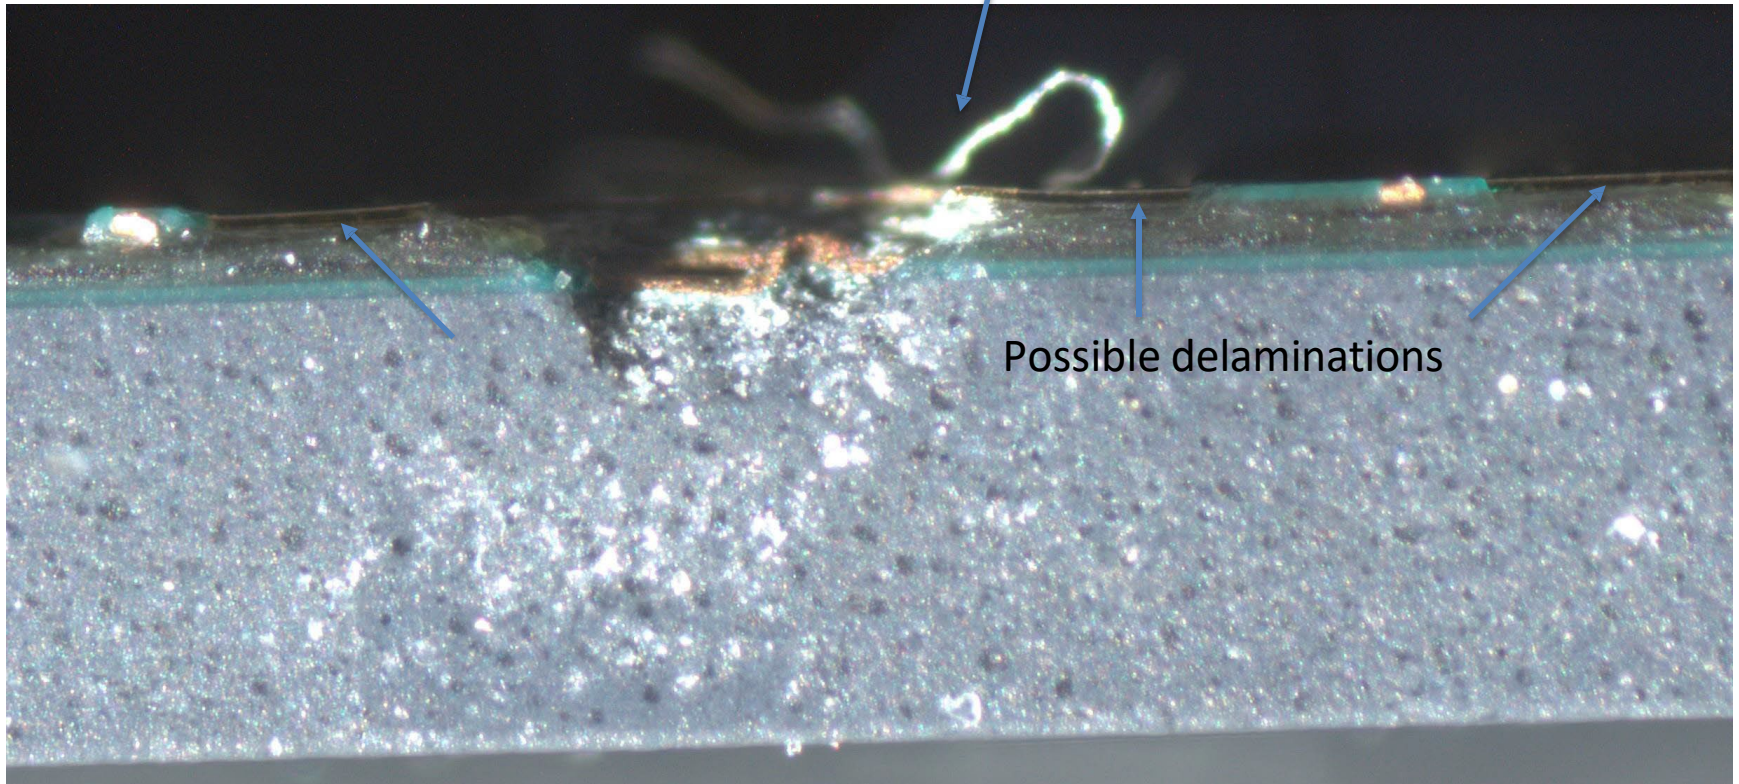
# Edge view

Possible delaminations

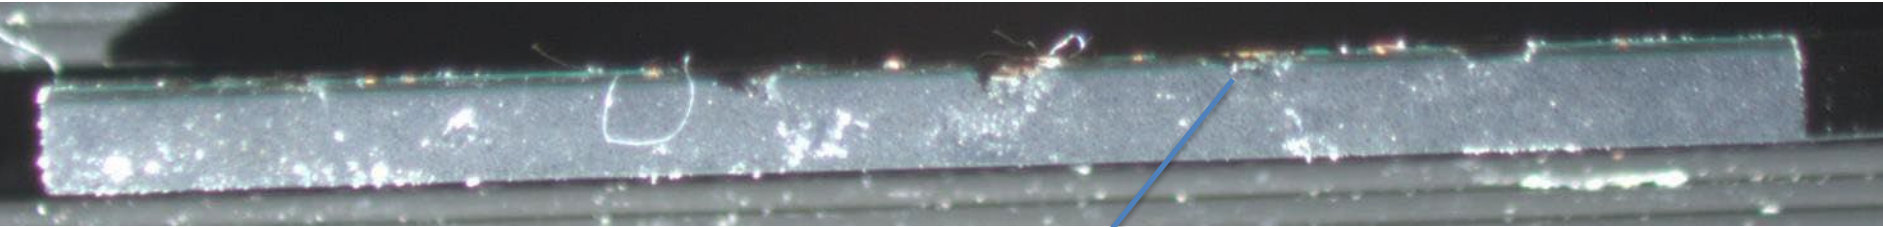
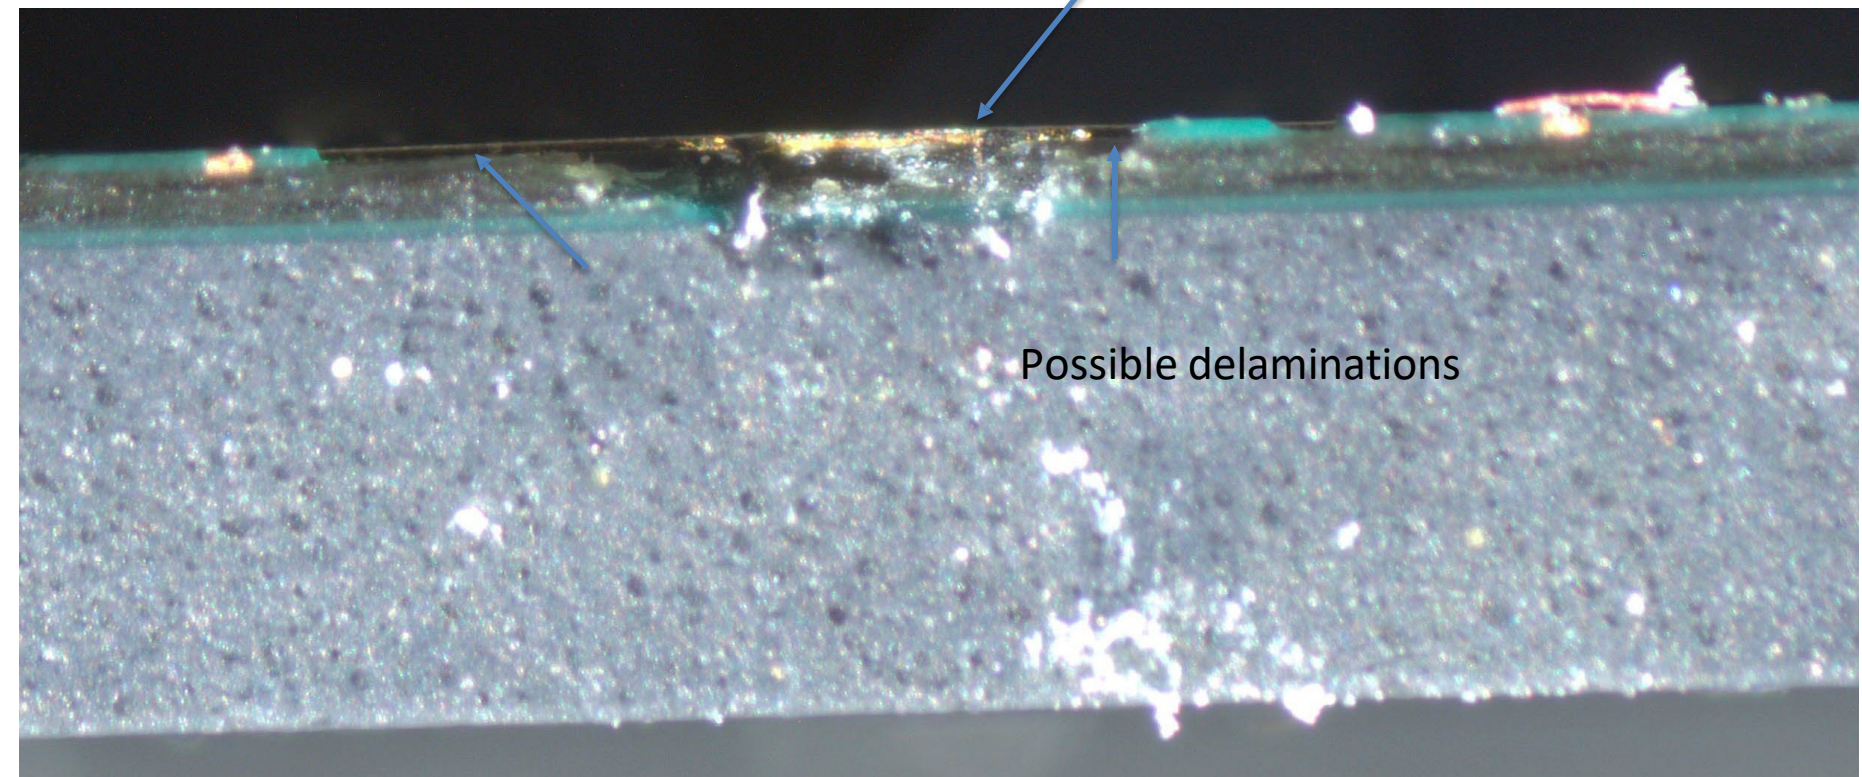
# Edge view

Possible delaminations

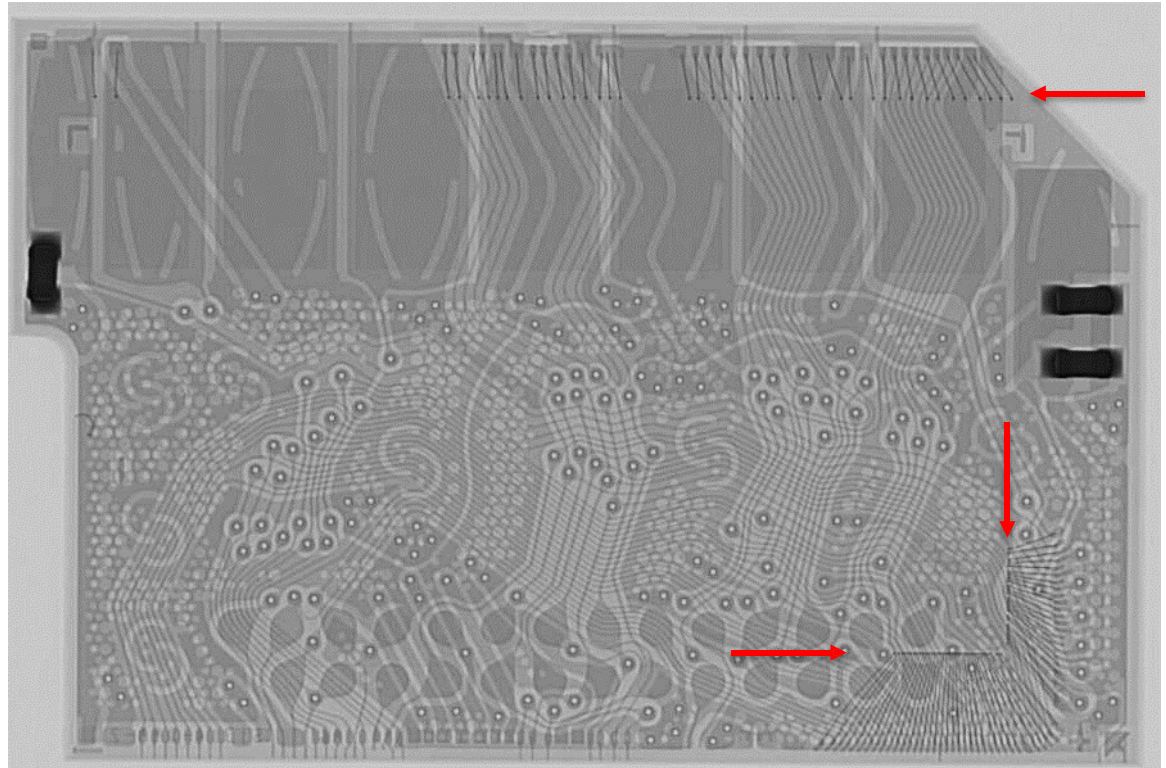
# Configuration of the Module

Edge view shows two layers of chips (red arrows)

Top view shows the wire bond footprint (red arrows)

- Small area in one corner
- Long line along the edge of the package
- Consistent with a stacked chip structure

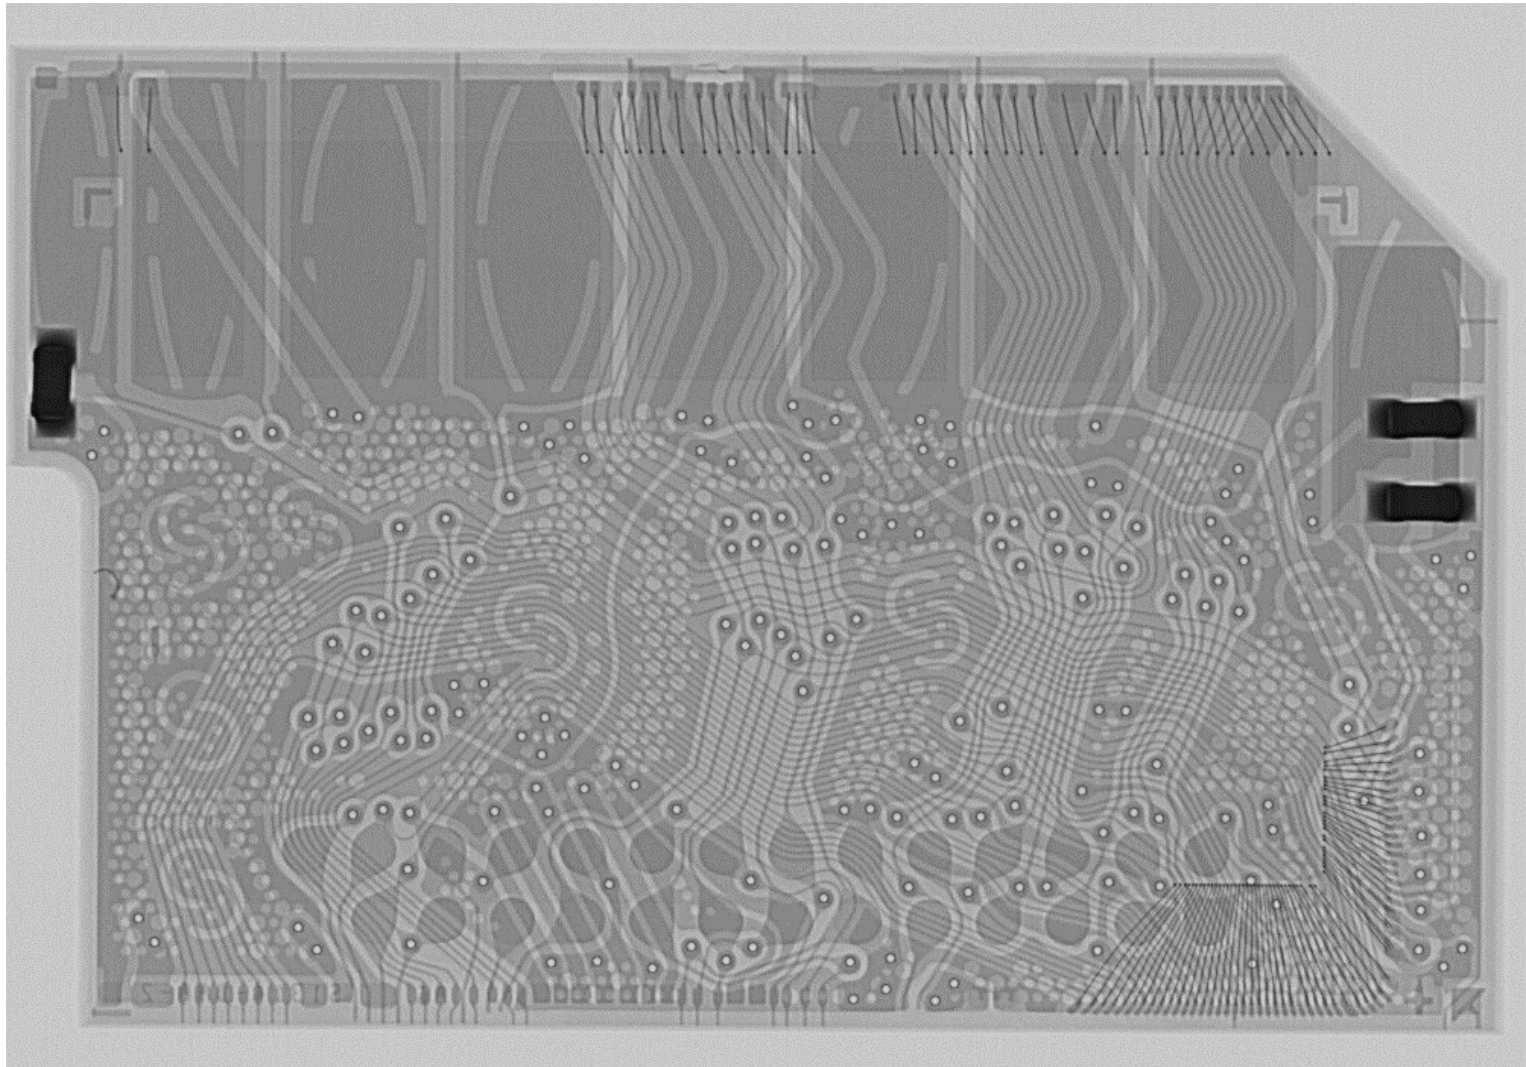
# Global View of the Module

All circuit lines in the interior appear to be intact

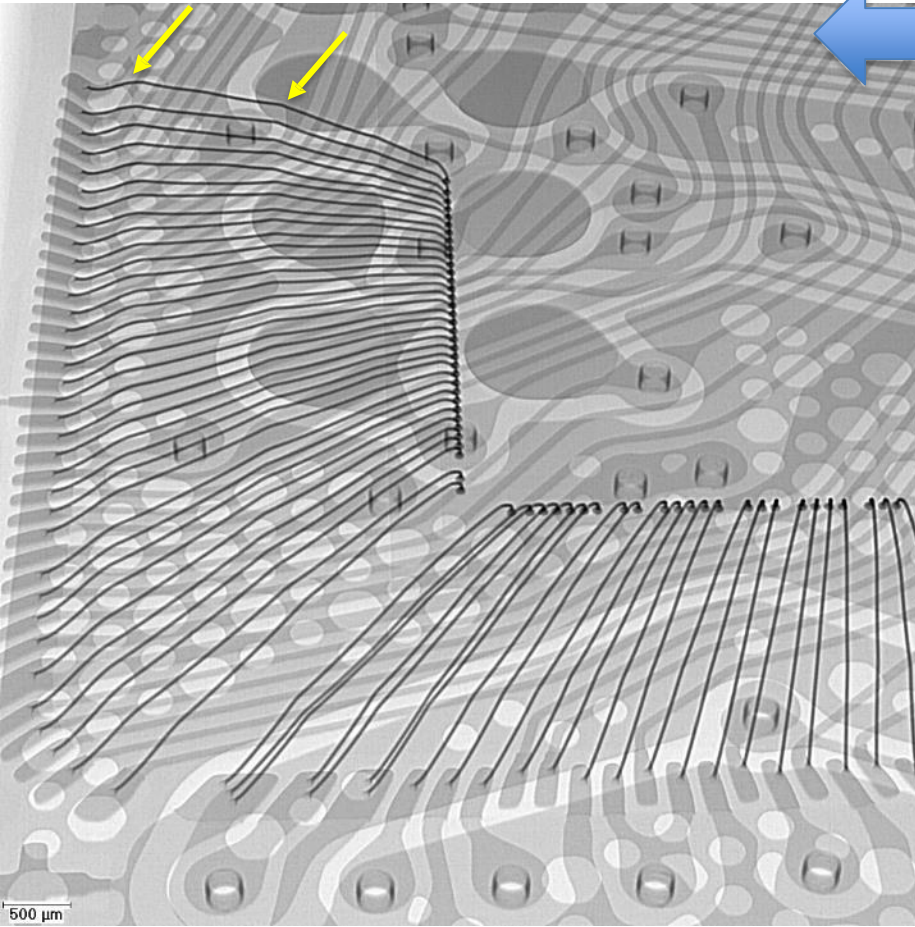
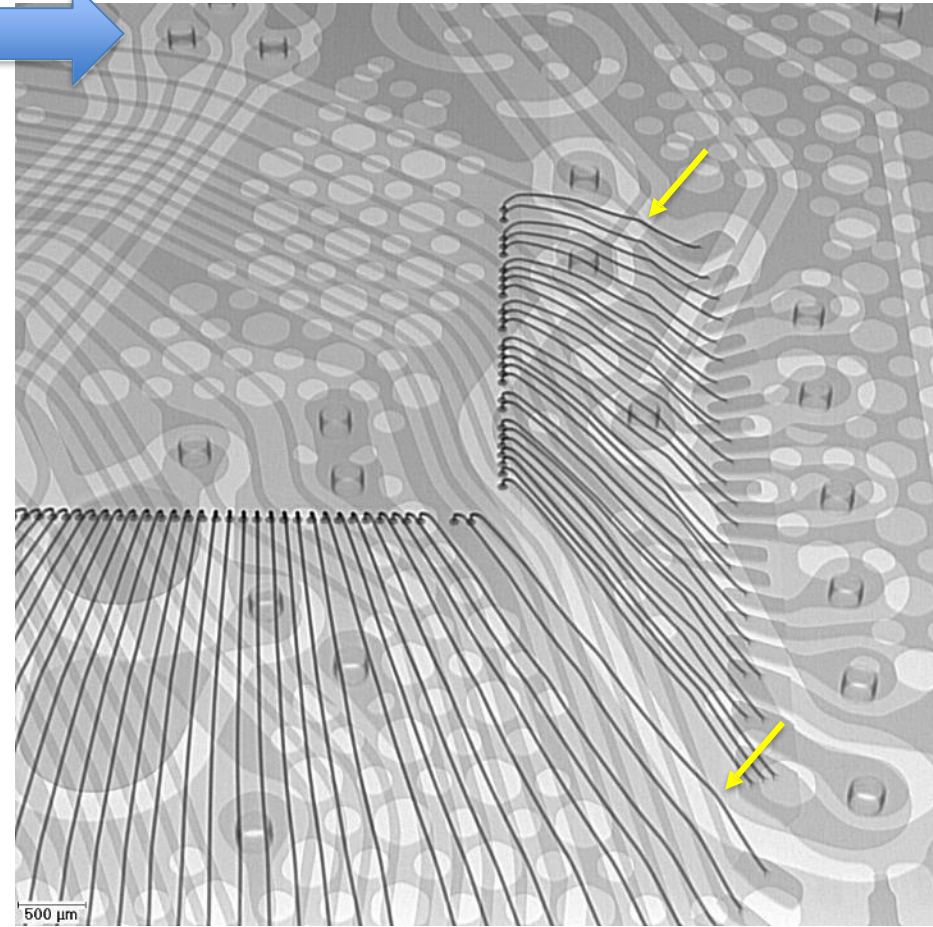
# 45° Tilt Showing Wire Bonds of the Corner Chip

Sharp bend in the wires (yellow arrows) is from the bonding process, not from a mechanical bend or crack of the package
