# National Transportation Safety Board

ERA23FA047

## **G-1000 SD CARD**

Specialist's Factual Report

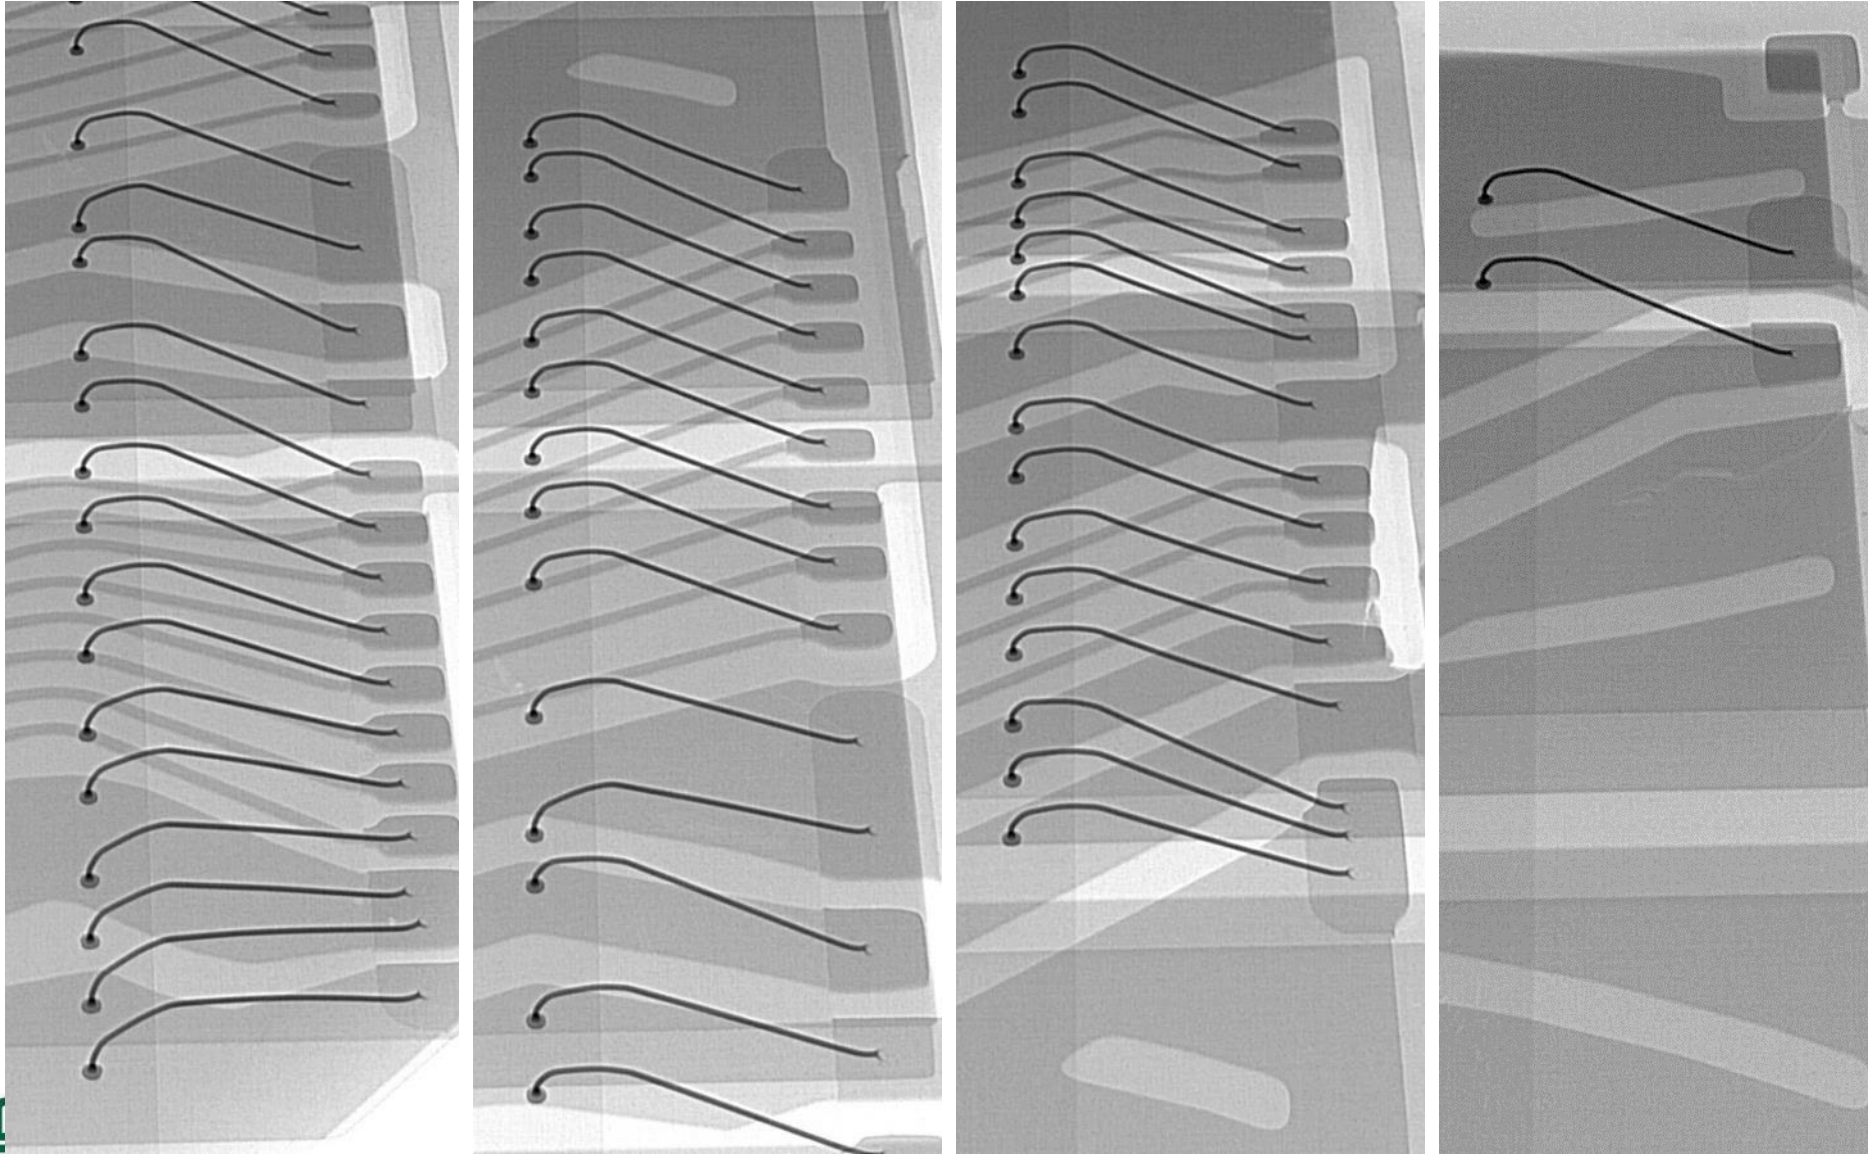
# 45° Tilted View of the Wire Bonds Along the Package Edge

All wire bonds well formed with no apparent breaks

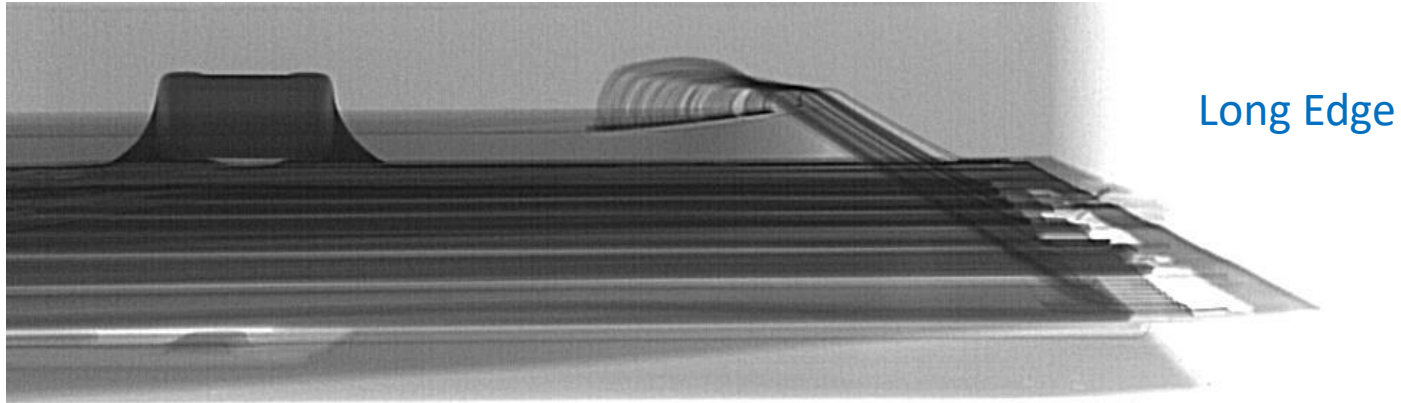
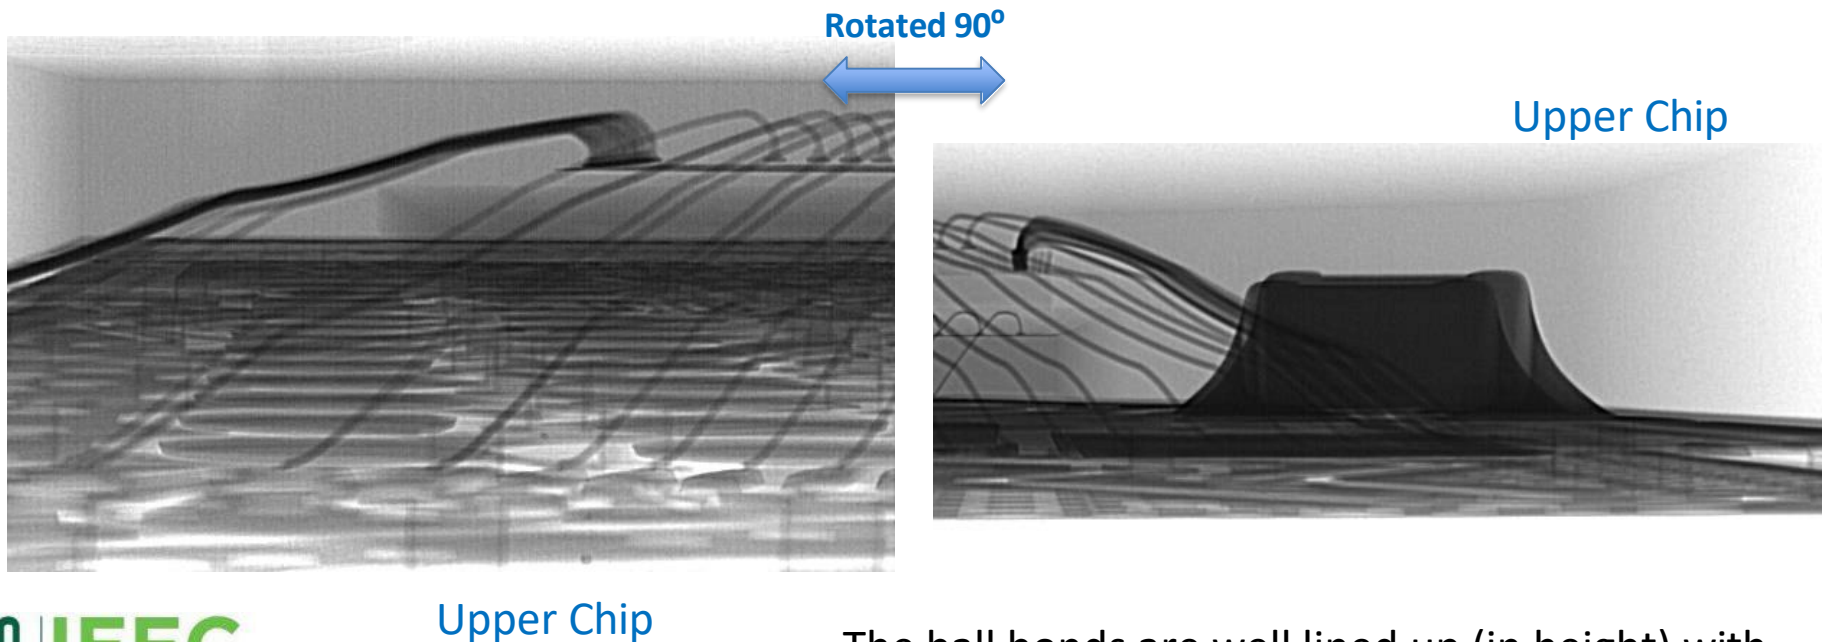
# End View of the Rows of Wire Bonds (Note the Ball Bonds)

The ball bonds are well lined up (in height) with no evidence of being lifted from the chip

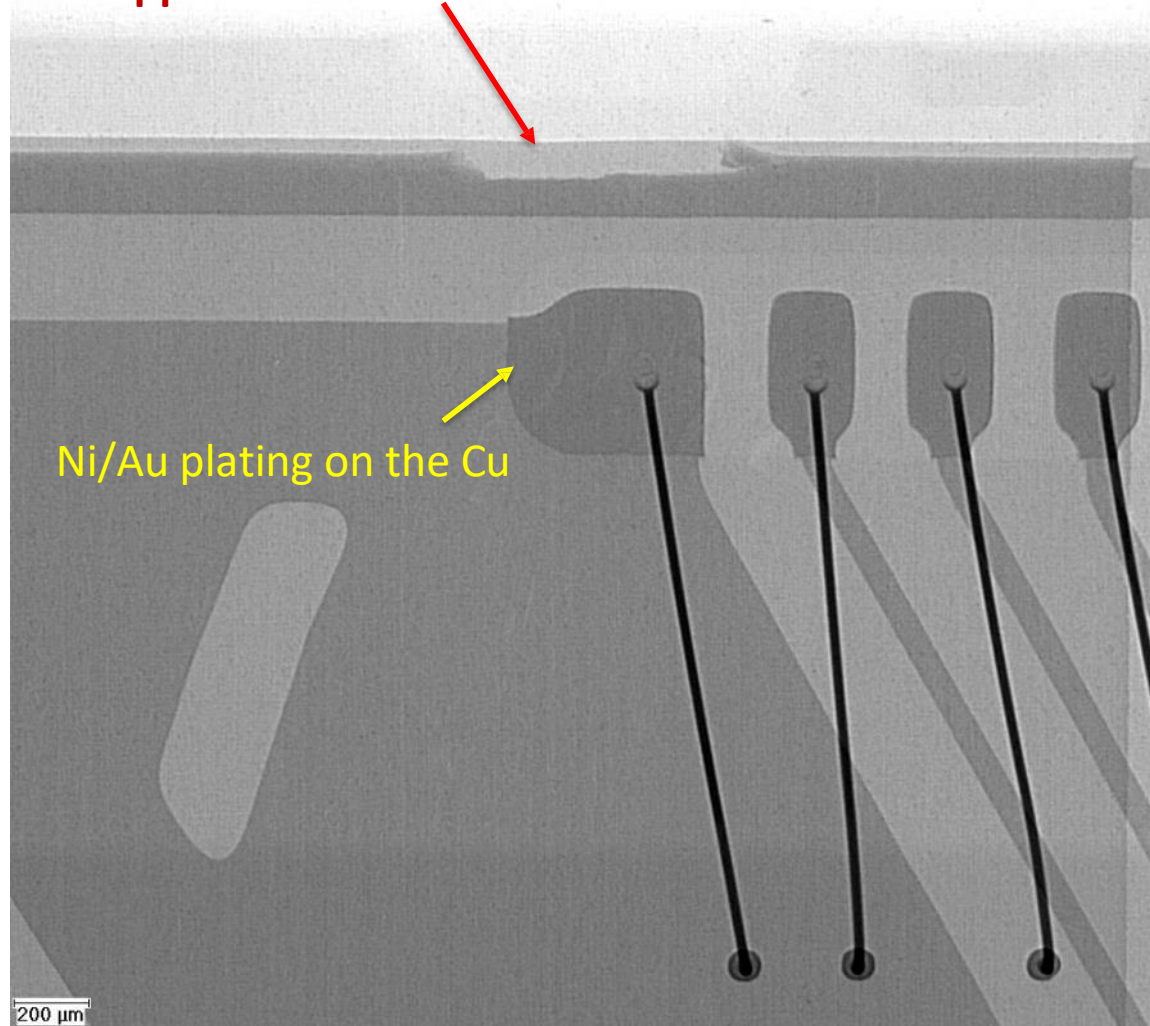
# Zoomed View of the Peripheral Damage

Damage does not appear to have severed the circuit line

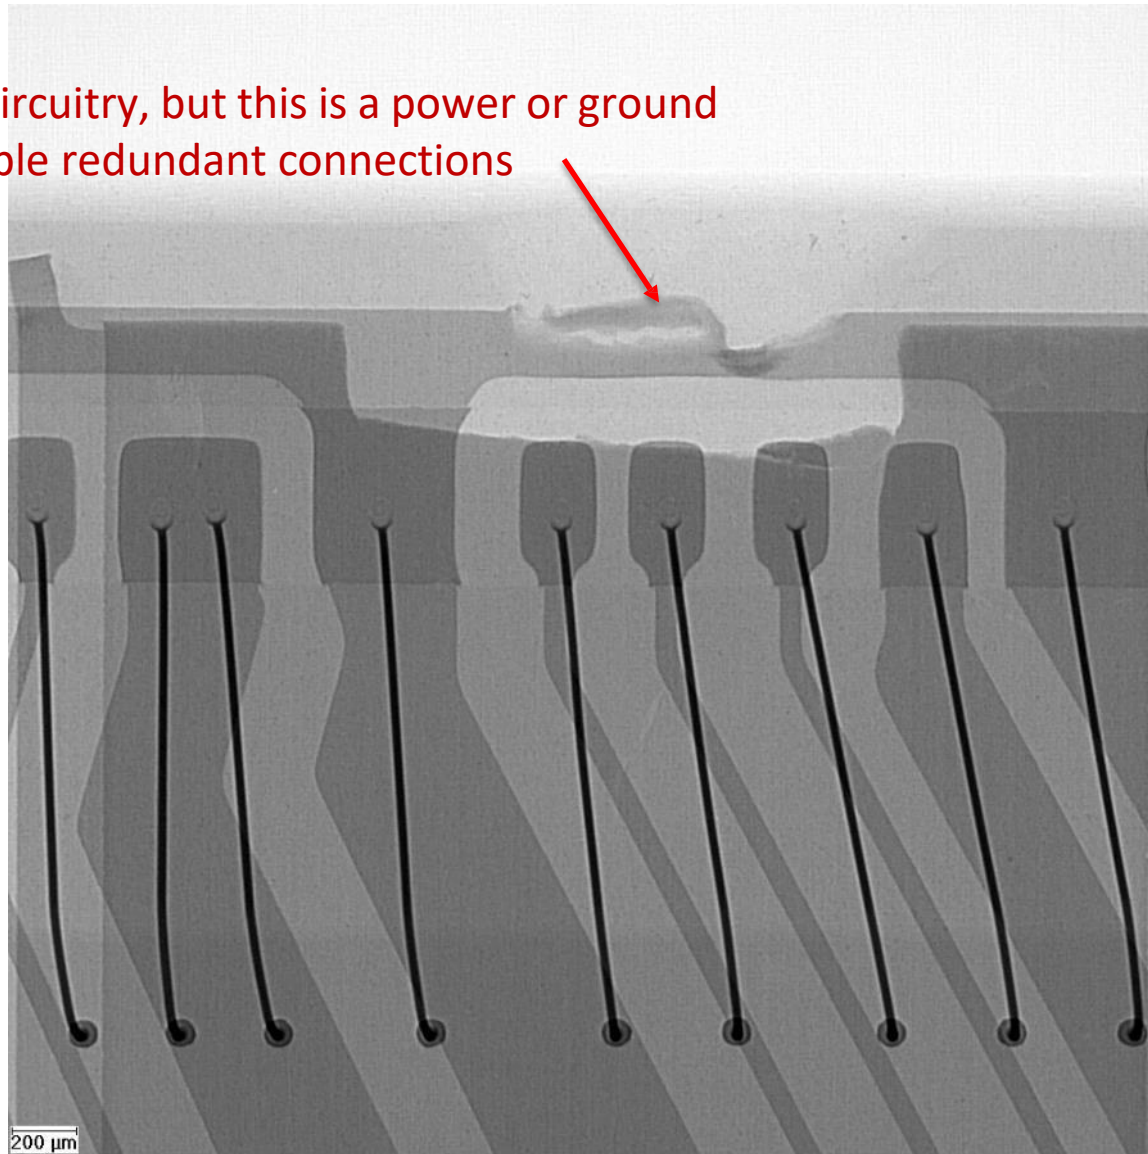
# Zoomed View of the Peripheral Damage, cont'd.

Damage to the circuitry, but this is a power or ground which has multiple redundant connections

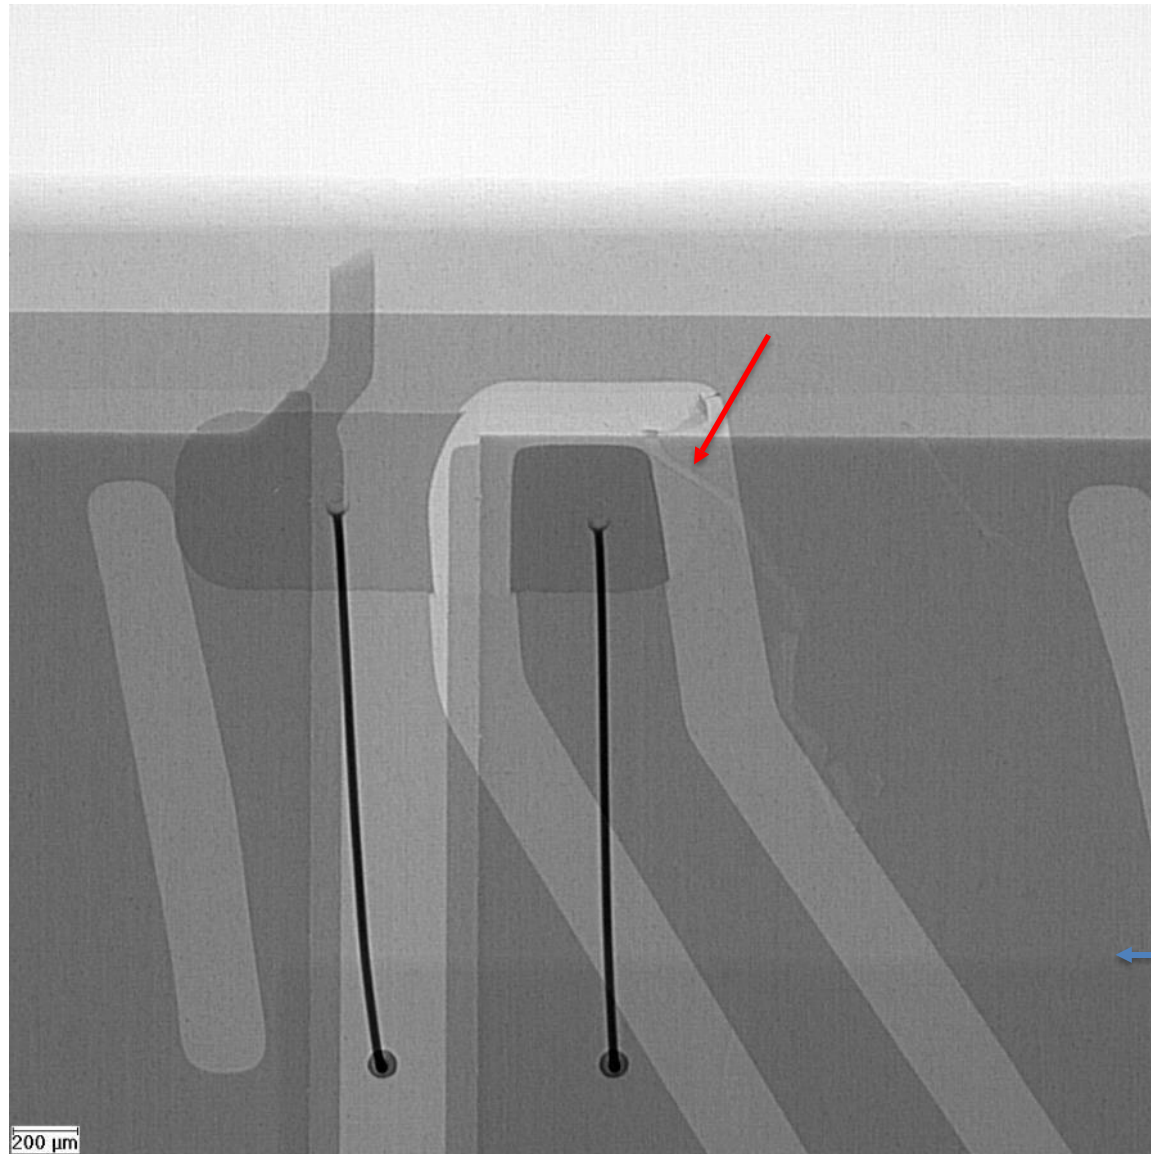
# Crack in the Package, but This Stops Before Reaching the Chip

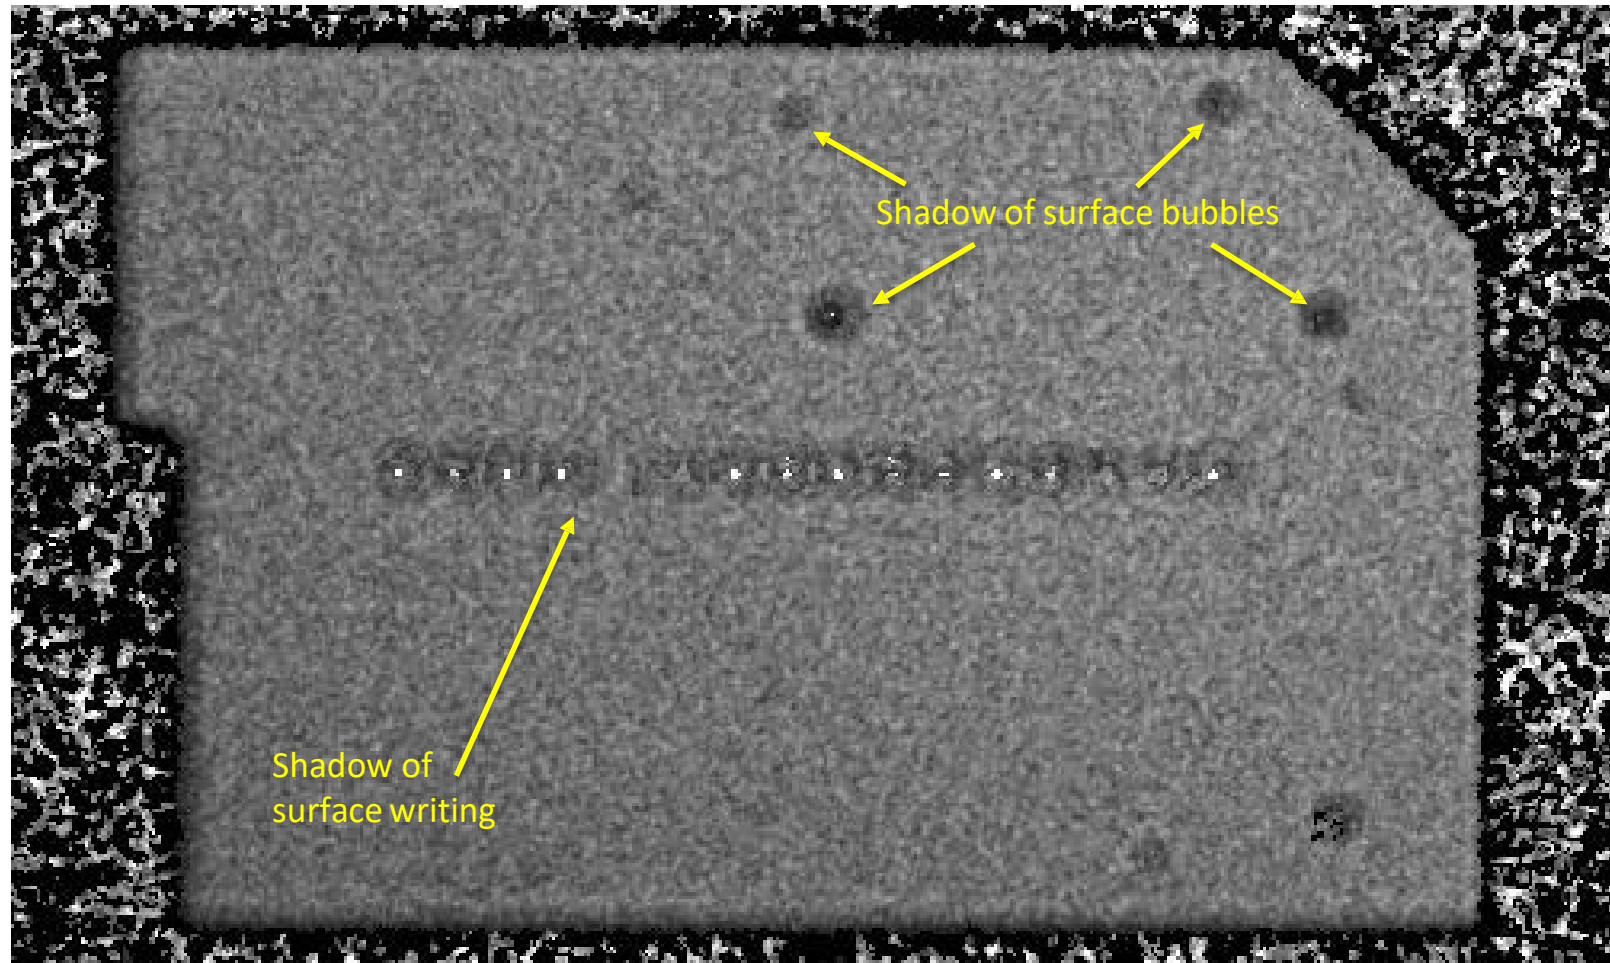
# Overmold

No evidence of damage inside the overmold

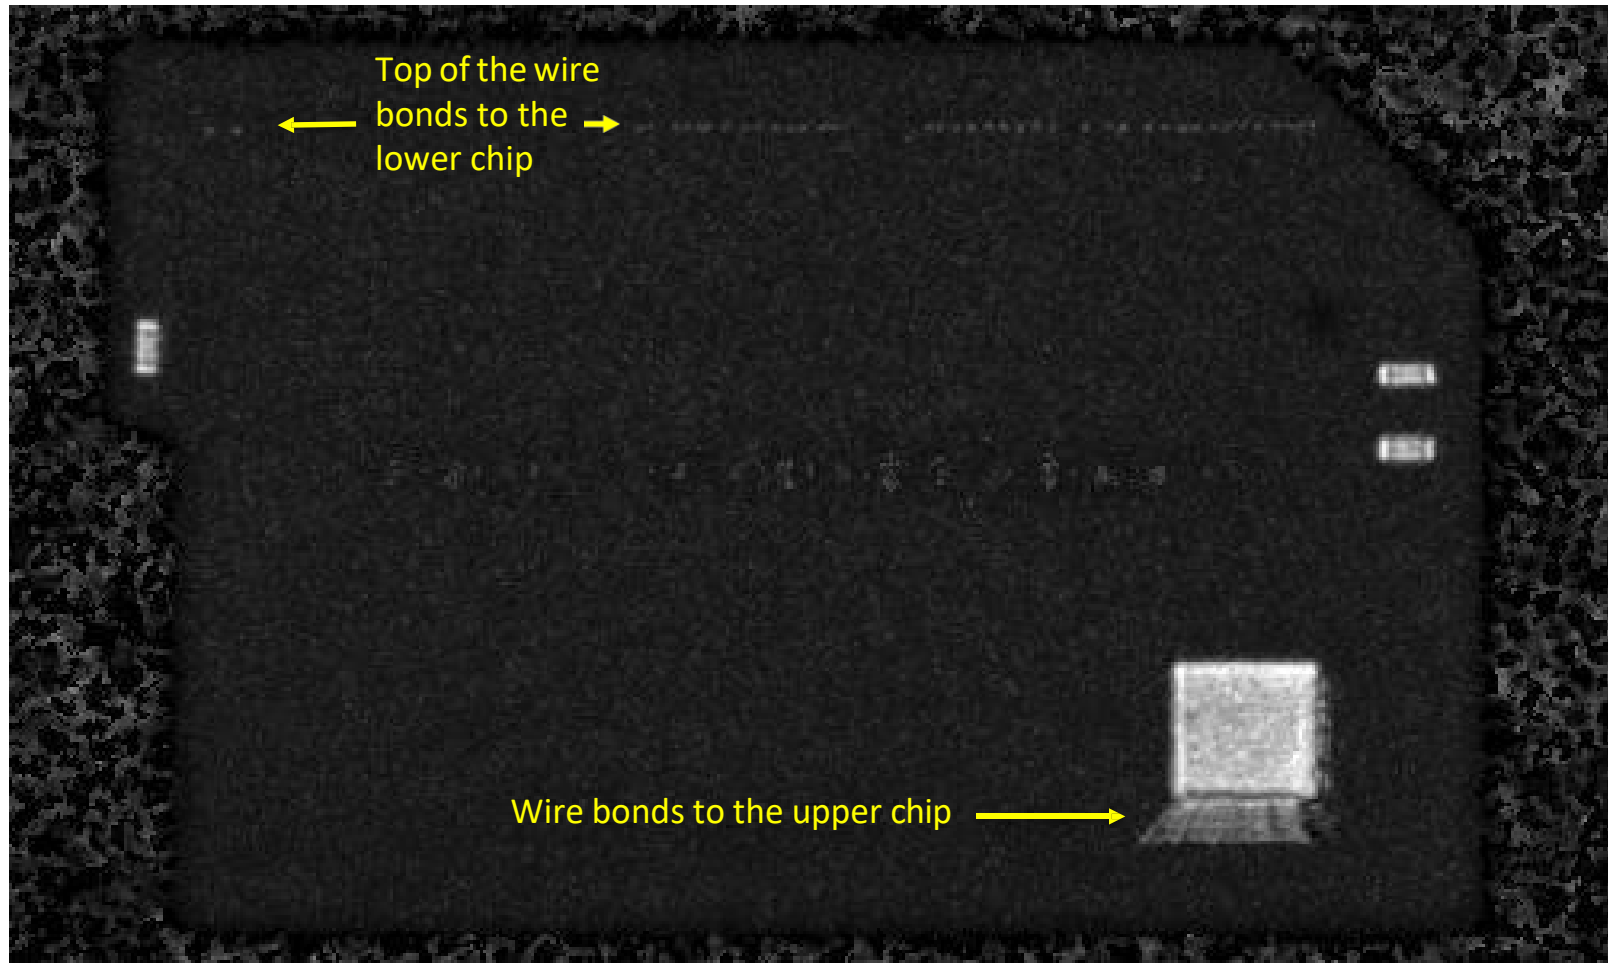
# Top of the Upper Chip

No evidence of damage to the upper chip

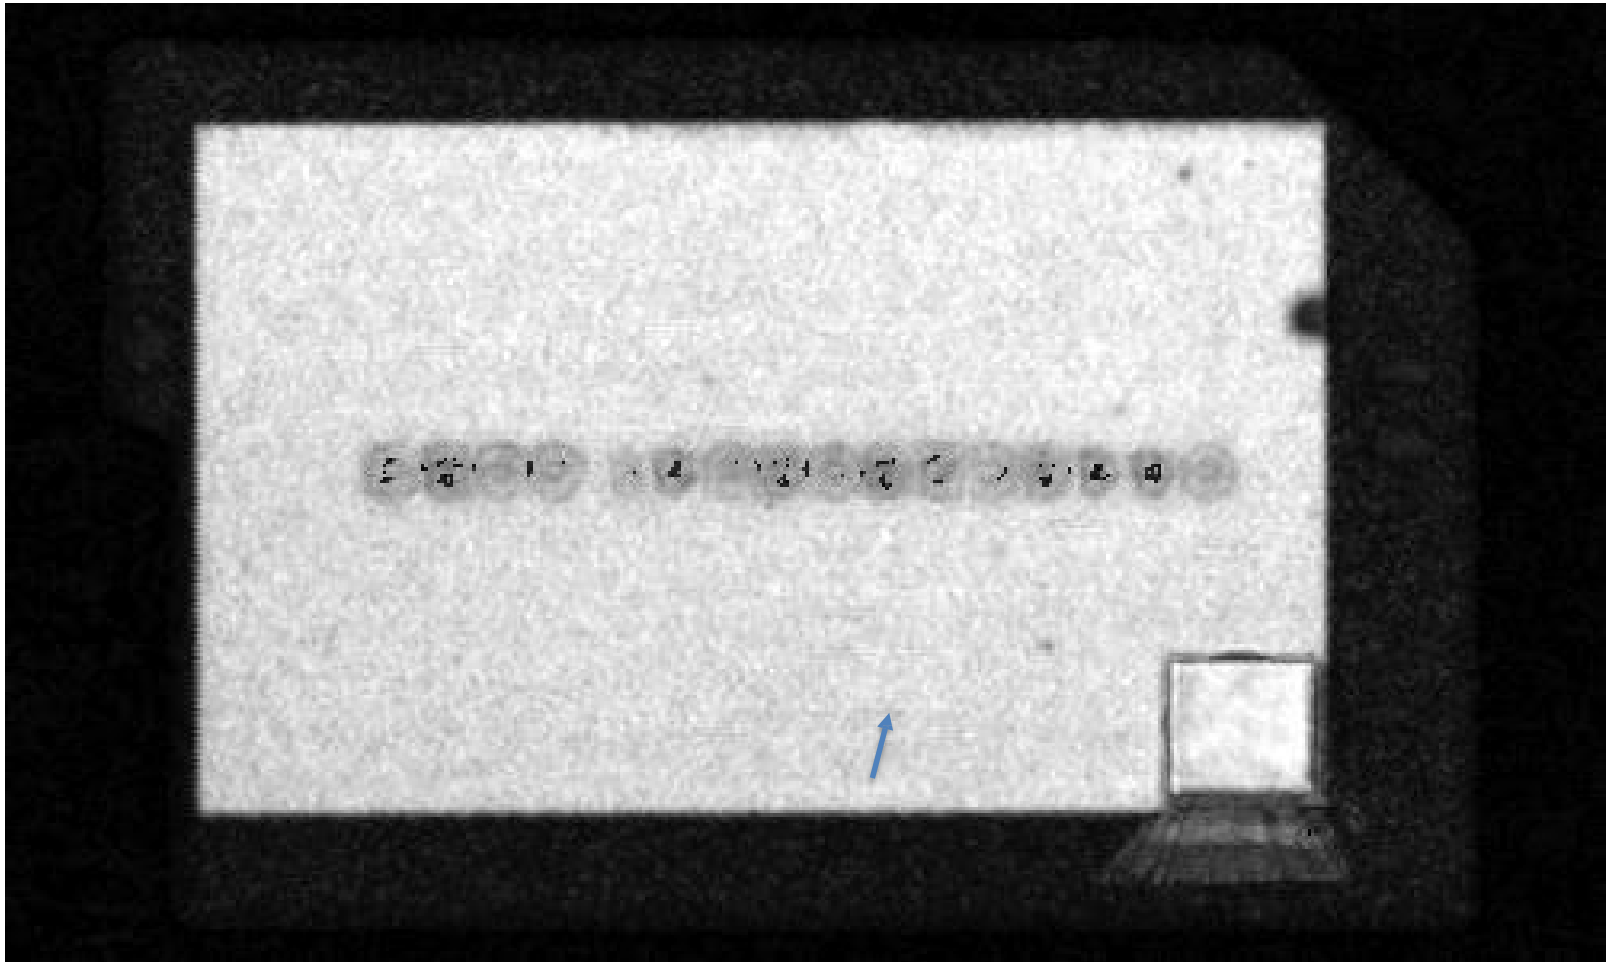
# Top of the Lower Chip

- Very faint line, possibly indicating a crack (arrow, and c.f. following page for highlight of the line)
- Unclear if this really is a crack, or simply an anomaly related to the molding compound

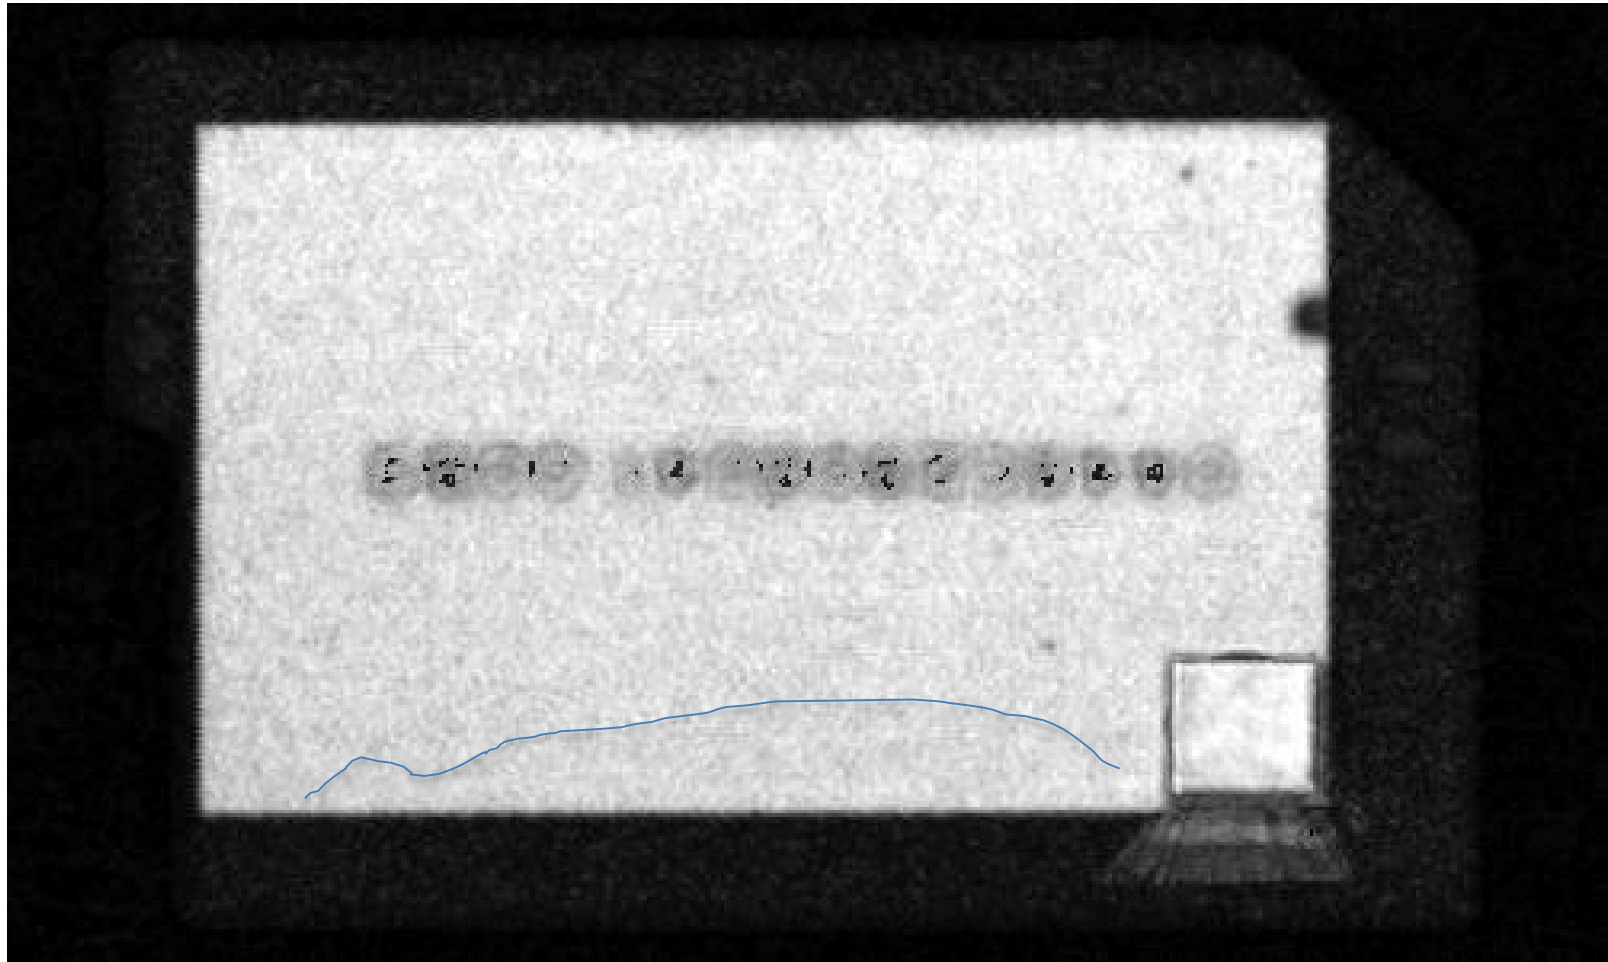
# Top of the Lower Chip with Line Highlighting the Anomaly

- Very faint line, possibly indicating a crack (c.f. line)
- Unclear if this really is a crack, or simply an anomaly related to the molding compound

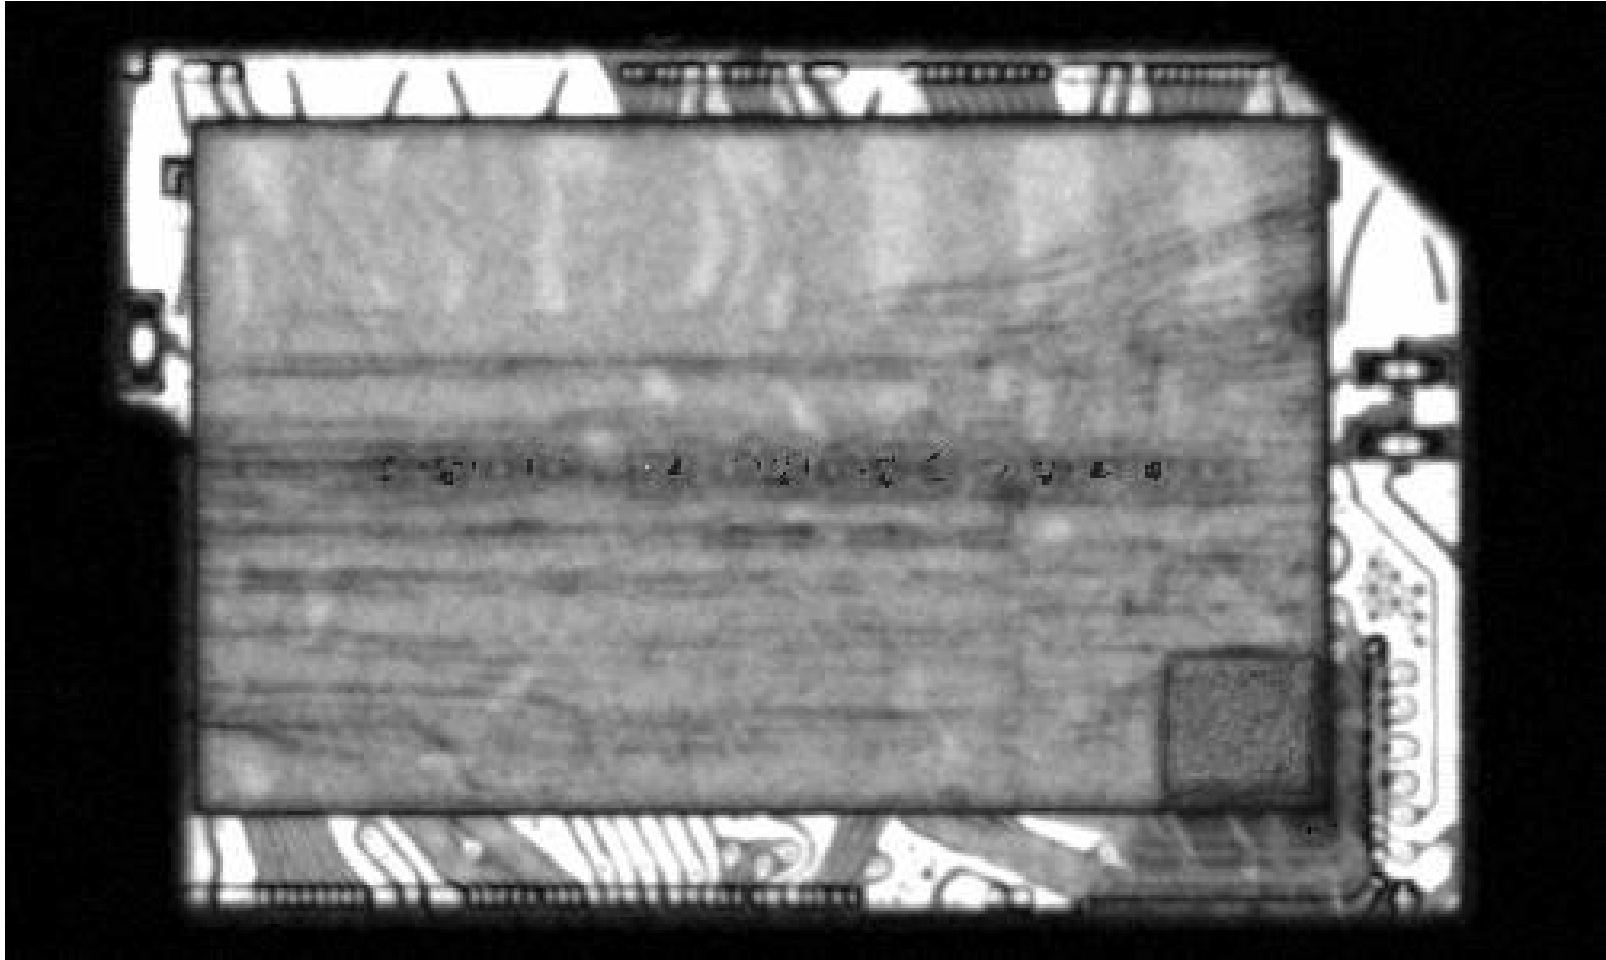
# Bottom of the Lower Chip (and Laminate Periphery)

- Horizontal streaks in the area of the lower chip are readily seen
- Unclear if these streaks indicate mechanical damage (hence likely damage to the chip), or if they are simply due to nonuniformities in the chip adhesive

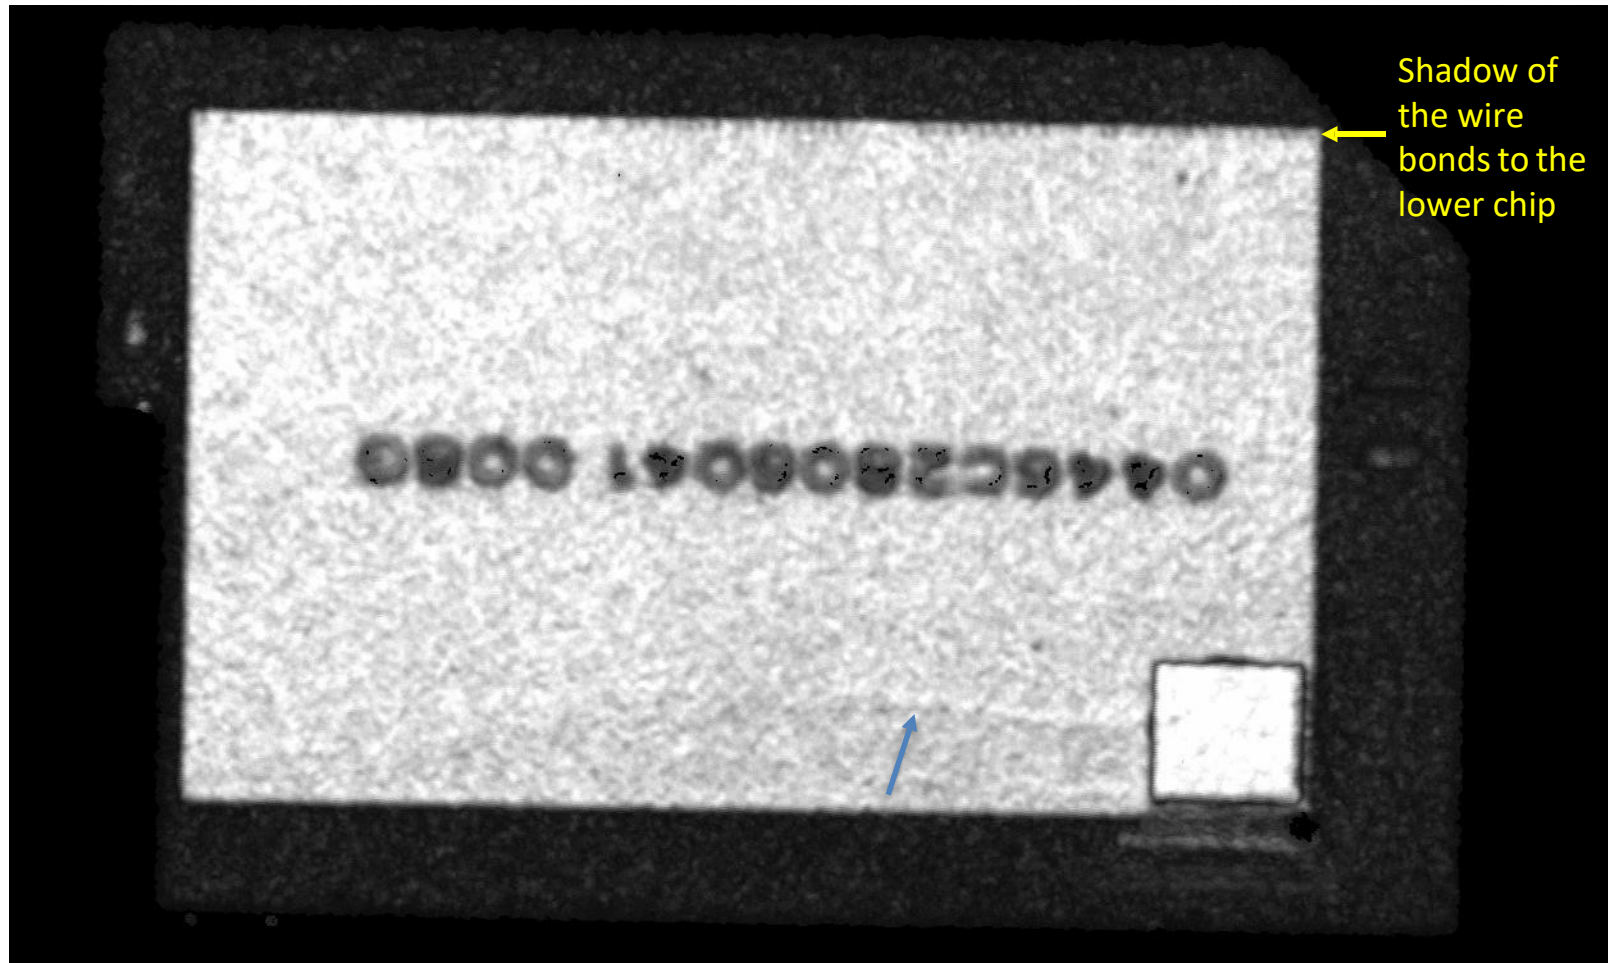
# Top of the Lower Chip with a 150 MHz Transducer

- Very faint line, possibly indicating a crack (blue arrow)
- Even with the higher resolution transducer, it remains unclear if this really is a crack, or simply an anomaly related to the molding compound

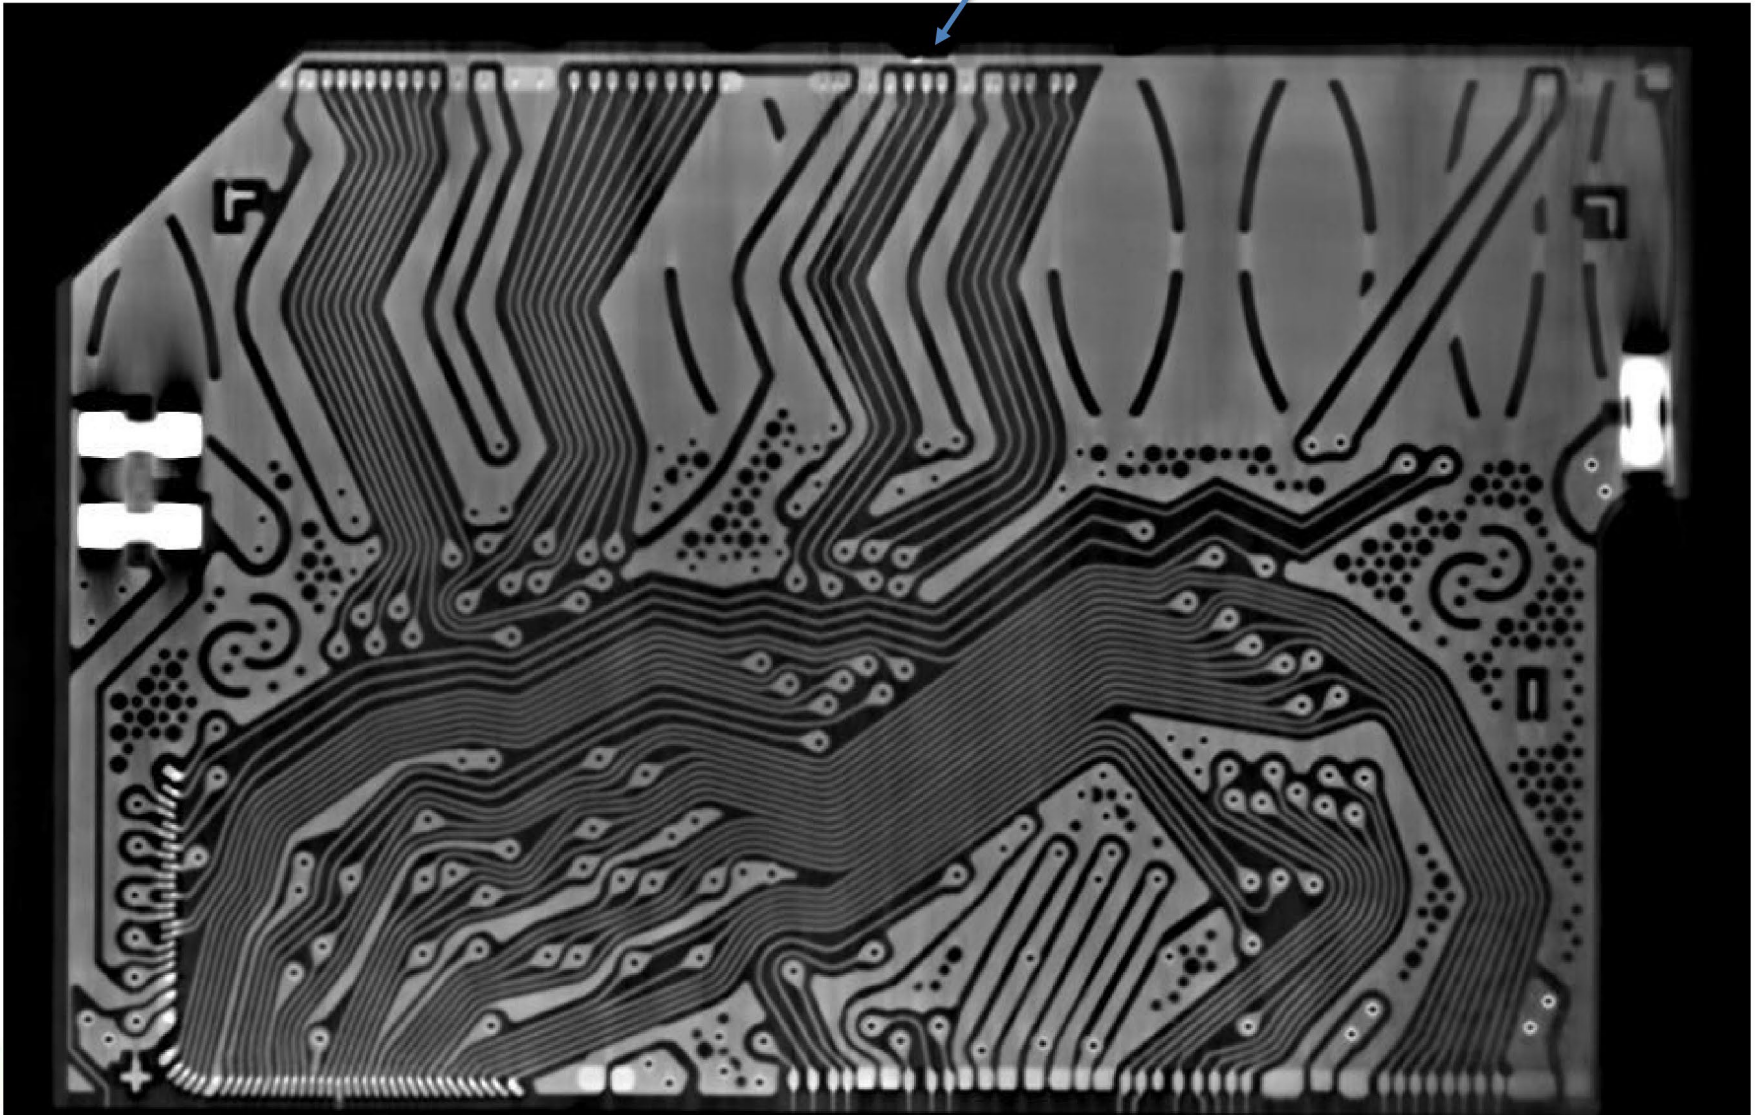
# Inner plane

Damaged area

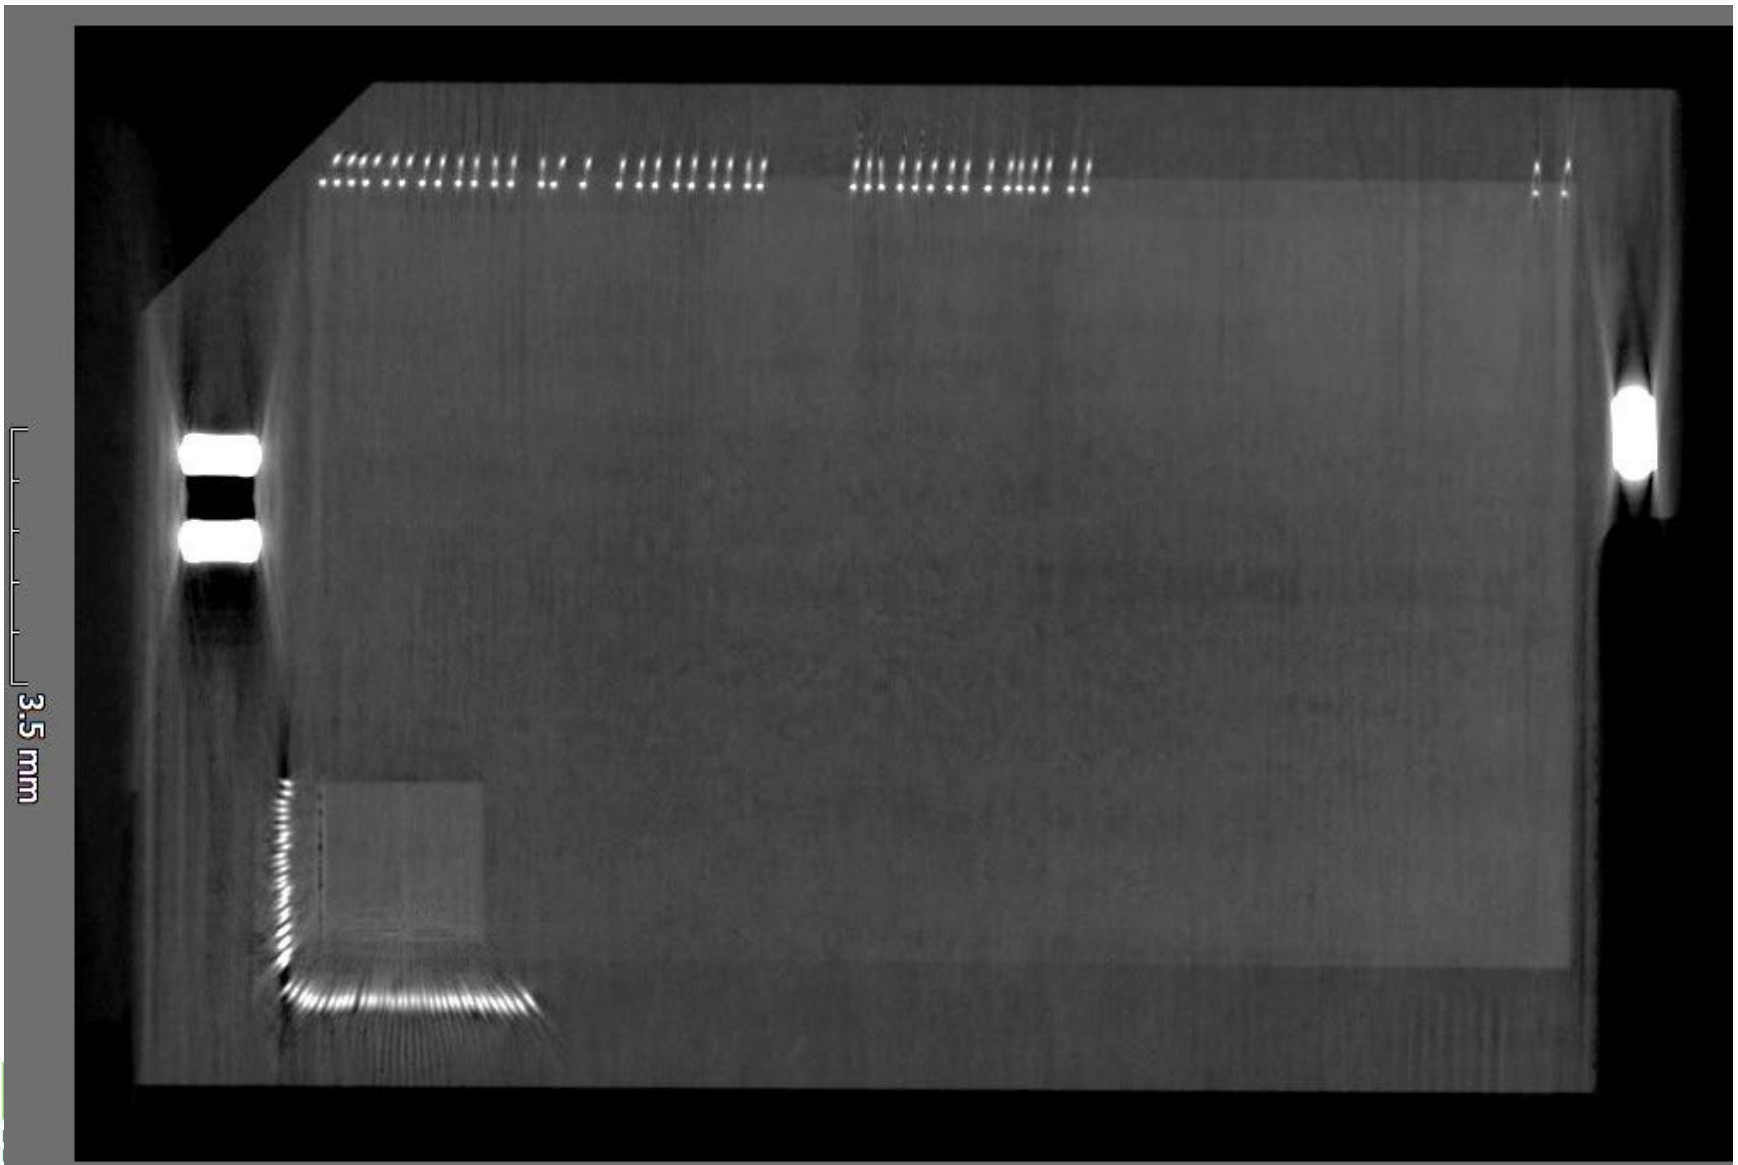
# Large and small die- no anomalies detected

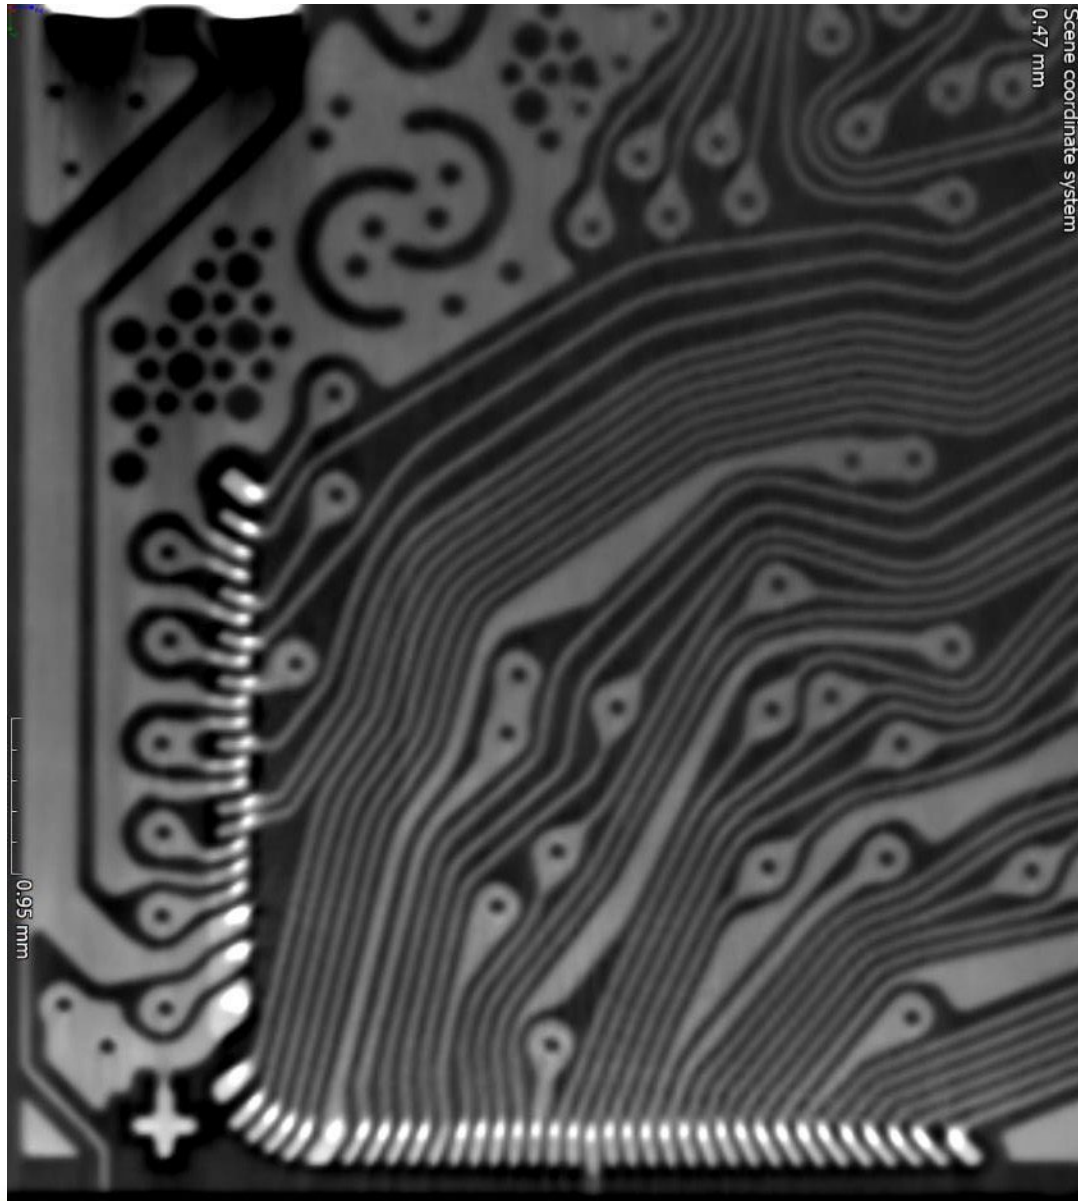
# Small die wirebonds- no anomalies found
