# National Transportation Safety Board

ERA23FA047

## **G-1000 SD CARD**

Specialist's Factual Report

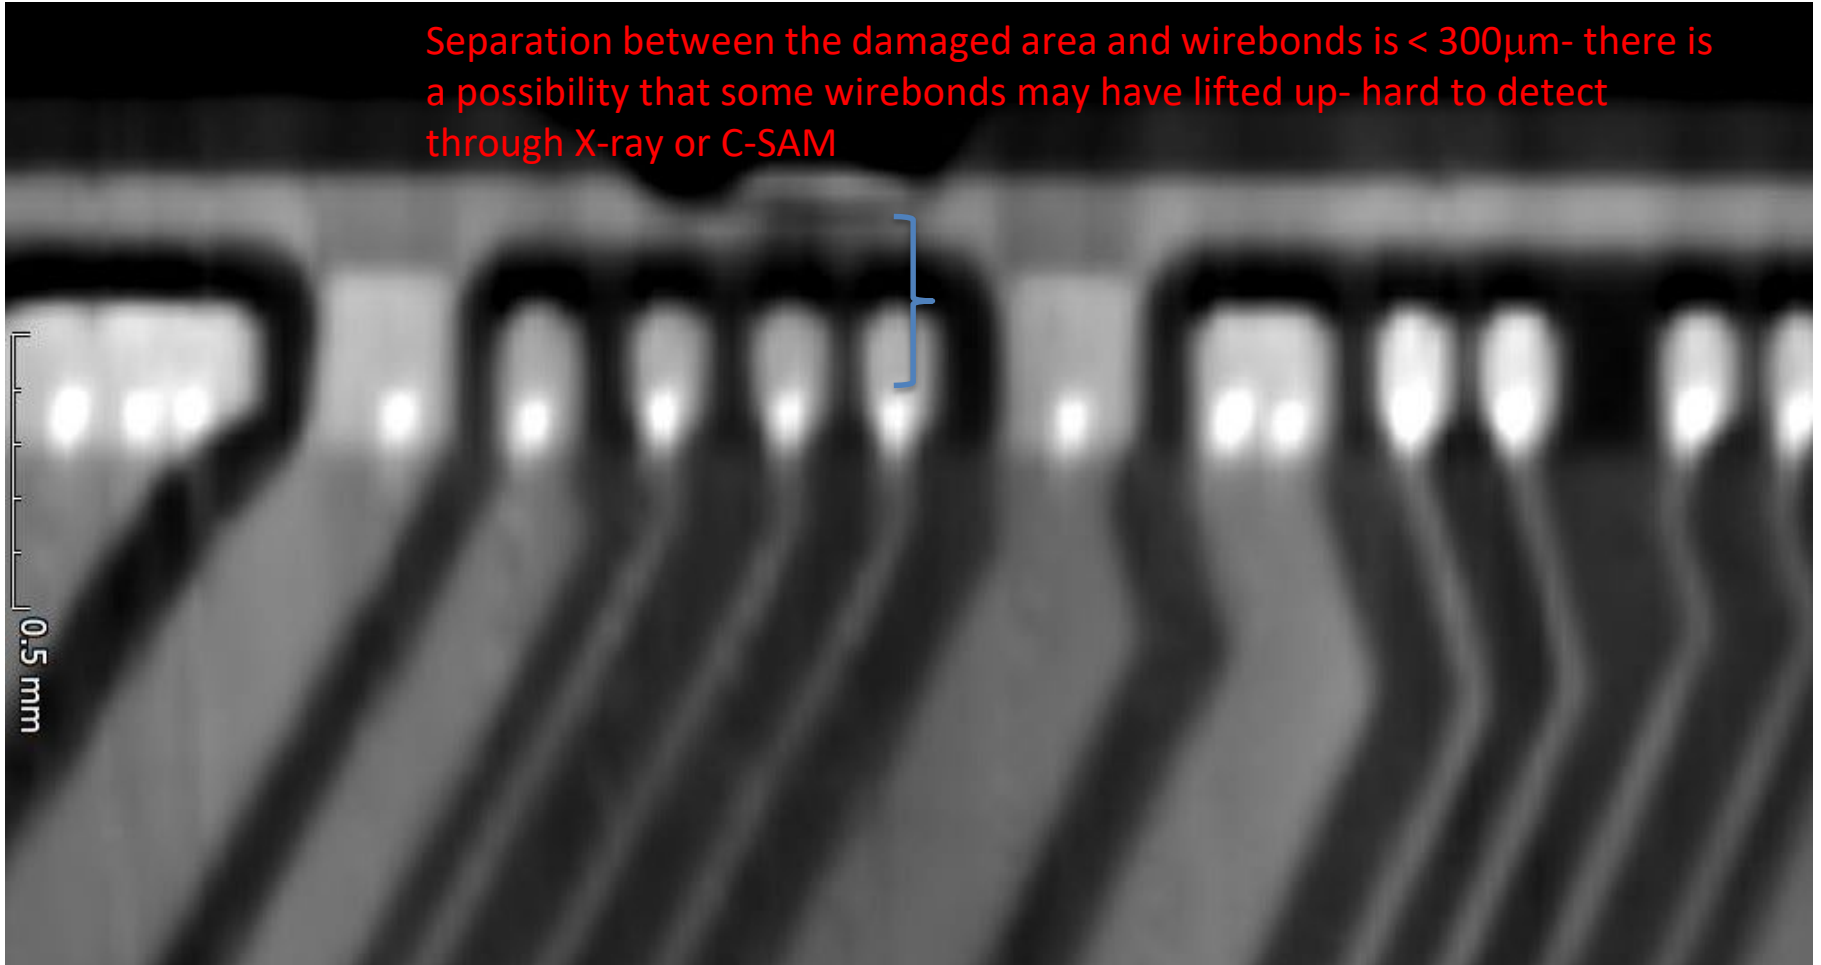
# Damaged areas:

Separation between the damaged area and wirebonds is  $< 300\mu\text{m}$ - there is a possibility that some wirebonds may have lifted up- hard to detect through X-ray or C-SAM

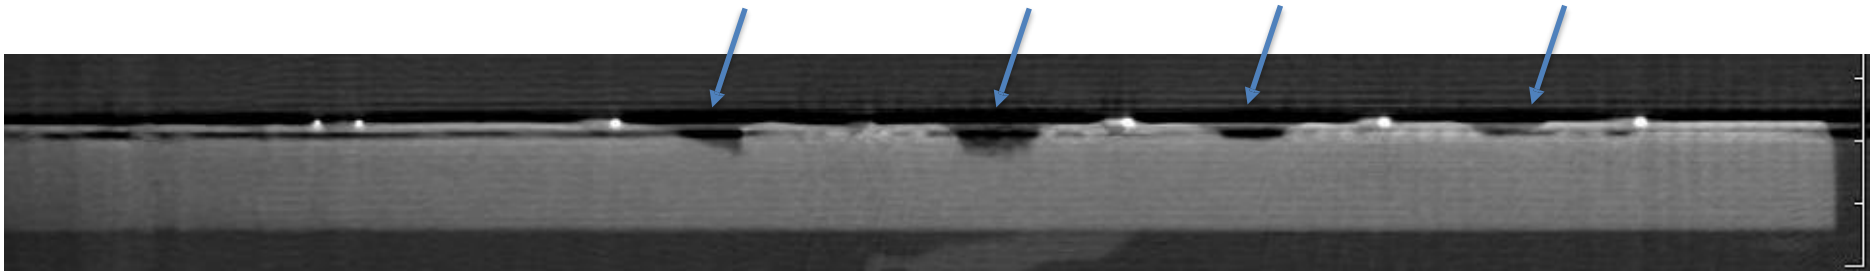
# CT slice view showing damage in the chipstrate

Damage on the substrate

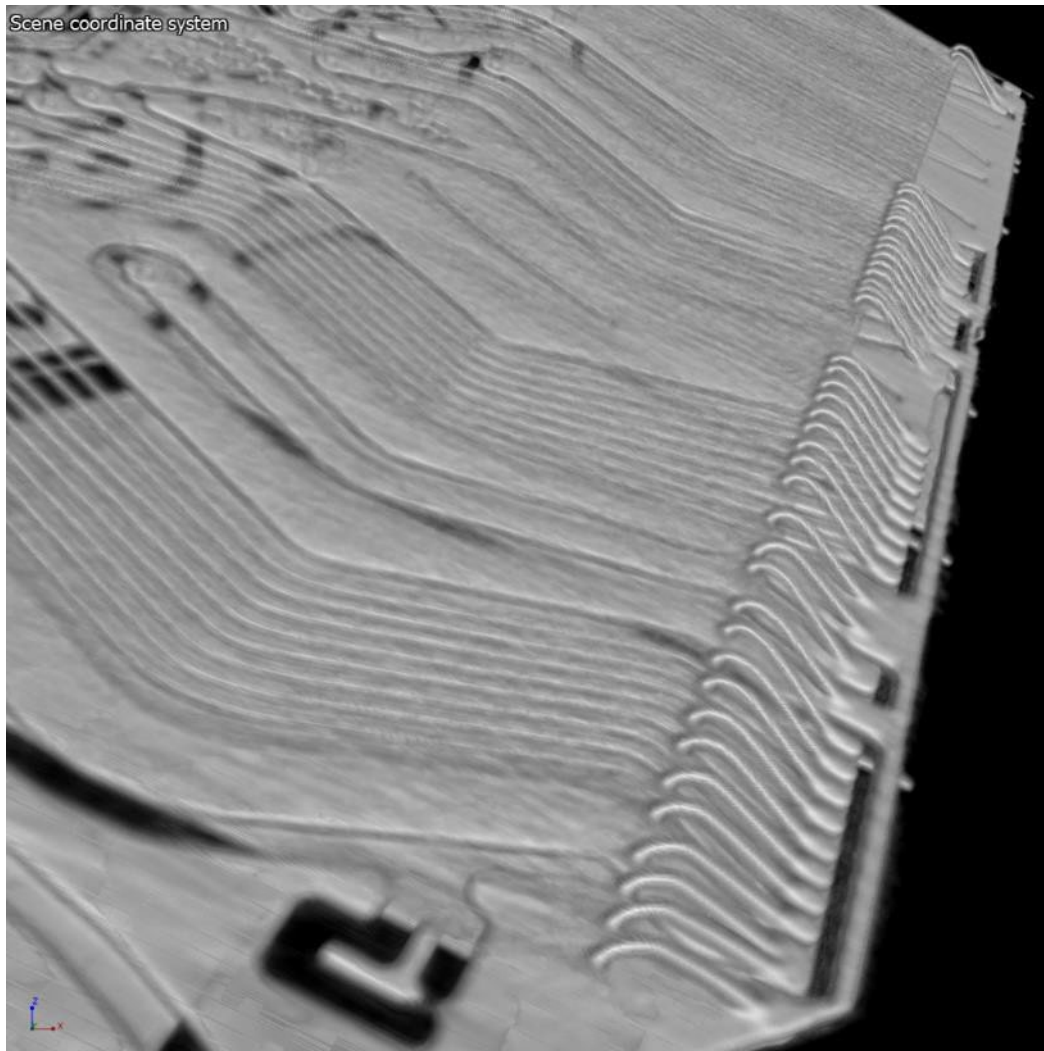
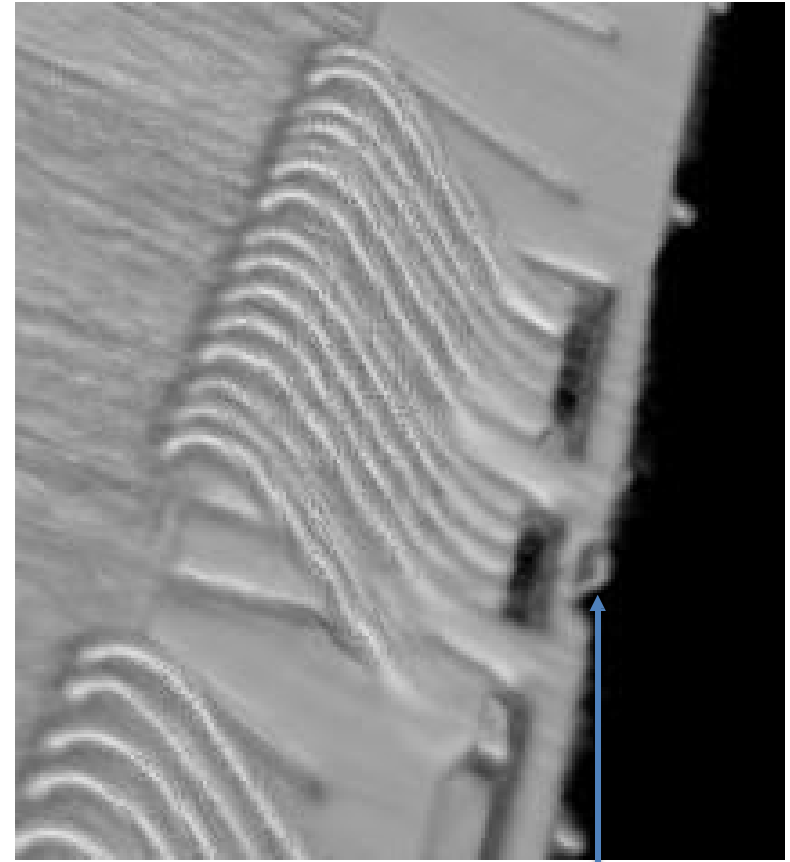
# 3 D snap shot of wirebonds on the large die

Damaged line, piece is away from the cu planes, possibly no interplane short circuit
