# National Transportation Safety Board

ERA23FA048

## **AIRWORTHINESS FACTUAL REPORT**

Location: Harlan, Kentucky  
Date: November 3, 2022  
Time: 1009 eastern daylight time  
1409 UTC  
Airplane: Beech A36, N84R

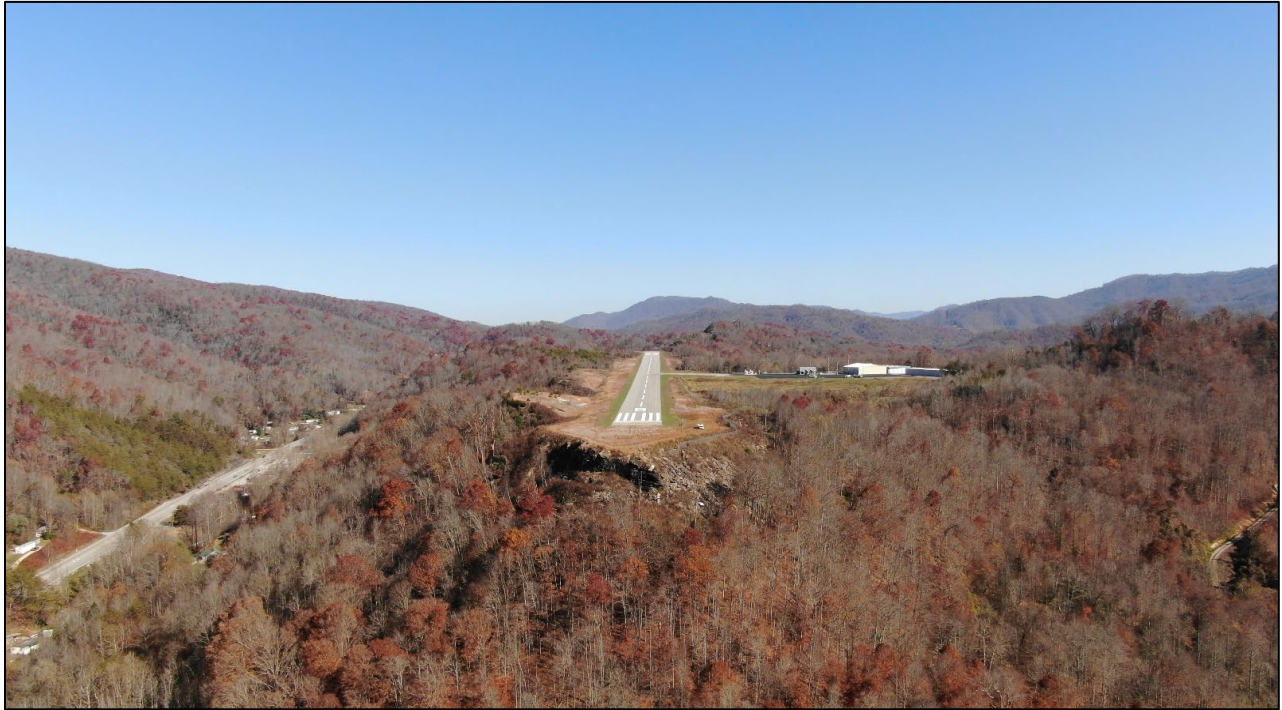
1,172 ft msl. The airport had one runway (8-26), which was 3,461 ft long and 75 ft wide. The airport was equipped with a light beacon and runway 8 was equipped with runway end identifier lights. Approaching runway 8, the terrain featured a steep rock wall ravine about 350 ft prior to the runway threshold. Figure 1 provides a view of the terrain approaching runway 8 at I35 airport.

**Figure 1: View of the terrain approaching runway 8 at I35 airport.**

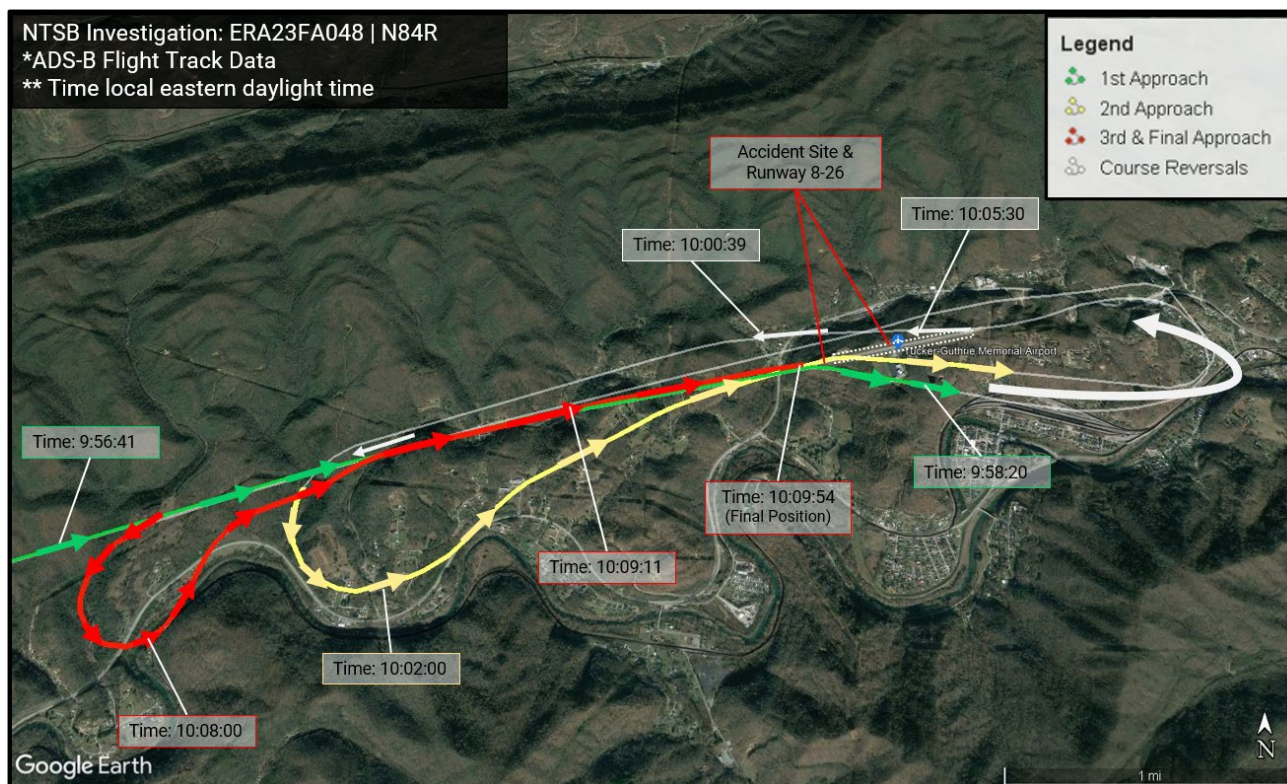
At 1009 EDT, the aircraft flew an approach toward Runway 8 and descended into the rocks. The last recorded position was at 1009:54, about .10 nautical mile from the runway 8 threshold. Figure 3 displays an overview of the ADS-B flight track.

**Figure 3: ADS-B flight track displaying the three approaches to runway 8 in addition to the 180° left teardrop turns (displayed in white). The green line represents the first approach. The yellow line represents the second approach, and the red line represents the third and final approach.**

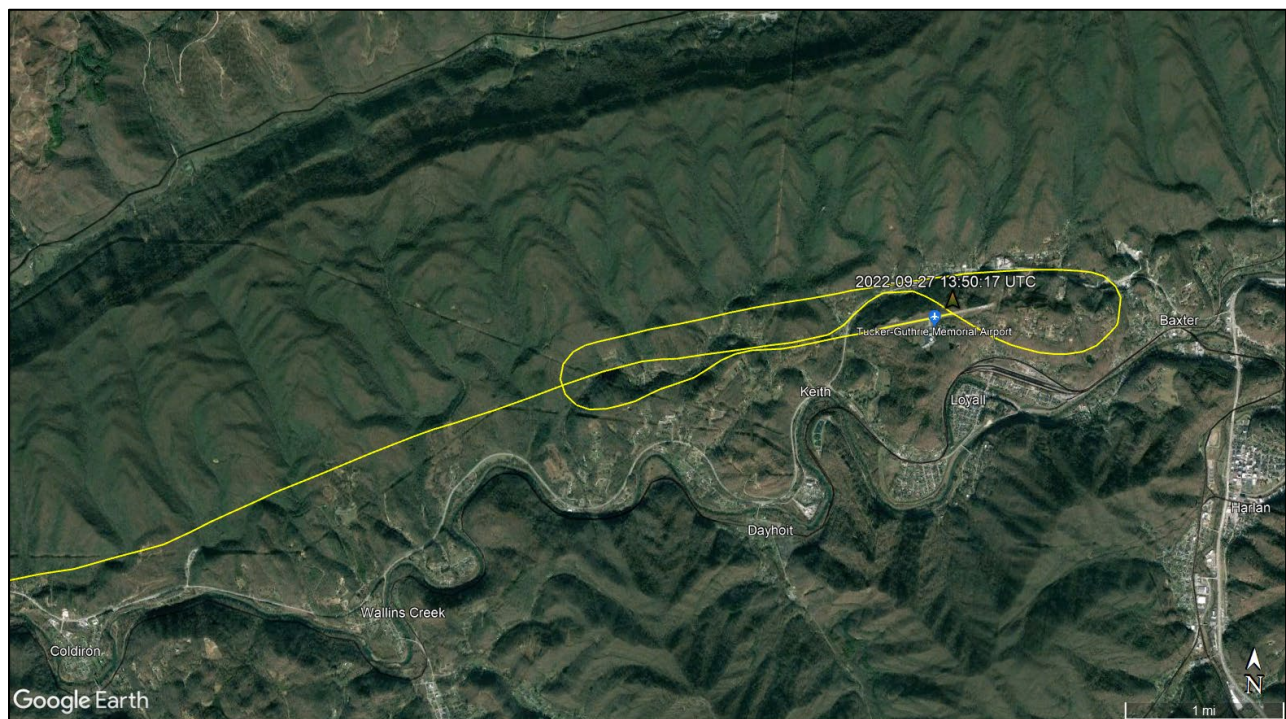
Review of the flight track data showed that the flight completed one pass over runway 8 before completing a 180° left turn to fly a parallel course over runway 26. The airplane then completed a left turning 180° teardrop back towards runway 8 in which a landing was made. The flight track was not consistent with the GPS-A approach procedure.

**Figure 4: September 27, 2022 flight into I35.**

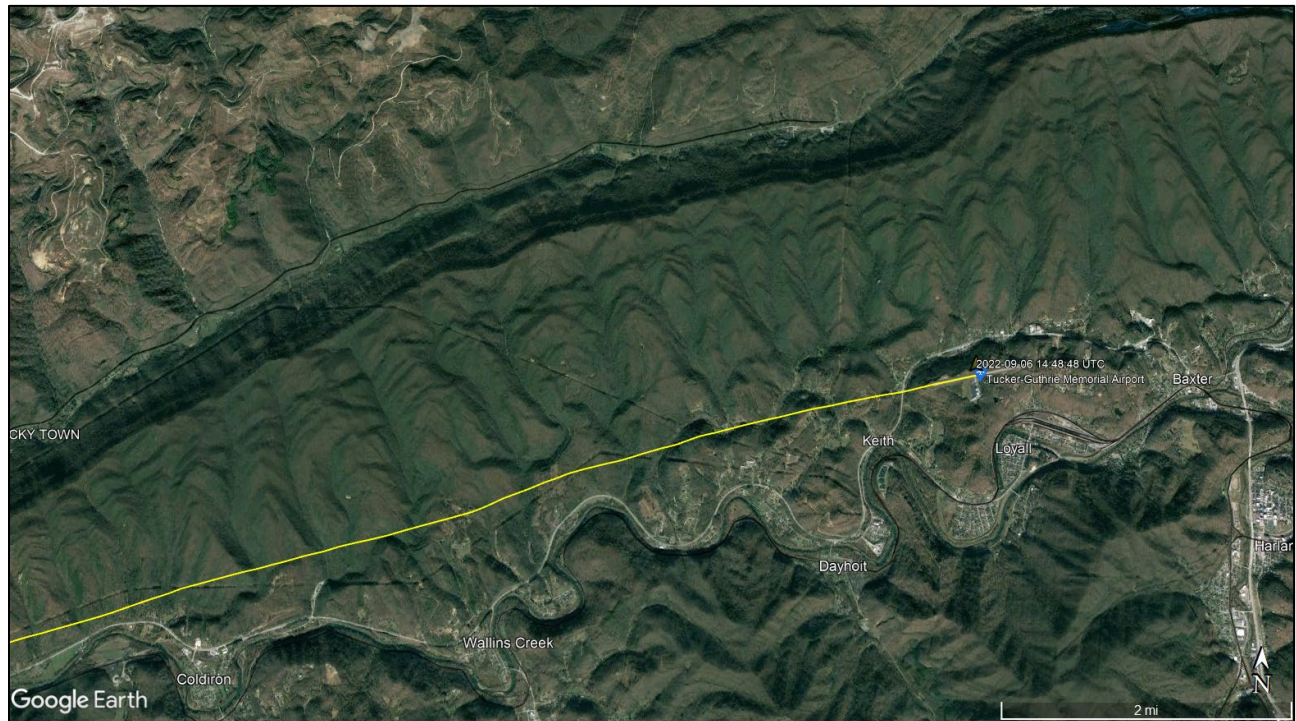
Review of the flight track showed that the pilot completed a straight-in approach to landing.

**Figure 5: Flight track data from the pilots September 6, 2022 flight into I35.**

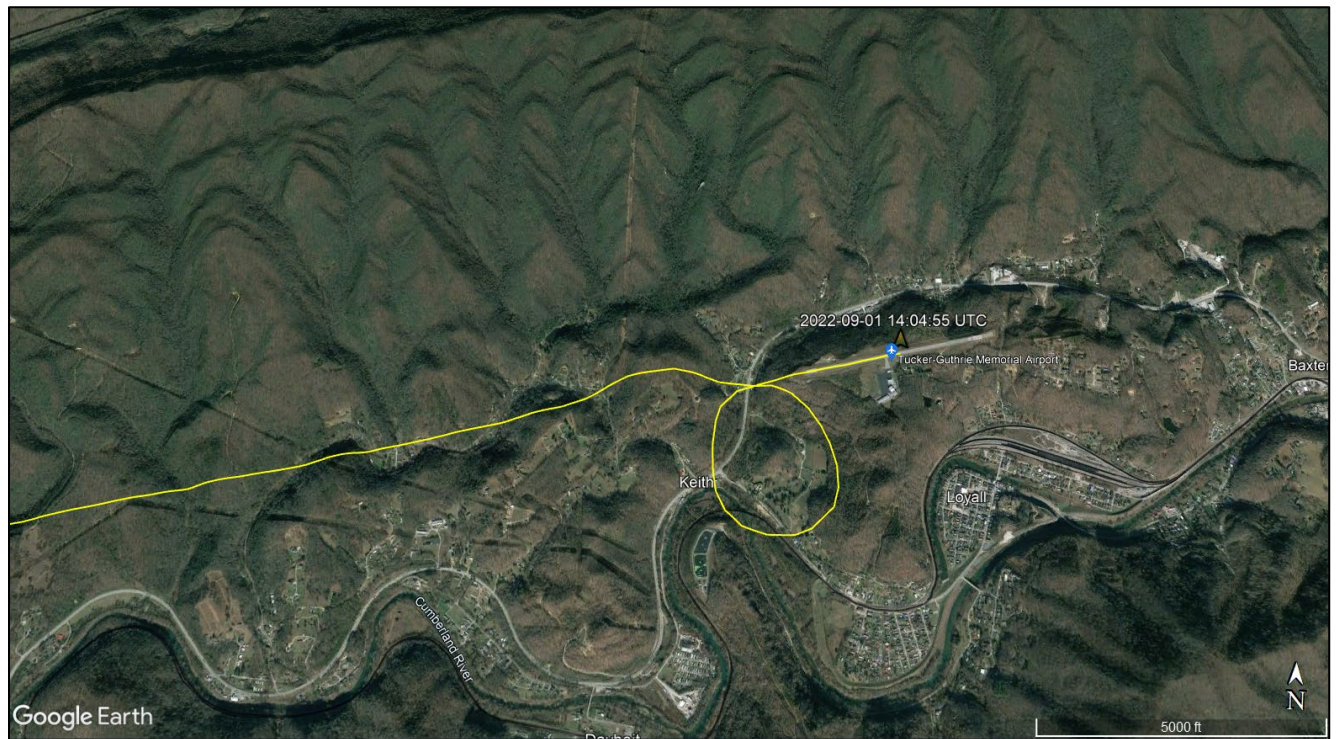
The pilot completed a straight-in approach to runway 8, however, prior to landing a 360° turn was completed before rejoining the final approach and landing on runway 8.

**Figure 6: Flight track data from the pilots September 1, 2022 flight into I35**

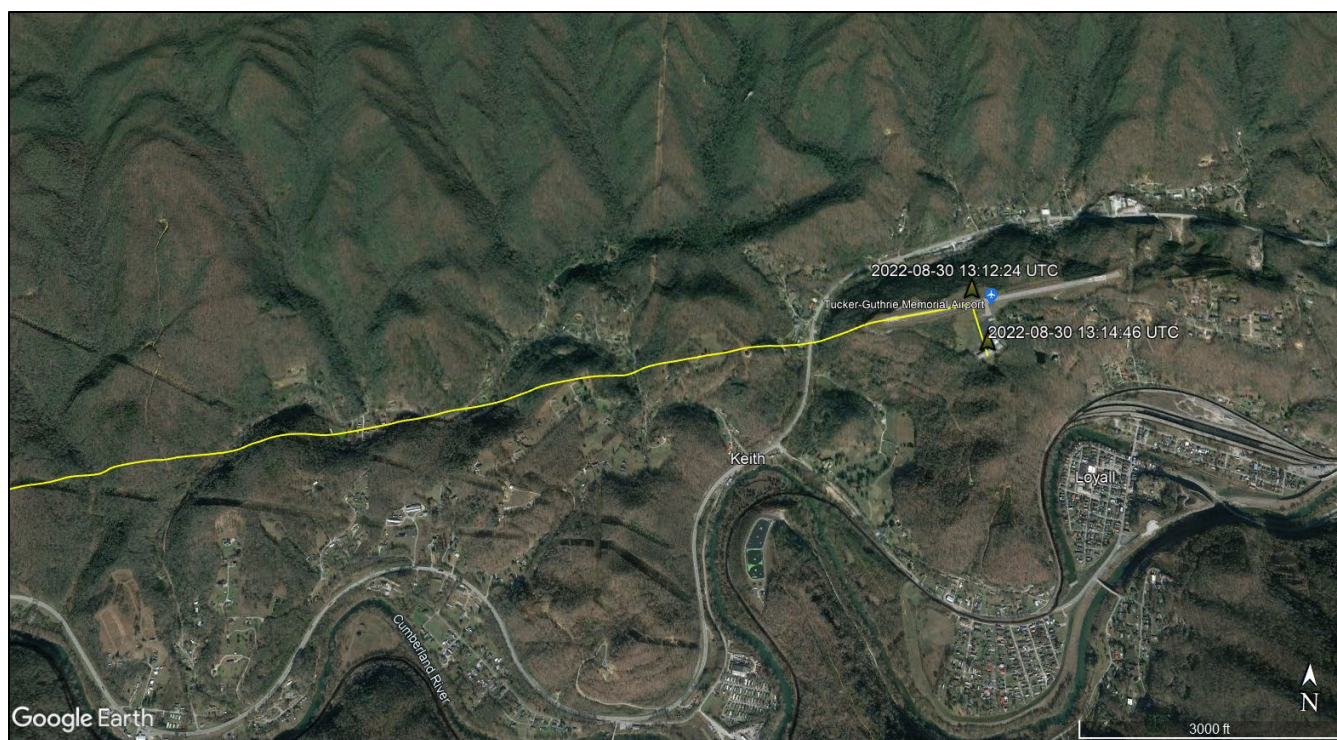
**Figure 7: Flight track data from the pilots August 30, 2022 flight into I35**

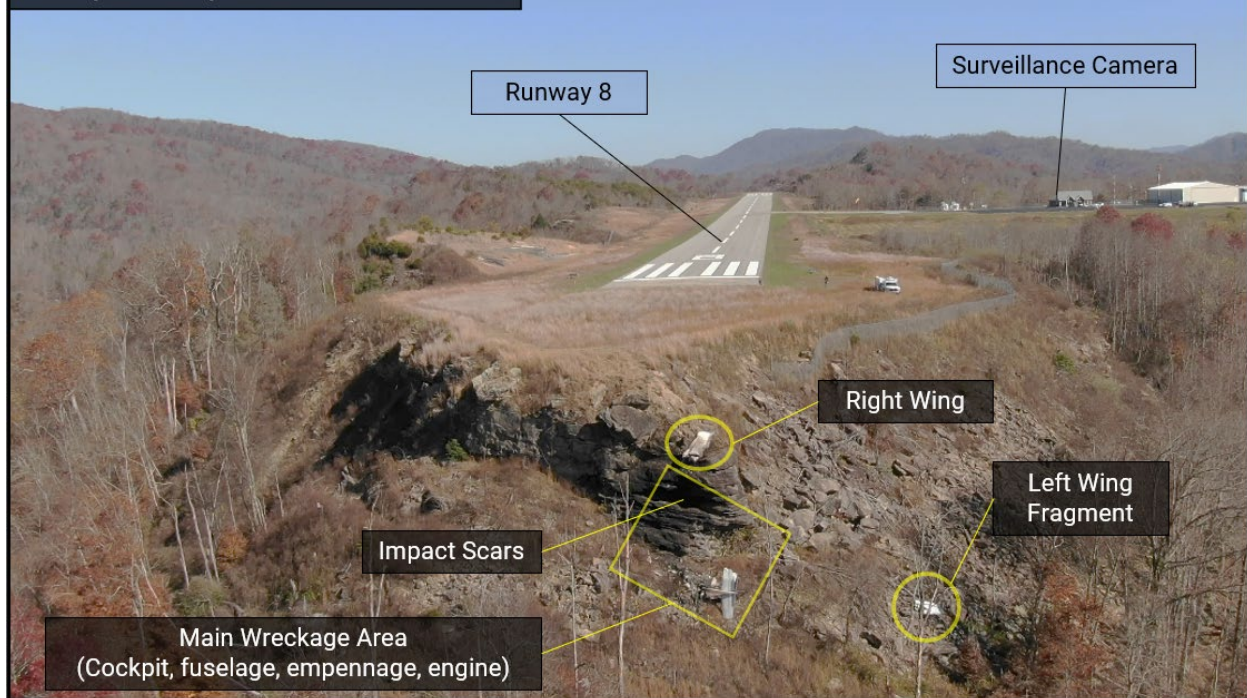
The airplane impacted a ravine and steep rock wall about 50 ft below the runway elevation and 375 ft from the runway 8 threshold. All major portions of the airplane were located, and a post-crash fire consumed a majority of the cockpit, fuselage, and portions of the left wing.

**Figure 8: Overview of the airport environment and distribution of wreckage**

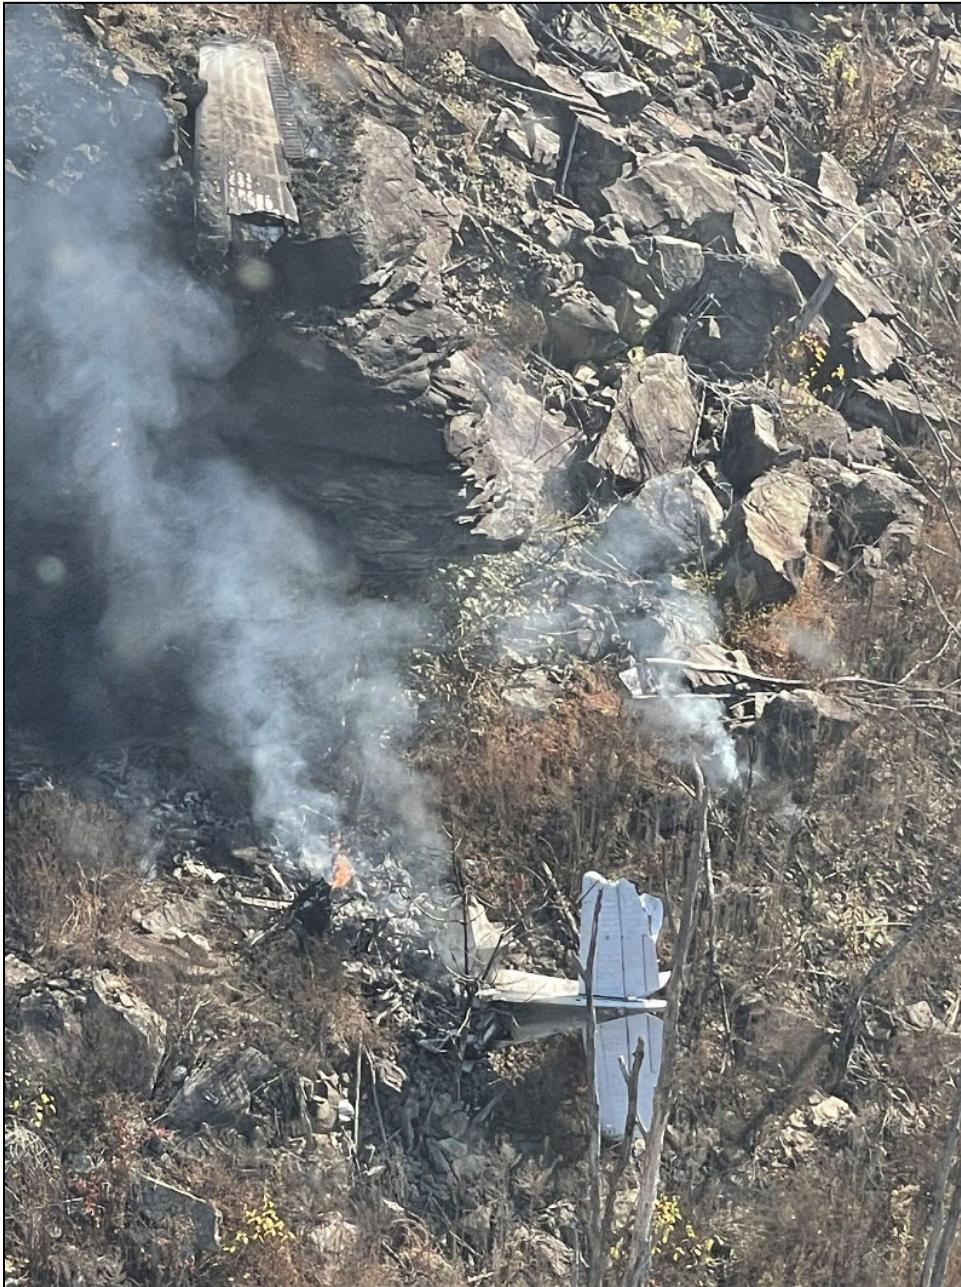
**Photo 1: View of the accident airplane after the impact with terrain. Photo Courtesy of Kentucky State Police.**

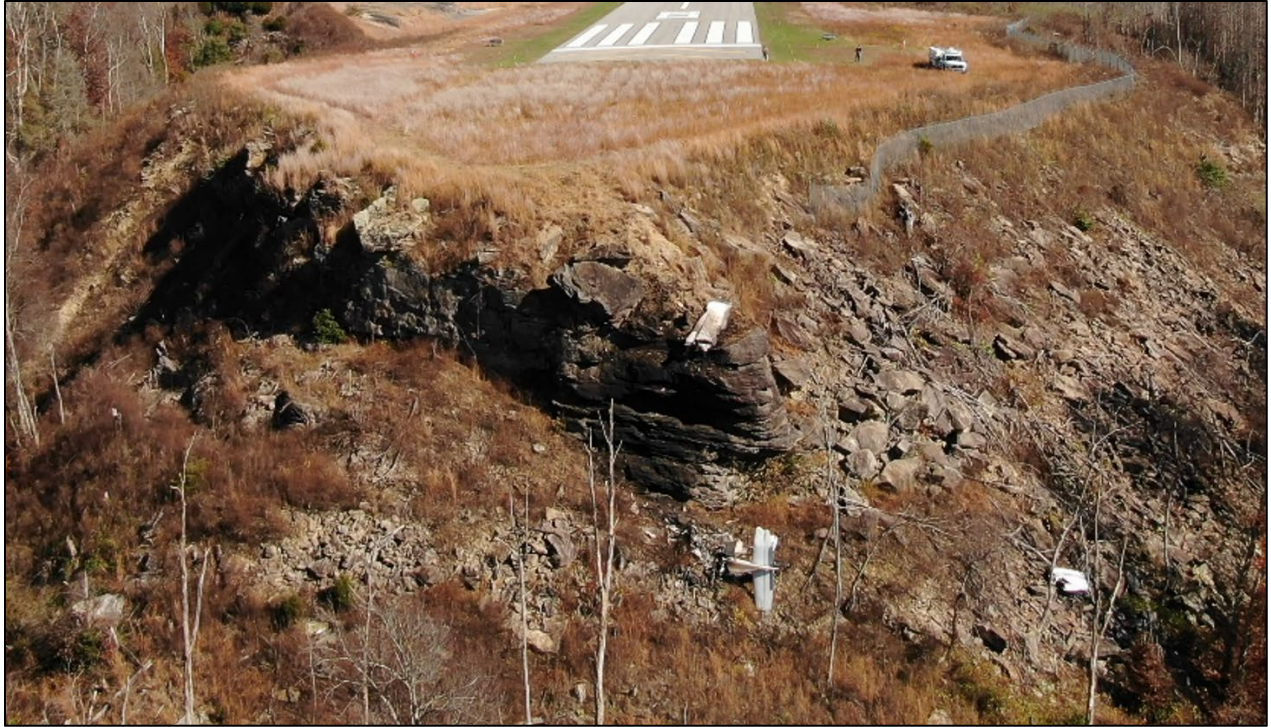
**Photo 2: Overview of the accident site. Photograph courtesy of the Kentucky State Police.**

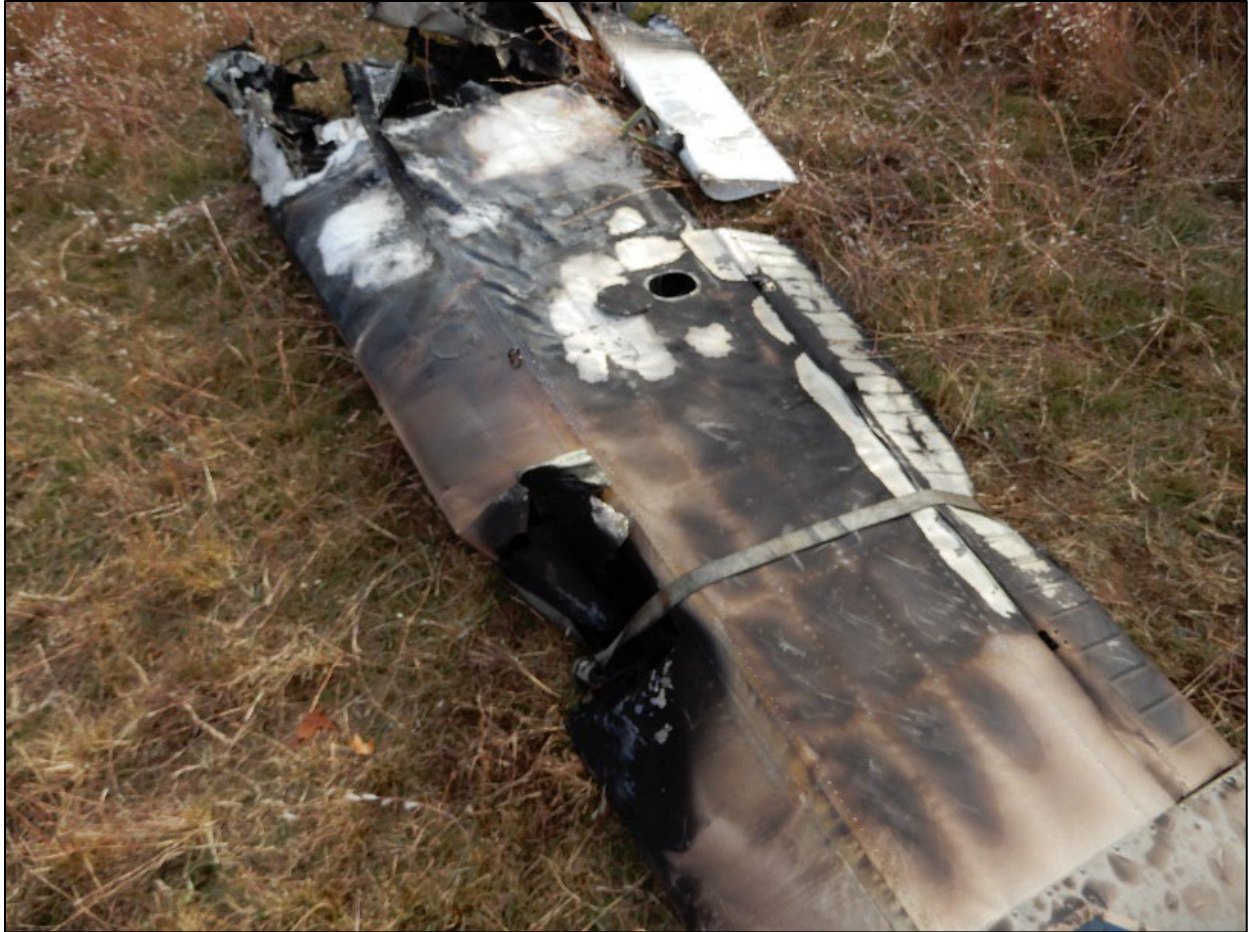
**Photo 3: View of the right wing recovered from the accident site.**

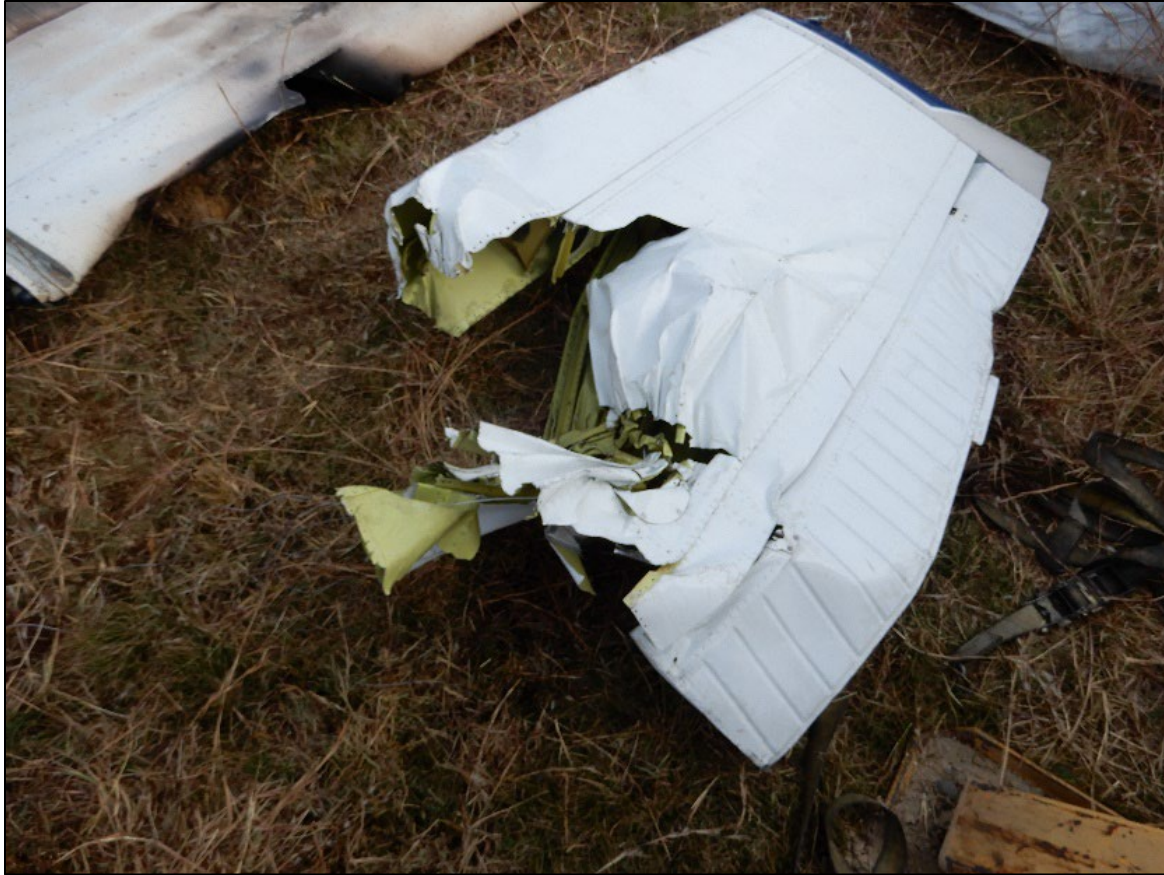
**Photo 4: View of the left wing fragment.**

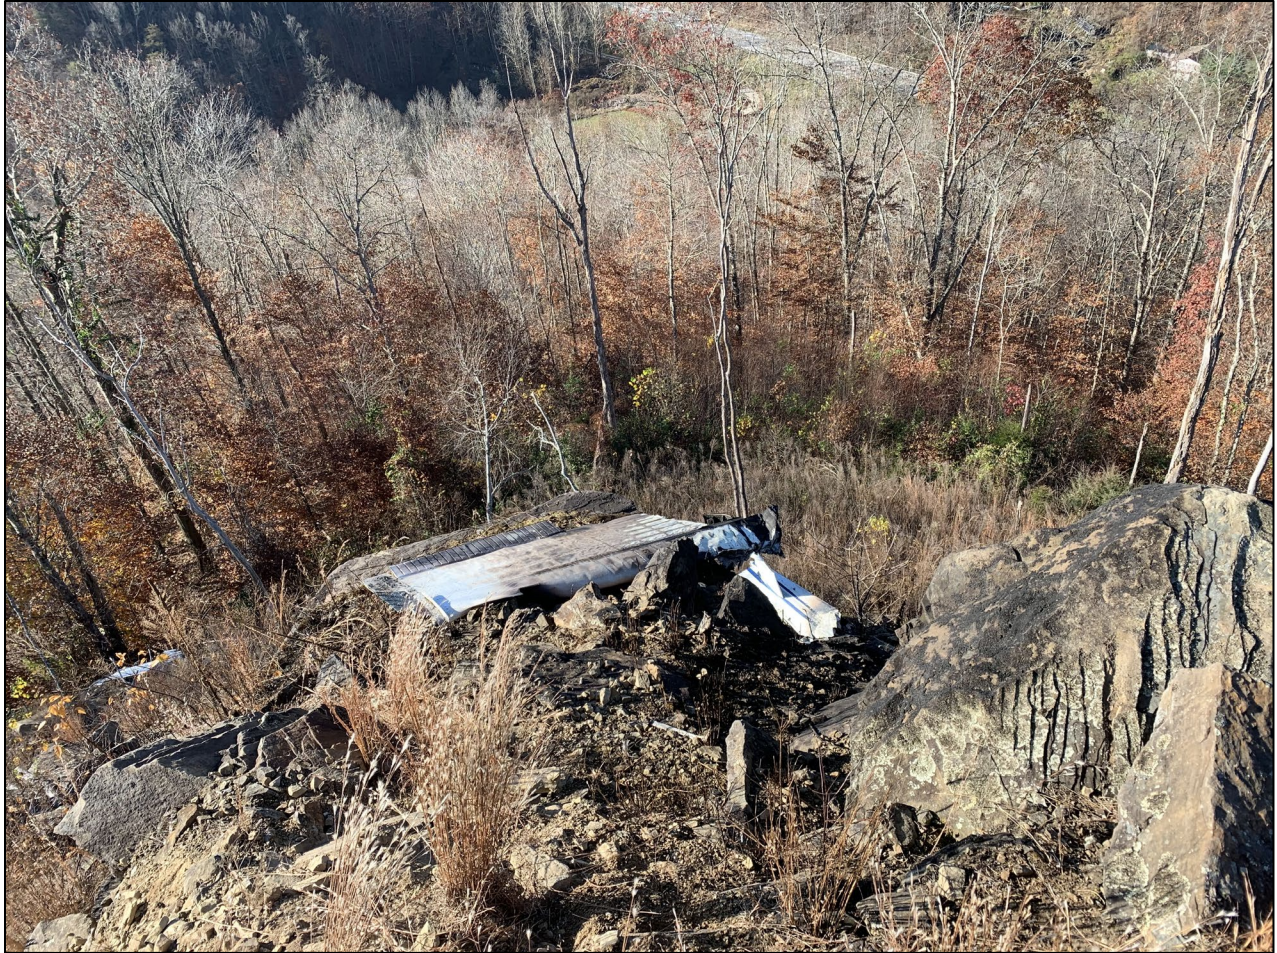
**Photo 5: View of the right wing as located at the accident site.**

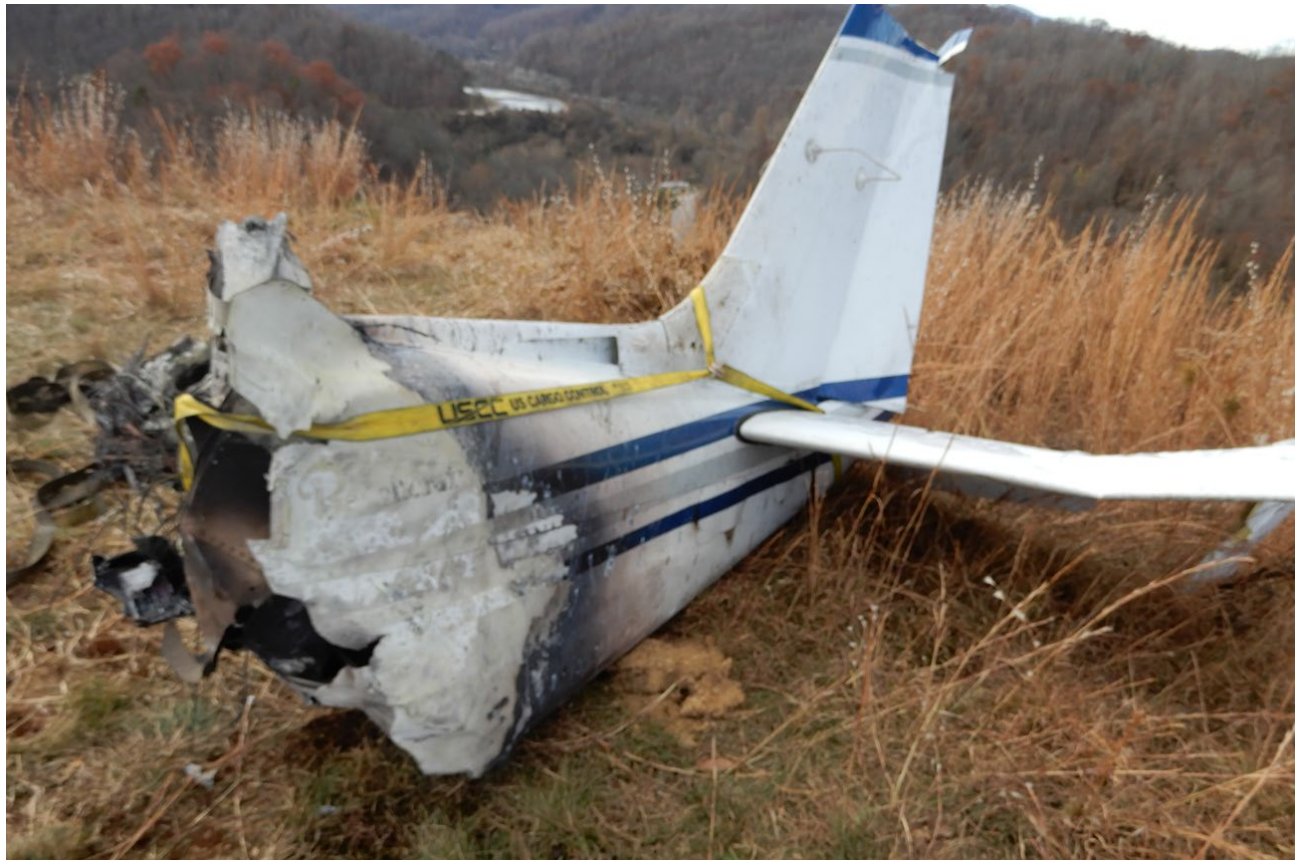
**Photo 6: View of the empennage after its recovery from the accident site.**

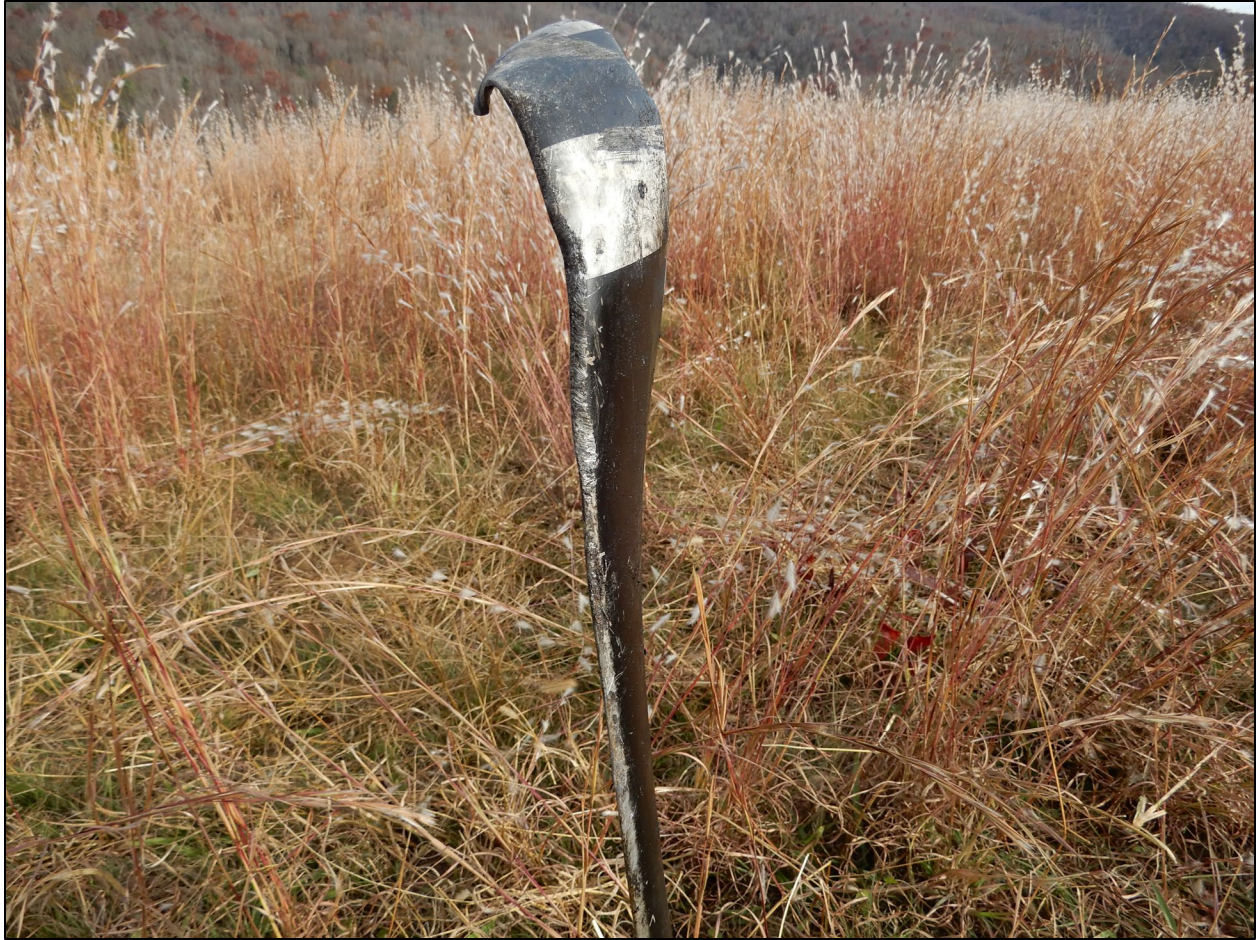
All propeller blades had separated from the propeller hub. Only one propeller blade was recovered at the accident site. The blade exhibited tip curling and leading edge gouging.

**Photo 7: View of a propeller displaying tip curling and leading edge abrasions and gouging.**

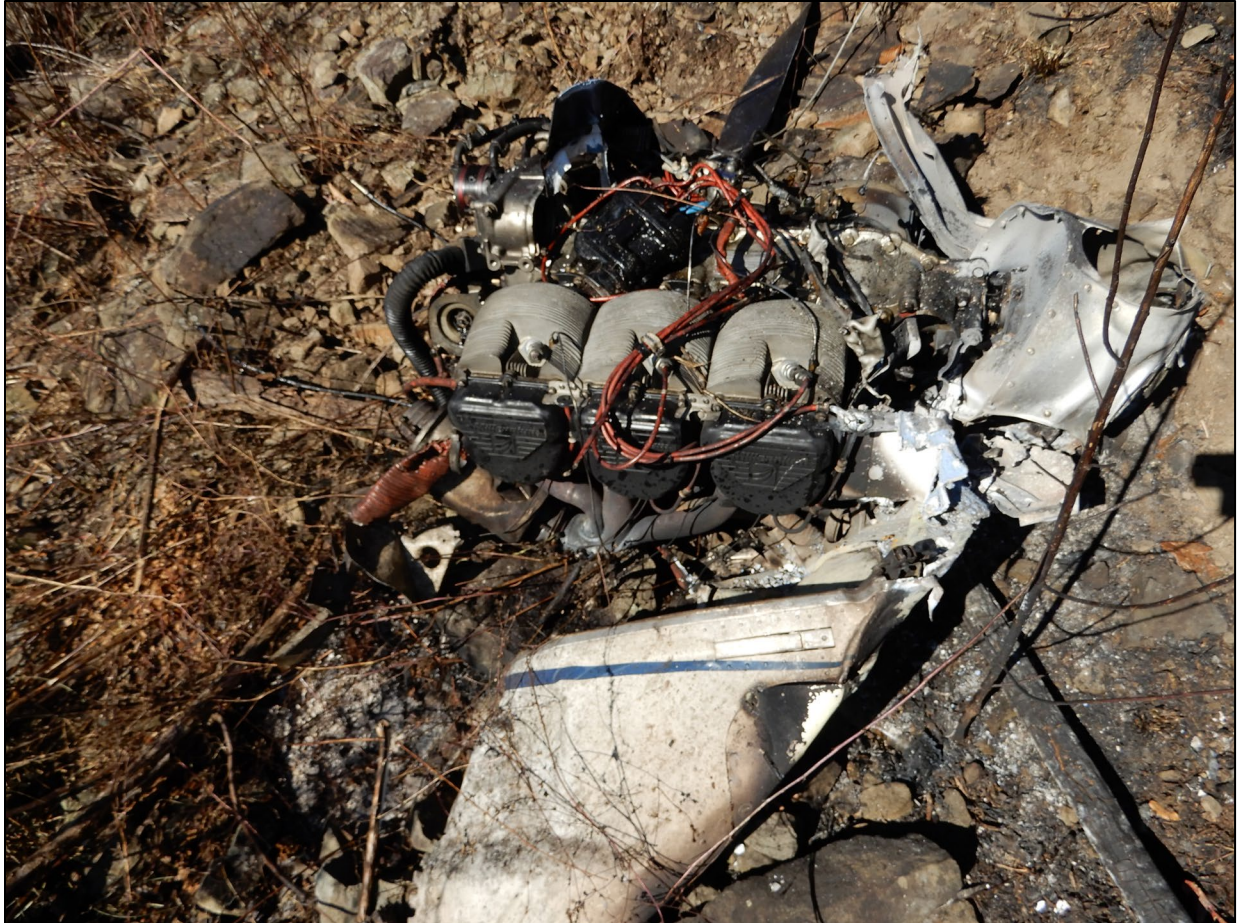
The engine was a Continental IO-520-BA piston engine (SN 822926-R). The engine had separated from its engine mounts and airframe. The engine exhibited impact damage and post-impact fire damage. The crankcase was fractured, and the crankshaft would not rotate; compression and continuity were not established. All rocker covers were removed. There was no evidence of engine damage to any of the valves or rockers. The oil filter was located in the debris. The casing was intact and displayed a written date of May 11, 2022, tach time 1010.2. The oil filter was removed, cut open and spread out. There were no metal contaminants observed.

**Photo 8: View of the engine as found at the accident site.**

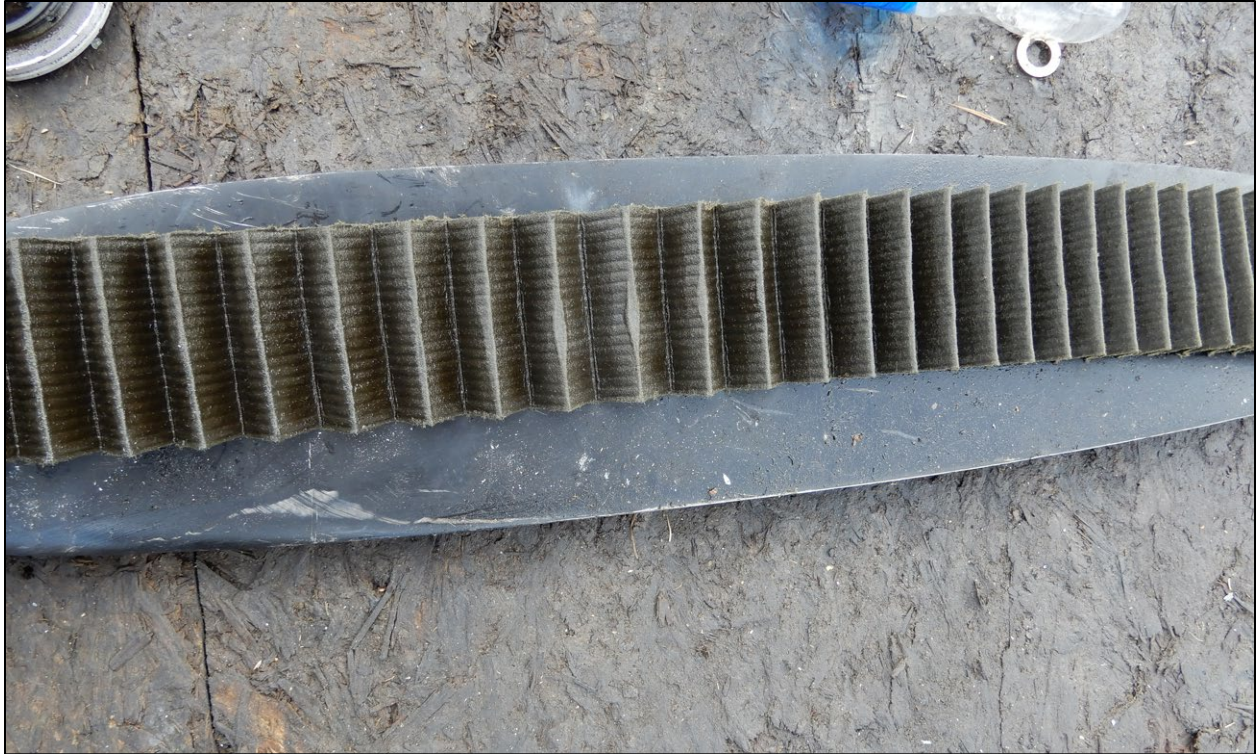
**Photo 9: View of the engine oil filter as viewed during its removal and examination.**

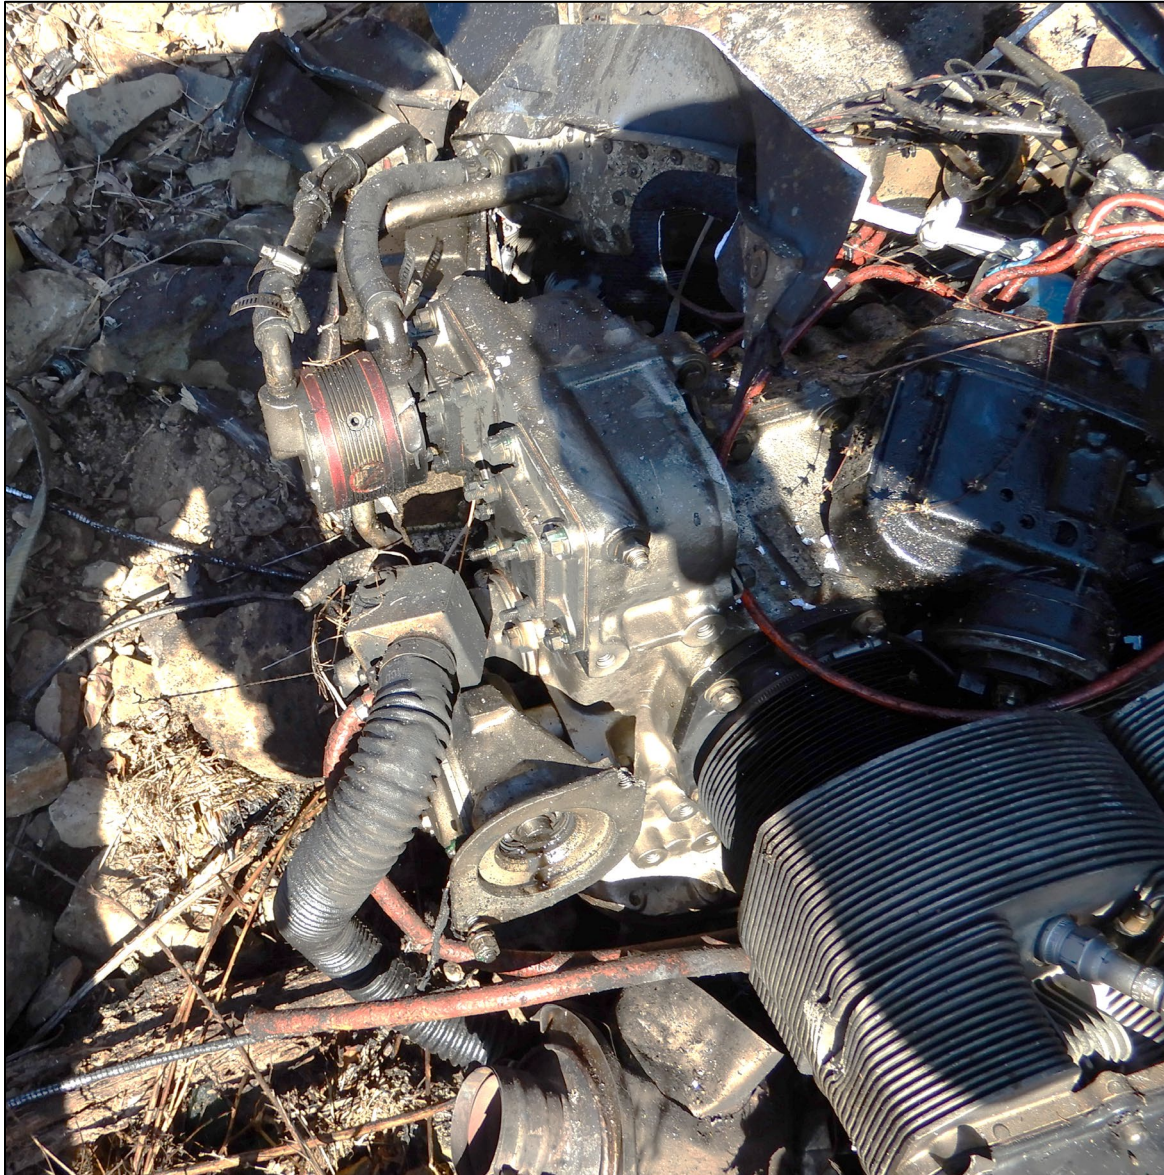
**Photo 10: View of the vacuum pump attached to the engine, as found at the accident site.**

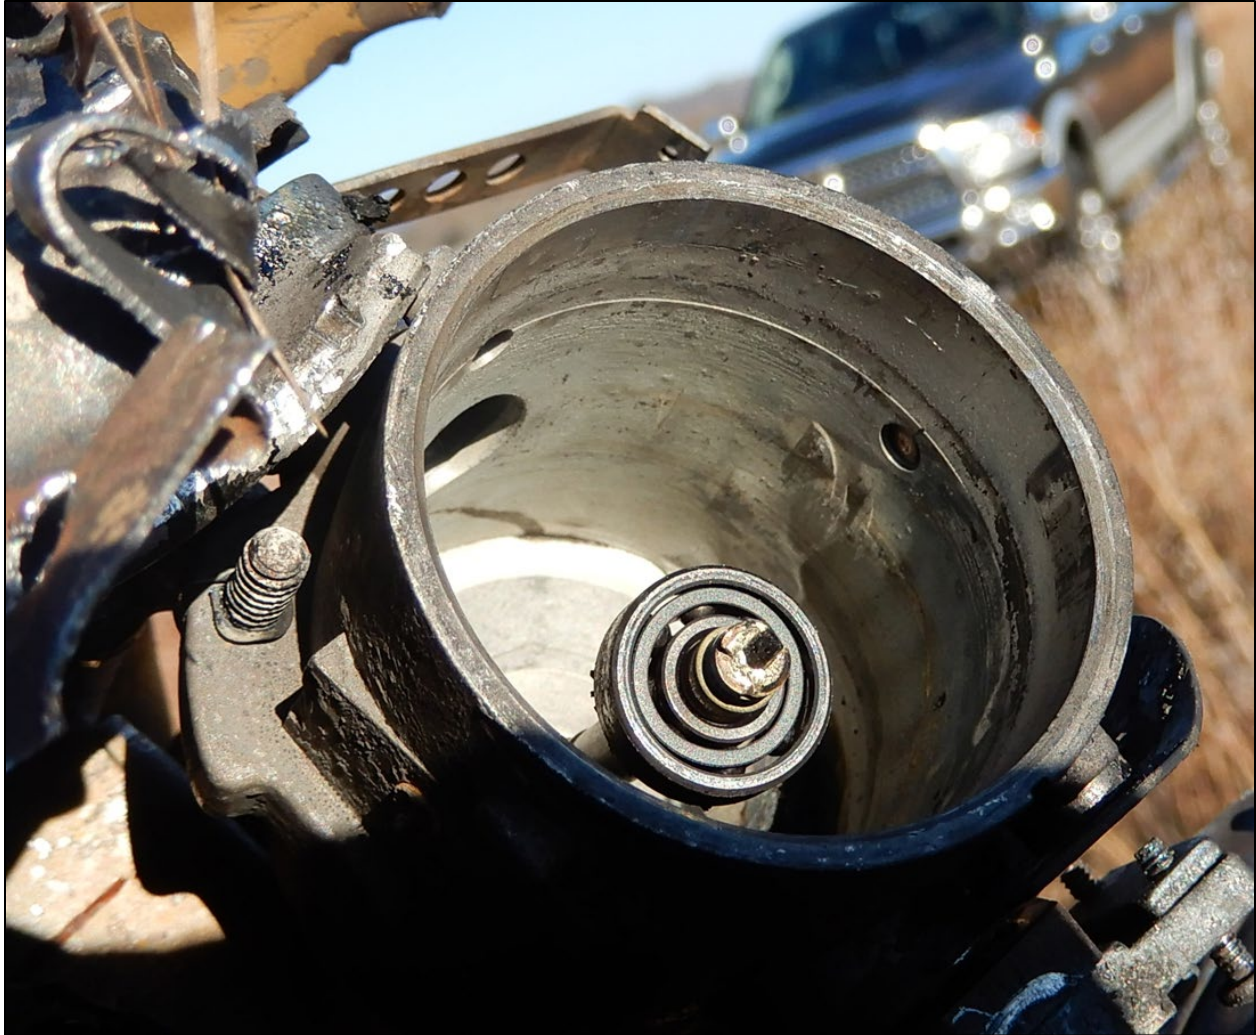
The cockpit, switches, levers, and flight instruments were all severely damaged by fire. It was not possible to obtain any instrument reading from any of the recovered instrumentation. The attitude indicator was disassembled, and its gyro and housing were observed. Evidence of rotationally scoring was observed inside the housing and the gyro.

**Photo 11: Internal view of the attitude indicator gyro housing. As viewed during its disassembly by the investigative team.**

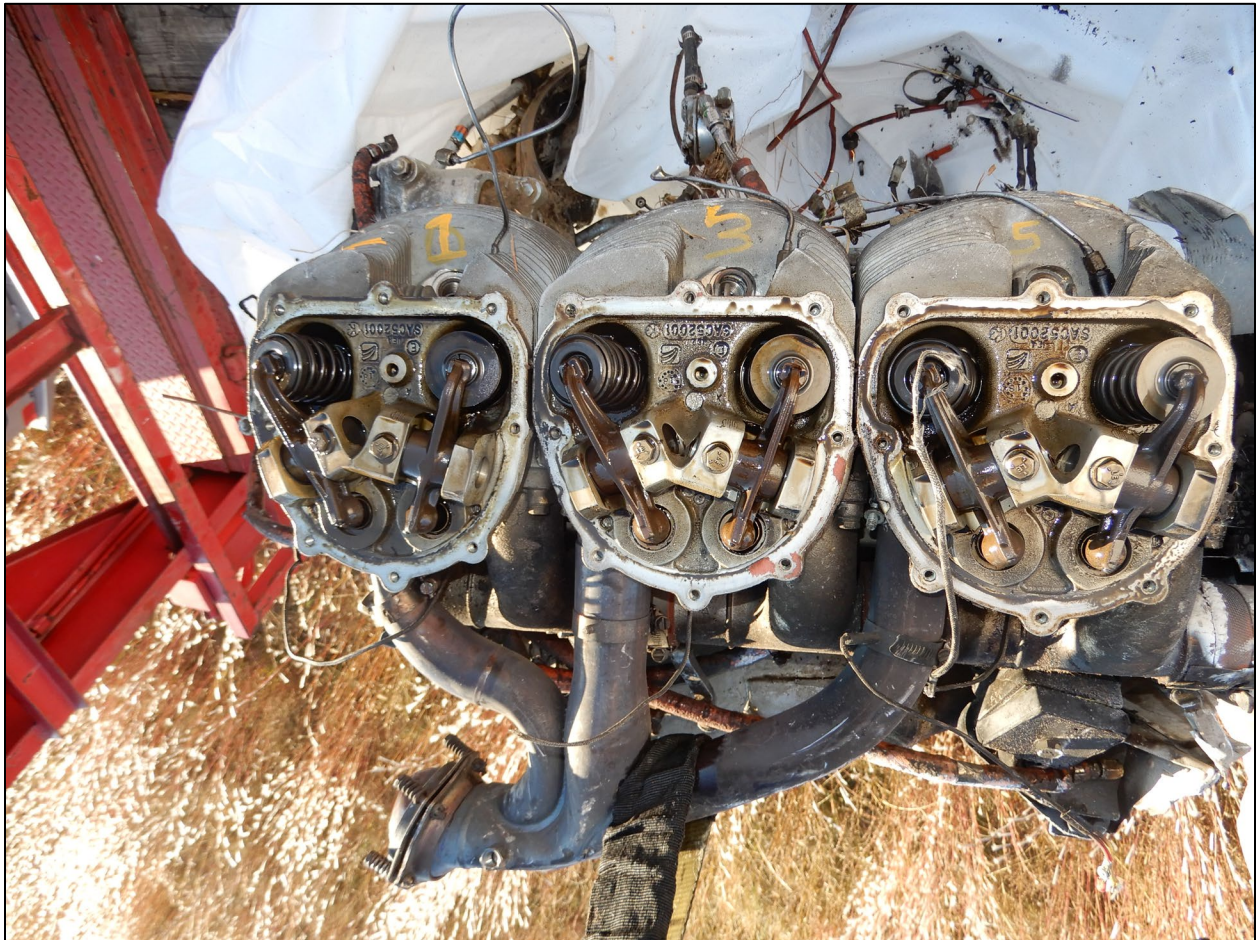
**Photo 12: View of the Nos. 1, 3, and 5 cylinders partially disassembled by the investigative team.**

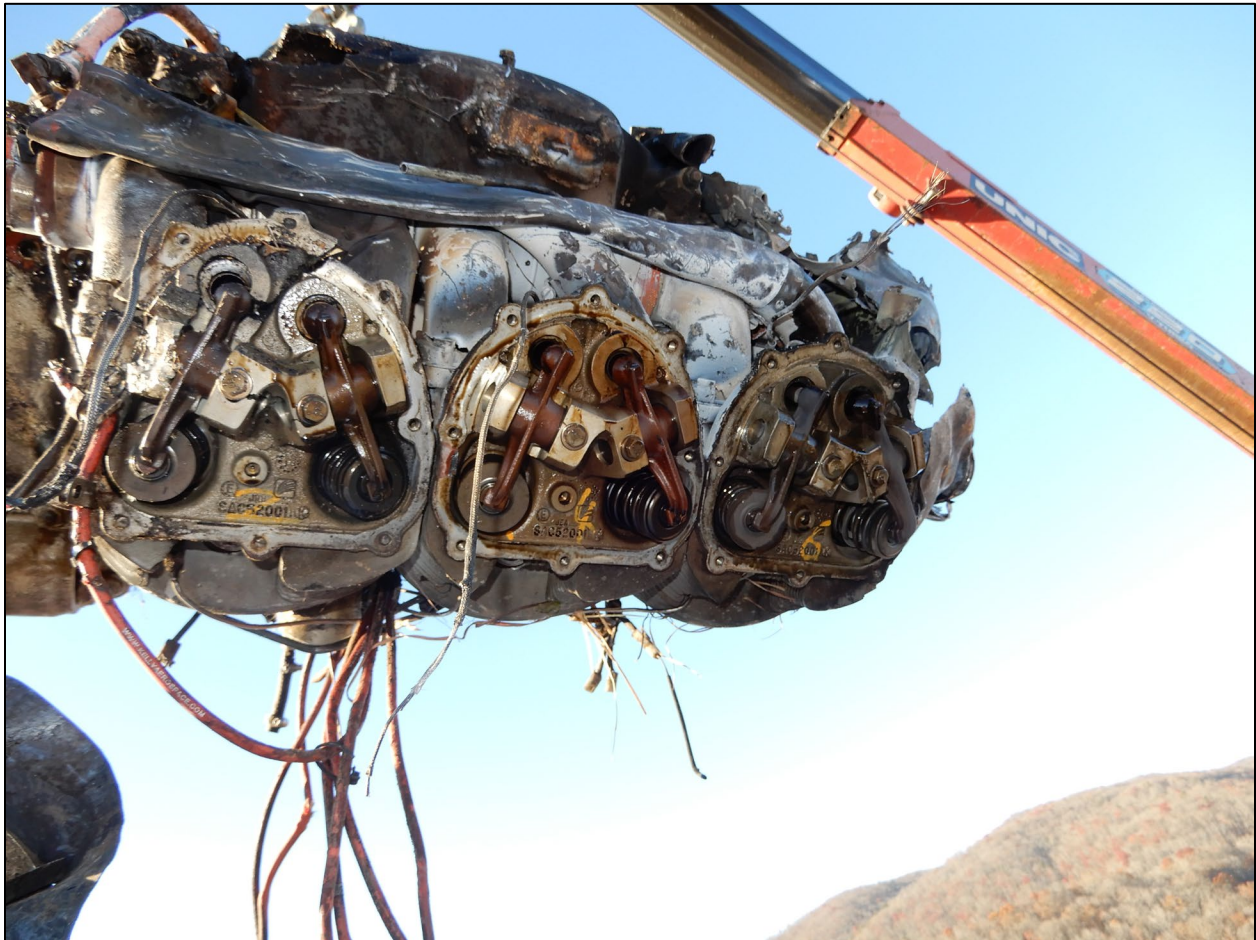
**Photo 13: View of the Nos. 2, 4, and 6 cylinders partially disassembled by the investigative team.**
