# National Transportation Safety Board

ERA23FA048

## **AIRWORTHINESS FACTUAL REPORT**

Location: Harlan, Kentucky  
Date: November 3, 2022  
Time: 1009 eastern daylight time  
1409 UTC  
Airplane: Beech A36, N84R

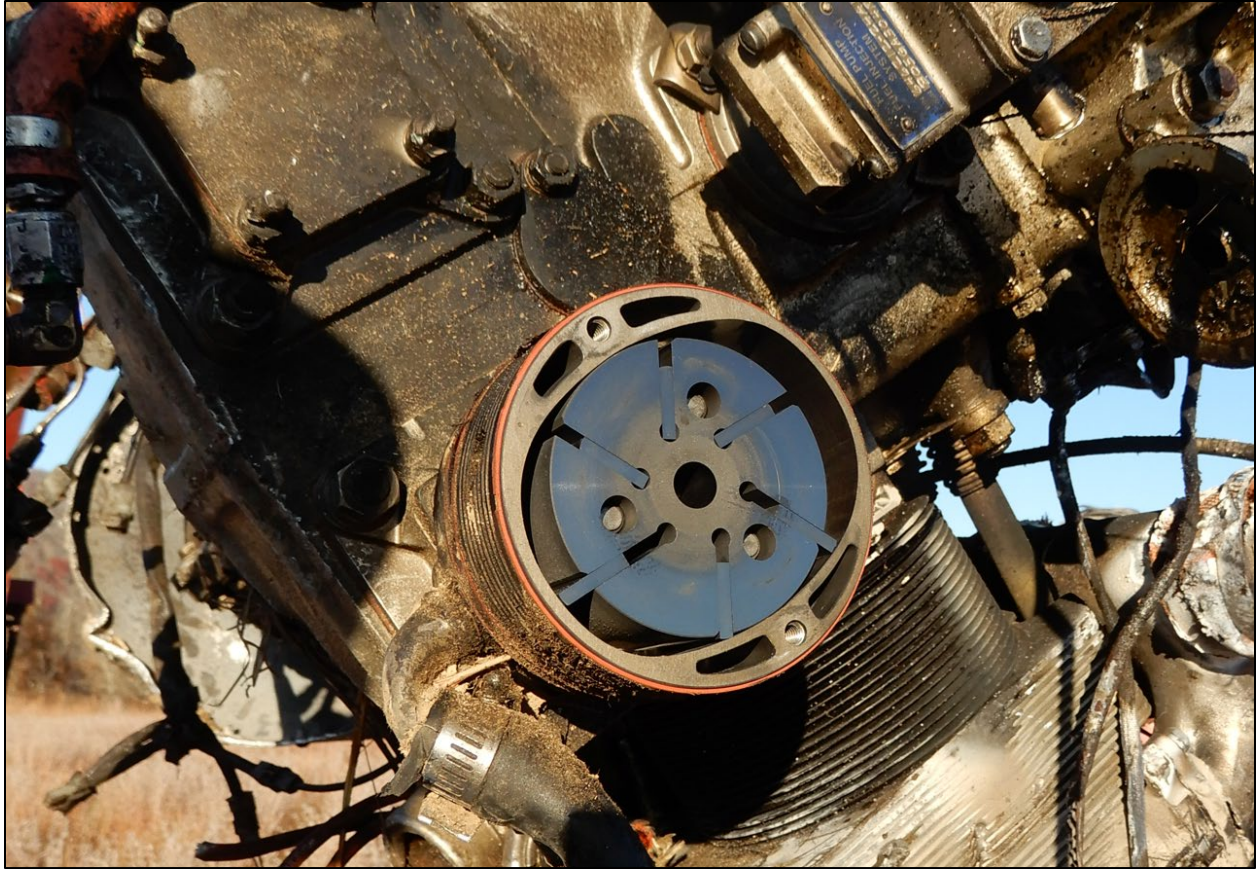
The majority of the engine accessories were separated from the engine. The vacuum pump remained attached to the engine accessory section. When the pump was partially assembled, its gear were intact and the unit appeared normal. The engine was attempted to be rotated by hand; however, it would not rotate.

**Photo 14: View of the vacuum pump, as viewed partially disassembled by the investigative team.**

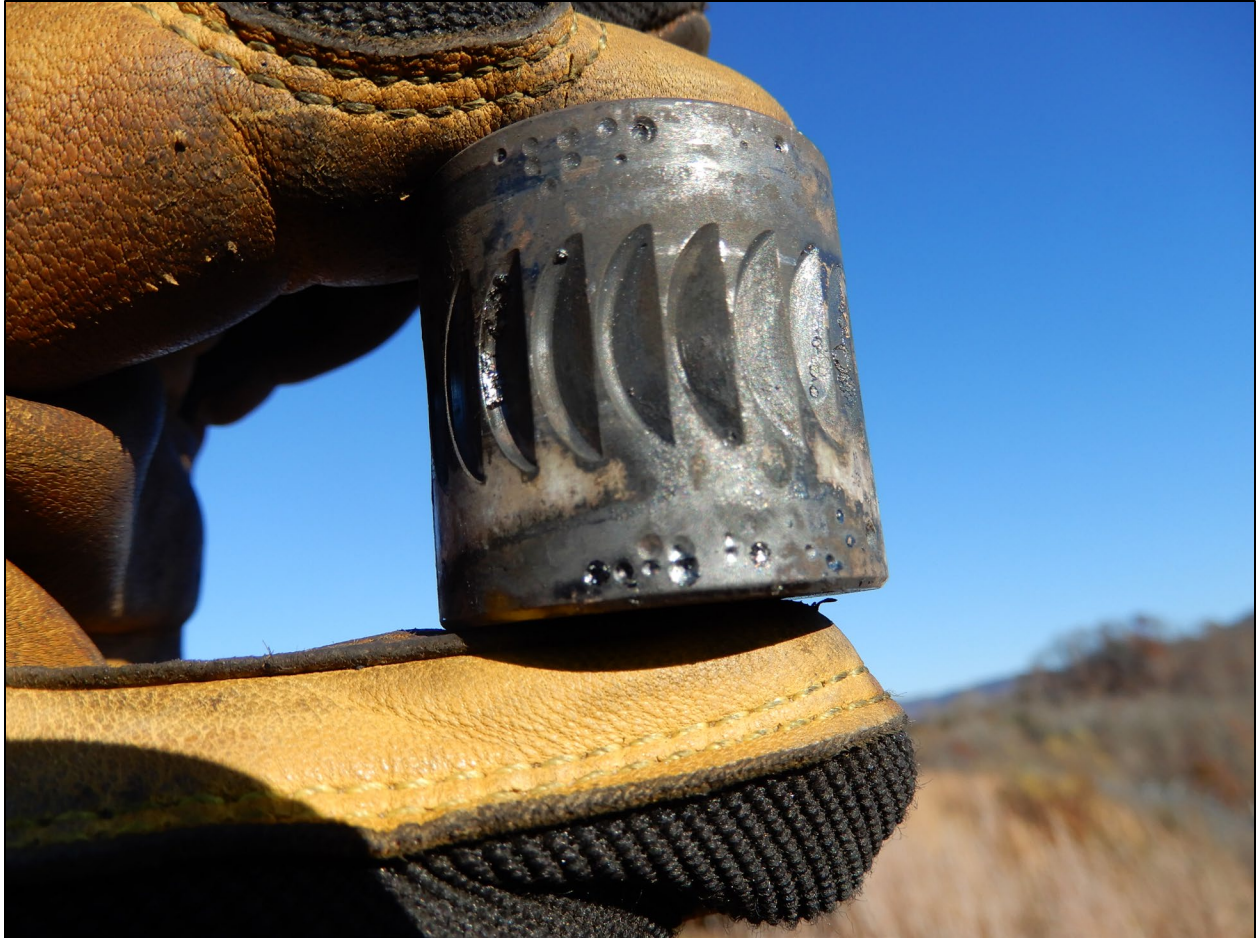
The cockpit, switches, levers, and flight instruments were all severely damaged by fire. It was not possible to obtain any instrument reading from any of the recovered instrumentation. The attitude indicator was disassembled, and its gyro and housing were observed. Evidence of rotationally scoring was observed inside the housing and the gyro.

**Photo 15: View of the attitude indicator gyro, as viewed during disassembly by the investigative team.**

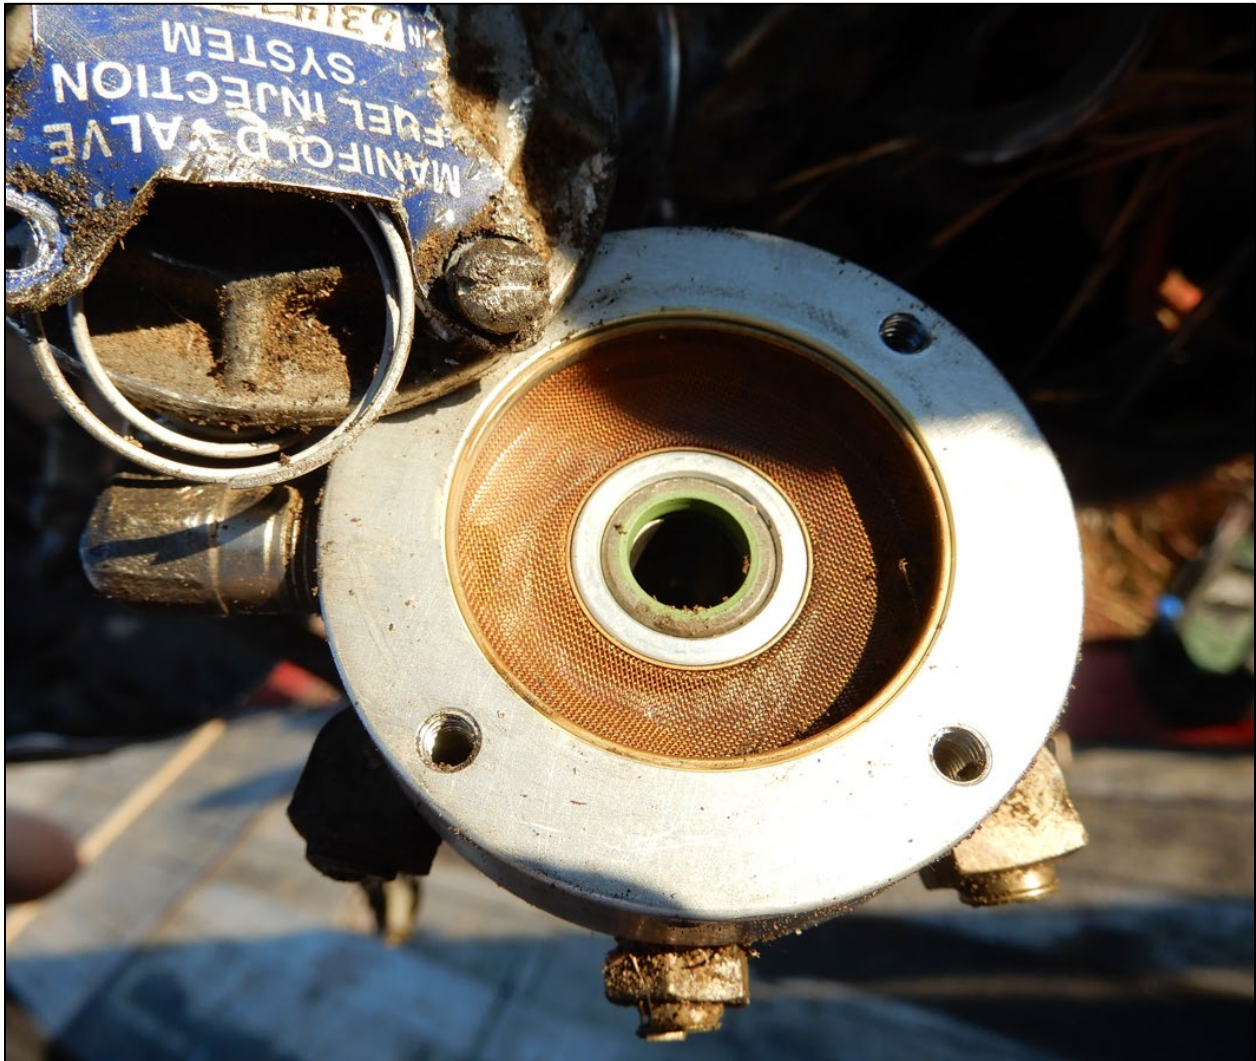
The fuel manifold was safety wired and remained partially attached to the engine. When disassembled, its fuel filter screen was clear of debris and the manifold smelled of aviation gas. The magnetos had separated from the engine. Both magnetos produced spark at all leads via the impulse coupling when turned by hand.

**Photo 16: View of the fuel manifold filter screen, as viewed when disassembled by the investigative team.**
