# National Transportation Safety Board

ERA23FA070

## **MATERIALS LABORATORY**

Factual Report 23-006

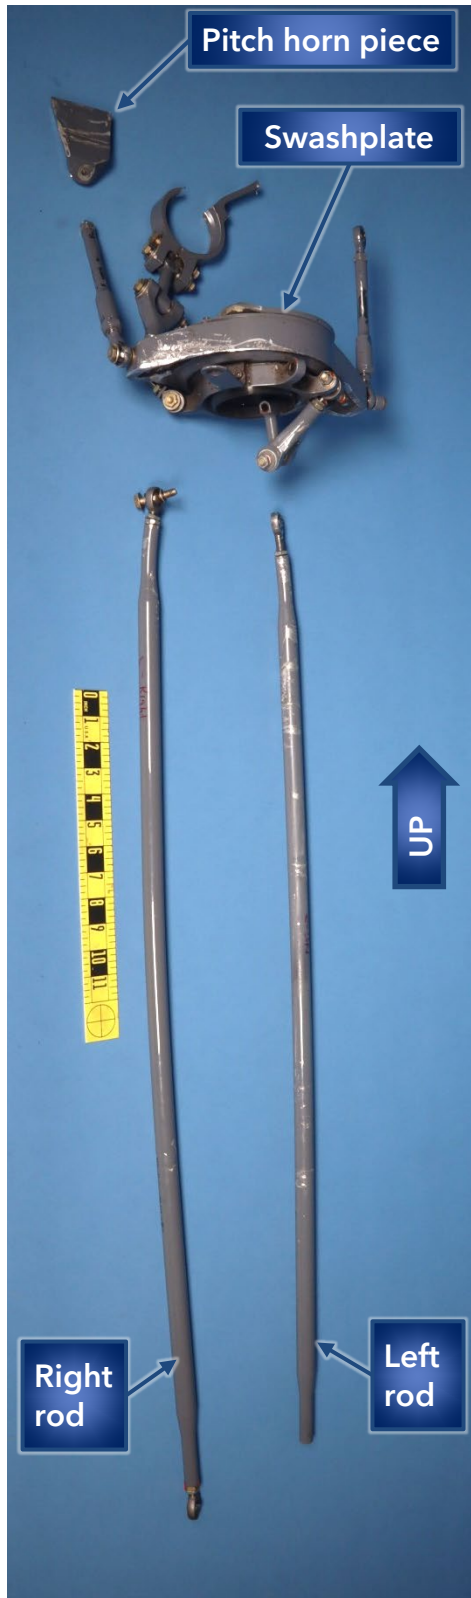
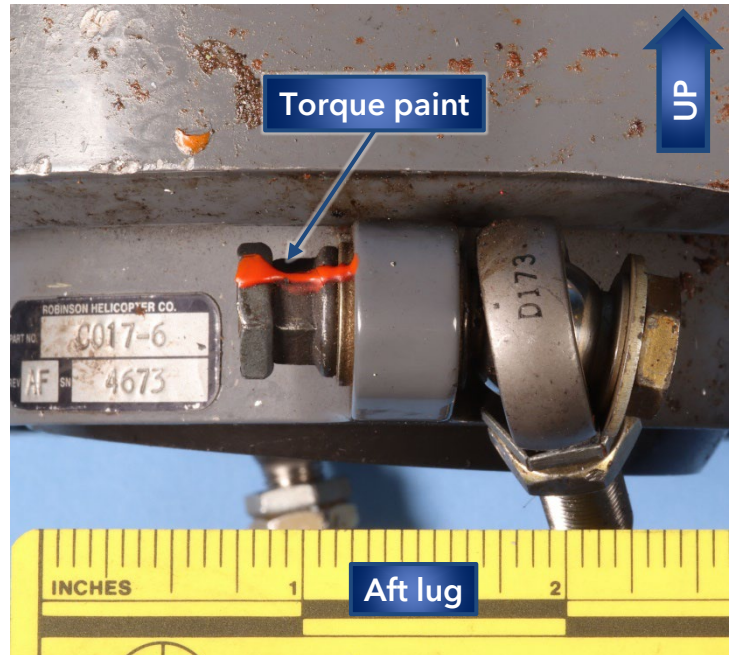
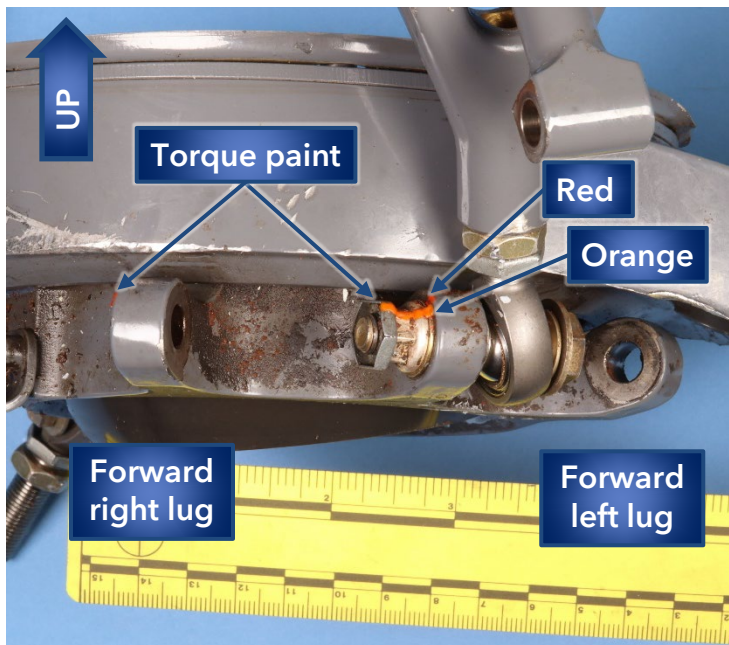
An overall view of the submitted components is shown in figure 1. The forward left upper flight control tube assembly was separated from the corresponding lug on the swashplate assembly, and the attaching hardware was missing. The forward right upper flight control tube assembly had been disassembled from the swashplate before the parts were sent to the NTSB materials laboratory. The yoke and one of the pitch control end fittings was fractured, and both had rough matte gray fractures and deformation consistent with ductile overstress fracture. The pitch horn piece, which had been cut from the rest of the blade, included the mating side of the fractured pitch control end fitting.

Close views of the forward and aft sides of the swashplate are shown at the right in figure 1. The upper end fitting for the aft upper flight control tube was attached to the swashplate lug, but the attachment bolt was bent. Orange torque paint was intact on the pal nut, nut, washer, and lug surfaces.

On the forward side of the swashplate assembly shown in figure 1, orange torque paint was observed on the palnut, nut, washer, and lug surfaces for the fixed link attachment on the center lug, and a remnant of red torque paint was observed on the lug surface adjacent to the orange stripe. A remnant of red torque paint was also observed on the forward right lug as indicated in figure 1. The submitted hardware for the forward right attachment included the bolt, washer, and spacers from the fitting side of the attachment and did not include hardware from the nut side of the attachment where the torque stripe is to be applied. No evidence of torque paint of any color was visible on the nut side of the forward left lug surface.

**Figure 1.** Overall view of the submitted components (left) with closer views of the flight control attachment lugs on the aft (upper right image) and forward (lower right image) sides of the swashplate assembly.

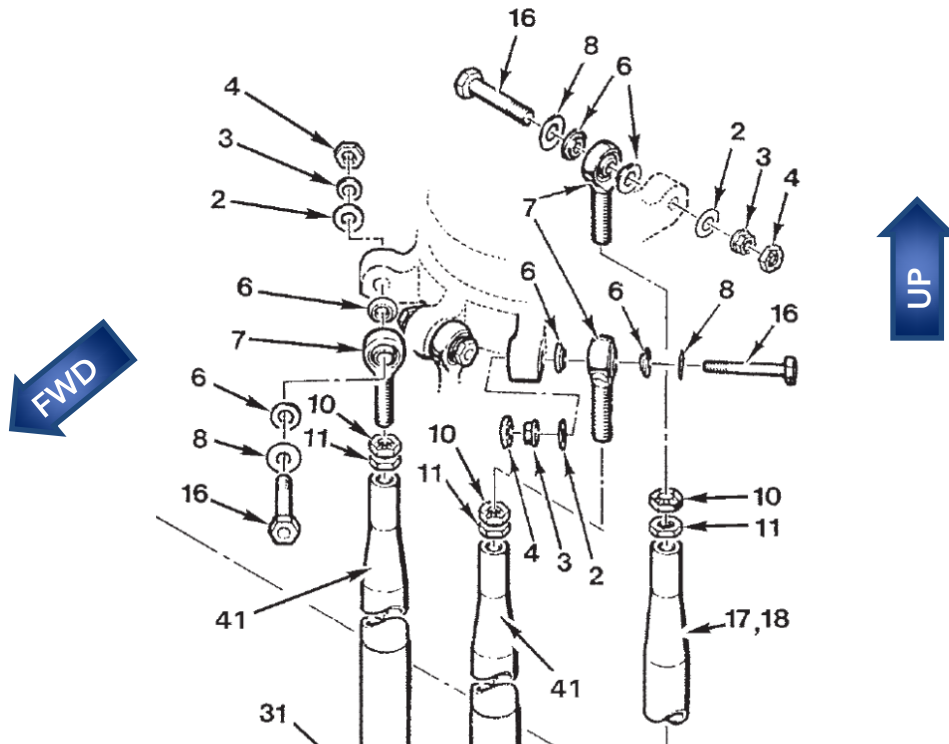
A diagram from the Robinson R44 Illustrated Parts Catalog shows the hardware used to attach the upper flight control tube assemblies. As shown in figure 2, the control attachment at each of the three locations consist of a bolt, two flat washers, two hat-shaped spacers, a nut, and a palnut. As shown in the diagram, the hat-shaped spacers are oriented such that the "top" of the hat faces the bearing in the control end fitting, and the "brim" of the hat faces the attachment lug on one side of the fitting and a flat washer on the other. As measured on an exemplar spacer in the assembly, the outside diameter of the "brim" portion measured 0.560 inch, and the outside diameter of the center "hat" portion measured 0.387 inch.

**Figure 2.** Diagram from the Robinson R44 Illustrated Parts Catalog showing the upper flight control tube assembly attachment to the swashplate assembly including the bolts (16), washers (2, 8), spacers (6), nut (3), and palnut (4).

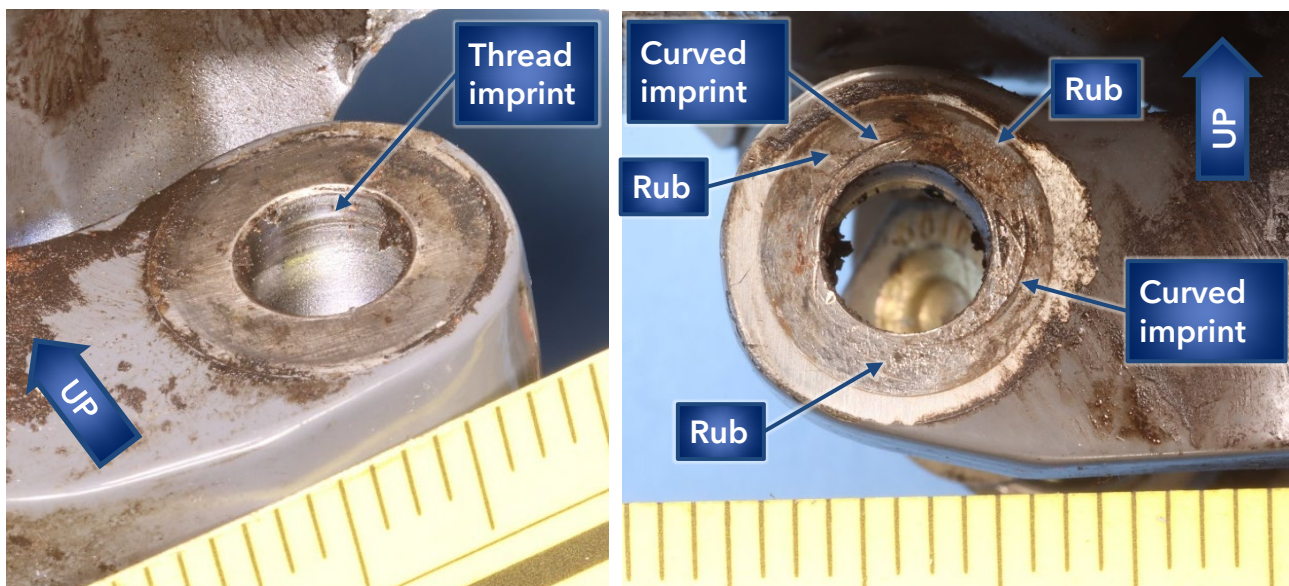
Closer views of the forward left lug on the swashplate assembly are shown in figure 3. The bore of the hole on the nut side of the lug was relatively shiny consistent with contact wear and had a circumferential imprint consistent with wear contact with a bolt thread. Areas of rubbing damage and multiple curved imprints were observed on the spacer contact face around the hole bore on the fitting side of the swashplate lug.

**Figure 3.** Close views of the swashplate lug for the forward left control attachment showing thread contact wear on the lug bore the right (nut-facing) side (left image) and rubbing damage and the two longest curved imprints around the hole bore on the left (fitting-facing) side (right image).

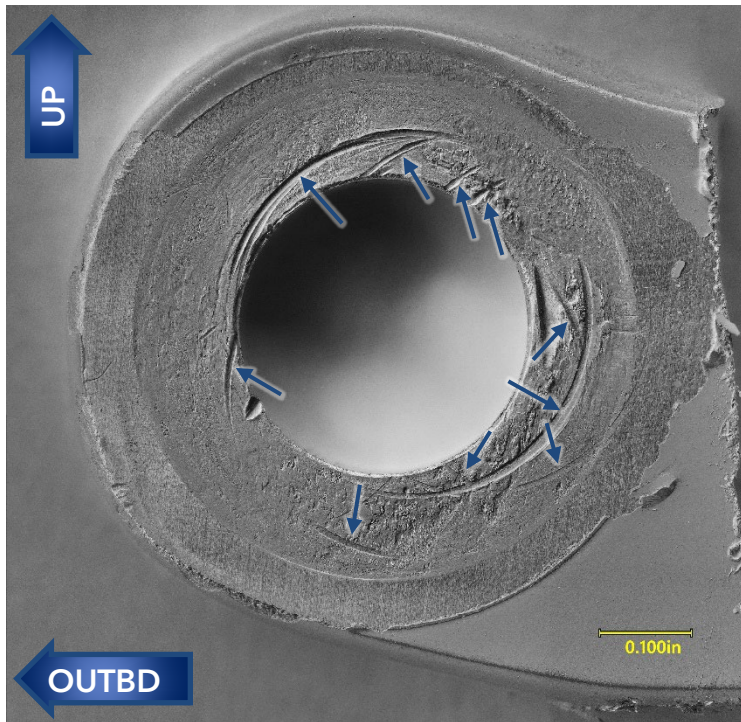
The cleaned and sectioned forward left lug was imaged using a Keyence VHX-7000 optical microscope using the stitching function and various lighting modes. A stitched image of the fitting-facing side of the lug is shown in figure 4 using the optical shadow mode. Various curved imprints on the surface are indicated with unlabeled arrows in figure 4.

**Figure 4.** Stitched optical image of the cleaned forward left lug after sectioning as viewed using a Keyence VHX 7000 in shadow mode showing multiple impacts on the control fitting (left) side of the clamping face.

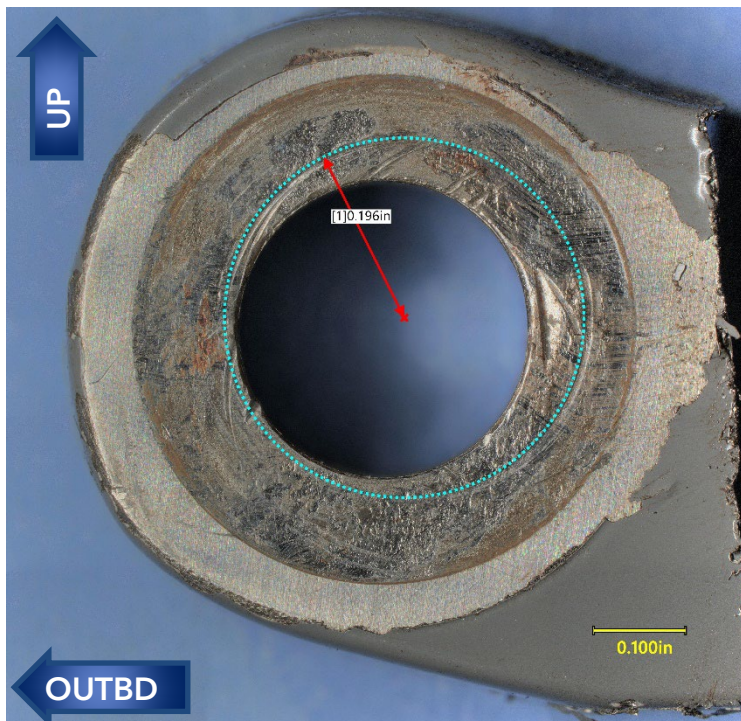
A stitched image of the same lug face using the glare removal mode is shown in figure 5. A circle fitted to one of the two longest curved imprints, the imprint on the upper outboard quadrant of the contact face, had a radius of 0.196 inch and had a center that was offset upward and inboard of the attachment hole axis. A dashed line in figure 5 shows the circumference of the circle, which intersected another of the longest curved imprints that was located on the lower inboard quadrant of the lug

face. The circle outlined with a dashed line in figure 5 had a diameter of 0.392 inch, which is slightly larger than the outside diameter measured on the "top" portion of the exemplar hat-shaped spacer, which measured 0.387 inch.

**Figure 5.** Stitched optical image of the cleaned forward left lug after sectioning as viewed using a Keyence VHX 7000 with glare removal measuring the radius of a circle defined by the edges of the two longest curved imprints.
