# National Transportation Safety Board

ERA23FA070

Group Chair's Factual Report

Location: Charlotte, NC  
Date: November 22, 2022  
Time: 1219 EST  
1719 UTC  
Helicopter: Robinson R44 / N7094J

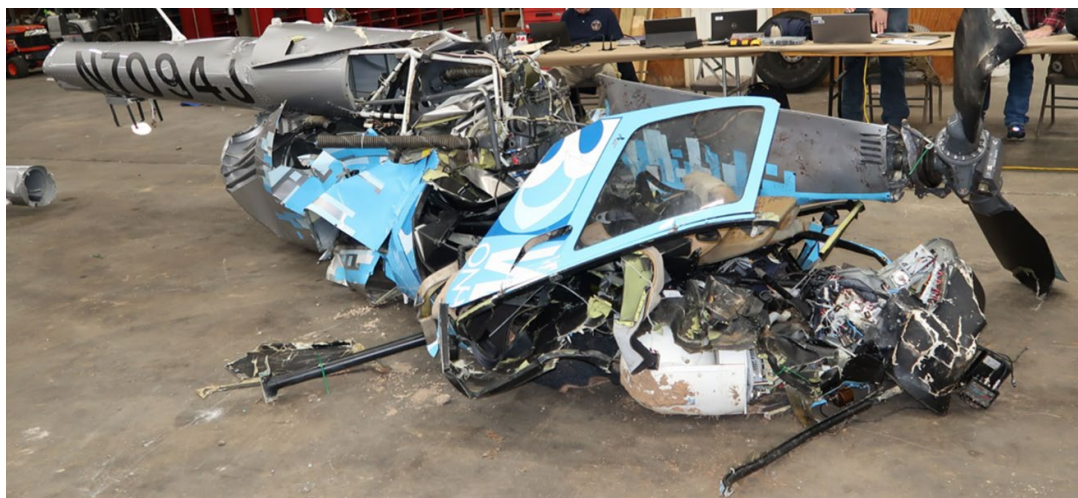
**Figure 2.** Main wreckage after recovery from the accident site.

The cabin area was completely collapsed downward with a flat upward crushing of the entire belly. The rotor, transmission, and rotor mast were attached to the airframe but displaced forward 90° rotated about the base of the transmission. The transmission/rotor mast assembly remained intact. The aft right-side door remained attached to the door frame. The pilot and copilot seats and their seat supports were collapsed downward. Extensive amounts of ENG equipment was contained in the cabin area behind the cockpit. The cockpit instrument panel was detached from the airframe but remained in the forward cabin area. The tail boom was attached to the aft airframe structure and extended 7 feet to a separation at the aft section of tail boom bay 4. The tail rotor drive shaft and tail rotor control rod had been cut by recovery personnel at the same location. The separated section of tail boom (approximately 6 feet) had the vertical and horizontal stabilizers attached, along with the tail rotor gear box and tail rotor assembly.

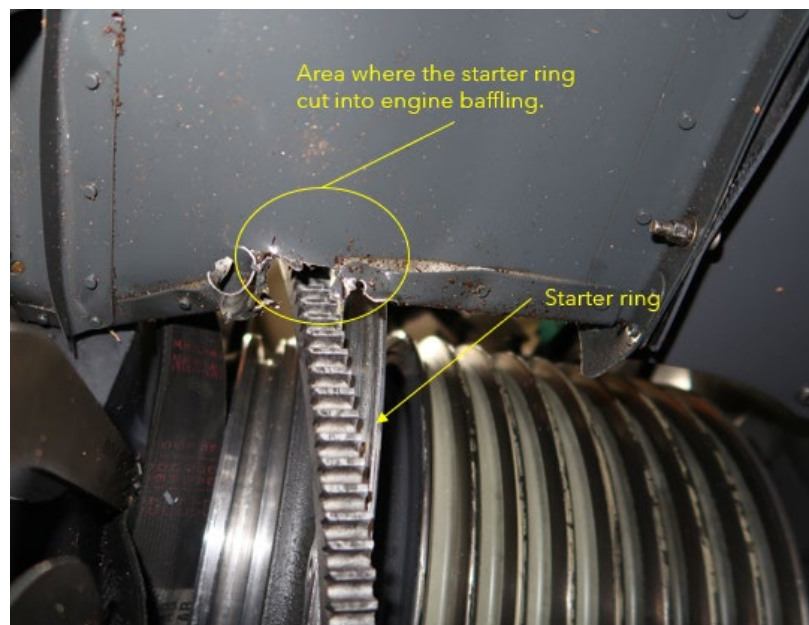
Both landing skids had separated from the fuselage. The right aft strut was attached to the skid tube but had separated from the cross-tube fitting; the forward strut had separated from the skid tube and remained attached to the cross tube in the fuselage. The left aft strut had separated from the skid tube at the skid tube attachment; the strut and cross tube were recovered in one piece. The left forward strut had separated from the skid tube and remained in the fuselage; the skid tube toe had fractured. Both main and auxiliary (aux) fuel tanks had separated from the fuselage. Both tanks had bladders installed, both contained some fuel, and both fuel caps were in place. The engine remained within the engine compartment, but the engine mounts had fractured, and the engine was restrained by the drive belts. The drive sheave and fan were attached to the engine, and the associated baffling was in place. The 4 drive belts were present but had shifted off their respective grooves on the sheave. The engine starter ring had cut into the nearby metal baffling (Figure 3).

**Figure 3.** A close in photo of the area where the starter ring had cut into the engine baffling.

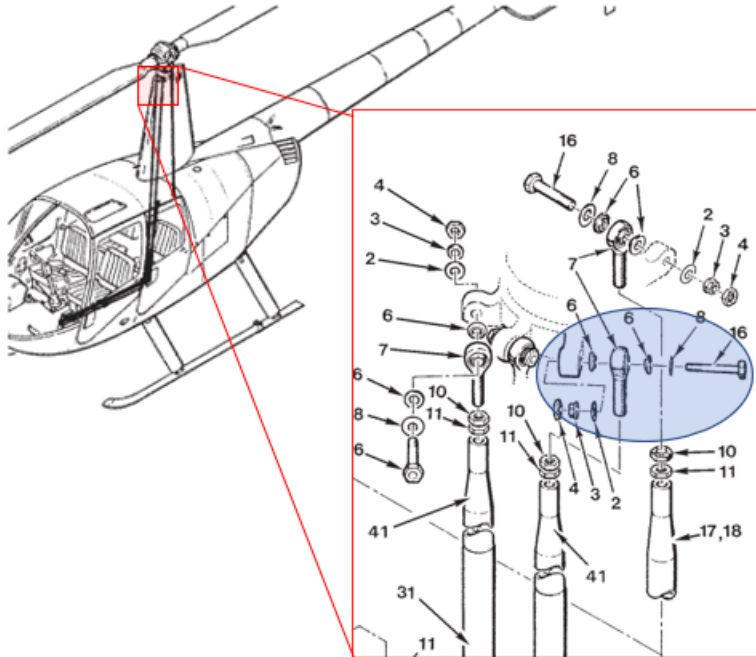
Cyclic and collective control was established from the cockpit aft to the stationary swashplate through multiple breaks in the control tubes. All bell cranks and control tube rod end connections were present except for the upper forward left control rod to swashplate flange. The left forward control rod end connection to the stationary swashplate flange was not connected (Figures 4 and 5), with the attaching bolt, nut, and palnut fastening hardware missing. The rotating swash plate had witness marks on the forward rotating face and the underside in line with the left forward control tube rod end (Figure 6). The control tube rod end had witness marks on its outer diameter, the palnut fastener was not present, and the rod end was extended (unscrewed) 3/4 inch from the control rod. The upper forward portion of the rotor mast fairing and control rod had damage consistent with the control rod repeatedly impacting the interior of the fairing (Figure 7).

**Figure 4.** Location of left control rod disconnect highlighted by blue oval. (Source: Robinson Helicopter Company)

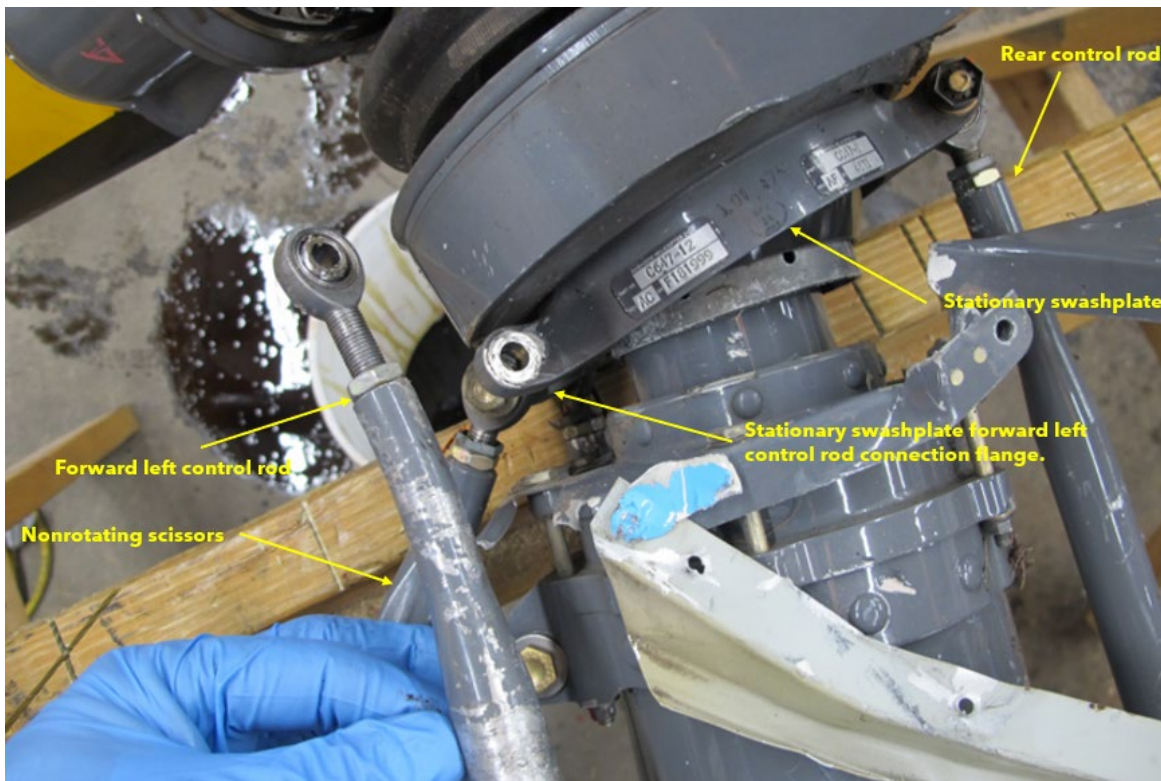
**Figure 5.** Photo of the upper controls showing the disconnected forward left control rod from the stationary swashplate.

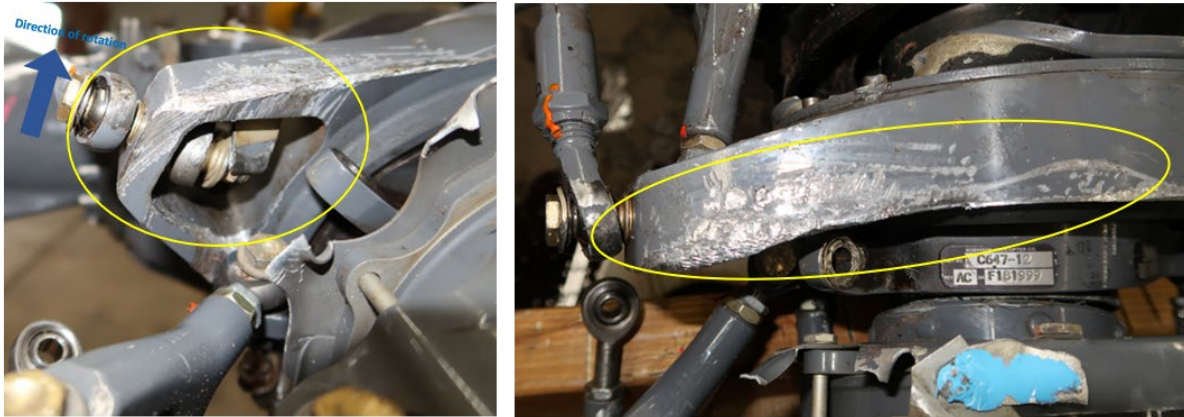
**Figure 6.** Witness marks identified by the yellow oval on the forward face of the rotating swashplate.

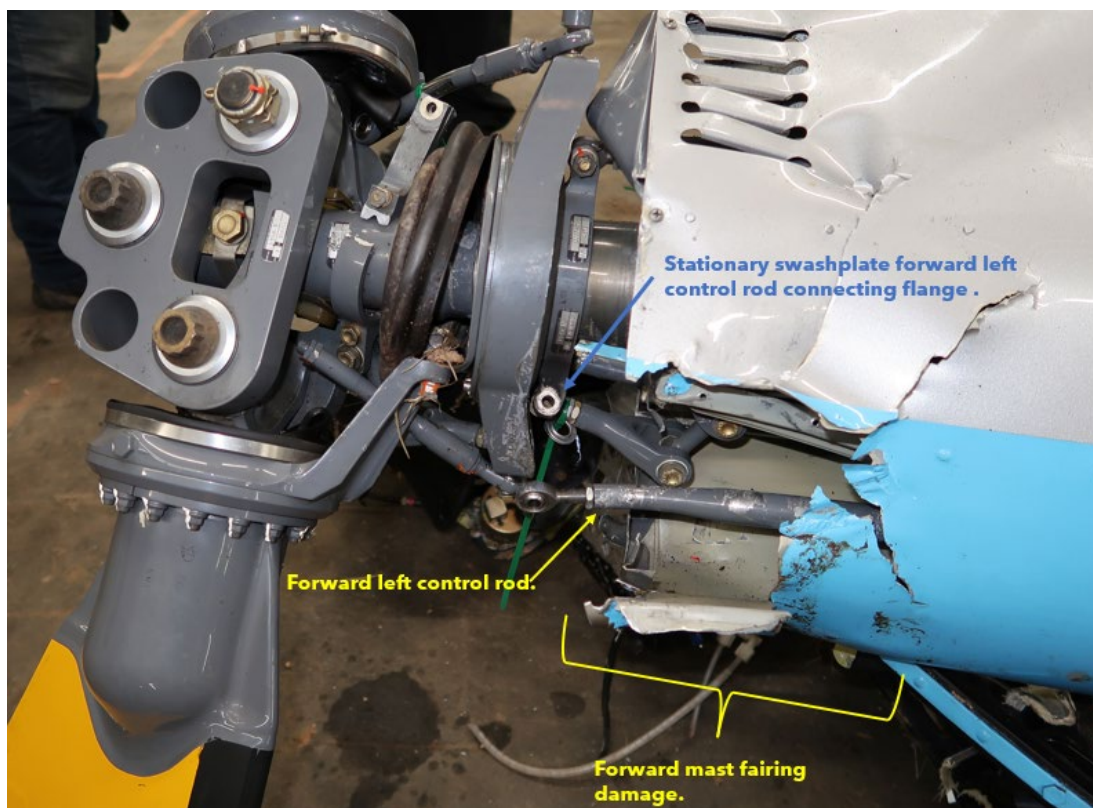
**Figure 7.** Upper portion of the mast fairing damage.

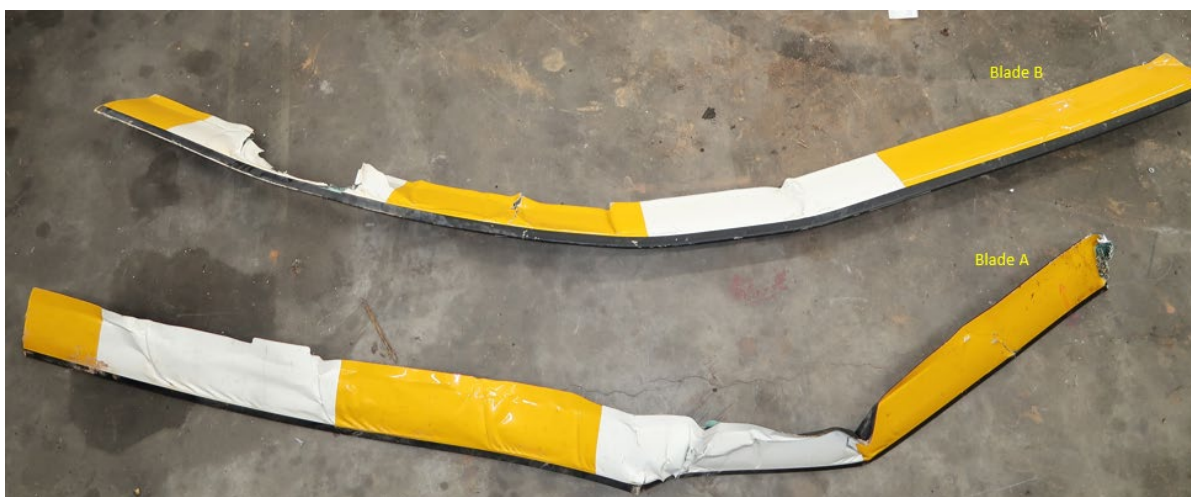
The rotor head, PN C154-1, SN 10963, remained attached to the rotor mast. Blade "A" had completely fractured chordwise 31 inches from the base of the spindle. Blade "B" was cut chordwise 27 inches from the base of the spindle by recovery personnel (Figure 8). Both mast bump stops exhibited crush damage across the middle.

**Figure 8.** Overhead view of both main rotor blades.

Blade "A", PN C016-7, Revision AJ, SN 10392; the entire blade was intact with a downward crease and a trailing edge buckle at 3 feet 6 inches from the fractured end. A second downward crease was 6 feet from the fractured end. The upper blade skin had buckling along the entire length and 45° angle creases along the leading edge of the outboard half of the blade. Only two inches of the tip cap trailing edge was present.

Blade "B", PN C016-7, Revision AJ, SN 10348; the entire blade had a distinct aft bend of the outboard half of the blade with trailing edge buckling. A 2-foot section of after body starting about 2 feet inboard of the blade tip had been liberated, which was characterized by blade skin tearing, peeling, and deformation. The entire tip cap remained attached to the blade.

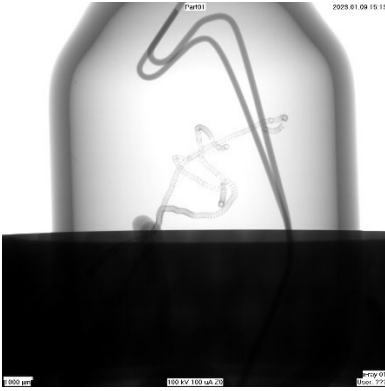
| <b>Indicator Light</b> | <b>Filament Condition</b> |
|---|---|
| Alternator | Broken, Stretched (Figure 10) |

**Figure 10.** Radiograph of the alternator light.

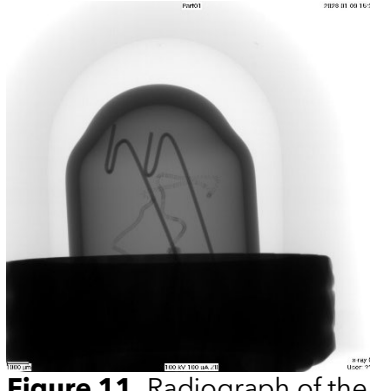
| <b>Indicator Light</b> | <b>Filament Condition</b> |
|---|---|
| Clutch | Intact, Stretched (Figure 11) |

**Figure 11.** Radiograph of the clutch light.

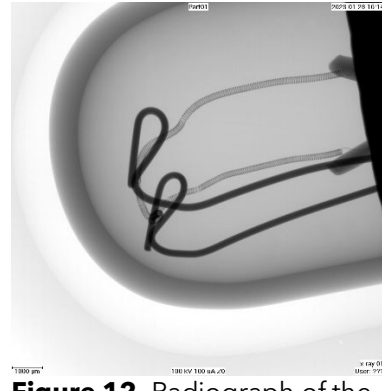
| <b>Indicator Light</b> | <b>Filament Condition</b> |
|---|---|
| Low RPM (rotor) | Intact, Not stretched (Figure 12) |

**Figure 12.** Radiograph of the Low rotor rpm light.
