# National Transportation Safety Board

ERA23FA070

## **MATERIALS LABORATORY**

Factual Addendum 22-006B

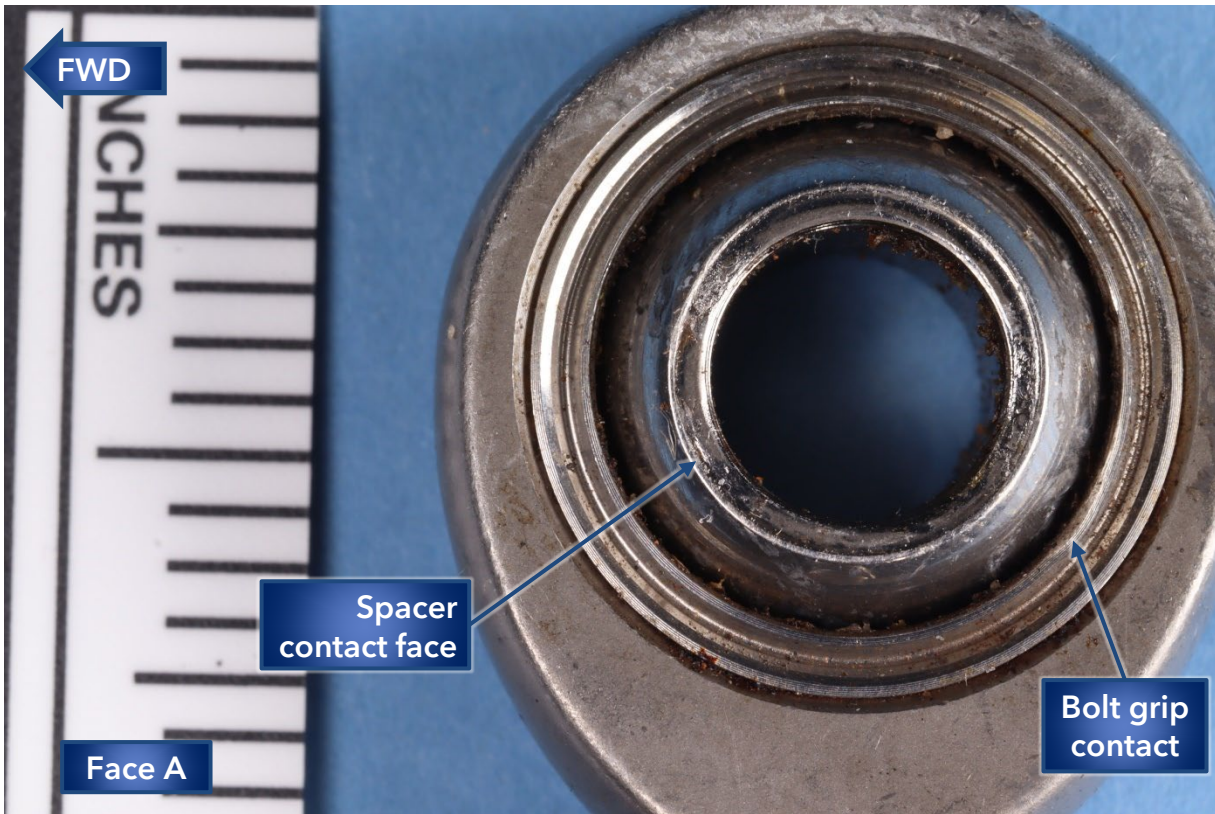
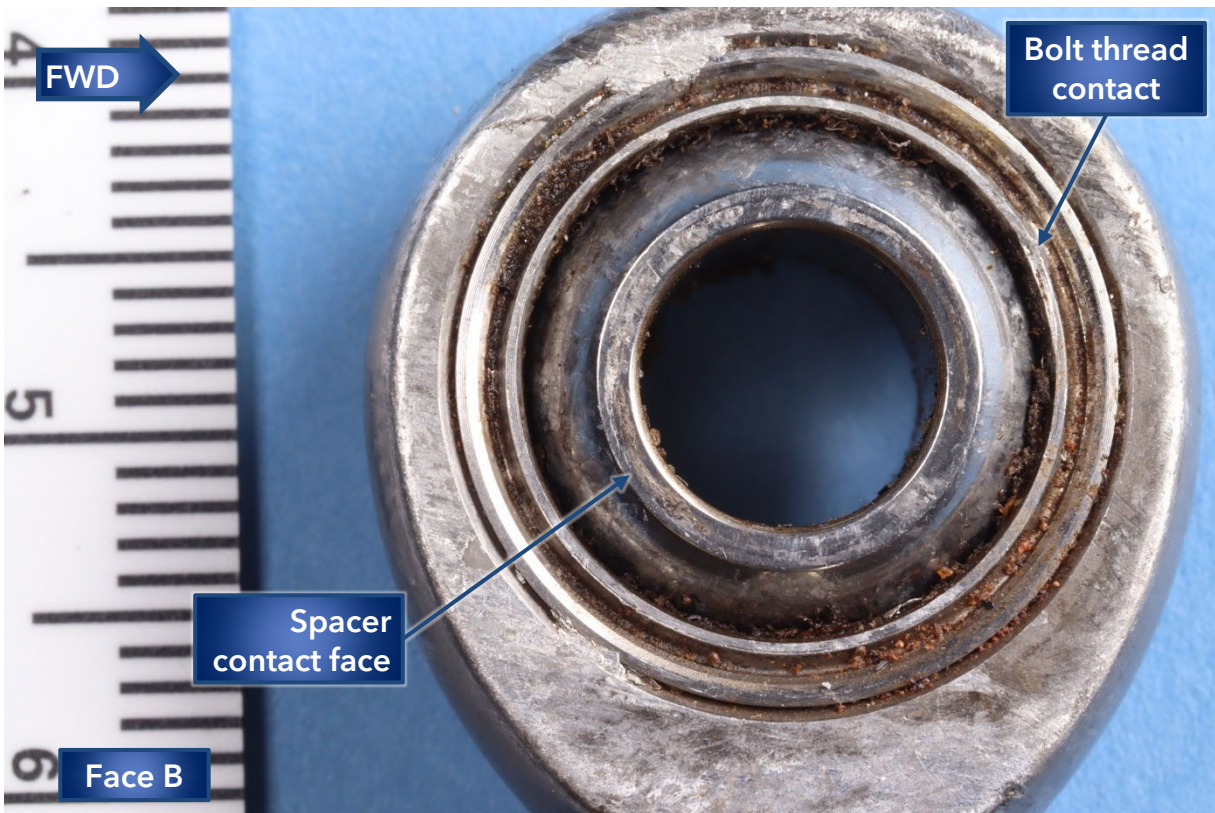
Macro photographs of each face of the end fitting are shown in figure 1. Contact damage and light gray deposits consistent with contact with adjacent aluminum structure and/or components was observed on the end fitting. The jam nut was loose, and orientation of the fitting relative to the aircraft was not noted on the assembly. For reference in this report, the faces of the end fitting were arbitrarily labeled A and B as shown in figure 1.

The spacer contact faces on the inner race of the end fitting bearing appeared rubbed and had pitting damage, features consistent with fretting damage, on both spacer contact faces as indicated in figure 1. Additional images of the damaged spacer contact faces on the inner race are shown in figure 2 as acquired using a Keyence VHX-7000 optical microscope in depth mode with optical shadow effect. On face A, the spacer contact face for the bearing inner race was worn, leaving a lip around the outside diameter of the contact face. In contrast, the wear on face B was relatively flat across the spacer contact face and did not show a lip at the outside diameter. As shown in the upper image in figure 2, the diameter of the recessed portion of the wear damage on face A measured 0.392 inch, which corresponded to the outside diameter of the central thicker portion of the hat-shaped spacer (measured on an exemplar spacer).

The inside diameter of the outer race on each face had localized deformation corresponding to contact with the attachment bolt shank. On face A, the damage had a smooth curving deformation consistent with contact with the attachment bolt grip (smooth portion of the bolt shank) at the location indicated in the upper image in figure 1. On the opposite face, the local deformation to the outer race had a different appearance with similar curvature, but with damage more localized to near the surface. The local damage to the outer race on face B corresponded to contact with the threaded portion of the attachment bolt shank at the location indicated in the lower image in figure 1.

The bolt shank contact marks on the outer race shown in figure 1 were on diametrically opposite sides of the end fitting, and the presence of witness marks from the threaded end of the bolt on face B with a corresponding grip contact mark on face A indicate that face A was closest to the head end of the attachment bolt, and face B faced toward the swashplate lug as installed with the threaded end of the bolt facing to the right through the swashplate lug. The orientation of the aircraft forward direction shown in figures 1 and 2 is based on this bolt orientation as determined by the corresponding witness marks on the bearing outer race.

**Figure 1.** Macro photographs showing opposite faces of the upper end fitting for the forward left upper flight control tube assembly.

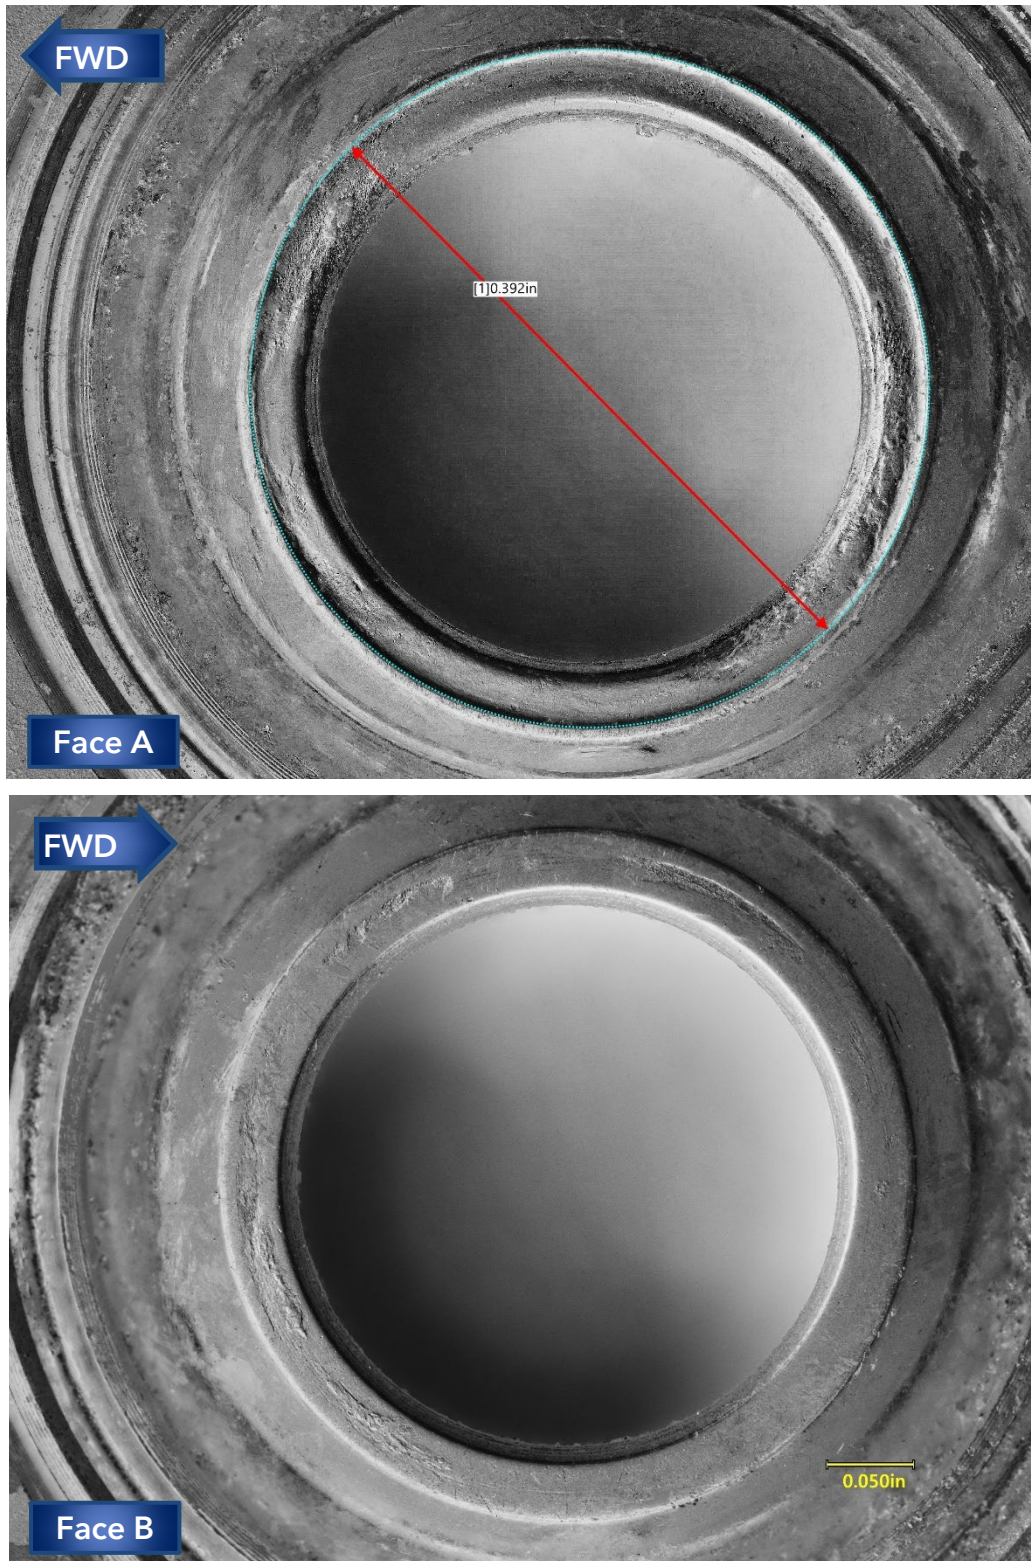
**Figure 2.** Images of the end fitting faces shown in figure 1 obtained using a Keyence VHX-7000 optical microscope in depth mode with optical shadow effect. The diameter of the recessed area on the spacer contact face of the inner race is indicated in the upper image.
