# National Transportation Safety Board

ERA23FA078

## **AIRFRAME EXAMINATION**

Location: Beverly, MA  
Date: December 4, 2022  
Time: 1135 EST  
1635 UTC  
Gyroplane: N401GR, Rotorsport UK, Cavalon

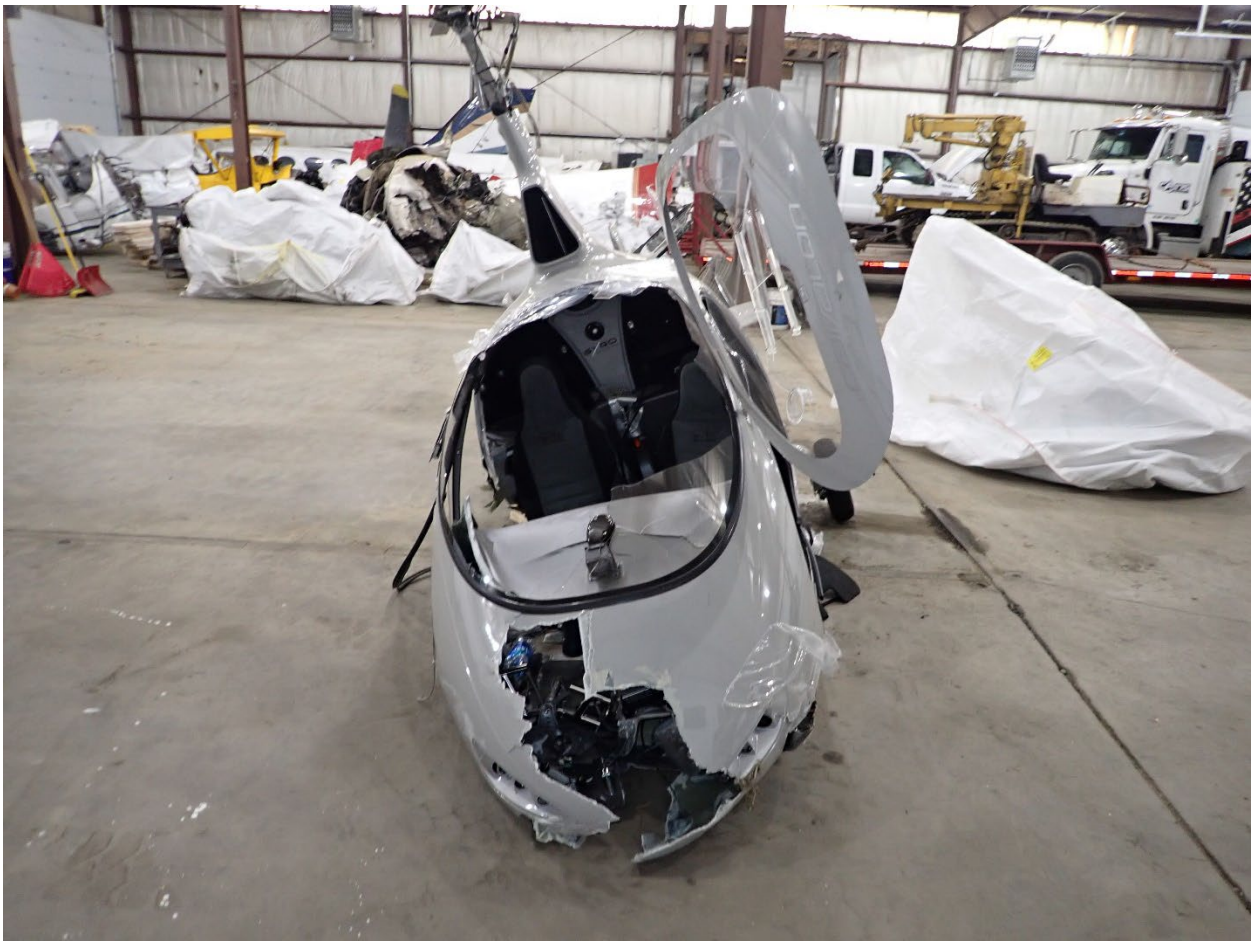
The fuselage remained intact and exhibited impact damage. The right door frame remained attached to the fuselage at one hinge and the bottom portion of the frame was impact separated, the glass of the right door was impact separated. The left door remained attached to the fuselage at one hinge. There was no evidence of a fire.

**Photo 1: View of the fuselage from the front.**

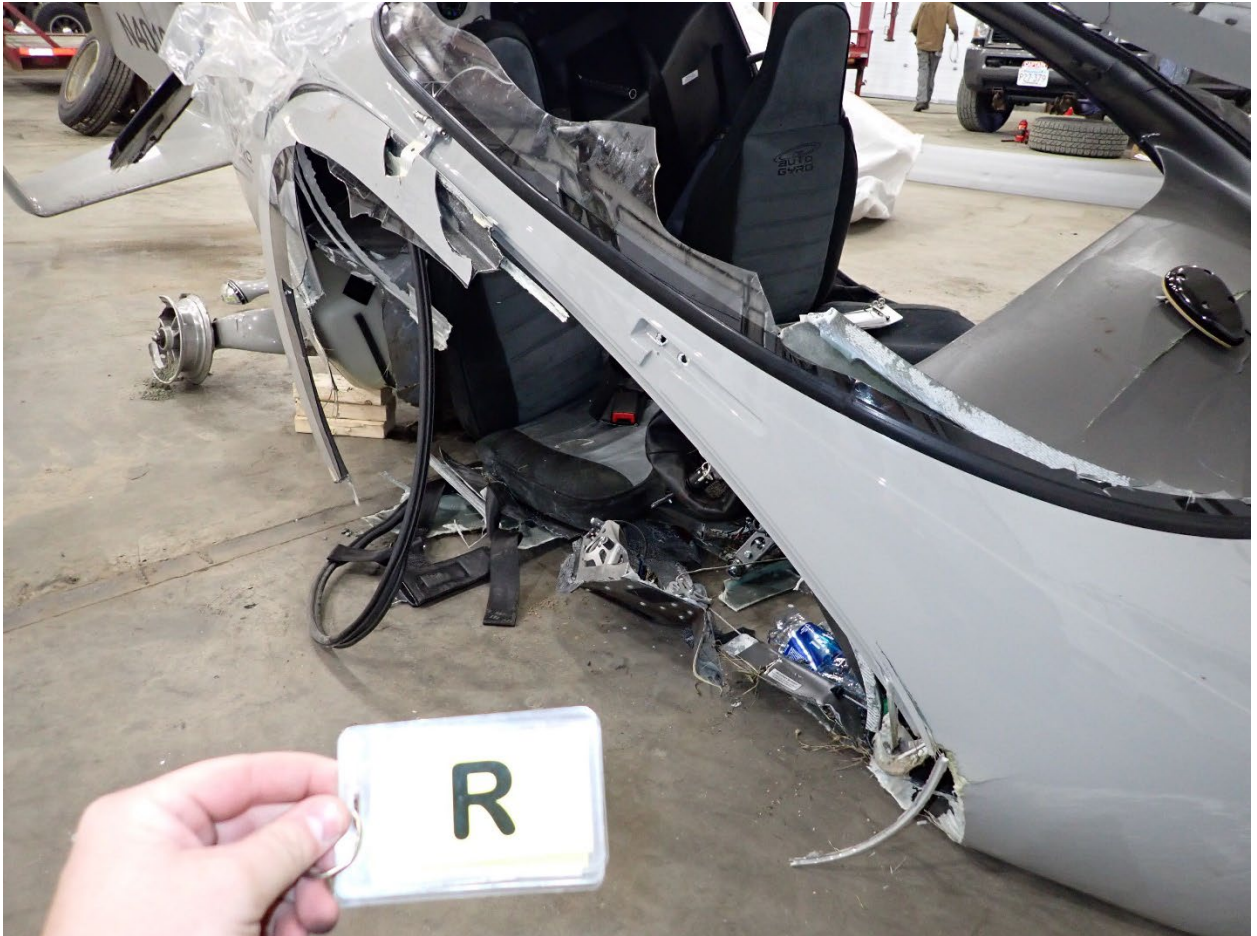
**Photo 2: View of the right door.**

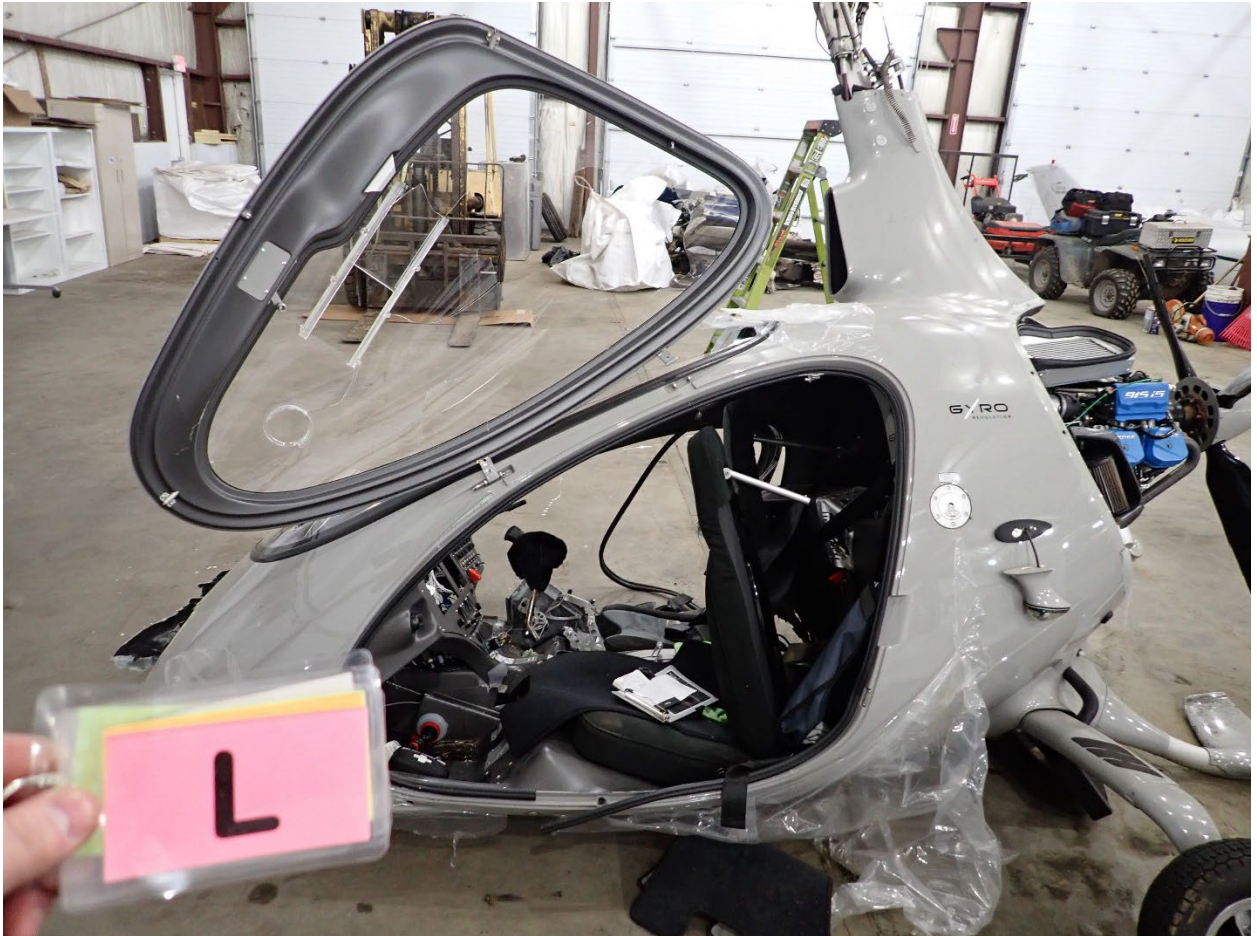
**Photo 3: View of the left door.**

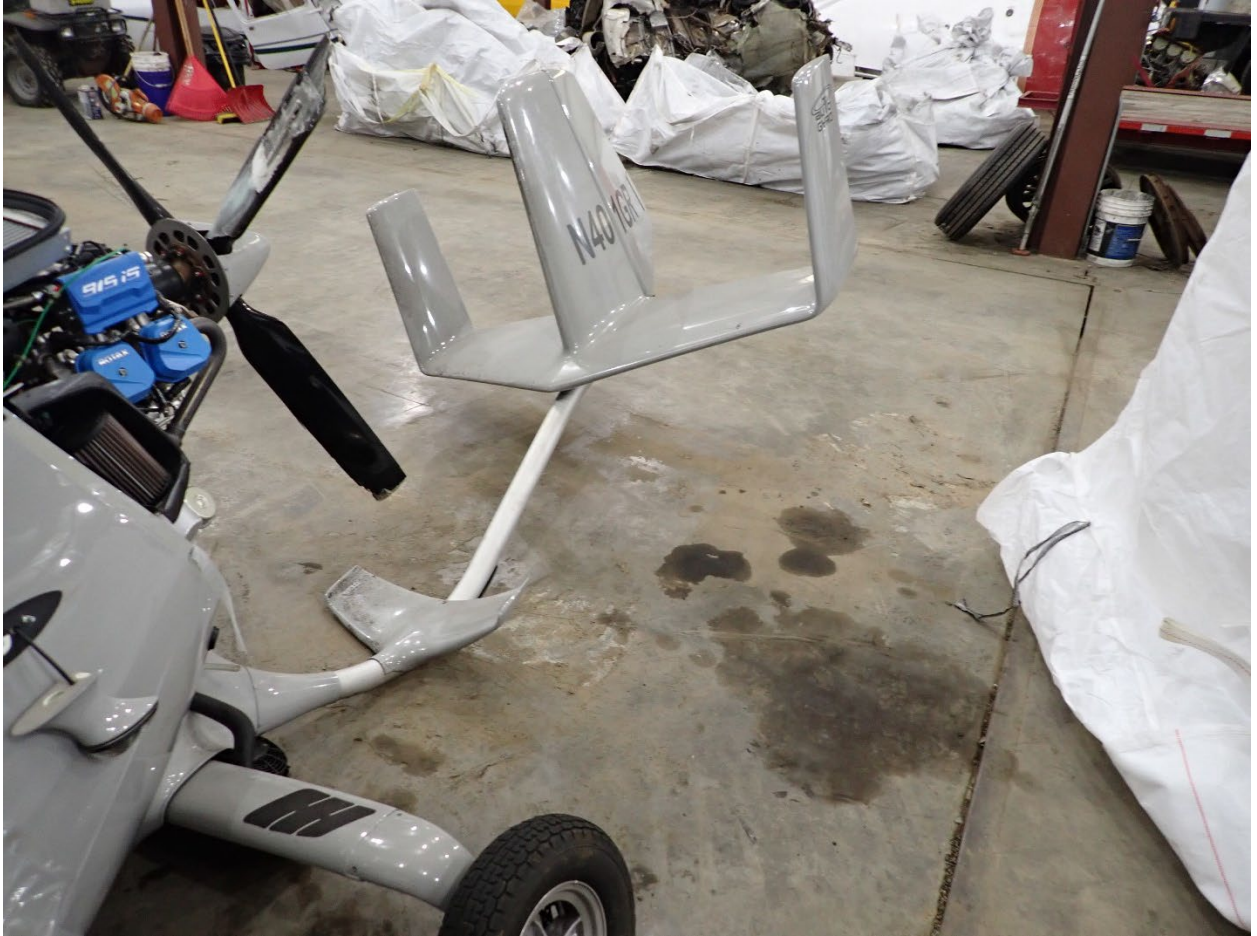
The empennage remained attached to the fuselage. The horizontal stabilizer remained intact and attached at all attachment points. The three vertical stabilizers remained intact and attached at all attachment points. Control continuity was confirmed from the rudder flight control surface to the pedals in the cockpit. The rudder trim tab was intact, at the accident site it was bent about 30° to the right and did not exhibit any impact damage or distortion.

**Photo 4: View of the empennage connected to the fuselage.**

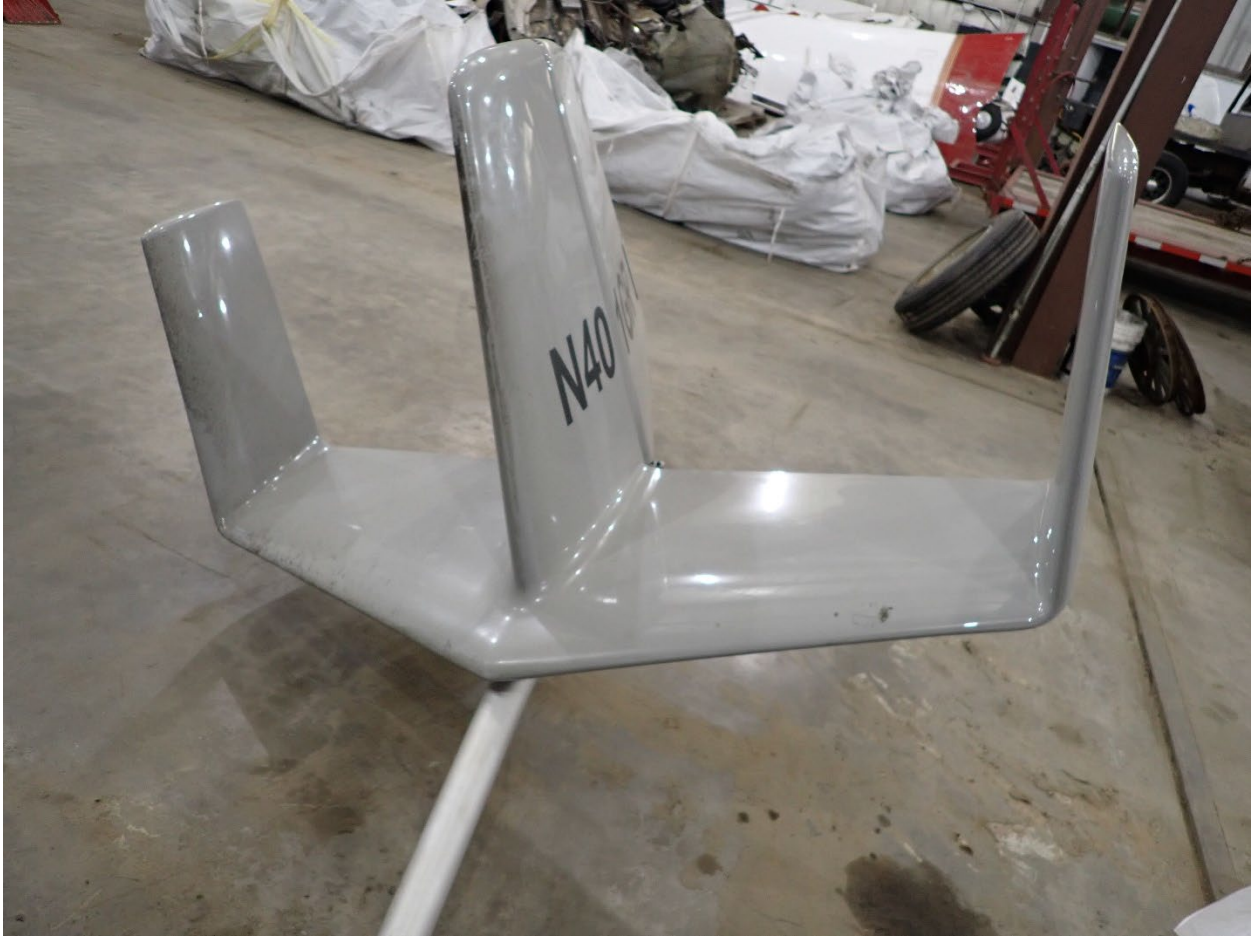
**Photo 5: View of the horizontal and vertical stabilizers.**

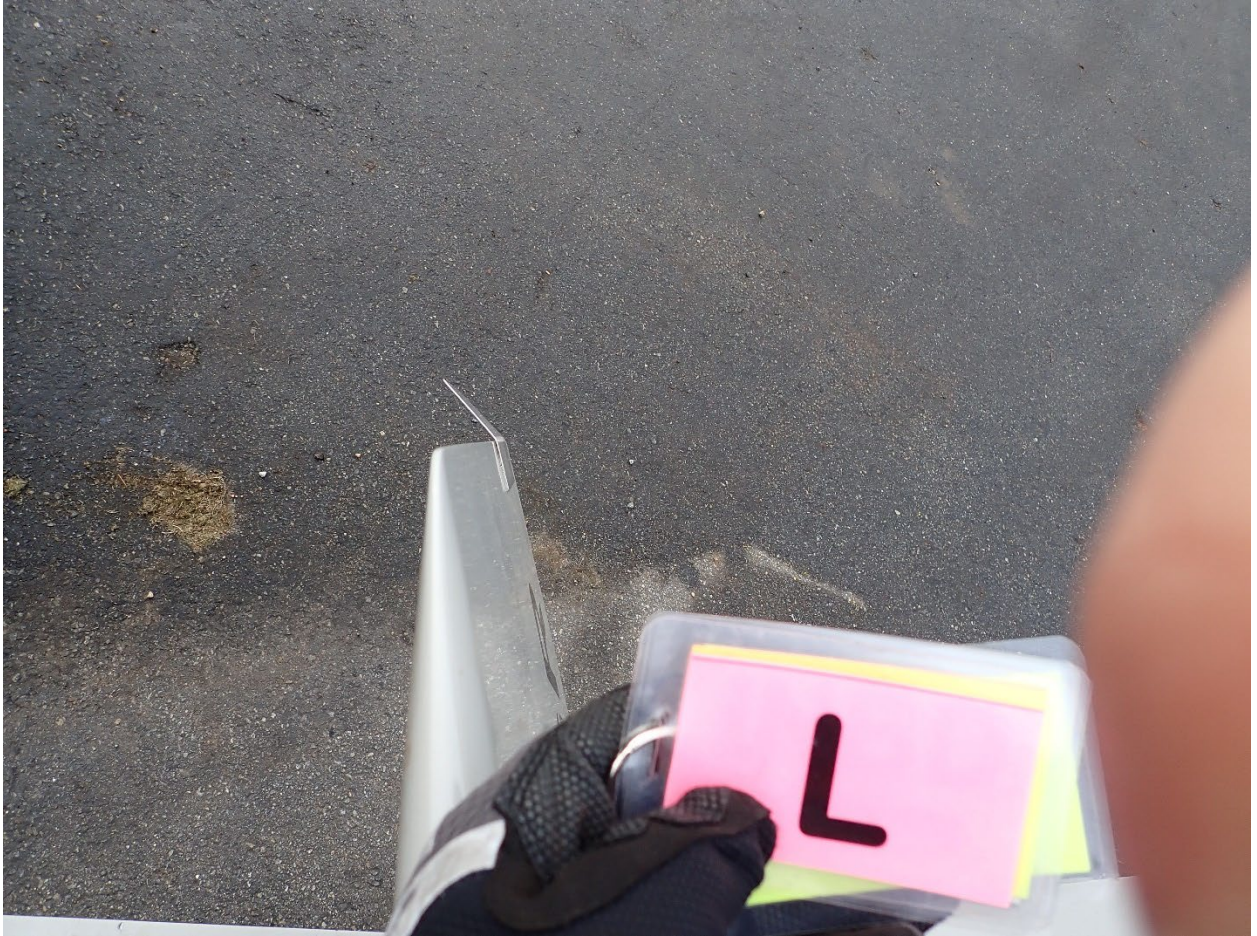
**Photo 6: View of the rudder trim tab at the accident site.**

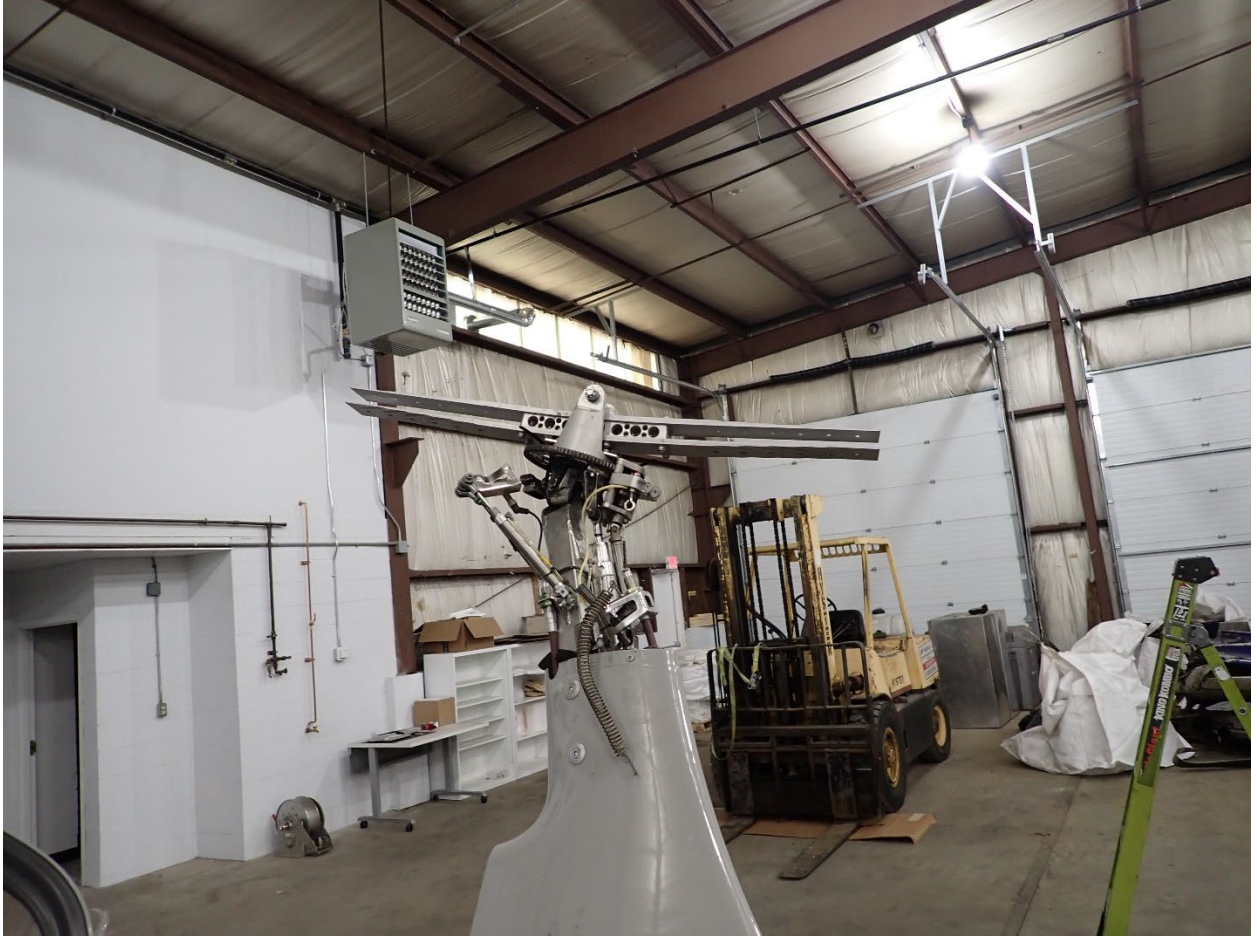
The rotor head was impact separated from the rotor mast, was disassembled from the rotor blades, and placed on top of the rotor mast and attached with zip ties for examination. Pitch control continuity was confirmed from the flight controls in the cockpit to the rotor mast and head through an overload separation of the rotor head pitch pushrod and pitch control cable. Roll control continuity was confirmed from the flight control in the cockpit to the rotor mast and head through an overload separation at the rotor head connection point.

**Photo 7: View of the rotor head attached to the mast with zip ties for examination.**

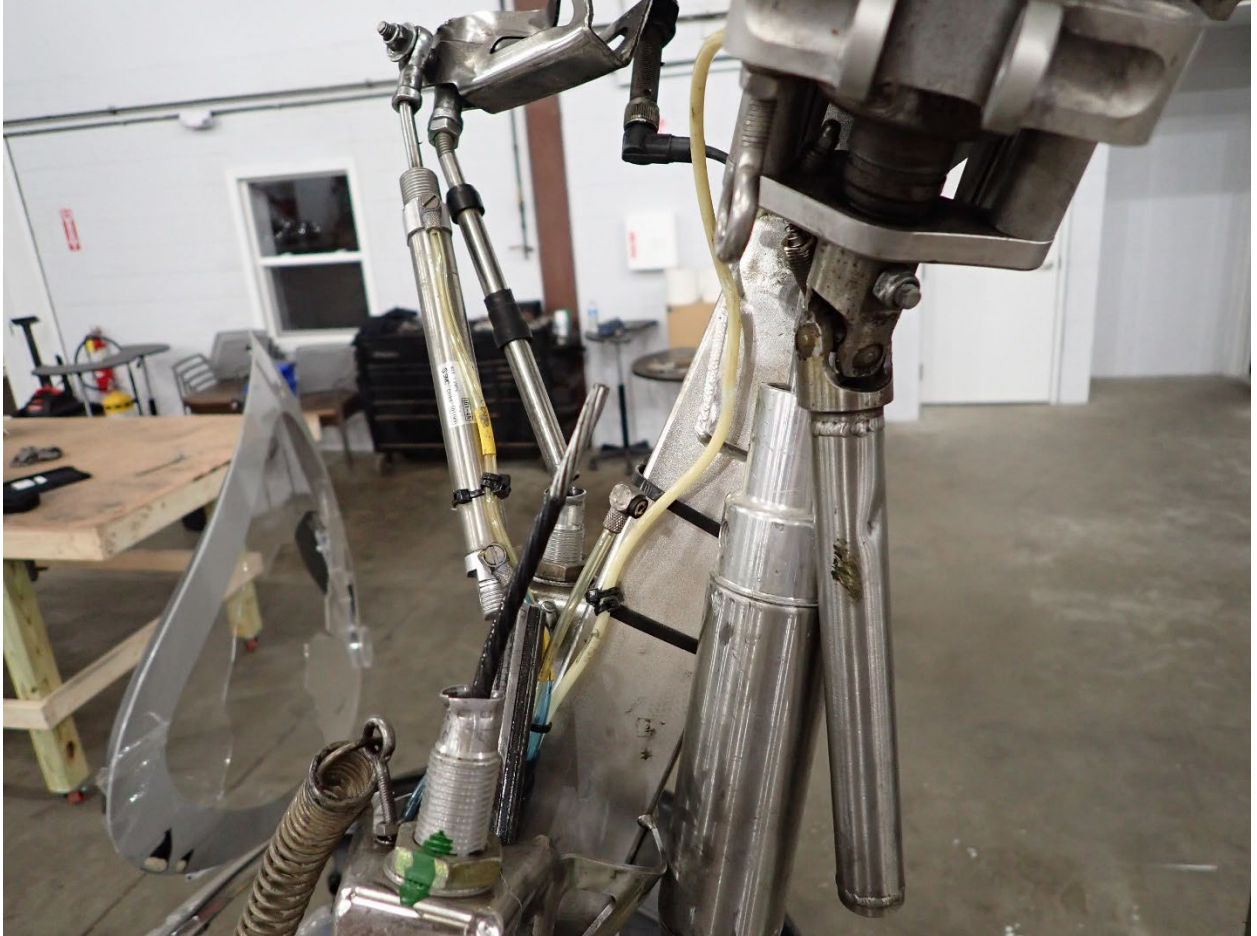
**Photo 8: View of the mast head assembly.**

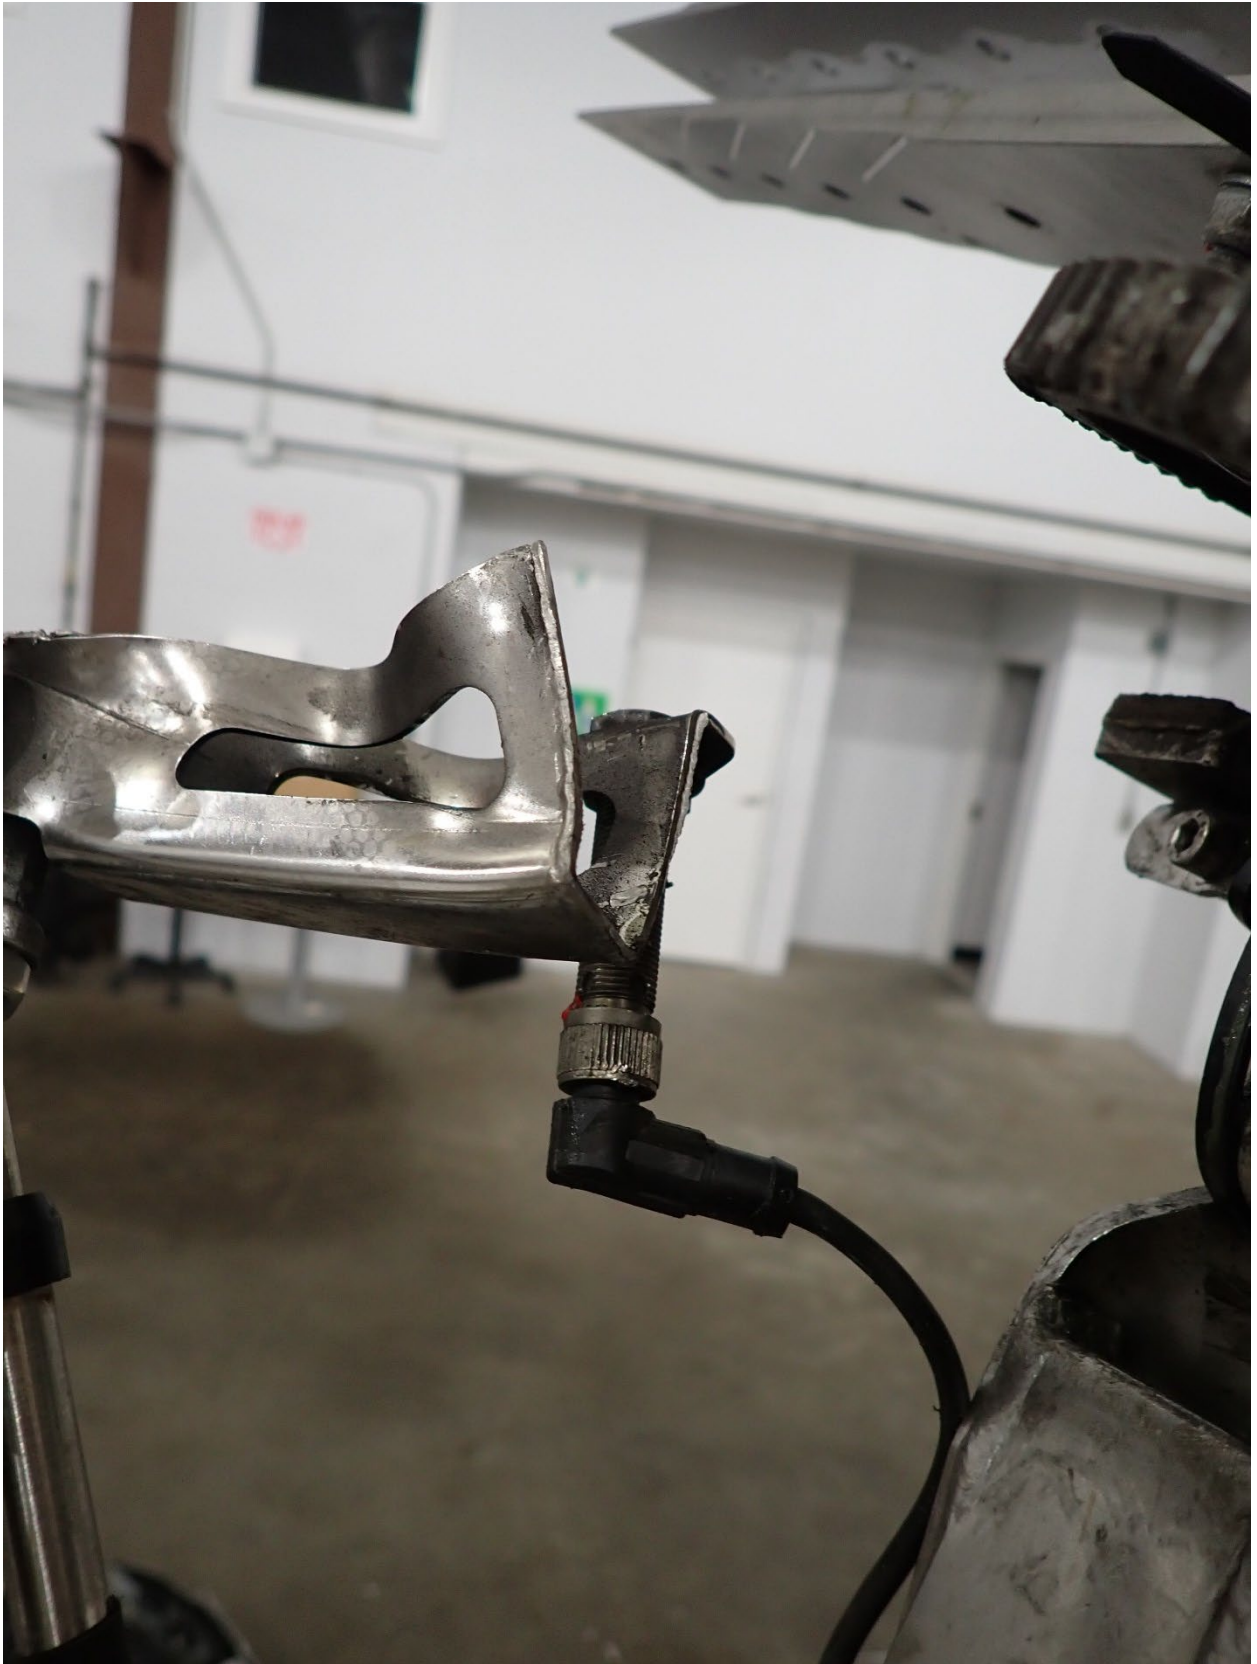
**Photo 9: Roll control rotor head attachment point.**

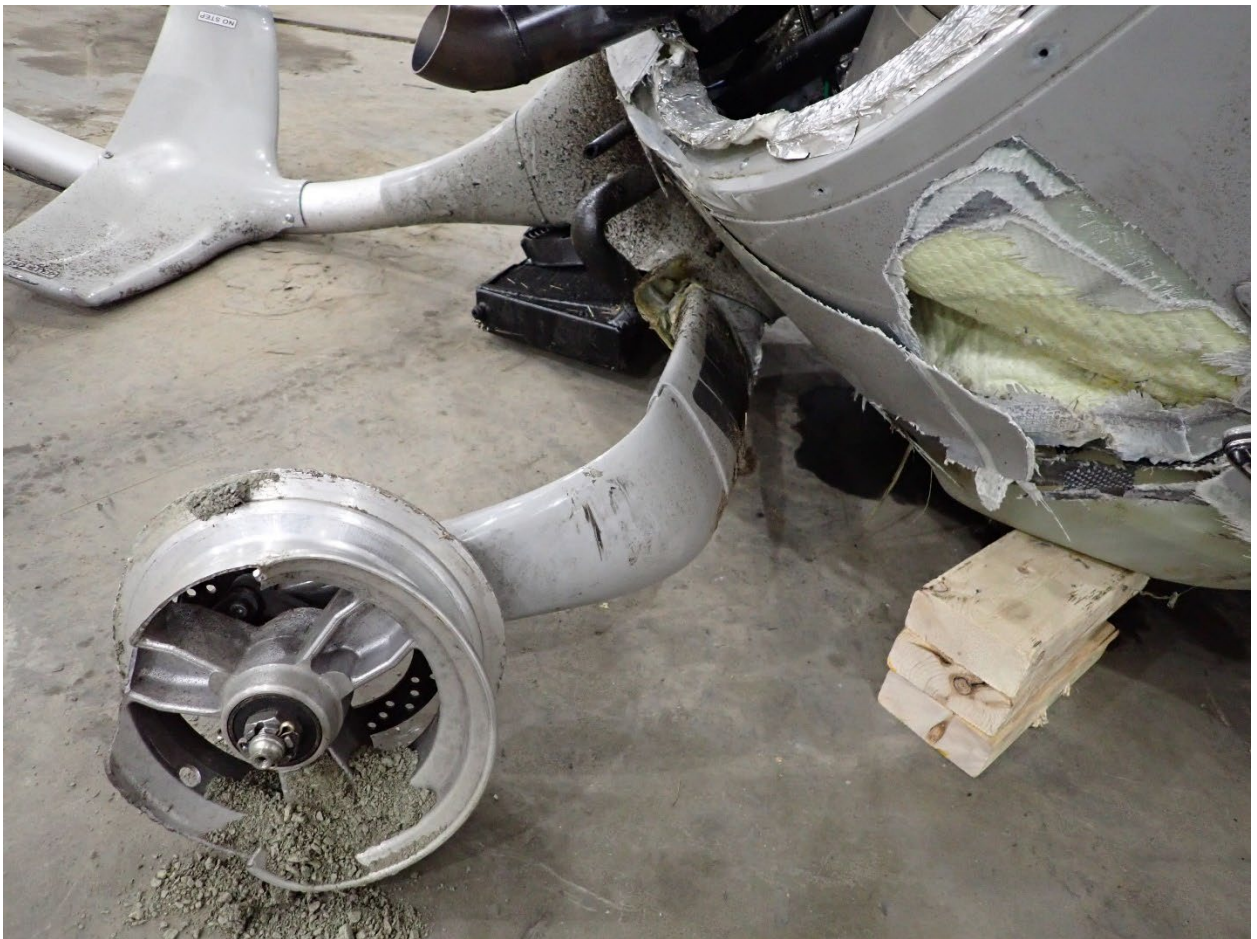
The nose landing gear collapsed and was crushed upwards into the cockpit. The right main landing gear was impact crushed/twisted aft and remained attached to the fuselage. The left main landing gear remained intact.

**Photo 10: Left main landing gear.**

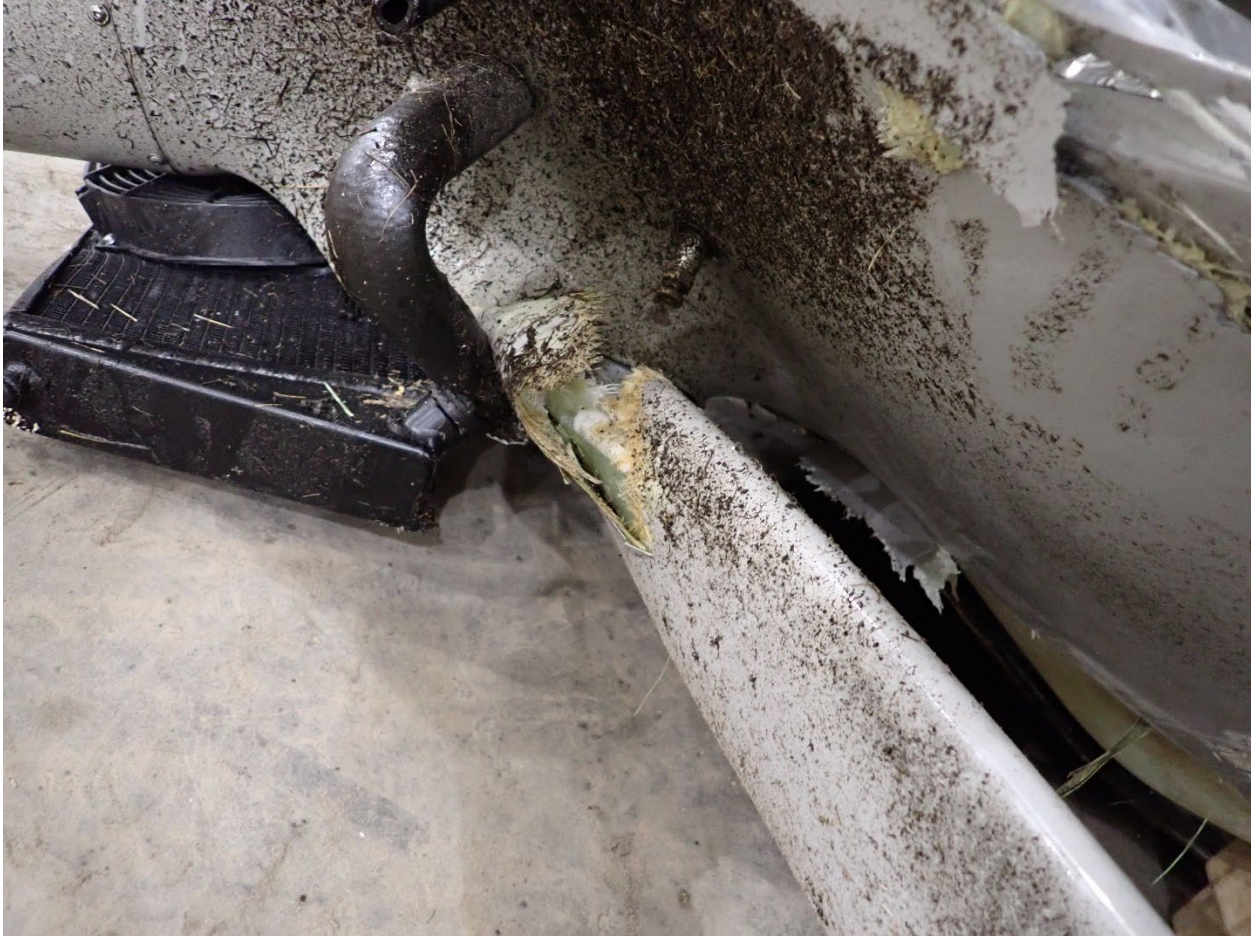
**Photo 11: Twisting of left main landing gear.**

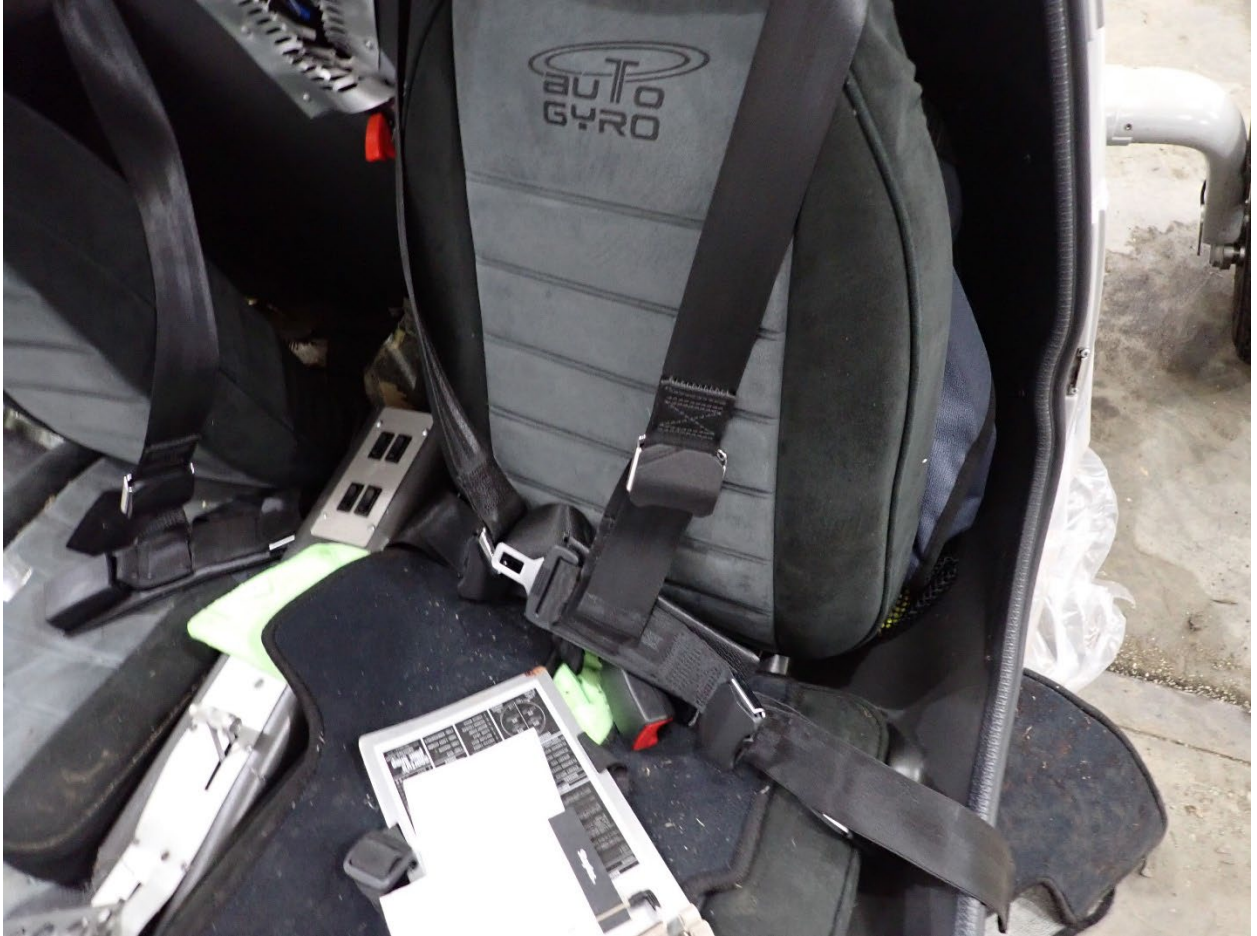
The left seat remained intact and was equipped with a four-point harness which remained attached at all attachment points. The right seat was intact, and the headrest attachment was impact separated from the aft fuselage structure, it was equipped with a four-point harness. The harness remained attached at all attachment points and was cut by fire rescue crews for recovery of the pilot. Both seatbelt buckles worked with no anomalies noted.

**Photo 12: Left seat with harness**

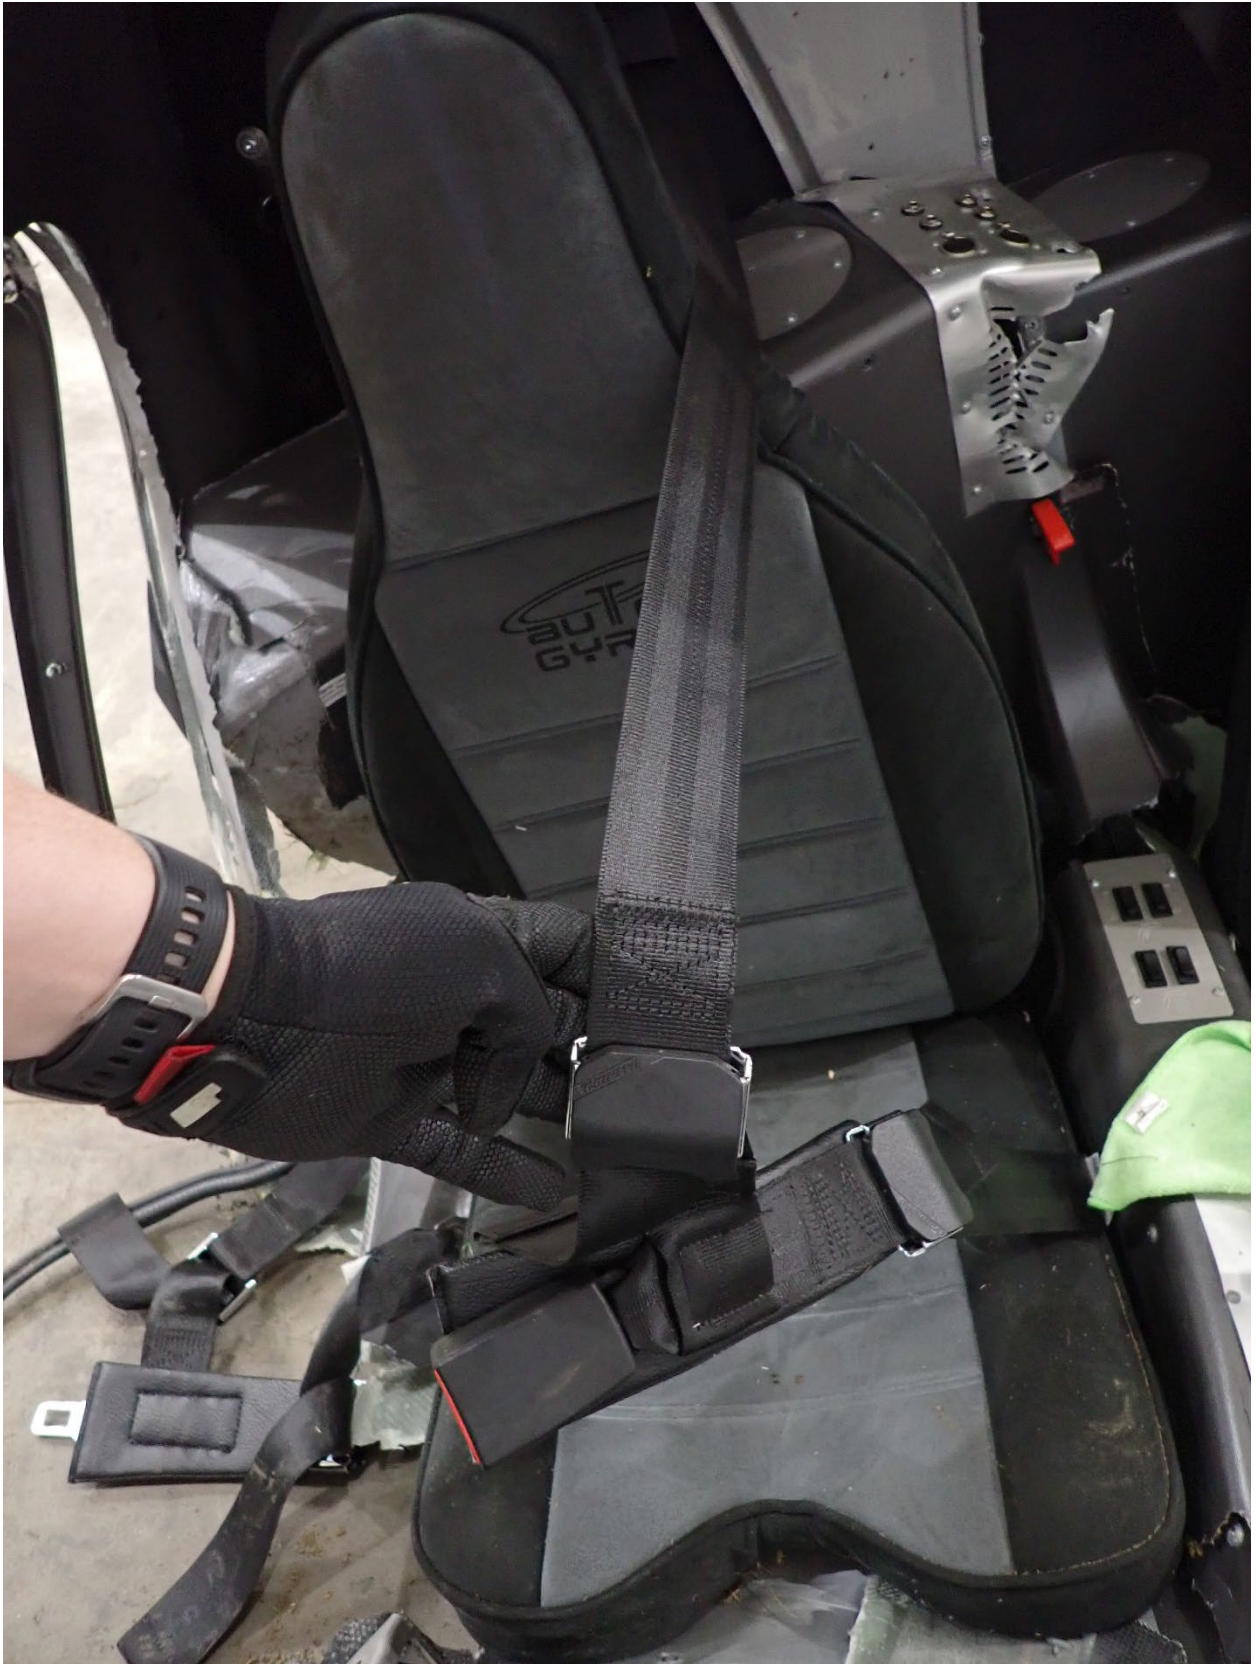
**Photo 13: Right seat and harness**

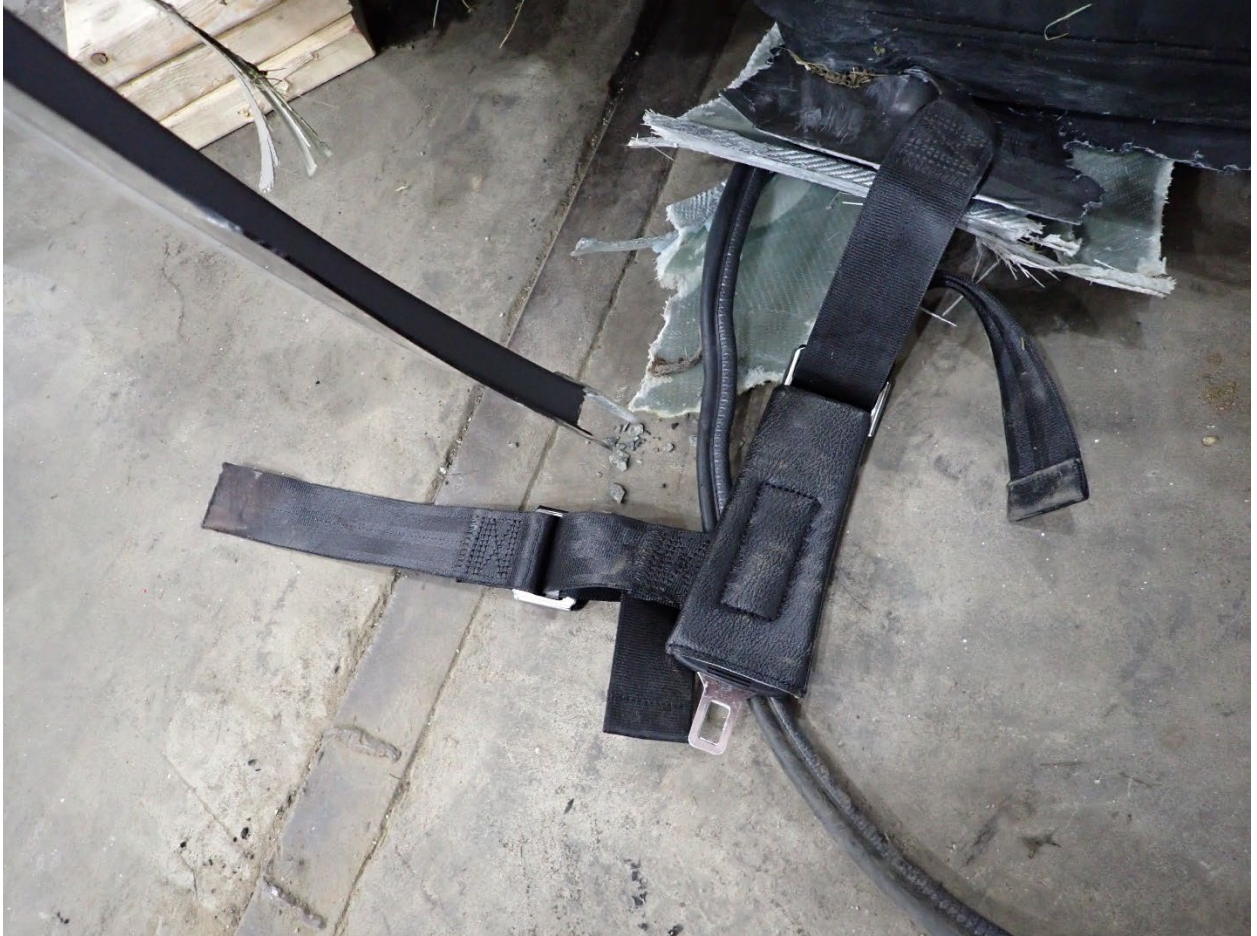
**Photo 14: Right seat harness**

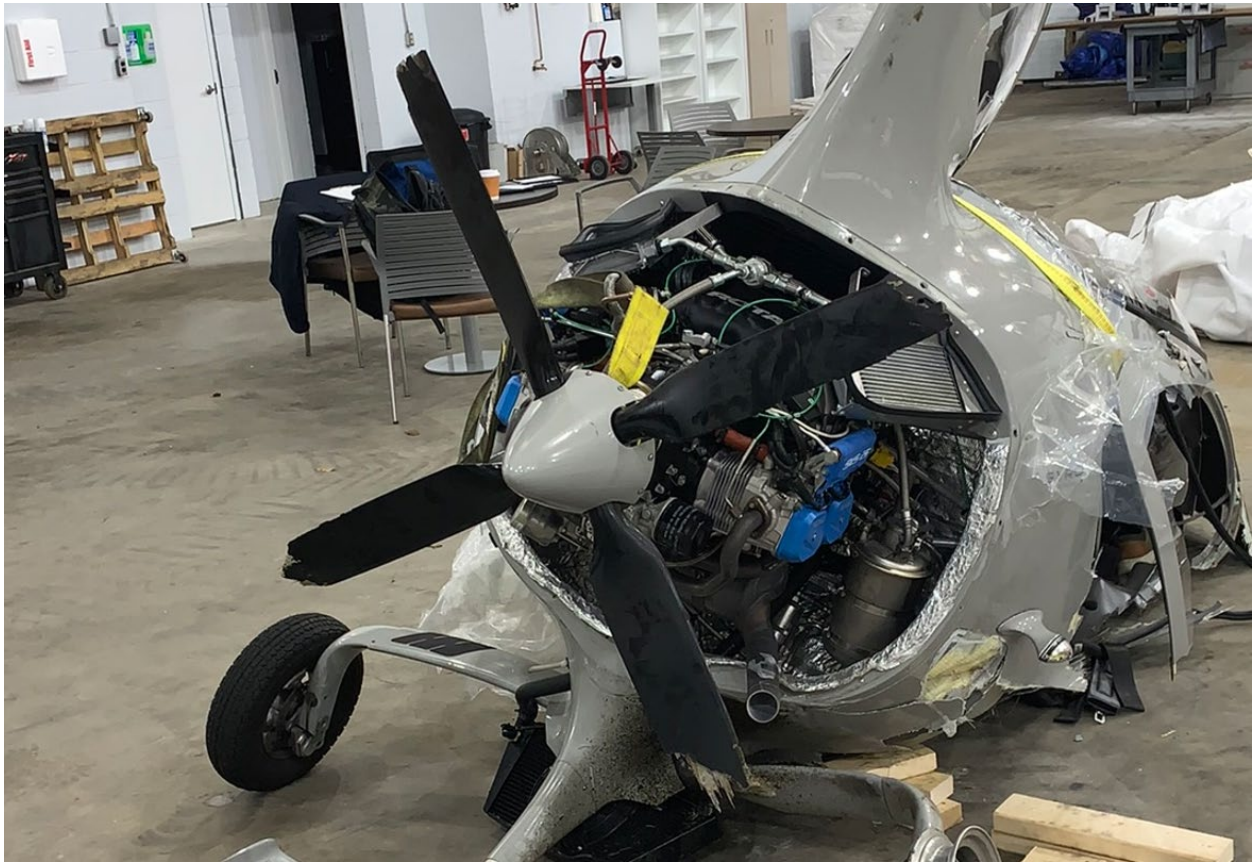
The engine remained intact and was operating at nearly full power for about 2 minutes after impact, until fire rescue personnel were able to shut down the engine; the engine nor the components did not reveal any pre impact anomalies that would have precipitated a loss engine power or performance. The 4 bladed wood & composite propeller in the pusher configuration was splintered and bent back opposite of the direction of rotation on the outer 6-inches of all 4 blades in a uniform pattern. The blades remained attached to the hub.

**Photo 15 Engine and Propeller**
