# **AIRFRAME AND ENGINE EXAMINATION**

NTSB ACCIDENT NUMBER: ERA23FA087

AIRCRAFT REGISTRATION: N74586  
OPERATOR: Rainwater Farms, LLC  
ACCIDENT LOCATION: Kellyton, AL

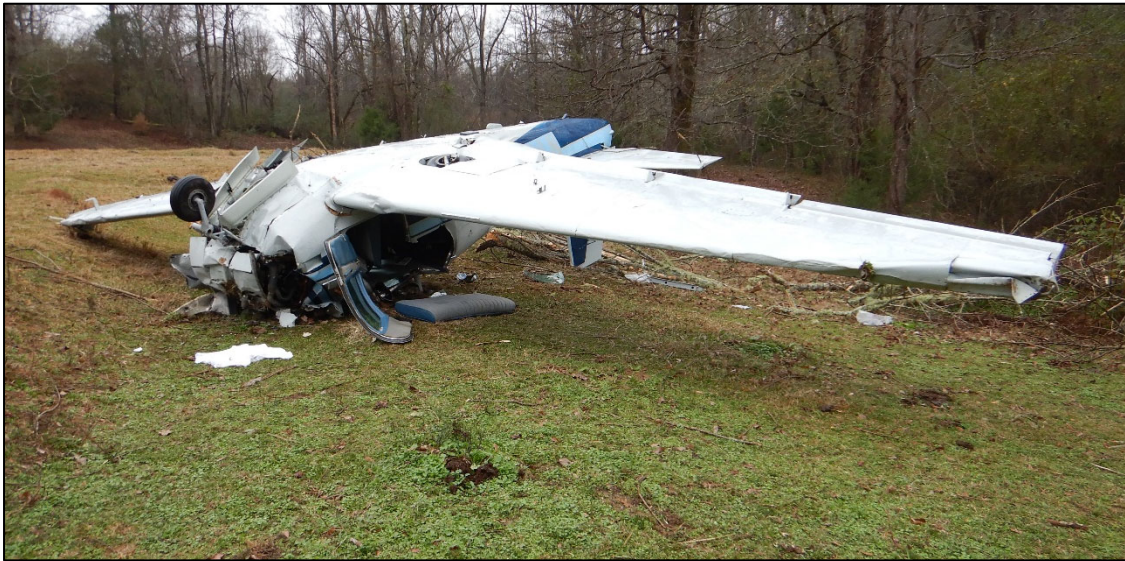
As first viewed, the airplane was inverted and folded over the engine and propeller, which imbedded in soil. The cockpit doors had been cut away to allow for extraction of the pilot. All portions of the airplane were in the vicinity of the main wreckage, which was intact except for the outermost portion of the left wing including the left aileron which was located at the base of some large trees about 68 feet from the main wreckage. The fractured outermost portion of the left wing exhibited leading edge damage consistent with tree impact while in a left turn.

*Photo 1 – View of wreckage prior to field examination.*

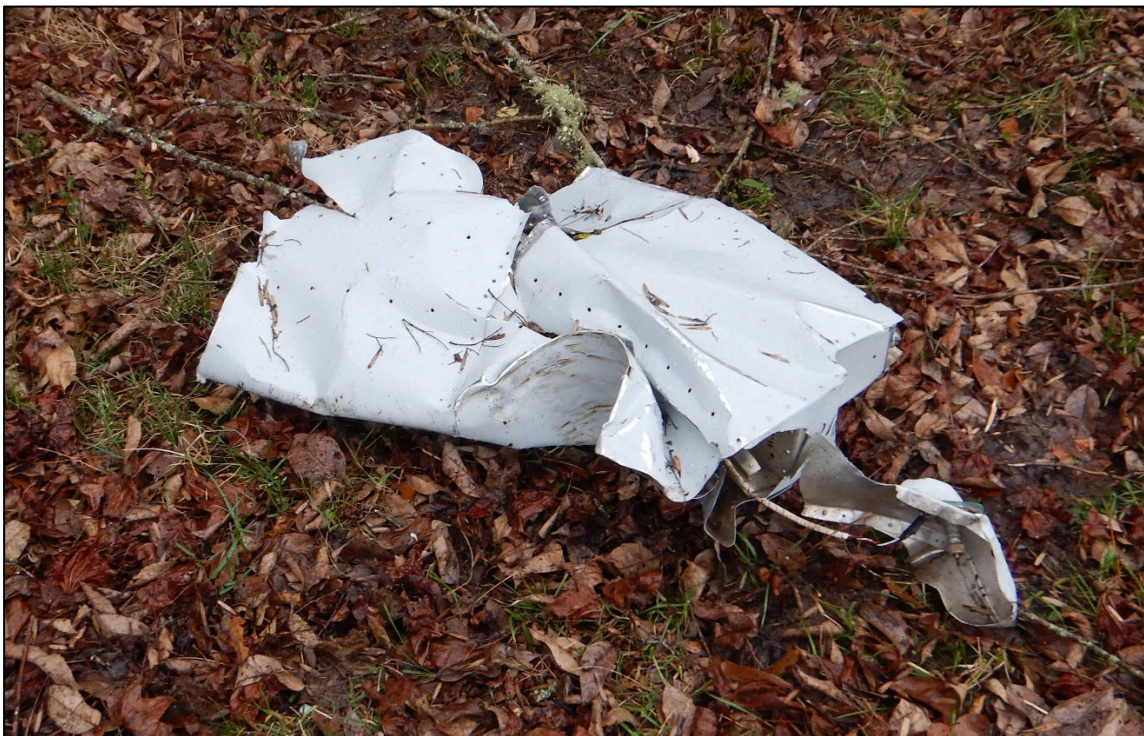
*Photo 2- View of outermost left wing leading edge with damage consistent with tree impact.*

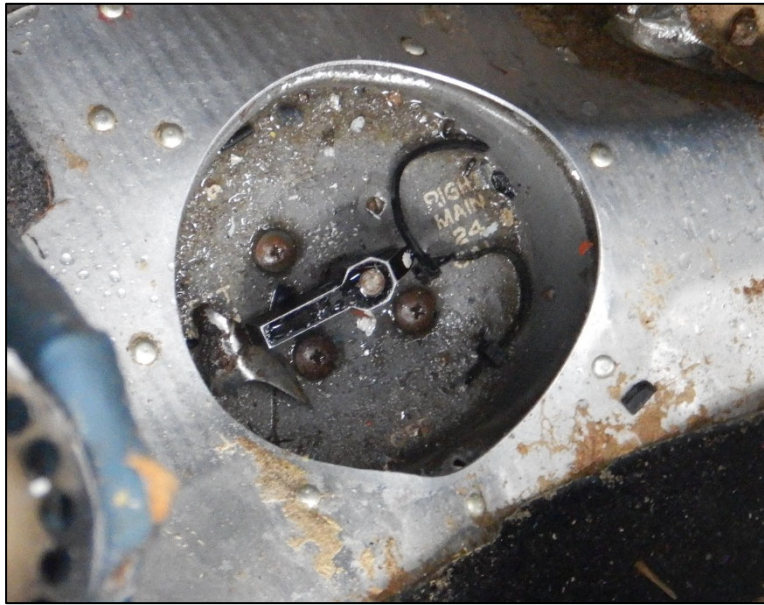
The engine compartment and cockpit control panel were impact crushed aft. The wings were attached to the fuselage with damage to the fuselage near the wing roots. The right wing with aileron and flap (retracted) intact contained no fuel in the bladder and no signs of leakage. The leading edge displayed impact aft crushing in the outermost 2.5 feet of the leading edge and evidence of impact with the ground. The left wing with flap (retracted) intact contained significant fuel, and the outer 2.5 feet including the aileron was fractured. The cabin area was impact crushed aft. The top of the fuselage displayed impact crush damage. The empennage with fully intact with impact damage to the left horizontal stabilizer and elevator. The main landing gear was stowed. The wings were placarded as 27.4 gallons of fuel for each wing. The cockpit fuel selector was placarded "Right main 24".

*Photo 3 - Fuel selector selected to right main tank*

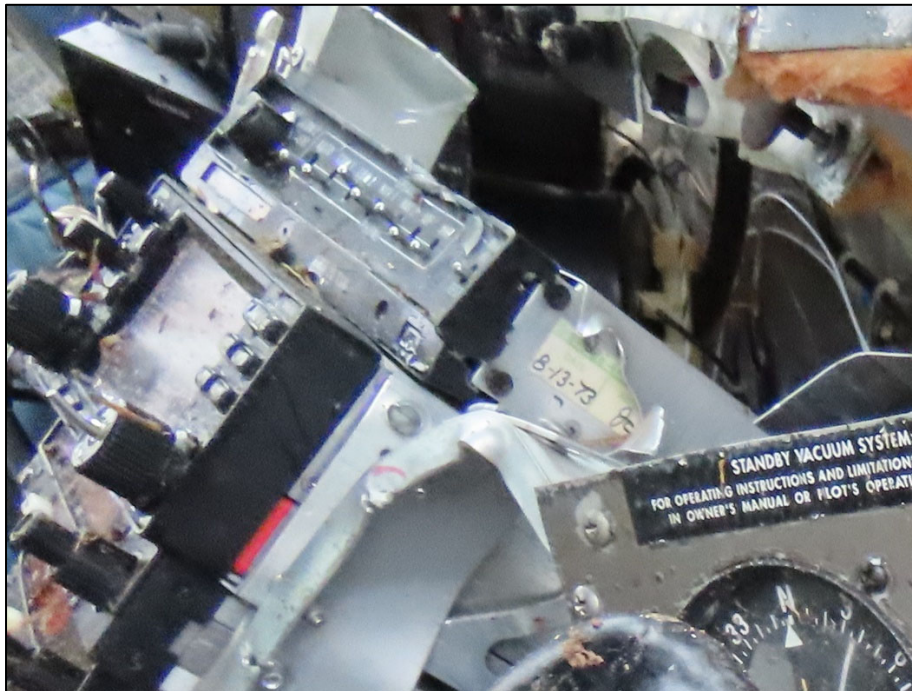
*Photo 4 - Carburetor heat (upper right of photo) off*

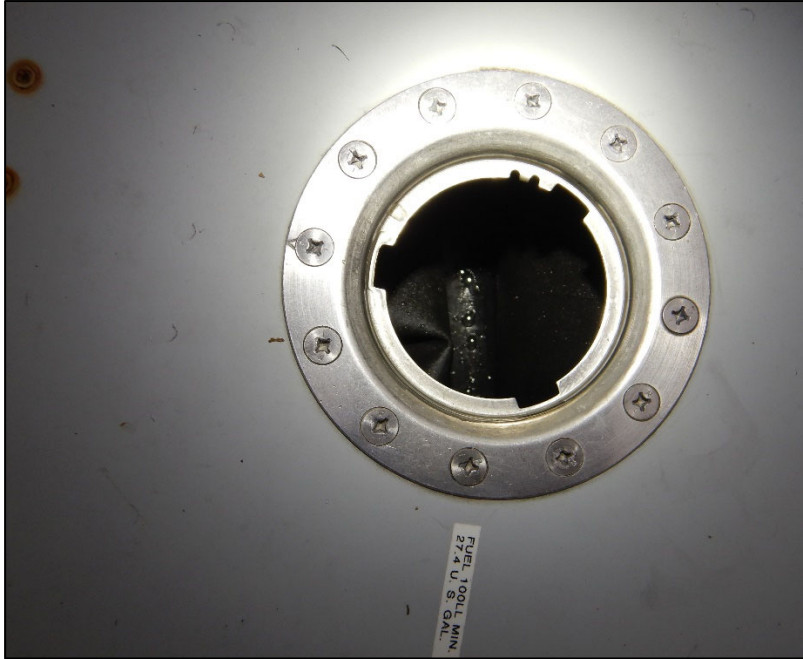
*Photo 5 - Right wing fuel bladder with no fuel present.*

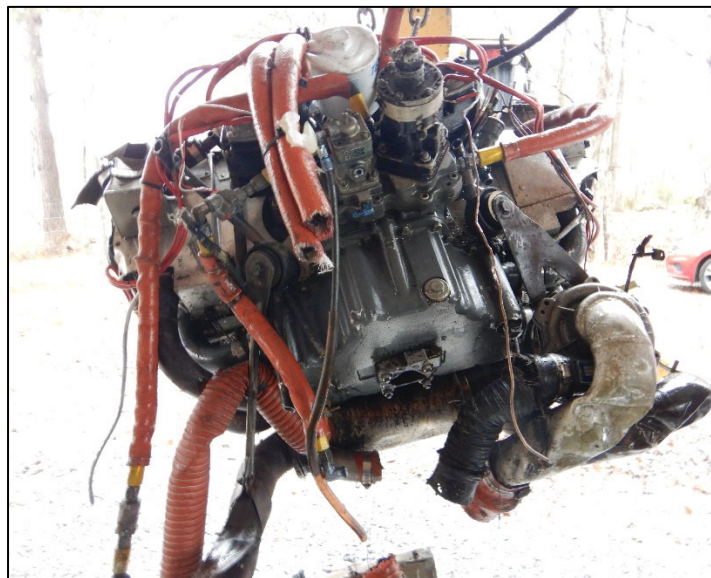
The engine was removed from its engine mounts and hoisted to facilitate examination. The engine was a Lycoming O-360-A1D, serial number L-4100-36. The engine suffered minor impact damage in the form of dents to rocker box covers, intake and exhaust pipes, and oil filter crushing. All accessories were found intact and tightly installed to the engine except for the carburetor which was found impact separated from the sump section of the engine. There was a witness mark on the starter Bendix housing from the starter ring, with no scoring and consistent with no propeller rotation at the time of impact.

*Photo 6 - Engine as hoisted before examination.*

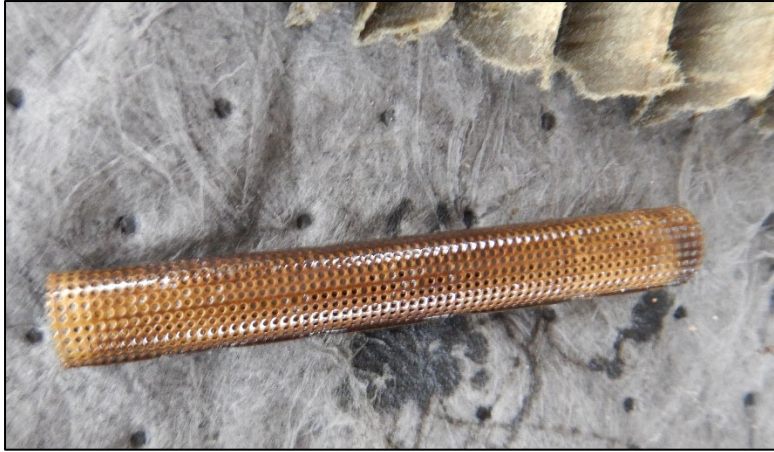
The oil system was examined, and the oil suction screen was found free and clear of any debris. The oil filter could not be removed from the engine due to impact force crushing and had to be cut to remove the filter element. The element was found clean.

*Photo 7 - Oil screen free from debris.*

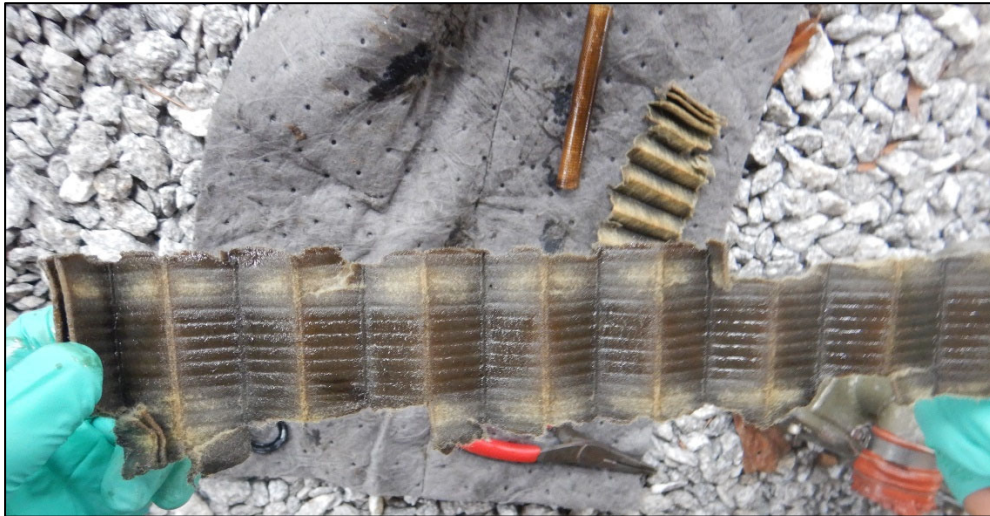
*Photo 8 - Oil filter free of debris after removal from housing.*

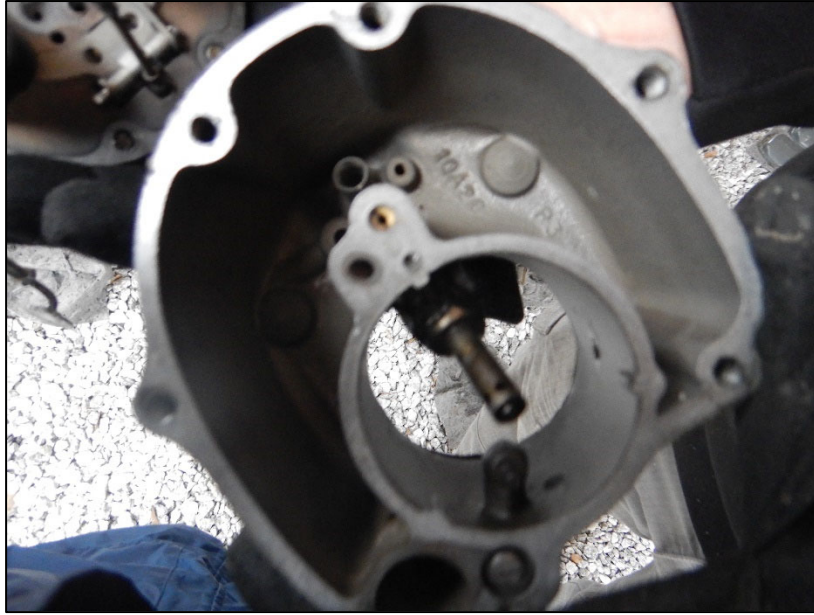
The carburetor was disassembled, and its inlet screen removed. The screen was clean and unobstructed of any debris. The float bowl was separated, and no fluid was found within the bowl and no sediment was present. The floats were of the black plastic style and moved freely throughout their travel range.

*Photo 9 – View of carburetor bowl which was free of fuel.*
