ERA23FA087

## INVESTIGATION PHOTOGRAPHS

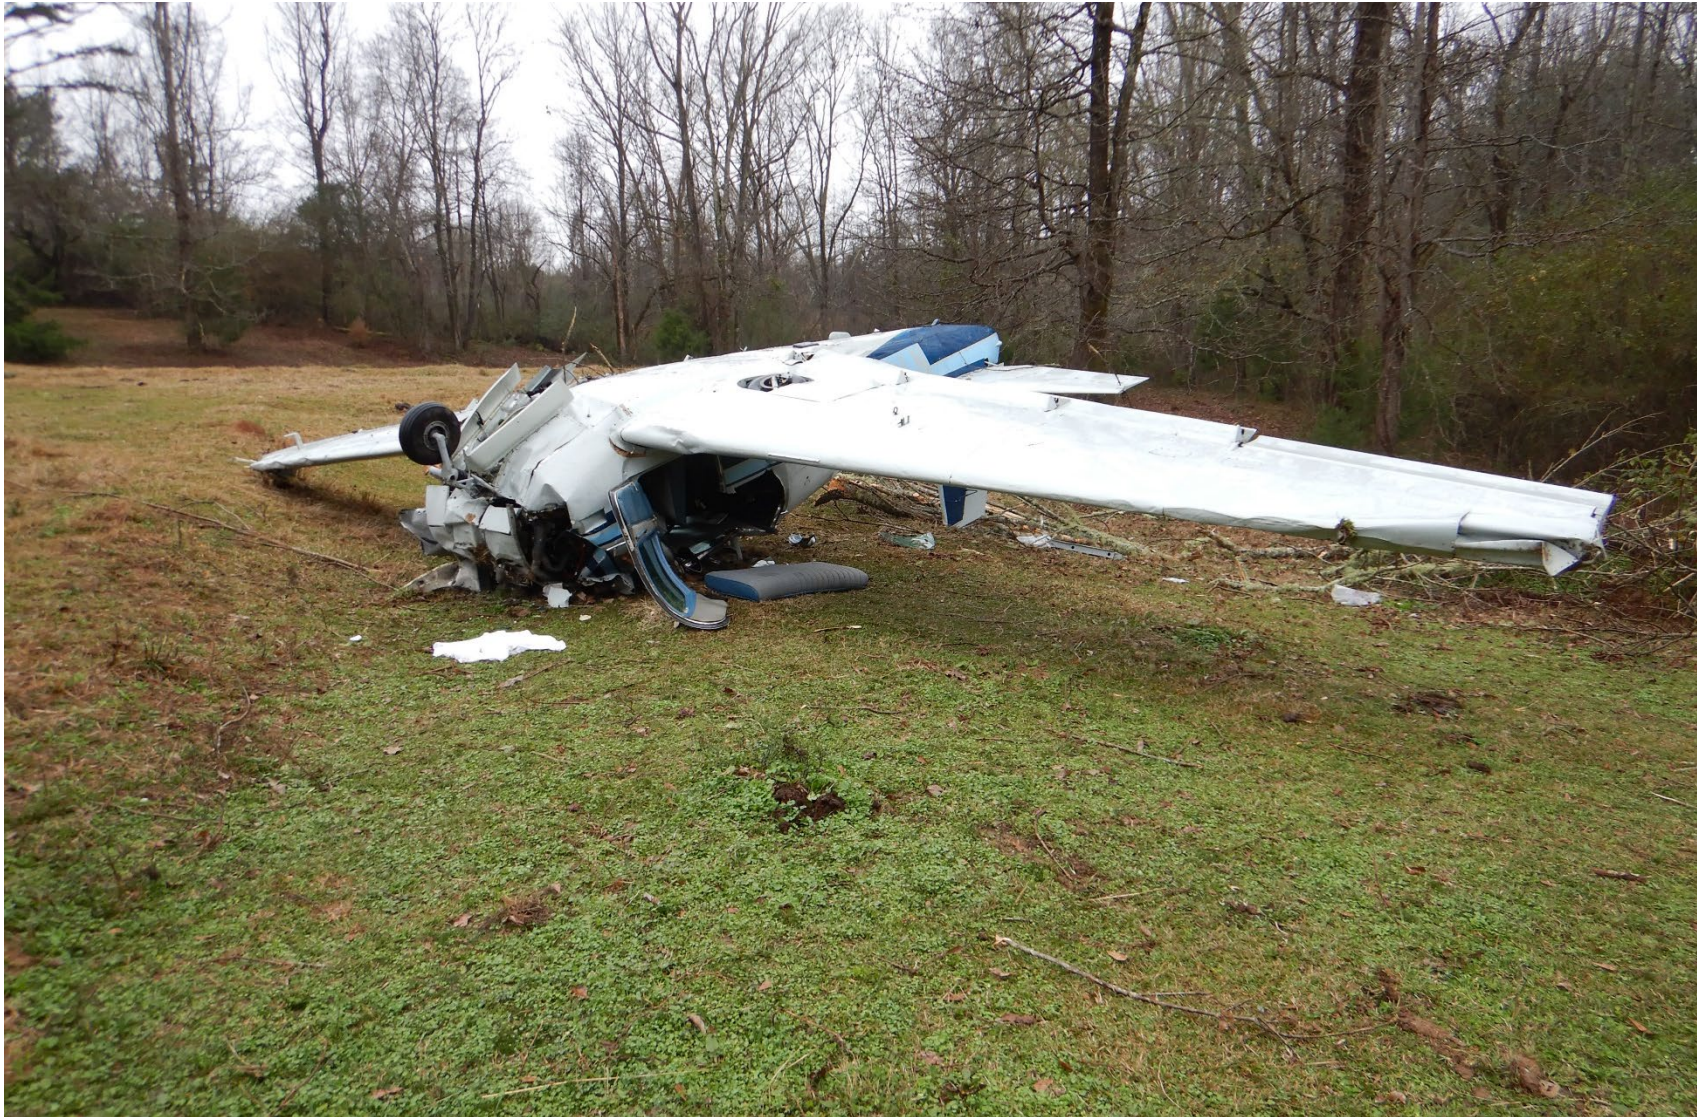
**Photograph 1 - View of inverted airplane from right wing**

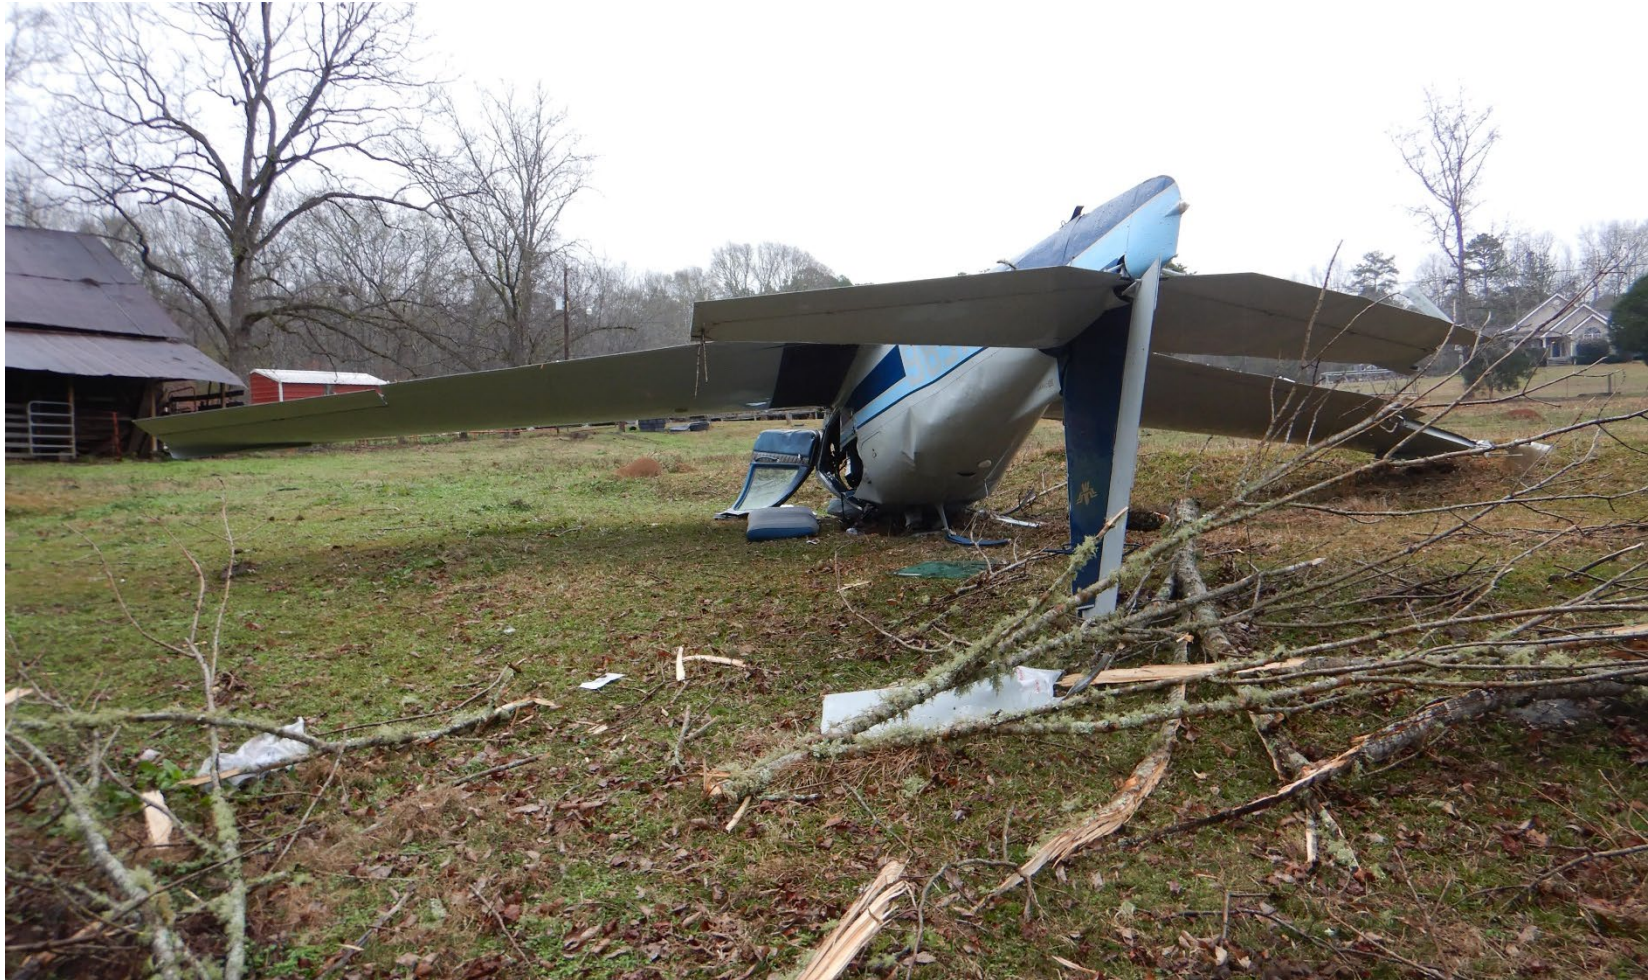
**Photograph 2 - View of inverted airplane from rear**

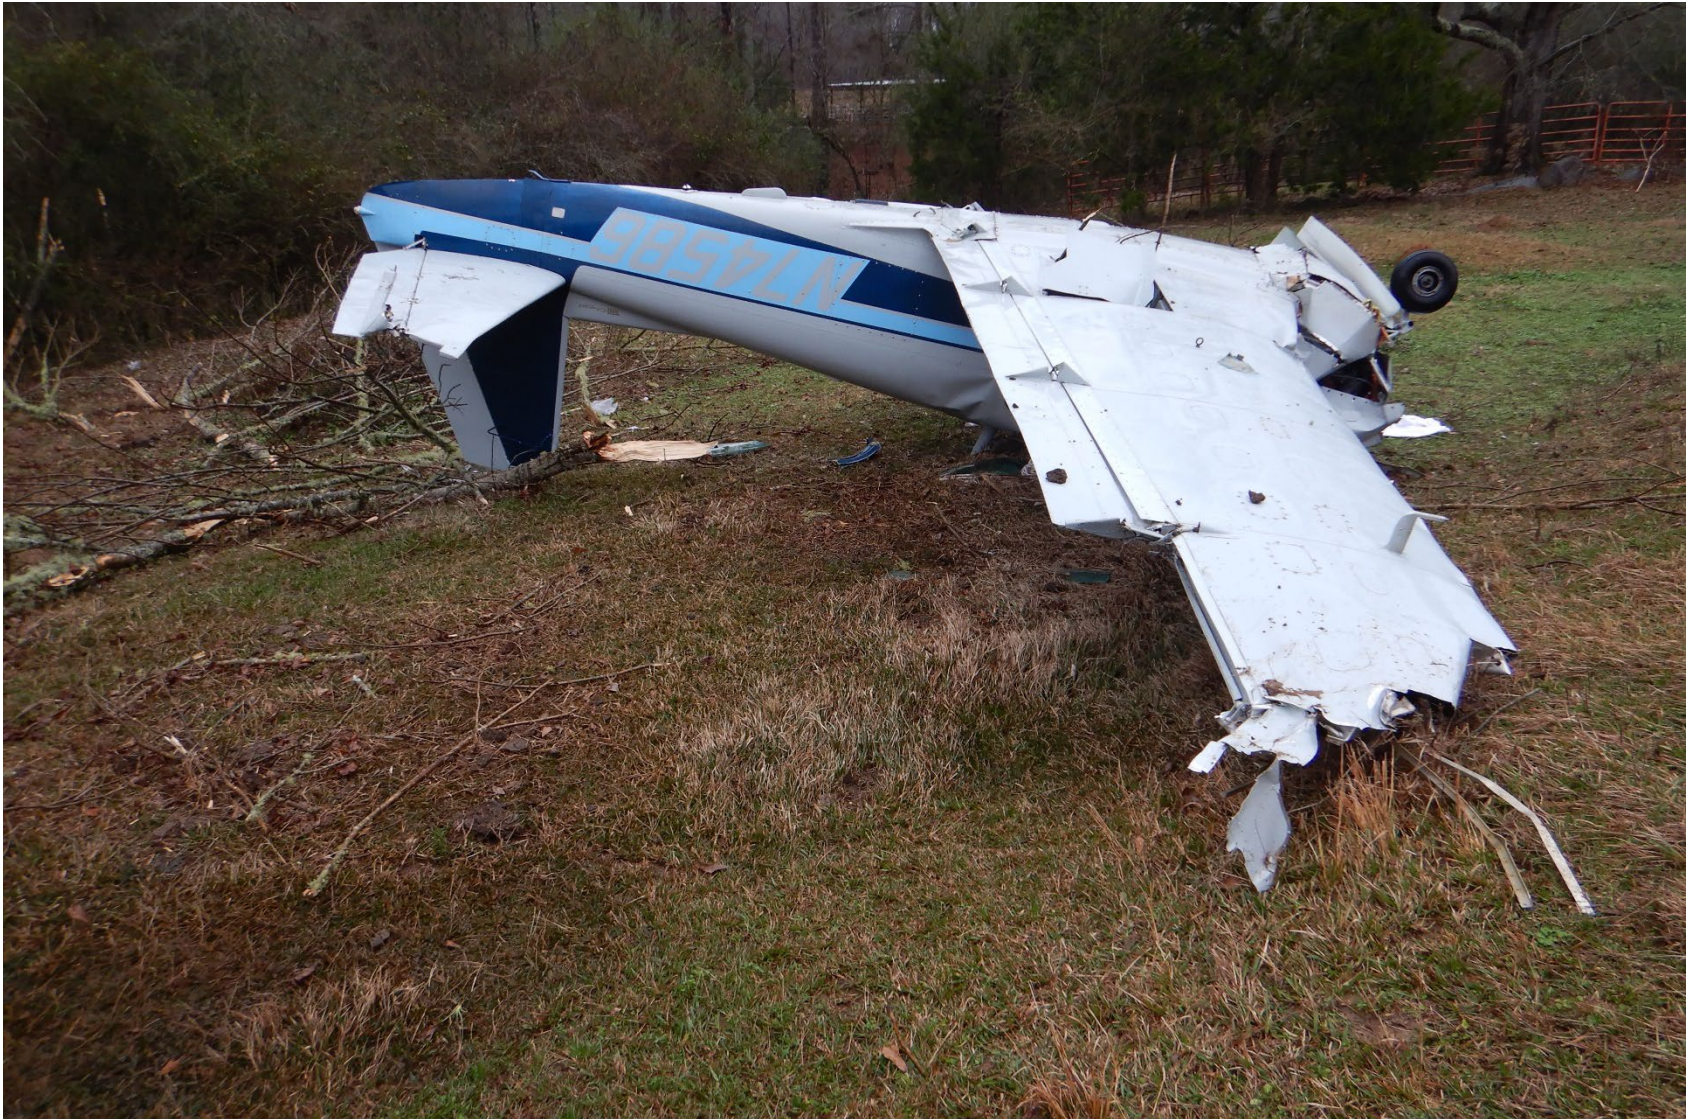
**Photograph 3 - View of inverted airplane from left wing (note missing aileron and wingtip)**

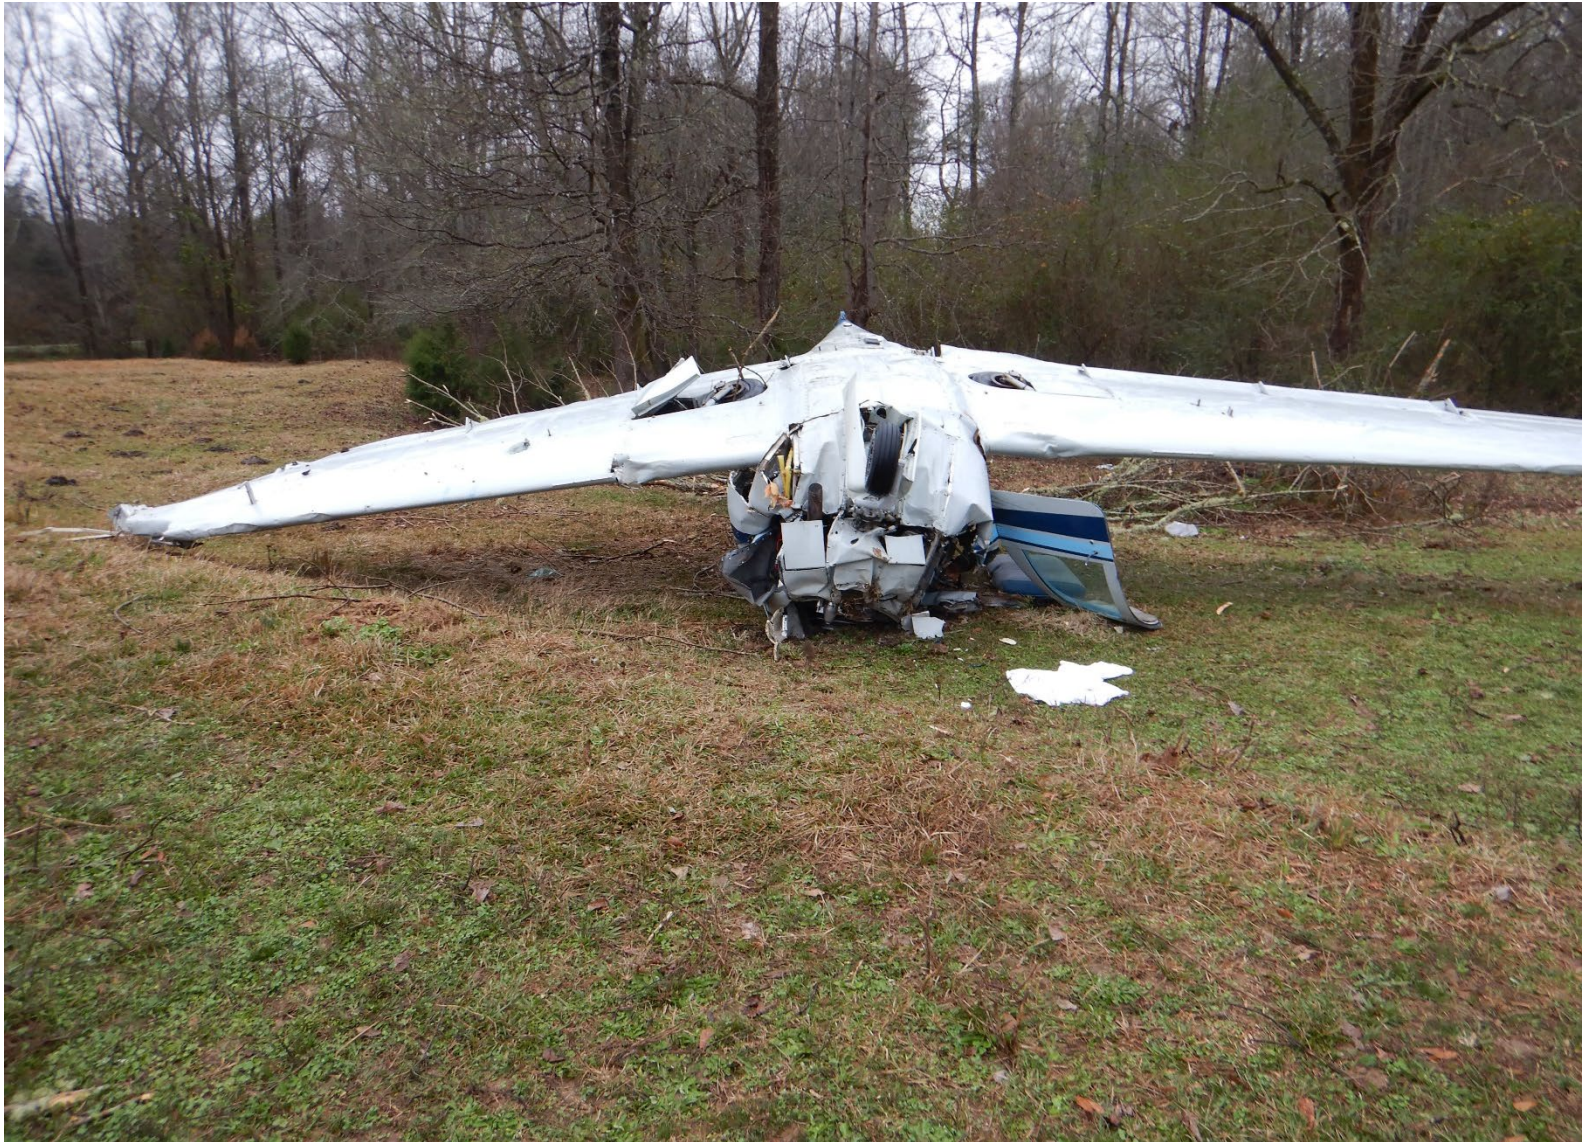
**Photograph 4 - View of inverted airplane from front  
(note putty on left wing fuel vent to stop leakage)**

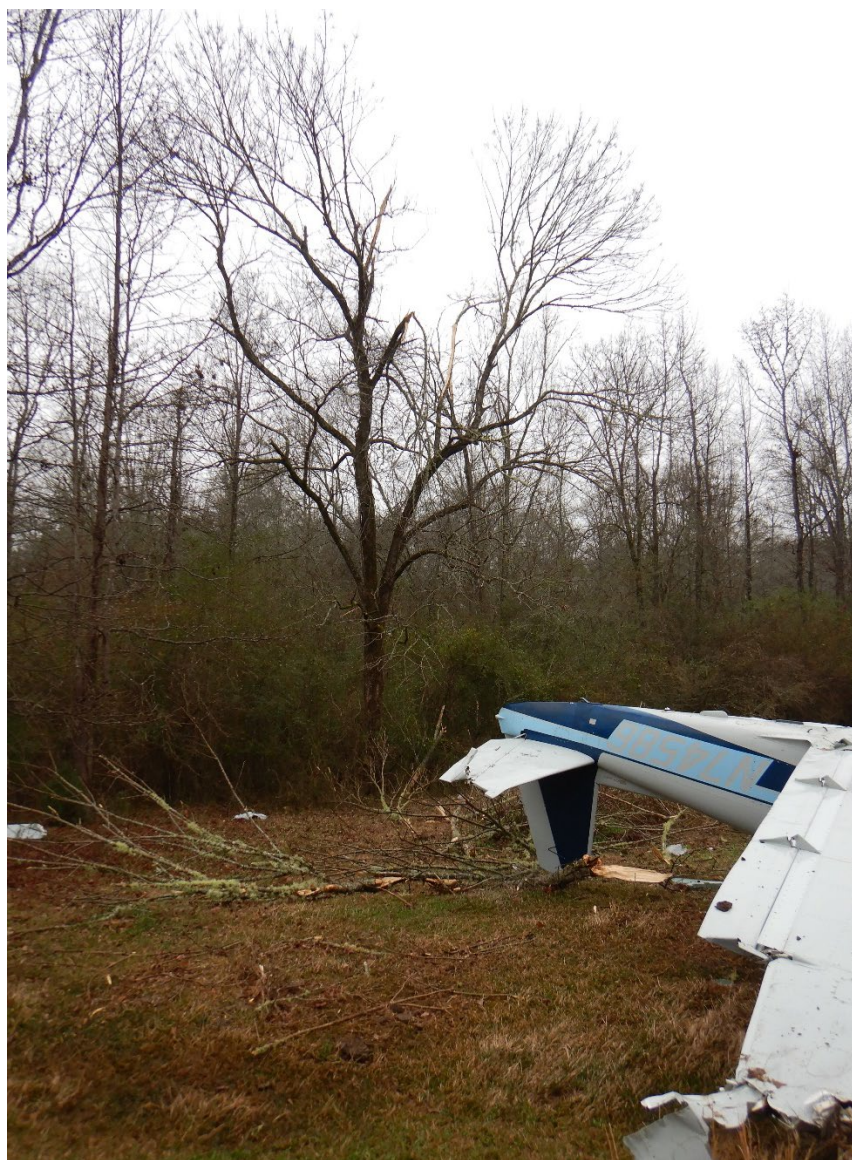
**Photograph 5 - View of empennage, tree impact scars, and tree debris**

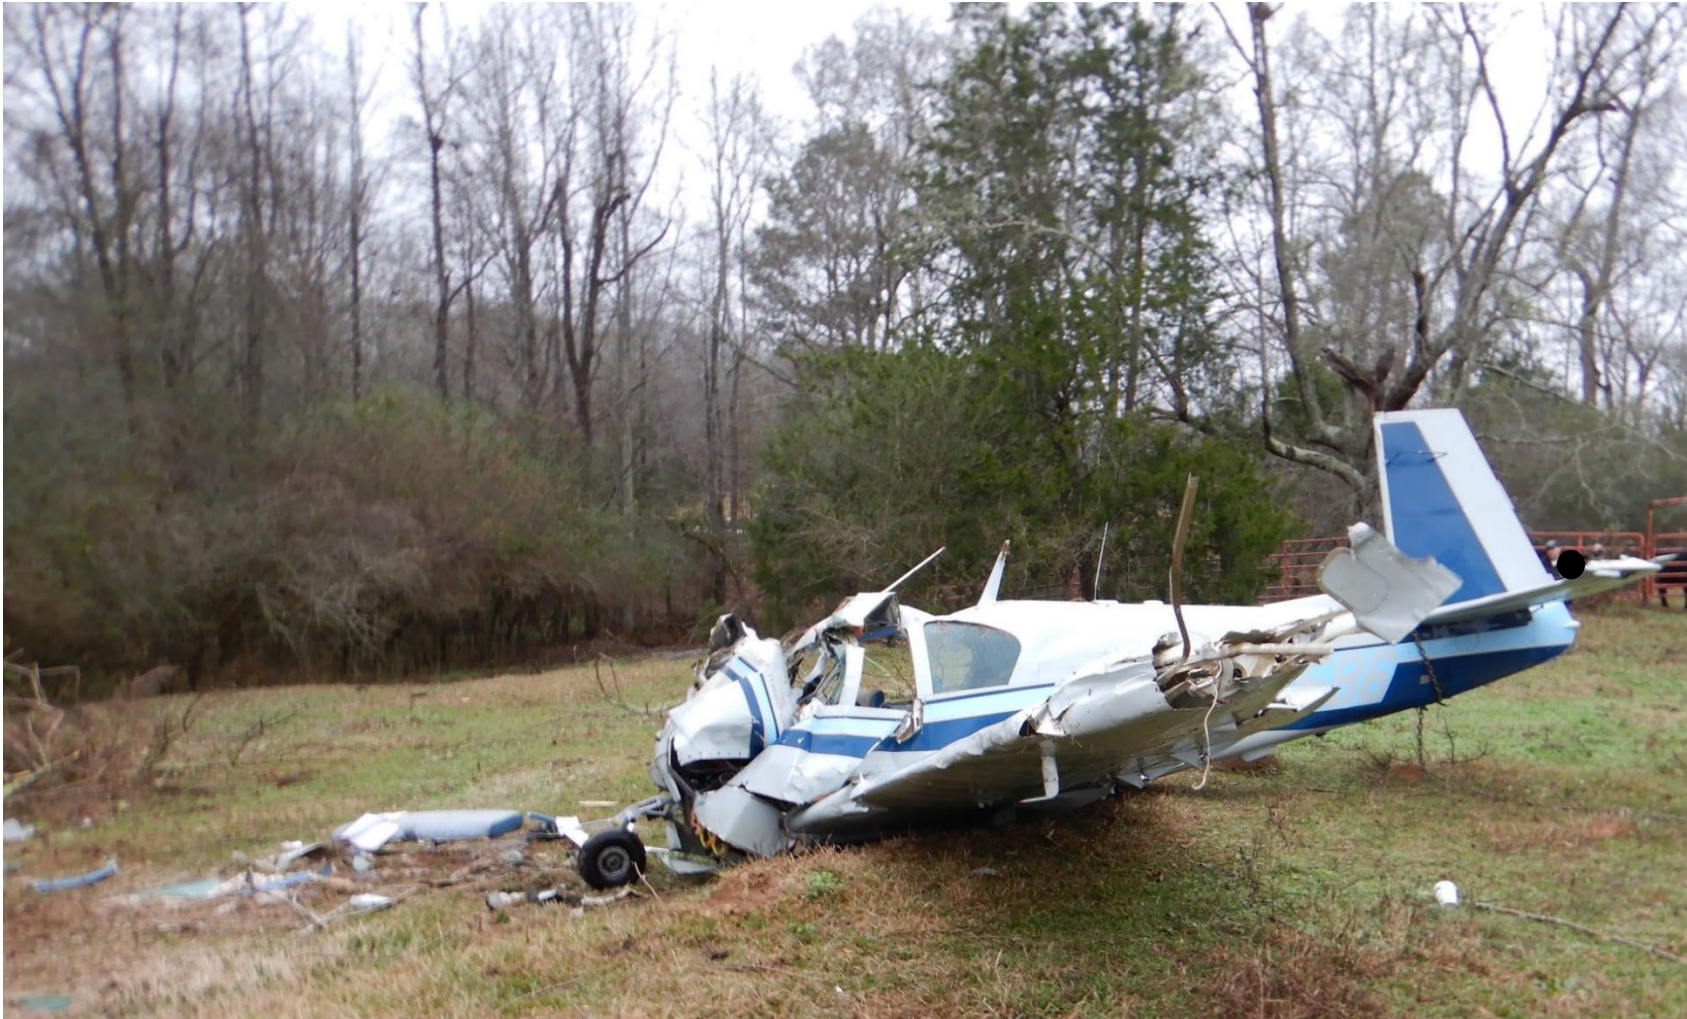
**Photograph 6 - View of up-righted airplane before examination**

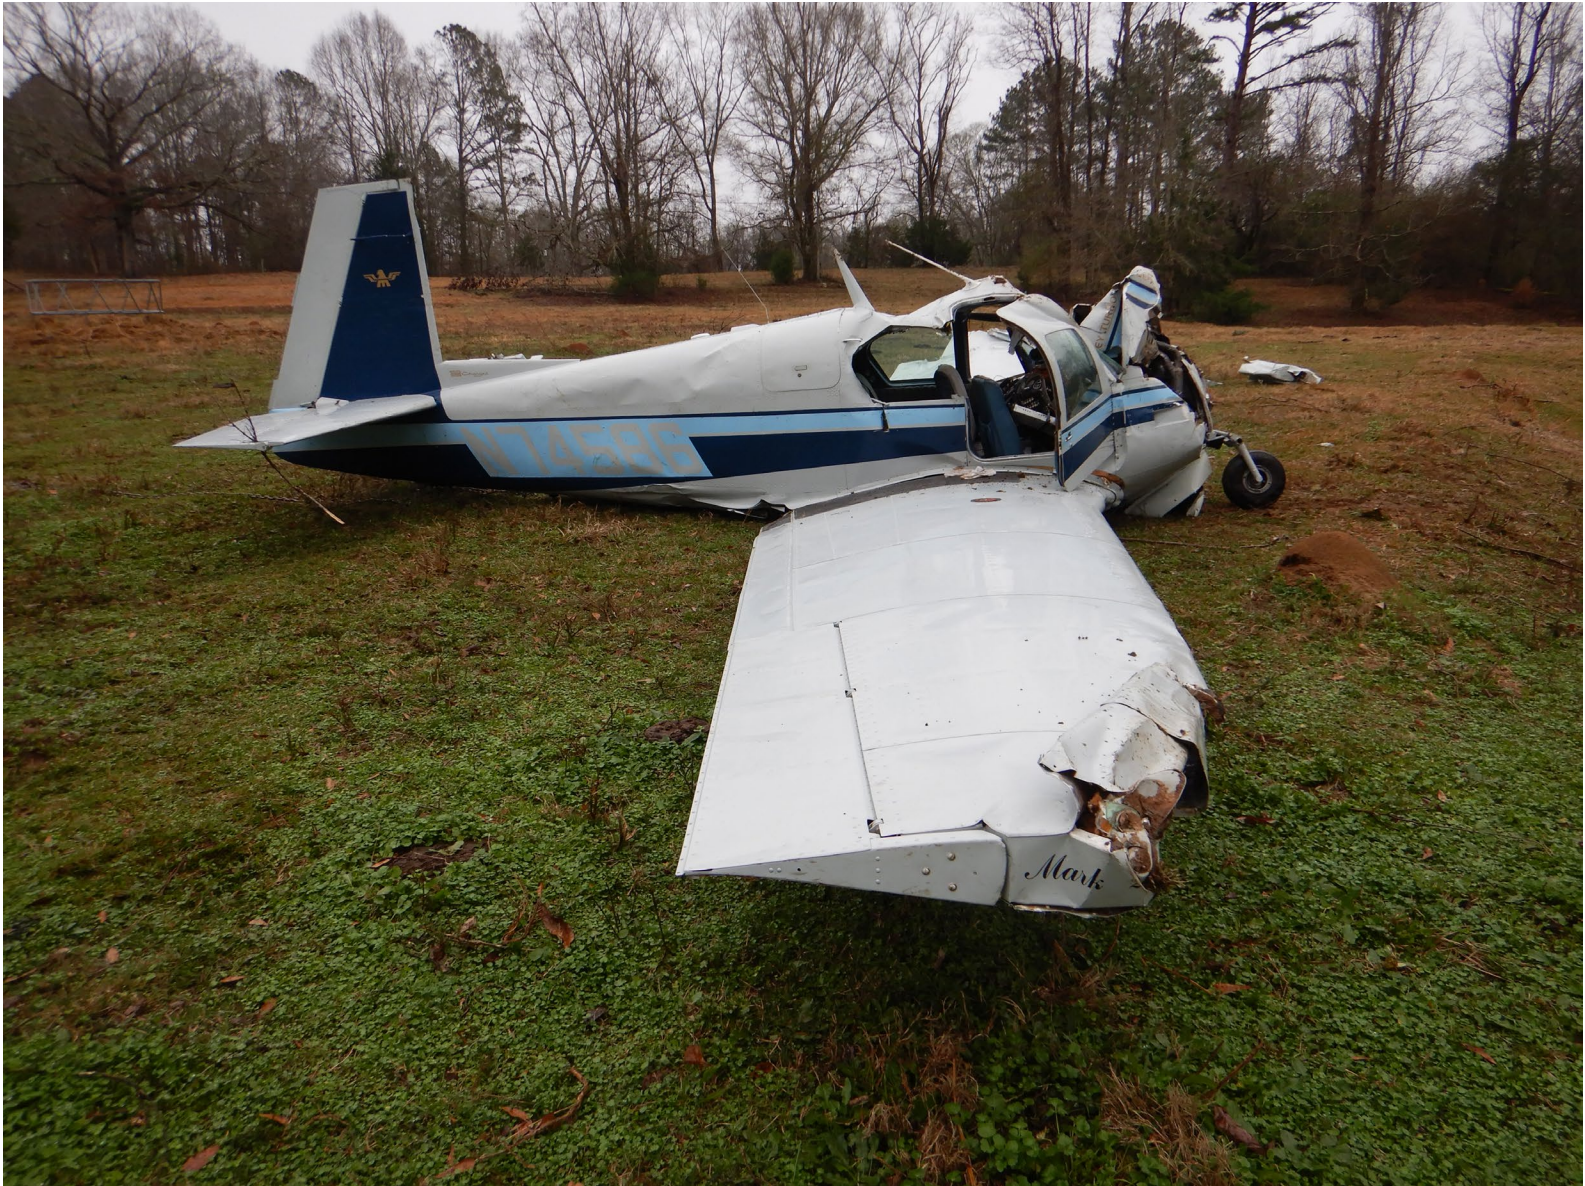
**Photograph 7 - View of up-righted airplane before examination**

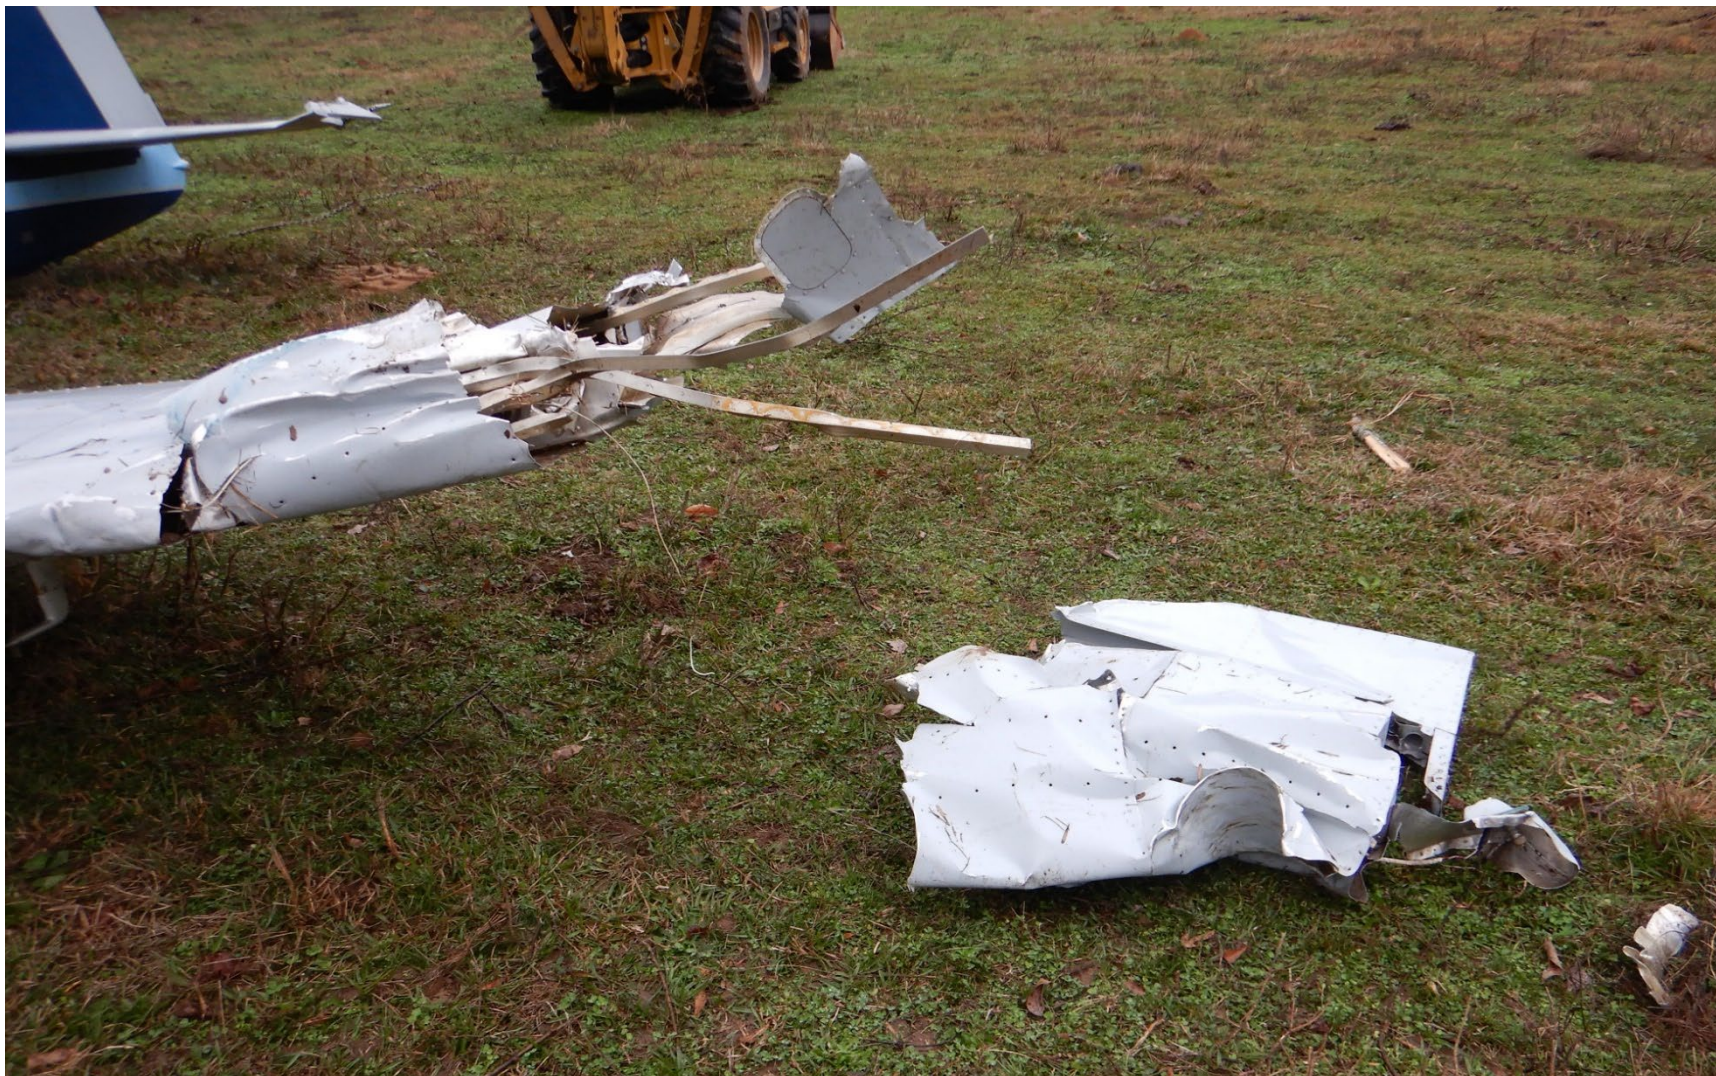
**Photograph 8 - Left wing fracture with damage consistent with tree impact**

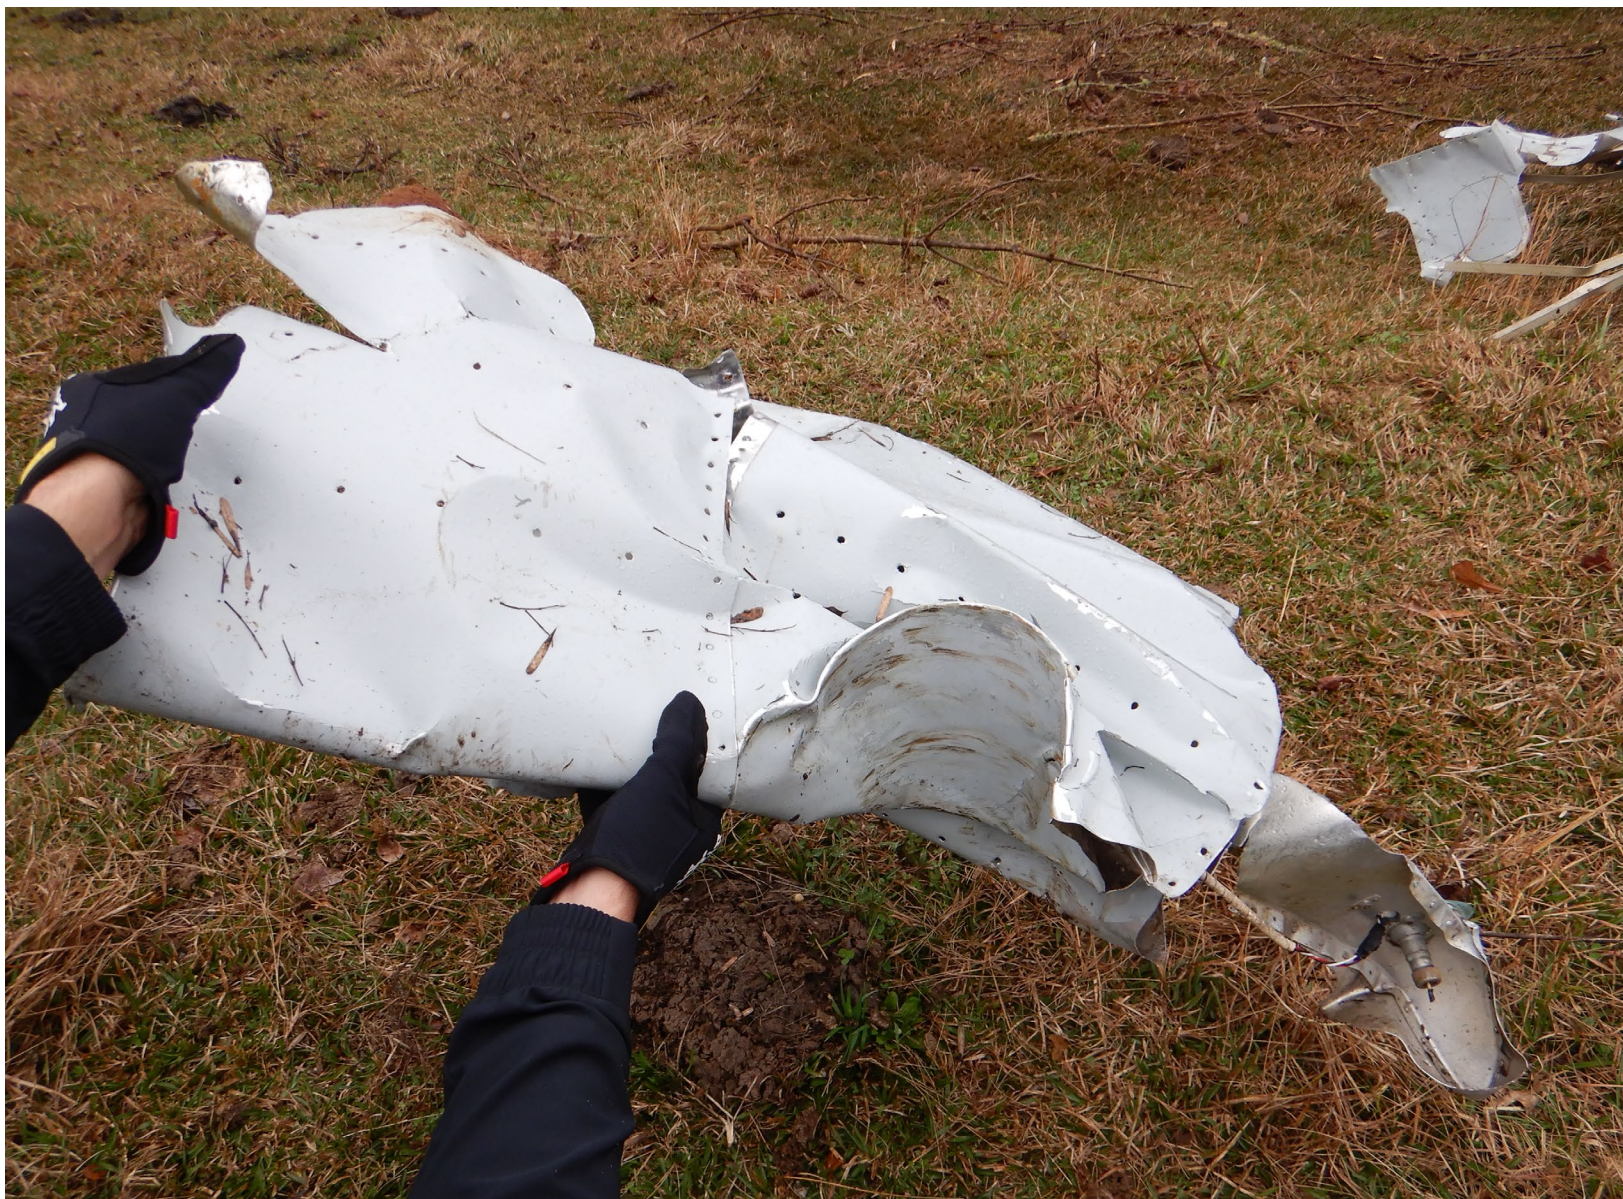
**Photograph 9 - Left wing damage consistent with tree impact**

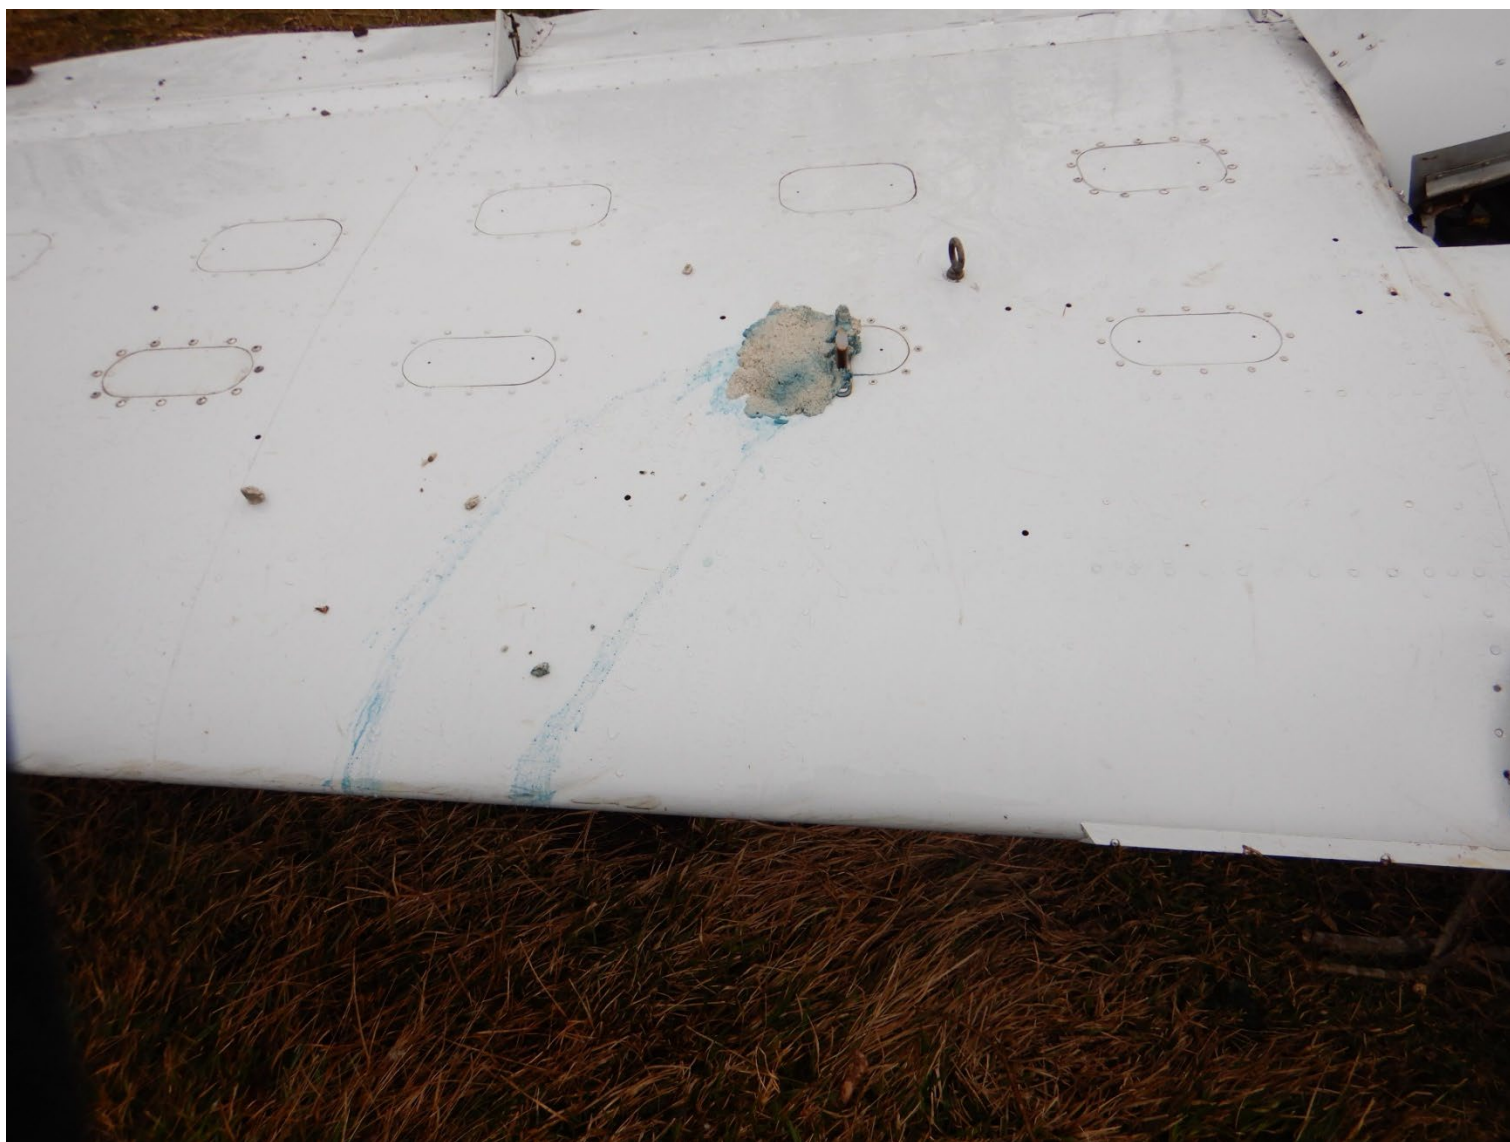
**Photograph 10 - Fuel leakage from left wing fuel vent stopped with putty**

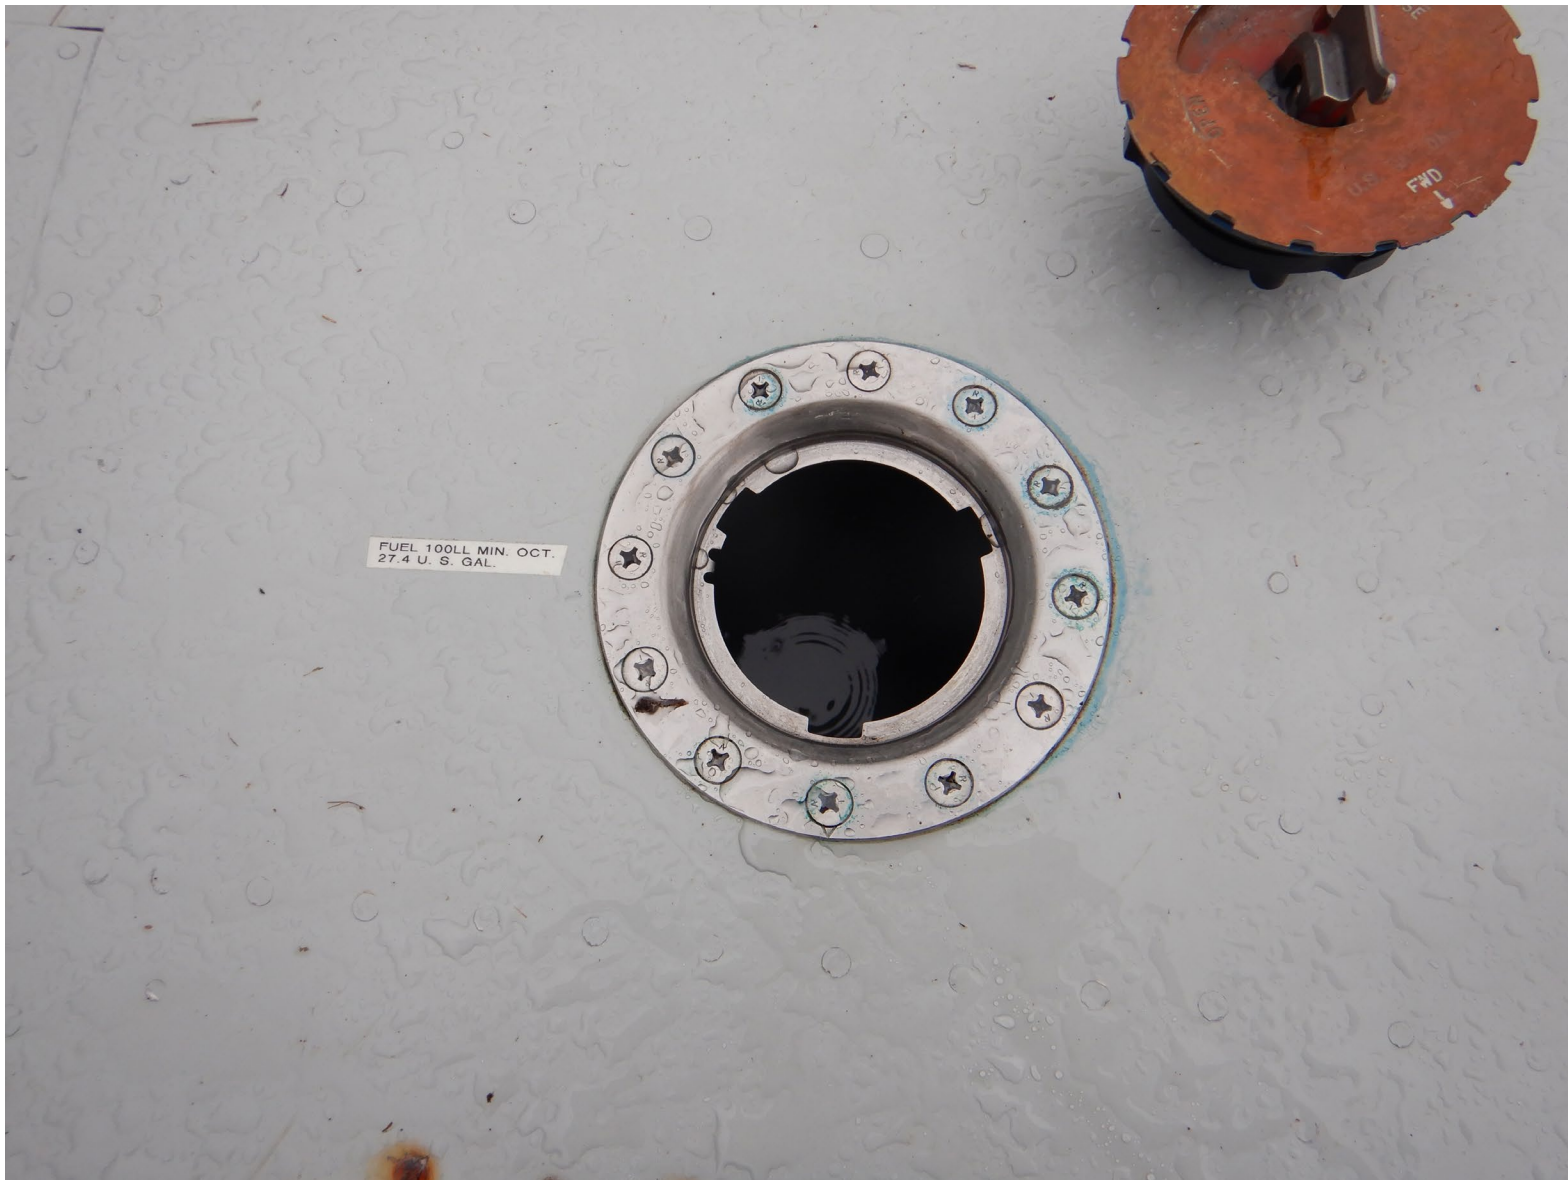
**Photograph 11 - Left wing fuel bladder with visible fuel**

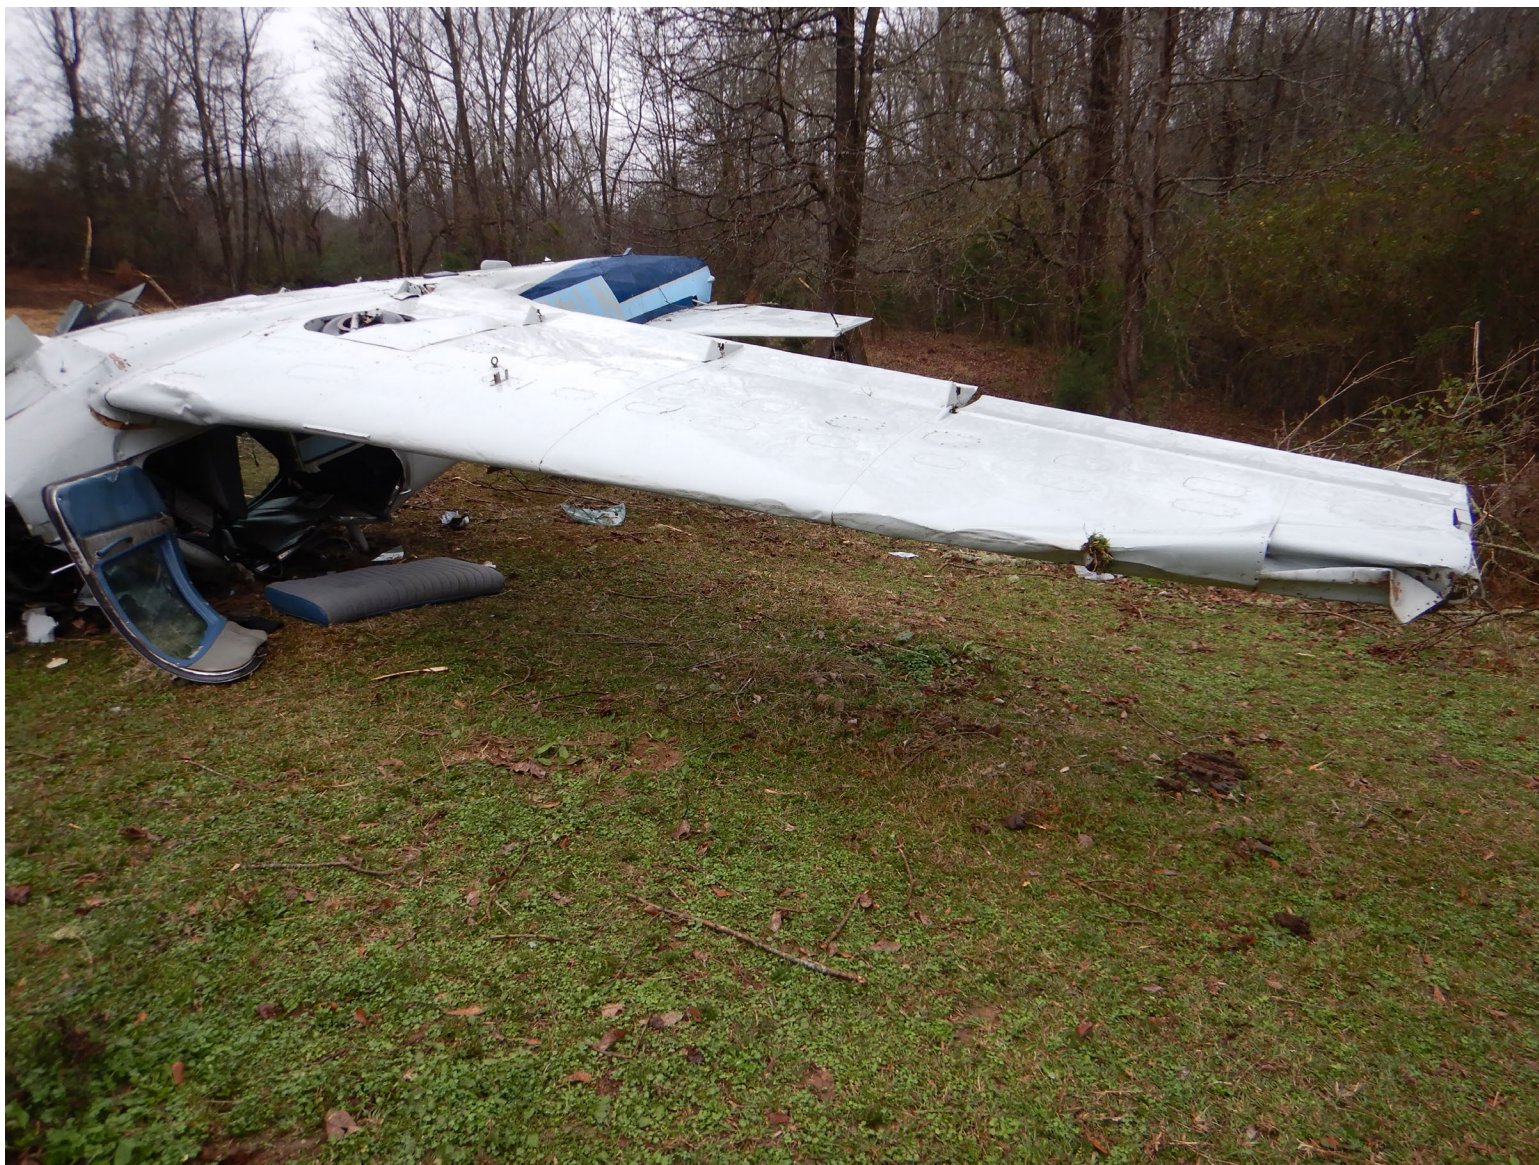
**Photograph 12 - Right wing absent of any fuel staining**

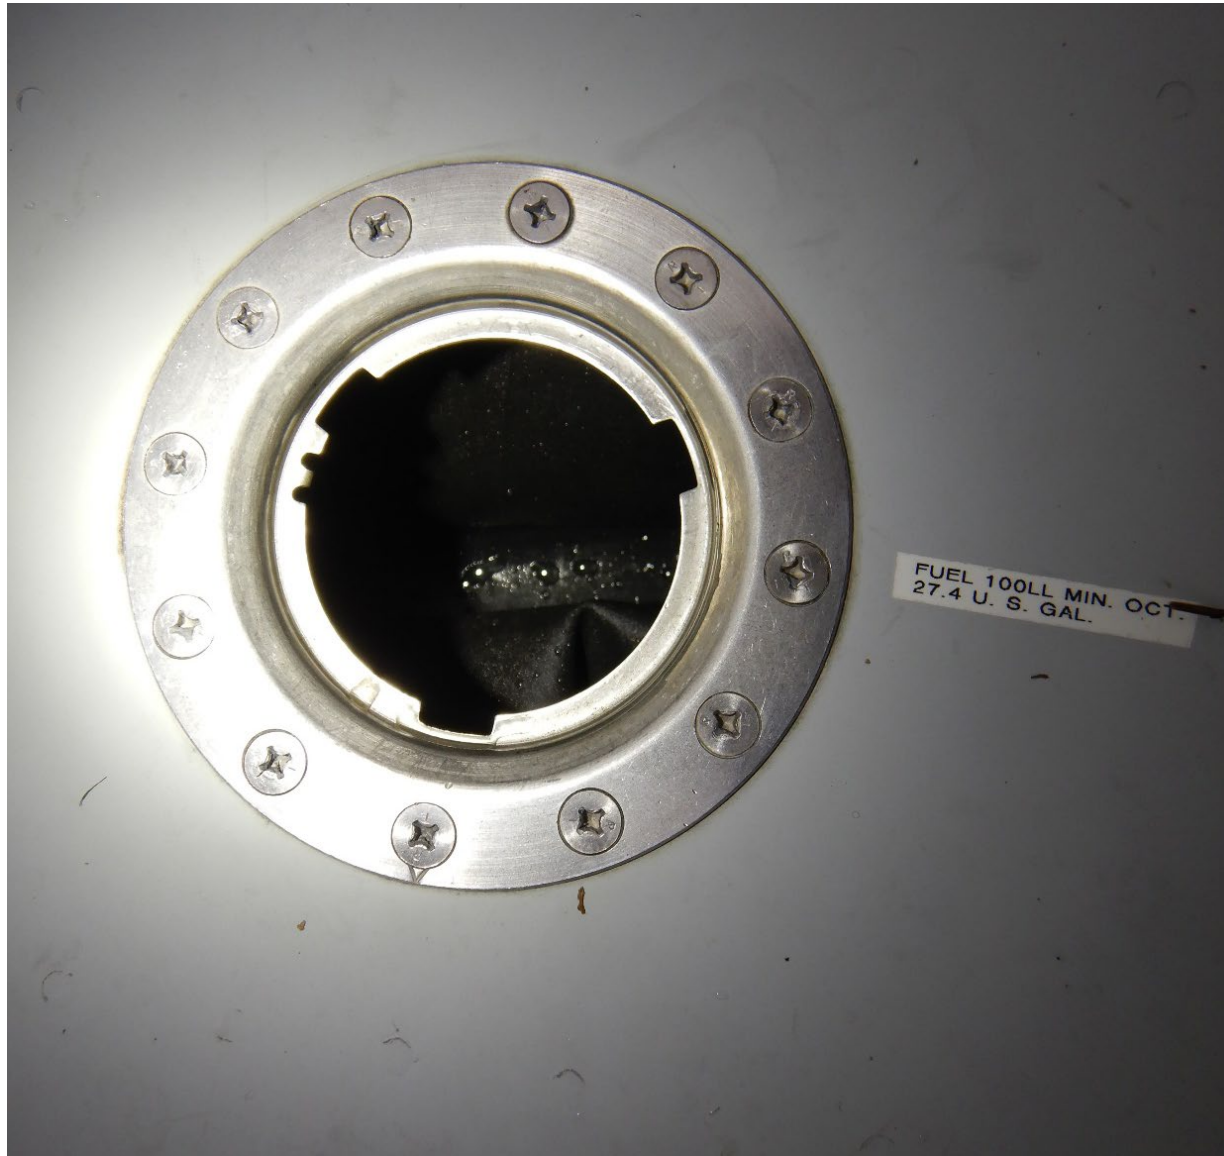
**Photograph 13 - Right wing fuel bladder with no visible fuel**
