ERA23FA087

## INVESTIGATION PHOTOGRAPHS

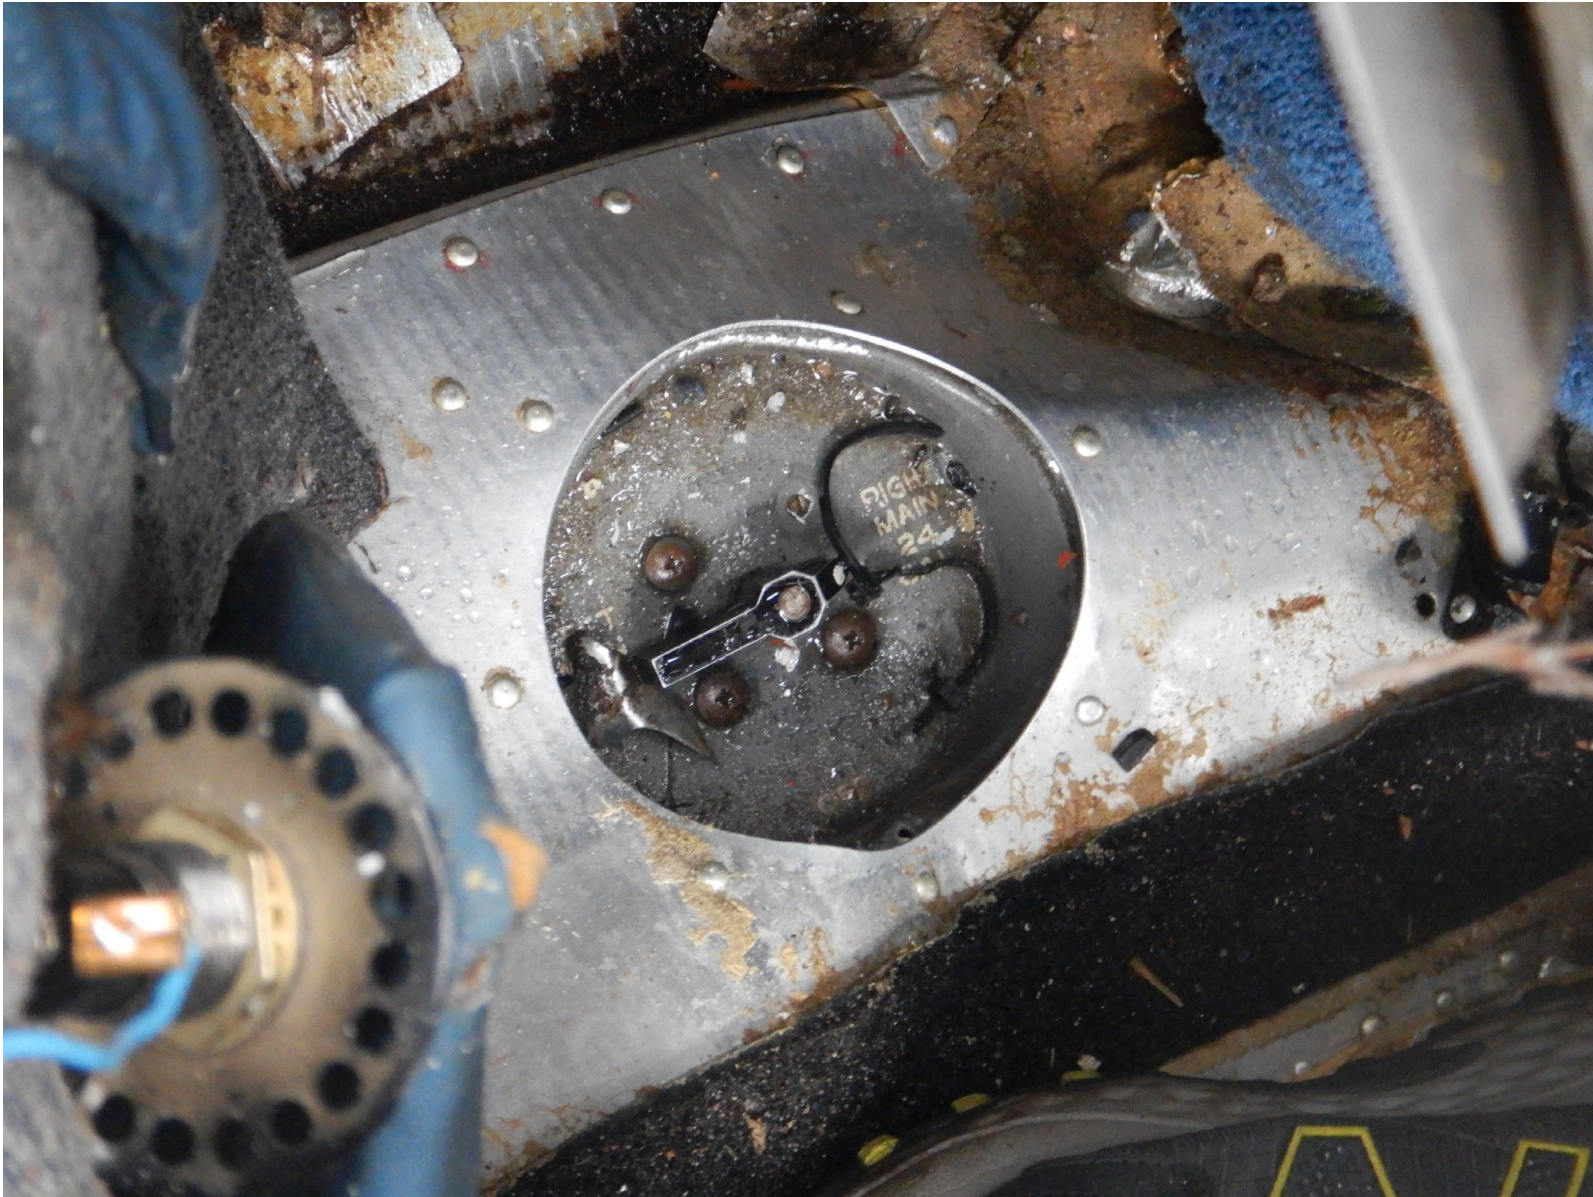
**Photograph 14 - Fuel selector with right main tank selected**
