# National Transportation Safety Board

ERA23FA087

## **AIR TRAFFIC CONTROL**

Group Chair's Factual Report

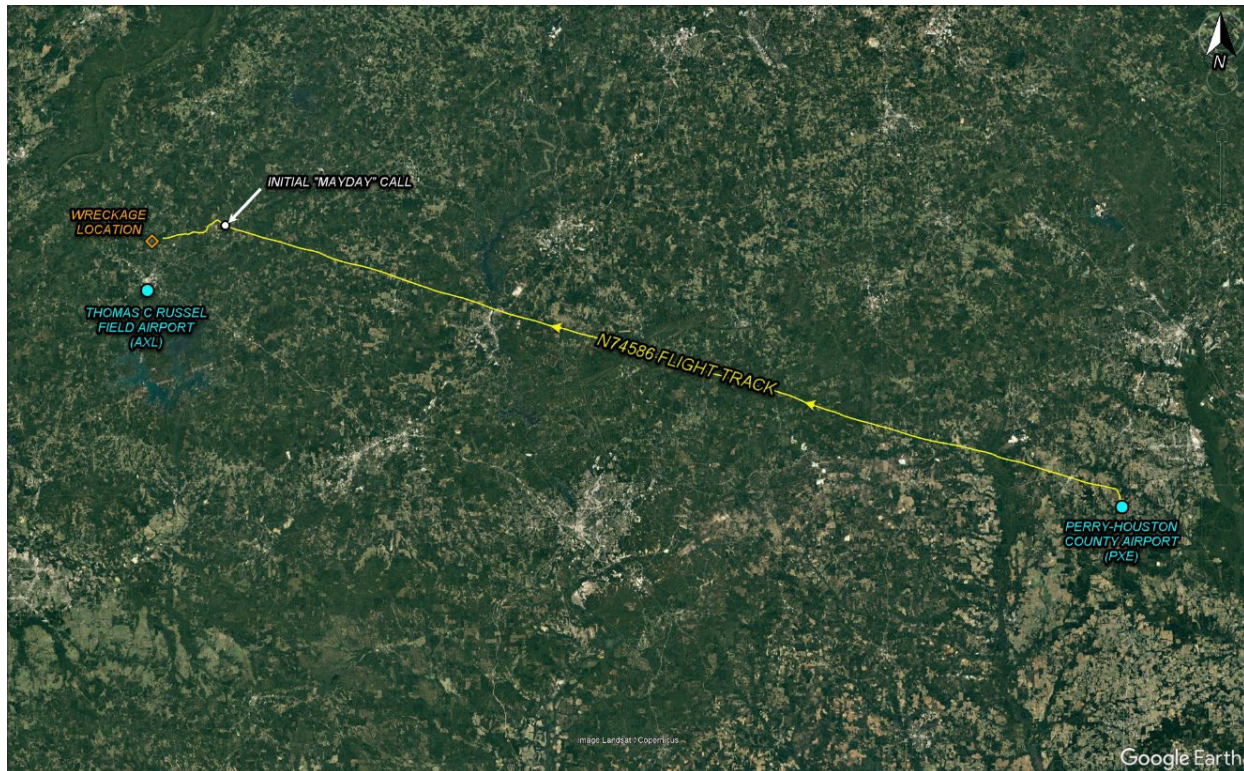
**Figure 1.** Overview of the entire accident flight track of N74586 overlaid onto satellite imagery.

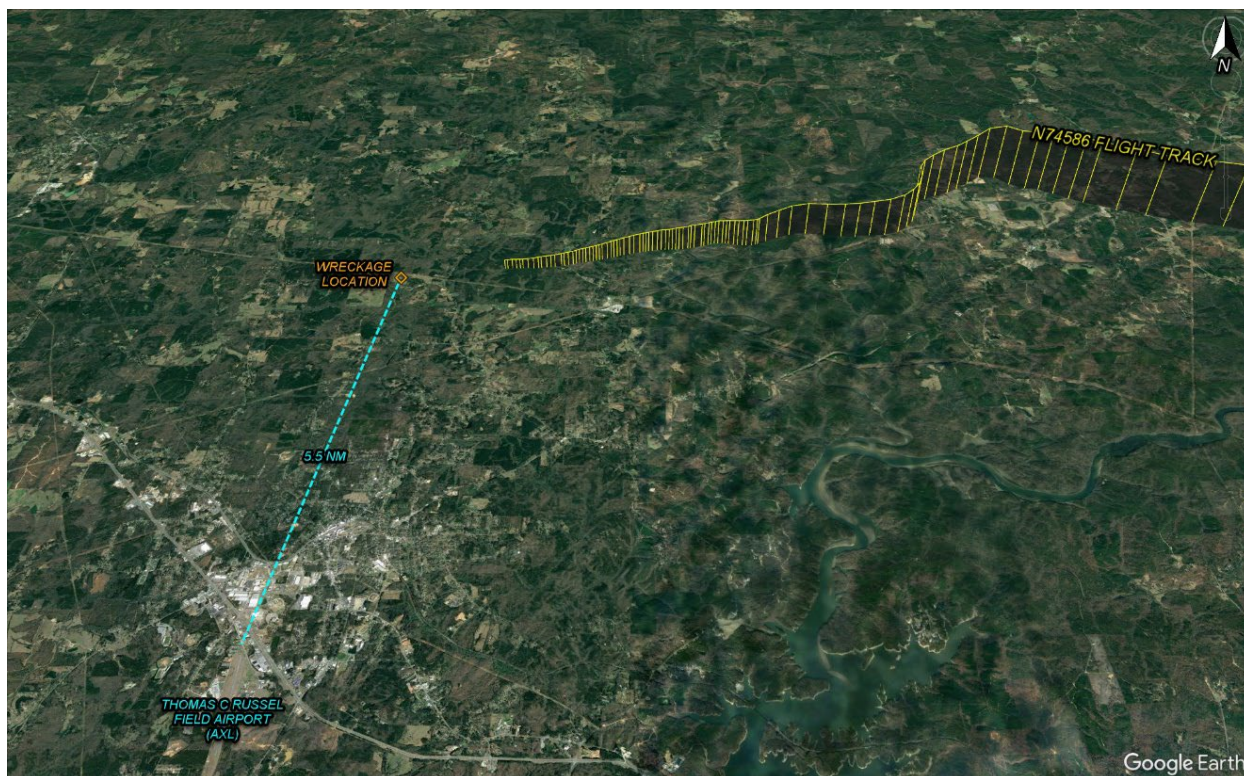
**Figure 2.** The final portion of the accident flight track of N74586 in profile view and overlaid onto satellite imagery.

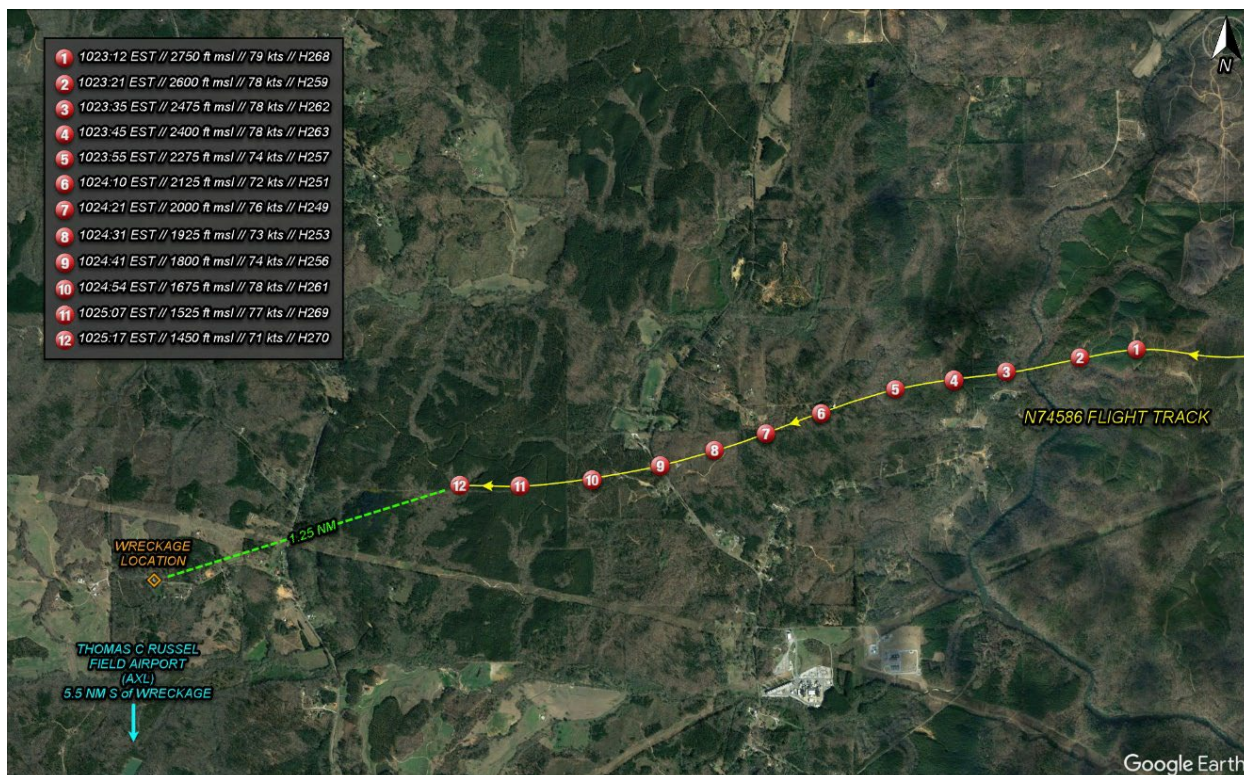
**Figure 3.** The final portion of the accident flight track of N74586 overlaid on satellite imagery with time, altitude, ground speed, and heading information included.
