**ERA23FA103**

**Piper PA-28-140**

**NTSB ENGINE EXAMINATION REPORT**

**January 30, 2023**

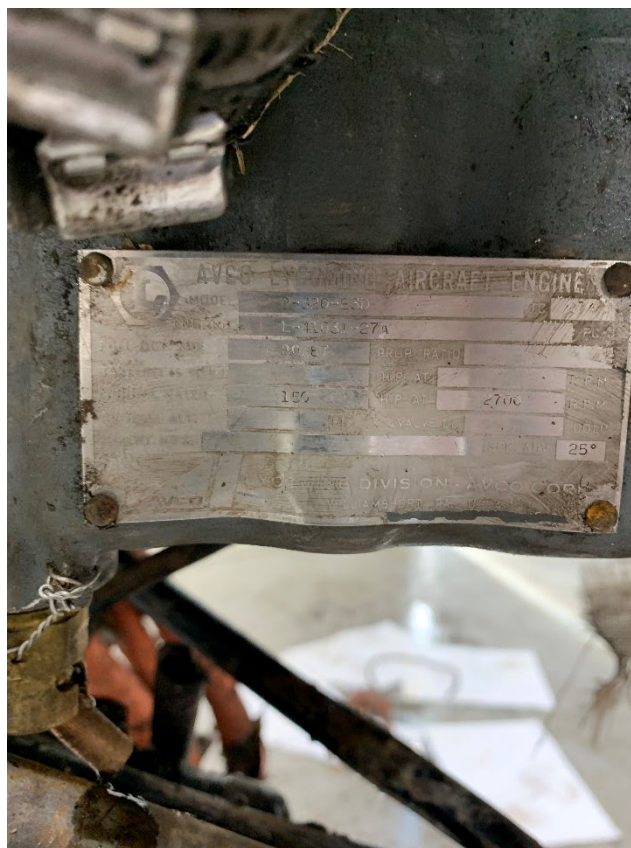
Figure 1 - Powerplant Data Plate (NTSB)

Engine Manufacturer: Lycoming  
Engine Model Number: O-320-E3D  
Engine Serial Number: L-41631-27A  
Recent Inspection: unknown  
Recent Recorded Tachometer Time: unknown

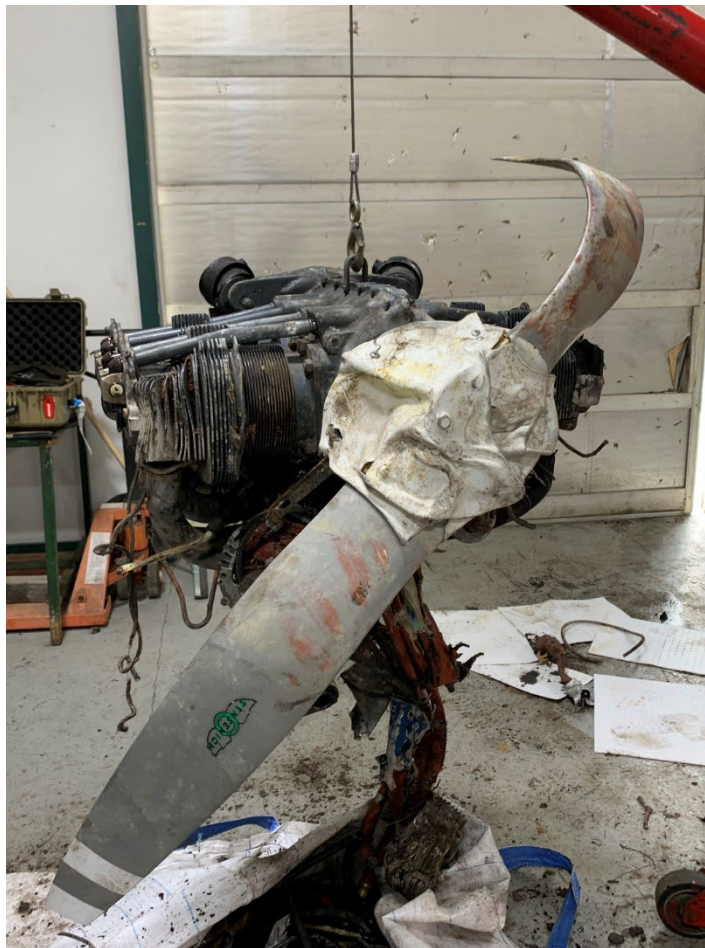
- The engine remained attached to the airframe through all engine mounts.
- The two-bladed propeller remained attached to the crankshaft flange.
  - Damage on both blades of the propeller showed “S” bending and rotational scoring consistent with crankshaft rotation at the time of impact.
- Impact damage crushed the exhaust system and bent portions of the engine mount around the engine accessories.
- The cylinders remained attached to the crankcase.
  - The #2 cylinder displayed substantial impact energy damage to the rocker area. Both rocker arms, the intake valve springs, intake keepers, rocker arm shaft, and rocker arm shaft bosses from the cylinder head were separated and missing from the examination.
- Engine crankshaft rotation was accomplished when force was applied to the propeller.

**Figure 2 - Powerplant on Hoist (NTSB)**

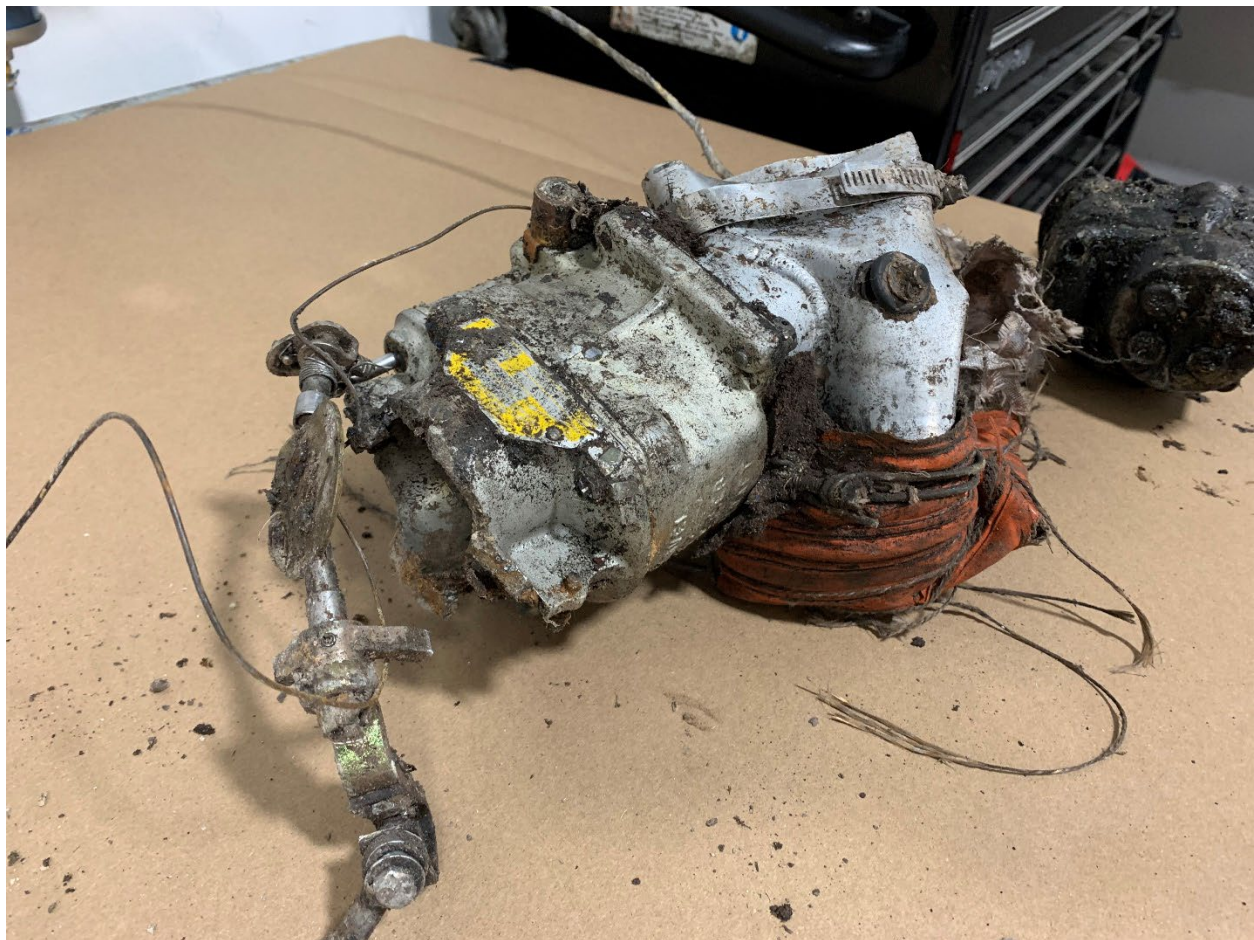
The carburetor was impact separated from the engine. The carburetor – a Marvel-Schebler model MA-4SPA with a setting of 10-5135 - had the mixture control cable attached to it. The fuel inlet screen was compromised from impact damage. The unit was opened for further examination. The floats remained intact and undamaged. The main orifice of the unit appeared unobstructed.

**Figure 3 - Carburetor, Separated from Engine (NTSB)**

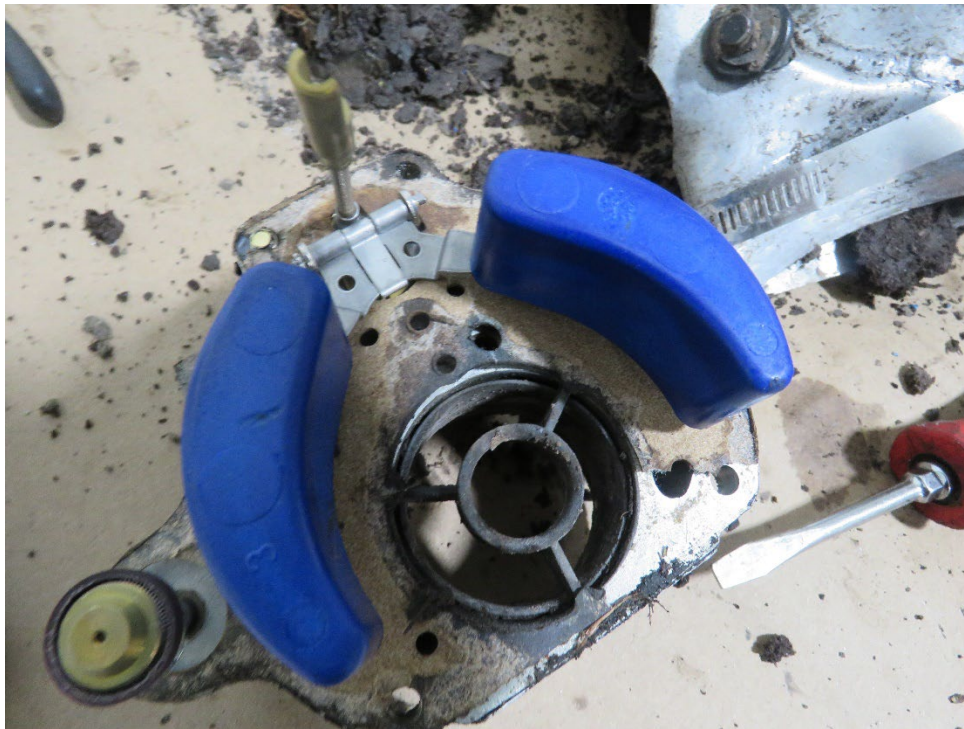
**Figure 4 - Carburetor, Internal Floats (Courtesy of Lycoming)**

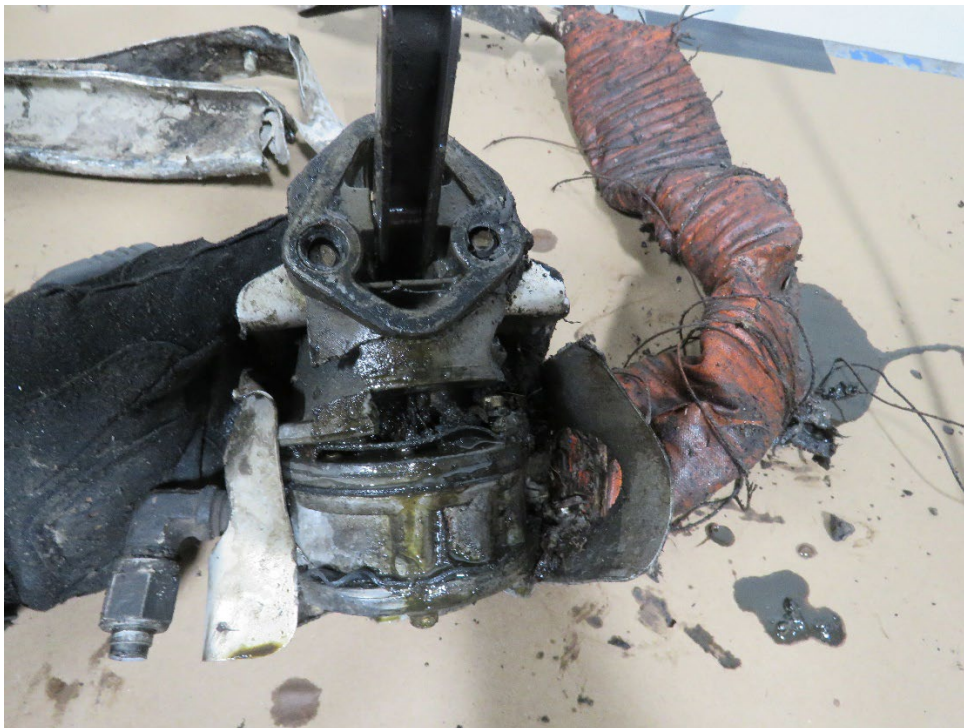
The fuel pump – a Lycoming LW-15472 with date code 9206 - remained secured to the engine accessory housing and was heavily damaged by impact forces.

**Figure 5 - Fuel Pump, Damaged (Courtesy of Lycoming)**

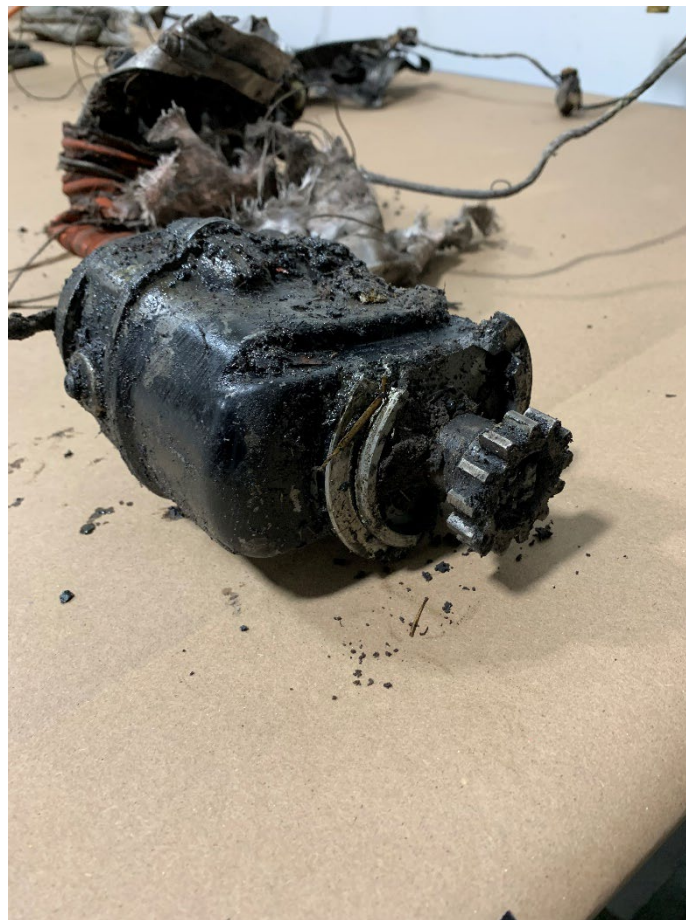
The right-hand magneto – a Slick model 4370, serial no. 07061547 - was impact separated from the accessory housing. The hold down nuts remained with the accessory housing and were finger tight against the remainder of the magneto mounting flange. The unit was opened for further analysis. Impact damage to the magneto housing bent the main shaft gear away from the timing gear, preventing the unit from producing spark. The point of the magneto opened as expected when the shaft was rotated by hand.

Figure 6 - Right-hand Magneto, Separated from Engine (NTSB)

The examination revealed that the hold down nuts for the magneto were finger tight.

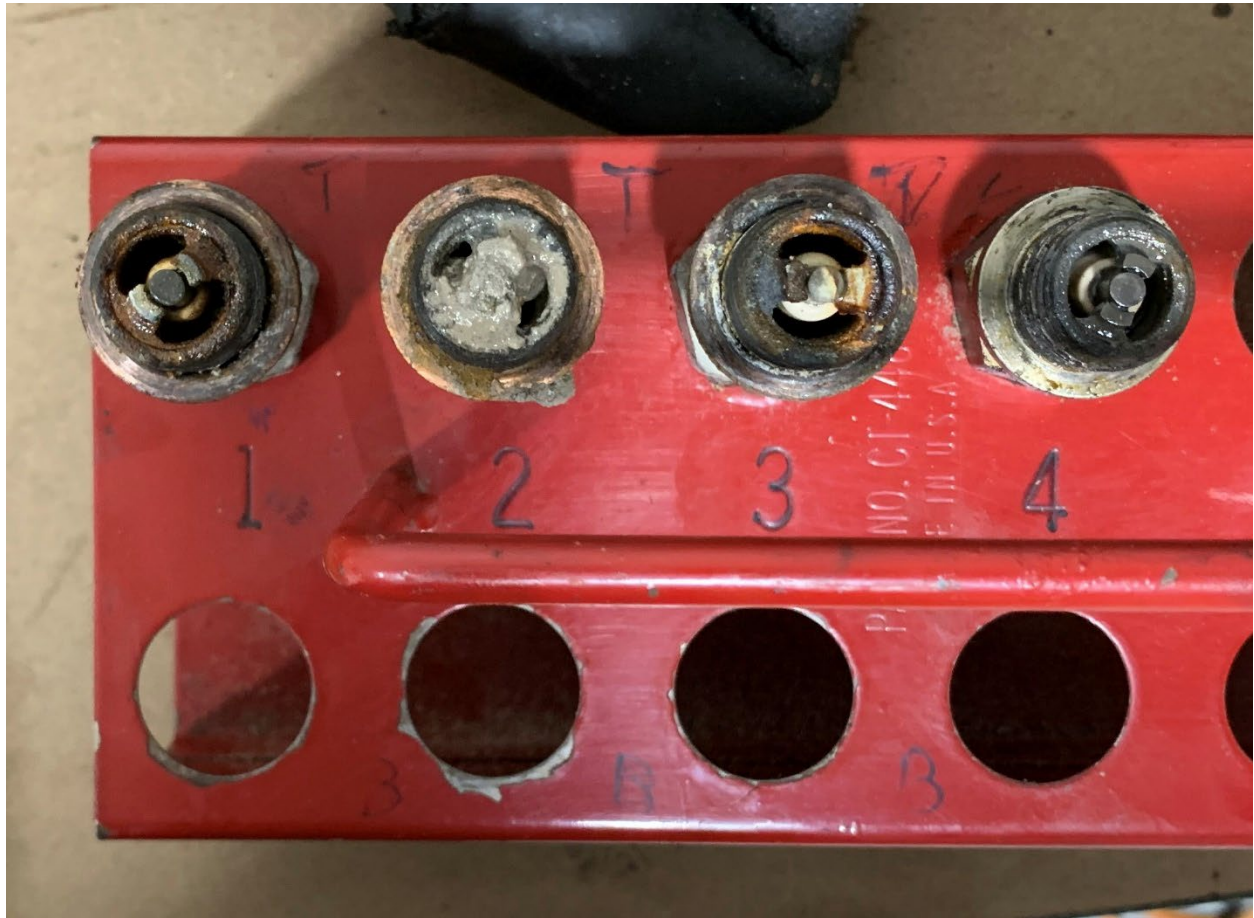
The spark plugs consisted of both Champion and Tempest manufacturers (SI 1042 approved). The number 2 top spark plug was contaminated with organic matter from the accident sequence. All four of the top spark plugs had undamaged electrode and were normal. The bottom spark plugs were not removed during the engine examination.

Figure 7 - Top Spark Plugs, Removed from Cylinders (NTSB)

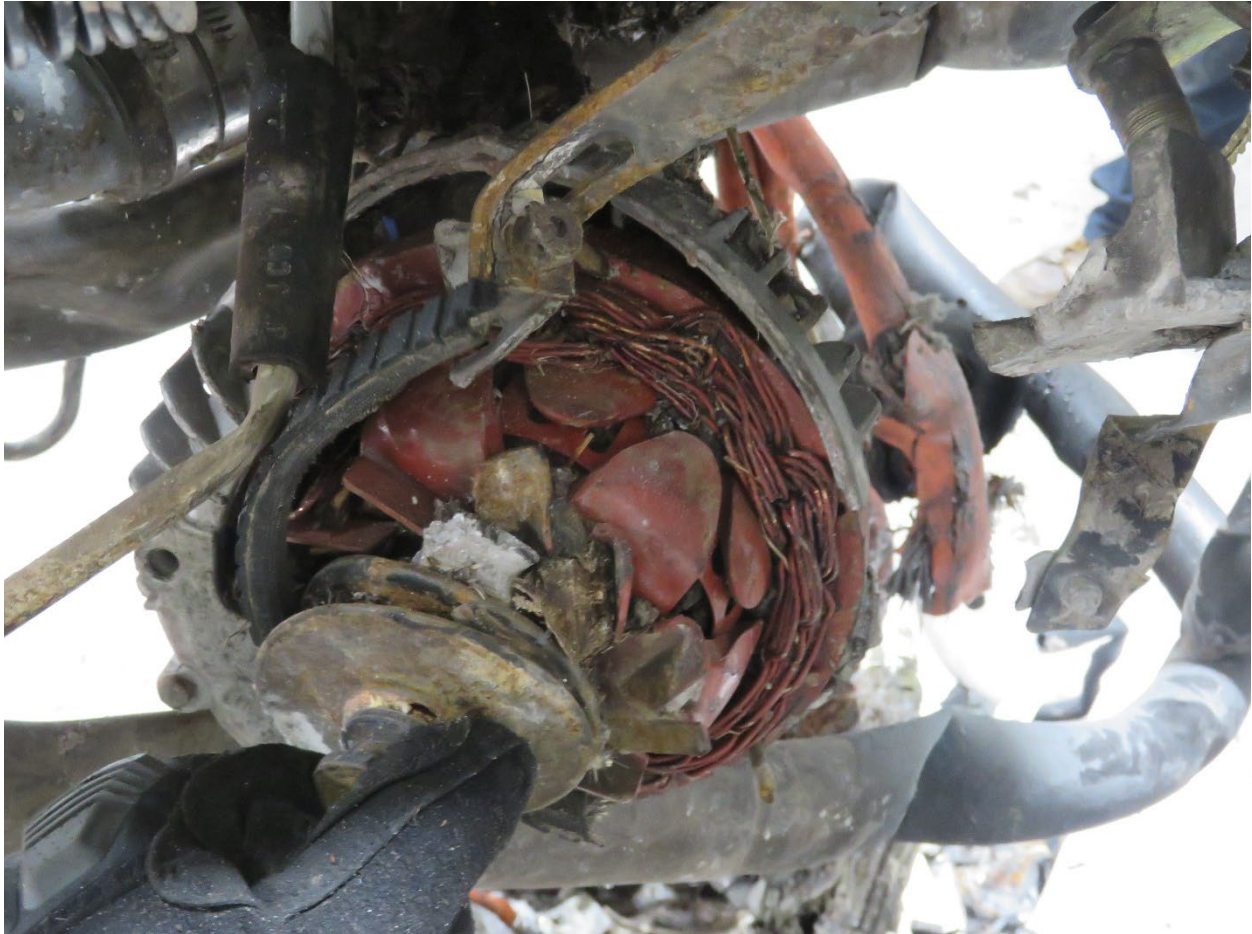
The alternator remained attached to the front of the engine and was substantially damaged by the impact forces. The unit was not removed during the engine examination.

**Figure 8 - Alternator, Damaged (Courtesy of Lycoming)**

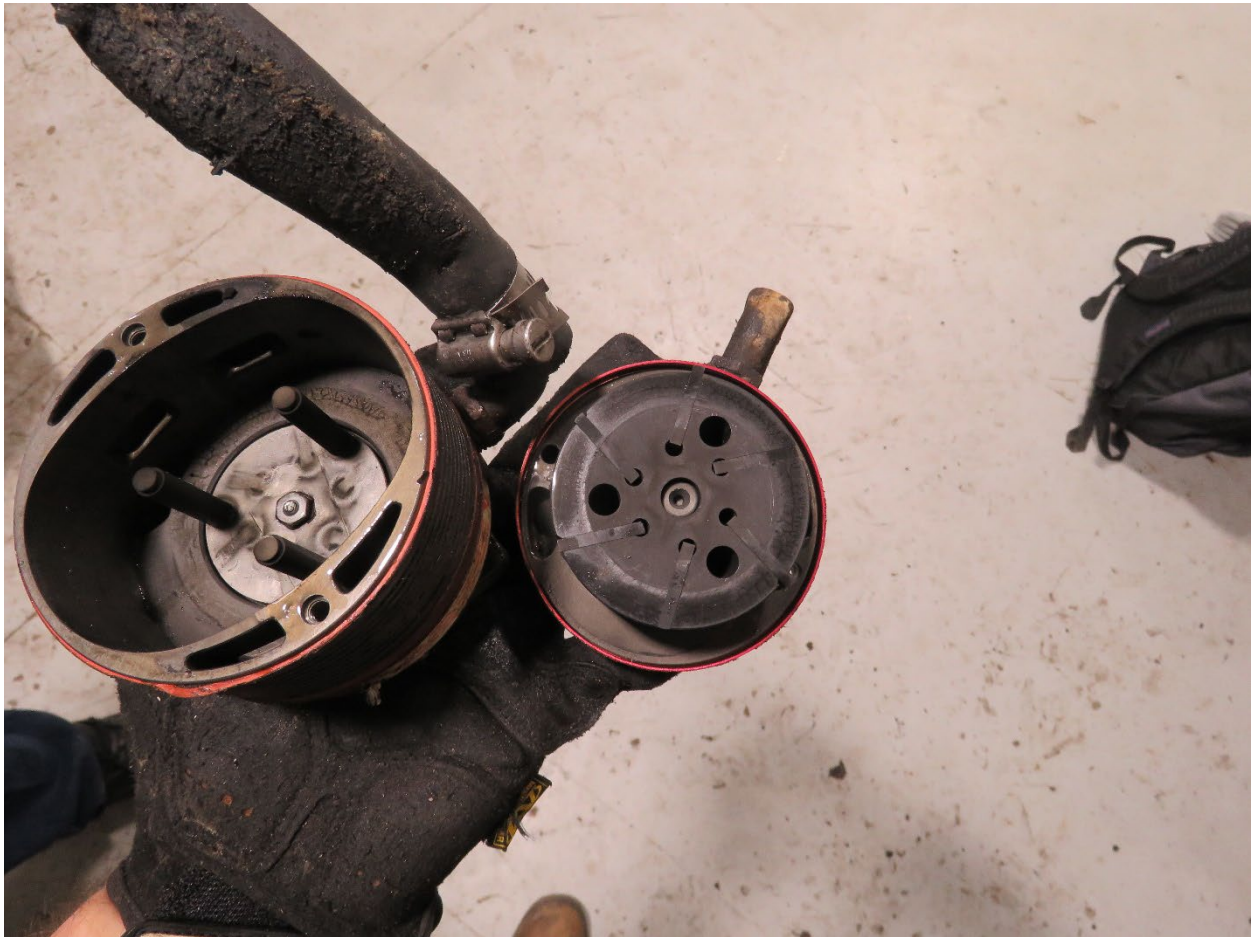
The vacuum pump – a Rapco RAP215CC, serial no. A72872 - remained secured to the accessory housing and was undamaged. The unit was removed for further examination. The shaft of the unit felt still and the pump was opened for further examination. The pump appeared undamaged internally.

Figure 9 - Vacuum Pump, Disassembled (Courtesy of Lycoming)

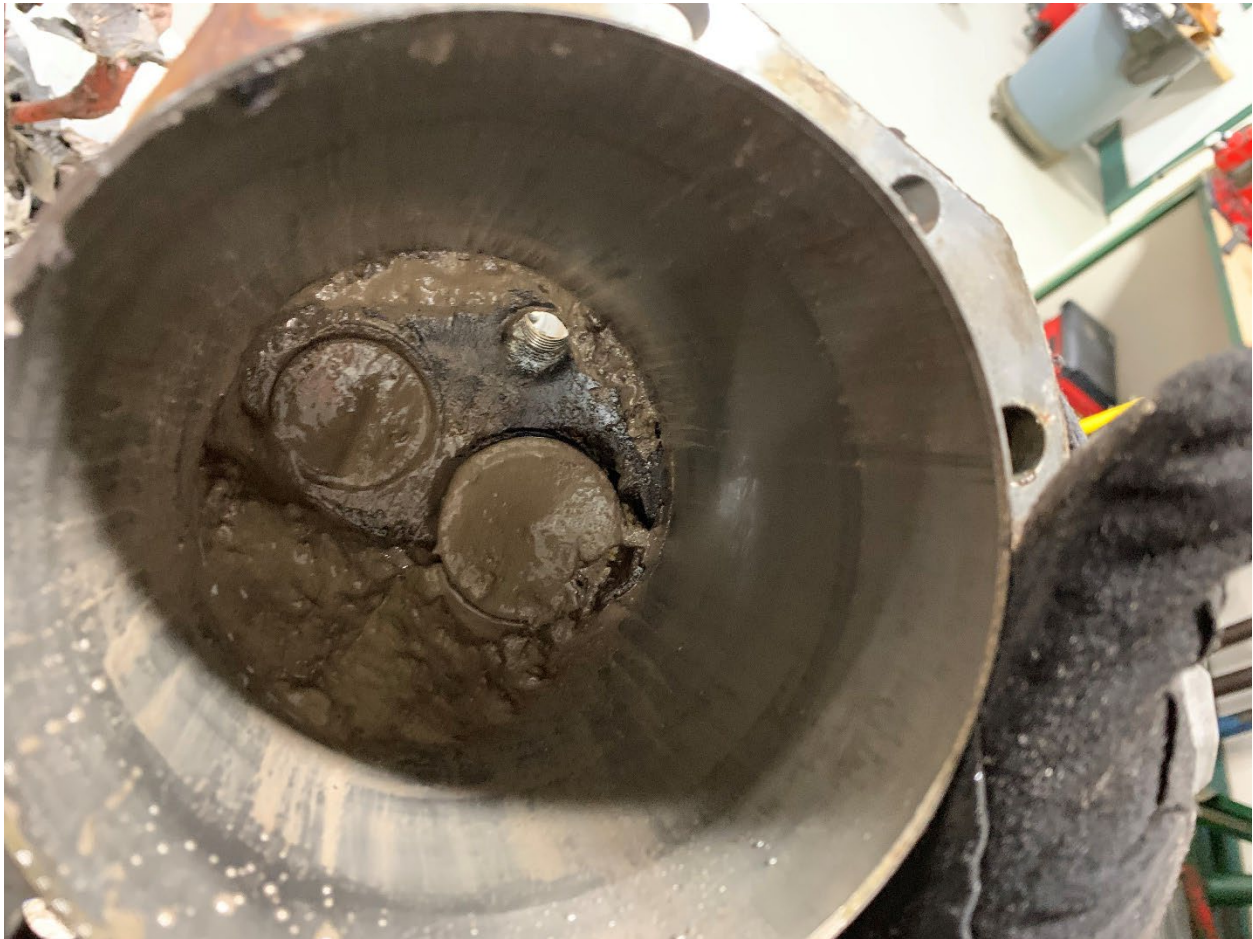
Thumb compressions and valve action lift was observed on cylinders 1, 3, and 4. The #2 cylinder was removed for additional investigation. The number 2 intake valve was stuck open from organic material and corrosion as a result of the impact sequence. The remaining cylinders were borescope inspected with no discrepancies noted.

**Figure 10 - Cylinder No. 2, Inside (NTSB)**
