**Wreckage Examination  
NTSB Accident Number  
ERA23FA103**

| Date: | January 7, 2023 |
| Aircraft: | Piper PA-28-140 |
| Registration | N592FL |

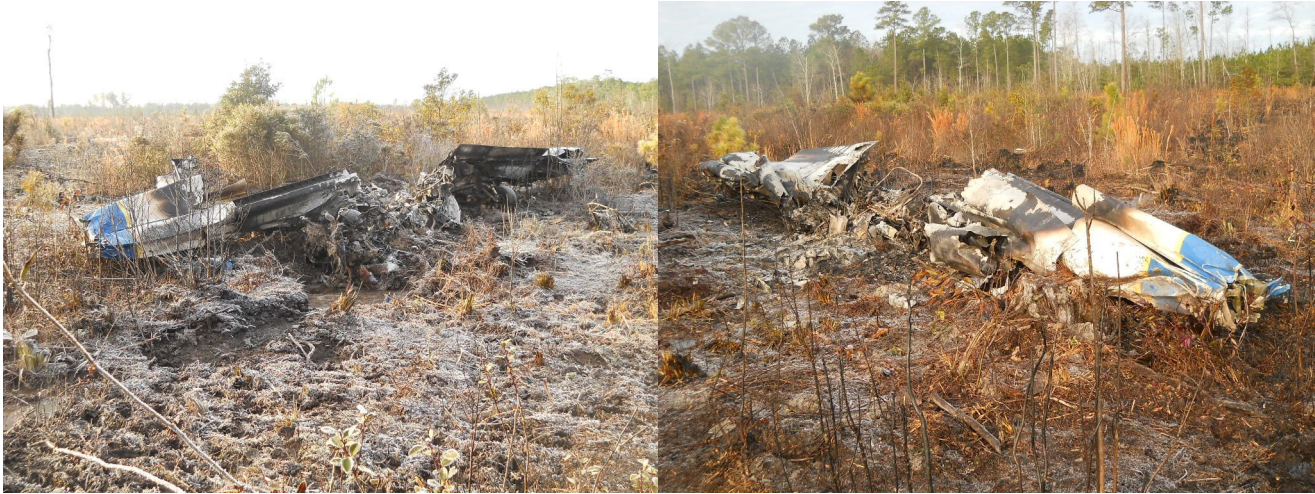
The airplane impacted nose-down in a marshy field and no debris path was observed. The wreckage came to rest upright and was oriented south. A section of engine cowling was located about 50 ft south of the main wreckage. A postcrash fire consumed the majority of the wreckage, with the exception of the wings and engine.

The aileron remained attached to the left wing, but the flap had separated and was consumed by fire. The left wing exhibited leading edge damage, buckling, and thermal damage. The aileron and flap remained attached to the right wing and the flap was in the retracted position. The right wing exhibited leading edge damage, buckling, and thermal damage. Flight control cable continuity was confirmed from both wing ailerons to the cockpit area. Due to impact and thermal damage, continuity could not be confirmed for the elevator and rudder, nor could an elevator trim setting be determined.
