# National Transportation Safety Board

ERA23FA103

## **AUTOMATIC DEPENDENT SURVEILLANCE- BROADCAST (ADS-B) STUDY**

Aircraft Performance Study

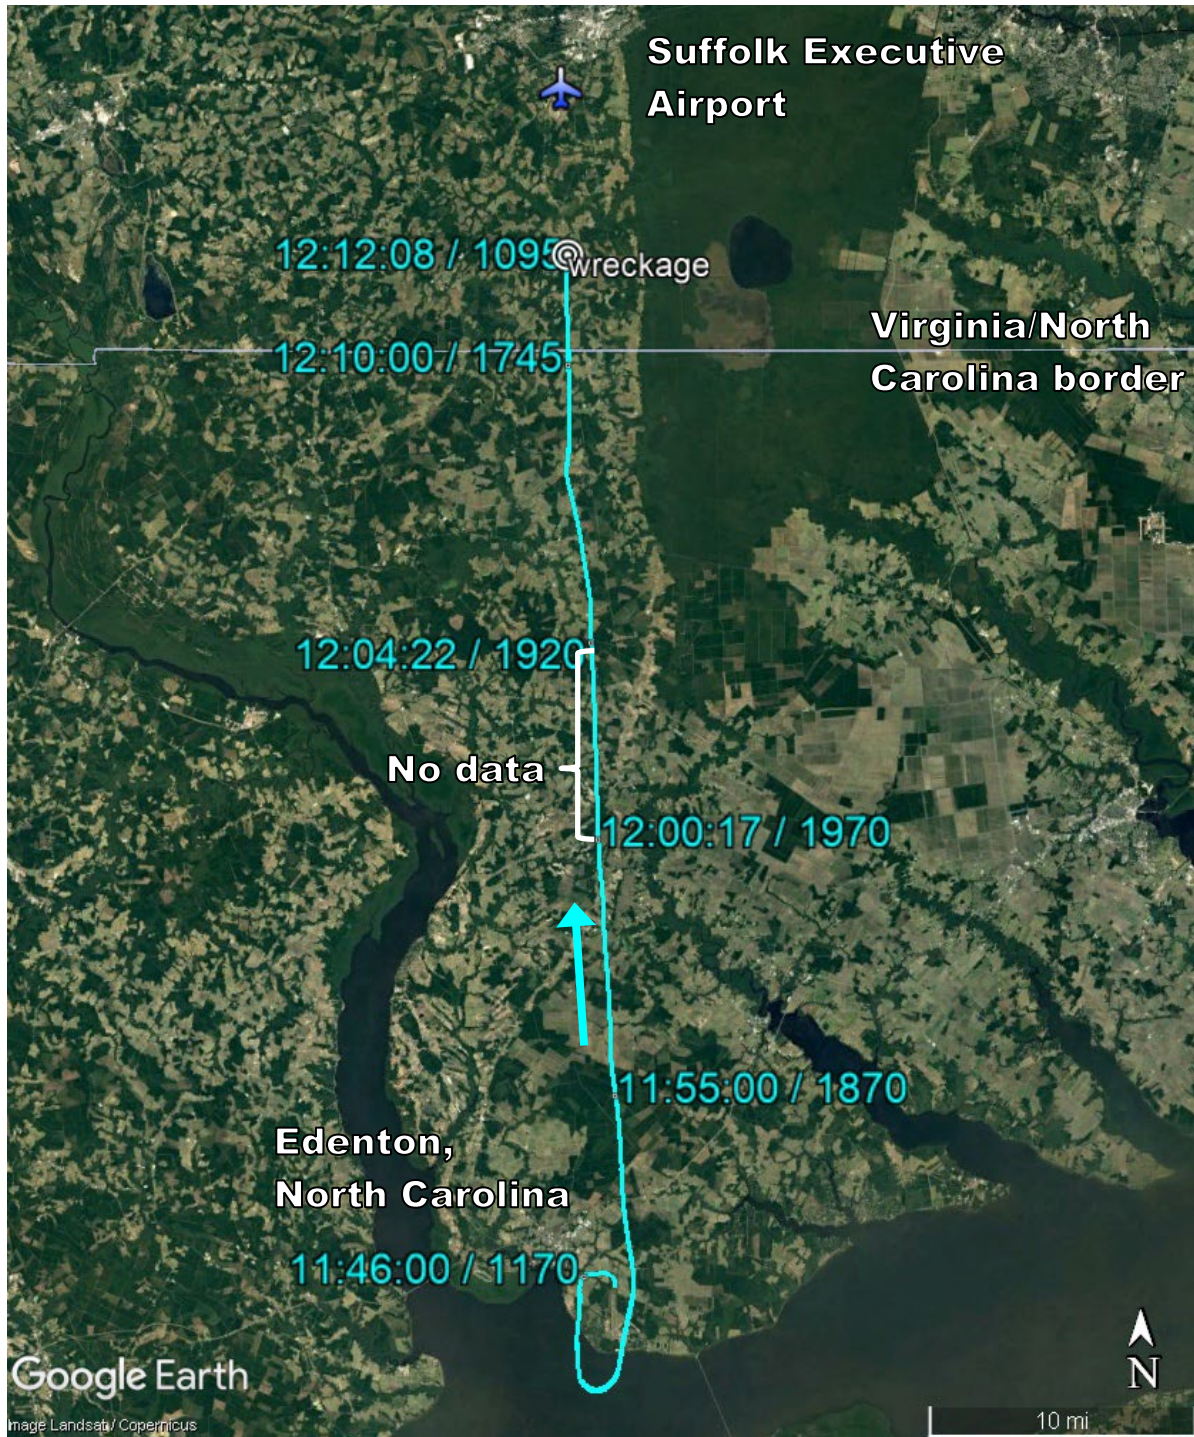
The airplane took off from Northeast Regional Airport (EDE) in Edenton, North Carolina at 11:44 (Figure 2). The planned destination was Suffolk Executive Airport. The airplane took off from runway 1, then circled to the left south of the airport before flying north. The airplane climbed to an altitude between 1,700 and 2,000 ft (Figure 3). The groundspeed varied between 90 and 100 kts.

**Figure 2.** ADS-B flight path with selected times and altitudes highlighted.

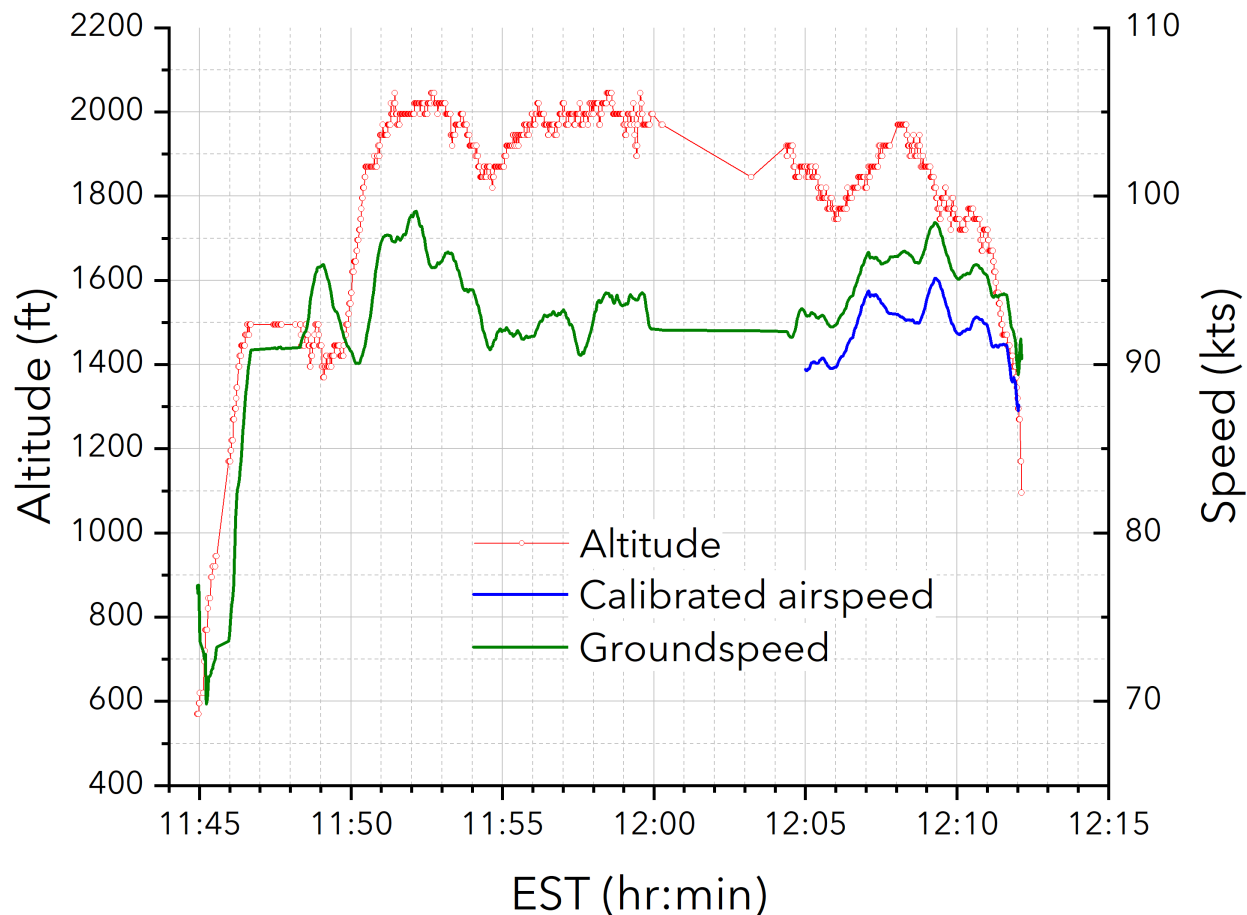
**Figure 3.** ADS-B altitude and calculated calibrated airspeed and groundspeed.

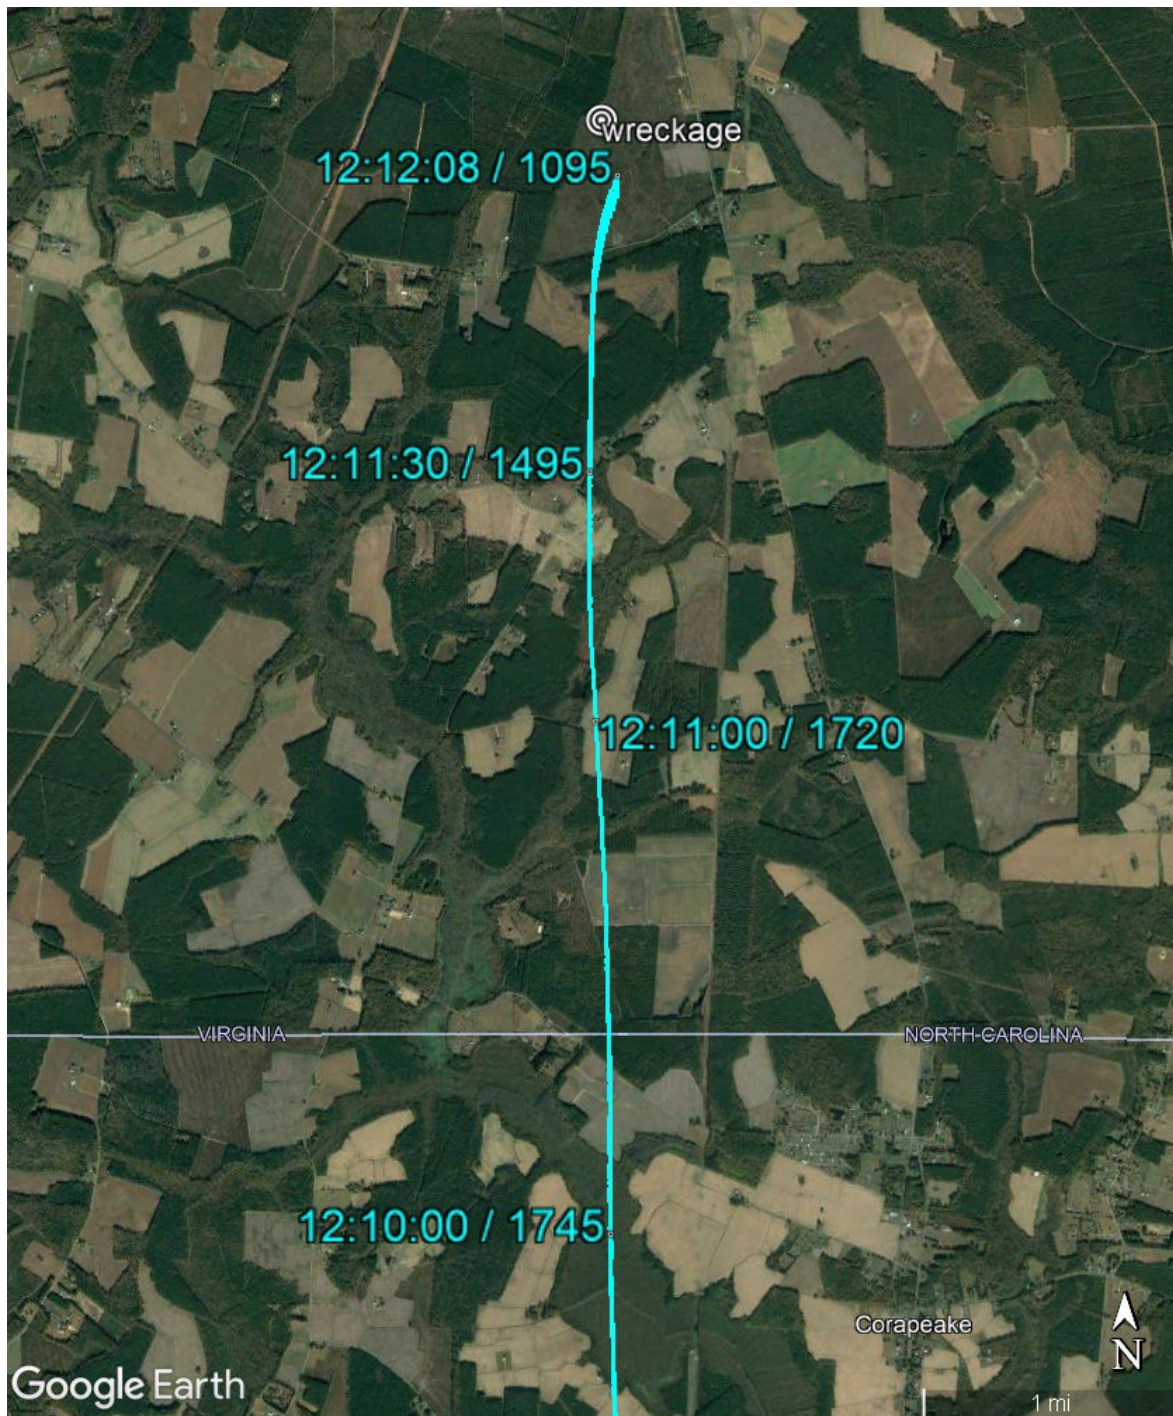
The airplane began to descend at 12:08 at an average rate of 100 ft/min. At 12:11, when the airplane was about two miles from the wreckage location (Figure 4 and Figure 5), the descent rapidly increased to 500 ft/min. The airplane's airspeed stayed just above 90 kts during this descent. From 12:11:30 to 12:12 the descent speed was arrested to 200 ft/min before again rapidly increasing to over 1,500 ft/min when the airplane was about 0.5 miles from the wreckage location. After 12:11:39 the airplane was losing both altitude and airspeed indicating a possible reduction in power. The last recorded position was at 12:12:08 when the airplane's altitude was 1,100 ft after which no ADS-B coverage was available. The wreckage elevation was 60 ft msl. At a descent rate of 1,500 ft/min, a possible 42 additional seconds of flight time was not recorded.

**Figure 4.** ADS-B flight path for the end of flight with selected times and altitudes highlighted. Ground elevation at the wreckage location is about 60 ft.

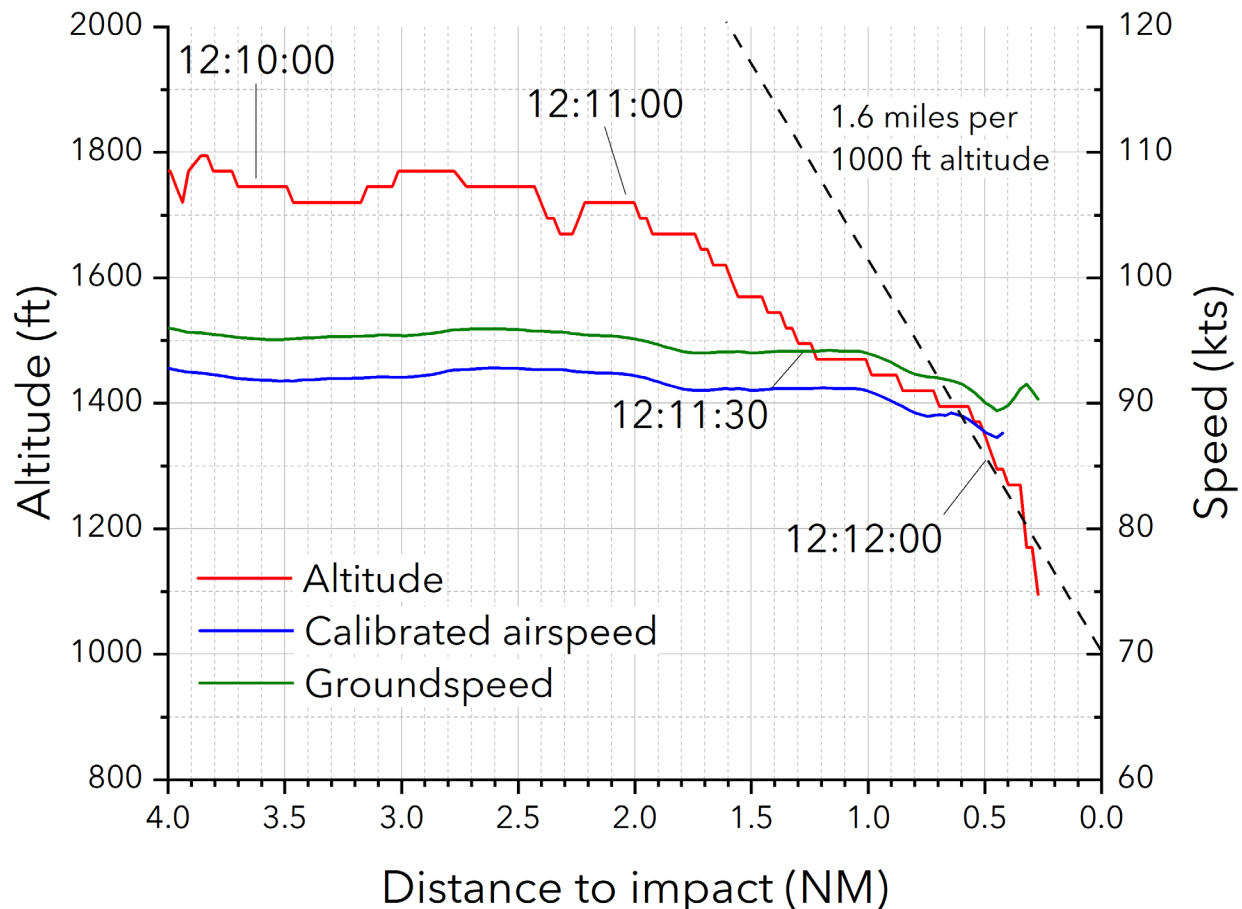
**Figure 5.** ADS-B altitude, calculated calibrated airspeed, and groundspeed versus distance for final four miles of flight. Shown as a black dotted line is the optimal glide performance.

The Pilot's Operating Handbook [1] states that if power is lost in flight, to maintain an airspeed above 79 kts indicated<sup>1</sup> to obtain a glide ratio of 1.6 miles for every 1,000 ft of altitude. The airplane's performance after 12:11 exceeded this glide ratio until 12:12 when the airplane descended more steeply.

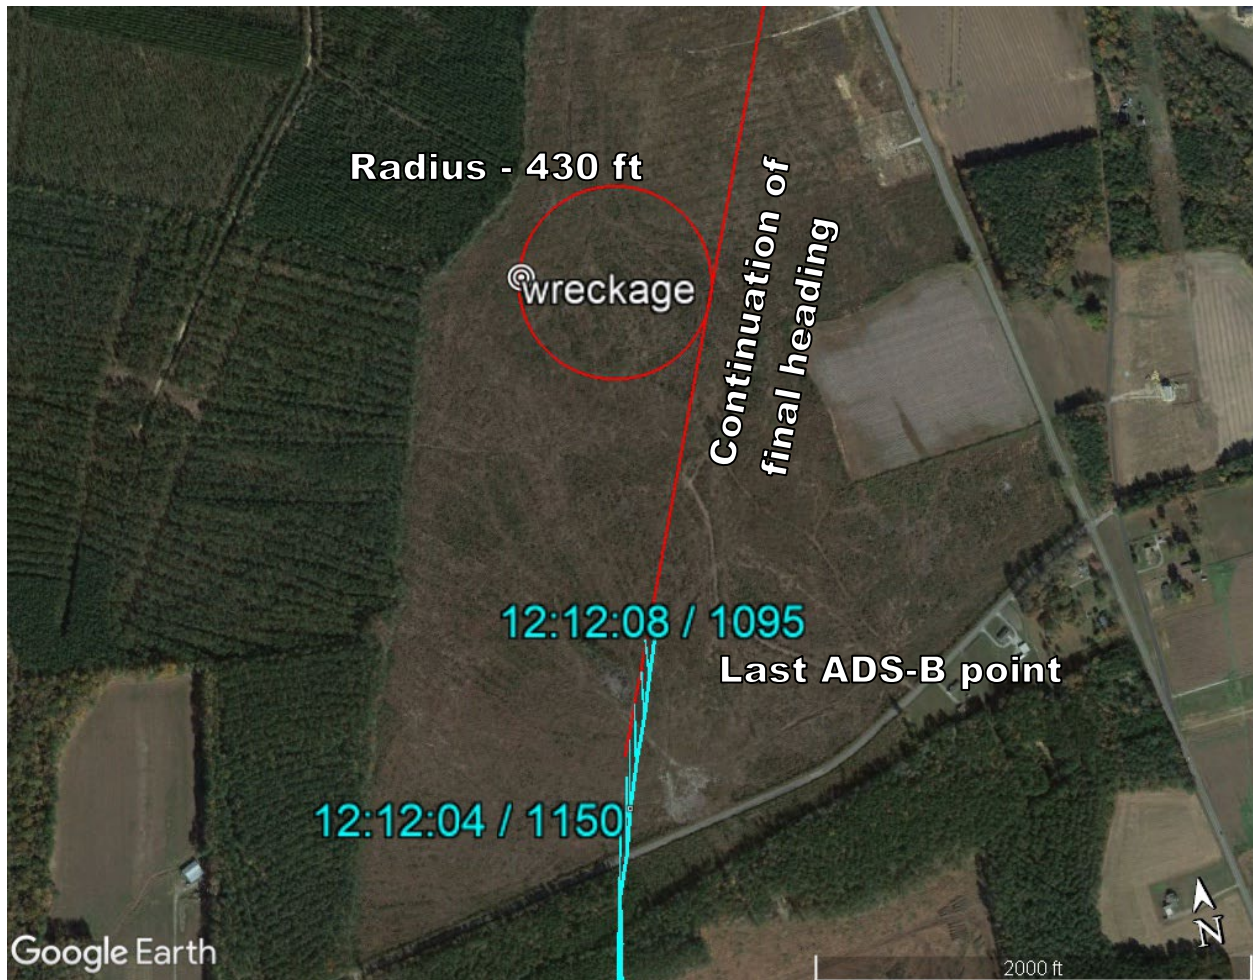
The listed stall speeds are 53 kts, power off, flaps 40° and 58 kts, power off, flaps 0°. The airplane's final calculated calibrated airspeed was 87 kts. For the airplane to have aerodynamically stalled its bank angle would have had to exceed 60°. The wreckage was oriented on a southerly heading, which would have required the airplane to complete a 200° turn from its last recorded northerly ground track of 20° before impact. Figure 6 shows the radius of the required turn from the last ground track. Assuming an airspeed of 87 kts<sup>2</sup> and a turn radius of 430 ft the bank angle,  $\theta$ , necessary for that turn can be calculated using

The required bank angle would be 57° indicating the airplane was approaching the stall speed.

**Figure 6.** End of ADS-B data and wreckage location. Included are the continuation of the final ground track and the radius of the turn to the wreckage location.
