# National Transportation Safety Board

ERA23FA108

## **AIR TRAFFIC CONTROL**

Group Chairman's Factual Report

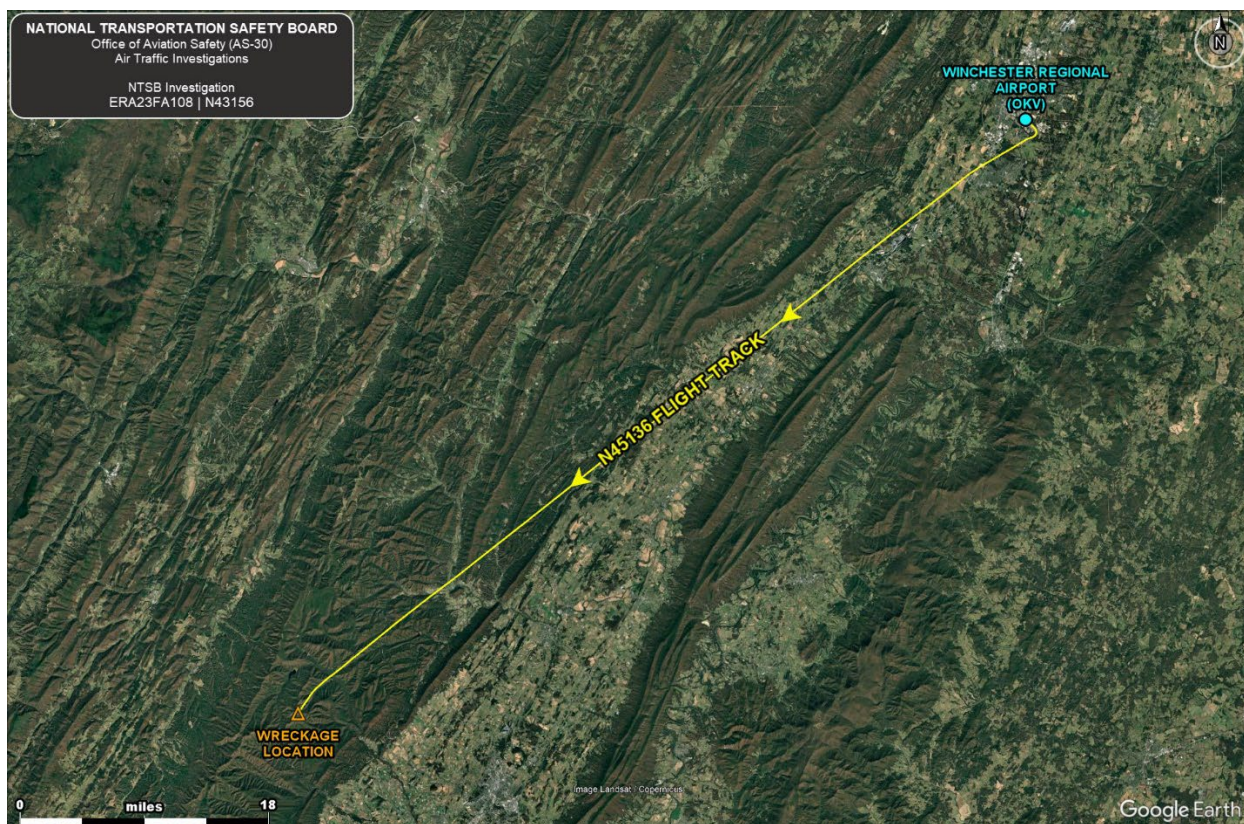
**Figure 1.** Overview of the entire incident flight track overlaid on satellite imagery.

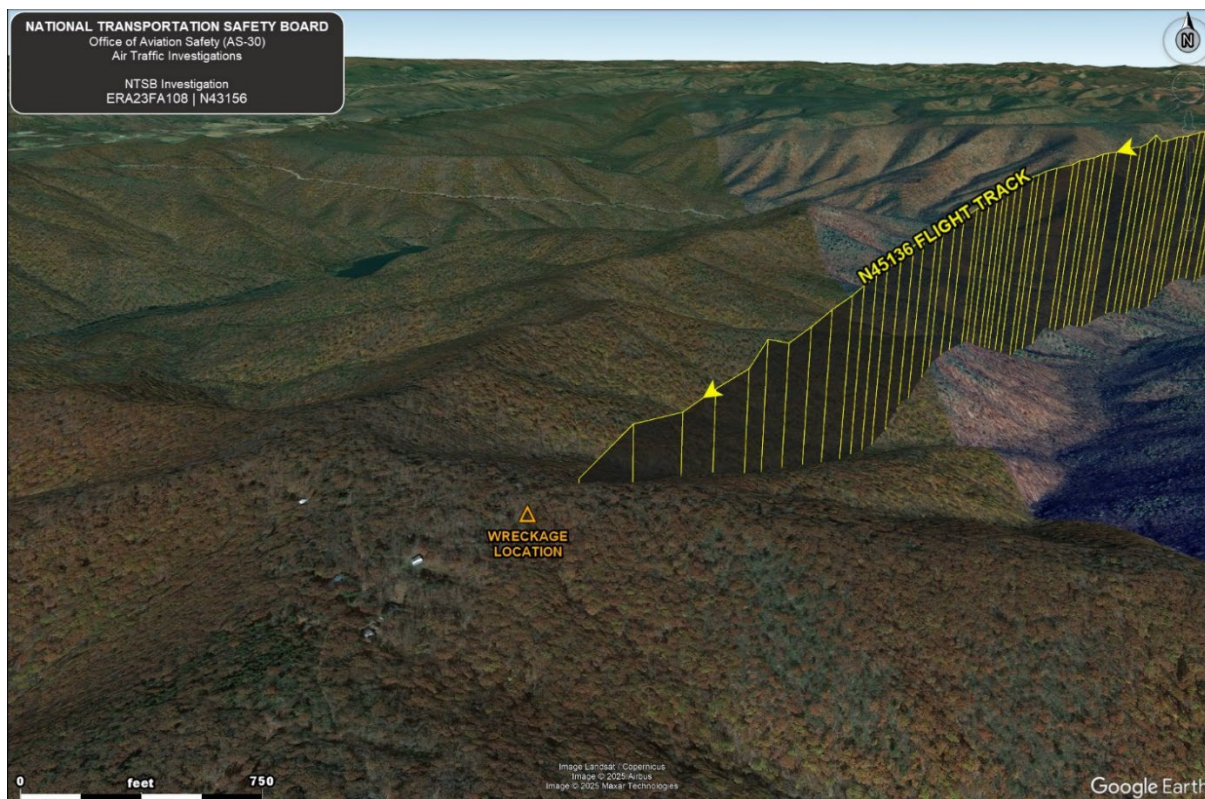
**Figure 2.** Final portion of the incident flight track in profile view.

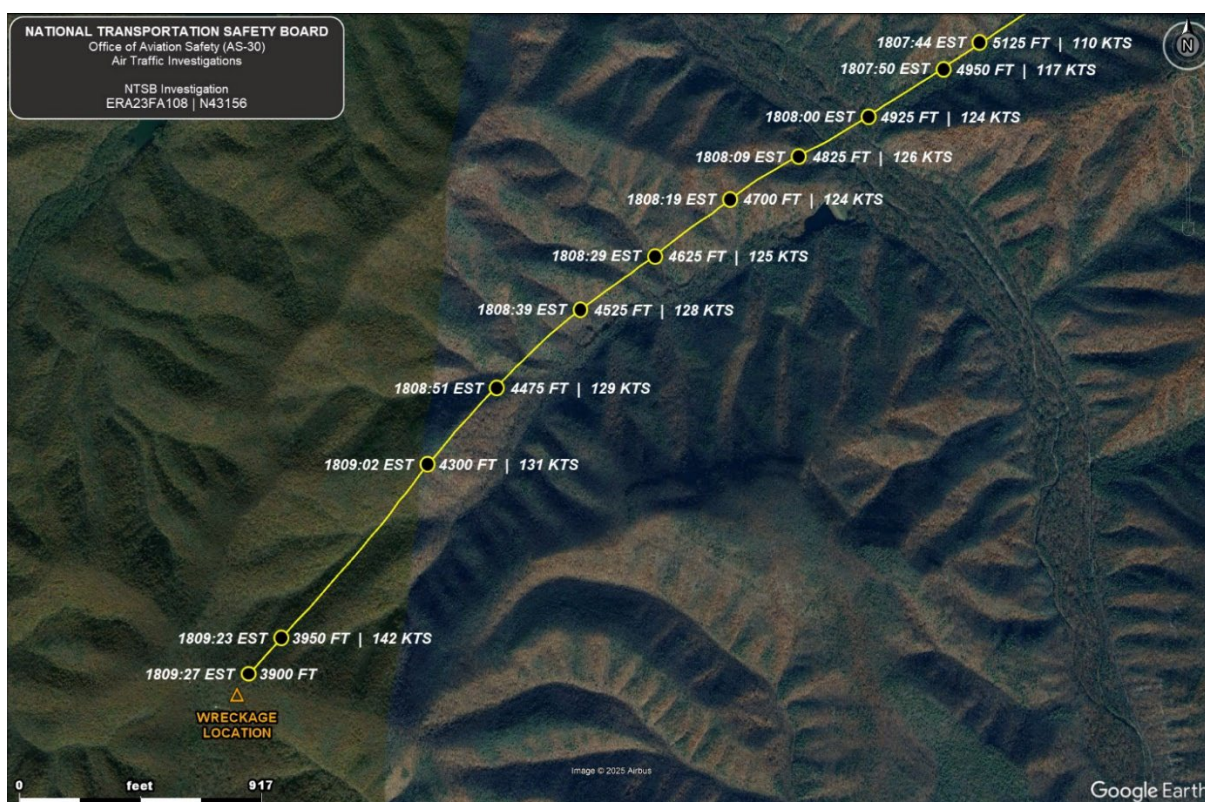
ADS-B<sup>3</sup> data were provided by the FAA and used to produce figures 1-3 below. In figure 3, ground speeds are estimated calculations and were not part of the ADS-B data transmitted from the accident aircraft. Altitudes are the geometric altitude<sup>4</sup> values from the ADS-B data.

**Figure 3.** Final portion of the accident flight with time, altitude, ground speed, and heading information included.
