# National Transportation Safety Board

ERA23FA109

## **AIRWORTHINESS FACTUAL REPORT**

Location: Dawsonville, Georgia  
Date: January 12, 2023  
Time: 2017 local  
0117 UTC  
Airplane: Piper PA28-180, N4254T

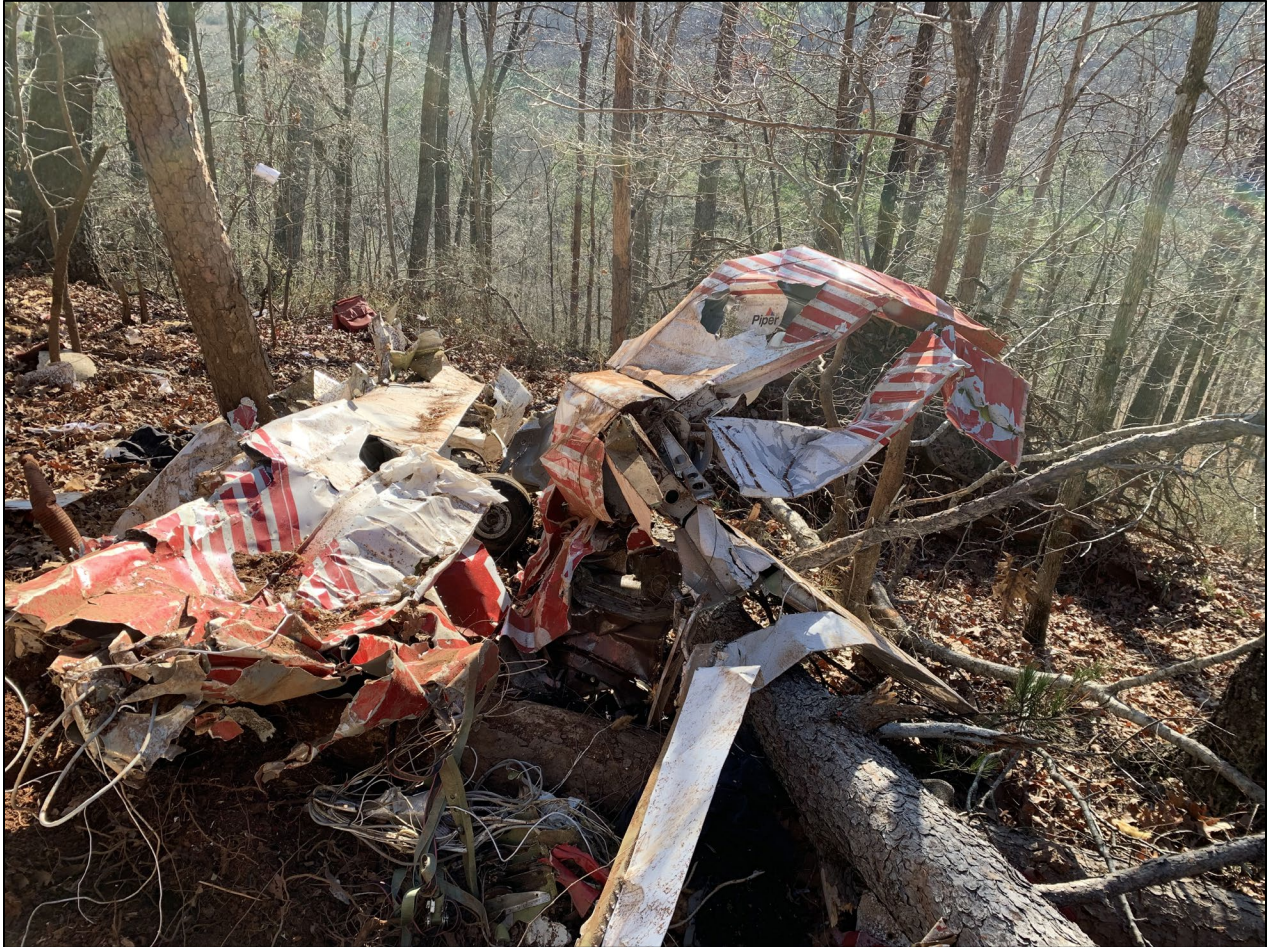
The airplane impacted wooded terrain near the top of rising terrain at an elevation of about 1,250 ft msl. The wreckage was highly fragmented and was located largely in one compact area. All major portions of the airframe were located. The engine was co-located with the cockpit and fuselage debris. There was no evidence of a post-crash fire or thermal damage to the wreckage.

**Photo 1: View of the wreckage as found at the accident site.**

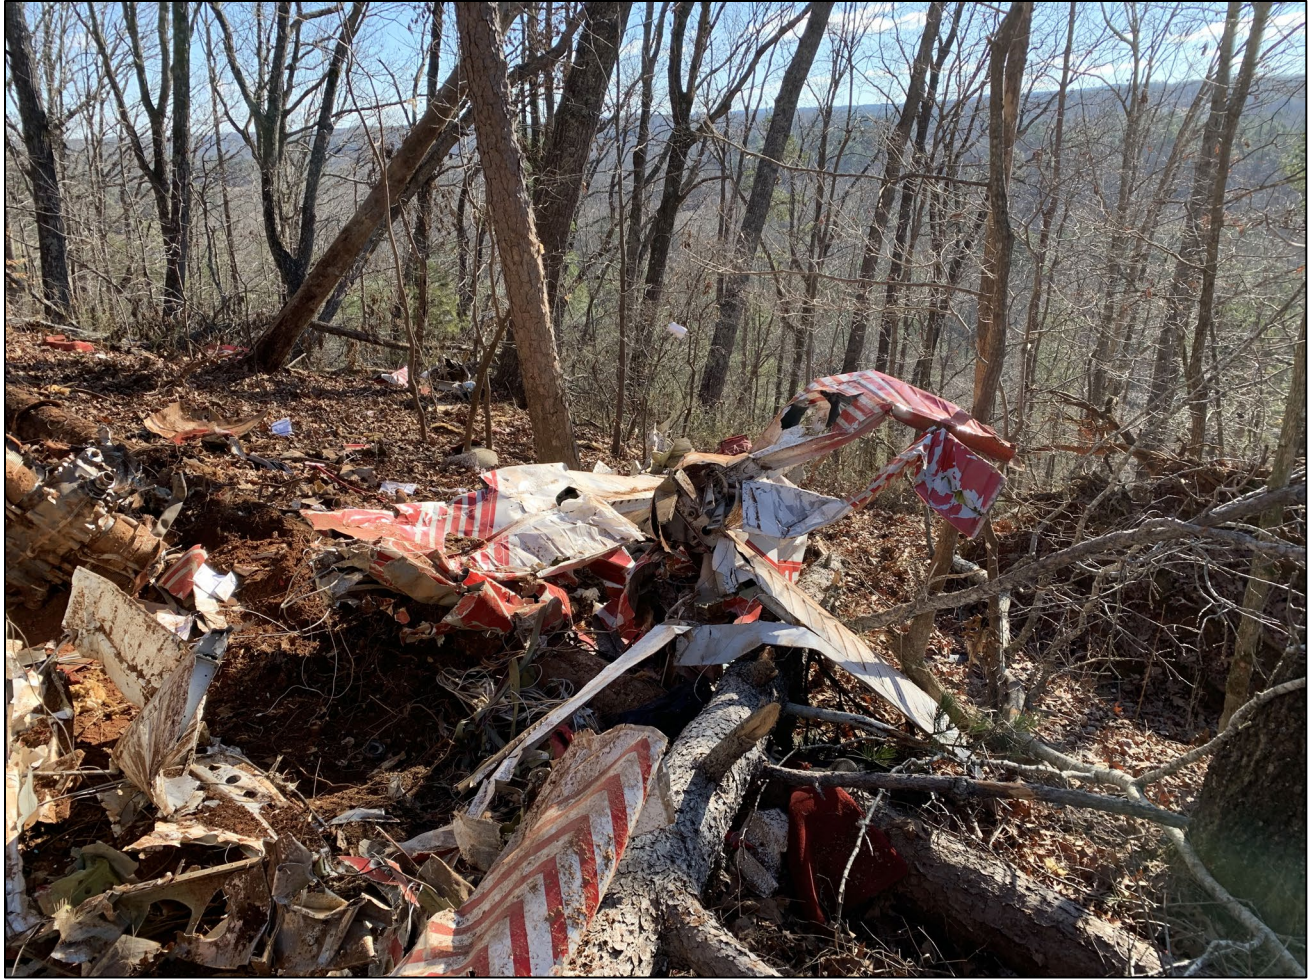
**Photo 2: View of the wreckage as found at the accident site.**

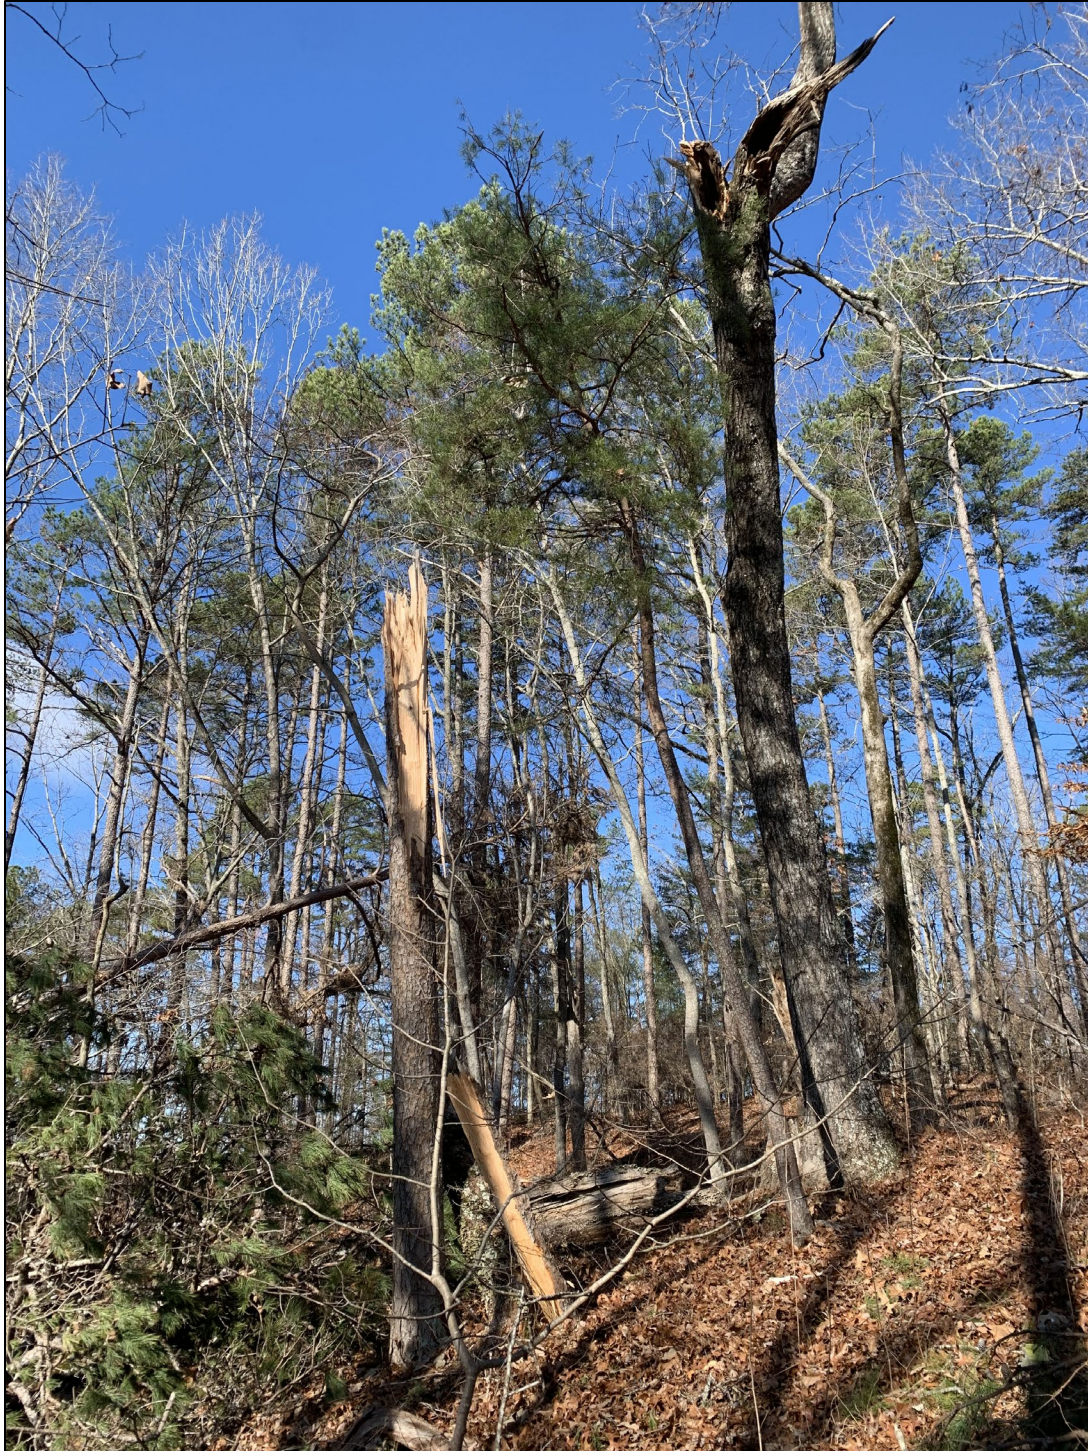
**Photo 3: View of the initial tree impact area.**

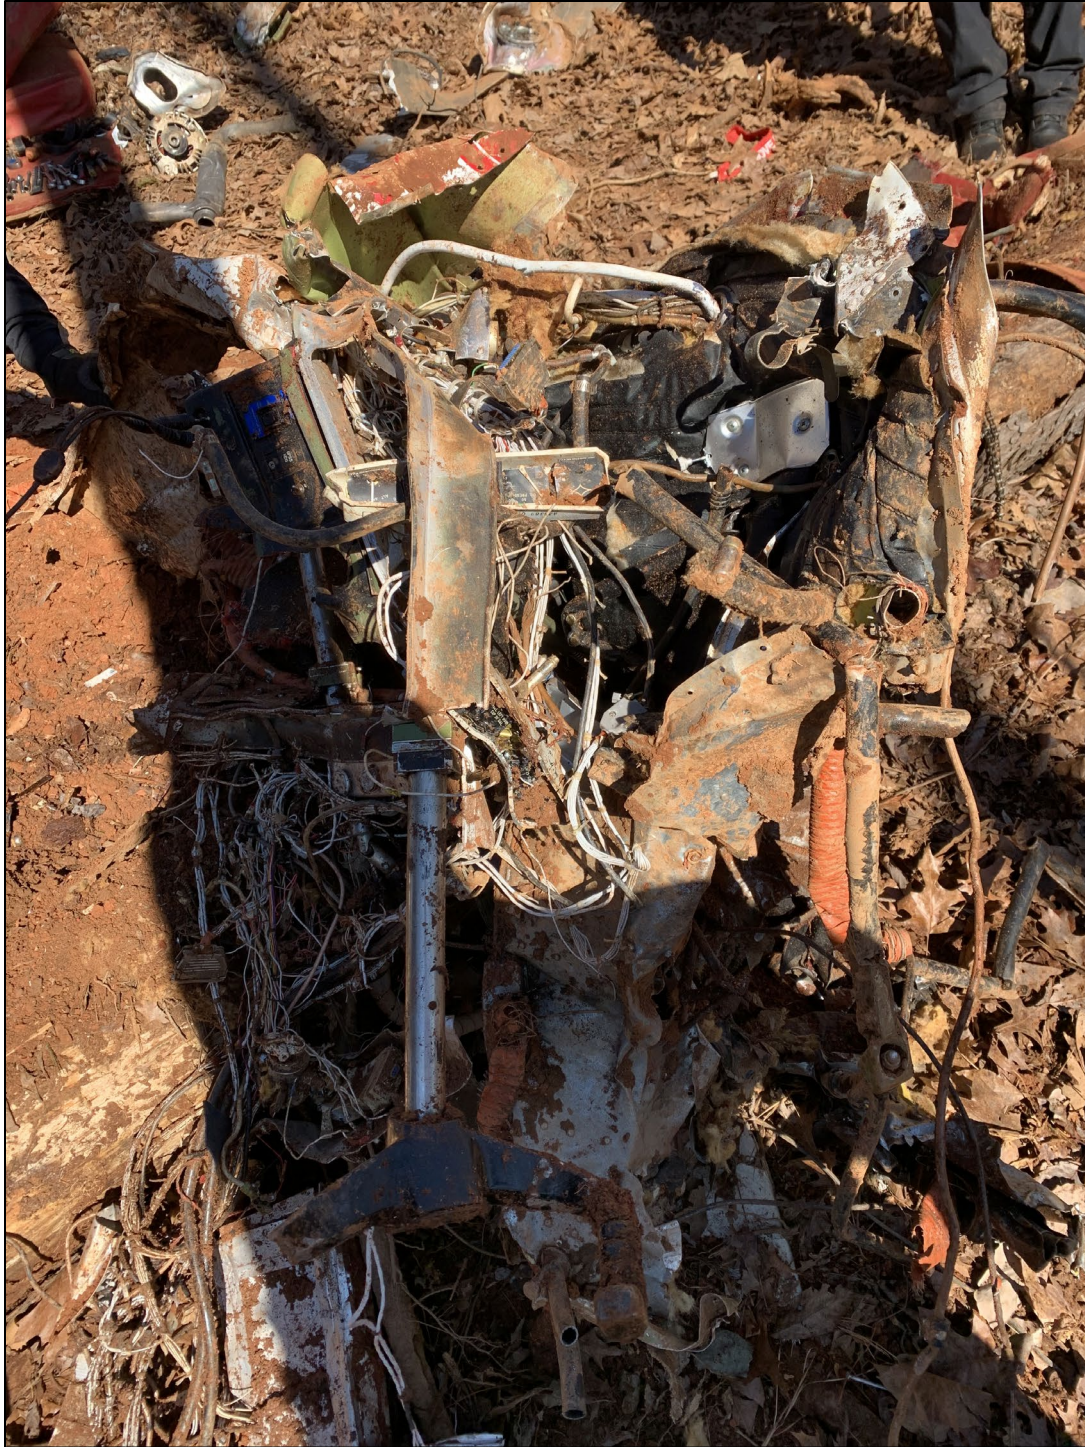
The cockpit, switches, levers, and flight instruments were all severely damaged by impact related damage. Several of the gauges/ switches were not readable or their position was unreliable due to impact damage. The tachometer was found indicating 2200RPM. The tachometer hour meter read 5560 hours.

**Photo 4: View of the heavily fragmented cockpit**

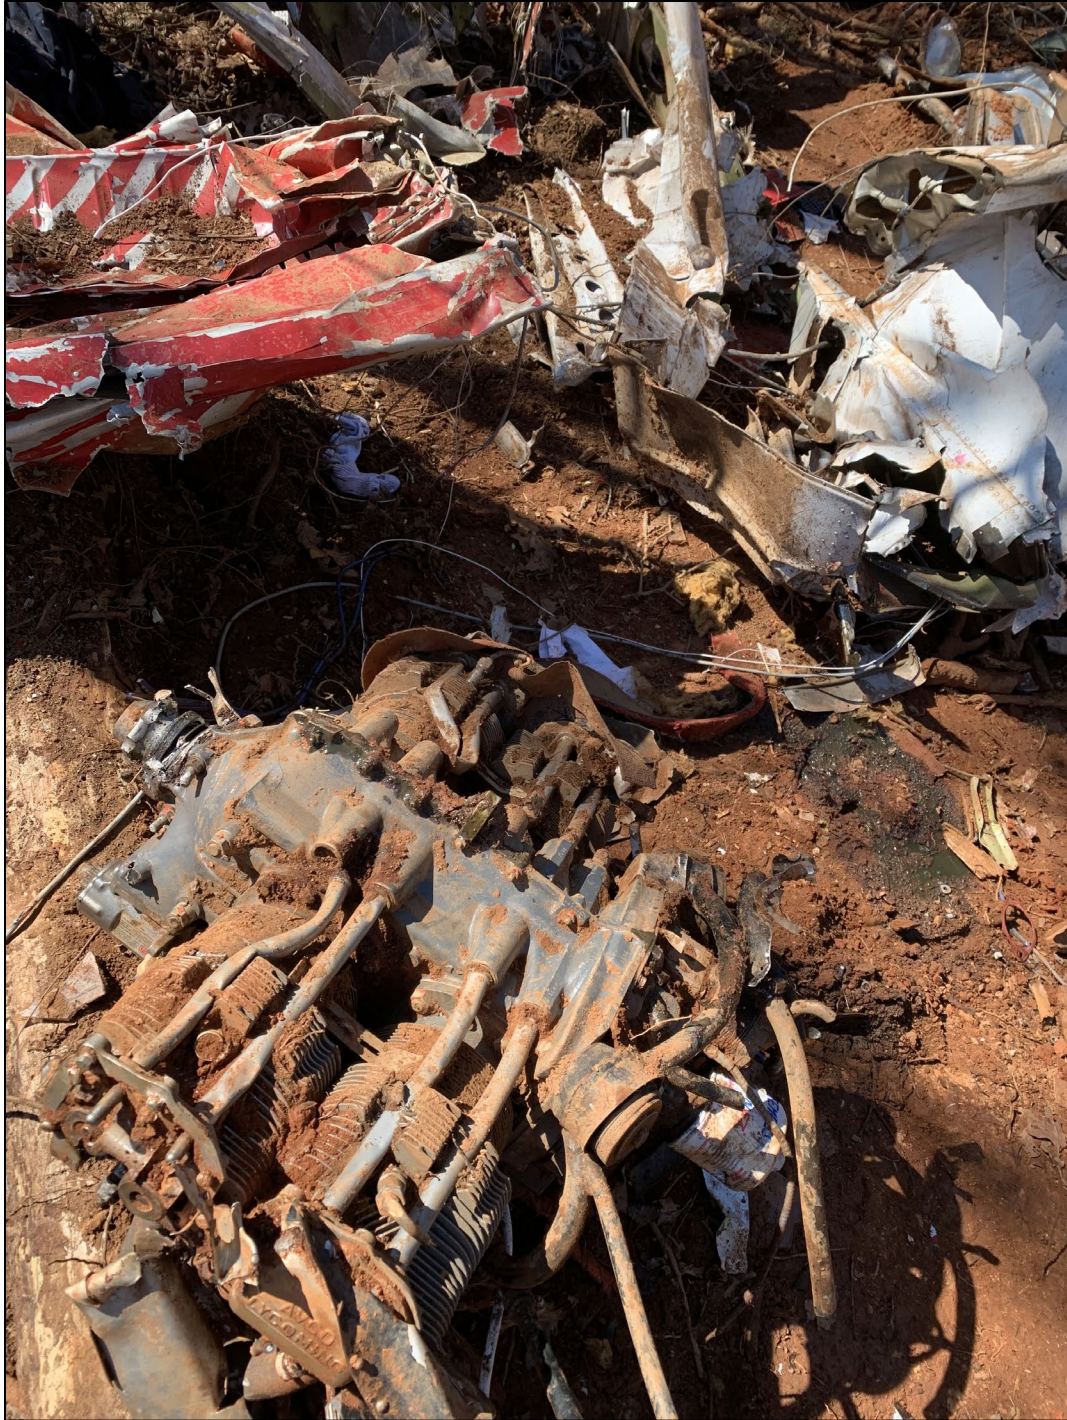
The propeller and crankshaft flange were partially separated from the engine crankshaft. The crankcase nose was fractured near the crankshaft flange. The pushrod tubes were impact damaged. The #2 cylinder rocker cover was separated, and the #2 cylinder head was impact damaged. The exhaust and induction tubing were impact damaged. The alternator and carburetor were impact separated from the engine. The exhaust mufflers were unobstructed.

**Photo 5: View of the engine.**

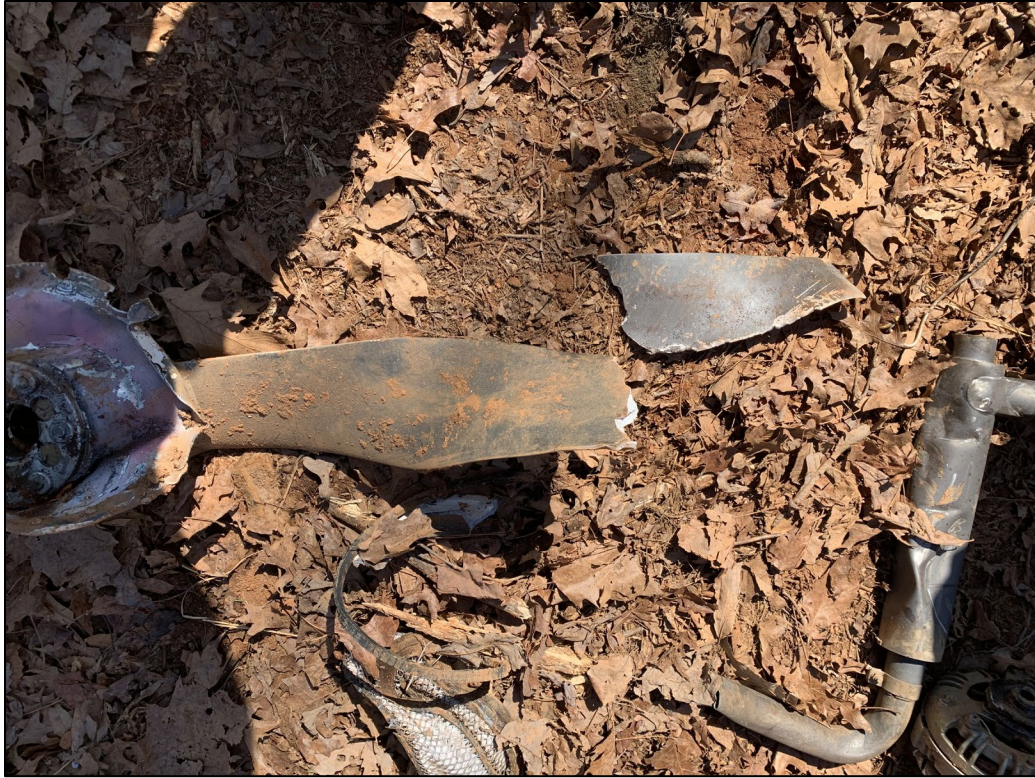
The fixed pitch Sensenich propeller remained attached to a portion of the crankshaft propeller flange. The propeller exhibited blade polishing, chordwise scratches, and s-bending. The outboard tips of the propeller had fragmented and were located in the debris.

There was no evidence of preimpact mechanical malfunctions or failures with the airframe or engine based upon the on-site examination of the wreckage. The propeller signatures were consistent with the engine operating under power at the time of impact.

**Photo 6: View of the propeller.**

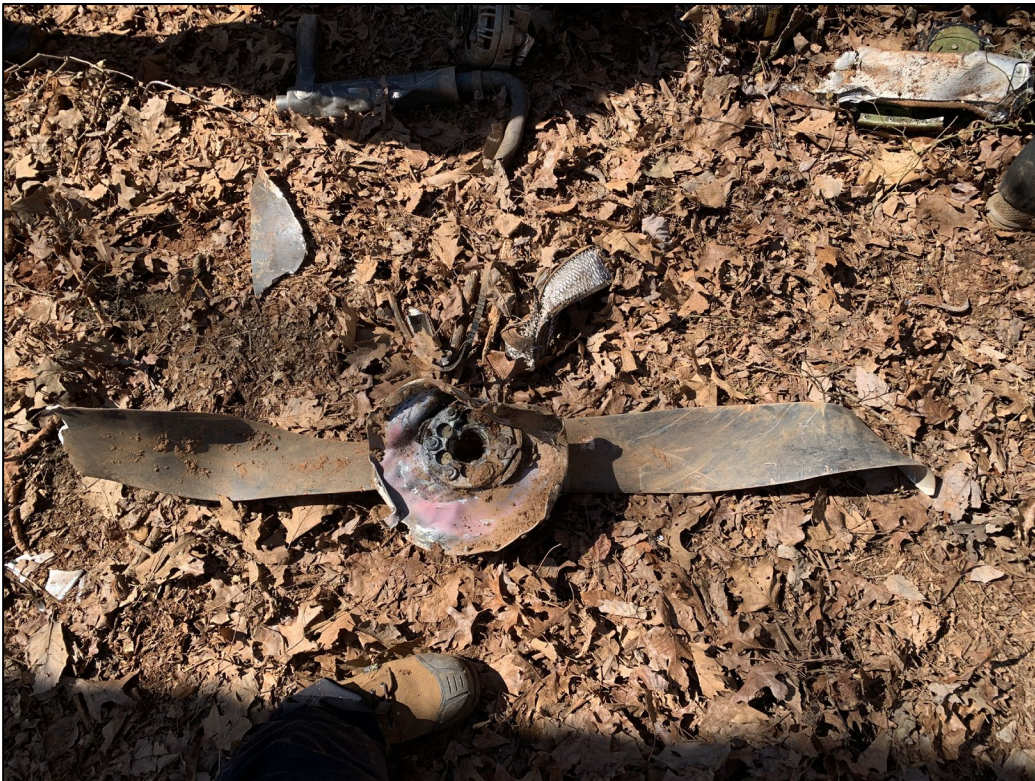
**Photo 7: View of the propeller.**

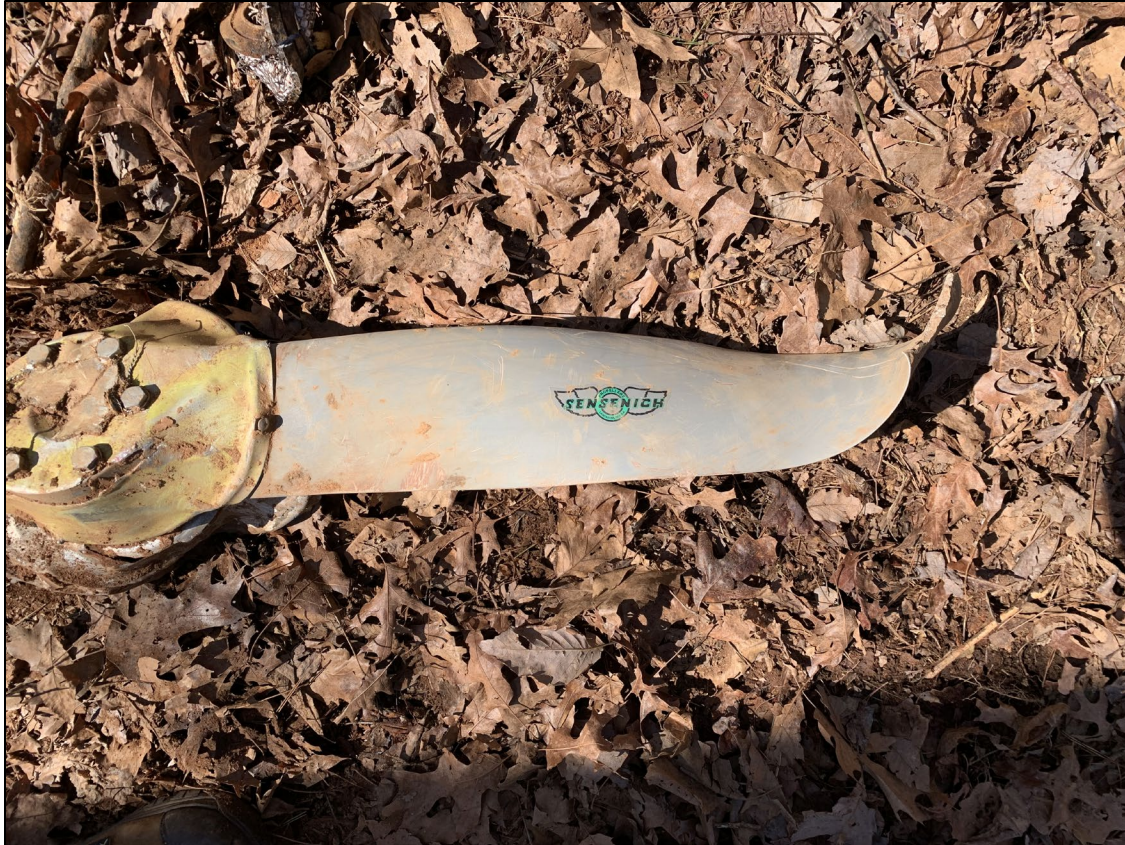
**Photo 8: View of the propeller.**

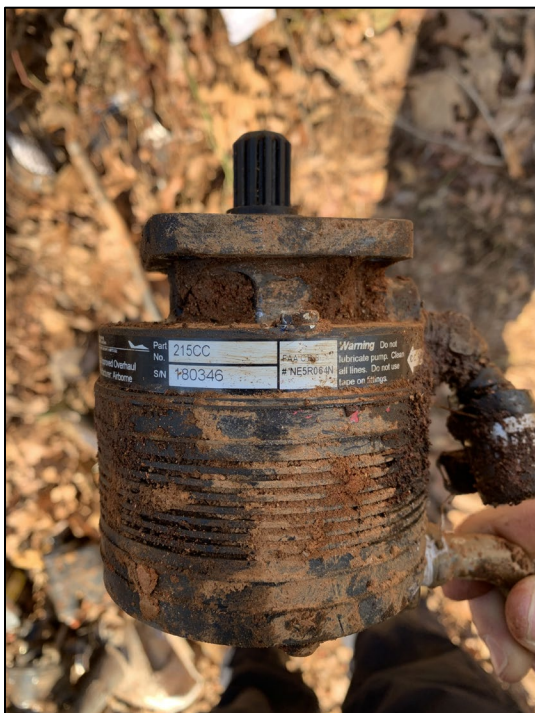
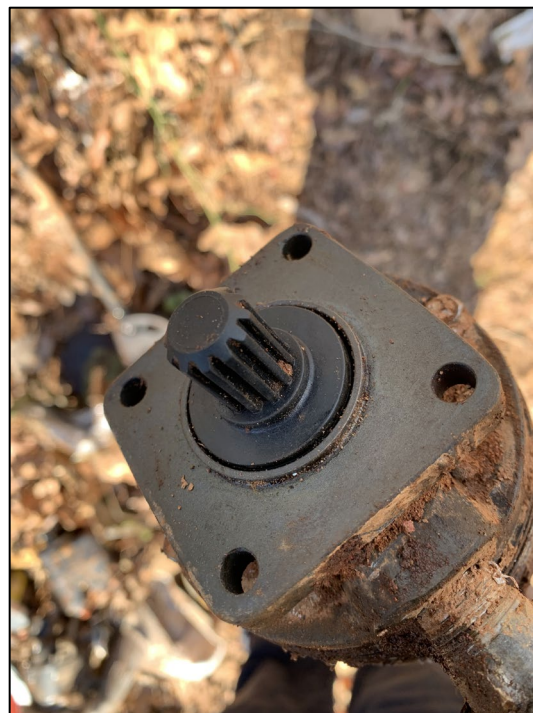
The vacuum pump remained attached to the engine accessory section. When the pump was partially assembled, its gears were intact, and the unit appeared normal.

**Photo 9: View of the vacuum pump after it had been removed from the engine by the investigative team.**

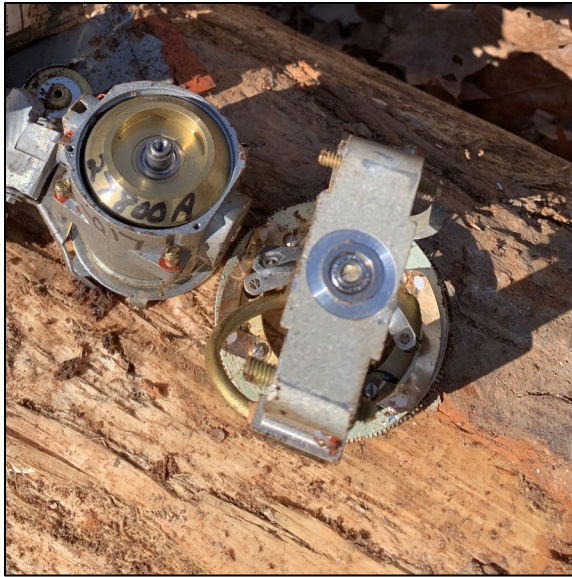
The directional gyro was disassembled, and its gyro and housing were observed. Evidence of rotationally scoring was observed inside the housing and on the gyro.

**Photo 10: View of the directional gyro during disassembly by the investigation team.**

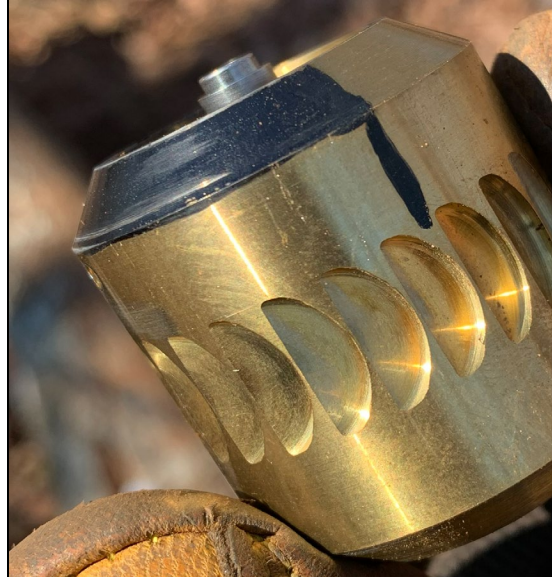
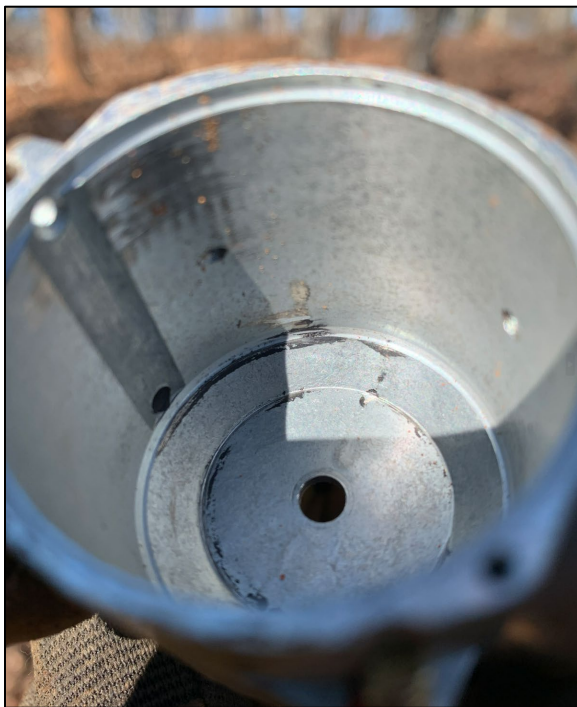
**Photo 11: View of the internal case of the directional gyro.**

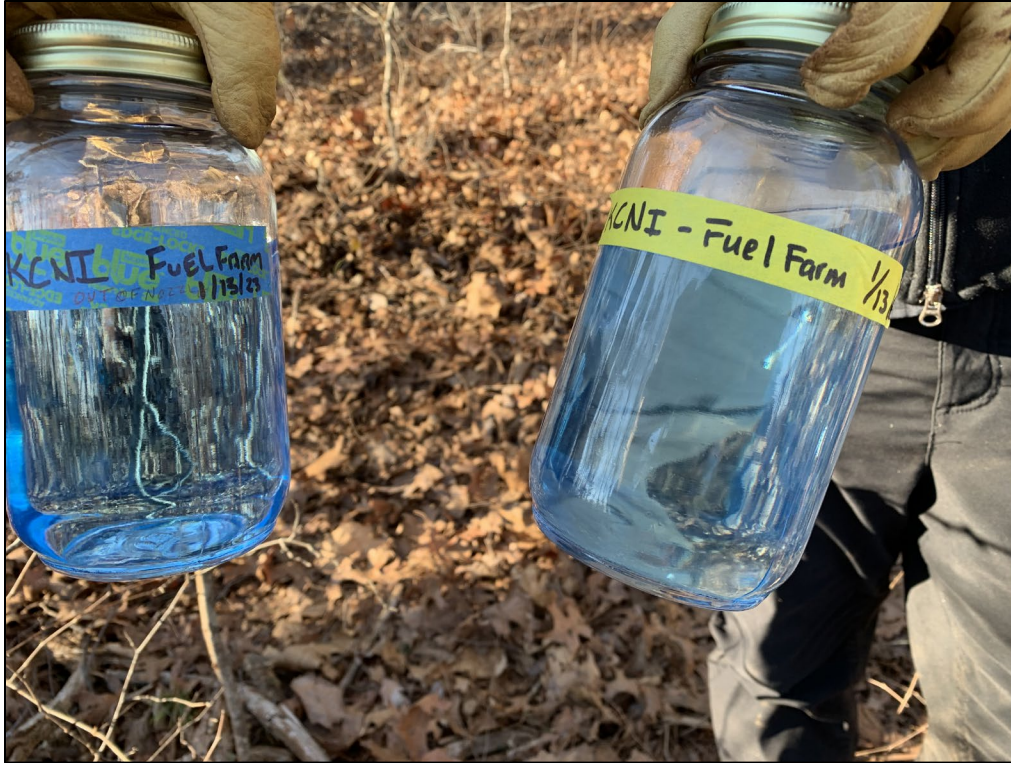
**Photo 12: Fuel sample from the departure airport.**
