# National Transportation Safety Board

ERA23FA113

## **ENGINE HISTORY AND NO. 4 CYLINDER SPARK PLUG EXAMINATION SUMMARY**

Location: North Castle, New York  
Date: January 19, 2023  
Time: 1729 EST  
2229 Coordinated Universal Time (UTC)  
Airplane: N19MT, Beech A36

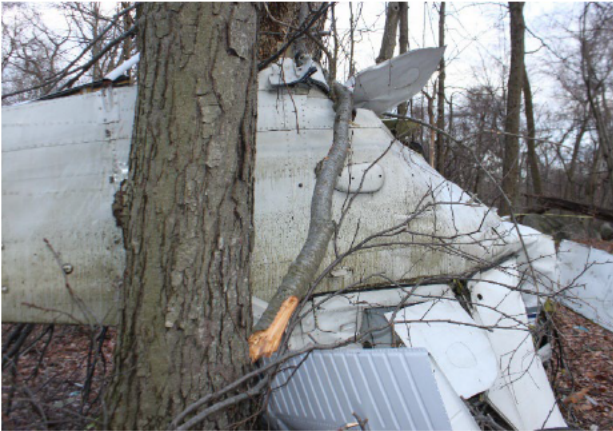
Examination of the wreckage at the accident site revealed fresh oil on the bottom of the fuselage (Figures 1 and 2). The oil was predominantly on the left side of the lower fuselage and appeared to be coming from behind the left cowl flap area. Because of the final resting position of the fuselage the oil was draining down towards the ground. Oil was also noted on the inside diameter and outlet of the lower crankcase breather line (Figure 3).

**Figure 1 View of the Bottom of the Fuselage. Note the Fresh Oil Clinging to the Bottom Fuselage Skin.**

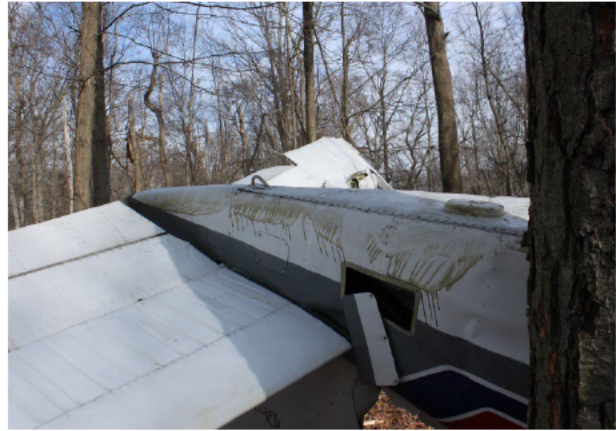
**Figure 2 View of the Bottom Portion of the Fuselage Near the Tailcone. Note the Fresh Oil Clinging to the Bottom Fuselage Skin.**

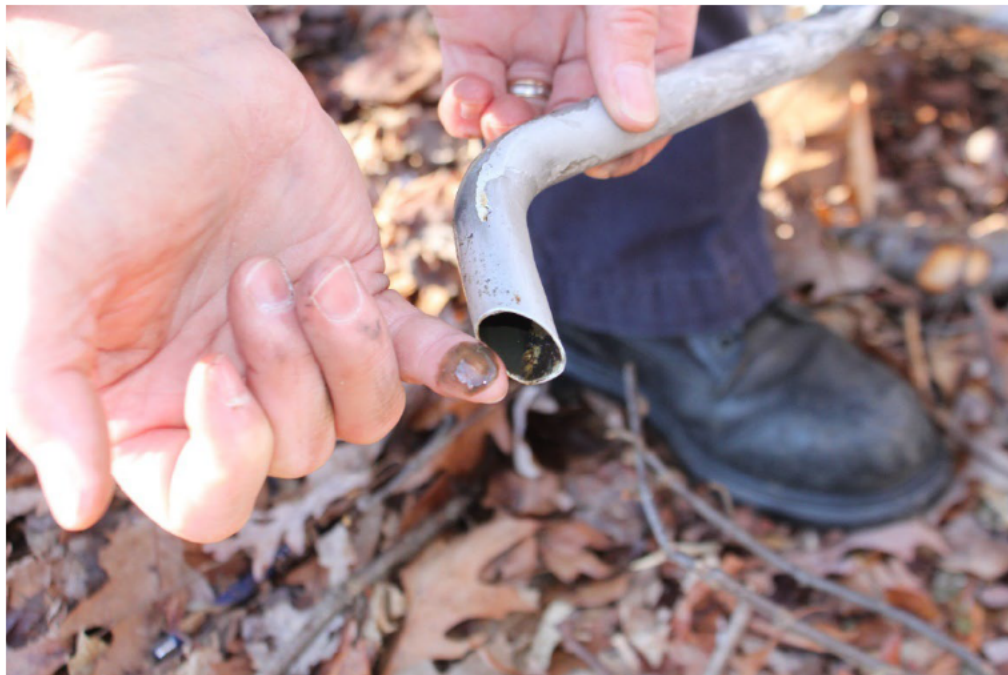
**Figure 3 View of the Outlet of the Lower Crankcase Breather Line. Oil on Finger was from the Inner Surface Immediately Adjacent to the Opening. Note the Fresh Oil.**

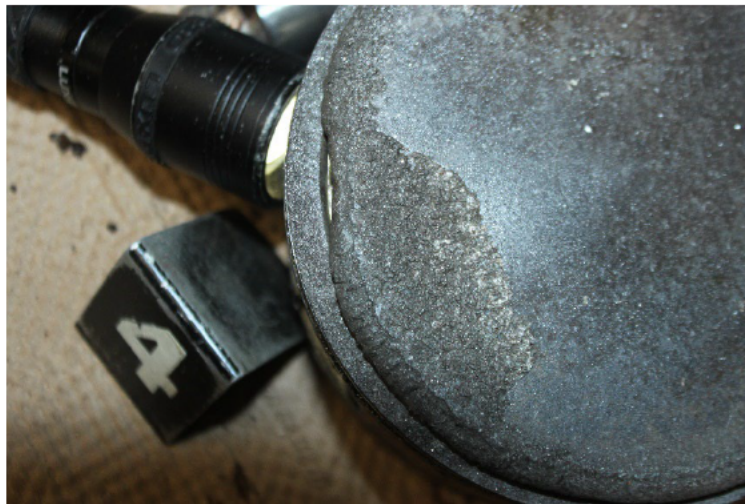
The engine was shipped to the manufacturer's facility for formal disassembly examination which revealed erosion damage to top and outer portion of the No. 4 piston (Figure 4). At the conclusion of that examination both spark plugs from the No. 4 cylinder were secured then subsequently shipped to the manufacturer's facility for testing and examination with NTSB oversight.

**Figure 4 View Showing the Damage to the No. 4 Piston**

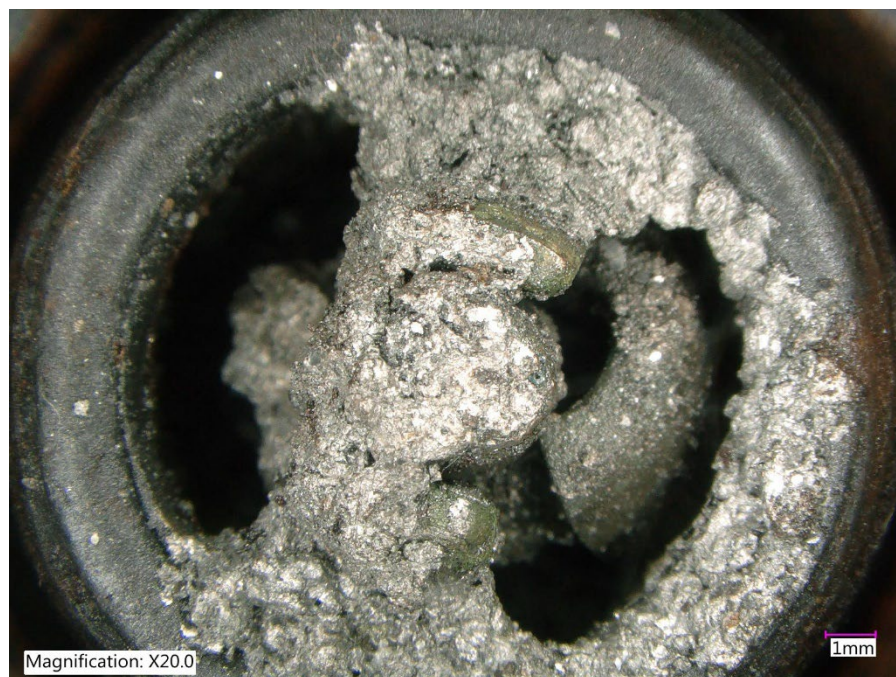
**Figure 10 20 Power Magnification of the 4T Spark Plug**

Examination of the plug revealed a piece of insulator/ceramic core nose was separated and heavy deposits bridged the gaps between the center electrode and the two ground electrodes (Figure 10). The separated portion of the insulator/ceramic core nose was visible. Deposits were compacted around the inner bore of the spark plug around the insulator. Deposits were also noted around the center electrode area where the insulator was cracked, indicating factually that the plug was operating after the insulator damage occurred<sup>1</sup>.

Because deposits bridged the gap between the center electrode and both ground electrodes resistance testing could not be performed.

<sup>1</sup> The deposits on the fracture surface of the core nose indicate the plug was operating after the core nose cracked. However, there is no factual way to determine if all of the deposits occurred after the crack.

The plug did not produce spark when tested at 180 psi air pressure at the firing end for any of the tests.

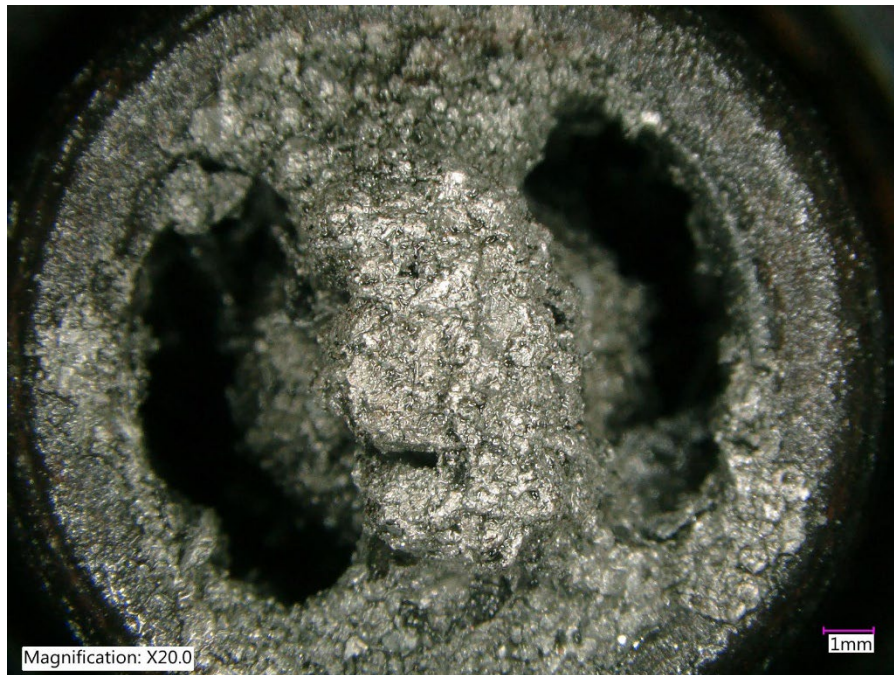
**Figure 11 20 Power Magnification of 4B Spark Plug**

Examination of the plug revealed the center electrode was football shaped, and deposits were compacted in the bore of the spark plug around

the insulator. Deposits bridged the gap between the center electrode and the two ground electrodes (Figure 11).

Because deposits bridged the gap between the center electrode and both ground electrodes resistance testing could not be performed.

The plug did not produce spark when tested at 180 psi at the firing end for any of the tests.

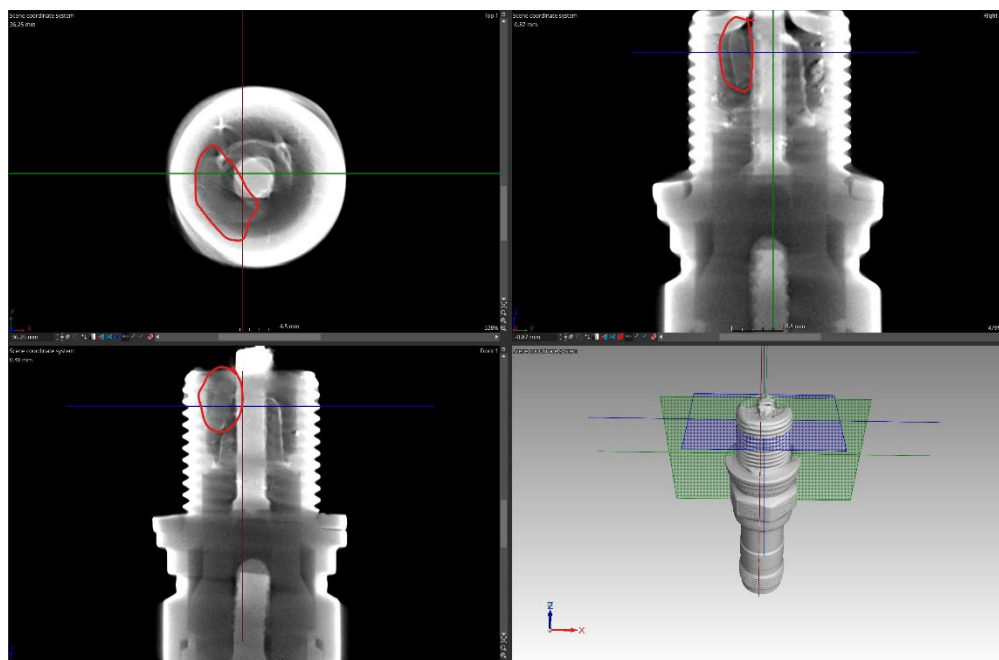
CT Imaging of the 4T spark plug confirmed the core nose was broken, and deposits were located inside the core nose where the crack occurred (Figure 12). Deposits from the center electrode and the core nose area were retained for confirmation as to material.

**Figure 12 Annotated and Non Annotated CT Images of the 4T Spark Plug**

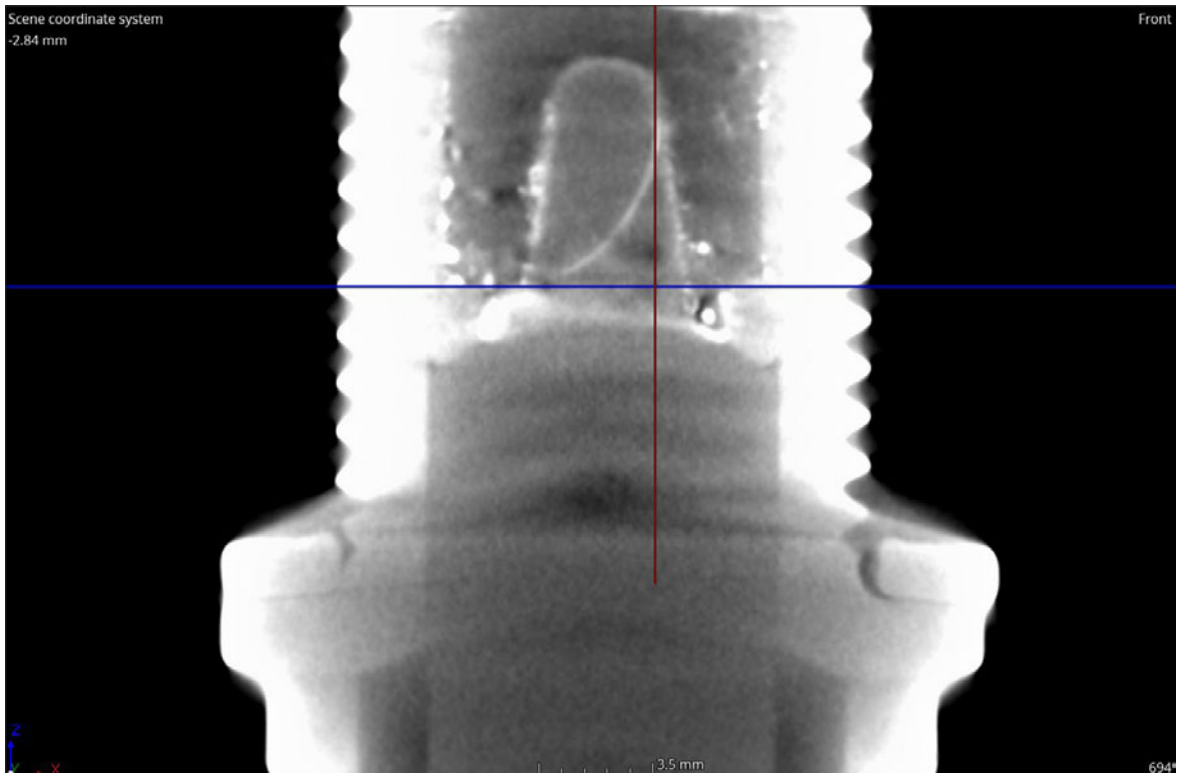
Imaging of the 4B spark plug confirmed there was a crack in the core nose insulator (Figure 13). Deposits were noted on the core nose. The center electrode was football shaped. The terminal button was correct with no defects. The core nose insulator was severely discolored with excessive combustion deposits. Deposits were taken from the center electrode and the core nose area and were retained for confirmation as to material. No piece of the core nose was missing.

**Figure 13 CT Image Showing Crack in Core Nose Insulator of 4B Plug**

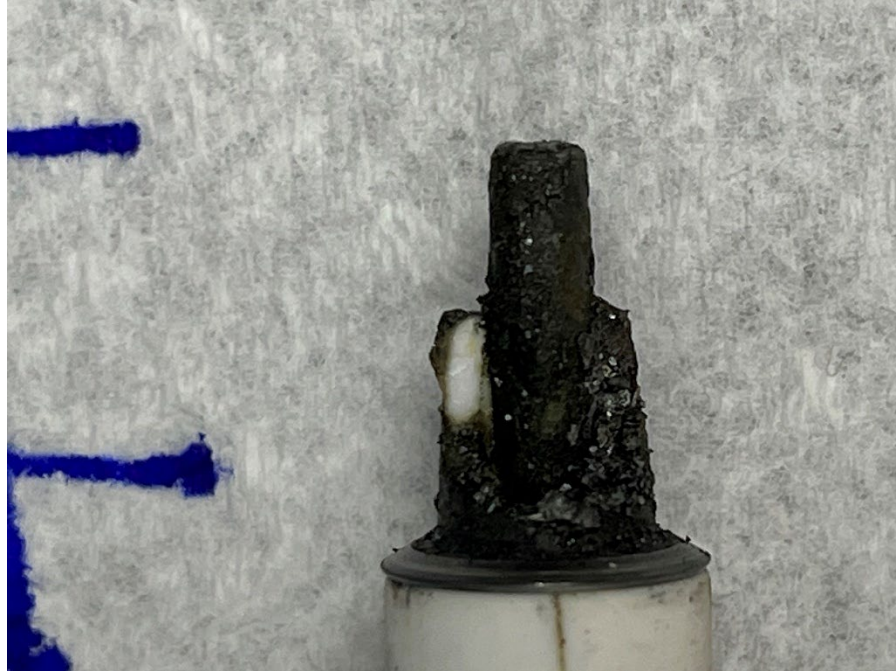
Following disassembly of the 4T spark plug lead deposits were noted inside where the core nose was cracked and a piece of the core nose was separated (Figure 14). Heavy deposits were noted.

**Figure 14 View of the 4T Spark Plug After Disassembly Showing Fractured Core Nose**

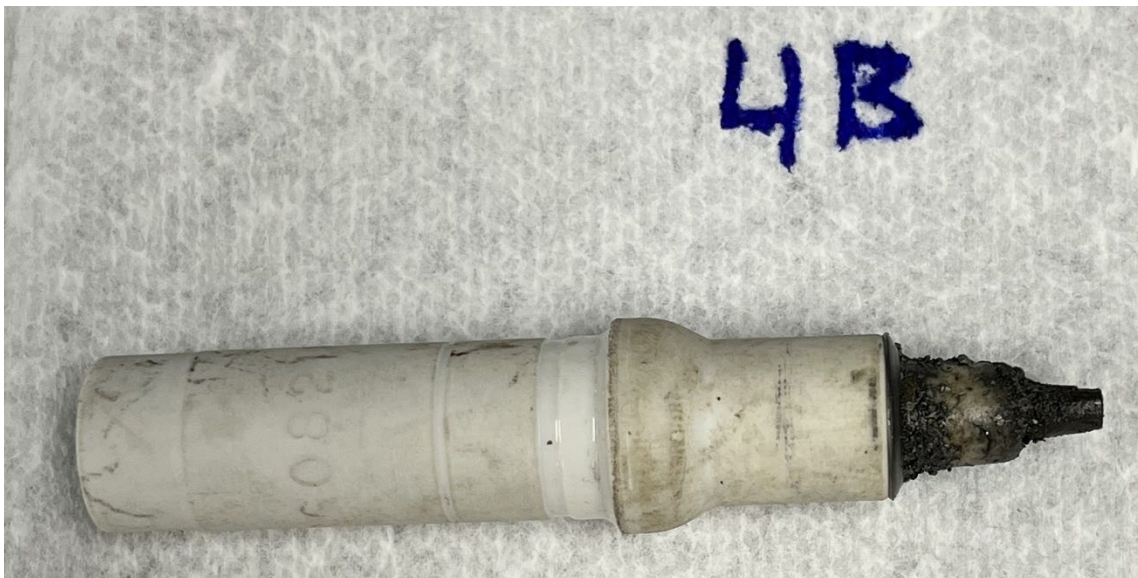
Following disassembly of the 4B spark plug revealed the core nose was severely discolored with excessive combustion deposits (Figure 15).

**Figure 15 View of 4B Spark Plug After Disassembly Showing Heavy Deposits on Core Nose Insulator and Discoloration.**

The manufacturer representative reported that lead deposits in the well of the spark plug can form when the cylinder is running too cold. The corrective action is to get a hotter plug, which will hold the heat on the core nose longer.

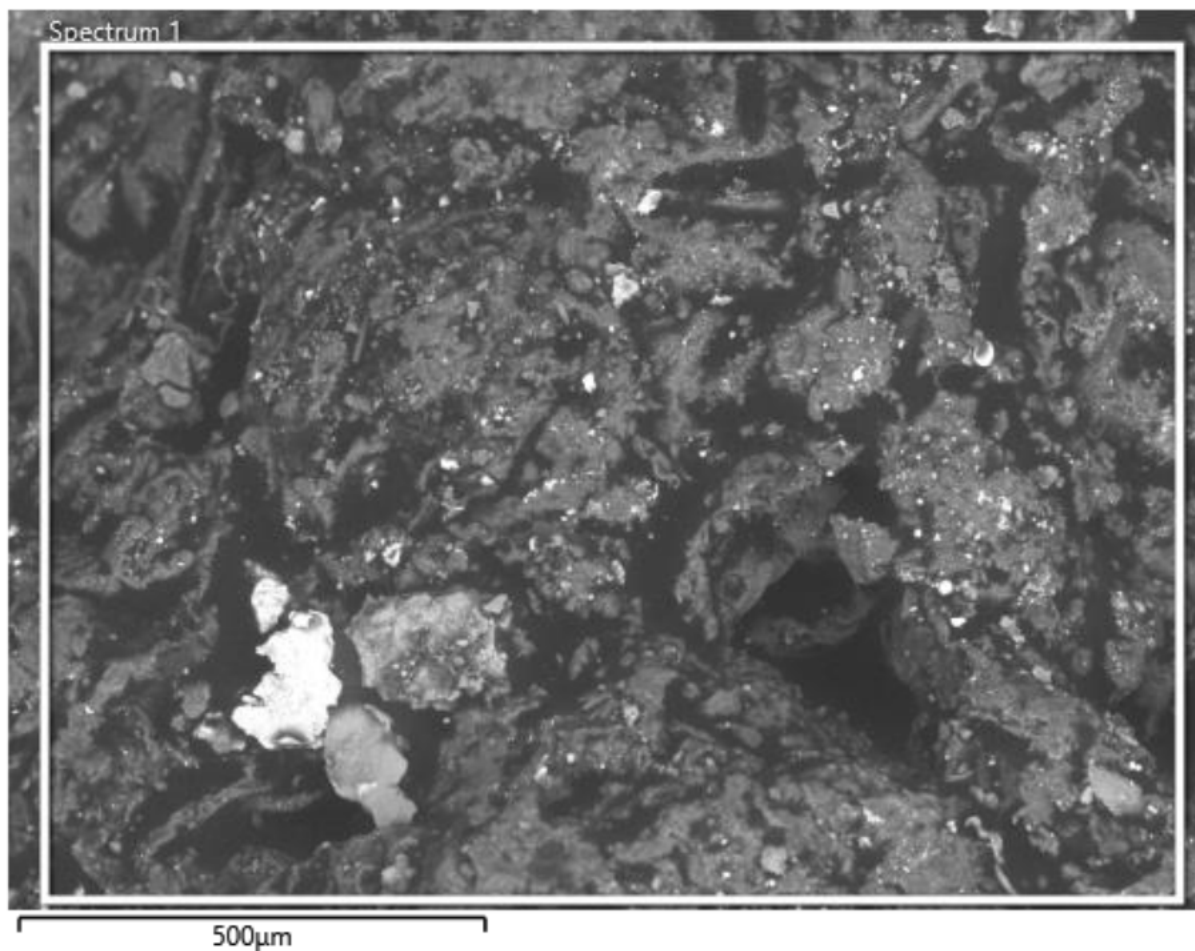
**Figure 1. Typical SEM photomicrograph and EDX analysis for 4T Surface Deposit Ground Electrode, 100X magnification**

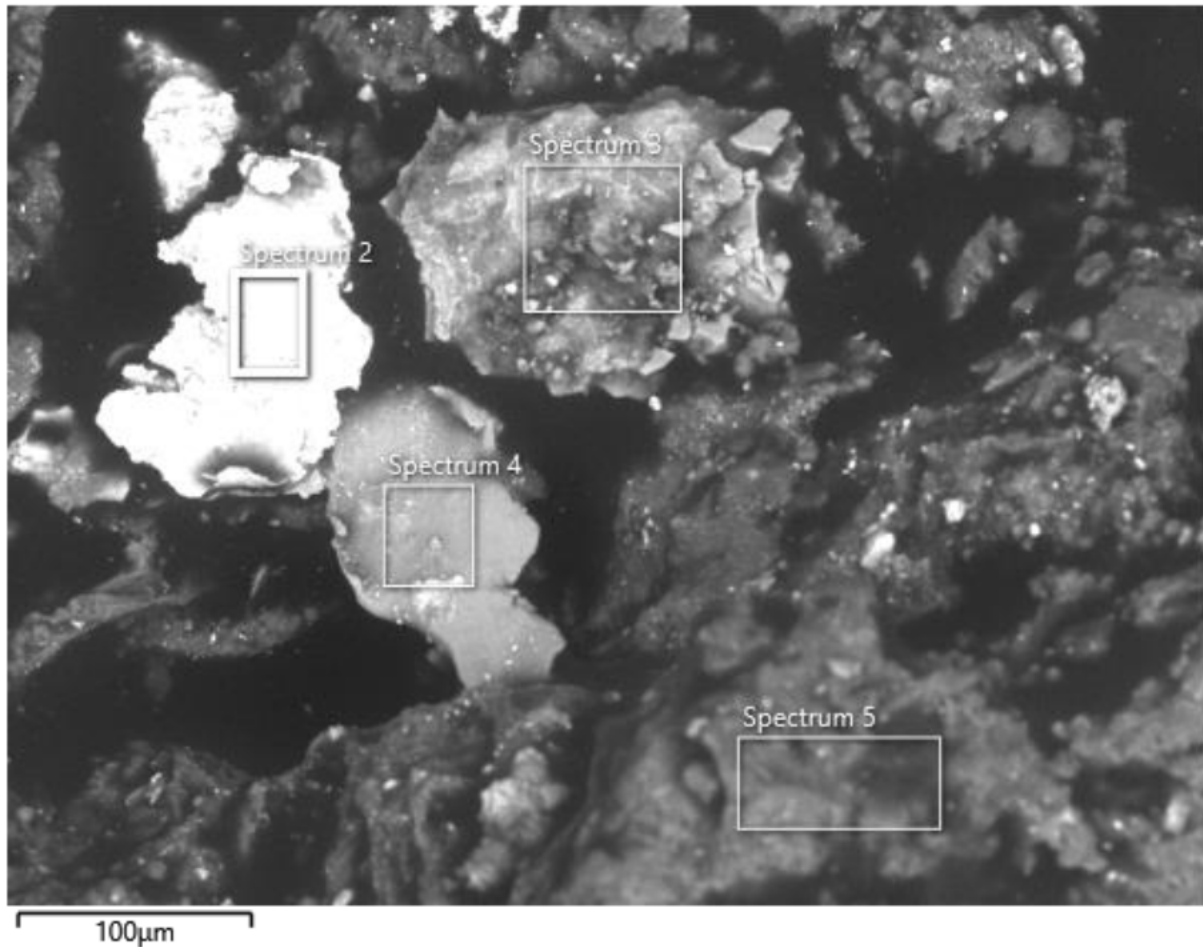
**Figure 2. Typical SEM photomicrograph and EDX analyses for 4T Surface Deposit Ground Electrode, 250X magnification**

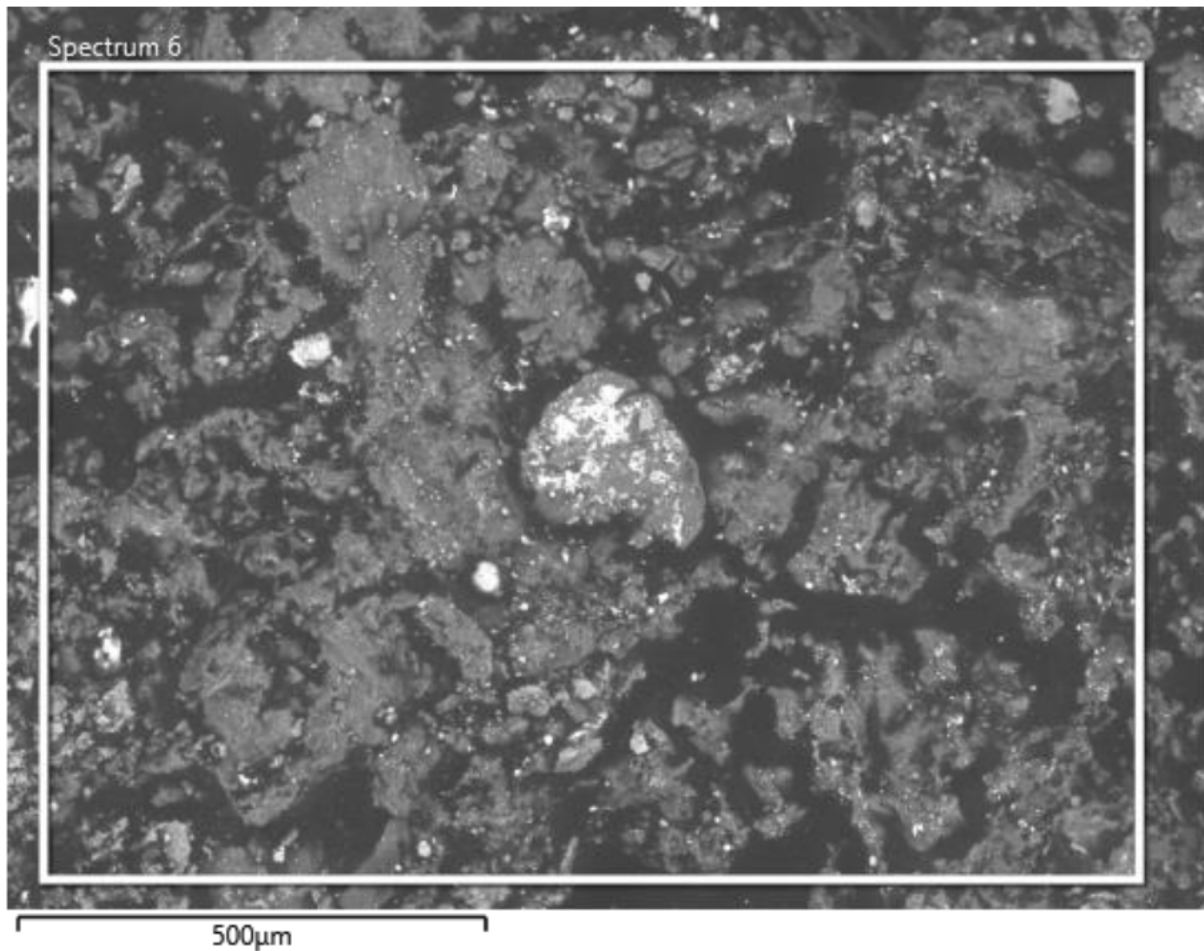
**Figure 3. Typical SEM photomicrograph and EDX analysis for 4T Surface Deposit Ground Electrode, 100X magnification**

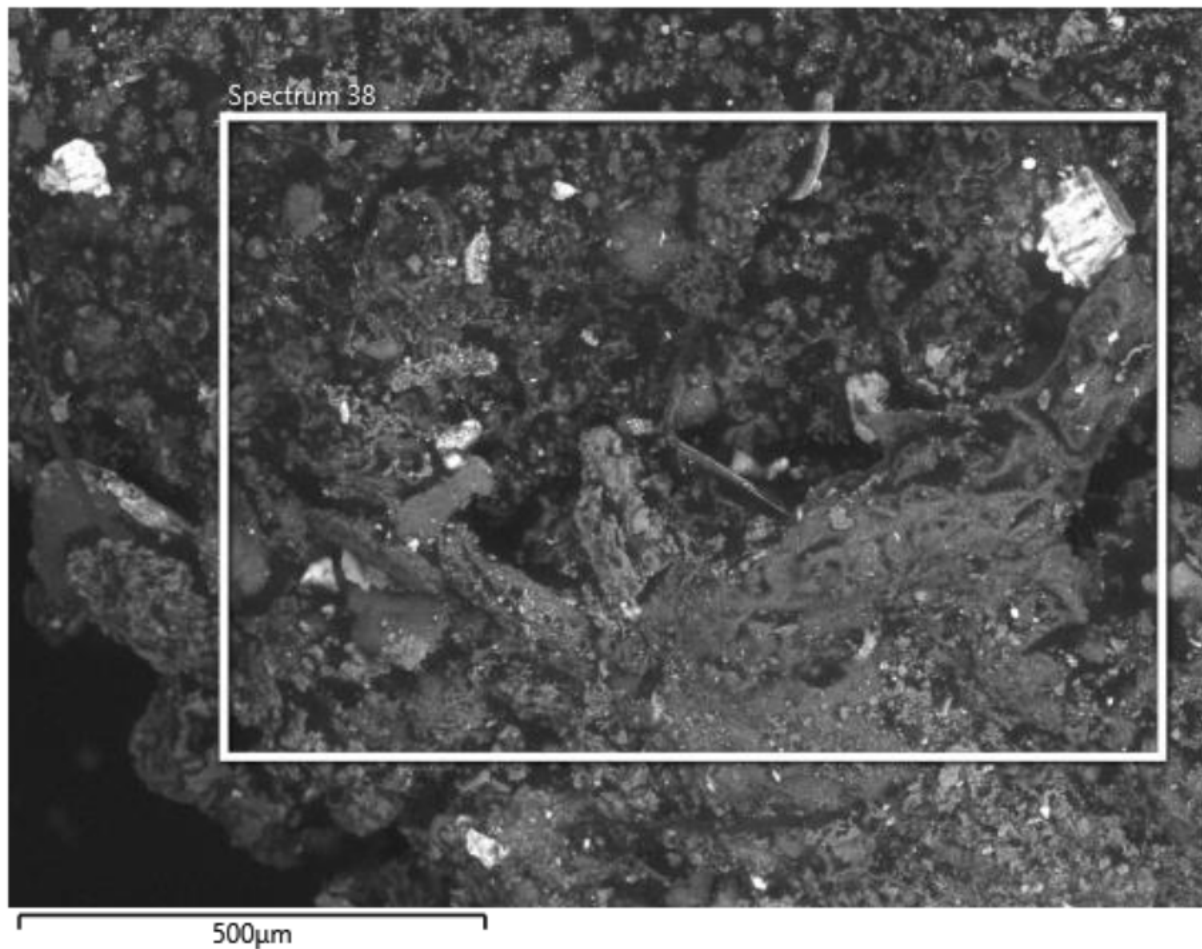
**Figure 15. Typical SEM photomicrograph and EDX analysis for 4T Surface Deposit Core Nose, Fracture, 100X magnification**

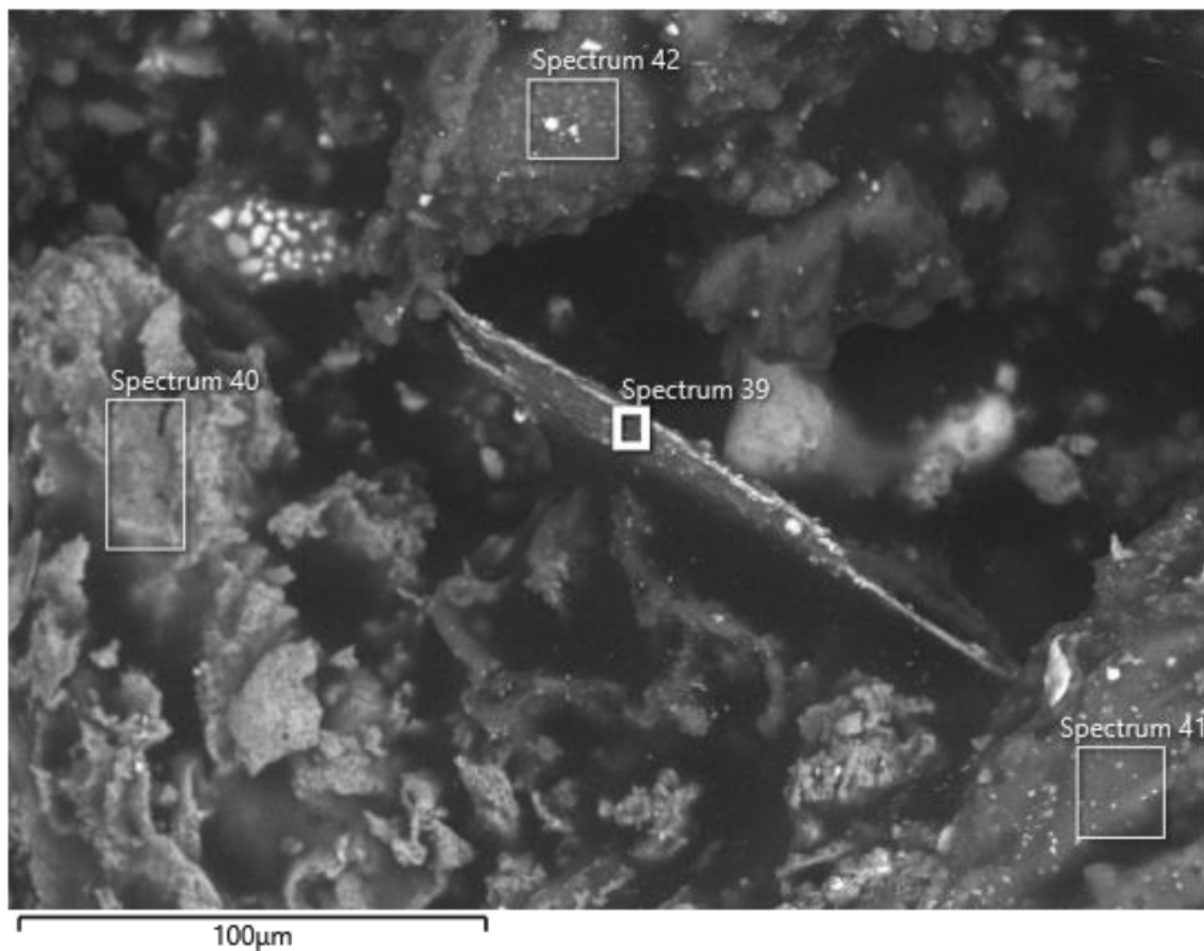
**Figure 16. Typical SEM photomicrograph and EDX analyses for 4T Surface Deposit Core Nose, Fracture, 500X magnification**
