# National Transportation Safety Board

ERA23FA113

## ON-SCENE EXAMINATION SUMMARY

Location: North Castle, New York  
Date: January 19, 2023  
Time: 1729 EST  
2229 coordinated universal time (UTC)  
Airplane: N19MT, Beech A36

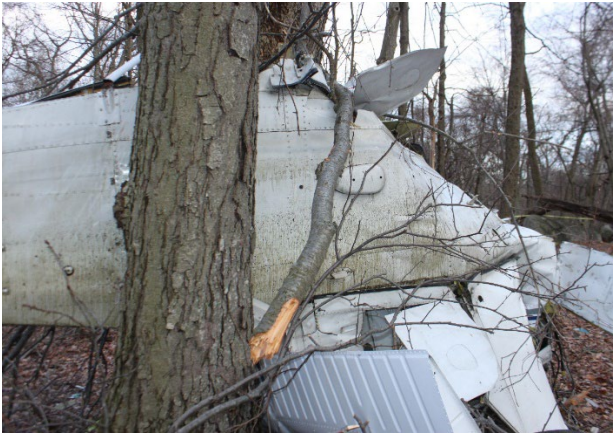
Examination of the wreckage at the accident site revealed fresh oil on the bottom of the fuselage (Figures 1 and 2). The oil was predominantly on the left side of the lower fuselage and appeared to be coming from behind the left cowl flap area. Because of the final resting position of the fuselage the oil was draining down towards the ground. Oil was also noted on the inside diameter and outlet of the lower crankcase breather line (Figure 3).

**Figure 1 View of the Bottom of the Fuselage. Note the Fresh Oil Clinging to the Bottom Fuselage Skin**

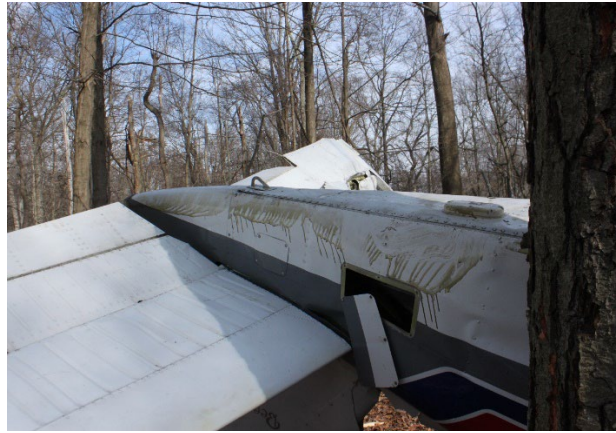
**Figure 2 View of the Bottom Portion of the Fuselage Near the Tailcone. Note the Fresh Oil Clinging to the Bottom Fuselage Skin**

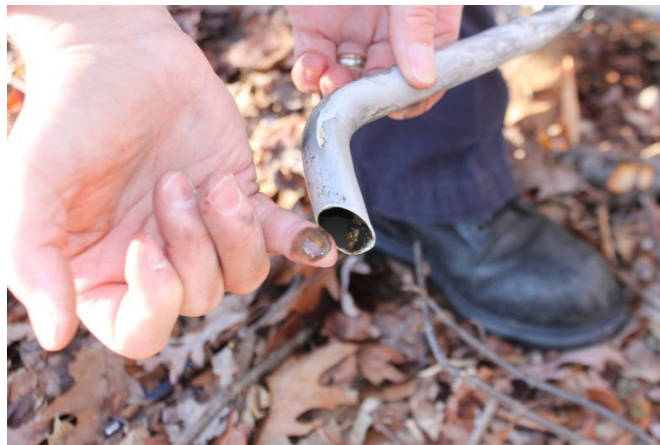
**Figure 3 View of the Outlet of the Lower Crankcase Breather Line. Oil on Finger was from the Inner Surface Immediately Adjacent to the Opening. Note the Fresh Oil.**

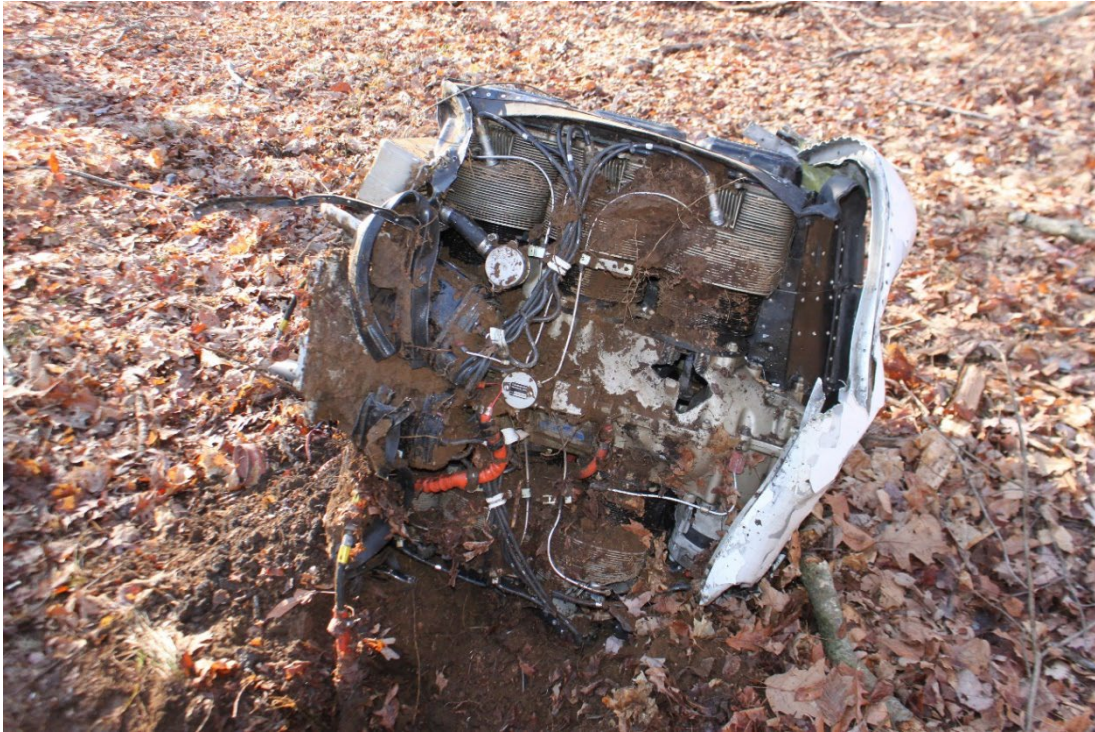
Examination of the engine at the accident site revealed it was separated and came to rest inverted. After rolling onto its right side a hole was noted in the engine crankcase above the No. 6 cylinder position (Figure 4). The connecting

rod cap with 2 entrapped fractured connecting rod bolts was found inside the engine below the hole opening. The cap was deformed.

**Figure 4: View Depicting the Engine After Rolling Out of its Impact Resting Spot  
Note the hole in the Crankcase at the No. 6 Cylinder Position.**
