# National Transportation Safety Board

ERA23FA113

## **ENGINE INFORMATION AND EXAMINATION SUMMARY**

Location: North Castle, New York  
Date: January 19, 2023  
Time: 1729 EST  
2229 coordinated universal time (UTC)  
Airplane: N19MT, Beech A36

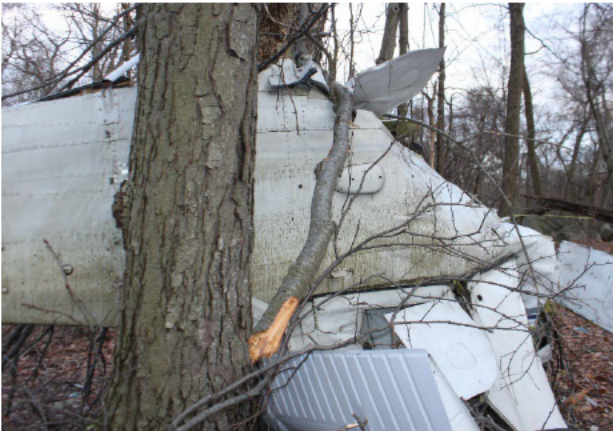
Examination of the wreckage at the accident site revealed fresh oil on the bottom of the fuselage (Figures 1 and 2). The oil was predominantly on the left side of the lower fuselage and appeared to be coming from behind the left cowl flap area. Because of the final resting position of the fuselage the oil was draining down towards the ground. Oil was also noted on the inside diameter and outlet of the lower crankcase breather line (Figure 3).

**Figure 1 View of the Bottom of the Fuselage. Note the Fresh Oil Clinging to the Bottom Fuselage Skin**

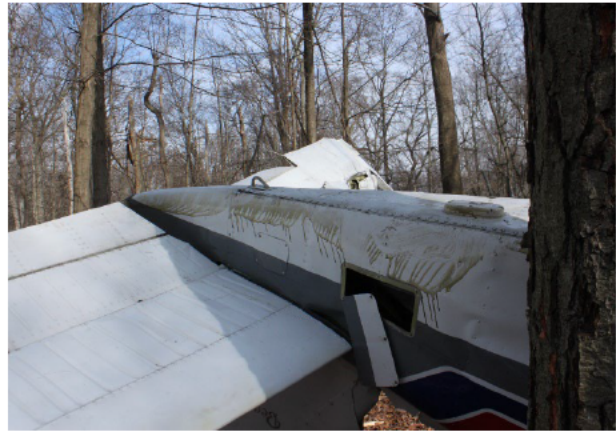
**Figure 2 View of the Bottom Portion of the Fuselage Near the Tailcone. Note the Fresh Oil Clinging to the Bottom Fuselage Skin**

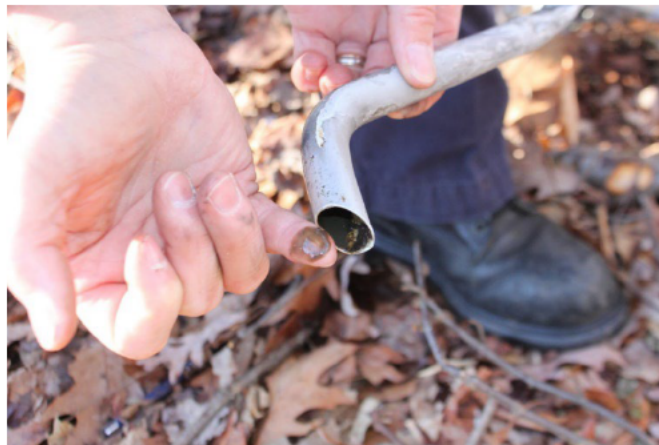
**Figure 3 View of the Outlet of the Lower Crankcase Breather Line. Oil on Finger was from the Inner Surface Immediately Adjacent to the Opening. Note the Fresh Oil.**

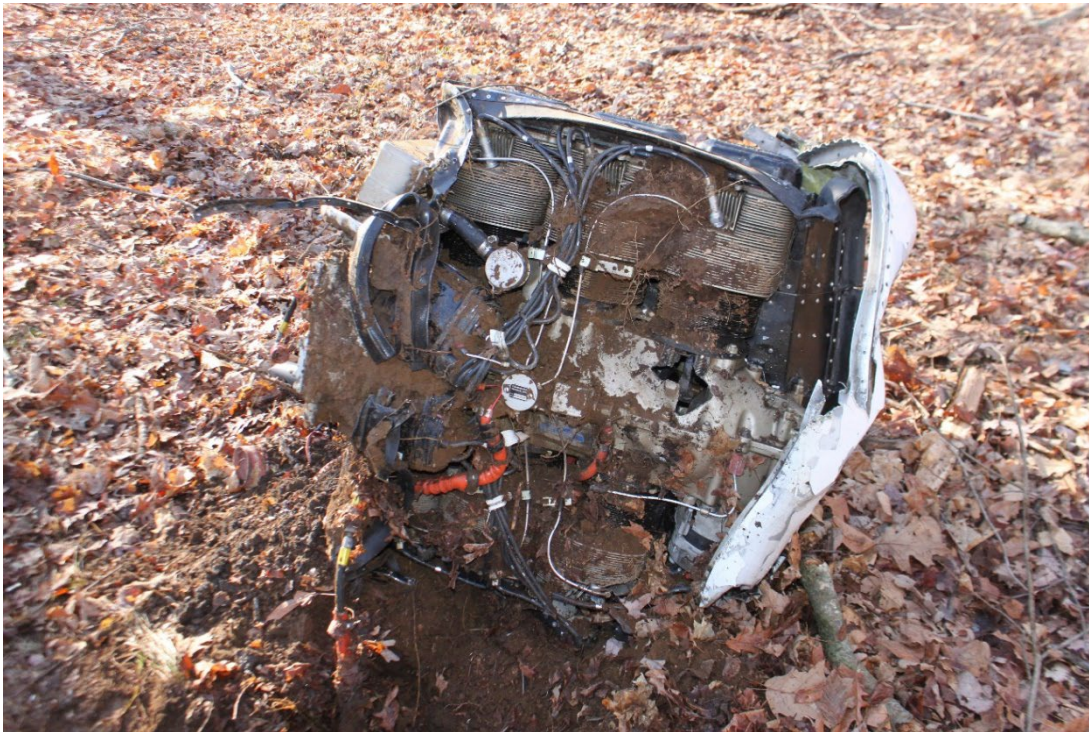
Examination of the engine at the accident site revealed it was separated and came to rest inverted. After rolling onto its right side a hole was noted in the engine crankcase above the No. 6 cylinder position (Figure 4). The connecting

rod cap with 2 entrapped fractured connecting rod bolts was found inside the engine below the hole opening. The cap was deformed.

**Figure 4: View Depicting the Engine After Rolling Out of its Impact Resting Spot  
Note the hole in the Crankcase at the No. 6 Cylinder Position.**

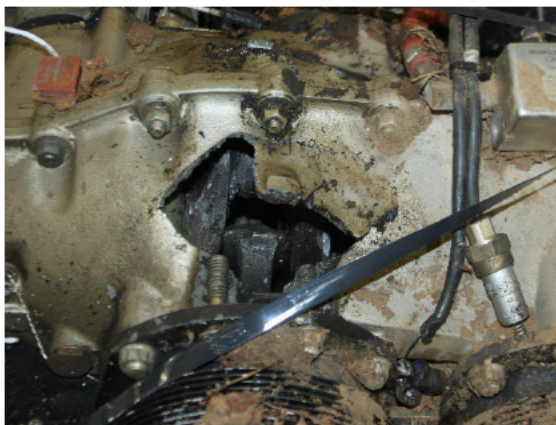
**Figure 17 View of Hole in Crankcase**

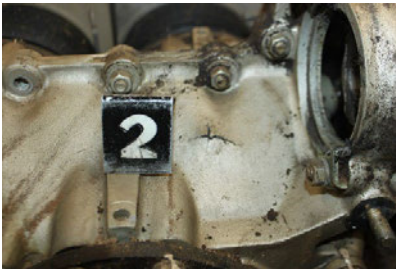
Further inspection of the engine crankcase halves revealed a slight extrusion on top of the crankcase above the No. 2 cylinder (Figure 19). Examination of the crankcase following removal of the oil sump revealed the crankcase near the backbone was cracked in-line with the Nos. 3 and 4 cylinders (Figure 20), and an outward displacement of the crankcase was noted near the No. 2 cylinder (Figure 21).

**Figure 19 View of the Damage to the Crankcase Above the No. 2 Cylinder**

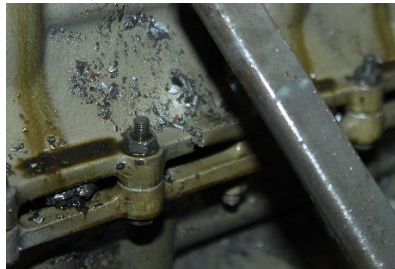
**Figure 20 View of the Crack in the Crankcase In-Line with the Nos. 3 and 4 Cylinders**

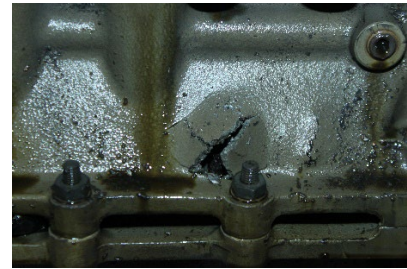
**Figure 21 Outward Damage to Crankcase near the No. 2 Cylinder**

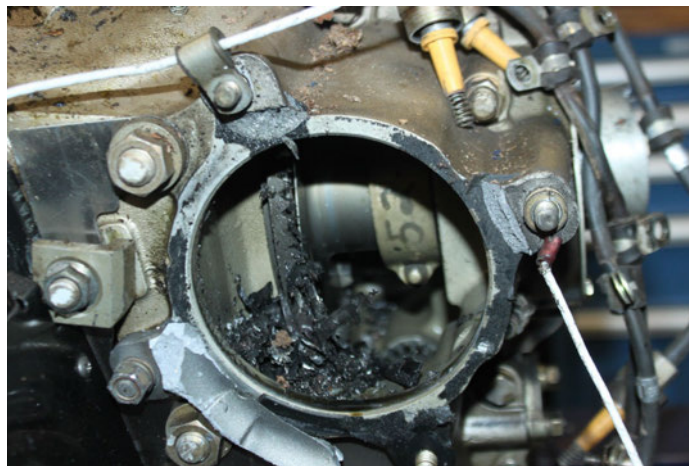
Following removal of the alternator, extensive particles were noted in the opening (Figure 22).

**Figure 22 View of the Contamination Inside the Alternator**

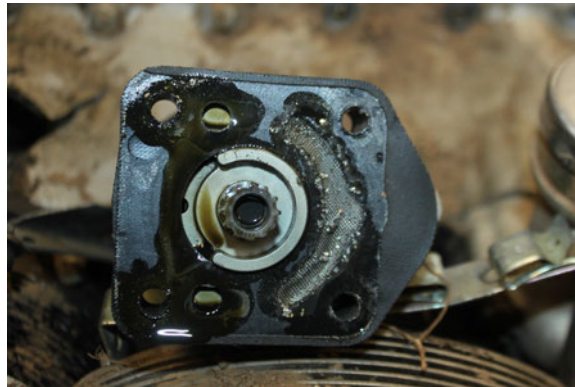
Following removal of the propeller constant speed governor, the screen was noted to have non-ferrous particles (Figure 23).

**Figure 23 View of the Contamination on the Screen of the Propeller Governor**

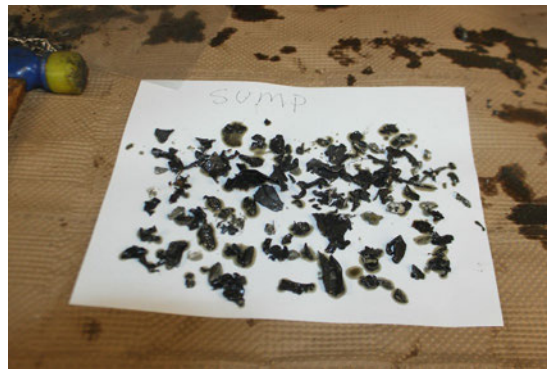
Following removal of the oil sump, ferrous and non-ferrous material was noted including 2 fractured connecting rod bolts without nuts attached (Figure 24).

**Figure 24 View of the Ferrous and Non-ferrous Material Found in the Oil Sump**

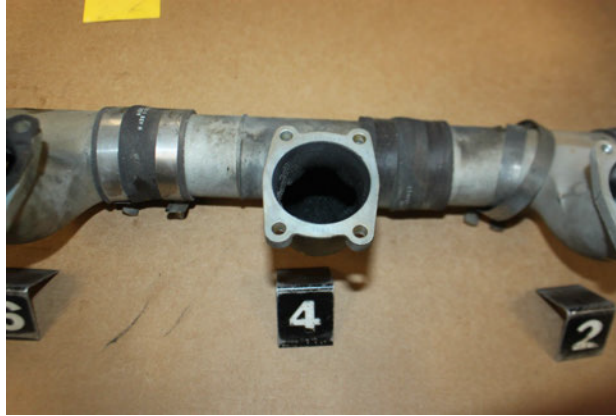
**Figure 26 View of the Flange of the No. 4 Cylinder Intake Elbow Note the lack of Discoloration**

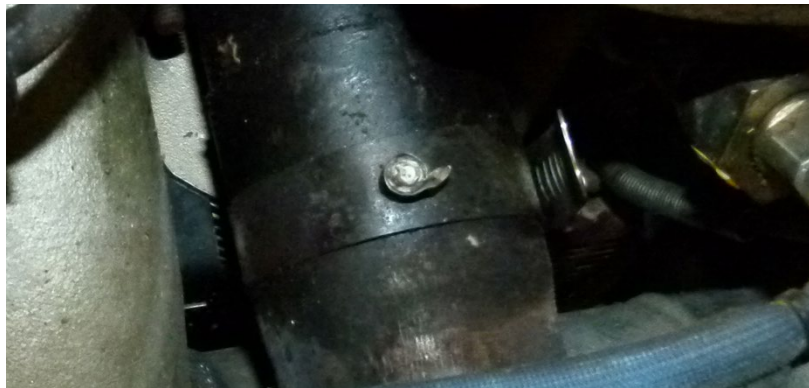
Inspection of the exhaust of the Nos. 2, 4, and 6 cylinders revealed the EGT probe for the No. 4 cylinder was fractured but the clamp remained in place (Figure 27).

**Figure 27 No. 4 Exhaust Gas Temperature Probe Mount Location with Installed Clamp and Remainder of Fractured probe**

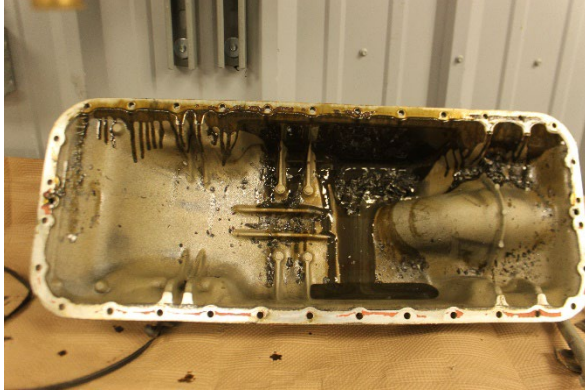
Inspection of the oil sump revealed it contained about 4 to 6 ounces of oil (Figure 28).

**Figure 28 View of the Oil in the Oil Sump**

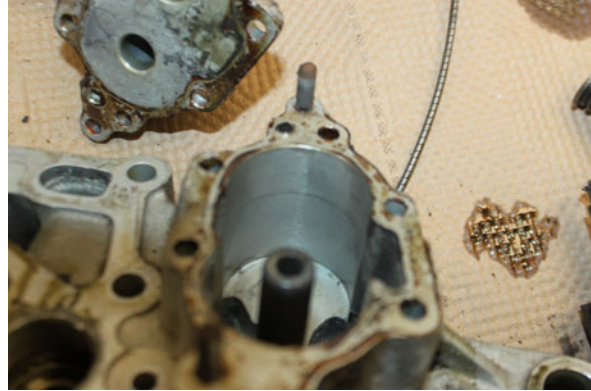
Inspection of the oil pump revealed slight scoring of the oil pump housing (Figure 29). The oil pump drive and driven gears exhibited slight non-ferrous specs. Following removal of the oil pressure relief valve, non-ferrous debris was noted on the plunger. There was no failure or malfunction of the oil pump assembly, or oil pressure relief valve.

**Figure 29 View of the Scoring Inside the Oil Pump Housing**

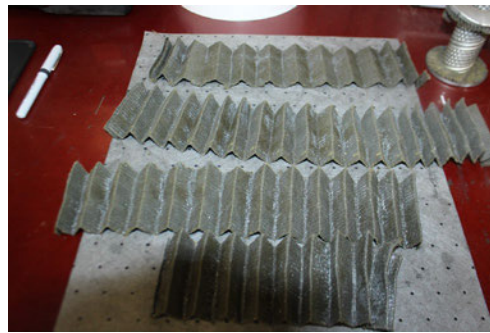
The oil filter was cut open and contained non-ferrous material (Figure 30).

**Figure 30 View of the Non-Ferrous Material in the Oil Filter Element**

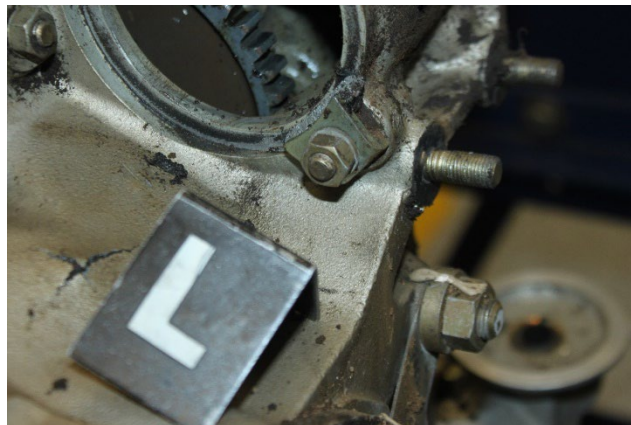
The left magneto, S6RN-1225, serial number F19HA182R was partially attached by one clamp, a section of magneto flange was fractured and remained secured under the lower hold down clip (Figure 31). The right magneto, S6RN-1225, serial number F19HA143R was tightly secured.

**Figure 31 View of the Fractured Section of Left Magneto Flange Beneath the Lower Hold Down Clamp.**

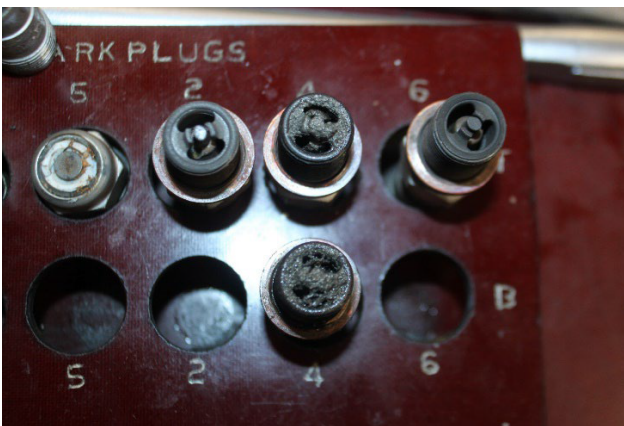
The upper and lower Champion RHB32E spark plugs from the No. 4 cylinder both exhibited re-solidified material (Figure 32). The condition of the center electrode of the Nos. 4B and 4T plugs could not be reliably determined. Inspection of the remaining plugs revealed all but Nos. 1B, 2B, and 5T center electrodes were football shaped and all plugs exhibited a slightly dark color (Figure 33). The No. 1B plug contained contaminant in the center well and the No. 3B plug was oil soaked.

**Figure 32 View Focused on the No. 4 Cylinder Spark Plugs**

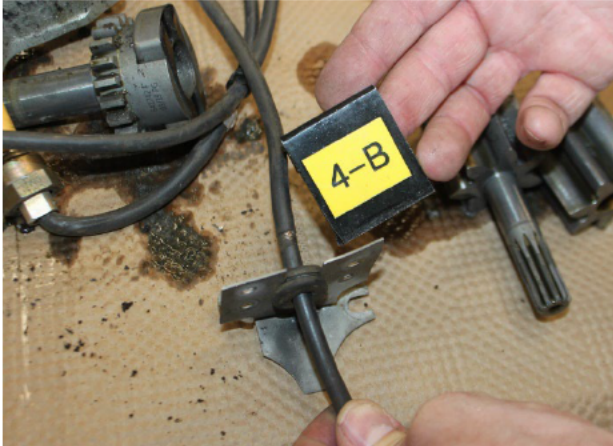
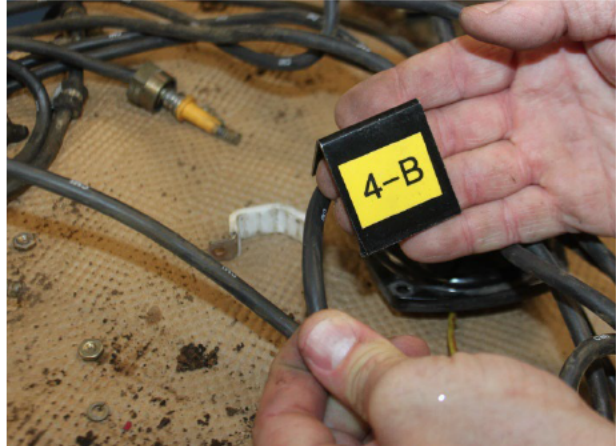
Inspection of the No. 4 cylinder top ignition lead revealed no visible damage to the external insulation. High tension testing of the lead was performed, and it passed the testing. Inspection of the No. 4 cylinder bottom ignition lead revealed chafing of the external insulation about 12 inches from the plug end in the area of engine baffling. The chafing was to the shielding (Figure 34), but it was not damaged. Additionally, very slight chafing was noted on the external insulation about 4 inches from the cap (Figure 35), but the chafing did not extend through the external insulation. Thus, the shielding was not damaged. The lead passed high tension testing.

**Figure 34 View of the Slight Chafing of the External Insulation of the 4B Ignition Lead.**

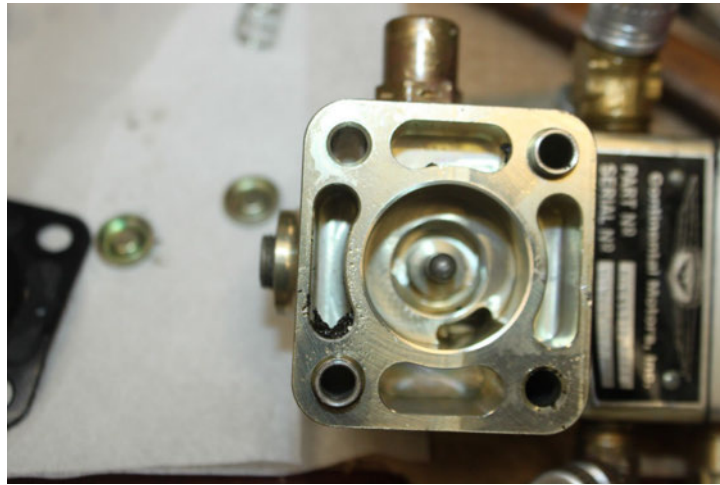
The engine-driven fuel pump was removed from the engine and the drive coupling was intact with no evidence of rounded corners. Following removal and replacement of the impact damaged inlet and vapor return fittings, exemplar fittings were installed for operational testing to production standards with no adjustment. During multiple operational tests internal contamination in the vapor ejector, fixed orifice, and pressure regulator section (Figure 36) affected the test results. The internal contamination was removed from all areas and the pump was again bench tested. As part of the testing, five test points were conducted recorded as Attachment 1. Three of the test points were conducted at 600 pump rpm (repeatability), and the remaining two were performed at 2,700 rpm (also repeatability). At 2,700 rpm the pump was set by the operator to flow between 220.0 and 222.0 pounds-per-hour (PPH). At that rpm and flow during the first and second tests, the unit discharge pressure was 3.67 psi greater than the upper limit and 0.66 psi greater than the upper limit, respectively.

**Figure 36 View of the Debris Inside the Pressure Section of the Engine-Driven Fuel Pump**

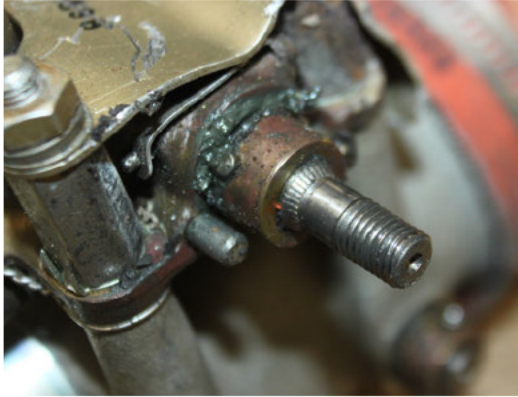
**Figure 40 View of the Deformed Serrations of the Mixture Control Shaft**

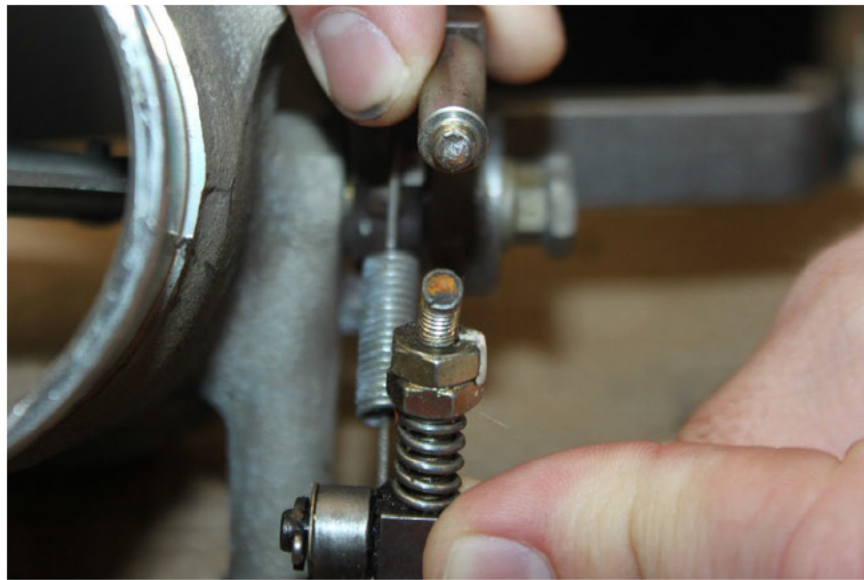
**Figure 42 View of the Bending Overload Fractured Throttle Linkage**

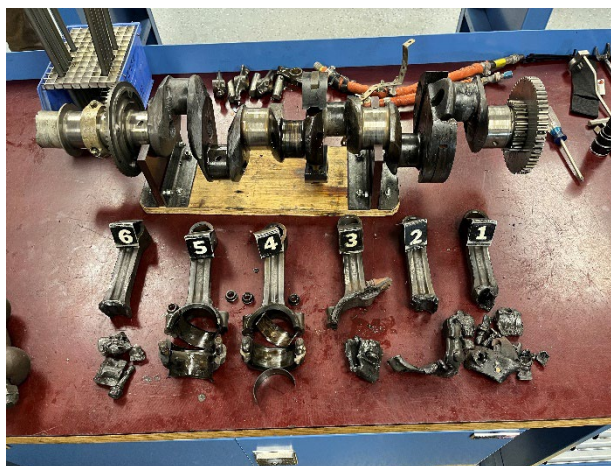
Inspection of the crankshaft revealed all connecting rod journals exhibited extensive heat discoloration consistent with lubrication distress (Figure 44). The Nos. 1-, 2- and 3-cylinders connecting rod journals also exhibited extensive mechanical damage. Inspection of each oil galley of the crankshaft which supply oil to the connecting rod bearings revealed all passages were clear.

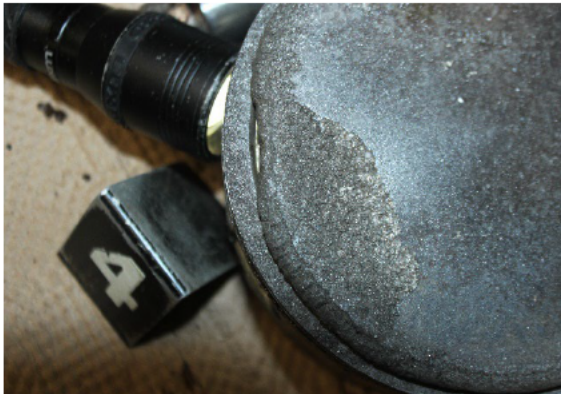
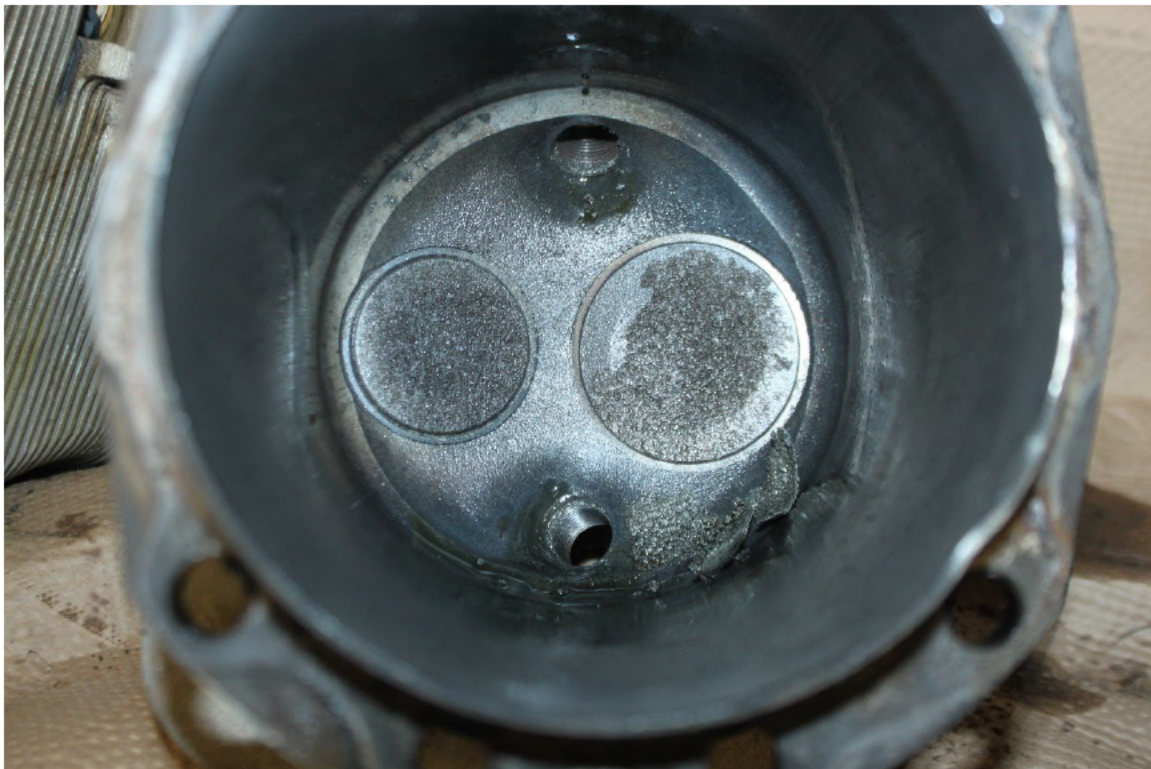
No. 4 - Had resolidified aluminum material inside the cylinder head near both spark plug holes and on both valves. The Cylinder skirt was damaged. The bottom of the piston was damaged. The piston exhibited erosion circumferentially with a visible gap in the piston extending from the dome past both compression rings and the oil control ring (Figure 45). The intake gasket remained installed on the cylinder and there were no cuts or visible damage (Figure 46). The debris by both spark plug holes was removed and both spark
