# National Transportation Safety Board

ERA23LA131

## **WRECKAGE EXAM SUMMARY**

Location: Hillsville, VA  
Date: February 27, 2023  
Time: 1715 EST  
2215 UTC  
Airplane: Cessna 150G, N2991J

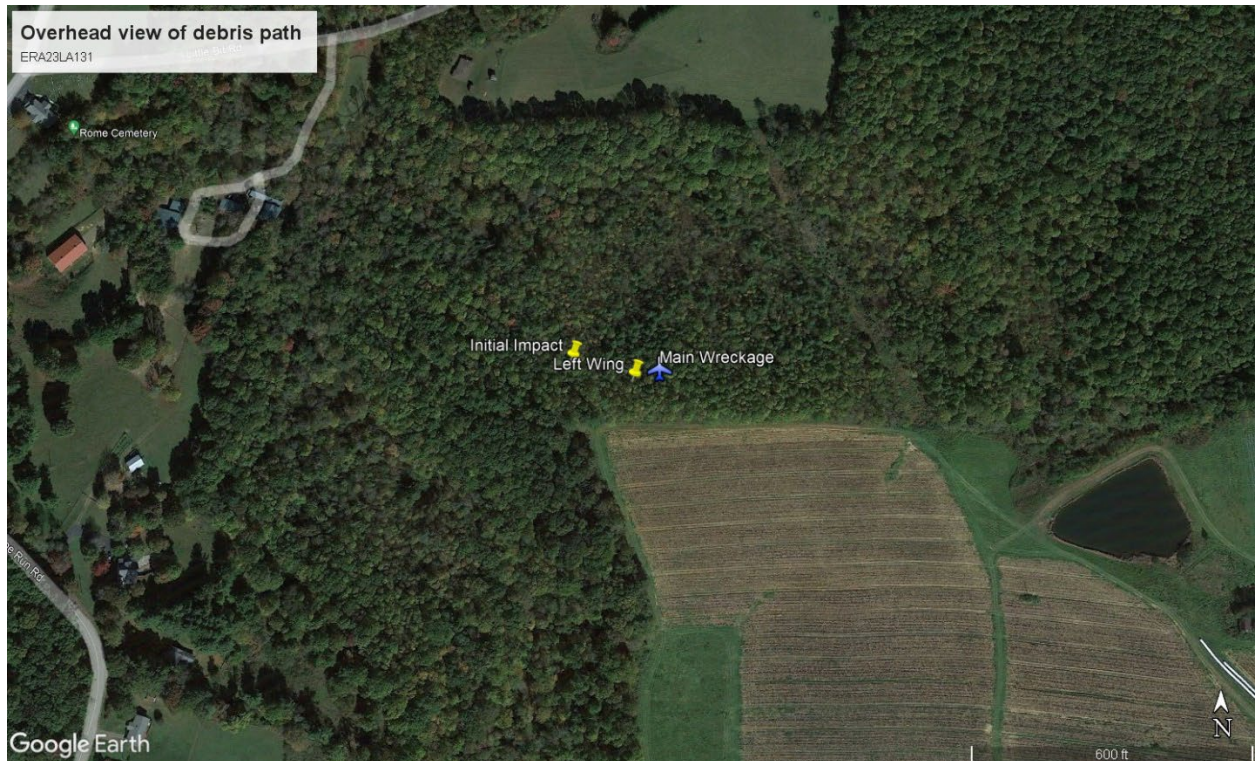
The airplane came to rest in a wooded area at an elevation of 2776 ft mean sea level. The airplane impacted a tree about 205 ft prior to the final resting place. There was no evidence of fire, and all major components of the airframe were located in the vicinity of the main wreckage. Flight control continuity was confirmed from the flight controls in the cockpit to the flight control surfaces through multiple overload breaks.

Figure 1: Debris path overview

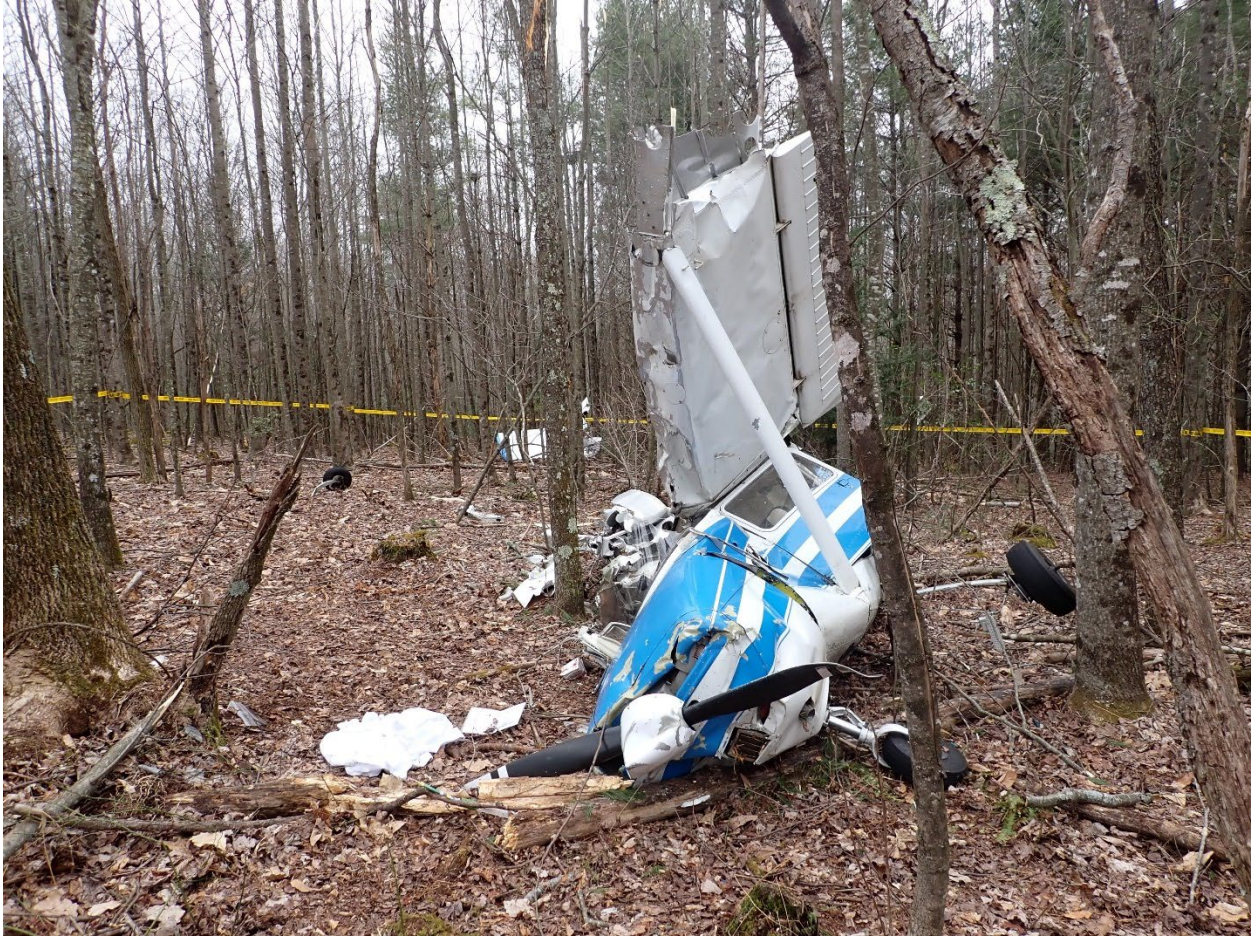
The fuselage remained intact but exhibited impact damage. There was no evidence of a fire.

**Figure 2: Front view of wreckage**

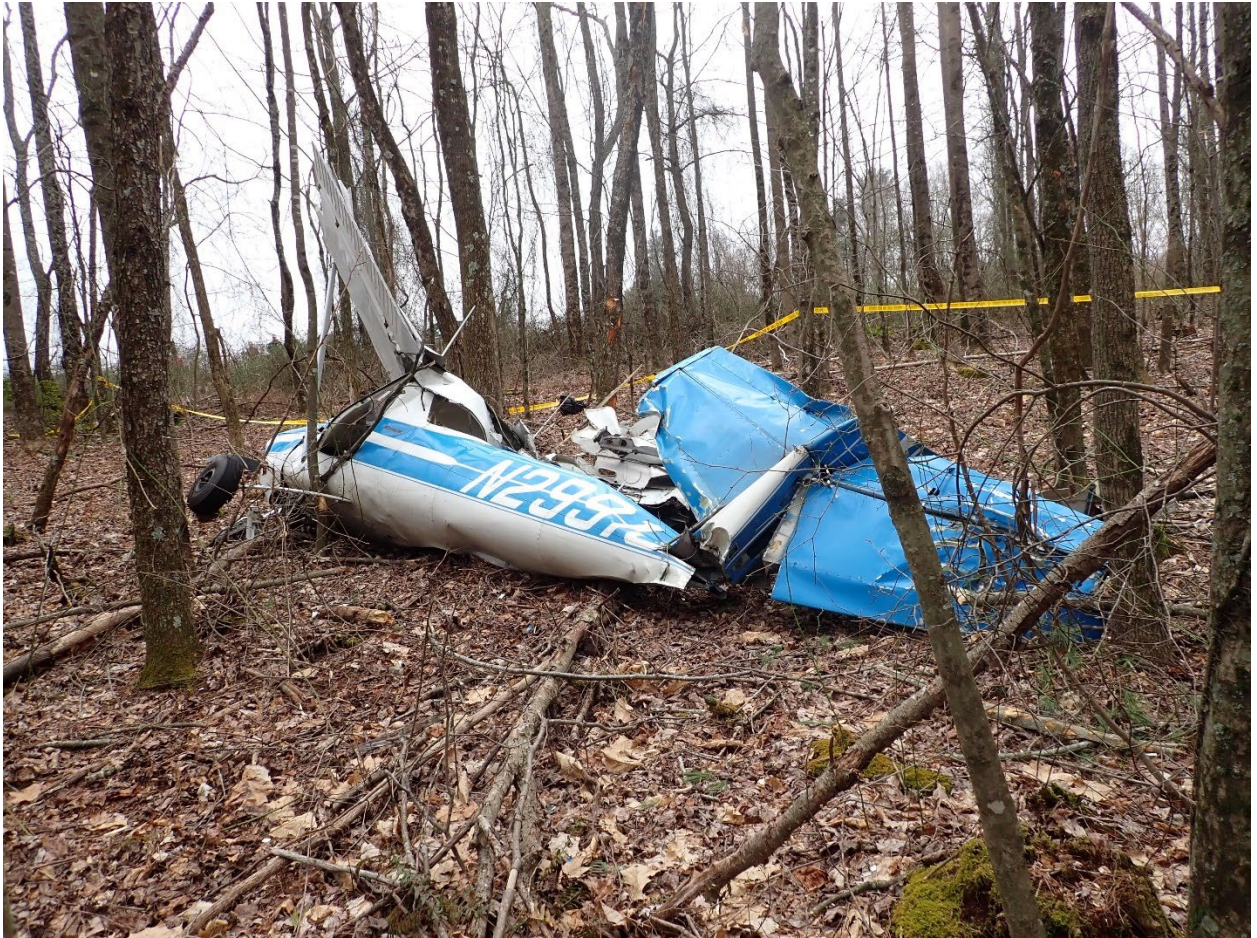
**Figure 3: View of wreckage from aft left corner**

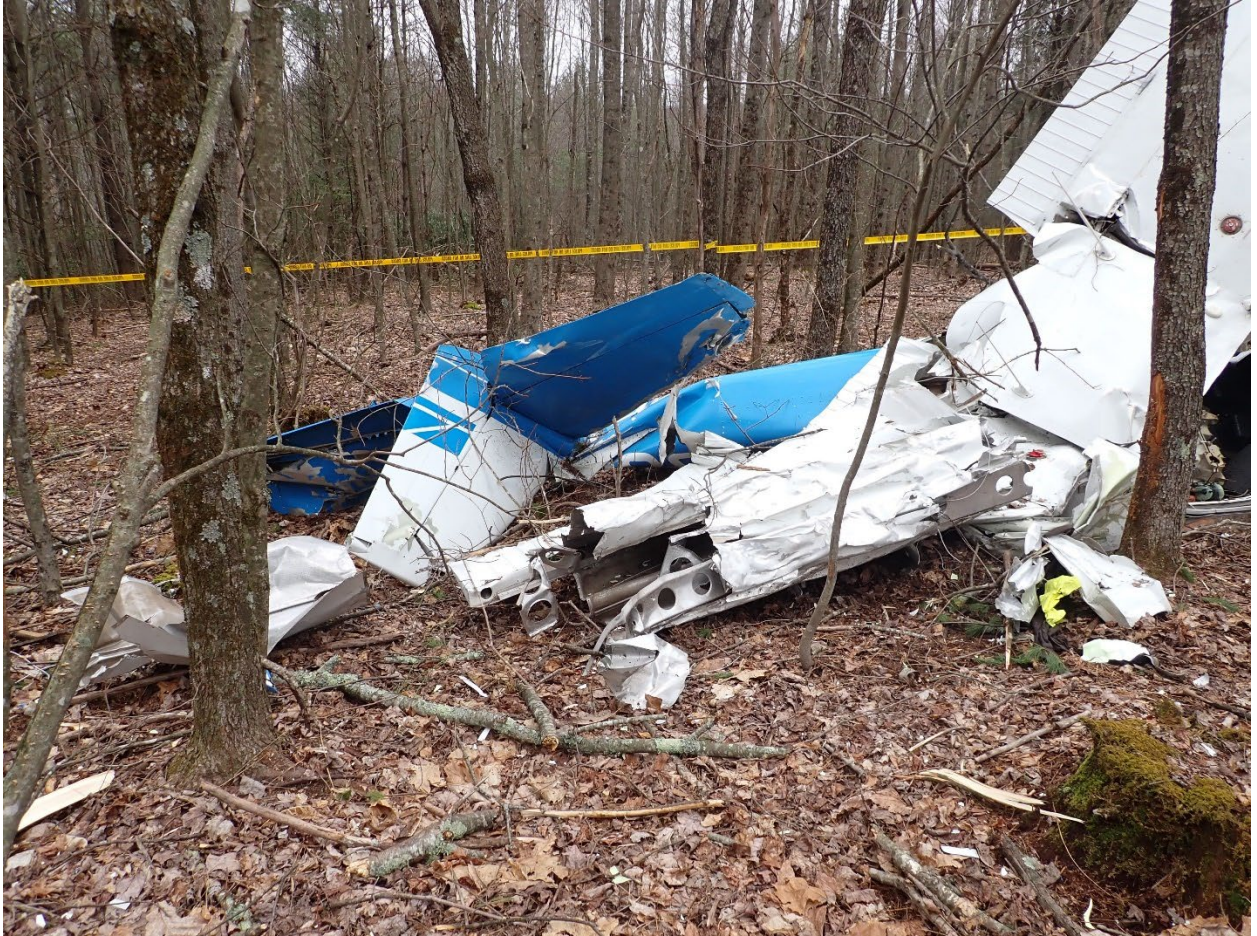
The empennage was twisted to the right but remained attached to the fuselage. The left horizontal stabilizer remained attached, and the leading edge was impact damaged, the tip of the leading edge was impact separated. The left elevator remained attached to the left horizontal stabilizer at all attachment points and the counterweight was impact separated. The right horizontal stabilizer was impact crushed aft but remained attached to the empennage. The right elevator remained attached to the right horizontal stabilizer at all attachment points and exhibited impact damage. Elevator trim tab remained attached at all attachment points and measured 5° tab up. Vertical stabilizer remained attached, and the tip was impact separated. The rudder remained attached and exhibited damage on the top and bottom.

**Figure 4: View of empennage from front right side**

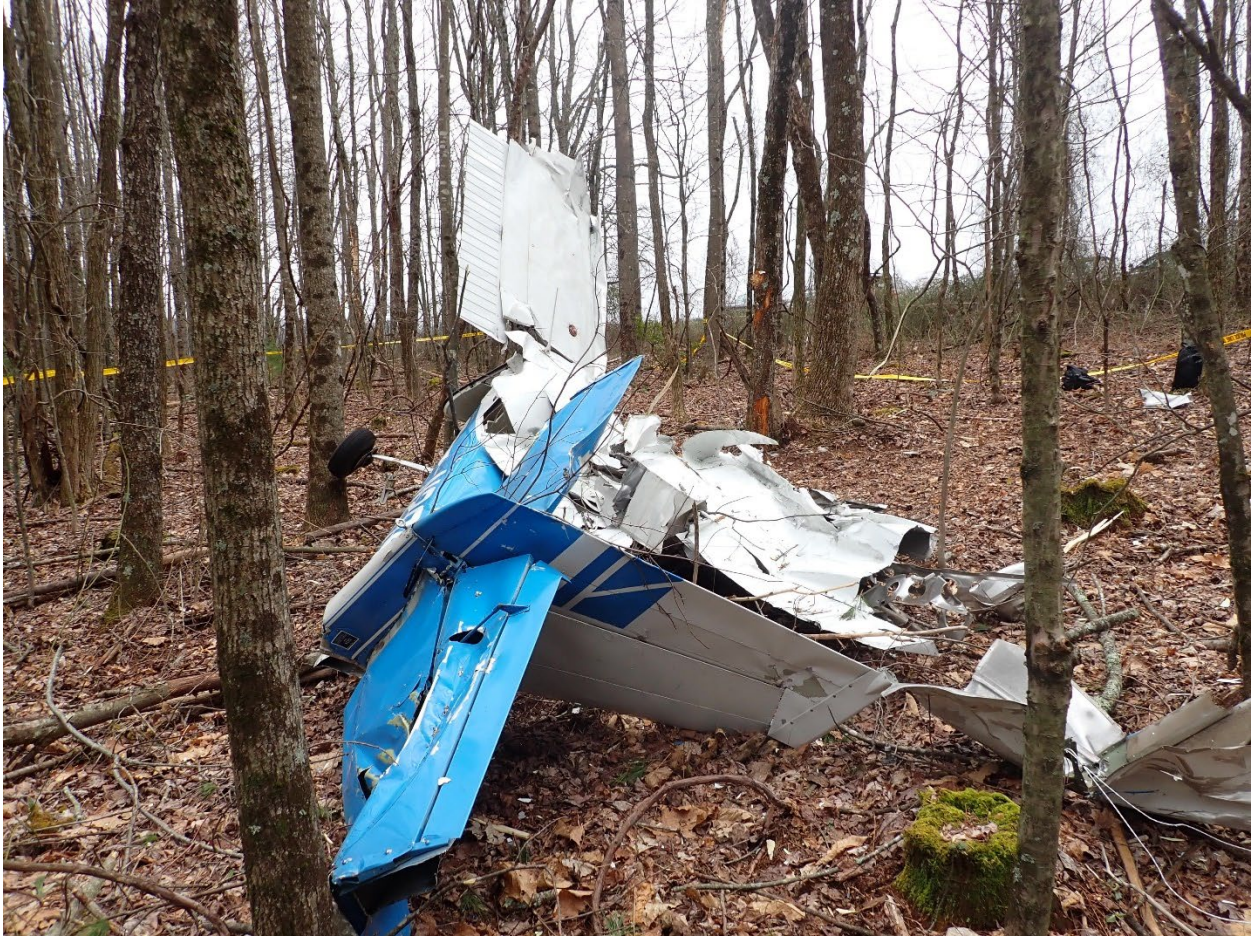
**Figure 5: View of empennage from the rear**

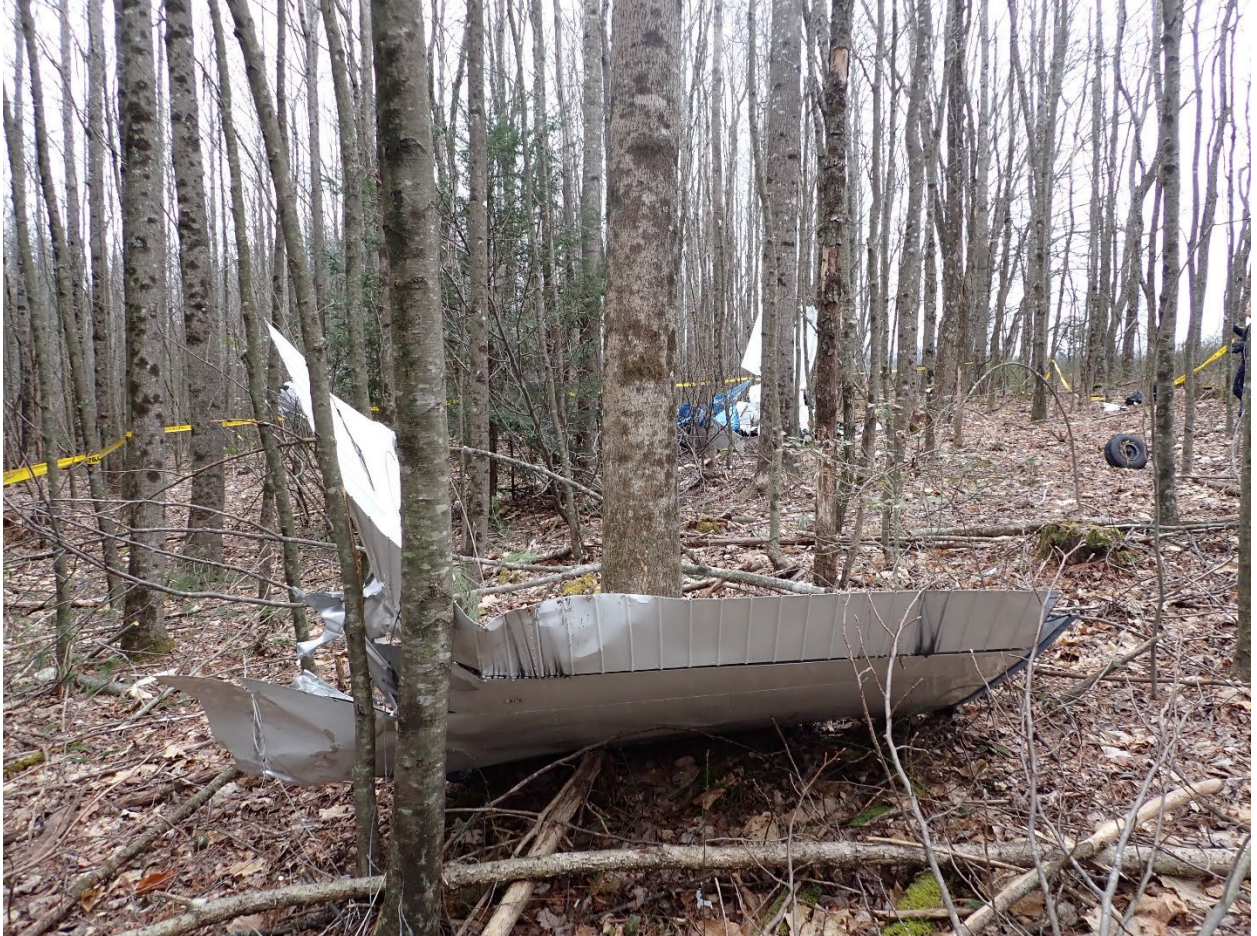
The left wing was impact separated outboard of the flap and found about 60ft from the main wreckage. The left aileron remained attached to the left wing at all attachment points. The leading edge showed aft crushing with a 1.5 ft deep semicircular indent. The wing tip remained attached to the wing. The inboard section of the left wing remained attached to the fuselage and the leading edge was crushed aft along the whole length. The flap remained attached and retracted.

**Figure 6: Impact separated section of the left wing**

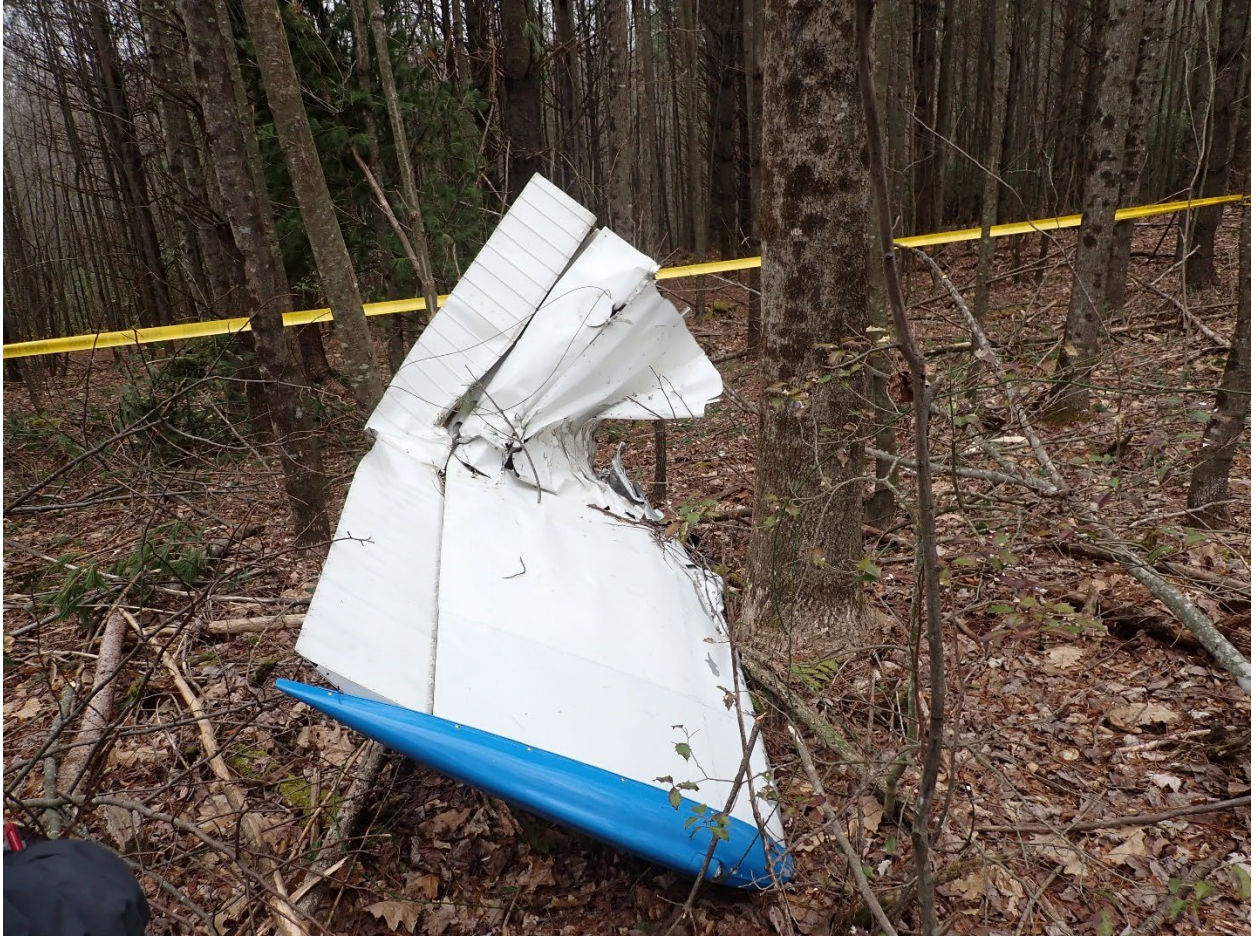
**Figure 7: Impact separated left wing section**

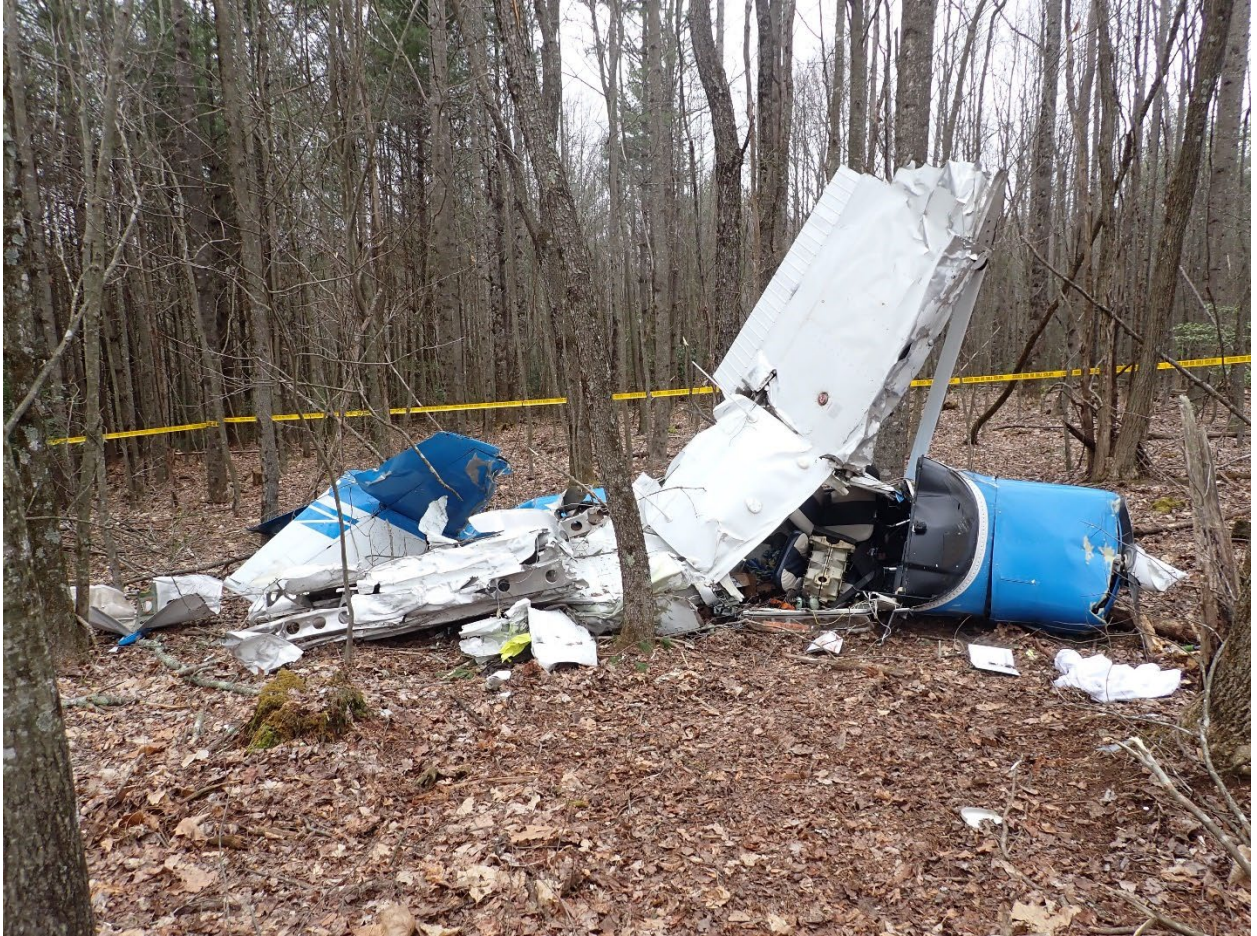
**Figure 8: Left wing attached to fuselage**

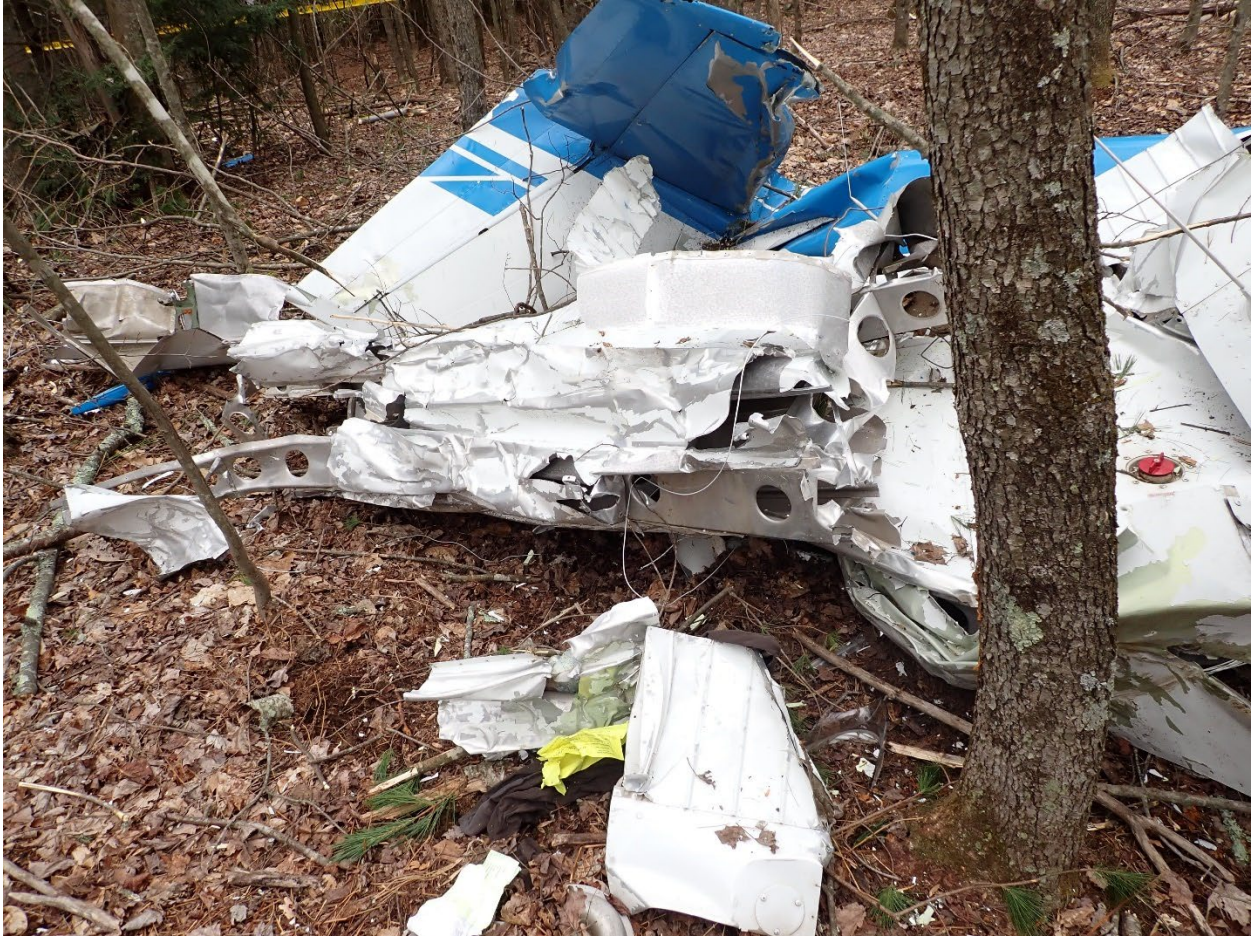
The right wing was impact crushed aft and a section outboard of the flap remained attached by an aileron control cable, the inboard section remained attached to the fuselage. The flap remained attached and in the retracted position, about a 1 ft outboard section was impact separated.

**Figure 9: Outboard right wing section**

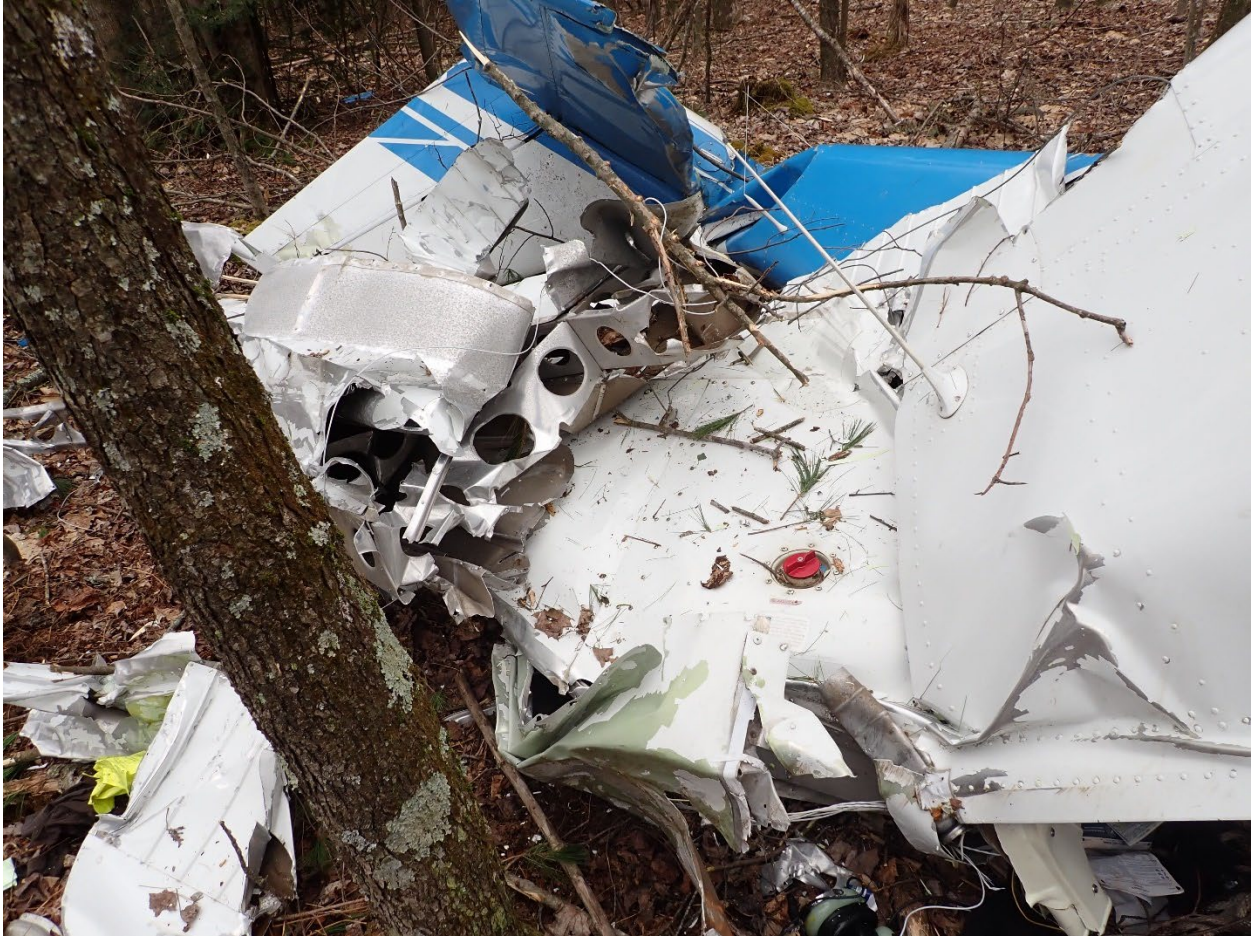
**Figure 10: Inboard right wing section**

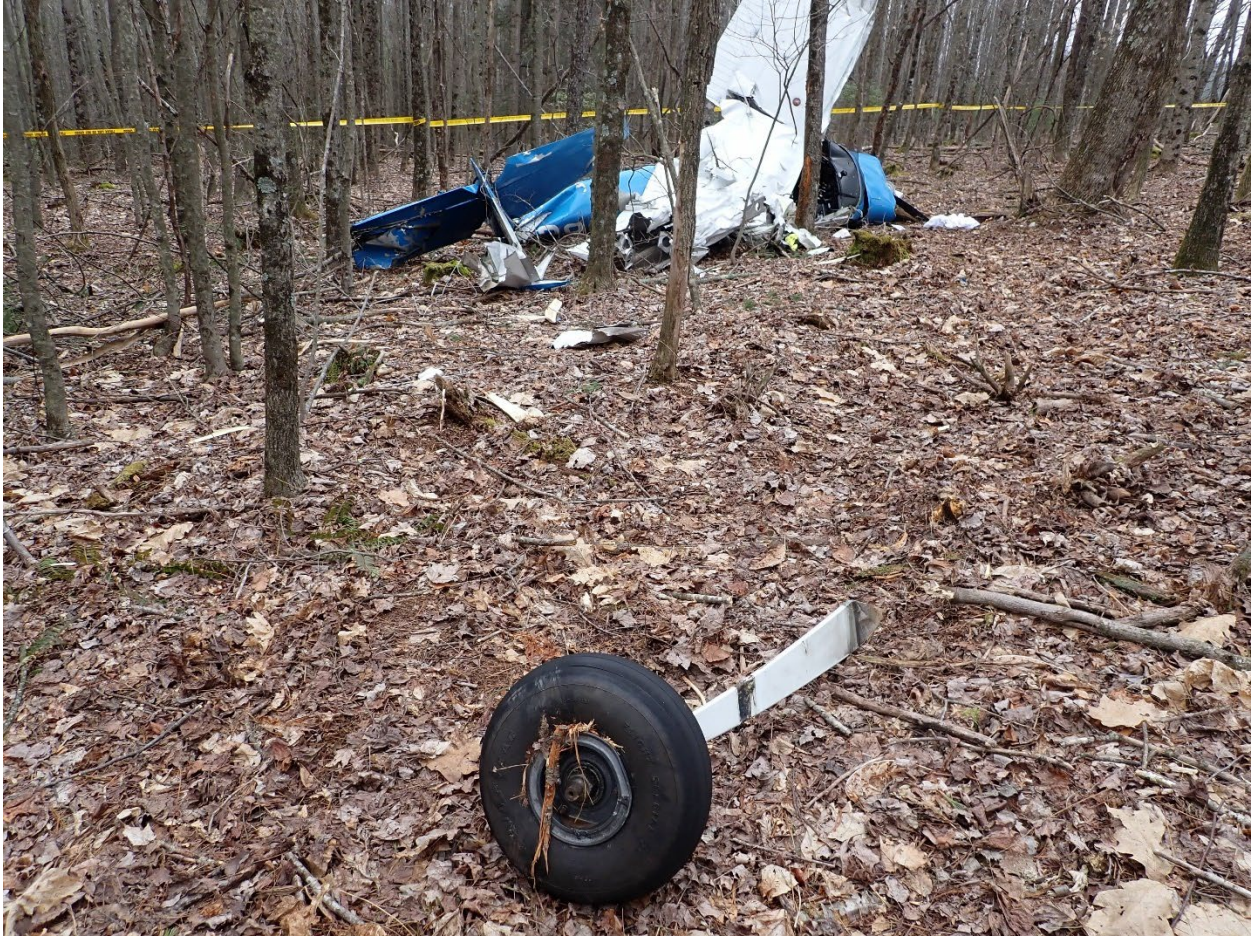
The right main landing gear was impact separated. The left main landing gear and nose landing gear remained attached to the airframe.

**Figure 11: Right main landing gear impact separated**

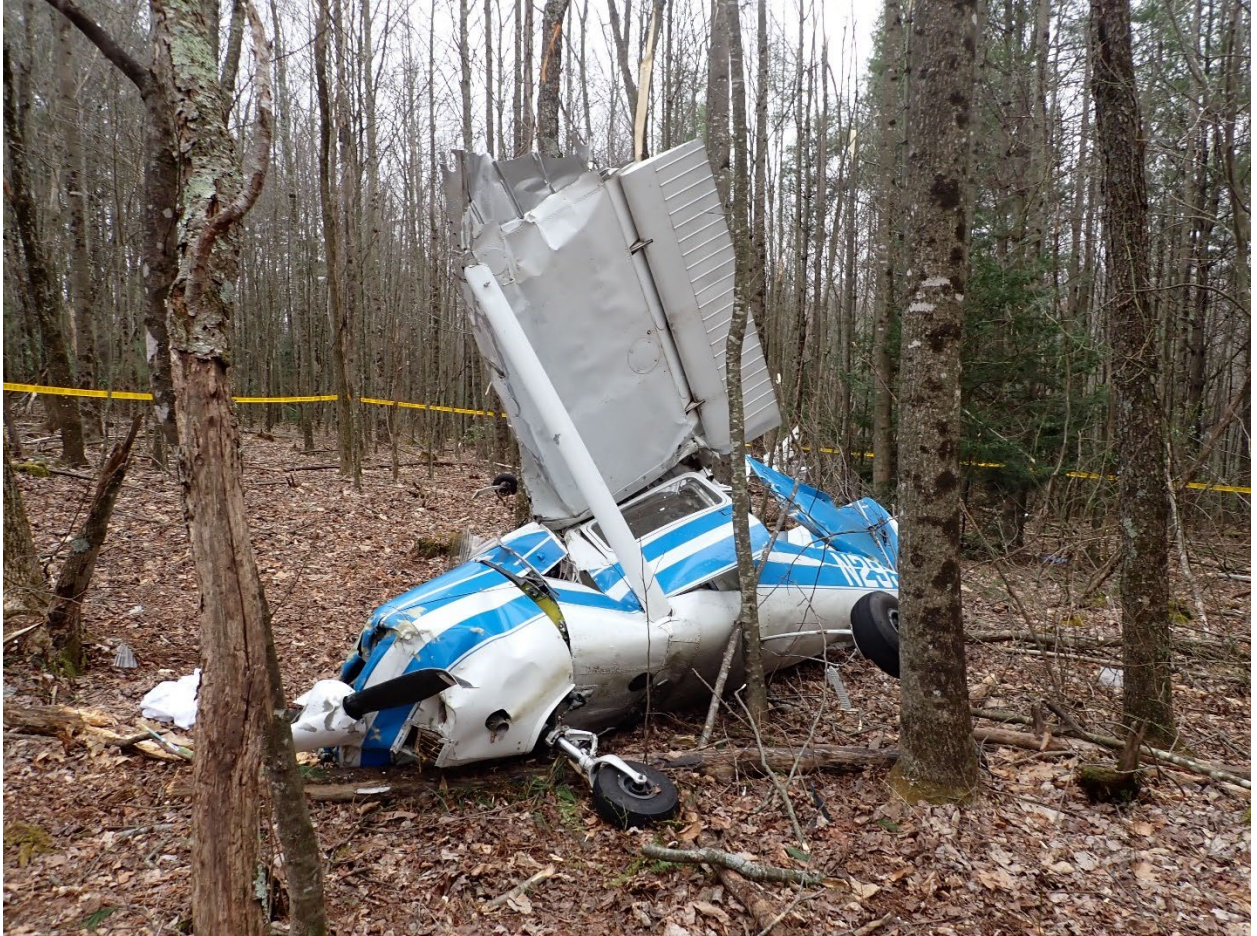
**Figure 12: Left main landing gear and nose landing gear**

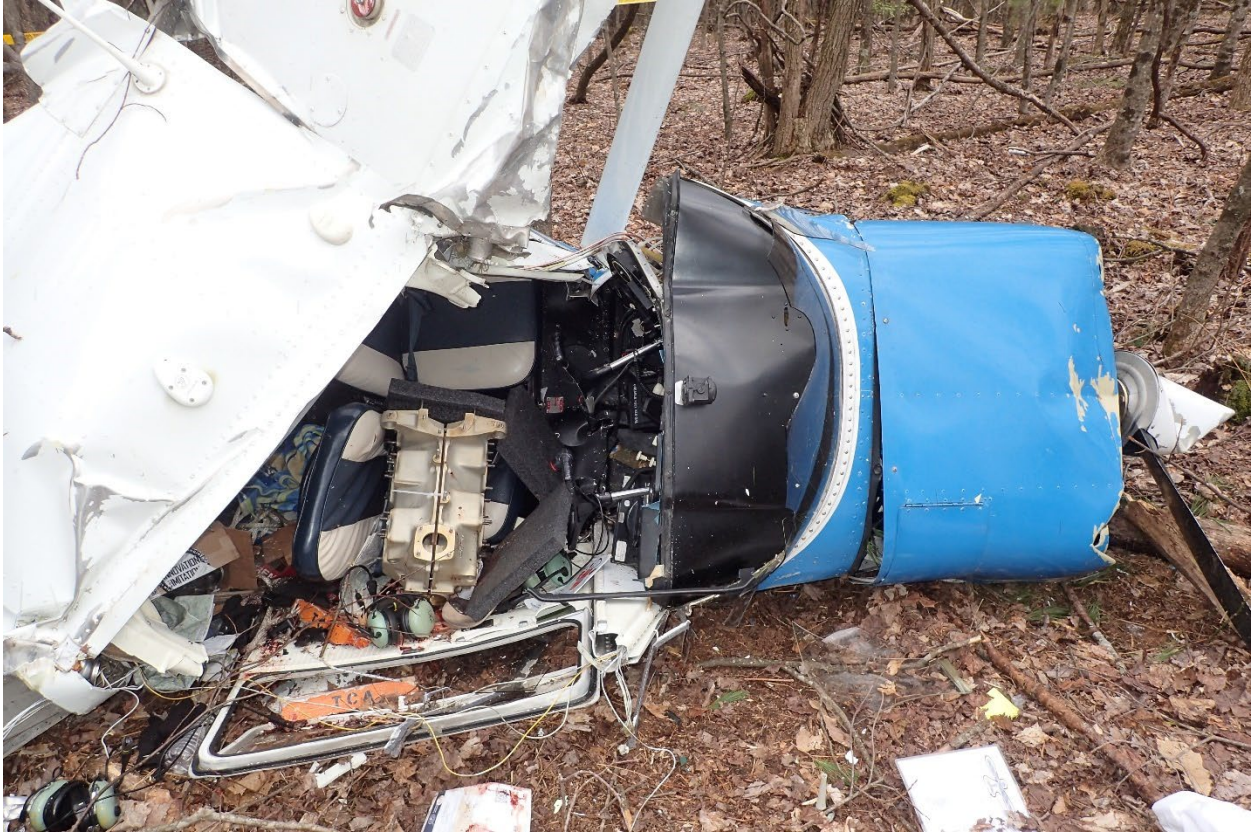
The carburetor heat knob was partially out. The cabin heat was found in the On position, and the cabin air was found in the Off position. The landing lights were found in the Off position, the beacon light was found in the On position, and the navigation lights were found in the Off position. The throttle was found to be mid travel and the fuel mixture was found full rich. A spare crankcase was found secured to the right front seat and other engine parts were found in the rear baggage compartment. The two seats were equipped with lap belts only.

**Figure 13: Overview of the cockpit (Textron Photo)**

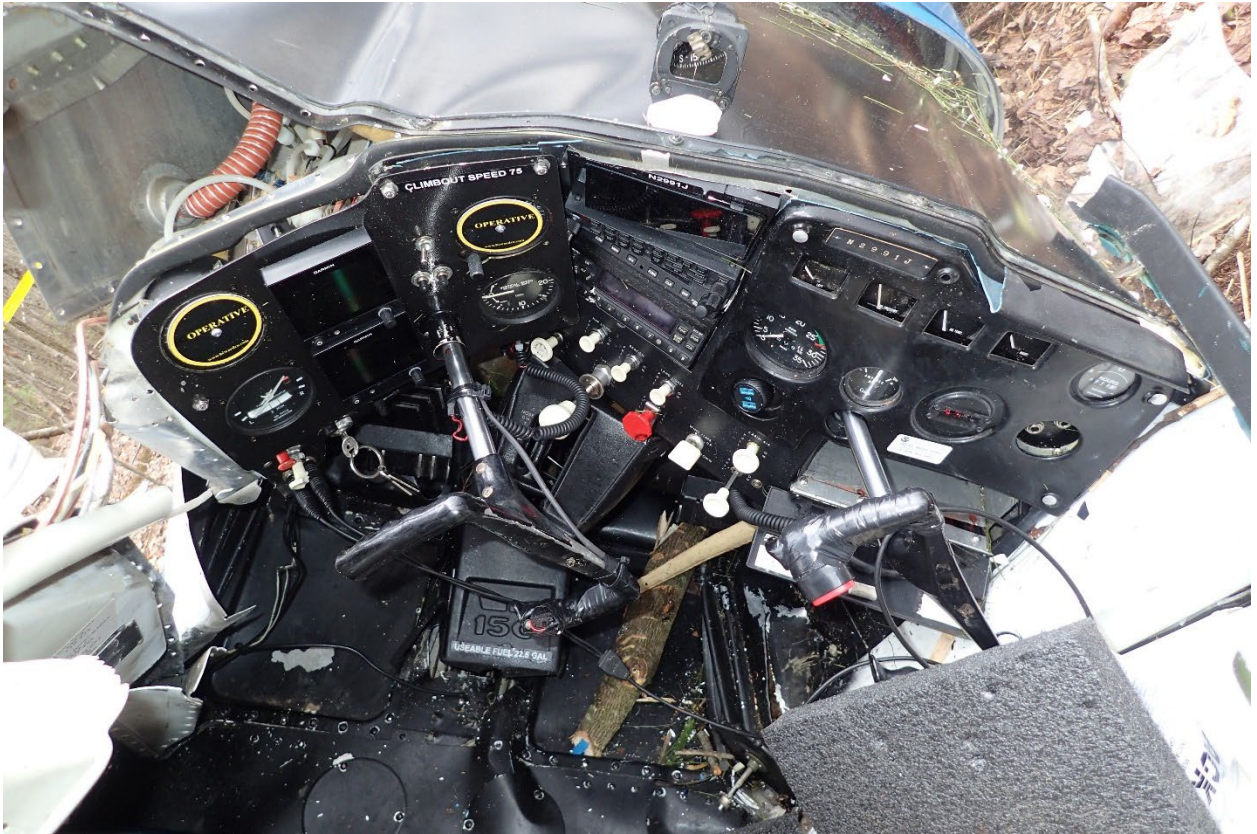
**Figure 14: Overview of the cockpit instrument panel**

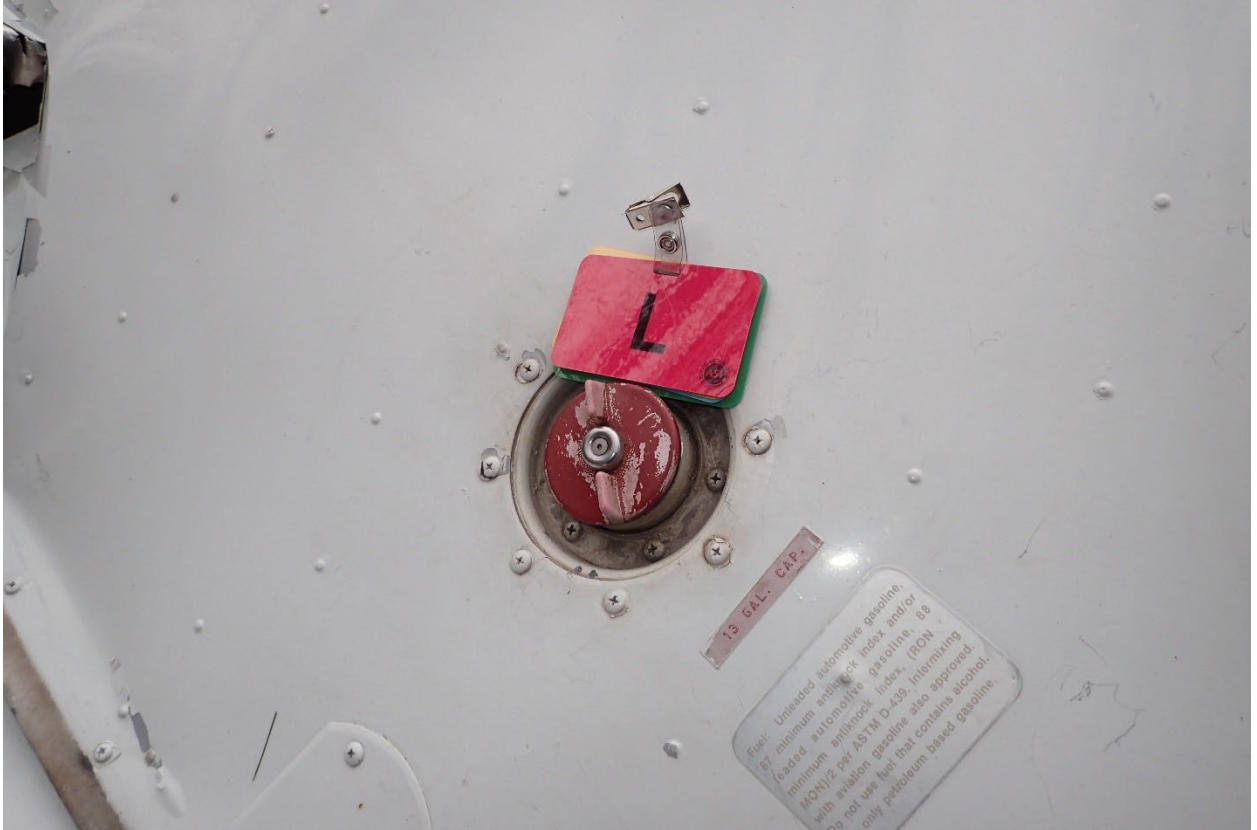
Both the right and left fuel tanks were examined with a lighted borescope and were found to be intact. The left fuel tank showed no fuel but an odor similar to 100LL was noted on scene, the cap remained seated. Fuel was noted in the right fuel tank and the cap remained seated. The fuel selector was found in the on position. The fuel strainer bowl contained a small amount of debris and the strainer screen was clear of debris. Continuity of the fuel system was confirmed by blowing air through the system.

**Figure 15: Left fuel tank cap (Textron Photo)**

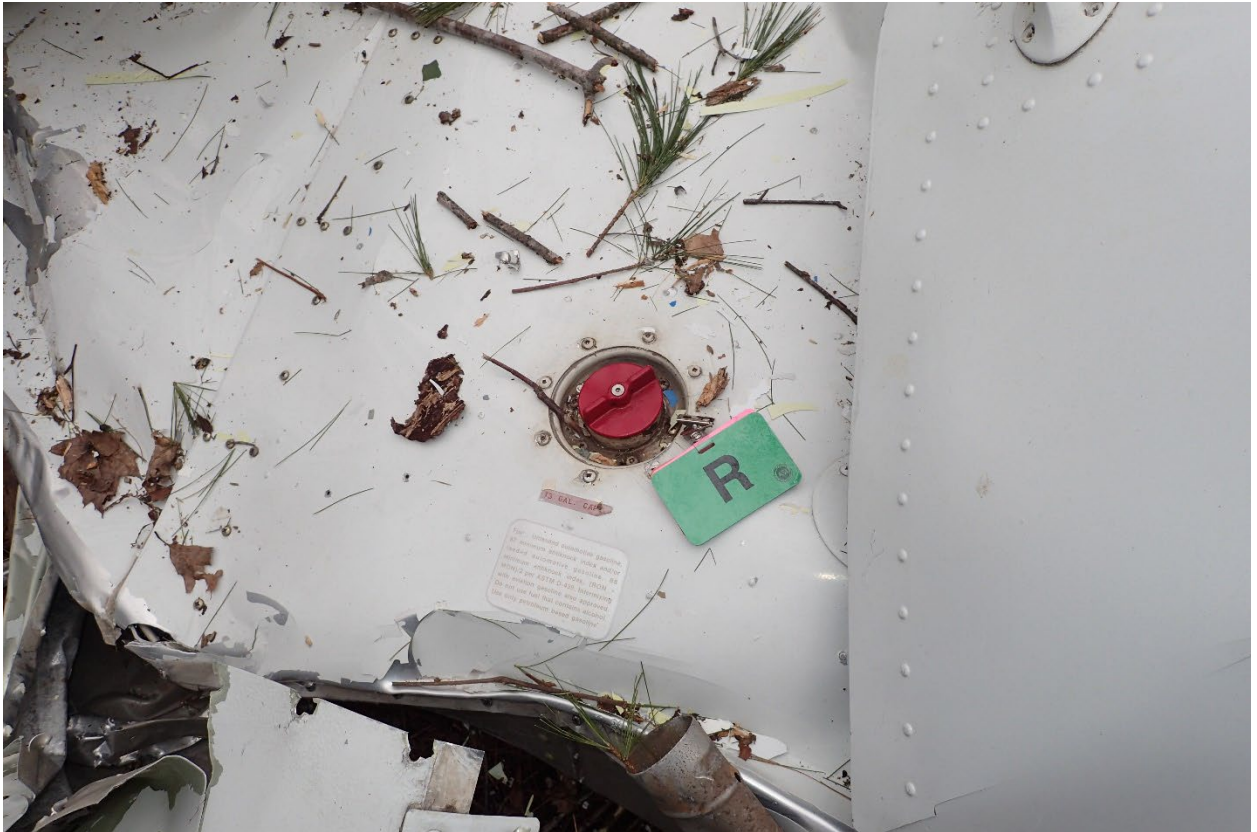
**Figure 16: Right fuel cap secured (Textron Photo)**

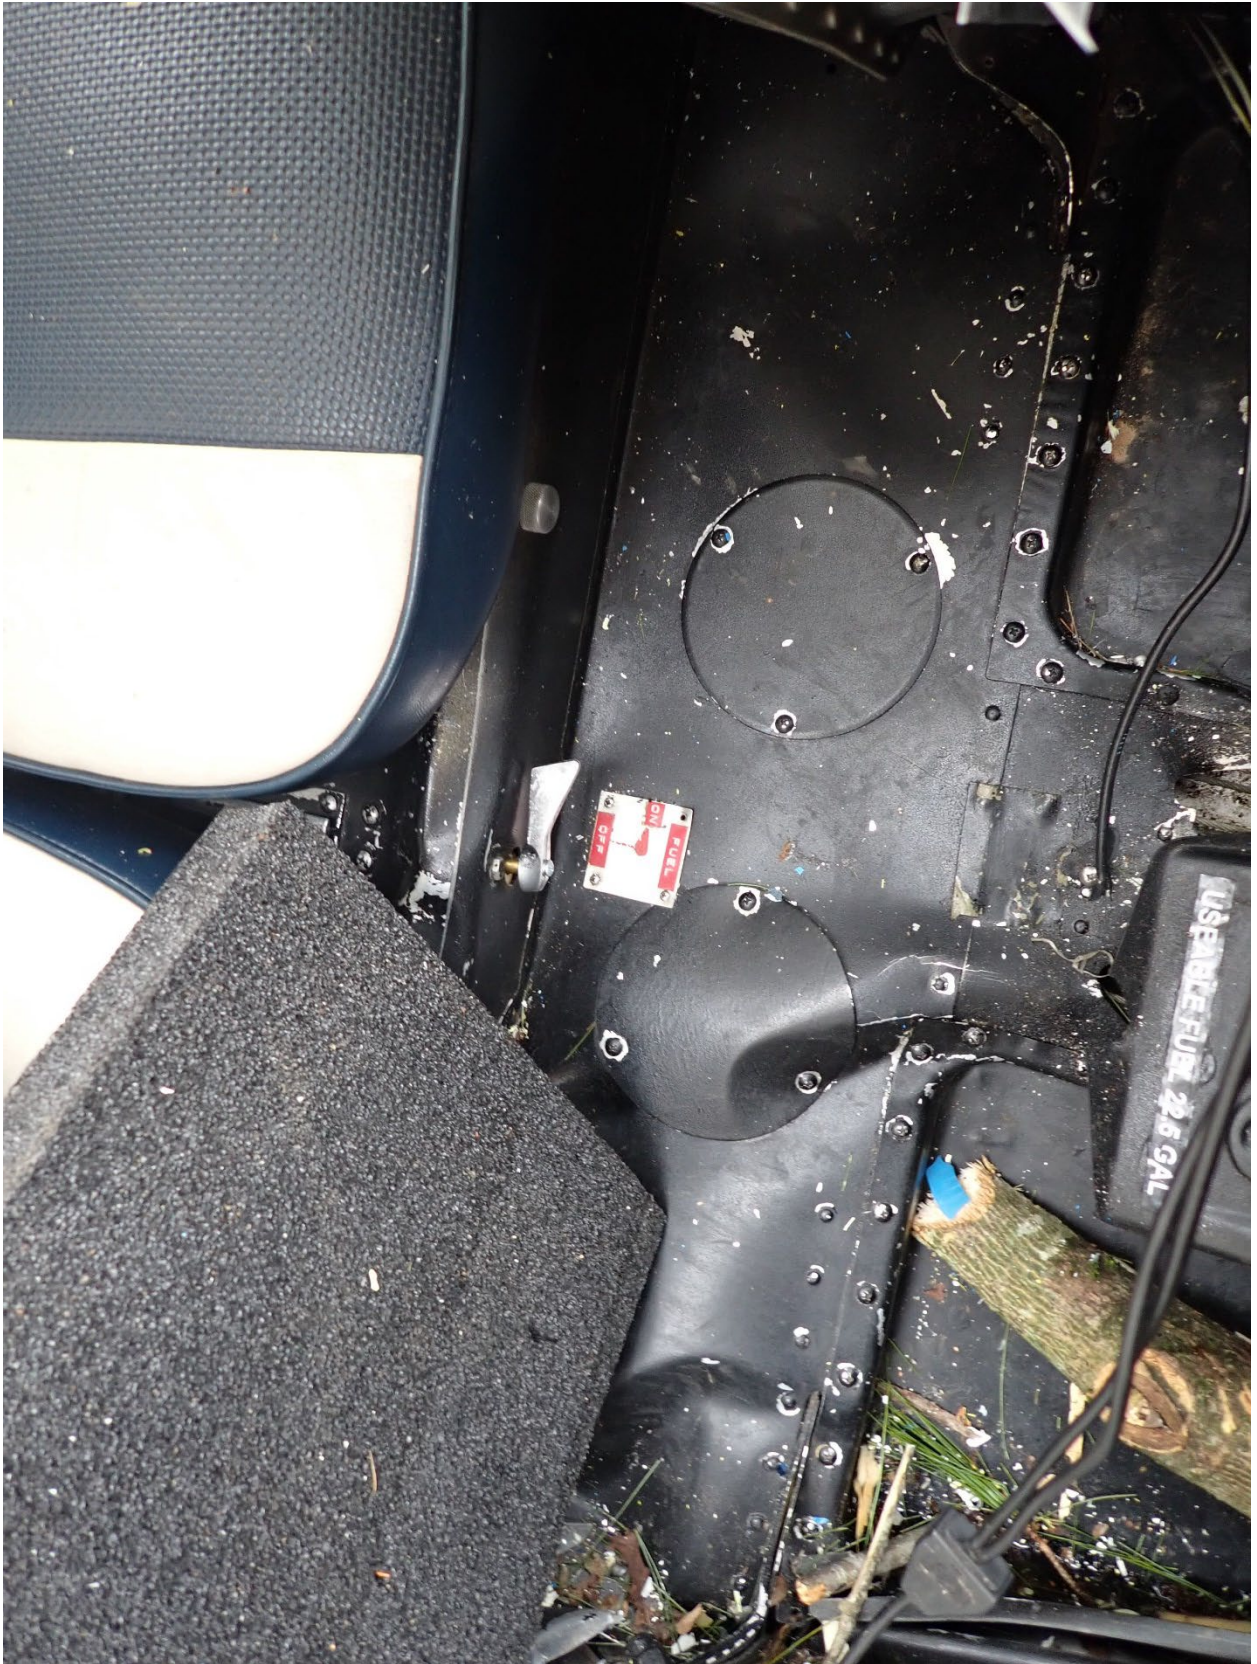
**Figure 17: Fuel selector in the on position**

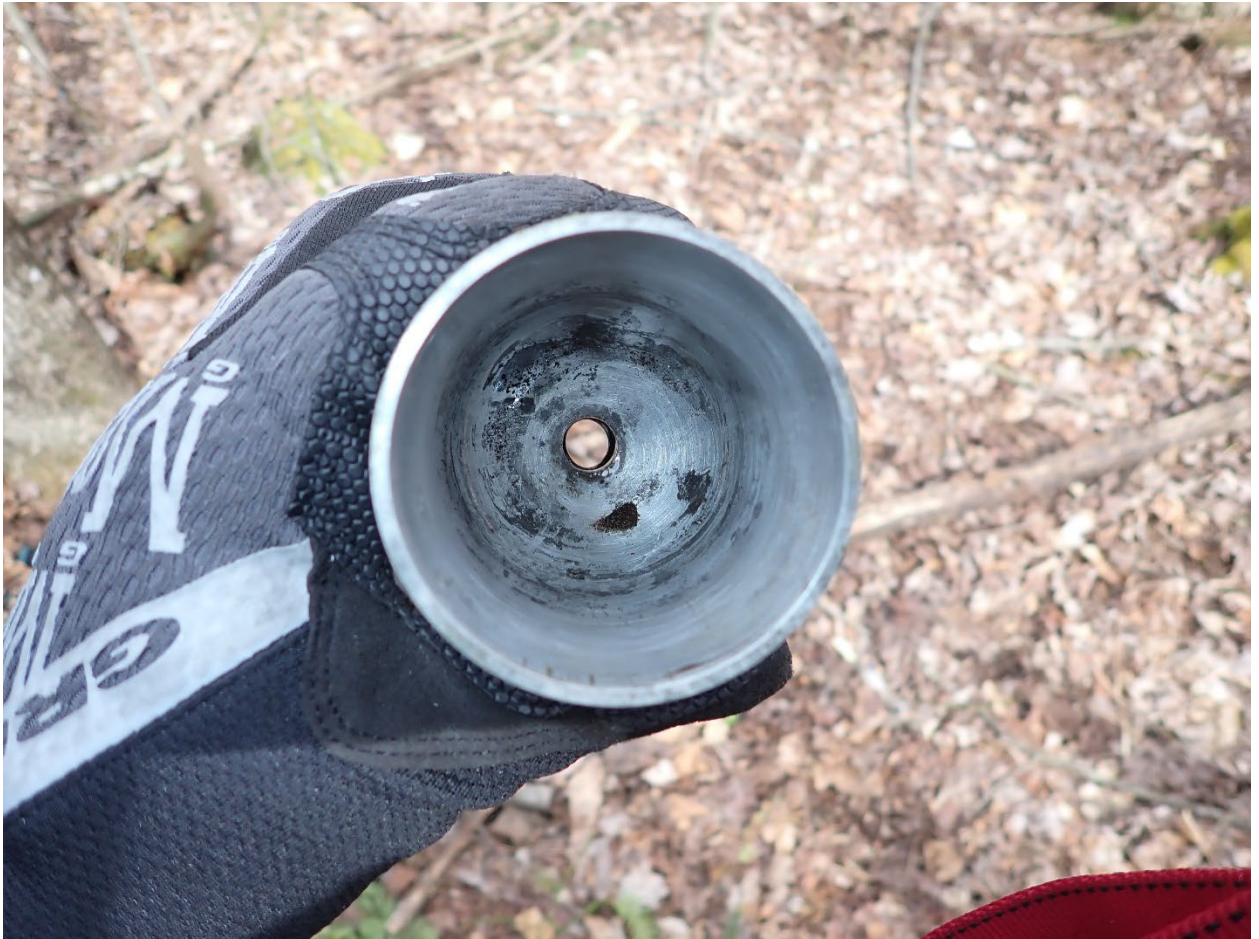
**Figure 18: Debris in bowl of fuel strainer**
