# National Transportation Safety Board

ERA23LA131

## **WRECKAGE EXAM SUMMARY**

Location: Hillsville, VA  
Date: February 27, 2023  
Time: 1715 EST  
2215 UTC  
Airplane: Cessna 150G, N2991J

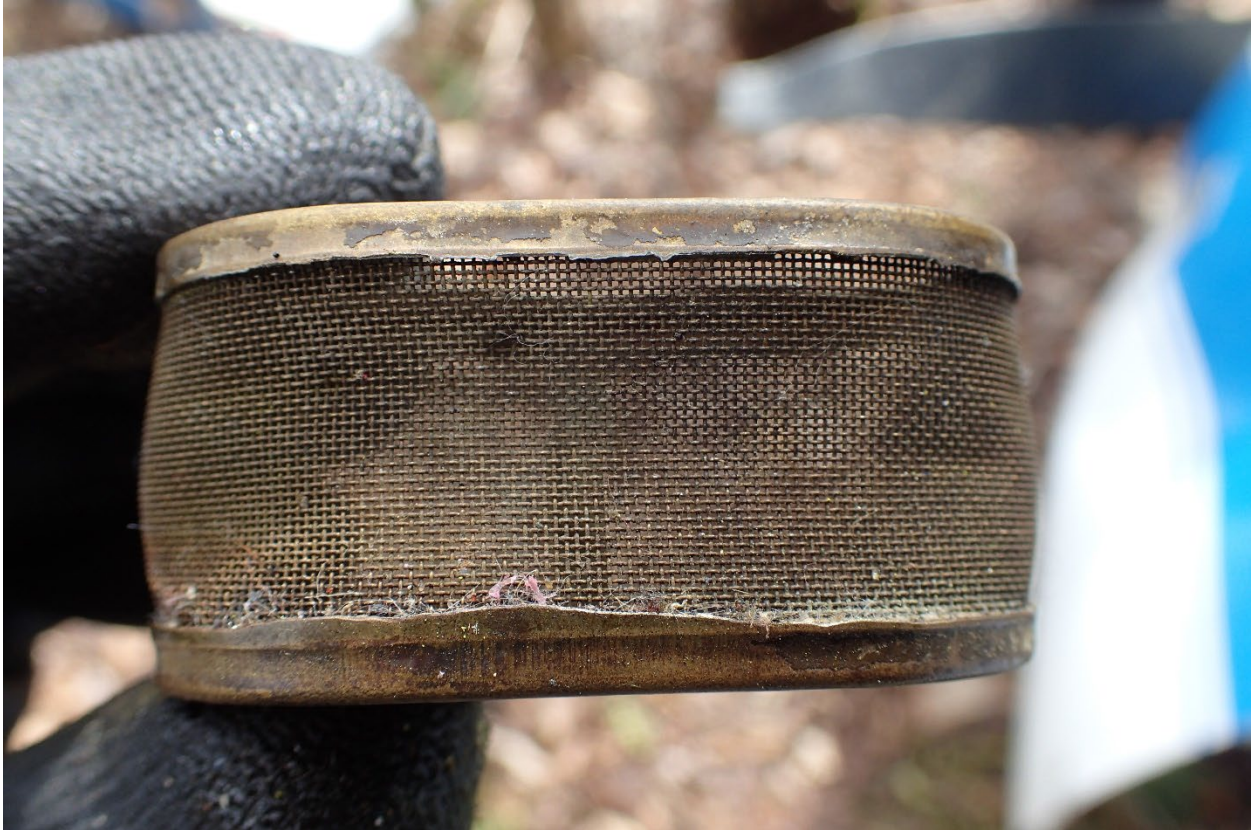
**Figure 19: Fuel strainer screen (Textron Photo)**

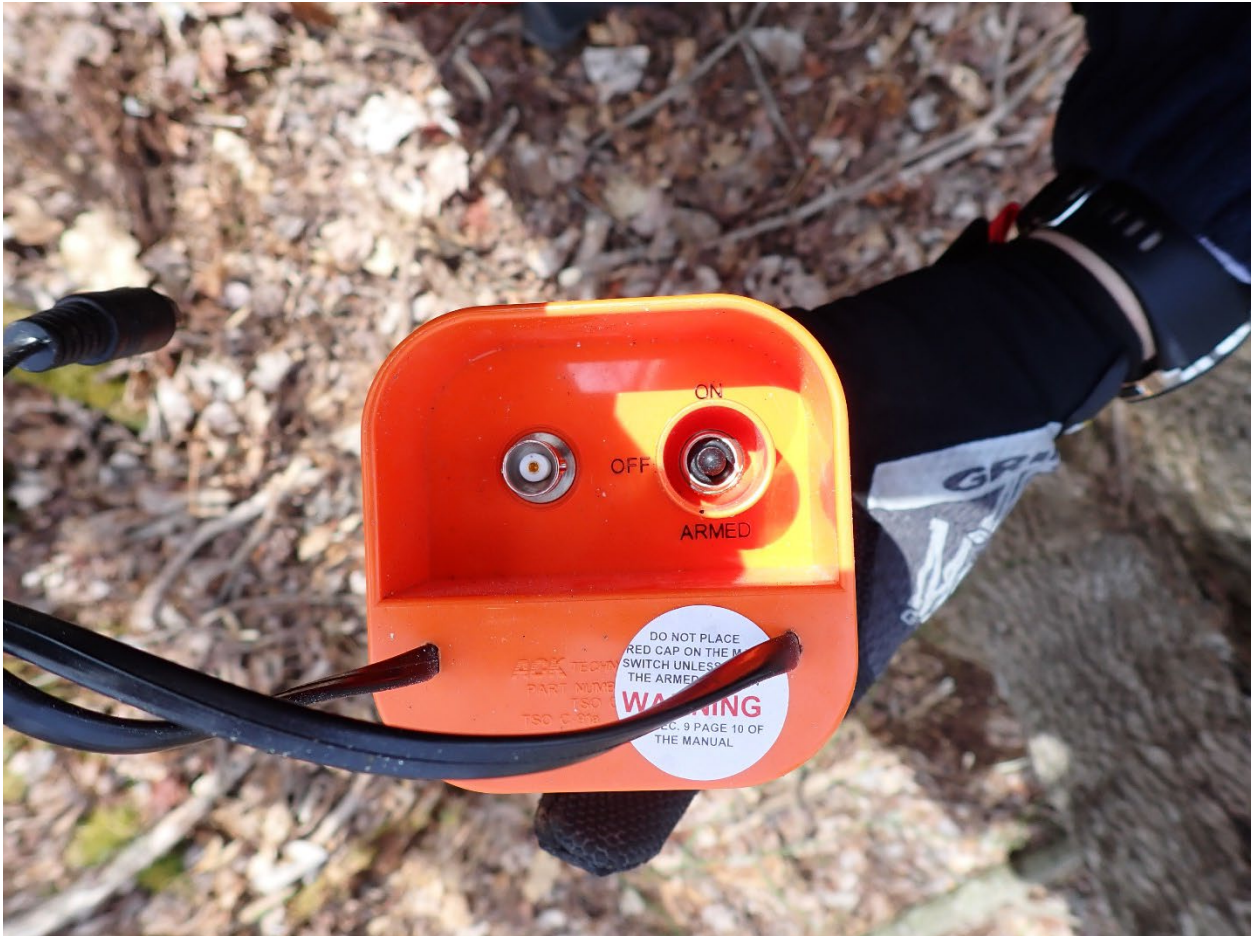
The emergency locator transmitter (ELT) was found secured in the aircraft fuselage and it was in the off position. The ELT battery expiration date was September 1, 2025.

**Figure 20: ELT in the off position**

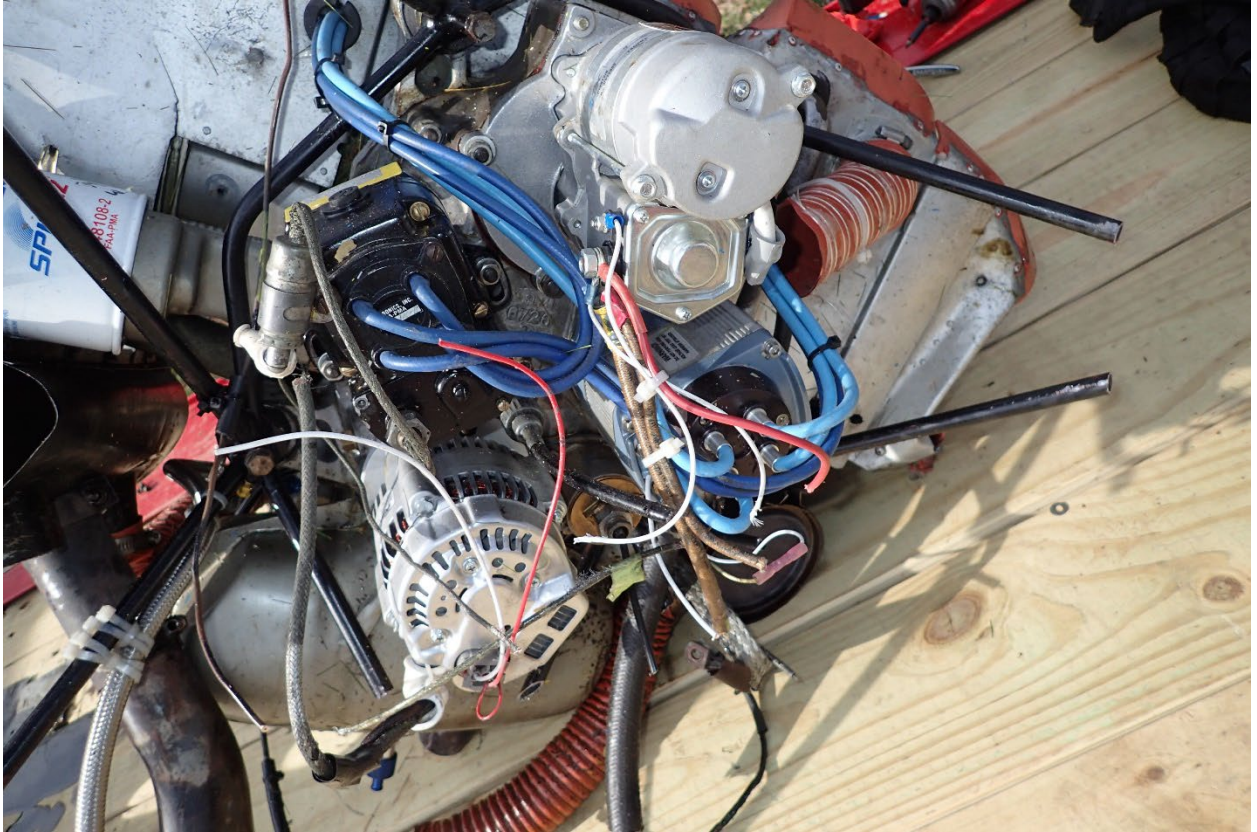
The airplane was equipped with 1 standard magneto which remained attached to the accessory case of the engine. It was also equipped with 1 Surefly electronic ignition system both remained attached the engine. Spark was obtained on all leads from the standard magneto.

**Figure 21: View of the accessories on the engine**

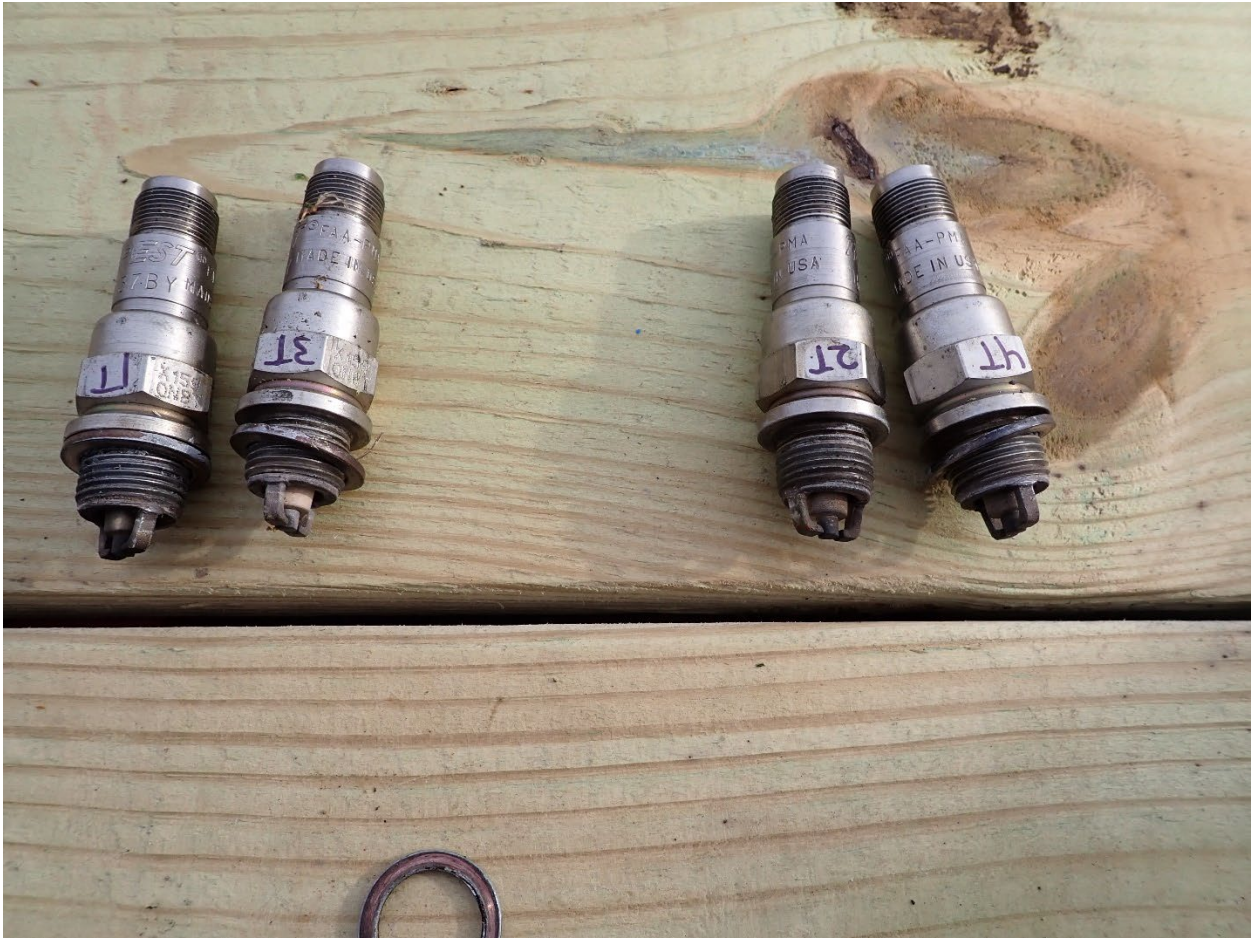
The airplane was equipped with a starter motor that remained attached to the accessory case of the engine. The top spark plugs were removed and examined using the Champion Aerospace Aviation Check-A-Plug chart. The no. 1 top sparkplug exhibited signs of carbon fouling, the nos. 2, 3, and 4 top sparkplugs exhibited worn out - normal wear.

**Figure 22: Top view of the top spark plugs**

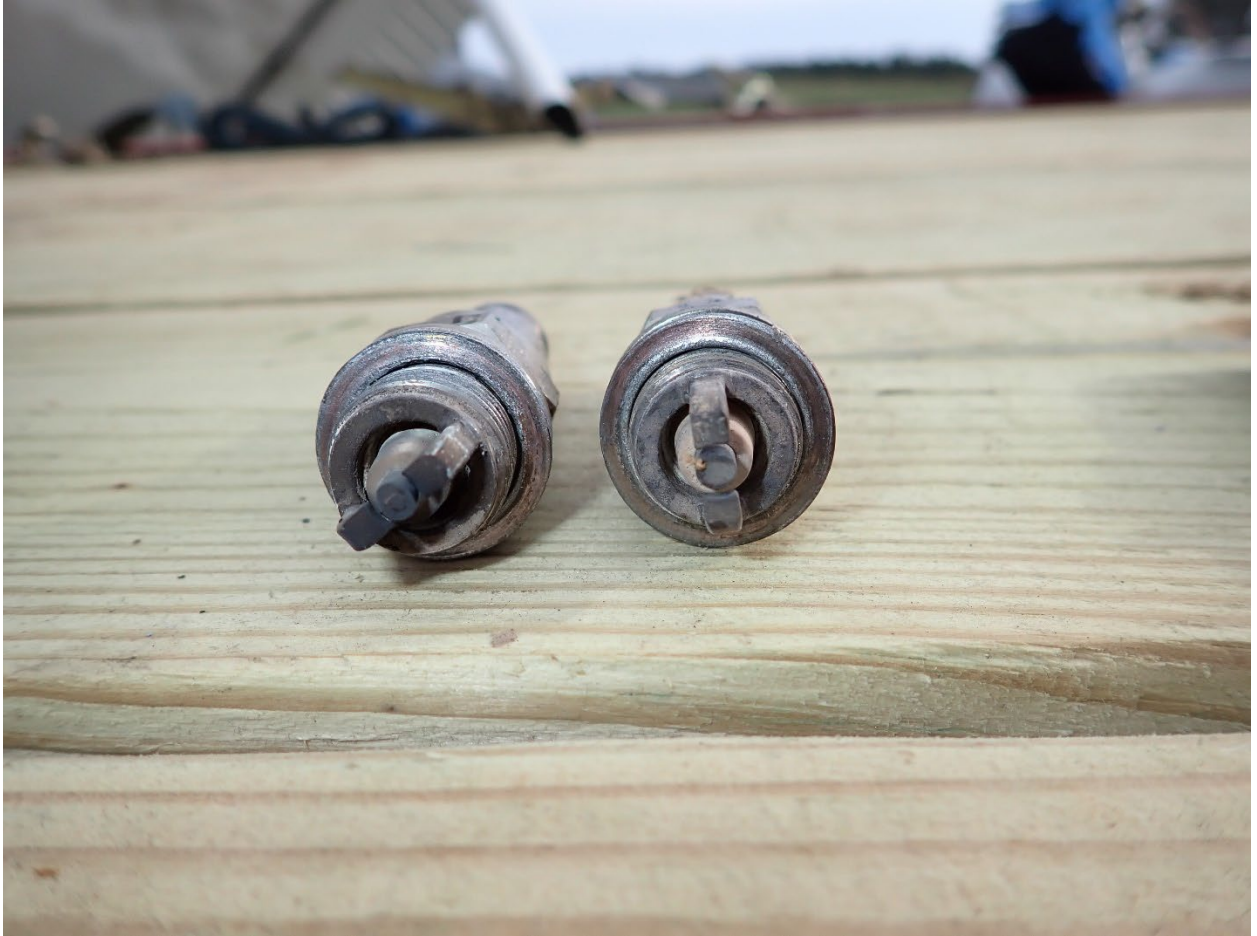
**Figure 23: Cylinder 1 and 3 top sparkplugs**

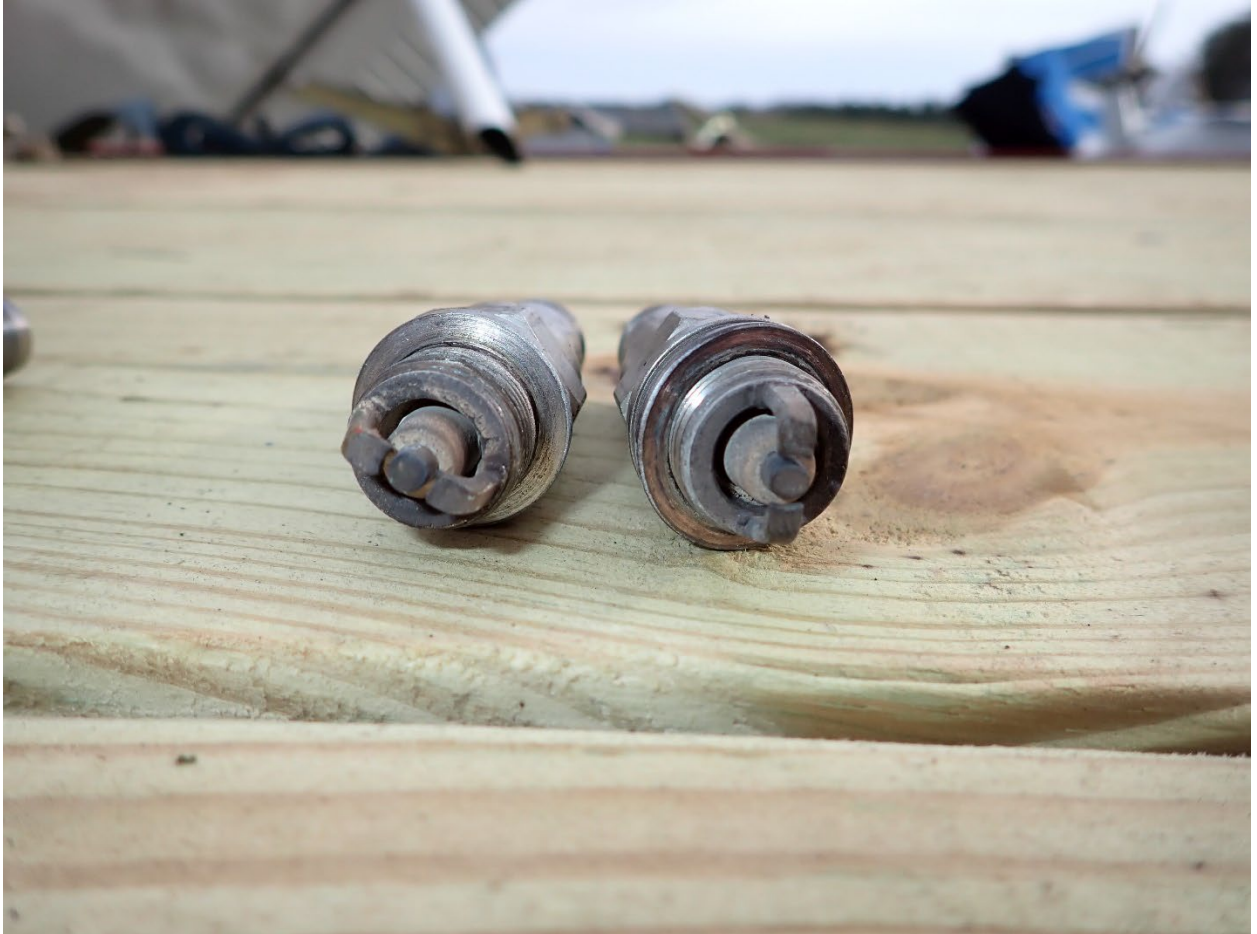
**Figure 24: Cylinder 2 and 4 top sparkplugs**

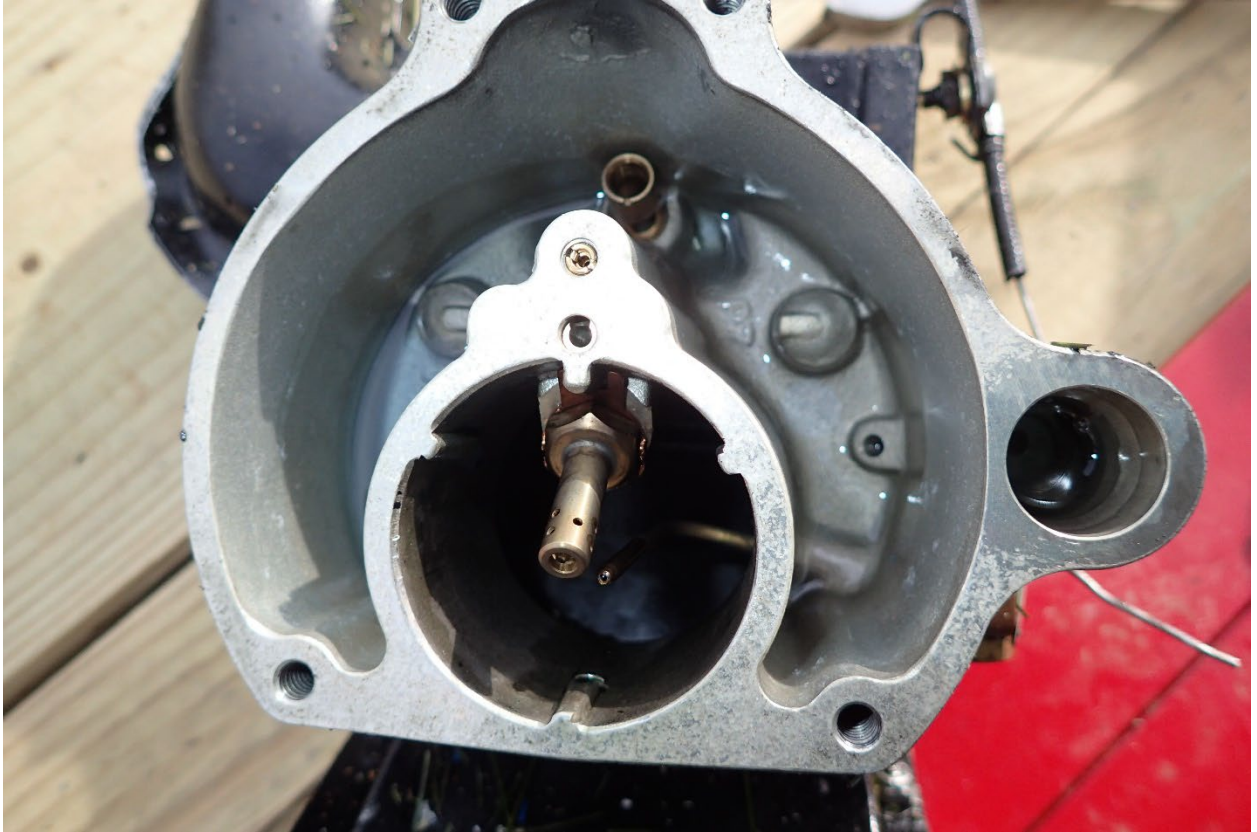
The carburetor was removed and disassembled. The accelerator pump was operated by hand and no anomalies were noted. There was fuel in the carburetor bowl, it was free of debris it was tested with water finding paste and it none was detected. The floats were examined and were not damaged. The fuel inlet screen was examined, and no debris was noted. The float needle valve was examined and operated without anomalies. The air inlet filter was examined and a small amount of organic tree debris was noted.

**Figure 25: Carburetor bowl (Textron Photo)**

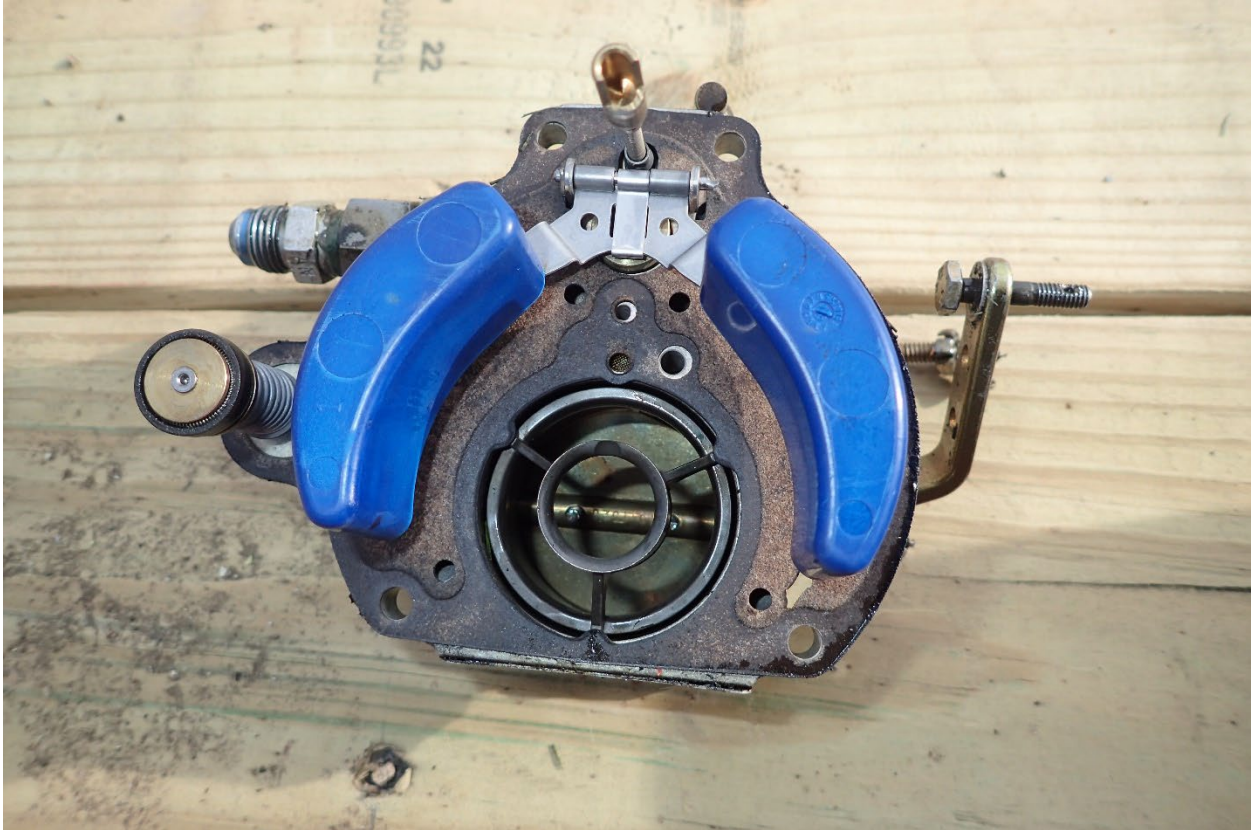
**Figure 26: Carburetor top housing (Textron Photo)**

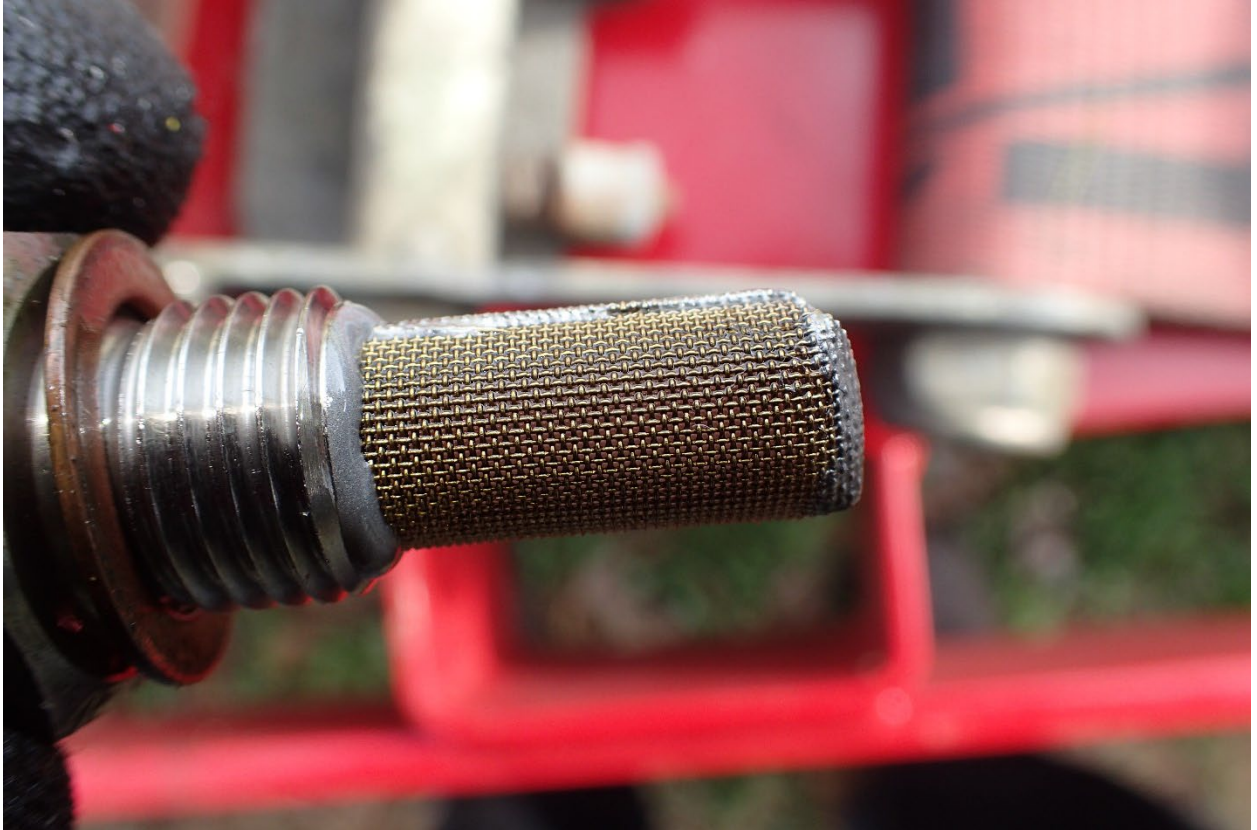
**Figure 27: Fuel inlet screen (Textron Photo)**

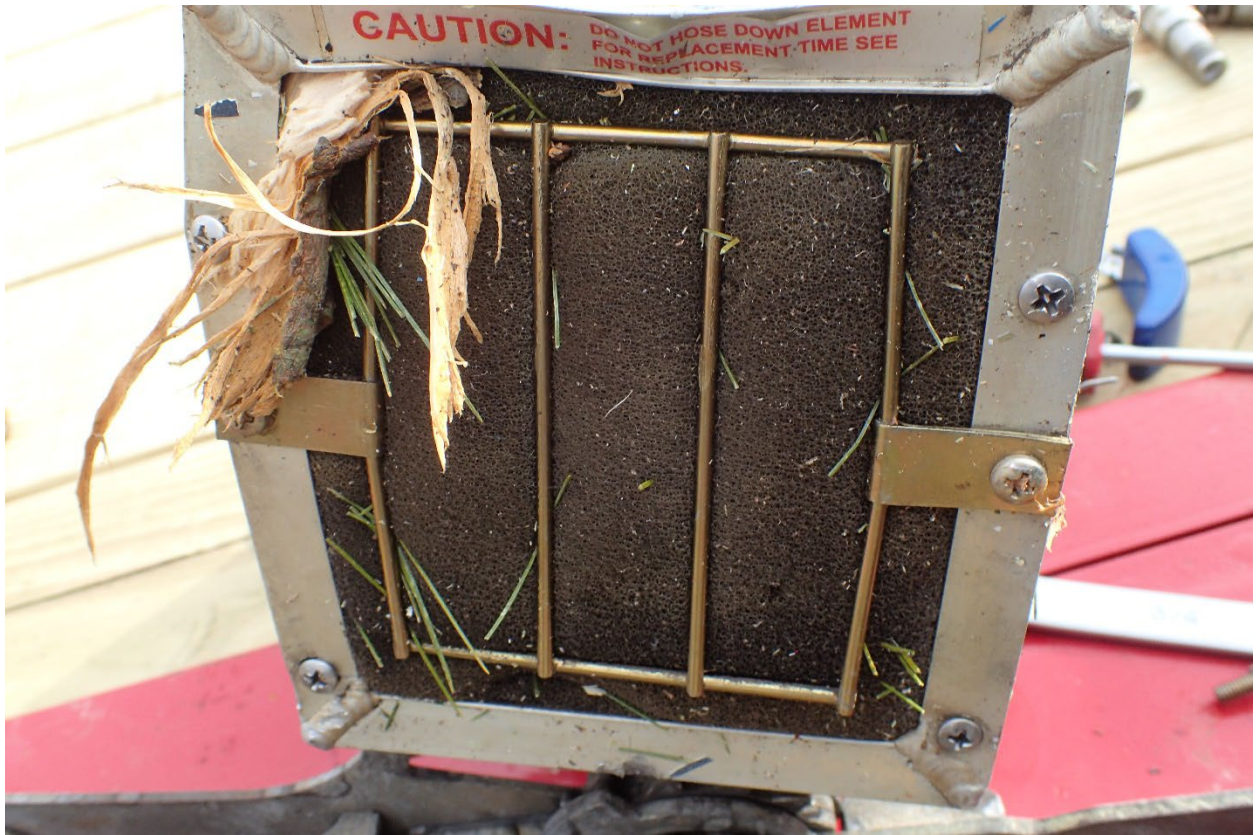
**Figure 28: Air inlet filter with tree debris (Textron Photo)**

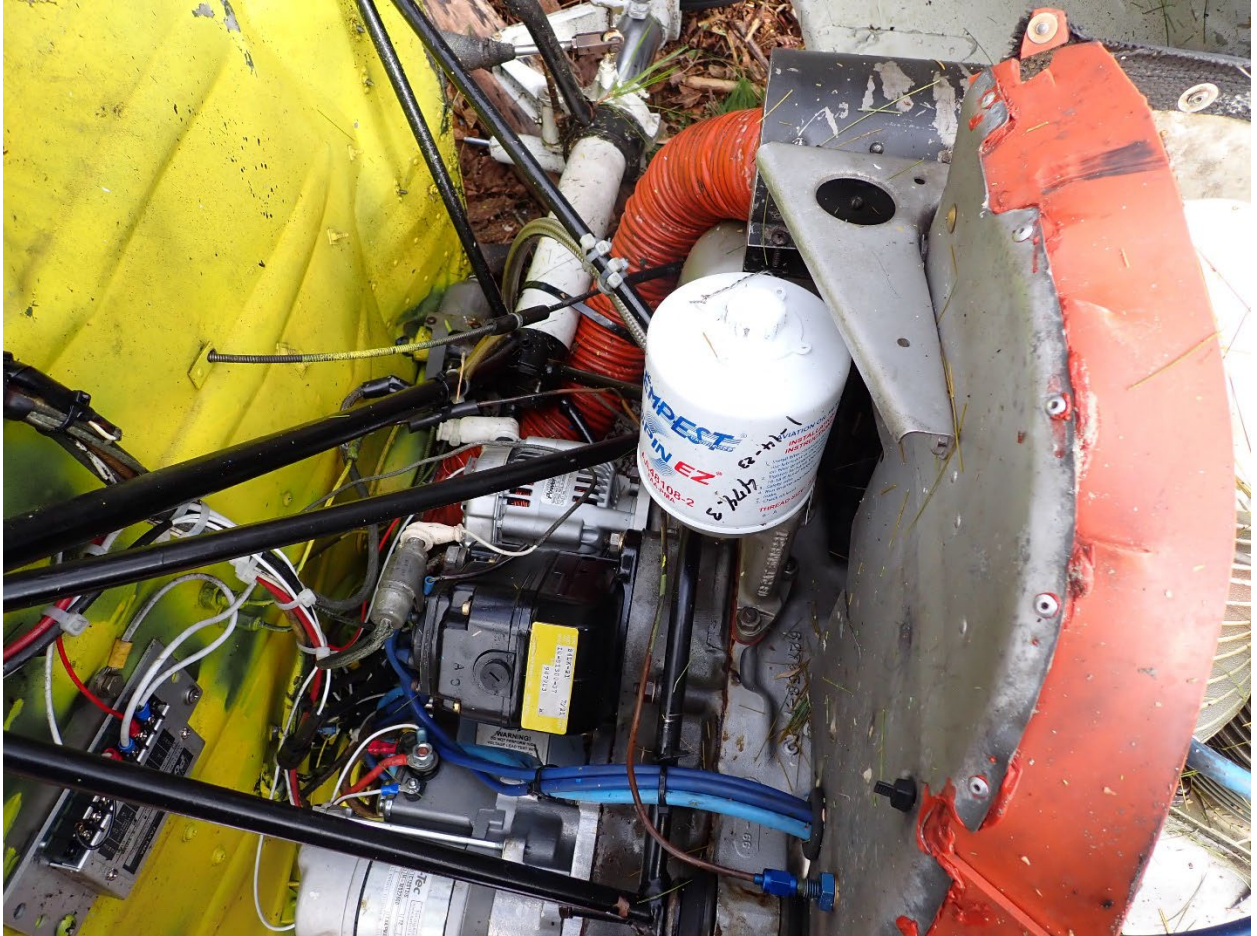
The oil filter remained attached to the engine. The oil filter cap remained attached and seated. Oil was noted throughout the engine.

**Figure 29: Oil filter attached to engine**

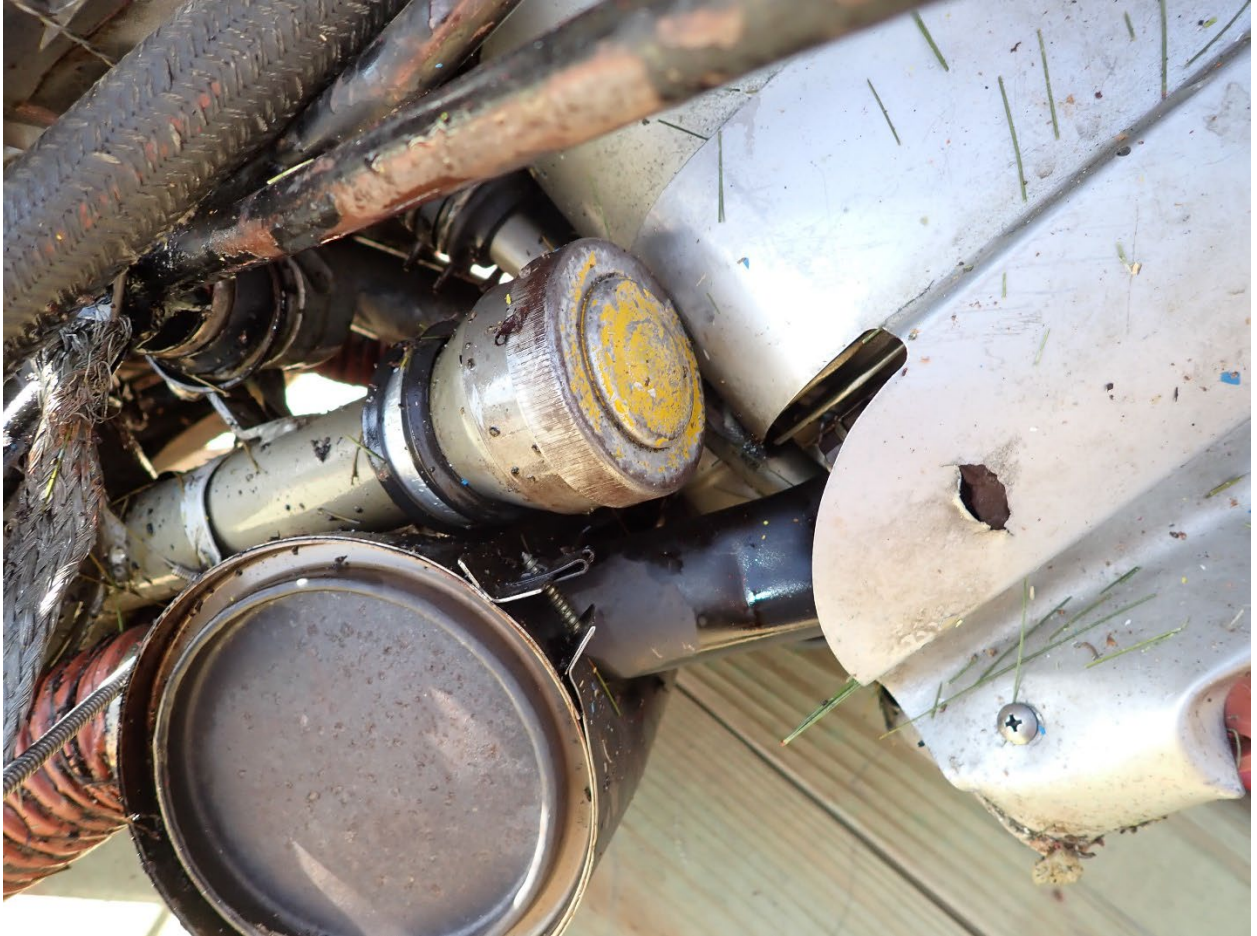
**Figure 30: Oil fill cap secured to the engine**

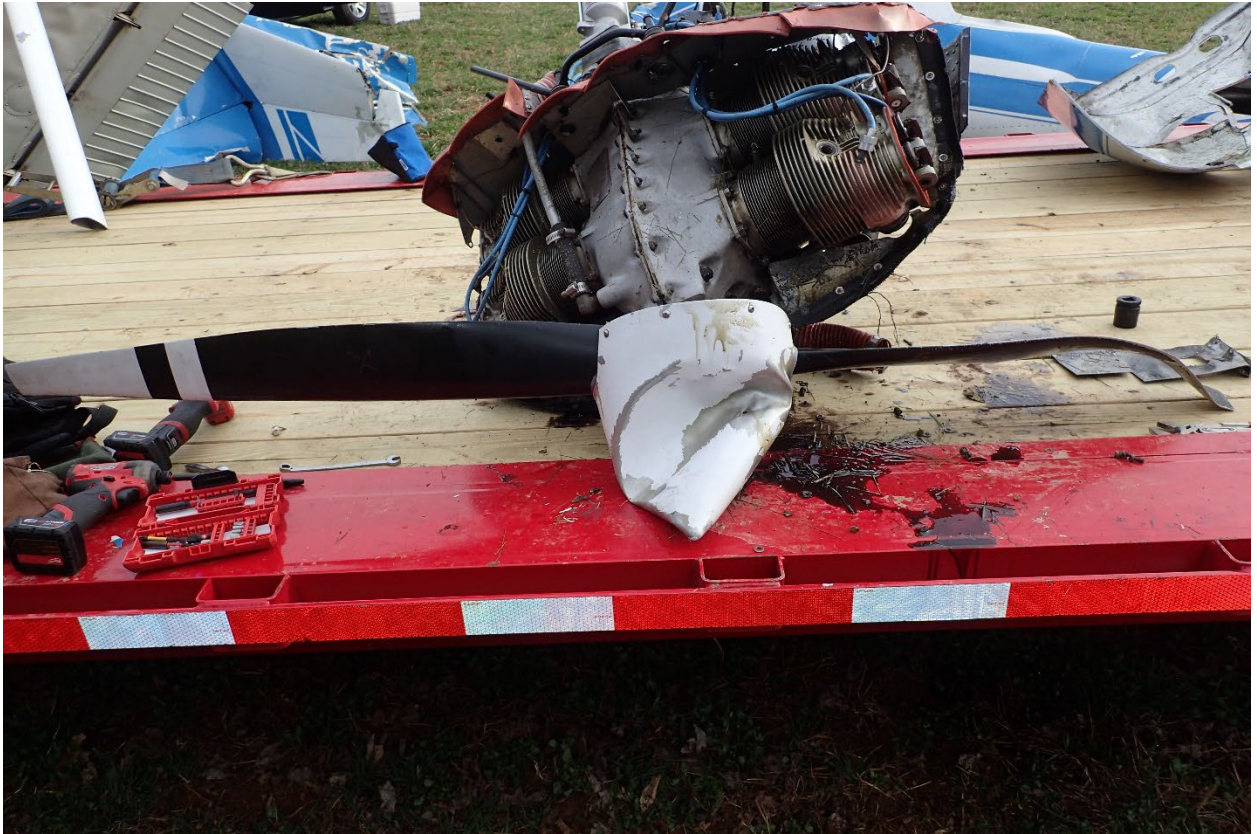
The fixed pitch propeller remained attached to the crankshaft flange and the two blades remained attached to the hub. Blade A exhibited chord wise scratching and was bent about 10°. Blade B exhibited chord wise scratching and s-bending. There were multiple pieces of wood cut at a 45° angle with black/grey paint transfer, consistent with propeller strikes.

**Figure 31: Overview of the propeller (Textron Photo)**

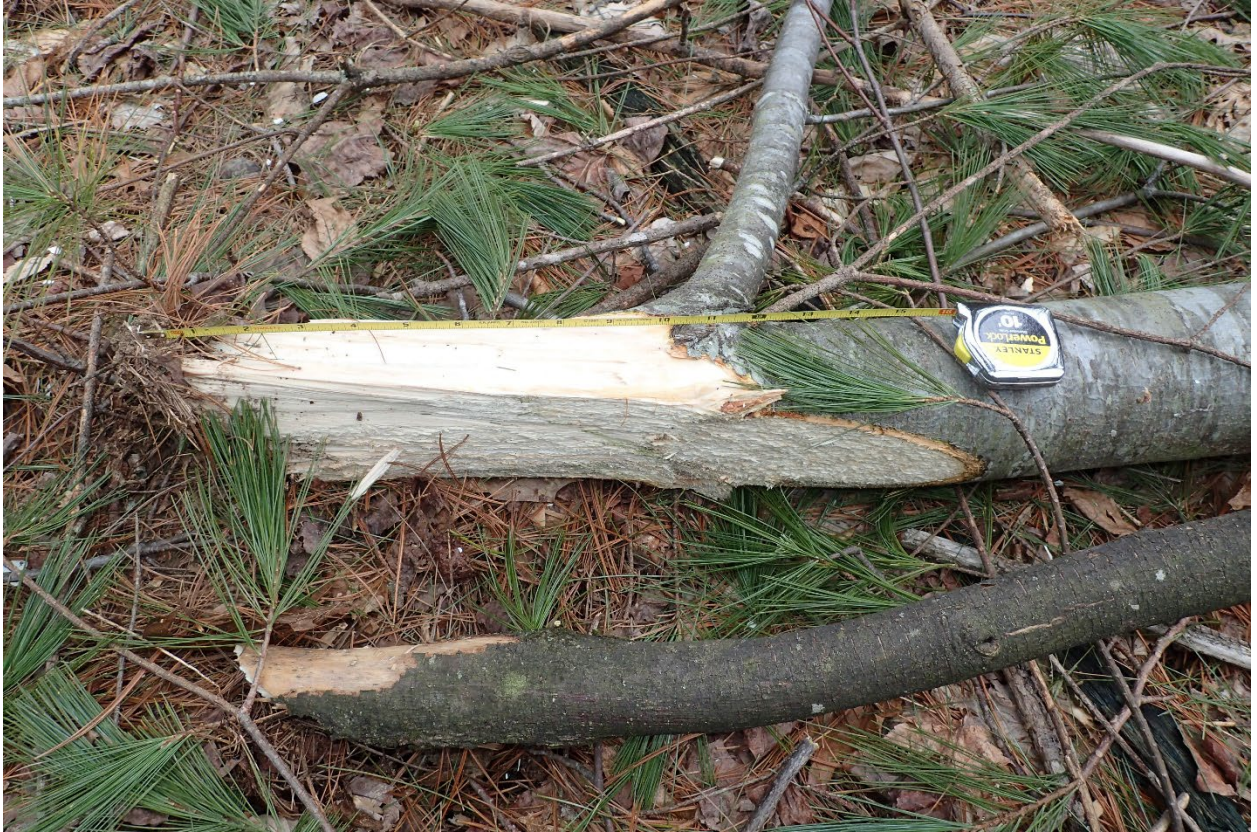
**Figure 32: Wood with a 45 degree cut (Textron Photo)**

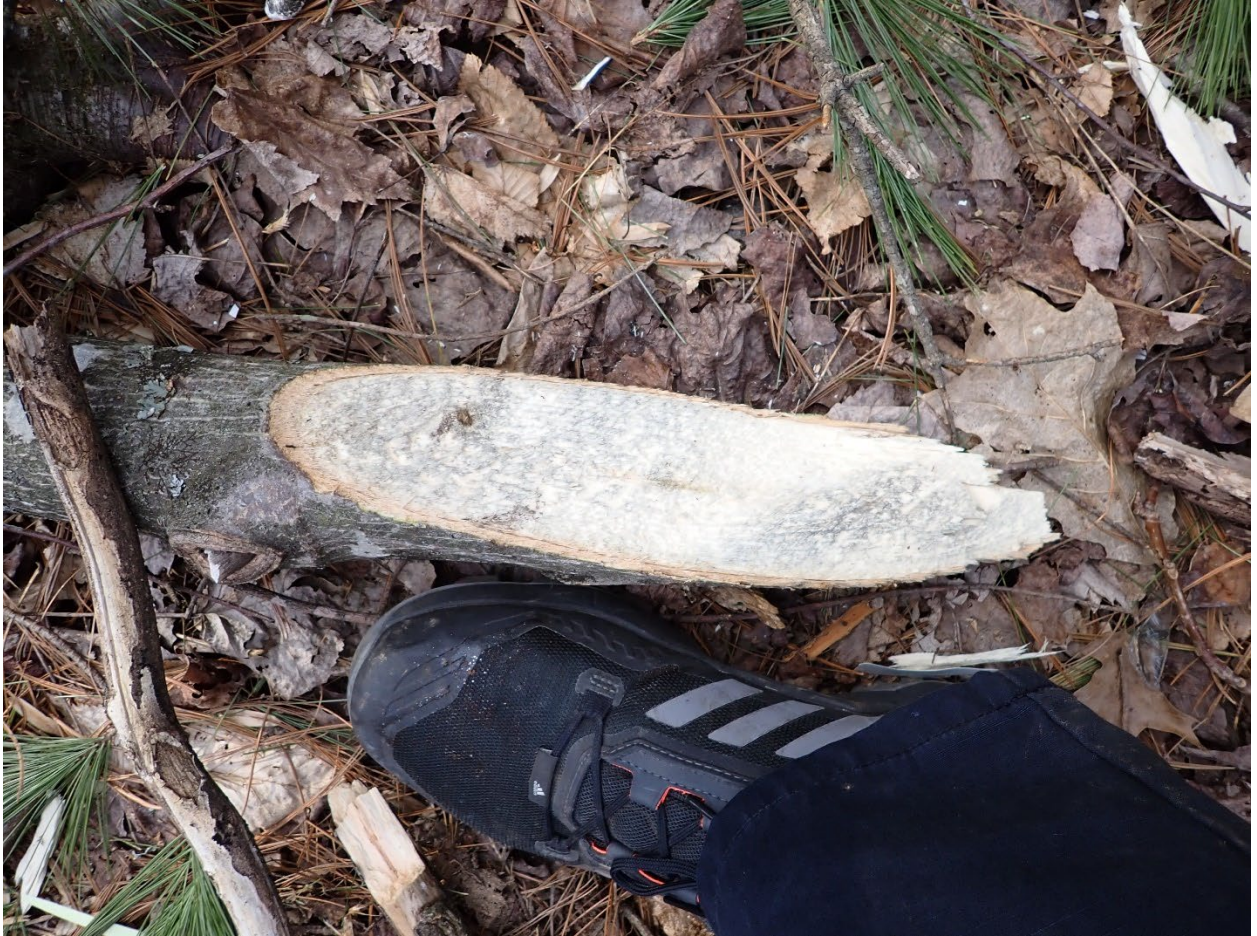
**Figure 33: Wood with 45 degree cut and black/grey paint transfer**
