Timothy W. Monville  
Sr. Air Safety Investigator  
OAS-Eastern Region Aviation

**Subject:** ERA23FA138, Record of Conversation/Interview

**Contact:** Aamro Aviation Personnel

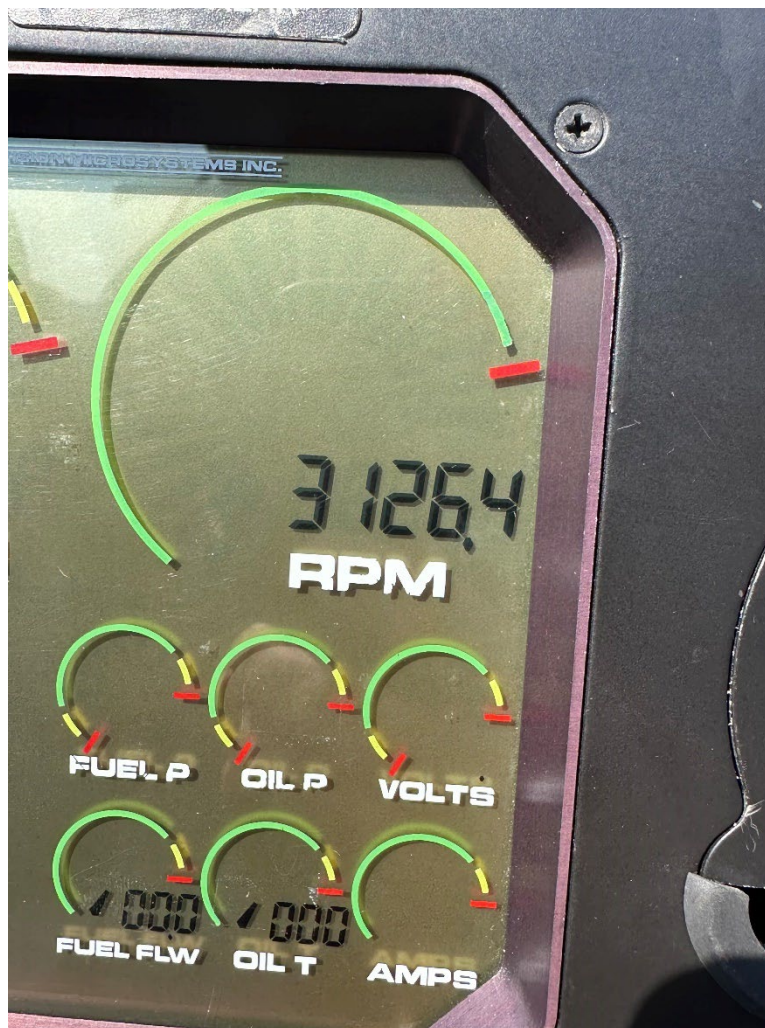
Yes, Mr. Loomis did. Mr. Loomis indicated that Mr. Marshall texted him the starting tachometer and hour meter reading when they took possession of the airplane (Figures 1 and 2).

Figure 1: Digital Photograph Provided by Mr. Loomis of Aamro Aviation. View of the Tachometer time of 3126.4, When Aamro Aviation took possession of N804ER.

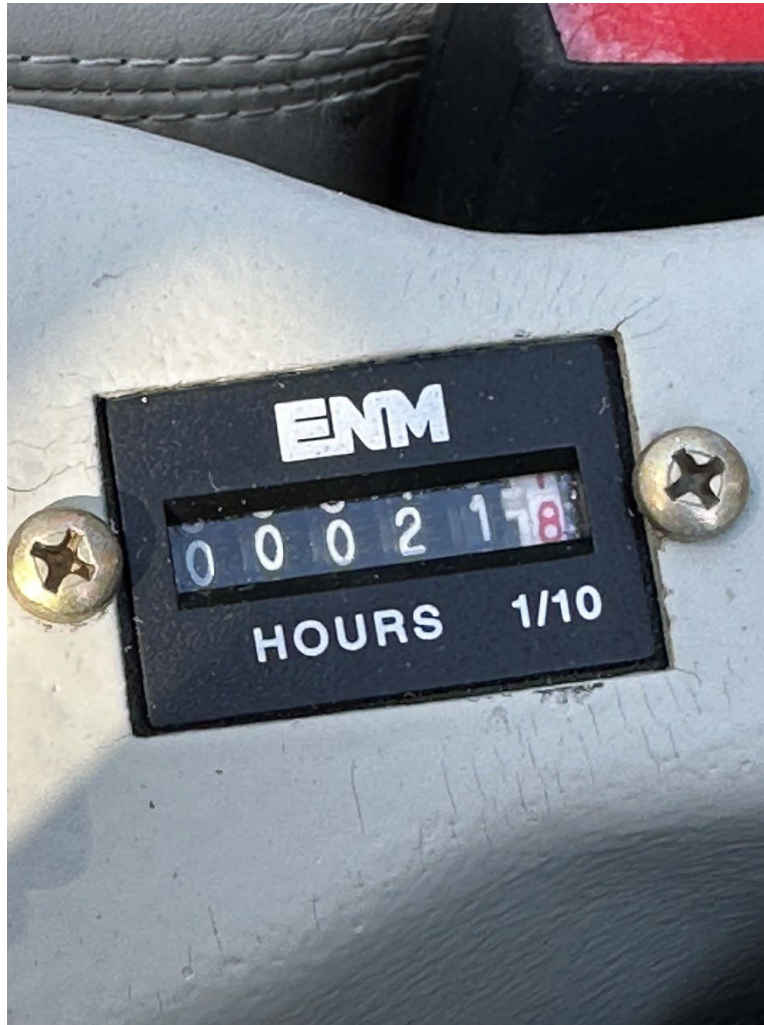
Figure 2: Digital Photograph Provided by Mr. Loomis of Aamro Aviation. View of the Hour Meter Reading 00021.8 When Aamro Aviation took possession of N804ER.
