# National Transportation Safety Board

ERA23FA138

## **MATERIALS LABORATORY**

Factual Report 23-101

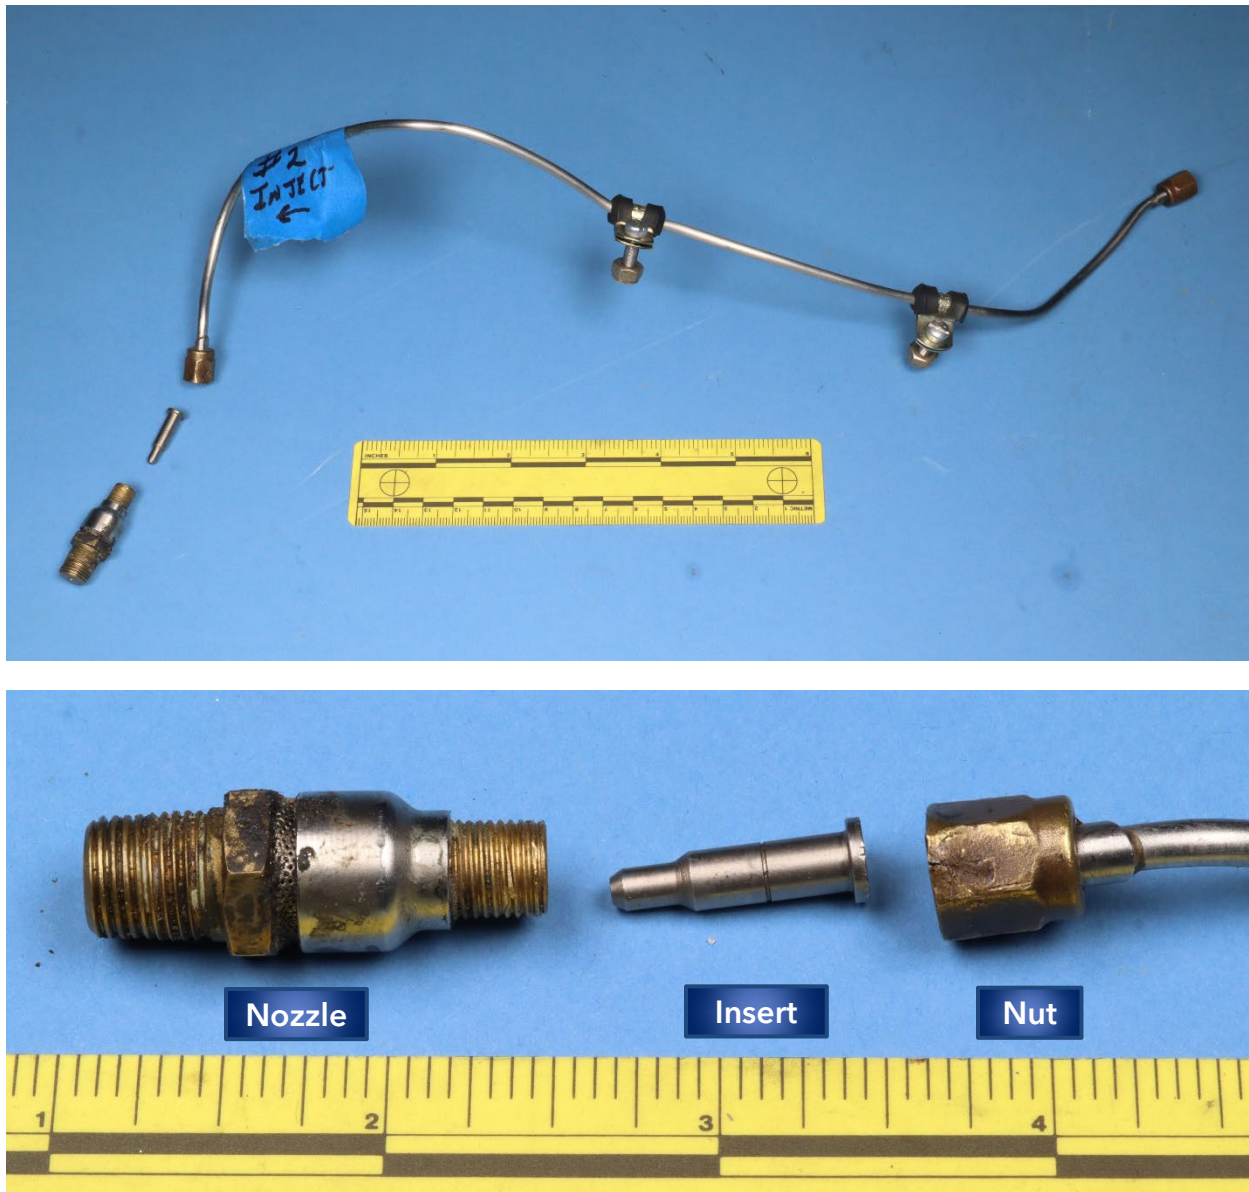
An overall view of the submitted number 2 fuel injector nozzle assembly and associated fuel line and closer view of the hardware at the nozzle are shown in figure 1. The nut and insert were received separated from the nozzle as shown in figure 1.

**Figure 1.** Overall view of the submitted number 2 fuel line and fuel injector nozzle assemblies (upper image) with a closer view of the fuel injector nozzle, nozzle insert, and nut at the nozzle end of the fuel line (lower image).

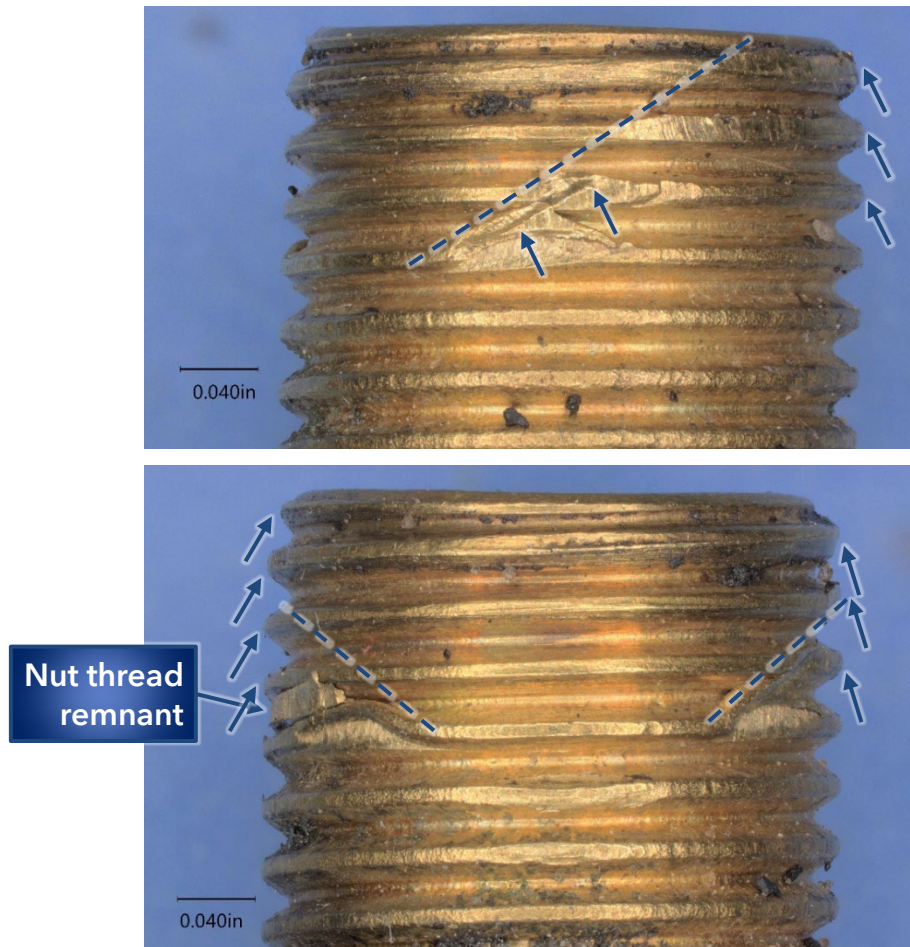
Two views of the fuel line attachment threads on the fuel injector nozzle are shown in figure 2. Around approximately  $\frac{3}{4}$  of the circumference, thread peaks showed smearing deformation toward the fuel line end of the fitting as indicated with unlabeled arrows in figure 2. In one quadrant, the thread were mostly intact as shown in the lower image in figure 2. On either side of the quadrant with intact threads, threads were fractured with angled displacement toward the fuel line end with increasing distance from the intact threads in either direction as indicated with dashed lines in figure 2.

**Figure 2.** Fuel line attachment threads on the fuel injector nozzle showing two orthogonal views rotated about the fitting axis. Arrows point to the direction of thread peak smearing, and dashed lines indicate displaced thread angles.

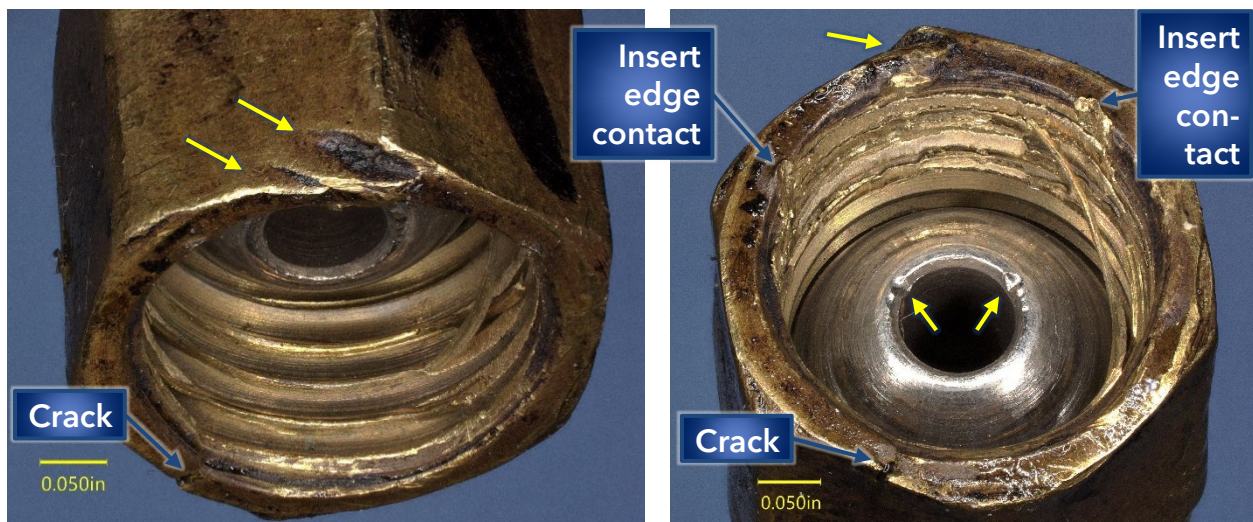
Views of the nut at the nozzle end of the fuel line are presented in figure 3, where threads on opposing sides of the nut are shown. On the quadrant shown at the left in figure 3, the threads were mostly intact with some thread damage mostly near the thread peak on the noncontact flank. On the opposing side of the nut, threads were fractured with sliding deformation consistent with the thread peaks displacing toward the nozzle relative to the rest of the nut. A small crack was observed at the end face near the middle of a wrenching flat on one side of the intact area, and the adjacent area with the intact threads was deformed radially outward.

Contact marks that deformed the edge of the nut were observed on the side of the nut opposite the intact threads as indicated with unlabeled arrows in figures 3 and 4. The marks were located on a flat adjacent to the nut end face that faced the nozzle, and the end face was deformed at the contact location. The contact marks

**Figure 3.** Views of thread damage on opposite sides of the nut for attaching the fuel line to the fuel injector nozzle. Unlabeled arrows point to contact damage on the inside diameter of the conical nipple and on the exterior of the nut.

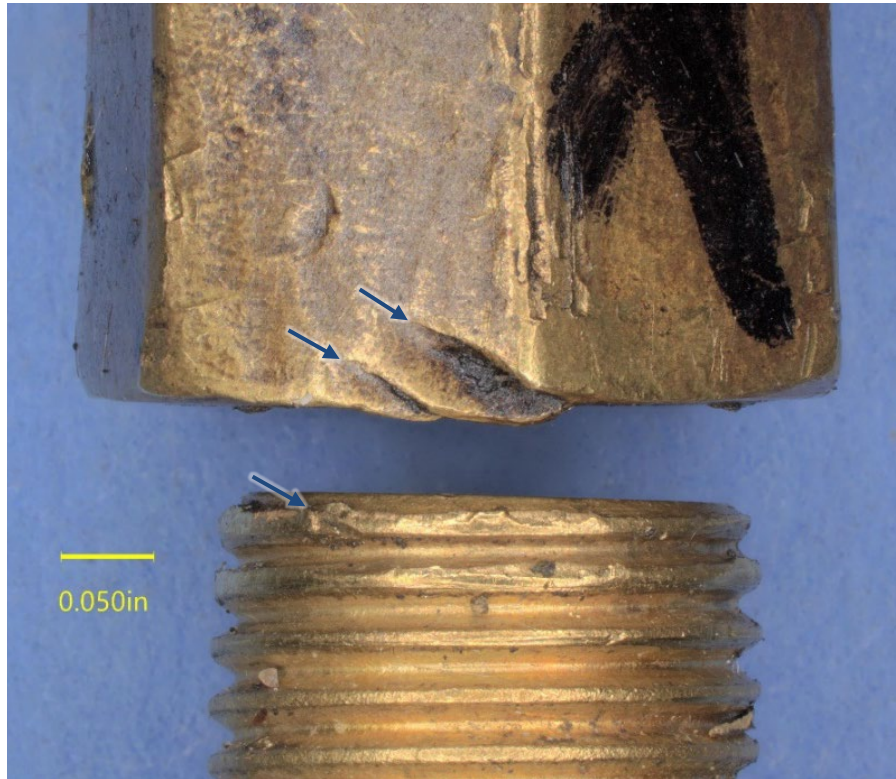
appeared as two smooth angled grooves, and arrows point parallel to the length of the groove. A groove at a similar angle and a similar location circumferentially was observed on the last thread of the nozzle as indicated in figure 4.

**Figure 4.** Contact damage on the side of the nut opposite the intact threads and corresponding thread damage on the fuel injector nozzle on the side opposite the intact threads shown in the lower image in figure 2. Unlabeled arrows point to similarly-angled contact grooves on the side of the nut and on the last nozzle thread.

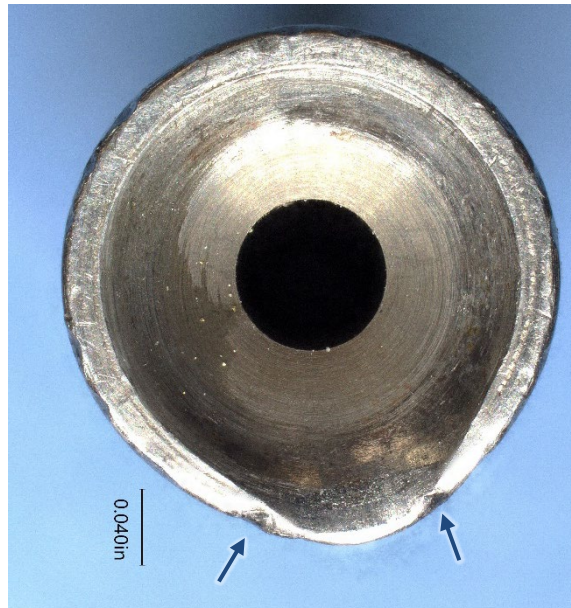
The conical sealing face for the insert from the fuel injection nozzle is shown in figure 5. One side of the sealing face was deformed radially outward with a smooth curving profile consistent with off-axis contact with the conical end profile of the mating nipple on the fuel line. Two distinct contact marks were observed at the edge of the insert on either side of the deformed area as indicated with unlabeled arrows in figure 5. The contact marks corresponded to mating marks on the inside diameter of the nipple end face as indicated in the right image in figure 3. Additional angled contact marks were observed on the sides of the nut corresponding to contact with the edges of the insert when the contact marks in the deformed area of the insert were positioned against the mating marks at the nipple opening. The contact marks corresponded to lateral and angular displacements of the fuel line nipple axis relative to the nozzle insert axis, and the orientation of the angular displacements were consistent with the orientation of the angular thread damage observed on the nozzle threads.

**Figure 5.** Seal face for the fuel nozzle insert showing a deformed edge on one side corresponding to angled contact with the mating seat on the fuel line. Unlabeled arrows point to contact damage that corresponded to marks at the inside diameter on the mating nipple as indicated in figure 3.
