# National Transportation Safety Board

ERA23FA138

## **WRECKAGE EXAMINATION SUMMARY**

Location: West Palm Beach, Florida  
Date: March 5, 2023  
Time: 2125 EST  
0225 coordinated universal time (UTC)  
Airplane: N804ER, Diamond DA-40

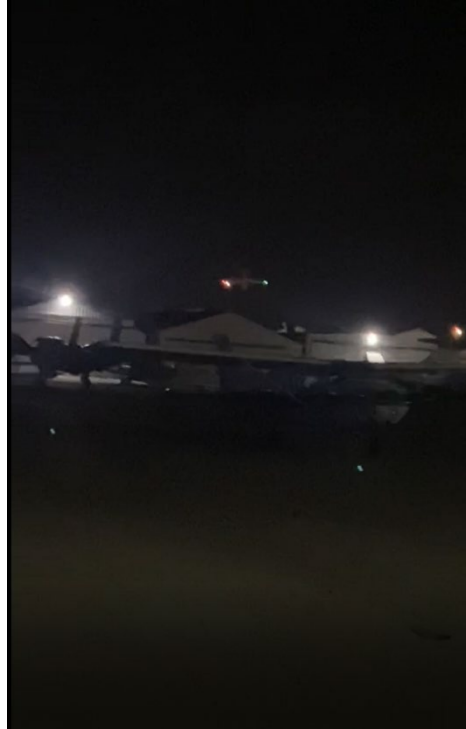
Two witnesses, both of whom knew both occupants of the airplane, were waiting on the ramp at LNA for the airplane to arrive and this information was known by the left seat occupant via text messages in-flight<sup>2</sup>. One of the witnesses held a private pilot certificate with about 60 hours total flight time and the other witness was a student pilot and a minor who had accrued about 40 hours total flight time. The pilot-rated witness reported seeing the airplane on a 10-mile final for runway 10. He reported that he planned to video record the airplane's arrival on short final but reported that at the intersection of runways 10/28 and 4/22, which was located about 800 ft from the approach end of runway 10, the airplane started to "go-around." It had descended no lower than 20 to 30 ft above ground level (agl) and did not touch down. He then began to record a video of the flight and reported that the engine was "constantly smooth" as the airplane flew over runway 10. He noted the airplane climbed no higher than between 200 ft and 250 ft agl, then when at or just past the departure end of the runway the airplane banked to the right, stalled, and rolled inverted (Figure 1).

The student pilot reported that when the flight was at the departure end of runway 10, it made a "sudden 45° right bank" which was not expected. It was at that point of the flight that he and the other witness began video recording with sound. He noted the airplane banked right, the nose leveled off, then entered a steep turn of 60°. When the nose of the airplane was pointed towards them, the right wing stalled,

and the airplane became inverted. He also stated that to him it never sounded like full power, and from the point of landing he never heard a huge change in engine sound. He also added that the engine sounded ok during the turn to behind the hangars, then it went silent.

Figure 1: ScreenShot From Witness Video. Note the Inverted Airplane Just Above the Hangars.

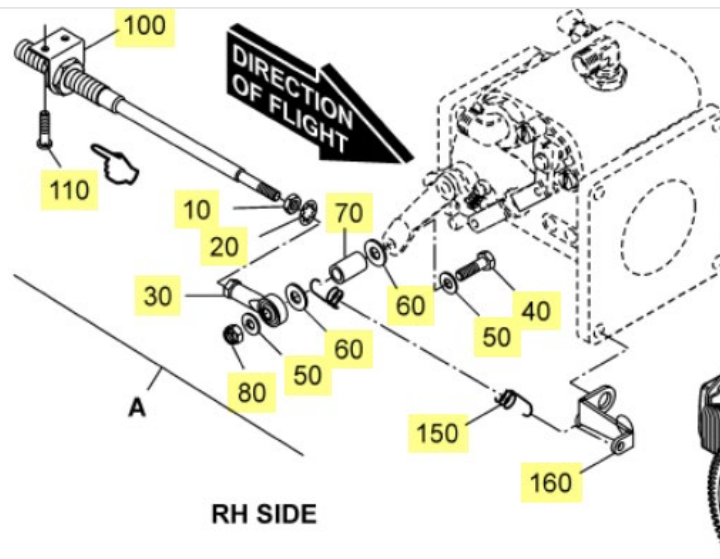
The fuel servo was controlled from the cockpit at an engine control assembly in the center console that holds in part the throttle and mixture control levers. The throttle control lever in the cockpit sets the position of the throttle control lever at the fuel servo and the two ends are mechanically connected by a Bowden cable. The throttle control cable has on the end in the engine compartment a cable eye, or rod end that attaches to the throttle control lever at the fuel servo. (Figure 2).

**Figure 2: Throttle Control Attachment at Fuel Servo.**

The throttle control cable attach hardware in the engine compartment was equipped with a spring, Part Number (P/N) RZ-063E-12X attached to the hardware securing the throttle cable to the throttle lever at the fuel servo and also to a Spring Anchor Bracket attached to the fuel servo. The spring was designed and part of the initial type certification so that if the throttle control separated at the engine fuel metering device, the tension spring was intended to drive the throttle control to full power.

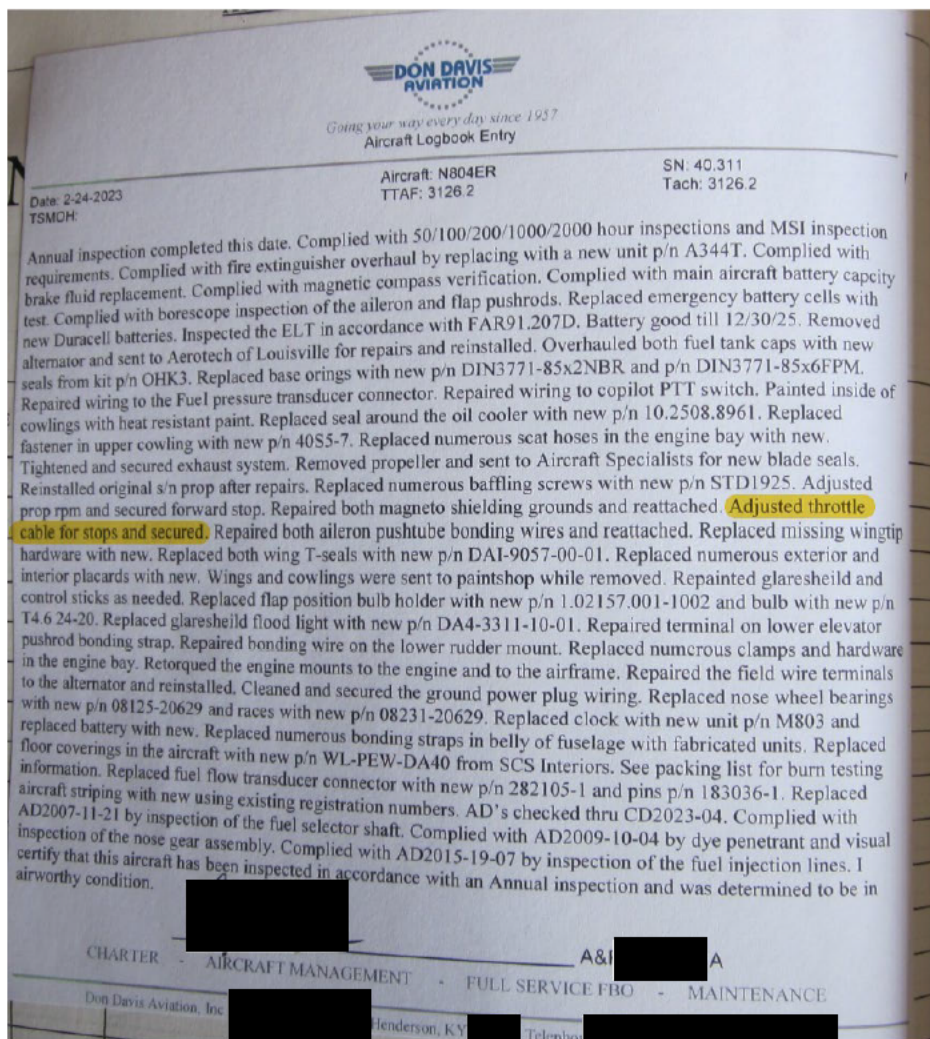
As part of the last airplane and engine inspection, the throttle cable was adjusted and secured (Figure 3).

**Figure 3: View of the Entry Showing Throttle Cable Adjustment.**

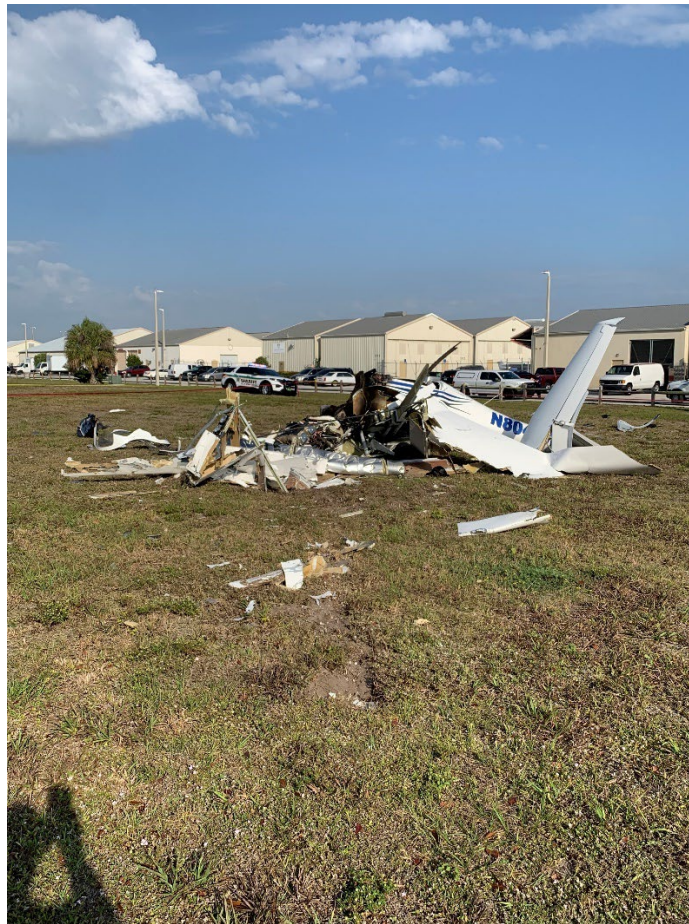
The airplane crashed on airport property near the departure end of runway 10, south of hangars on the south end of the airport adjacent to Lantana Road (Figure 4). The accident site was located at 26.588181° north latitude and -

**Figure 4: View of the Wreckage at the Accident Site Location.**

Examination of the accident site revealed a ground scar associated from the left wing consistent with the airplane being on a magnetic heading of 228°. The airplane was upright leaning on its right side on a magnetic heading of 221°. All components necessary to sustain flight remained attached or were found in close proximity to the main wreckage.

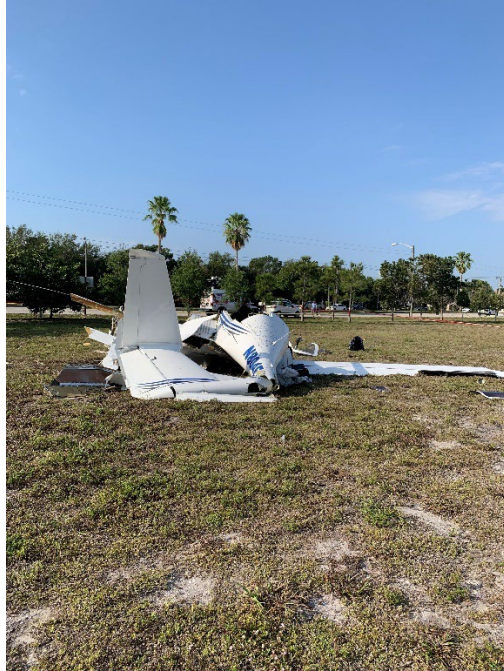
The aft empennage was displaced to the left (Figure 5).

**Figure 5: View Showing the Aft Empennage Displaced to the Left.**

Examination of the elevator flight control system revealed continuity from the control surface to the idler lever where the threaded portion of the eye end fitting with spherical bearing exhibited bending overload. The rod was deformed

about 90° near the lower fin in the area where the aft empennage was displaced to the left.

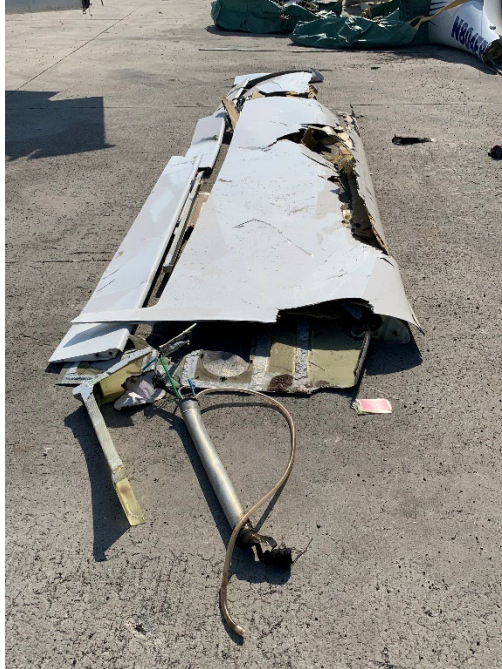
Examination of the left wing (Figure 6) revealed it was fragmented which exposed the fuel tank which was impact damaged. The main spar was fractured. The flap was fragmented into 2 pieces but found in close proximity to the wing. The transfer pins of the transfer lever were nearly parallel to the longitudinal axis of the fuselage.

**Figure 6: View of the Reconstructed Left Wing.**

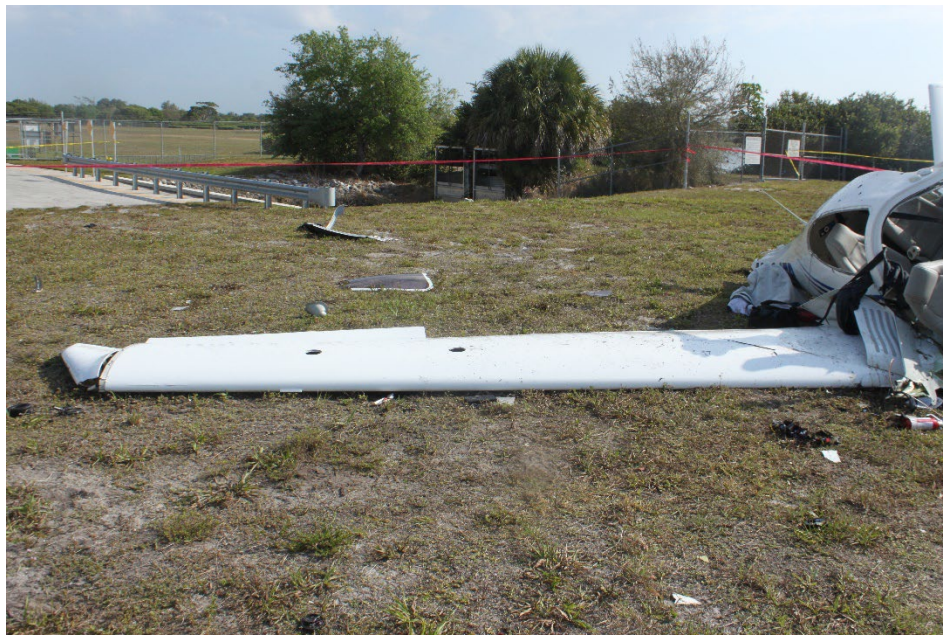
Examination of the right wing (Figure 7) revealed it was full span; the wingtip was in close proximity to the end of the wing. The flap appeared to be extended, but the transfer pins attached to the transfer lever appeared to be parallel to the longitudinal axis of the airplane<sup>5</sup>. About 6 gallons of fuel consistent with 100LL were drained from the fuel tank. The flap and aileron remained connected. The flap was separated at the inboard connection at the transfer lever/pins and the outboard hinges; the outboard hinge was displaced aft consistent with impact. All remaining flap hinges remained connected.

**Figure 7: View of the Right Wing.**

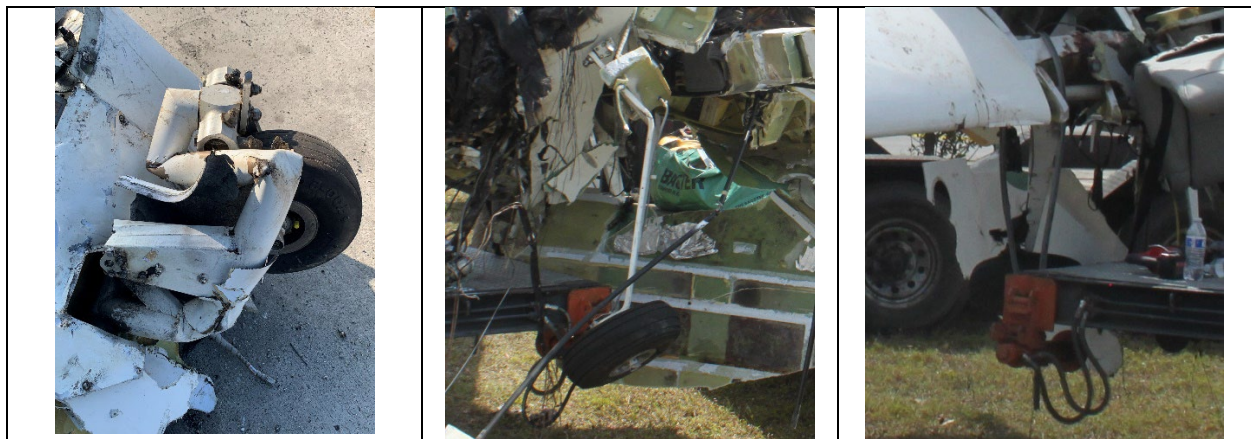
The nose landing gear was displaced from its normal position and the nose gear leg tubular strut exhibited extensive impact damage. The left main landing gear attach hardware and mounting block remained in position, but the adjacent structure was separated. The right main landing gear was displaced from its normal position.

**Figure 8: Views of the Landing Gears.**

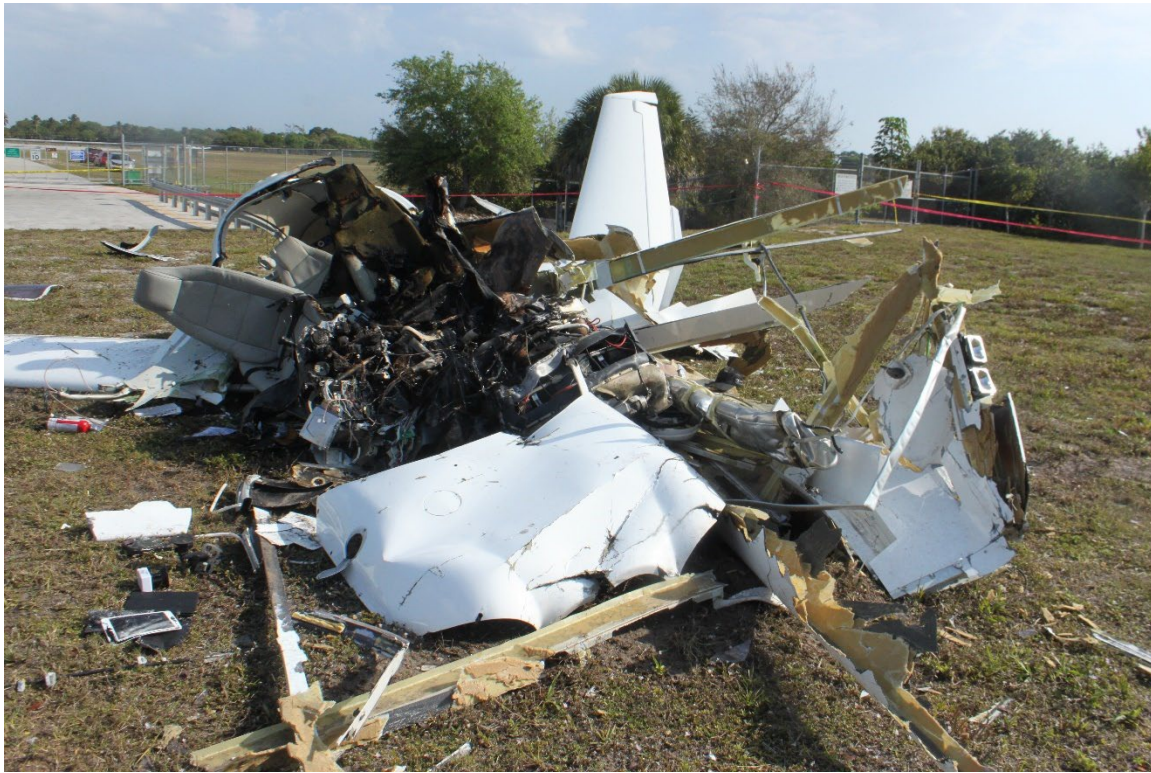
Examination of the cockpit revealed extensive impact damage in addition to fire damage to the left front seat, the left side of the instrument panel, the

inboard edge of the right front seat, firewall, and slightly to the aft portion of the engine (Figure 9).

**Figure 9: View Showing the Damage to the Cockpit.**

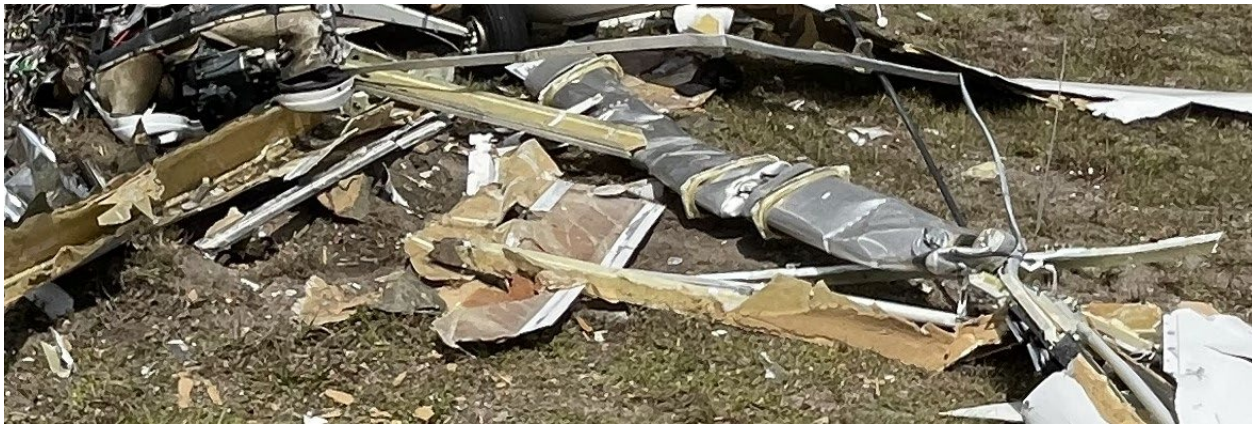
The left fuel tank was impact damaged (Figure 10), while the right fuel tank was drained and found to contain about 6 gallons of 100 low lead fuel.

**Figure 10: Impact Damaged Left Fuel Tank.**

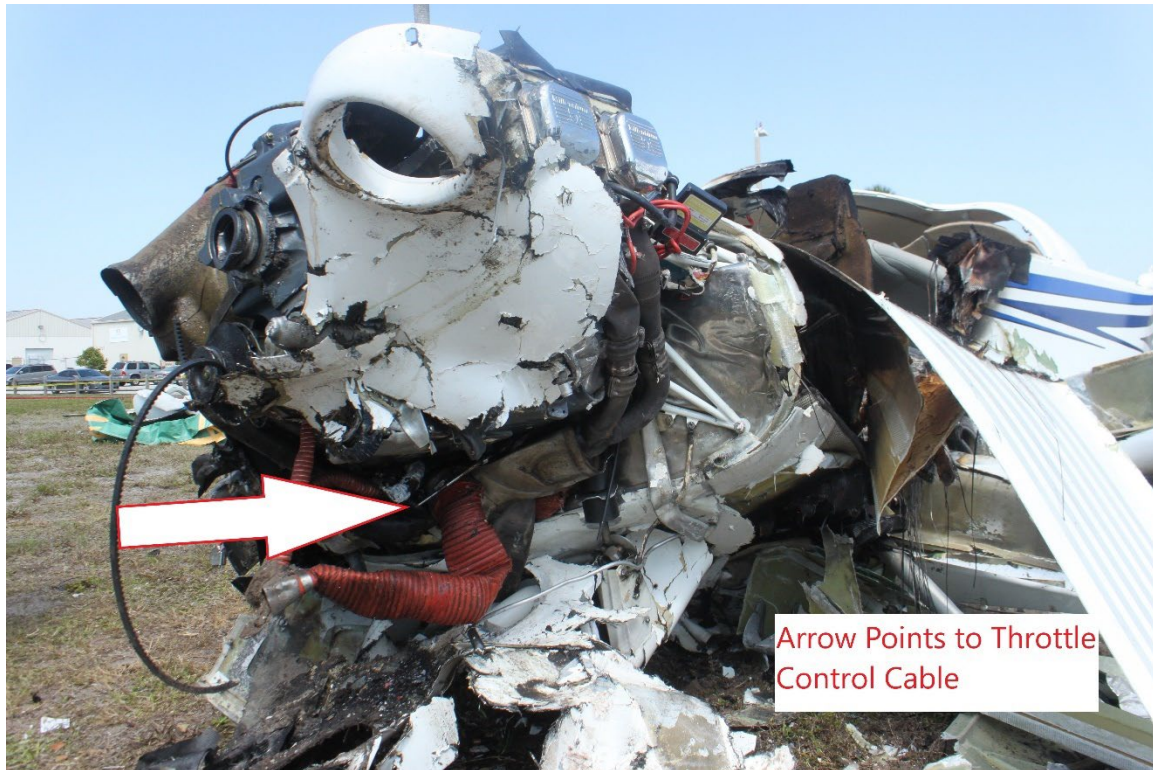
While lifting the wreckage for recovery, the throttle control cable was not attached to the throttle control lever of the fuel servo (Figure 11).

**Figure 11: View Showing Separated Throttle Control Cable.**

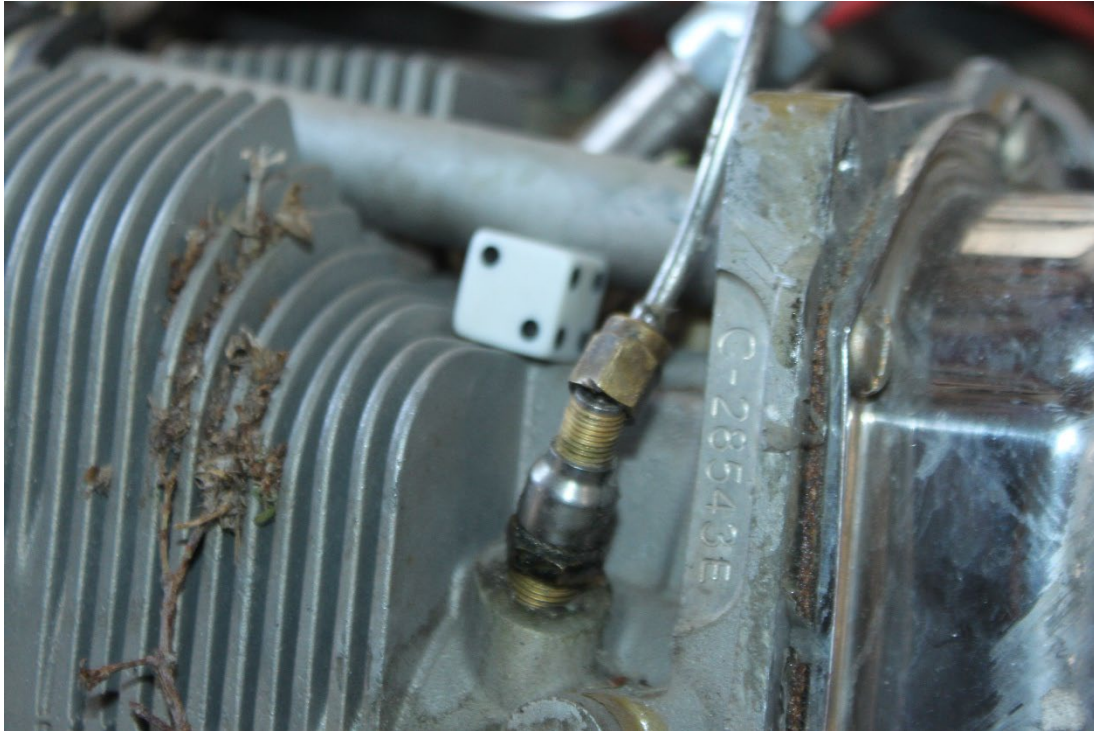
Examination of the engine fuel metering system revealed the No. 2 cylinder injector line was separated from the injector nozzle, but the line was near the nozzle (Figure 12). All other lines remained tightly secured to their respective nozzles. The fuel servo remained attached to the oil sump and air plenum and the mixture control cable remained attached to the mixture control lever that was impact damaged, but as previously noted, the throttle control cable was not attached to the throttle control lever. The end of the throttle cable that would have contained a rod-end exhibited bending overload (Figure 13). A bolt that secured the throttle control to the throttle control lever was in-place at the lever, but a nut was not affixed to the bolt, and the nut and throttle control rod-end were not located<sup>8</sup> (Figure 14). The flow divider was free of contaminant and the diaphragm was intact. Examination of the fuel servo inlet screen revealed it was clean; a slight amount of fuel consistent with 100 low-lead drained from the inlet when the fuel line was removed.

**Figure 12: View Showing the Separated Fuel Injector Line From the No. 2 Fuel Injector Nozzle.**

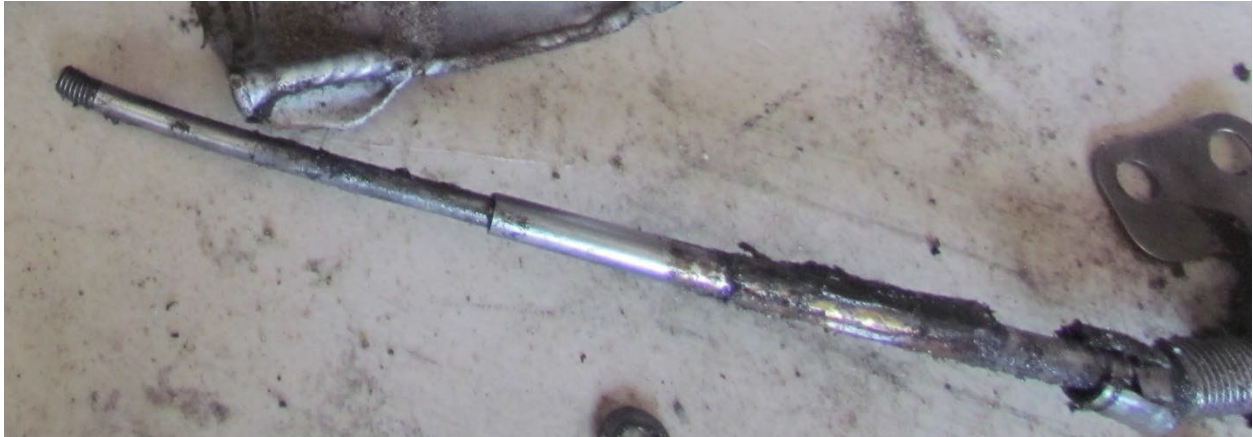
**Figure 13: Bent and Fractured Throttle Control Cable.**

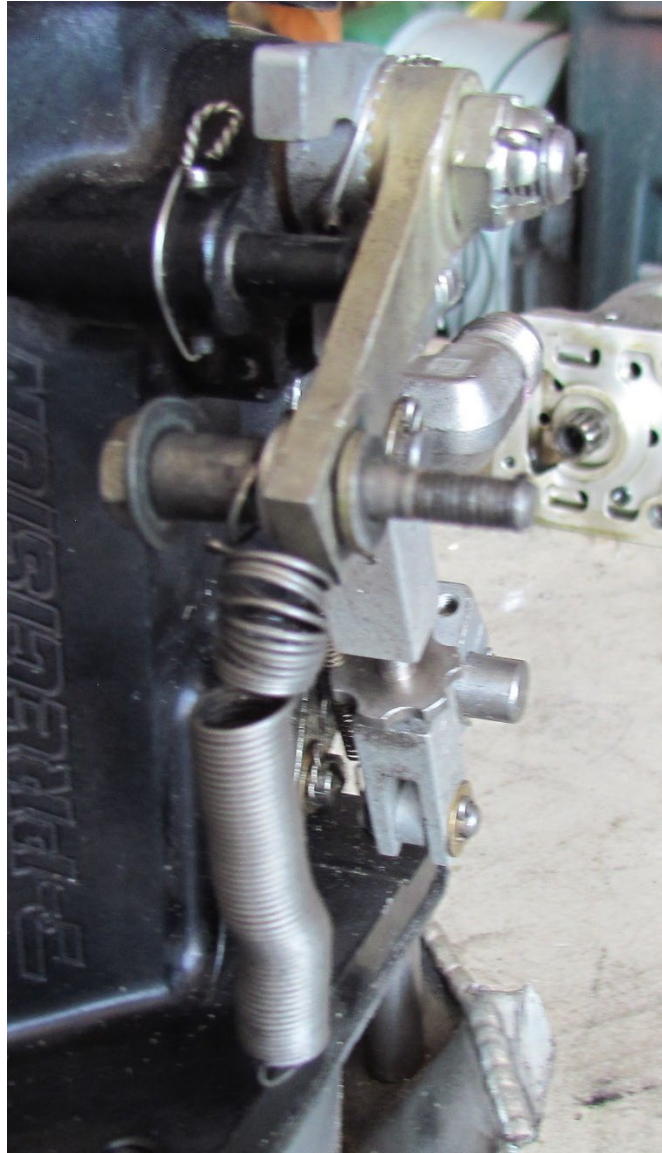
**Figure 14: View of the Hardware Still Attached to the Throttle Control Lever at the Fuel Servo.**

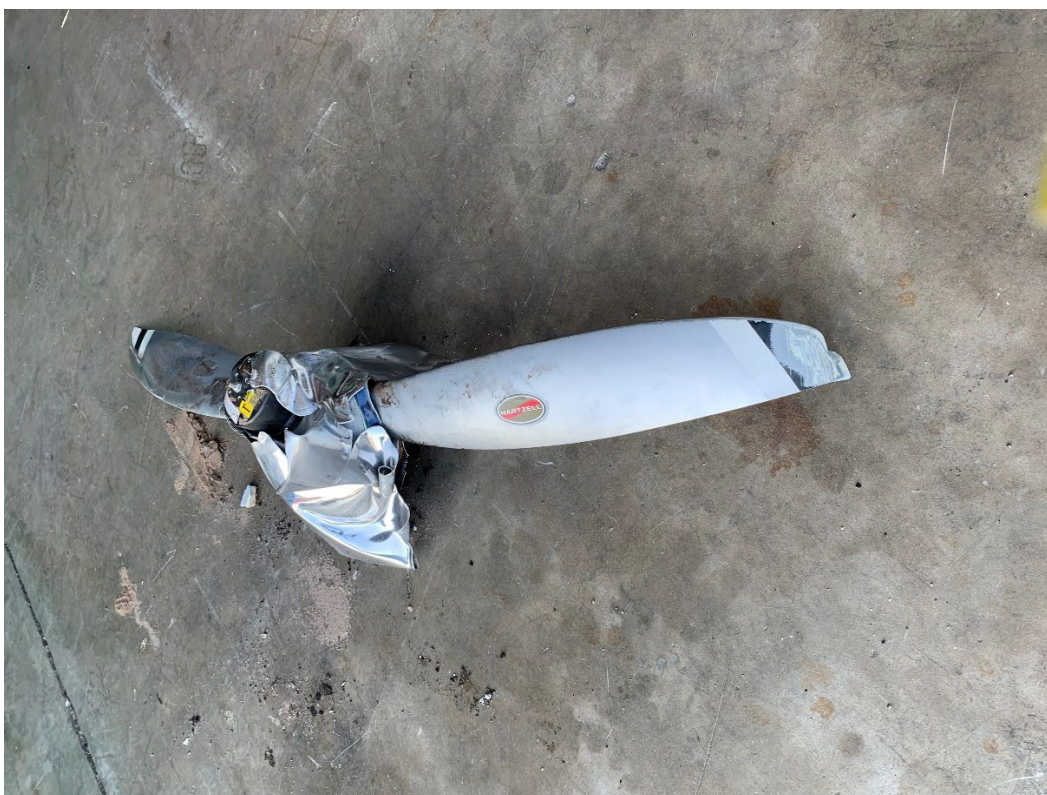
Examination of the Hartzell propeller, S/N CH39358B revealed both blades remained secured in the propeller hub and the crankshaft flange remained attached to the propeller flange (Figure 15). Blade marked "A" exhibited a slight aft bend about 10° and leading-edge twisting towards low pitch. The blade tip was curled aft about 90° beginning 3 inches from the tip. The leading edge of the blade was polished from about 1/3 span out to the tip. A section of blade was missing at the tip on the trailing edge. Blade marked "B" exhibited scratches on the cambered side of the blade, and a heavy gouge on the blade back about 5.5 inches from the hub.

**Figure 15: View of the Propeller Assembly.**
