# National Transportation Safety Board

ERA23FA163

## **WRECKAGE EXAMINATION**

Aircraft: AR-1 gyroplane

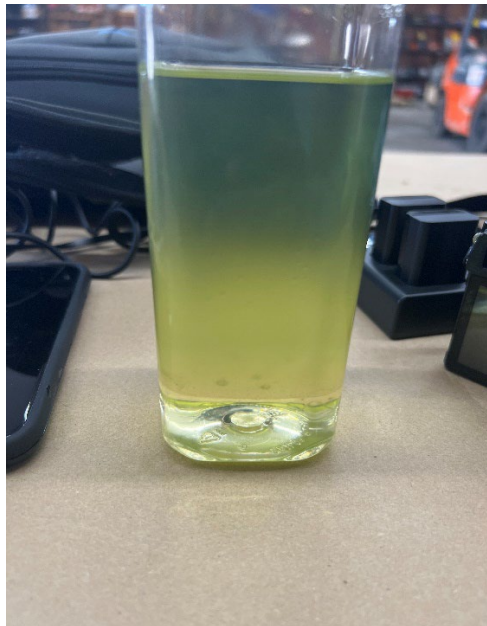
The fuel system remained intact, with the fuel cap securely locked in place. The fuel sample drained from the tank was light green in color. A fuel sample defueled from the tank showed a significant amount of water contamination. About 6 gallons of fuel was defueled, and the fuel pumps were activated to remove the remaining contaminated fuel. Water-finding paste confirmed the presence of water. The fuel was placed in a clear container, and visible water was observed after the fuel mixture settled.

Image of water settled in the bottom of the container

Multiple test runs were performed using both fresh and contaminated fuel. During the engine test, all contaminated fuel recovered from the fuel tank was used in the initial test runs. It was observed that when the contaminated fuel was mixed, the engine ran normally until the fuel and water began to separate and settle. Once this separation occurred, the engine would sputter, lose power, and eventually stall. Aside from the fuel contamination, no other issues were found that would prevent normal engine operation.
