# National Transportation Safety Board

ERA23FA163

## **ONBOARD IMAGE & GPS DEVICE**

Location: Gainesville, Georgia  
Date: March 25, 2023  
Time: 13:52 eastern daylight time (EDT)  
Gyroplane: Preiss AR-1, N47AR

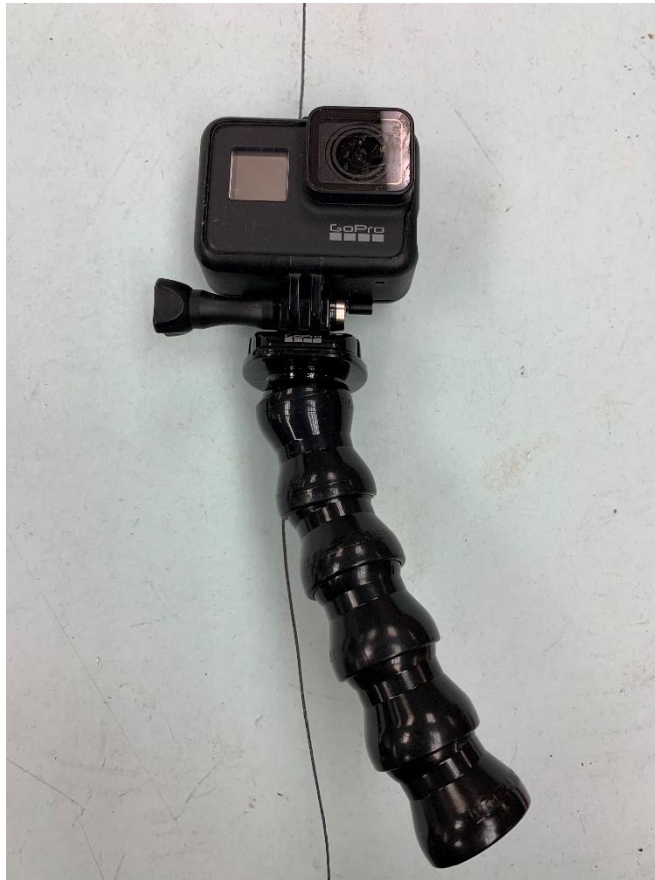
Both devices were in good condition and the data were downloaded using the manufacturer's procedure.

**Figure 1.** Photo of GoPro Hero 7 Black.

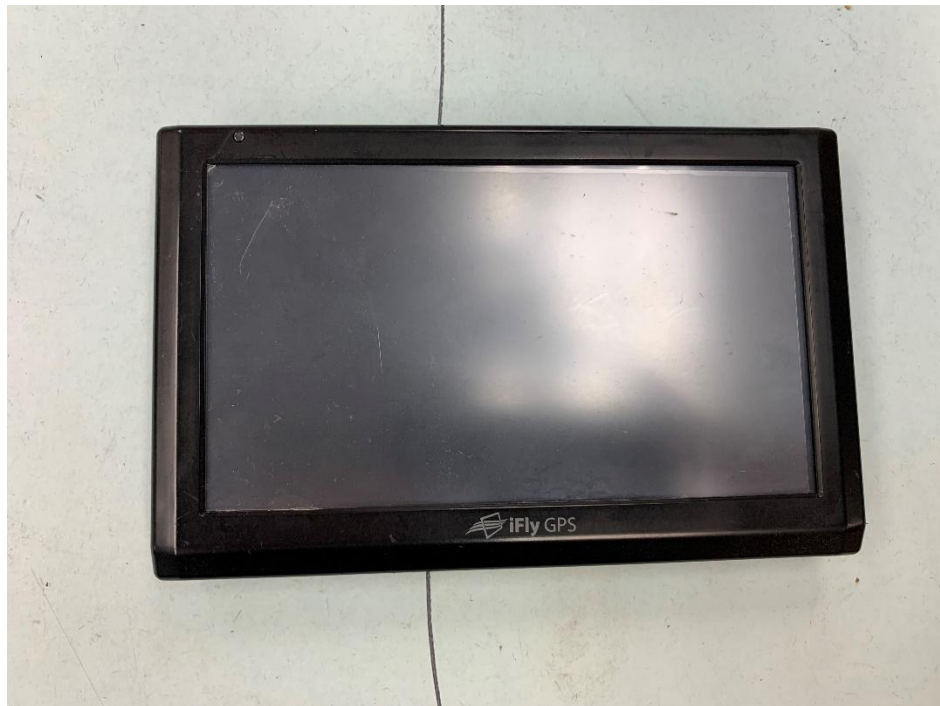
**Figure 2.** Photo of iFly GPS.

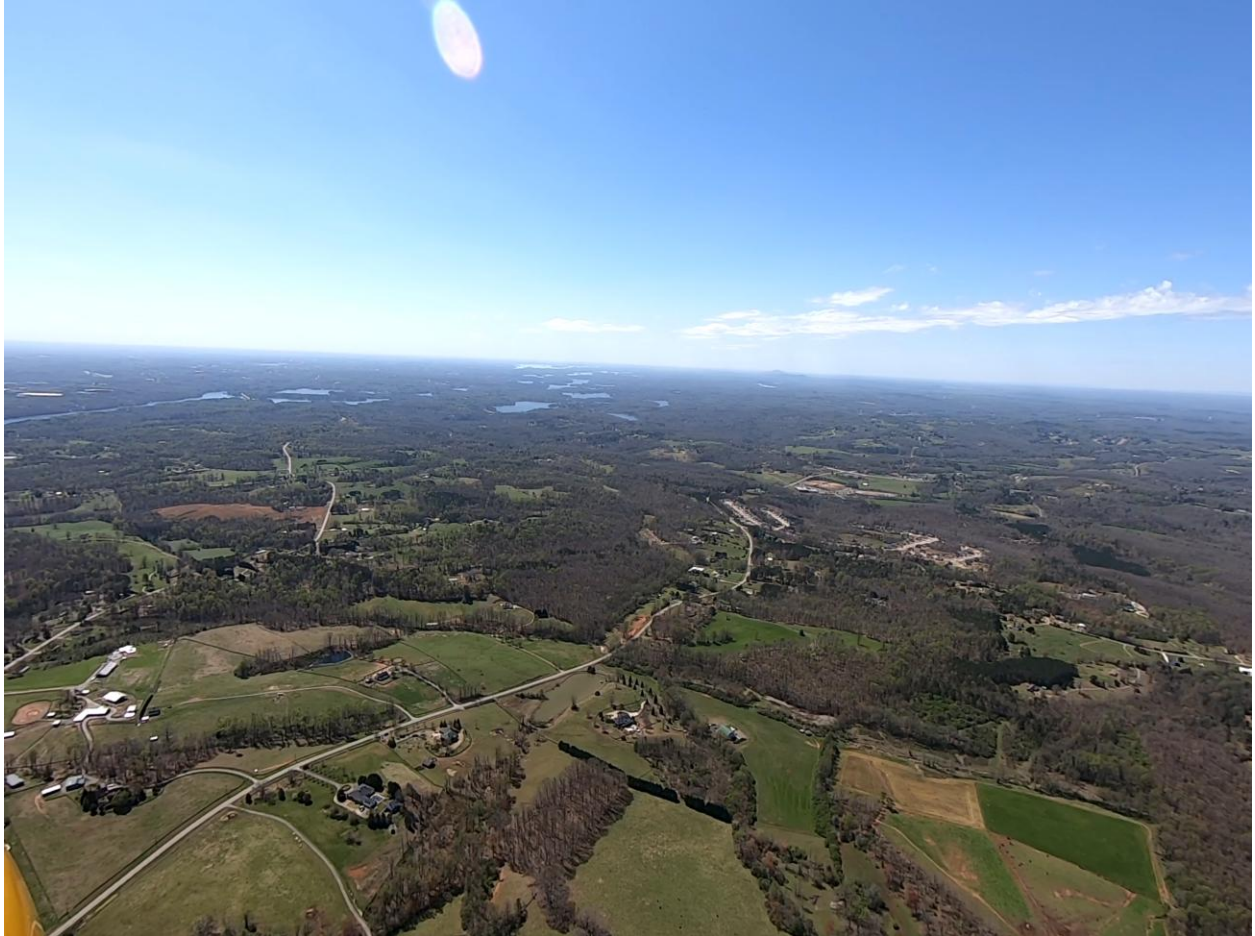
Around 4 minutes and 40 seconds elapsed time, the engine noise appeared to surge three times. By 4 minutes and 50 seconds elapsed, the engine noise appeared to significantly lessen. Steady rotor noise was still audible. Figure 3 is a screenshot from the GoPro at this time which shows the terrain ahead and partially below the gyroplane.

Around 4 minutes and 50 seconds elapsed, the audio could be characterized as being primarily wind and rotor noise. At this time, the gyroplane appeared to pitch down and begin a steady, controlled descent.<sup>8</sup> The gyroplane was on a heading toward suburban homes with large lots. These lots were partially cleared and partially trees. There was a road through the lots which appeared to contain powerlines along the road.

**Figure 3.** A screen capture taken at 4 minutes and fifty seconds elapsed time. This was the time when the engine, rotor and wind noise lessened significantly.

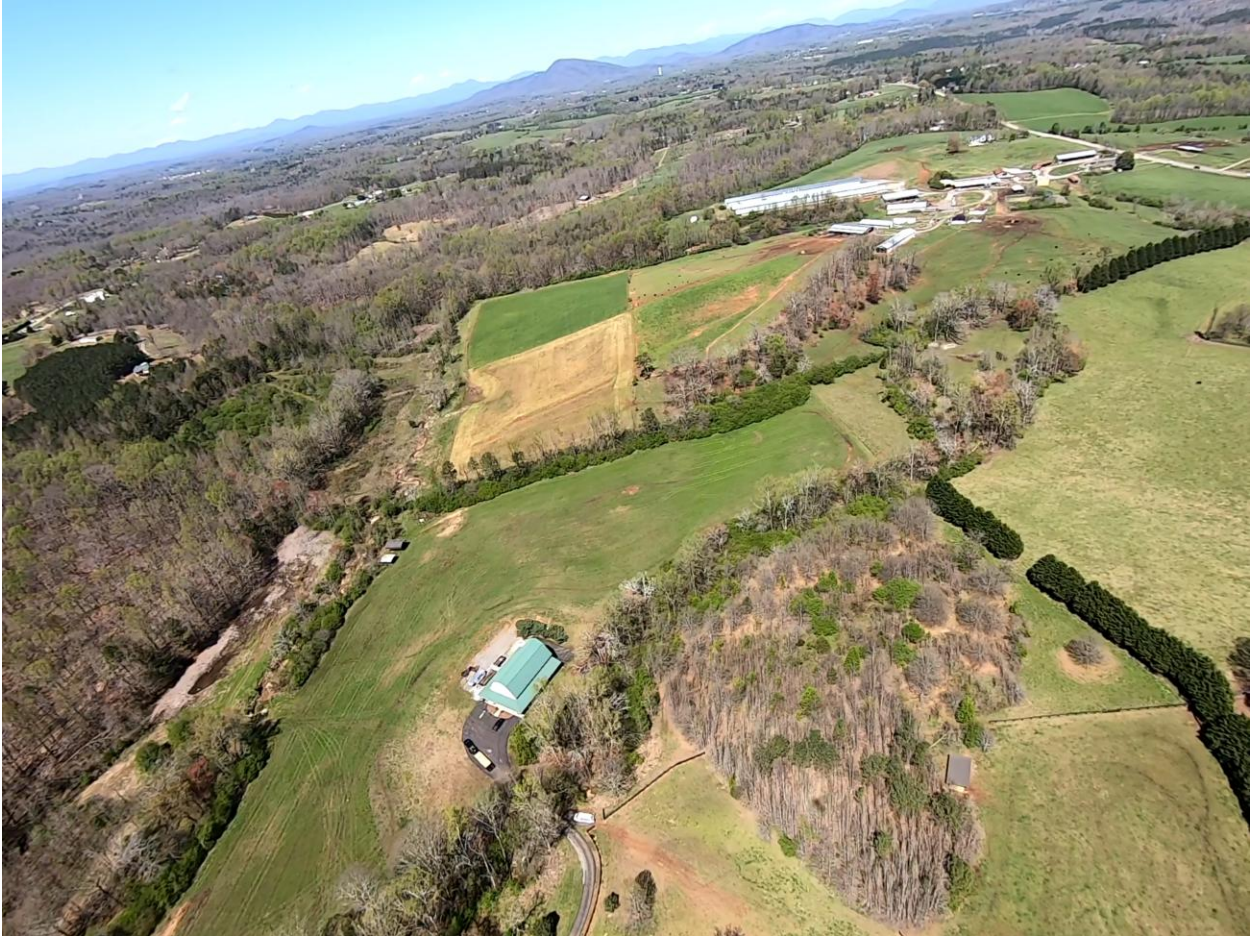
Around 5 minutes and 30, the gyroplane changed heading to the right and continued in a steady, controlled descent. Figure 4 is a screen capture at 5 minutes and 41 seconds elapsed showing the terrain in front of the gyroplane and partially below after it changed heading to the right.

**Figure 4.** A screen capture at 5 minutes and 41 seconds elapsed time showing the terrain in front and partially below the gyroplane after it changed heading to the right.

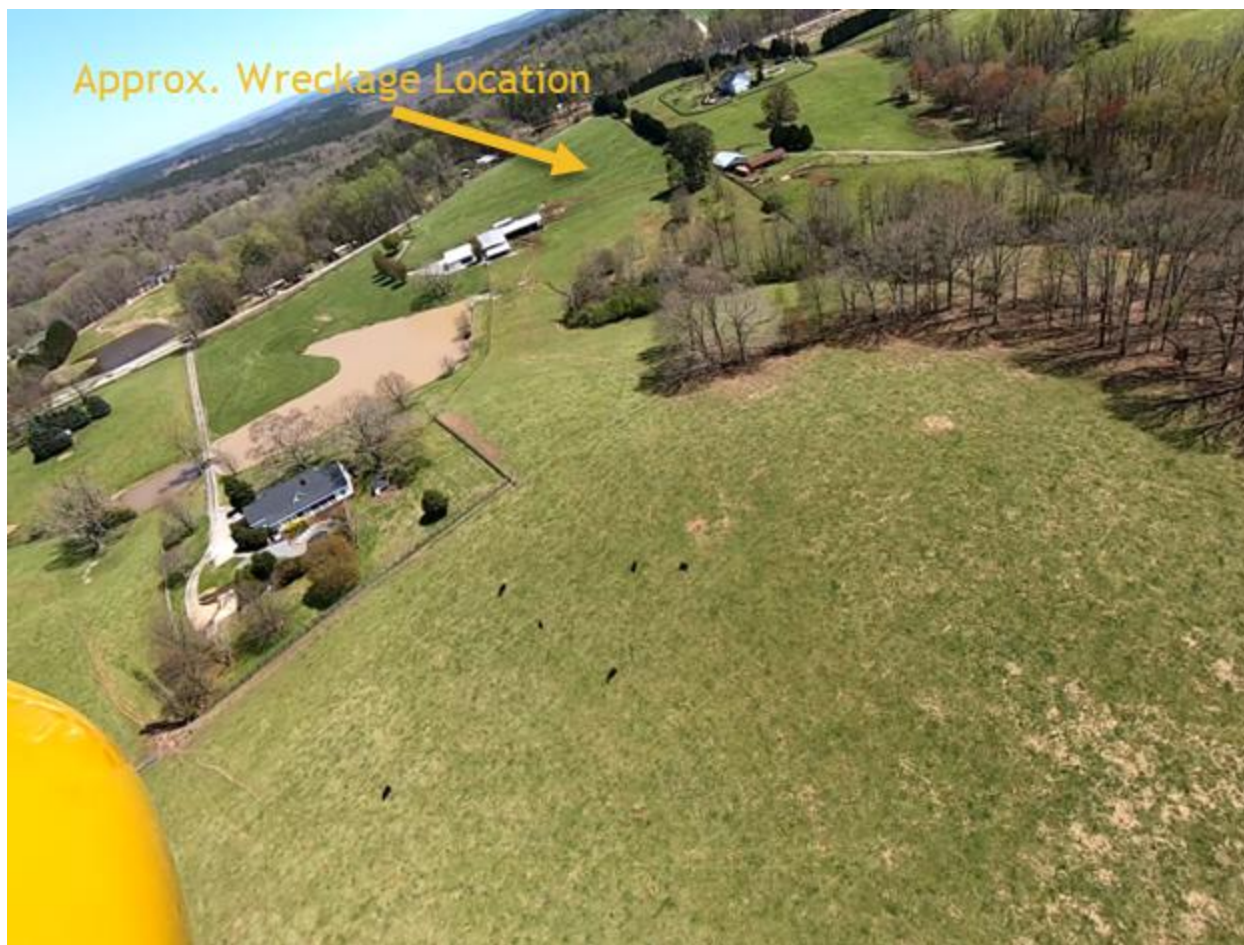
Nine seconds later, at 5 minutes and 50 seconds elapsed time, the gyroplane made an additional right bank. The gyroplane was still in a controlled descent. Figure 5 is a screen capture at this time showing the gyroplane appearing to line up with a cleared grass upsloping lot. The accident location is indicated with a yellow arrow.

**Figure 5.** A screen capture at 5 minutes and 52 seconds elapsed time. The accident site is indicated with a yellow arrow (approximated).

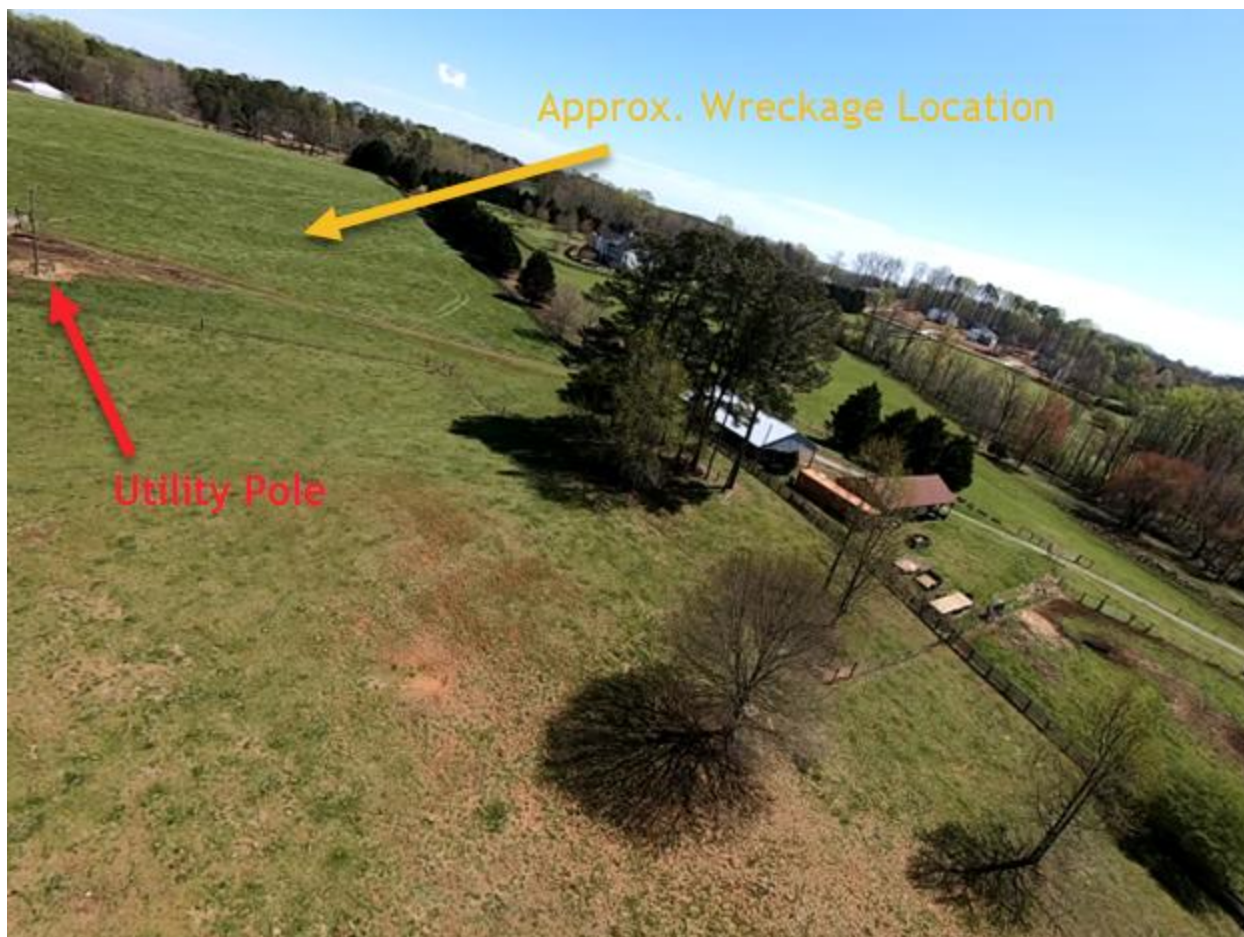
The gyroplane continued a descent straight ahead toward the up-sloping lot. Figure 6 is a screen capture at 5 minutes and 59 seconds elapsed time. A yellow arrow indicates the approximate wreckage location. A red arrow indicates a utility pole. Power lines were not immediately apparent in the camera's image.<sup>9</sup>

At 6 minutes and 2 seconds elapsed time, the gyroplane impacted the powerlines. There were no visible evasive maneuvers prior to the gyroplane striking the powerlines. The impact with the powerlines appeared to last for approximately 2 seconds. There was a sound similar to a metallic cable stretch (plucked cable under tension) at this time. The gyroplane's motion can be described as an initial rapid pitch up. Around 6 minutes and 4 seconds elapsed time, a sound similar to a wire breaking was noted, the gyroplane's rapidly pitched nose down and began a rapid roll to the left. Though it is difficult to quantify the gyroplane's motion due to the camera's digital stabilization scheme, impact appeared to be nose low and approximately 90 degrees left roll. The area around the camera's image at this time was cut grass. Upon impact at approximately 6 minutes and 6 seconds elapsed, the camera

**Figure 6.** A screen capture at 5 minutes and 59 seconds elapsed time showing the gyroplane's final approach to the upsloping lot. The accident site is indicated with a yellow arrow (approximated). A utility pole is indicated with a red arrow.

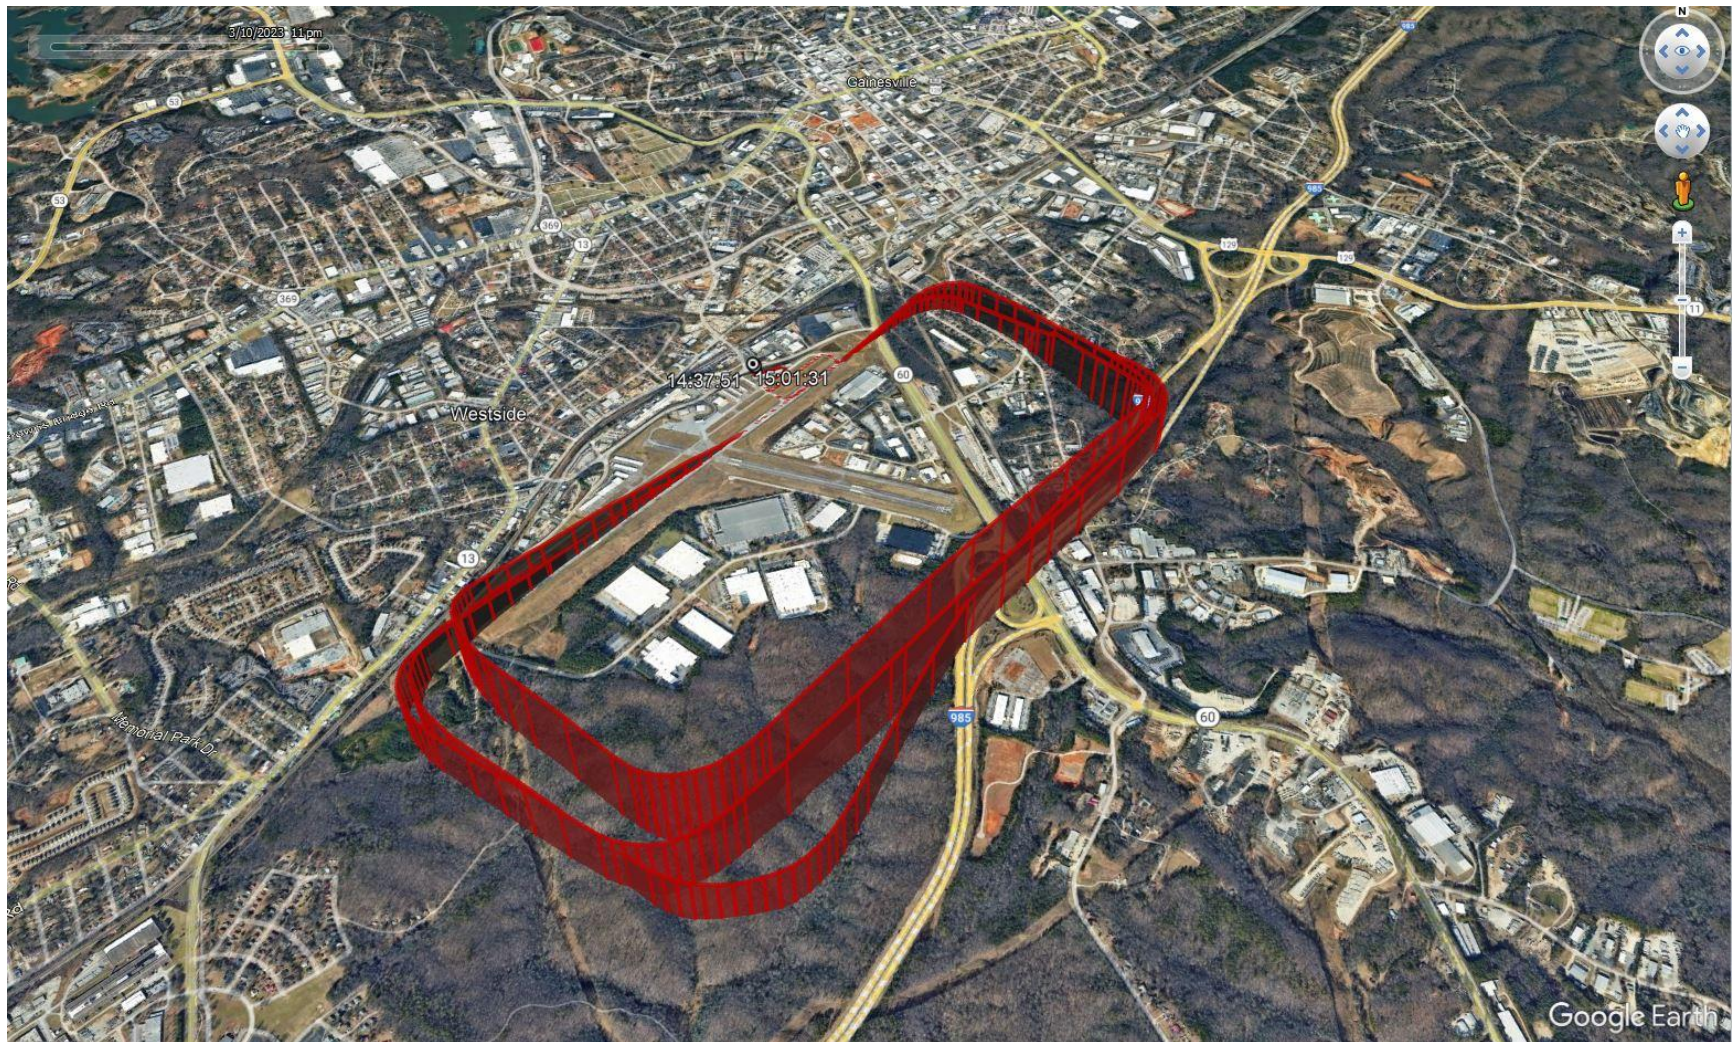
Figure 7 is a Google Earth overlay of the GPS data associated with the flight previous to the accident. Note that all Google Earth overlays may not accurately depict the weather and lighting conditions present at the time the data was logged.

**Figure 7.** GPS tracklog data associated with the flight previous to the accident.

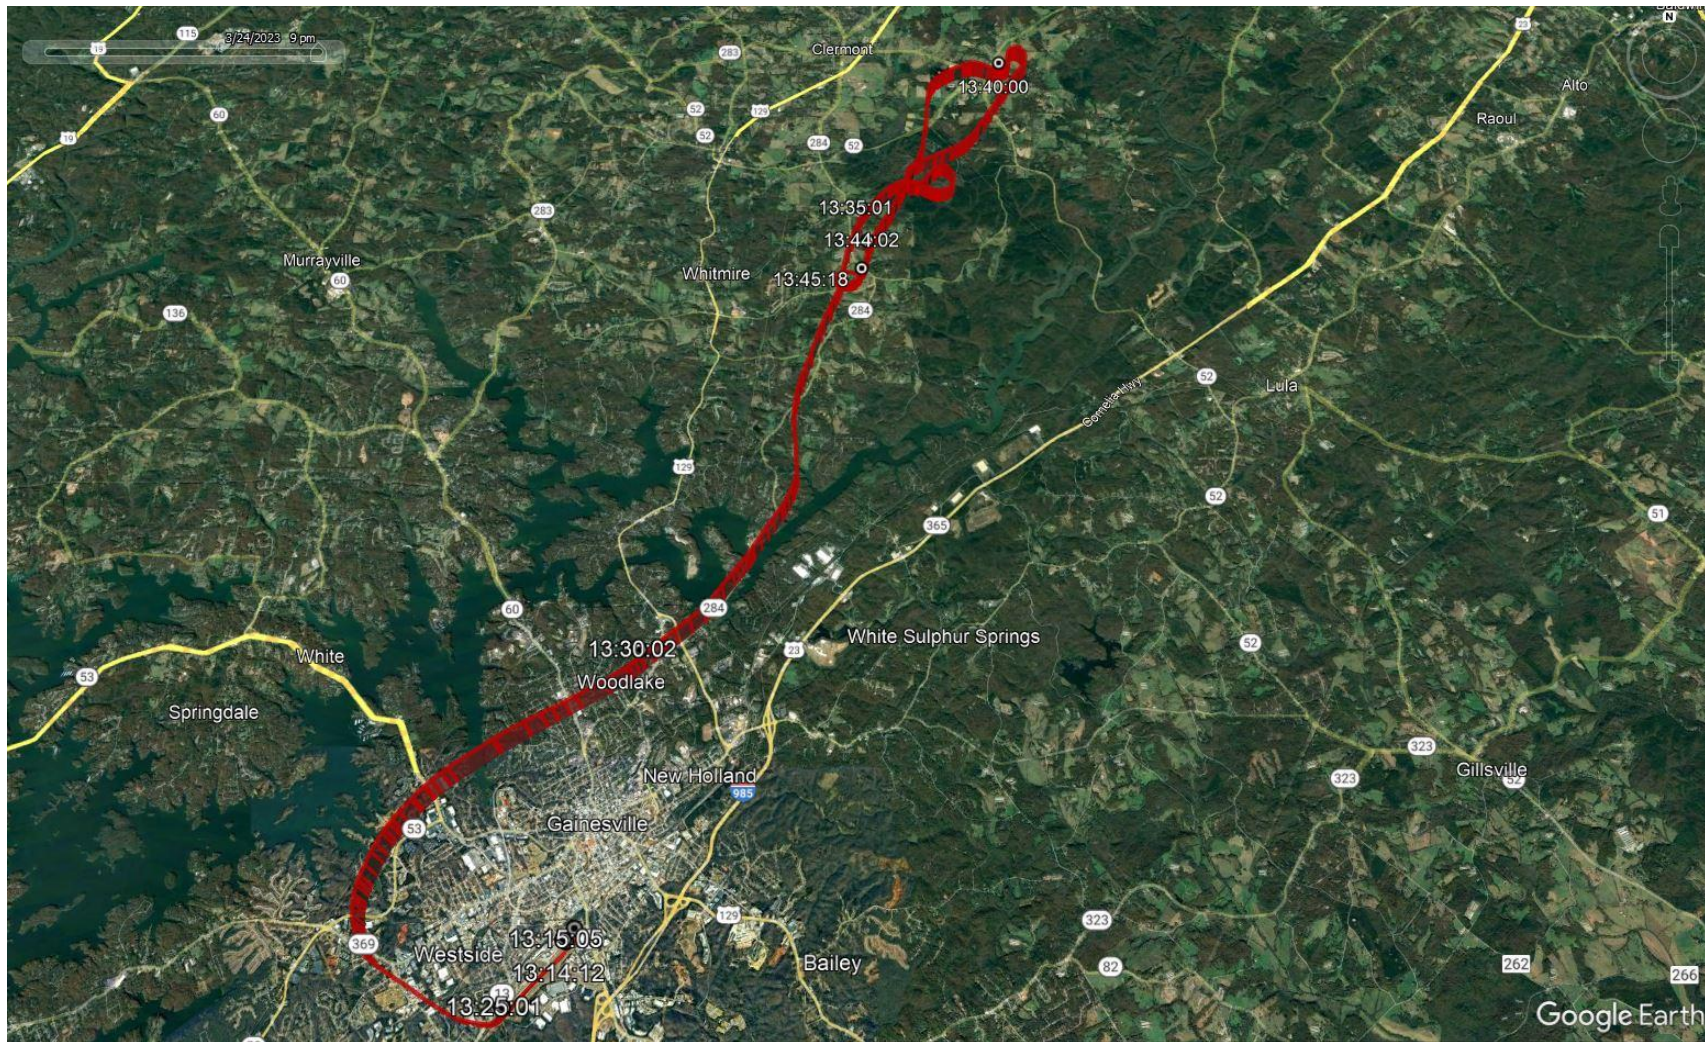
Figure 8 is a Google Earth overlay of the GPS data associated with all the recorded tracklog points recorded during the accident flight.

**Figure 8.** GPS tracklog data associated with all the GPS tracklog points for the entire accident flight recording.

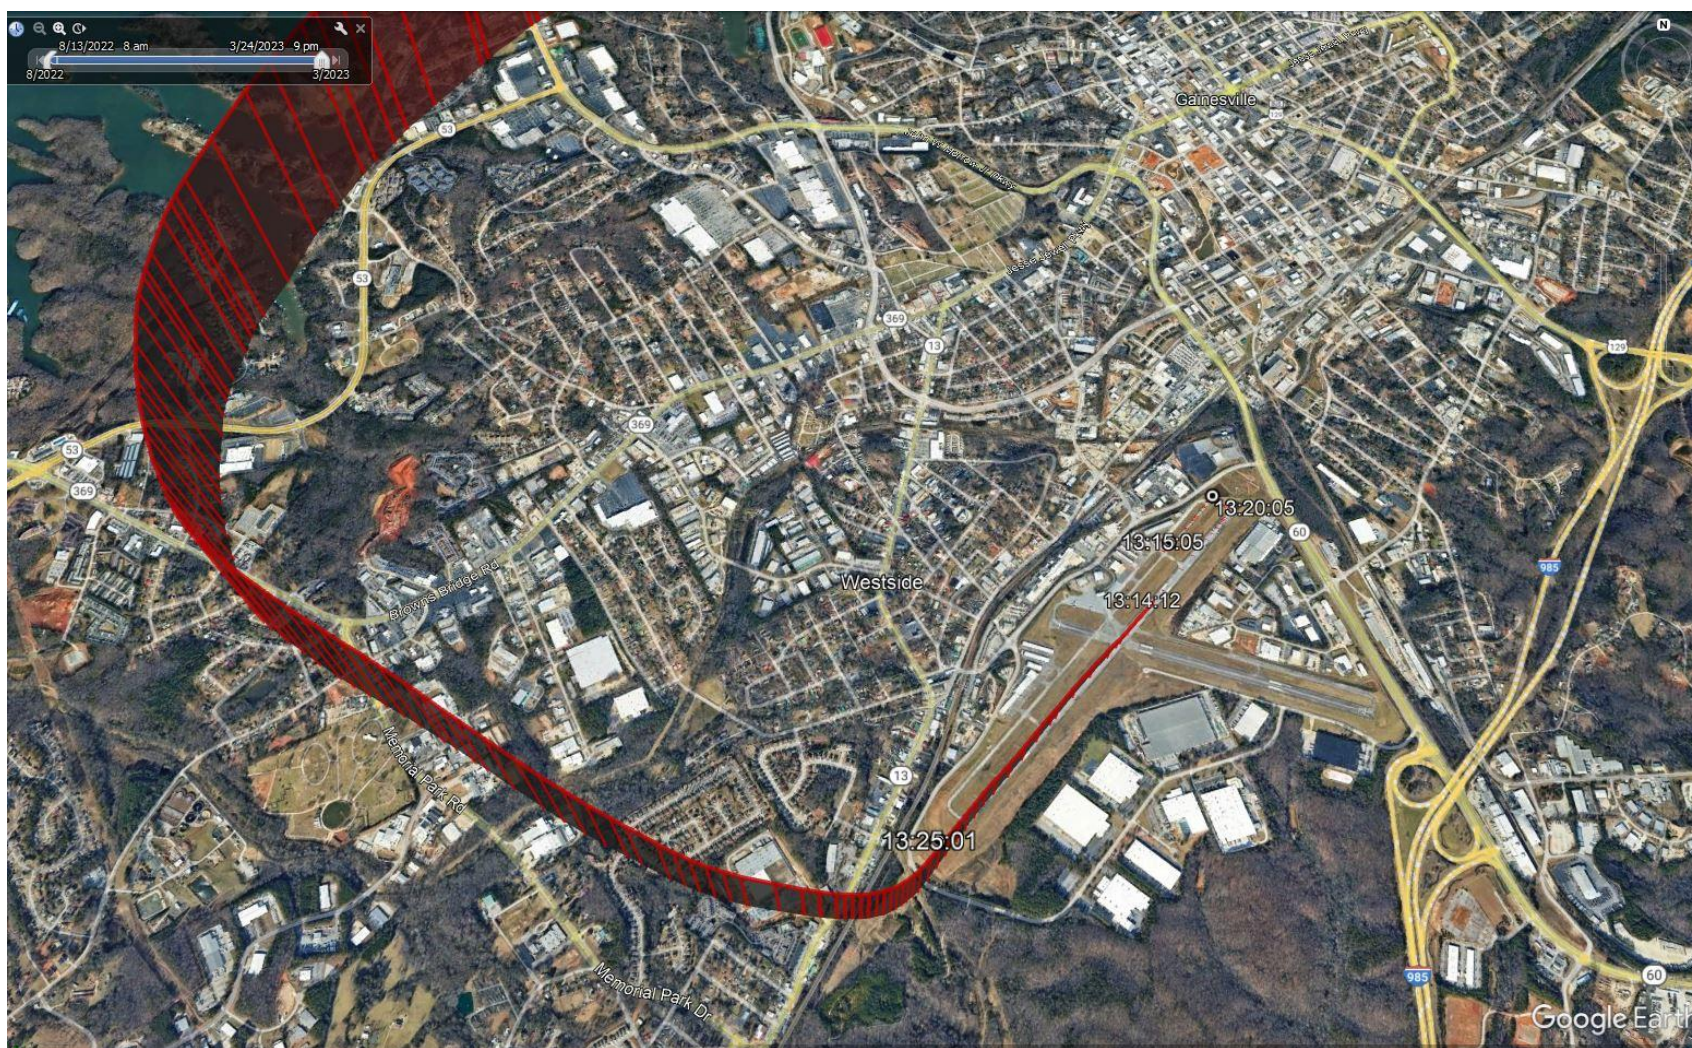
Figure 9 is a Google Earth overlay of the GPS data associated with the departure portion of the accident flight.

**Figure 9.** GPS tracklog data associated with the departure portion of the accident flight.

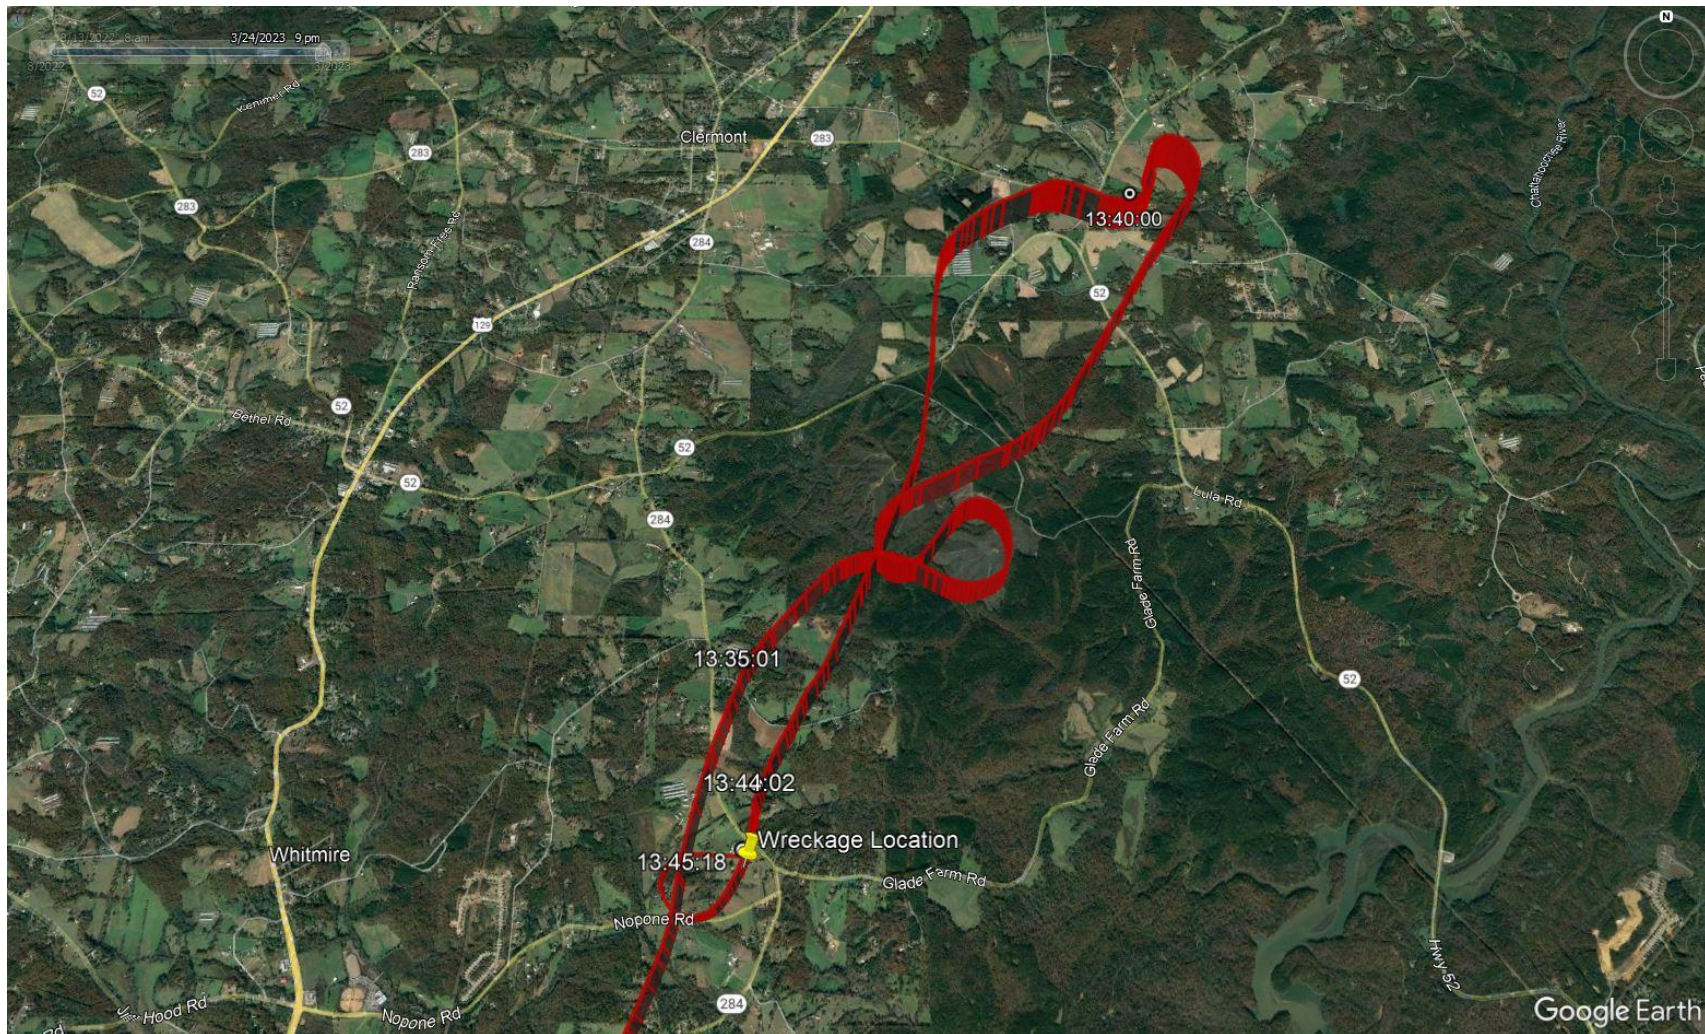
Figure 10 is a Google Earth overlay of the GPS data associated with the maneuvers in the vicinity of the accident flight.

**Figure 10.** GPS tracklog data associated with GPS tracklogs recorded in the vicinity of the wreckage location.

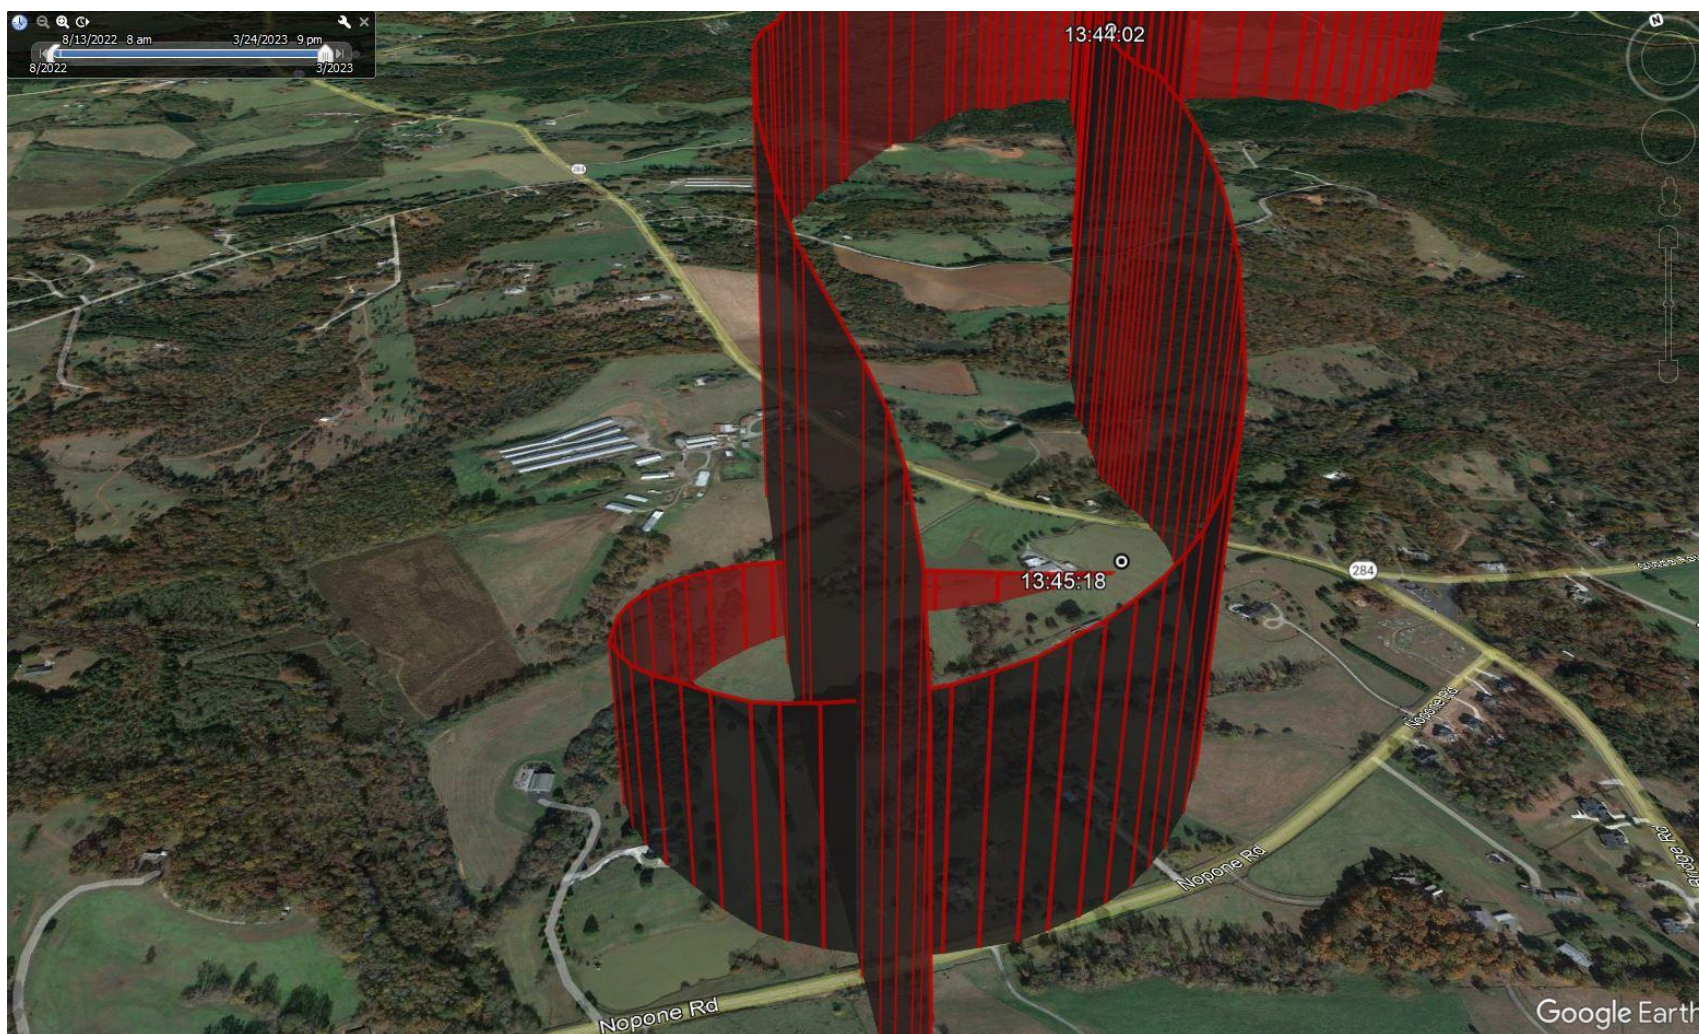
Figure 11 is a Google Earth overlay of the GPS data associated with the final descent phase of the accident flight.

**Figure 11.** GPS tracklog data associated with the gyroplane's descent to the accident location.

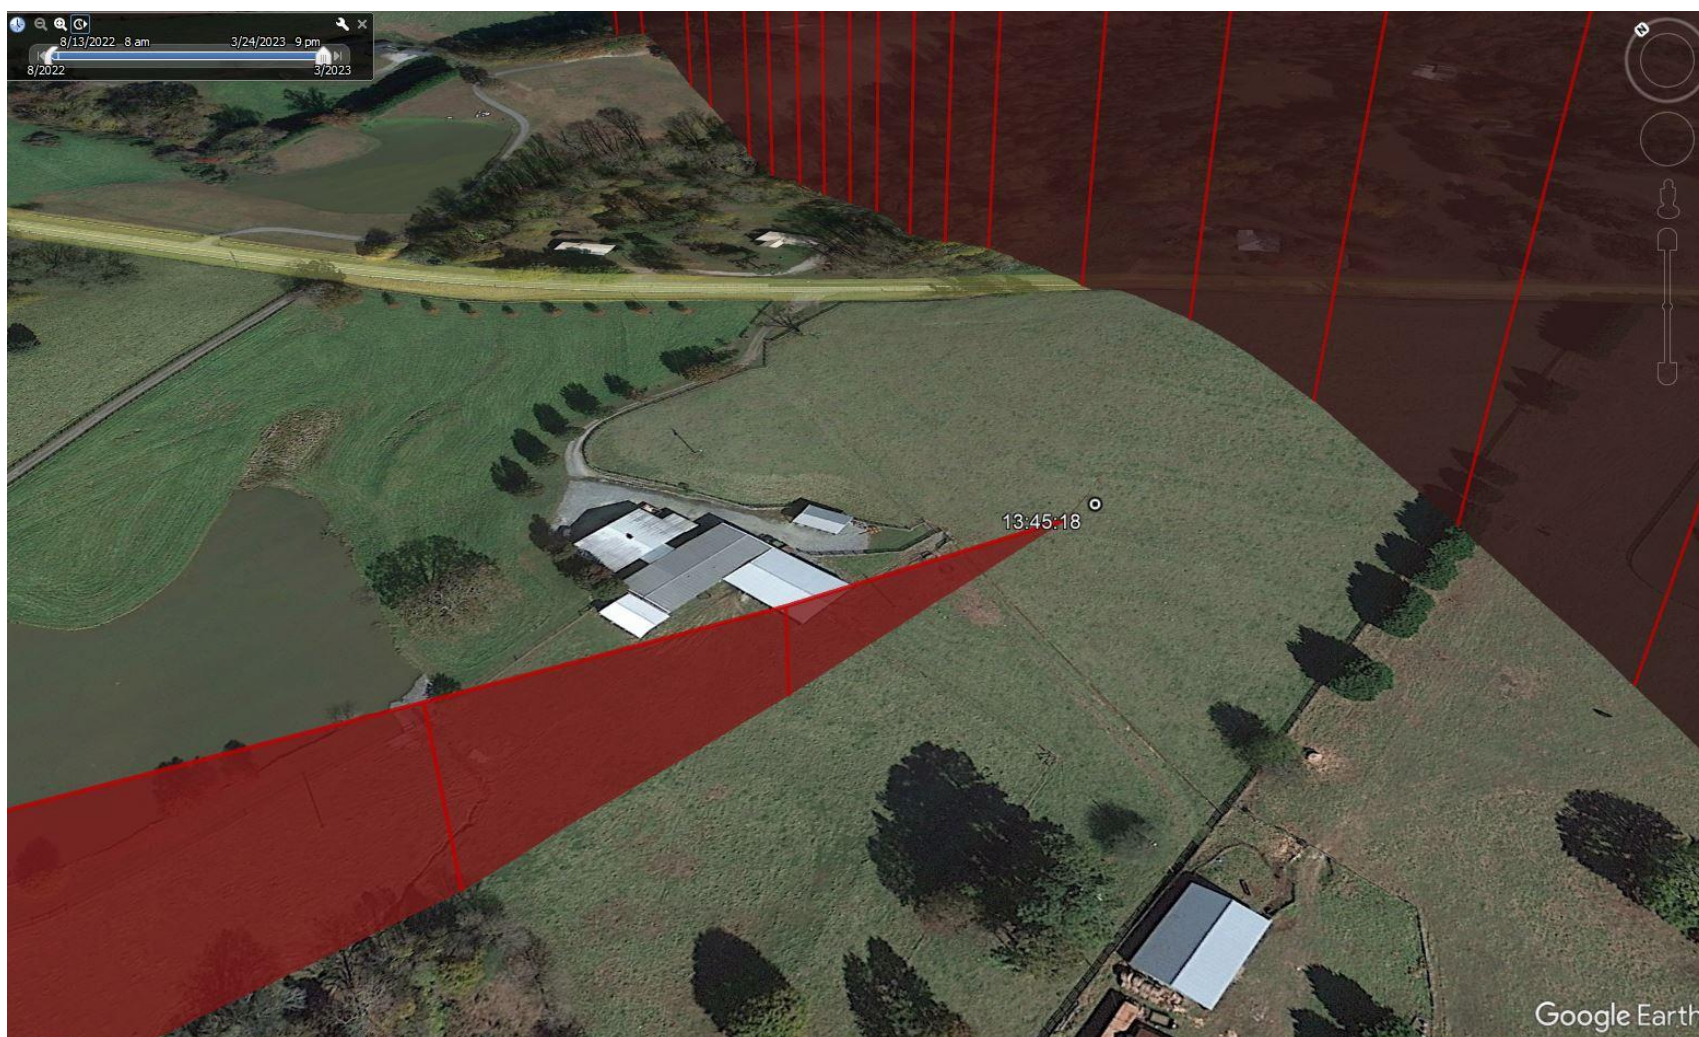
Figure 12 is a Google Earth overlay of the GPS data associated with tracklog points recorded near the wreckage location.

**Figure 12.** GPS tracklog data associated with the gyroplane's final tracklog points.
