# National Transportation Safety Board

ERA23FA174

## COMPUTED TOMOGRAPHY

Specialist's Factual Report

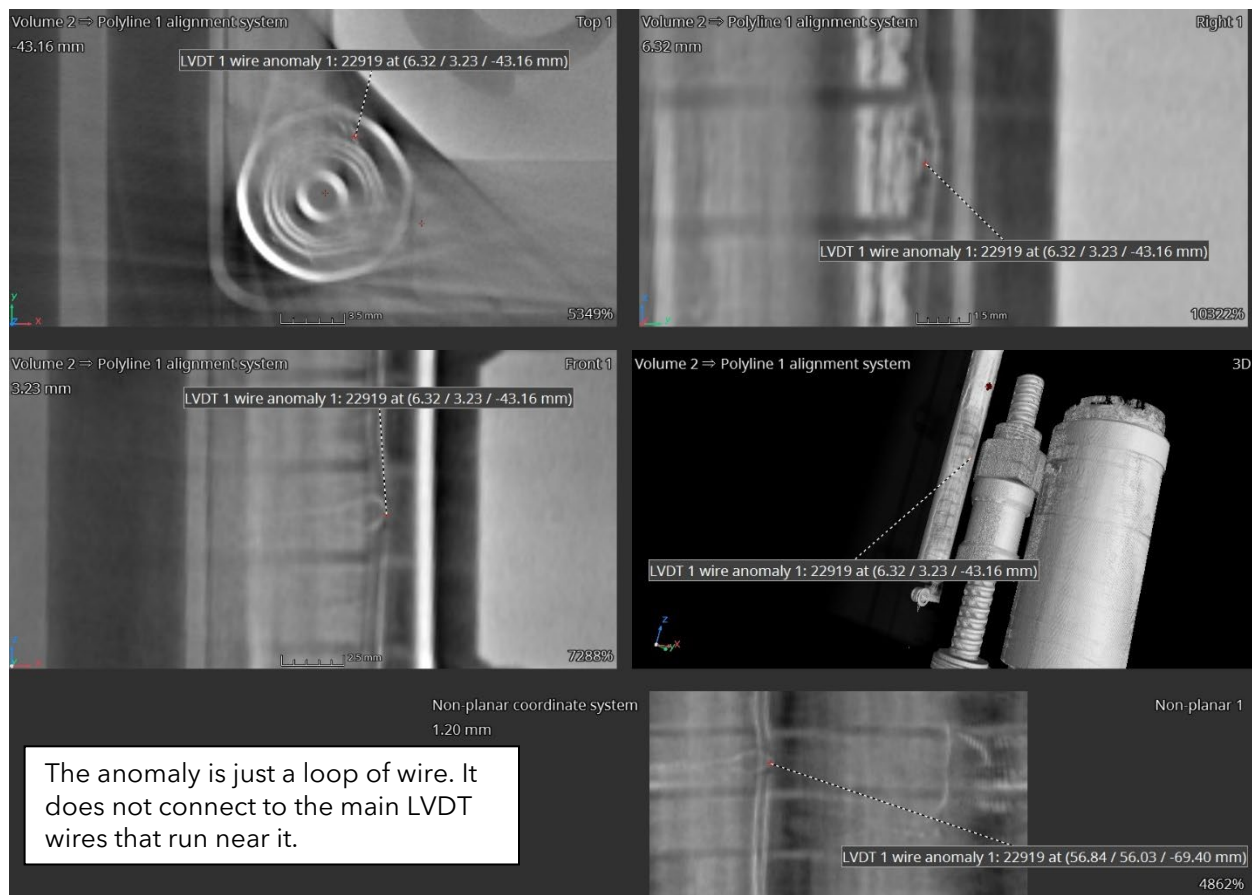
The CT results for the left TCU are shown in Figures 1 through 44. Review of the images indicated that, when the scans were conducted, there were no indications of missing or broken components. The Linear Variable Differential Transformers (LVDTs) 1 and 2 had some wire anomalies. The LVDT anomalies are being noted as points of interest, but it is not definitive from the scan results alone whether the noted anomalies are due to physical abnormalities or image resolution effects.

**Figure 36.** Left TACS control unit – LVDT 1 – wire anomaly 1.

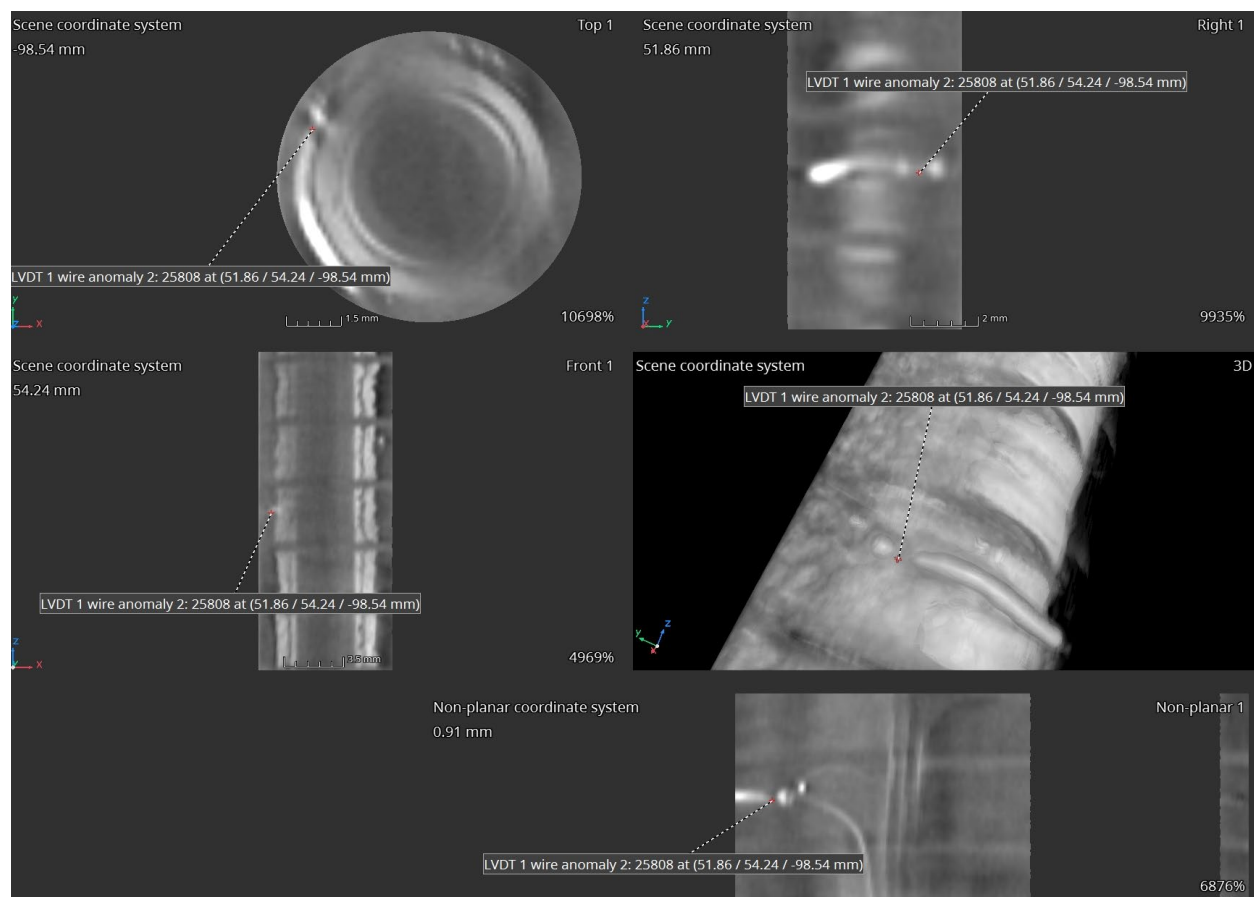
**Figure 37.** Left TACS control unit - LVDT 1 wire anomaly 2.

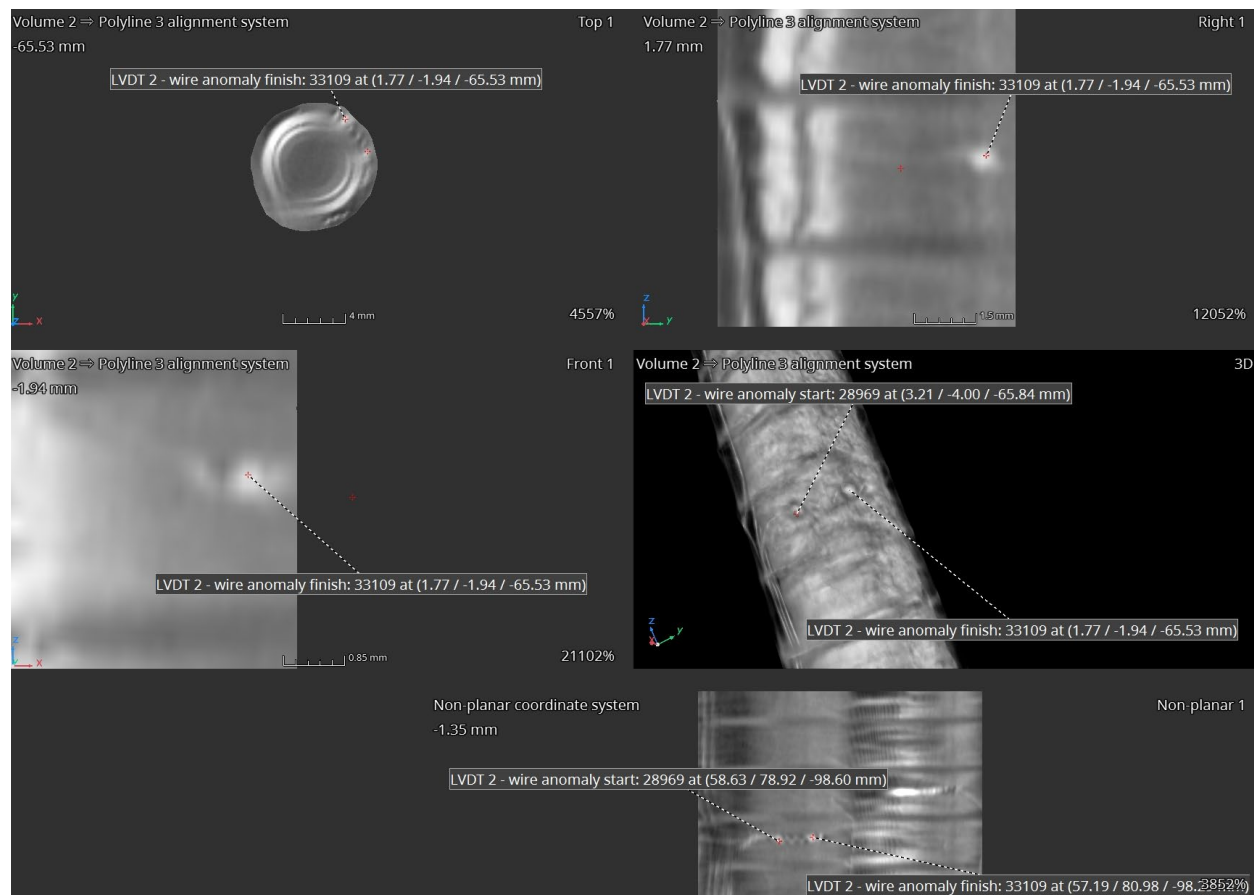
**Figure 41.** Left TACS control unit - LVDT 2 wire anomaly 1.

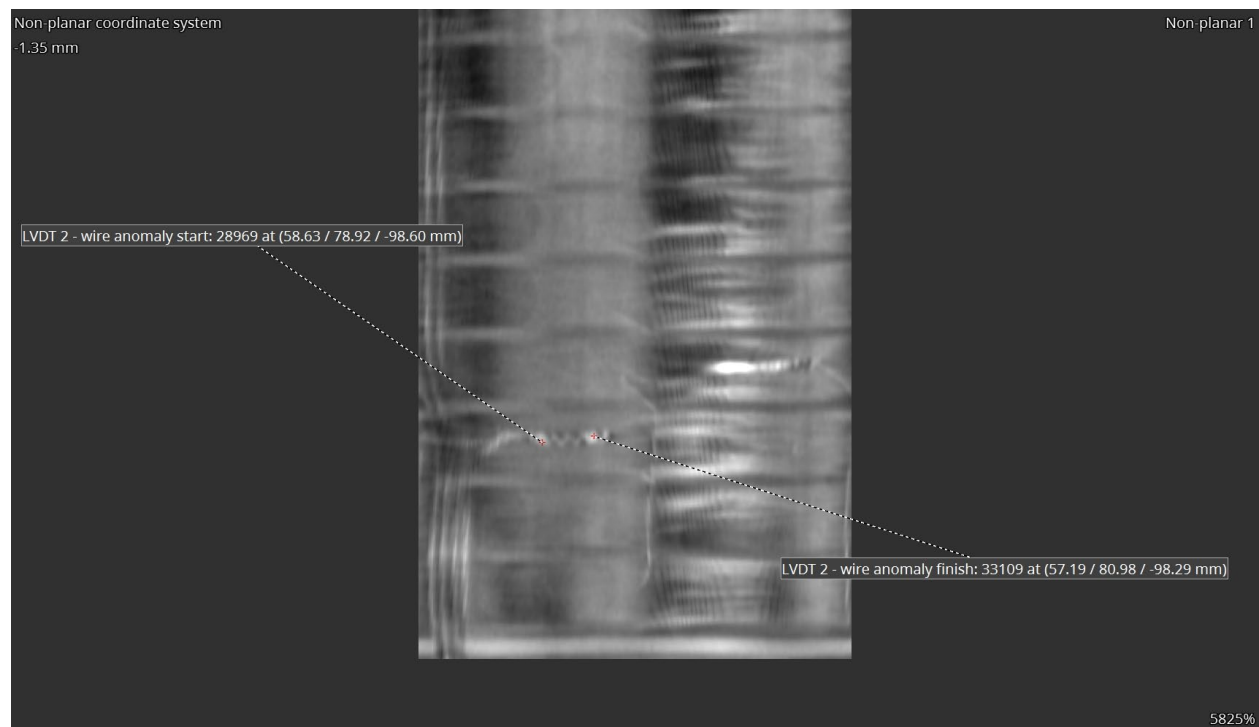
**Figure 42.** Left TACS control unit - LVDT 2 wire anomaly 1 unrolled.

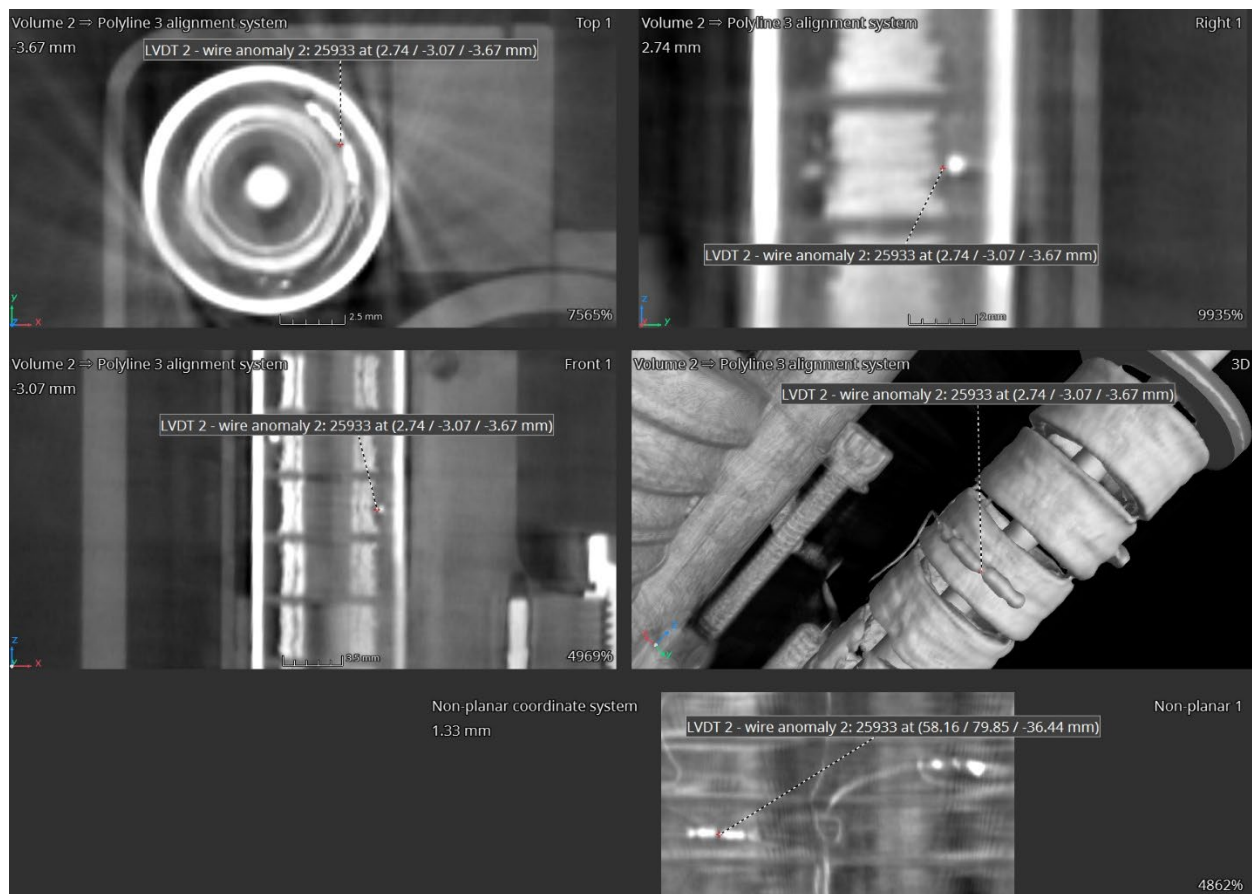
**Figure 43.** Left TACS control unit - LVDT 2 wire anomaly 2.
