# National Transportation Safety Board

ERA23FA174

## **SYSTEMS**

Group Chair's Factual Report

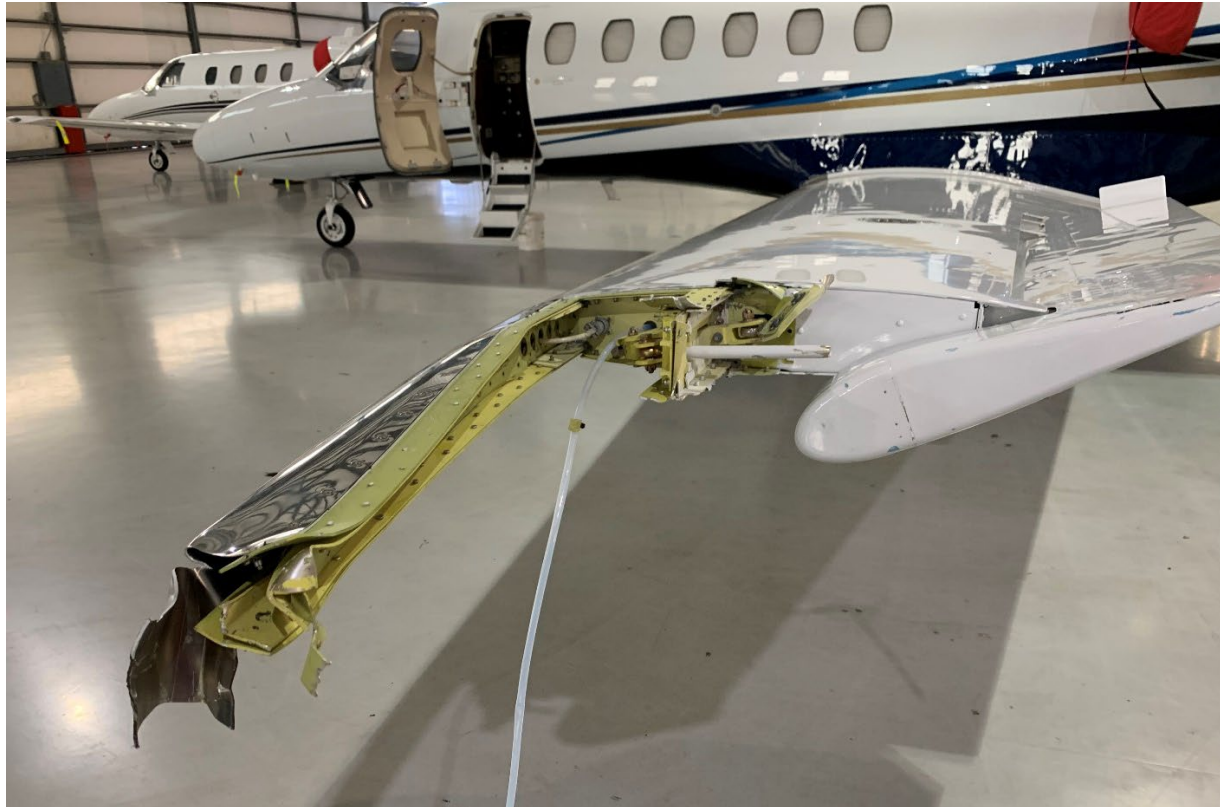
The left wing extension, winglet, and TACS were all missing except for approximately 28 inches of the leading edge of the wing extension (see Figure 5). Approximately 7.5 inches outboard from the wing extension root, the forward spar (with leading edge skin still attached) was buckled, and the remaining structure started to bend downward. The top of the leading edge skin bent downward and gradually closed in on the lower skin as the skin went outboard. The entire leading edge skin for the wing extension was present. The outboard 3 inches of the leading edge skin was bent 90 degrees down and was partially severed. The leading edge of this section was flattened (approximately 1 inch wide at the outboard tip) compared to the rest of the leading edge, and there were scratches and gouges on the inside curvature of the skin including along the two edges of the flattened section. The

forward spar in this area was bent aft away from the leading edge skin and failed along a rivet line with any remaining outboard section of the forward spar missing. The wire harness from the strobe and navigation light was missing from the wing extension area but the wire protection tube was still present.

**Figure 5. Picture of the left wing as found.**

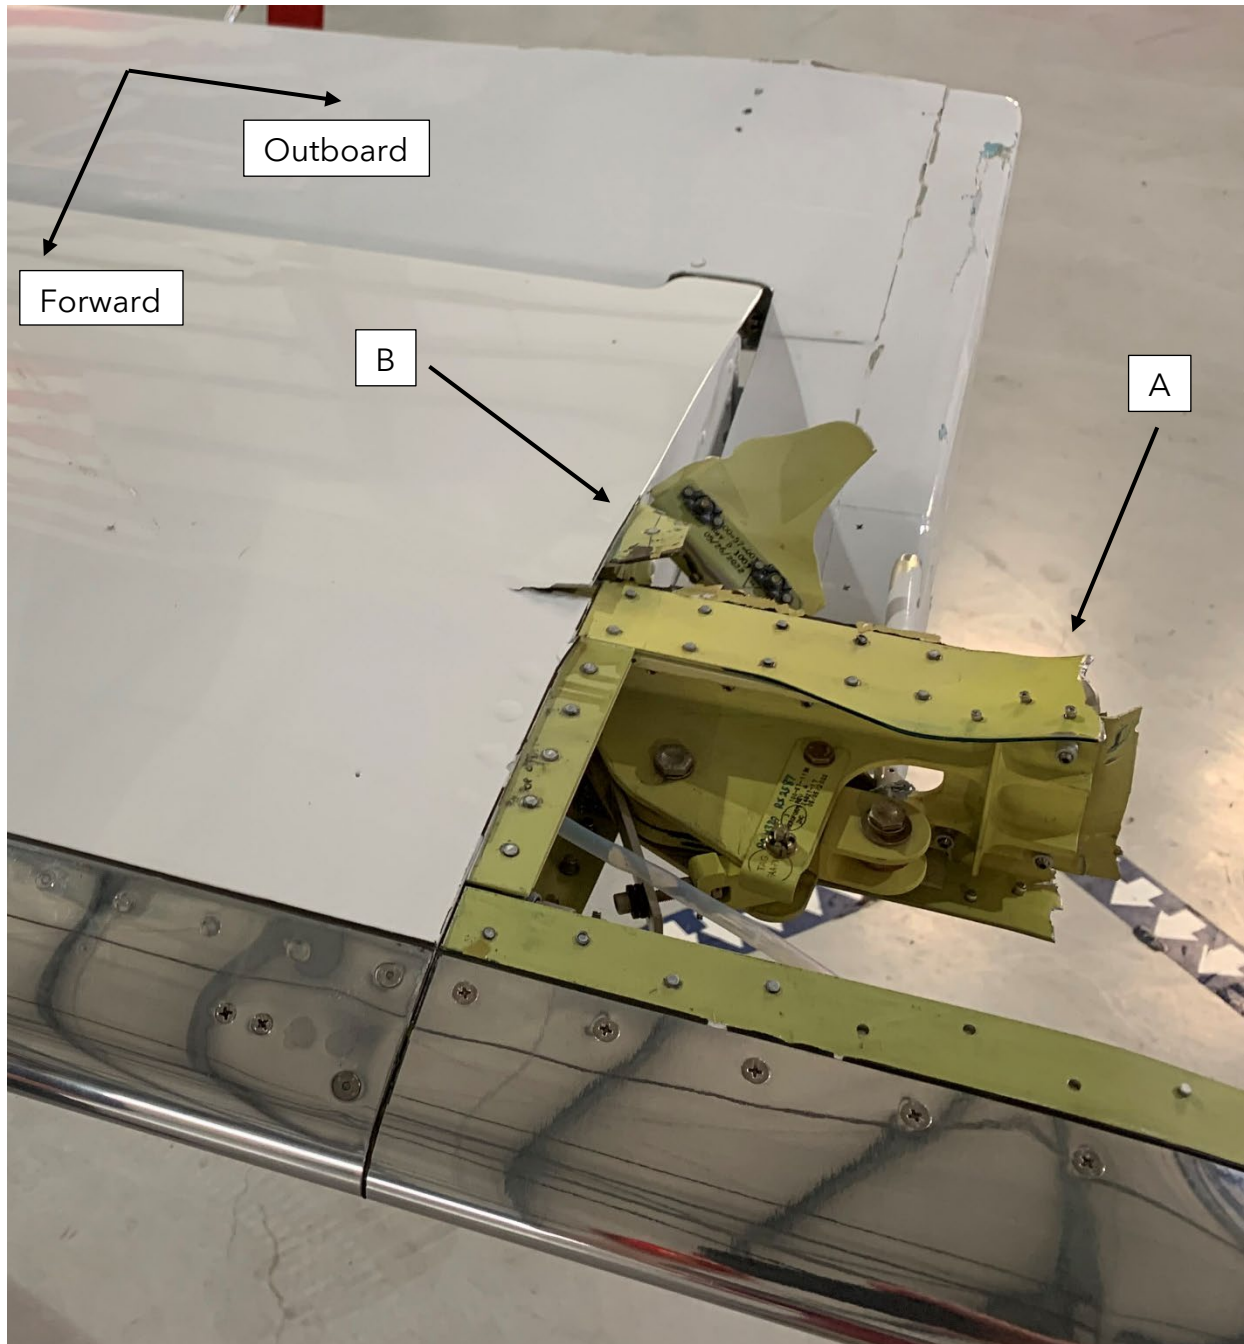
The wing extension aft spar (which attaches to the airplane mid spar) was fractured approximately 7 inches from the inboard end (see Figure 6, arrow A). The top cap of the aft spar was bent upwards, the bottom cap of the aft spar was bent slightly downwards, and the aft part of the spar web was bent aft. The production break upper closeout rib cap was bent with the aft portion bent downwards, the forward portion bent upwards, and the surrounding skin around the forward end separated and bent upwards consistent with the upward bend to the rib cap (see Figure 6, arrow B).

**Figure 6. Left wing extension attachment area. Arrow A points to the remaining wing extension aft spar. Arrow B points to the damaged production break upper closeout rib cap.**

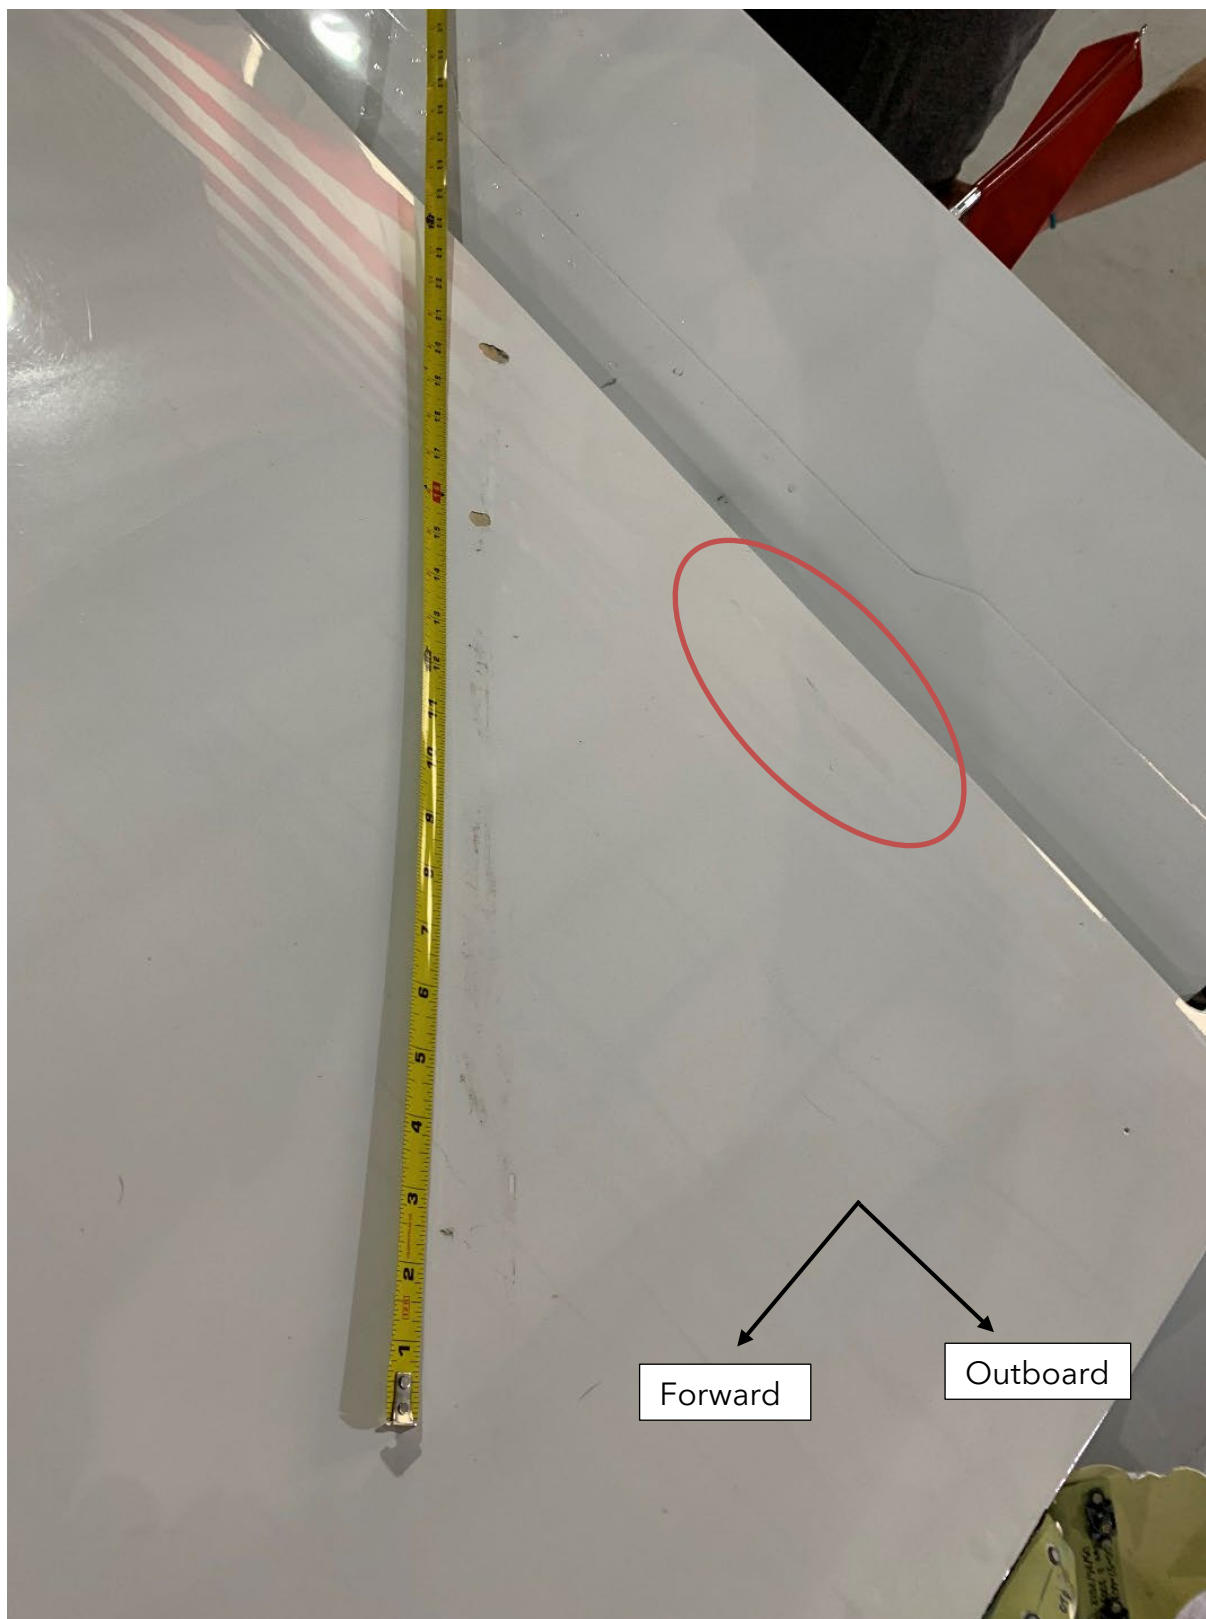
The top of the wing had a line of chipped paint and residue marks starting at a point approximately 6 inches inboard of the wing extension attachment, and 9 inches aft of the leading edge. This line transitioned at approximately a 45 degree angle aft and inboard, to a point approximately 22 inches inboard of the wing extension attachment, and two inches forward of the aft edge of the wing (see Figure 7). From this point, another line of slight deformation and cracked paint traversed straight outboard to a point approximately 9 inches from the wing extension attachment (see

Figure 7, partially circled in red (note the entirety of this line of damage is difficult to see in the figure)). The bottom of the wing had a small residue mark near the aft side approximately in line with the outboard static wick on the aileron. The aileron had an upward impact mark on the bottom side of the trailing edge approximately 4.5 inches from the outboard end. This area was buckled and pressed up, with chipped paint. Cracking in the paint was present along the aileron outboard tip cap production break. The bottom forward side of the aileron tip cap had a 4 inch gouge with small dents centered approximately 3 inches aft of the leading edge of the tip cap. The outboard static wick was missing and the threaded portion of the wick base was missing. The wick base appeared to be slightly separated from the aileron at the forward and aft ends, and some paint was missing on the aileron trailing edge just aft of the wick base. Residue was located on the bottom of the aileron on the inboard side of this wick base, and the paint on the aileron trailing edge in this area was chipped. Nearly in line with this static wick base, approximately 6.5 inches forward of the aileron trailing edge, more residue and a chip in the paint was located at the leading edge/trailing edge aileron skin seam on the bottom side of the aileron. See Figure 8 for damage to the bottom side of the aileron and wing. The top side of the forward aileron surface had two dents. One was located approximately 20 inches inboard of the outboard side of the aileron tip cap, and approximately 10 inches forward of the trailing edge of the aileron. The other dent was located approximately 24 inches inboard of the outboard side of the aileron tip cap, and approximately 10 inches forward of the trailing edge of the aileron. The aileron trim tab was flush with the aileron surface.<sup>2</sup>

**Figure 7. Chipped paint and residue in line on top surface of wing. Part of a second line of damage that runs in an inboard/outboard direction is circled in red (entirety of this line of damage is difficult to see in this picture).**

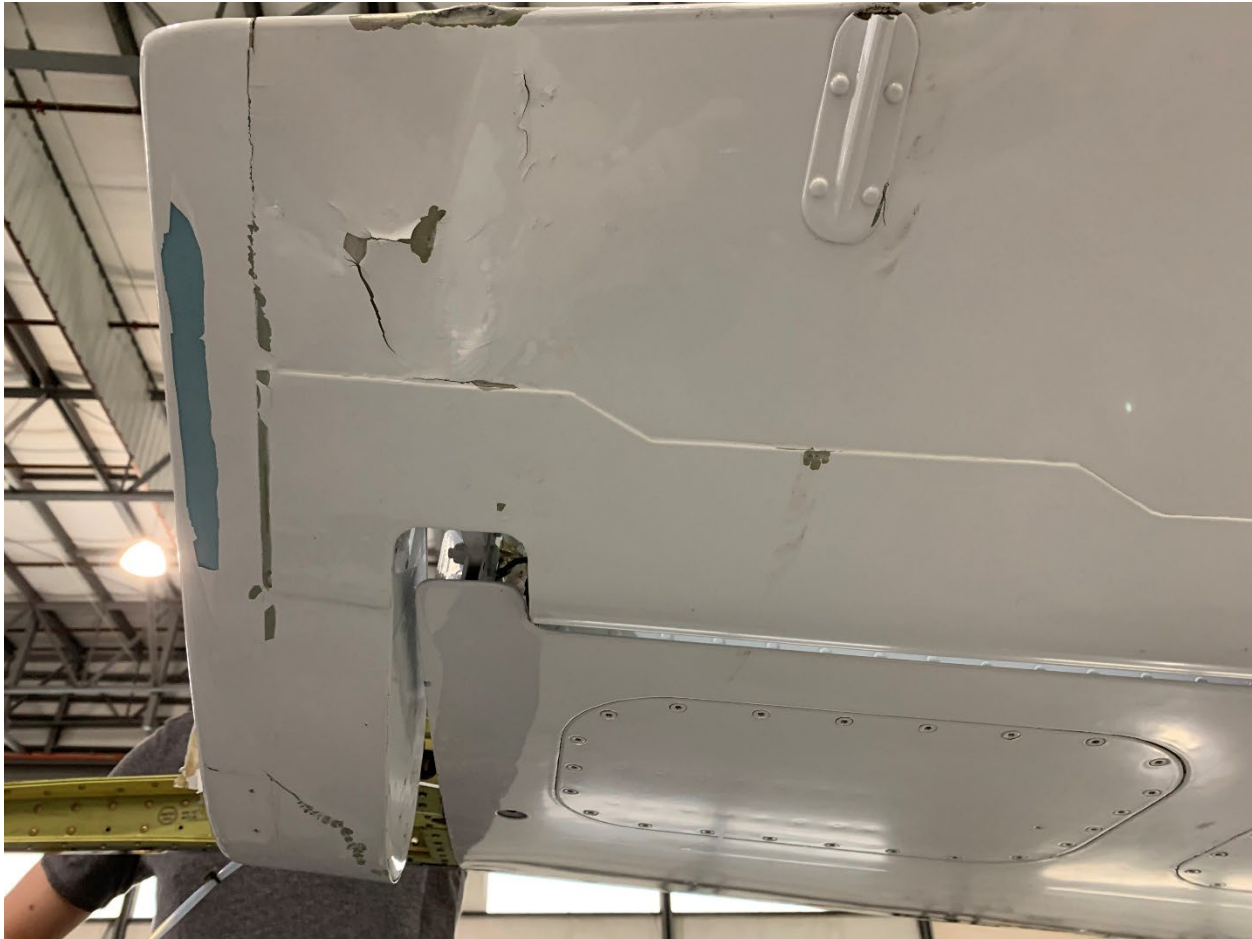
**Figure 8. Damage to the bottom side of the aileron and wing**

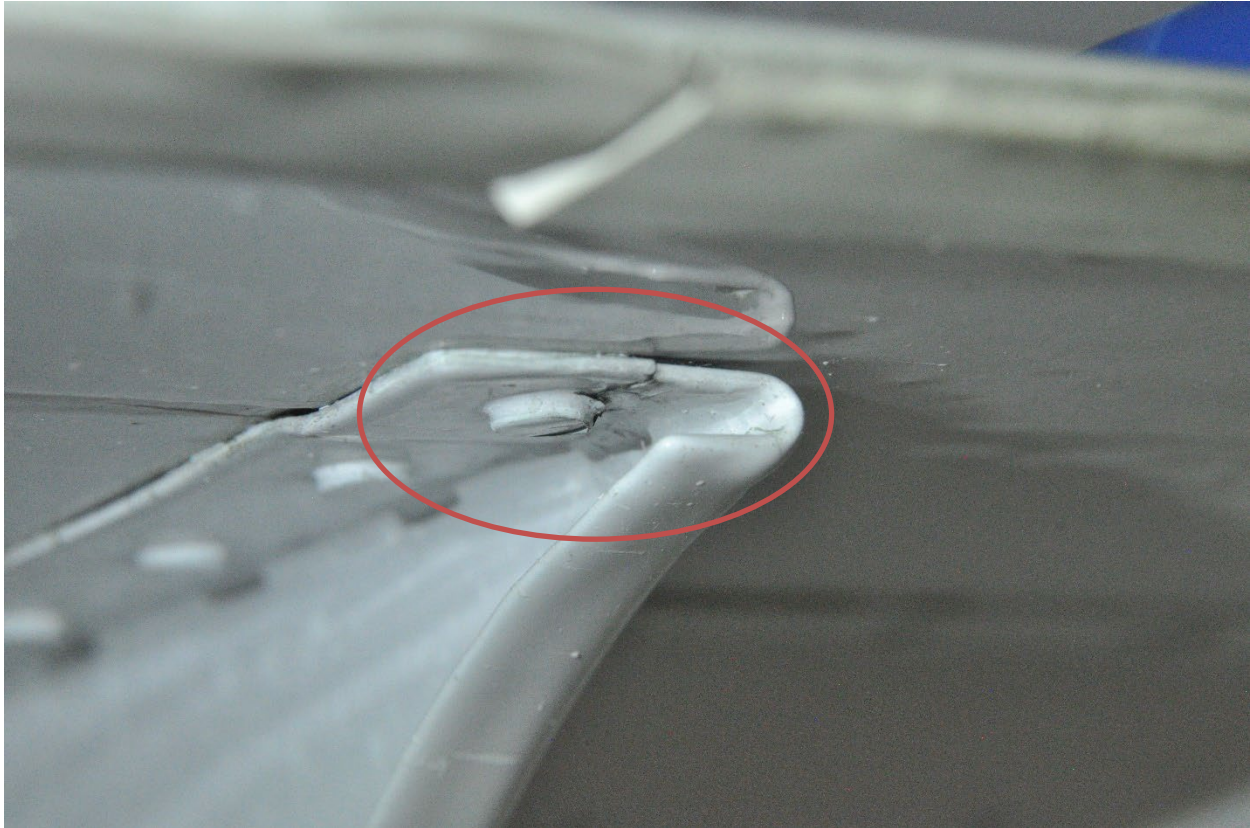
Two small cracks were located along flap cove ribs (near the inboard edge of speedbrake and near the flap actuator).<sup>3</sup> The cracks extended from the aft most rivet to the aft edge of the cove rib (see Figure 9, crack circled in red, for an example). A possible crack (unknown if it was only in the paint or if it was in structure) was found on the aft upper spar cap just inboard of the flap actuator, and extended upwards from a High-Lok fastener and ended just before the upper radius of the cap.

**Figure 9. Example of flap cove rib cracking near aft rivet (crack is circled in red)(picture location near Right Wing Station 106)(courtesy of Tamarack Aerospace Group).**

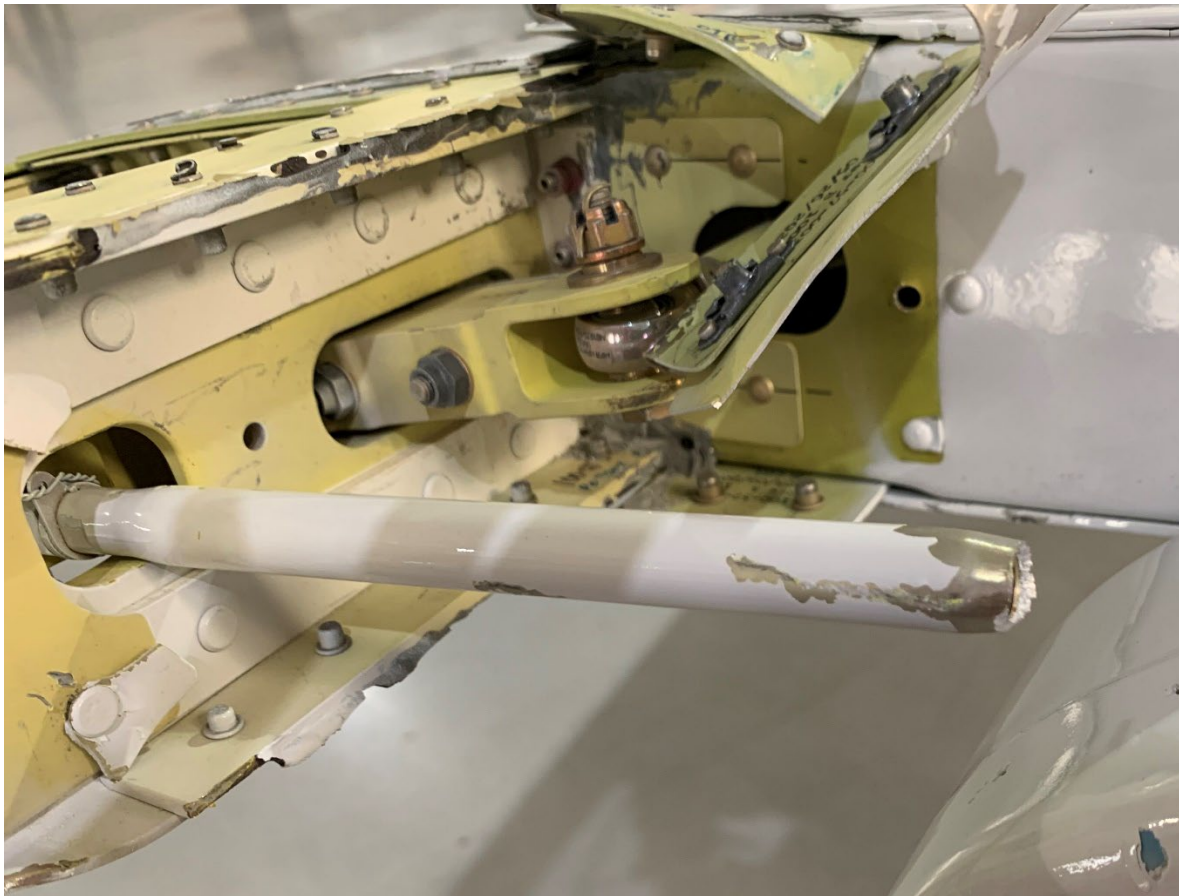
**Figure 10. Picture of the "long push rod" with missing rod end and scraped paint.**

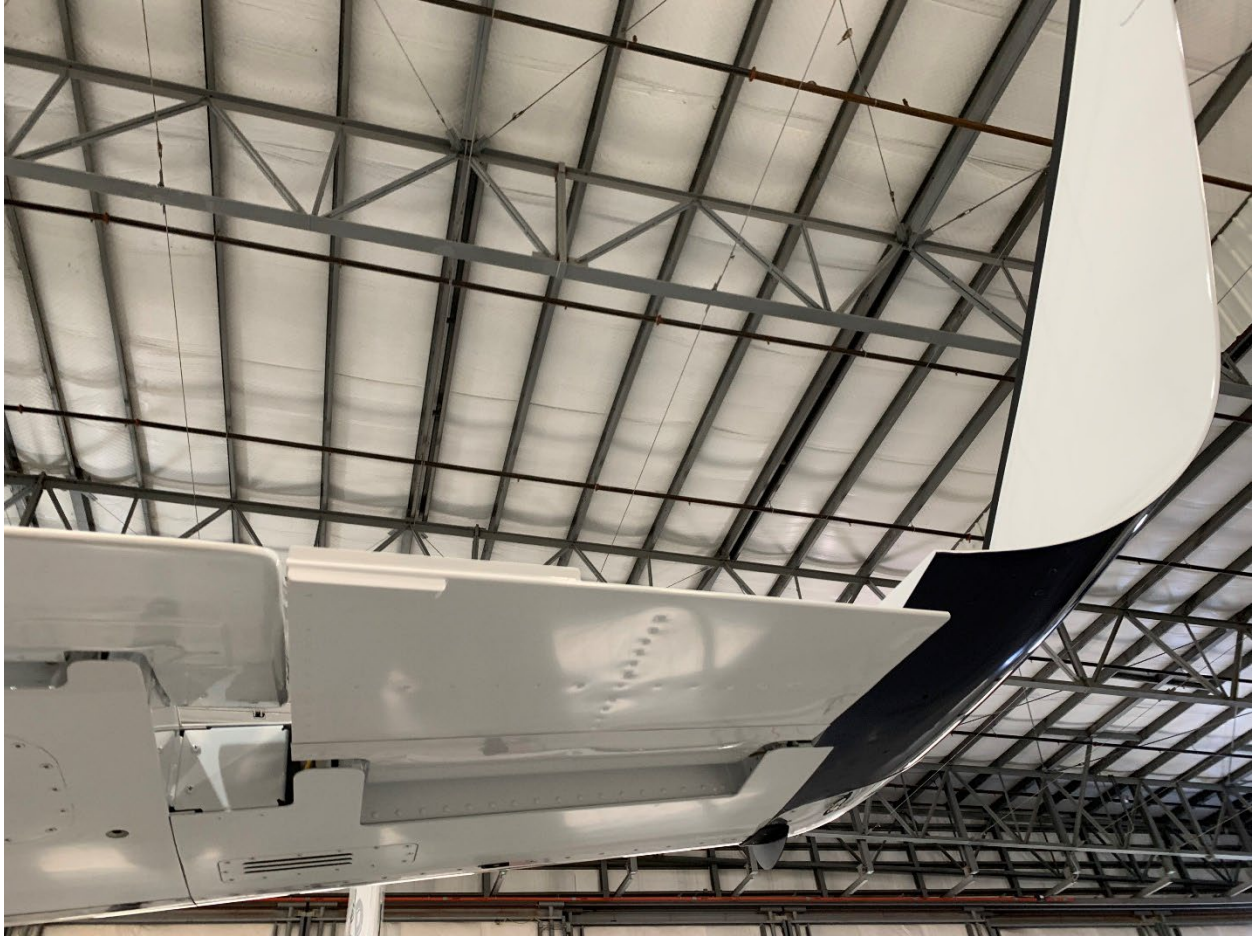
The right wing TACS was inspected with no anomalies noted. Centering strips were installed on the trailing edge of the TACS. The TACS surface was found approximately 2-5/8 inch down measured from the trailing edge of the winglet to the outboard trailing edge of the TACS surface (see Figure 11). According to the Tamarack representative, this would be approximately full trailing edge down. As stated earlier in this report, when power is not applied to the TCUs, the units are free to move with an applied force of 10 lbs or less, and it is therefore unknown if the TACS position had changed prior to the arrival of investigators. The access panel for the TCU was removed. The TCU was part number 100-37-0300-04 and serial number 1385. The TCU remained securely attached to the wing mid spar with some allowable rotation which was considered normal. The actuator ram tube extension measured 4-3/8 inch from the TCU actuator barrel to the center of the walking beam attach bolt. According to Tamarack, this extension was consistent with the TACS in the as-found approximately full trailing edge down position. The TCU grounding point to structure was intact as well as the case bonding straps. The electrical connector to the TCU was intact with no obvious damage to the wiring. All anti-rotation hardware appeared to be present.

**Figure 11. Right wing with intact wing extension, winglet, and TACS. TACS is near the full down position.**

The trailing edge of the TACS control surface was moved by hand with expected force and sound from the actuator. The TACS trailing edge was moved full up and measured 4-3/8 inches from the trailing edge of the winglet, and the TACS trailing edge was moved to full down measuring 2-5/8 inches from the trailing edge of the winglet.

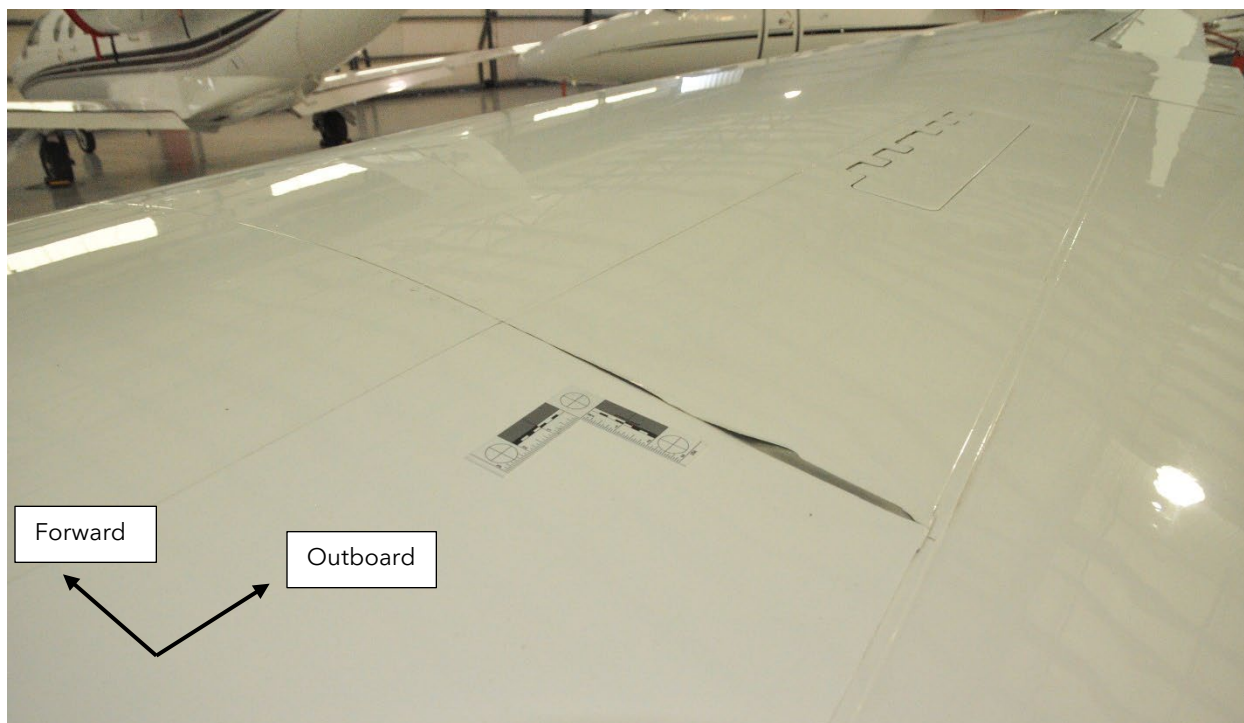
Chipped/peeling paint was located on the aft portion of the right wing in line with the flap actuator (see Figure 12). There was slight chordwise deformation visible in some lighting conditions near this area also. Three small cracks similar to those noted on the left wing were located on cove ribs in the area of the inboard edge of speedbrake, area of the flap actuator, and the area of the inboard flap hinge. The cracks extended from the aft most rivet to the aft edge of the cove rib.

**Figure 12. Chipped/peeling paint found on top side of right wing (courtesy of Tamarack).**
