# National Transportation Safety Board

ERA23FA174

## **AIRPLANE PERFORMANCE STUDY**

Location: Gulf of Mexico, near Clearwater, Florida  
Date: March 30, 2023  
Time: 1847 EDT  
2247 GMT  
Airplane: Cessna Citation 525B, N869AC

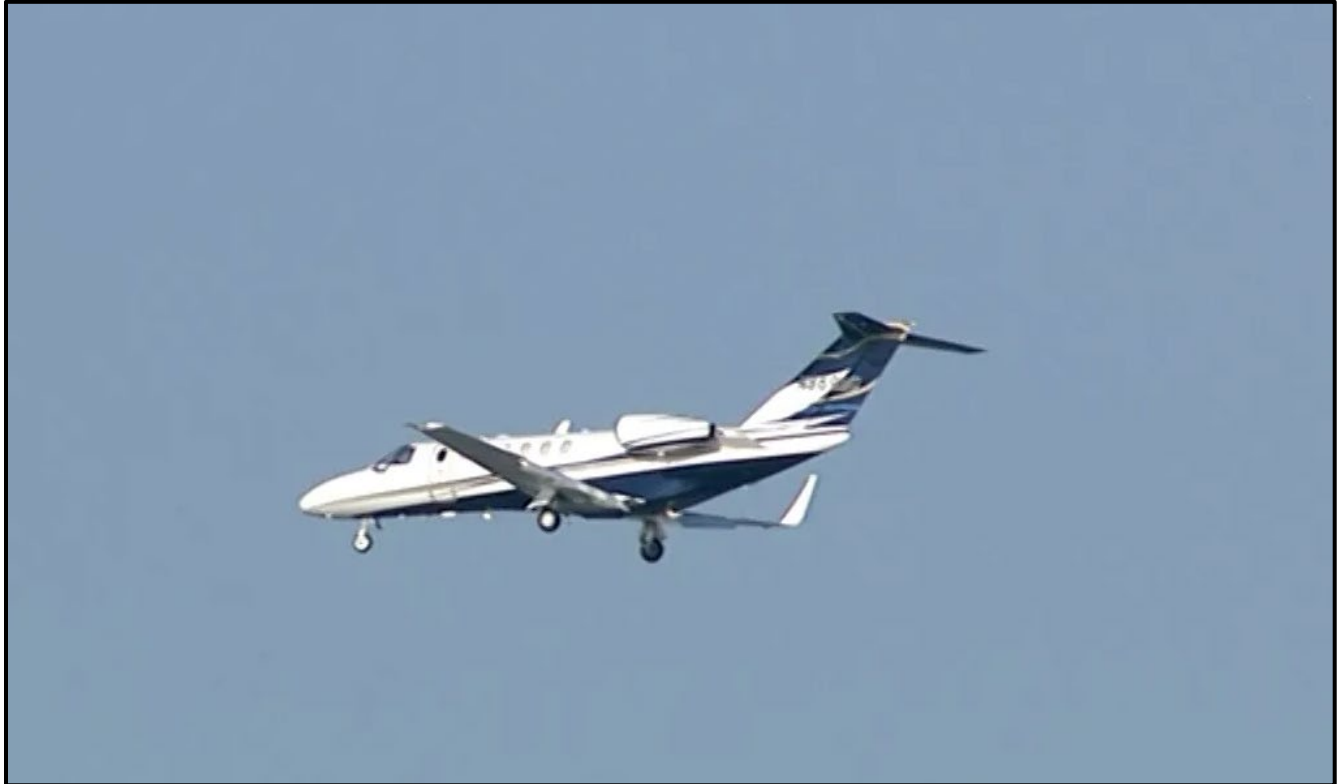
A picture of the accident airplane, a Cessna Citation 525B, is shown in Figure 1. The airplane was manufactured by Cessna in 2005 and is registered to Minnesota Equipment Leasing Services, Inc.

**Figure 1: Accident Airplane, N869AC, a Cessna Citation 525B, Making an Emergency Landing at TPA with a Missing Left Winglet**

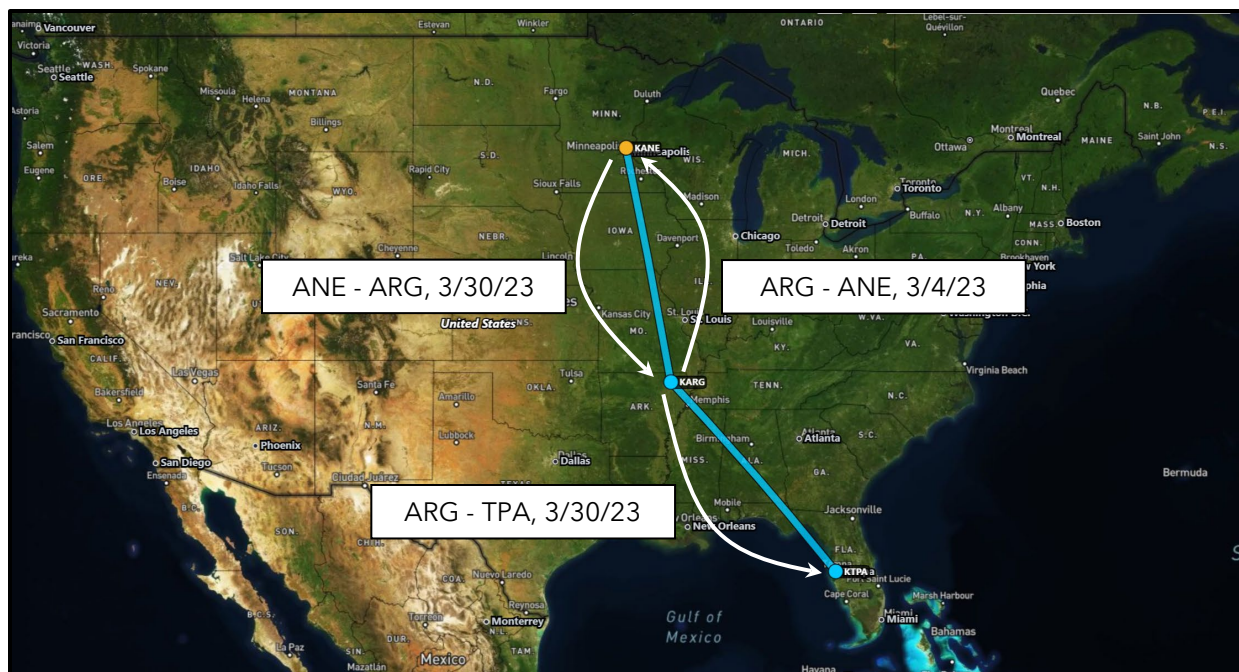
Figure 2 highlights the flight legs that were used in the study to compare altitude, speed, and rate of climb. Figures 3 and 4 show the comparisons.

**Figure 2: Flight Legs Used in the Study for Comparison**

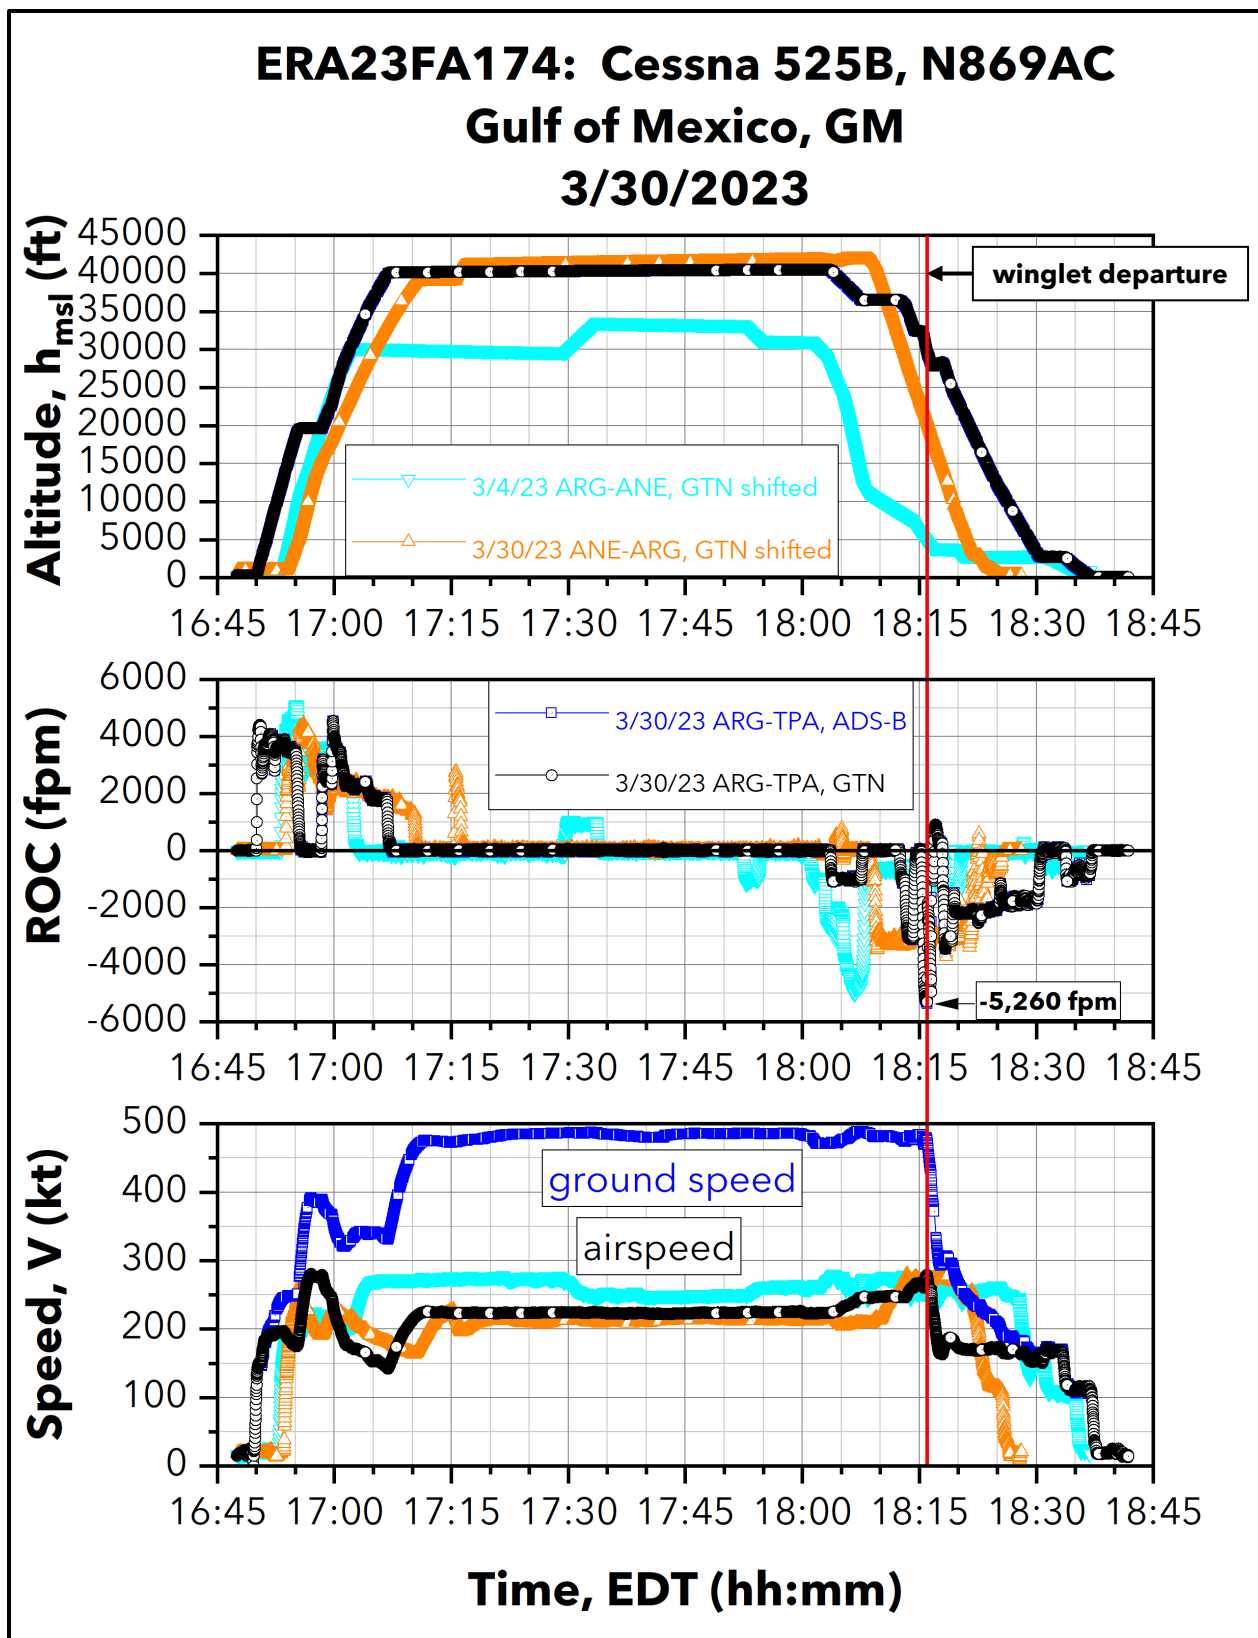
The flight leg from ARG to TPA where the left winglet departed the airplane recorded the highest decent rate of any of the flight legs that were examined. Both GTN and ADS-B data indicate a descent rate of about 5,300 ft/min<sup>2</sup> as the airplane

descended through 30,000 ft (where the pilot reported losing the winglet). The GTN data from the preceding flight leg (ANE to ARG) recorded a maximum descent rate of about 3,100 ft/min. In addition, GTN data from a flight earlier in the month (ARG to ANE) indicate a maximum descent rate of about 5,000 ft/min.

**Figure 3: Garmin and ADS-B Altitude, ROC, and Speed from Accident Flight and Previous Flights**

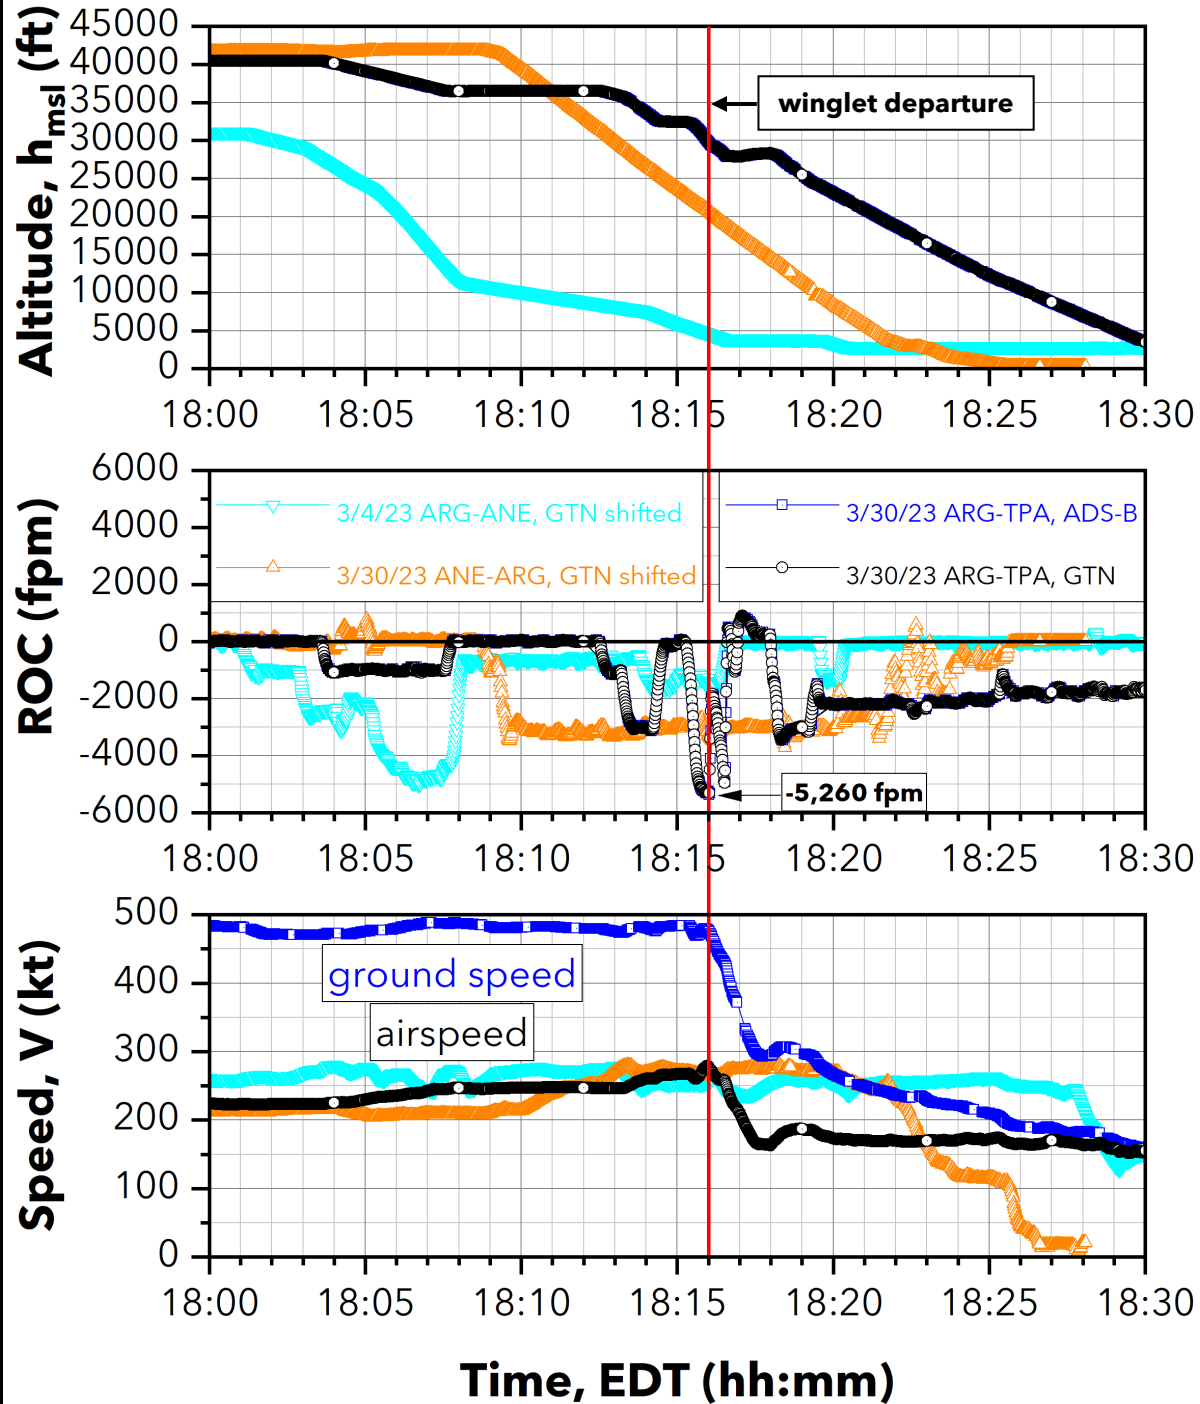
**Figure 4: Garmin and ADS-B Altitude, ROC, and Speed from Accident Flight and Previous Flights Around the Time of Winglet Departure**

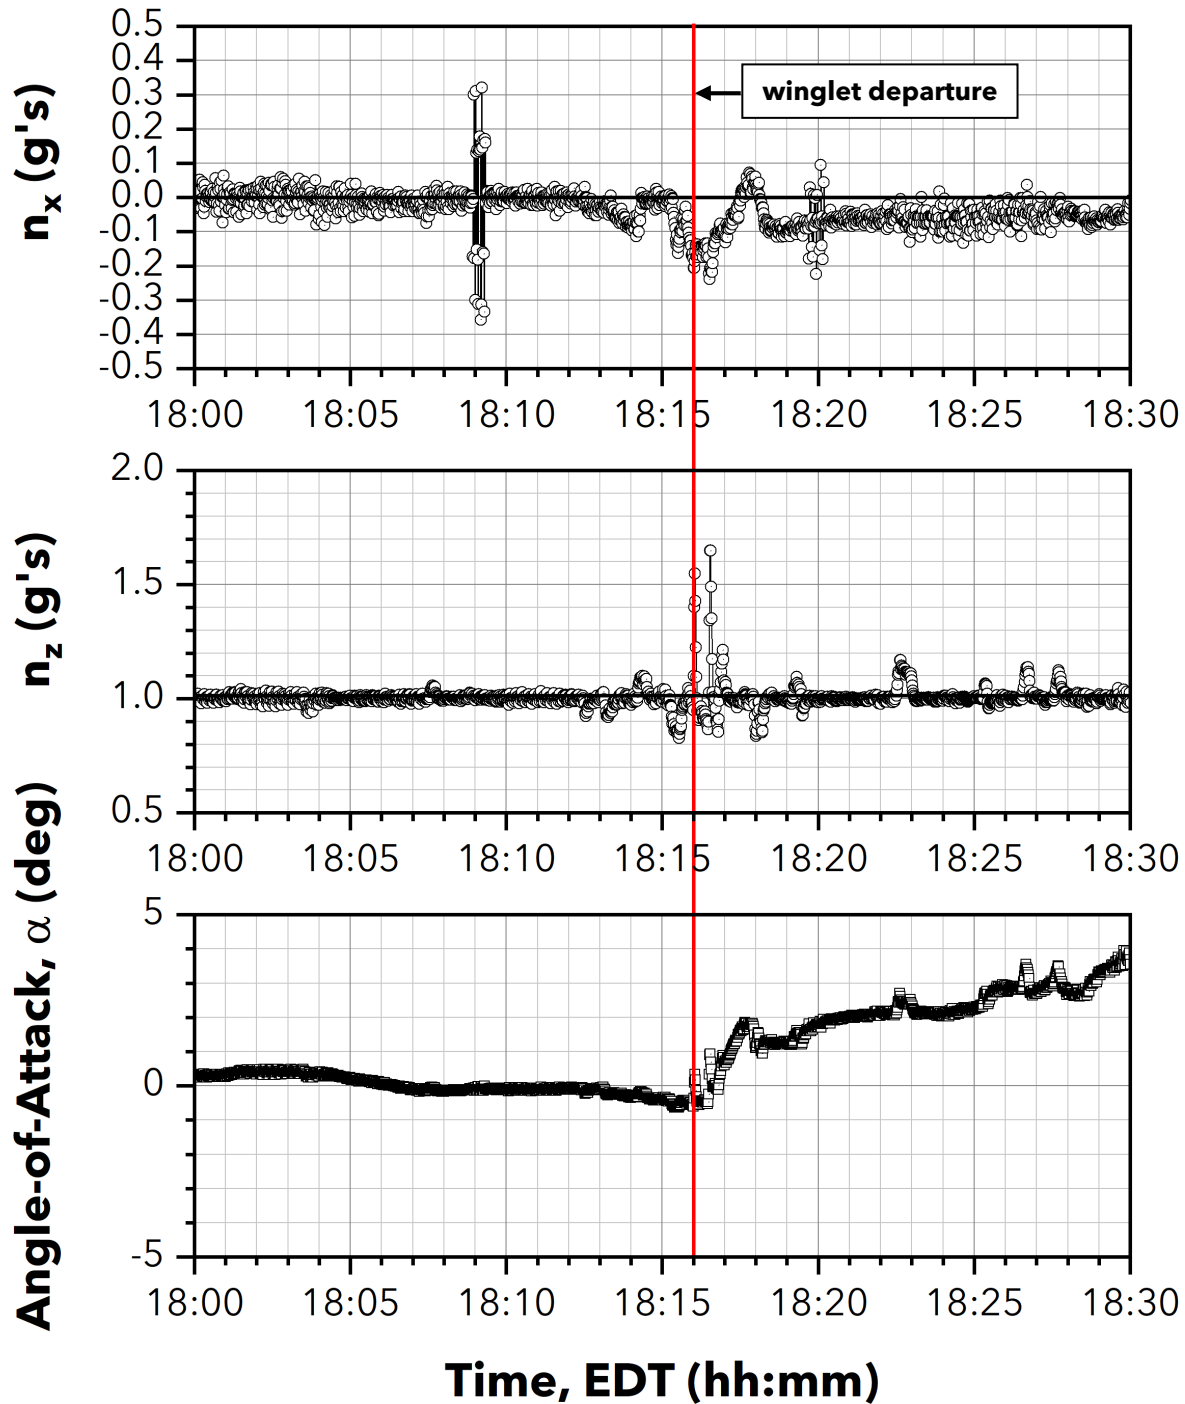
Finally, Figure 5 shows the accelerations estimated from GTN data for the accident flight.

The pilot of N869AC reported losing the left winglet while in a cruise descent at an altitude of about 30,000 ft. At this point in the Garmin and FAA data, the airplane was descending at about 5,300 fpm, the highest descent rate in the 41 flights since installing the winglets according to FAA ADS-B data. Just prior to losing the winglet, the airplane experienced a +0.2 g increase in longitudinal acceleration as well as a -0.2 g decrease in vertical acceleration: this is likely associated with the pilot's airplane-nose-down elevator input to initiate the cruise descent. About a half-minute later, the winglet departed, and the airplane experienced a +0.5 g increase in vertical acceleration as the airplane pitched up.

**Figure 5: Accelerations and Angle-of-Attack Estimated from Garmin Data  
Around the Time of Winglet Departure**

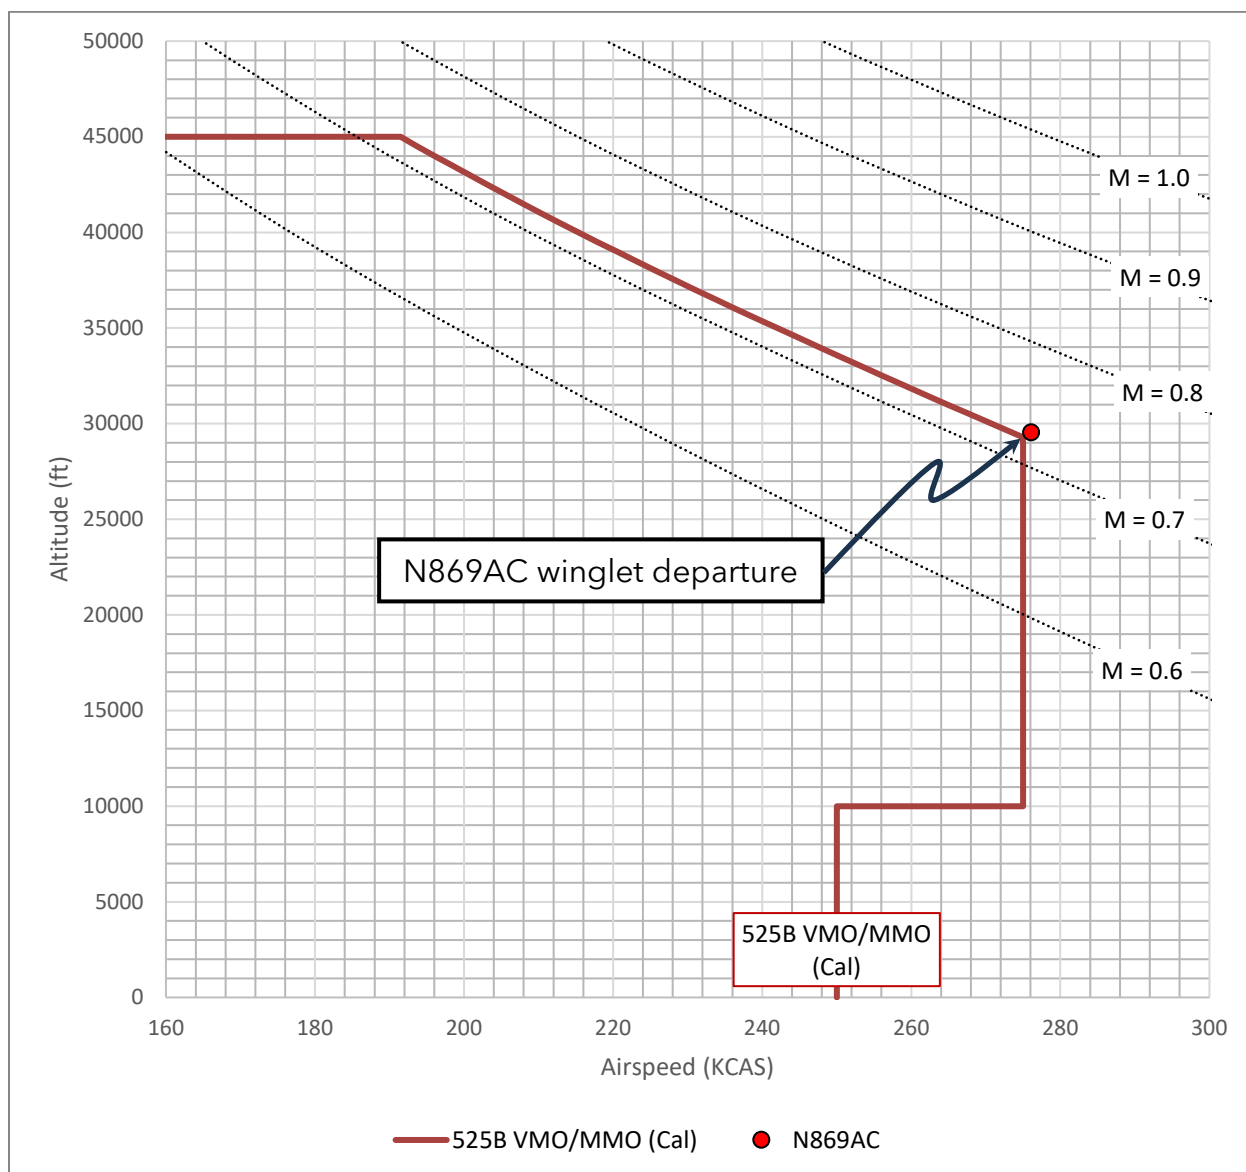
Figure 6 shows the altitude, airspeed, and Mach number where the winglet departed N869AC along with the 525B flight envelope provided by Tamarack<sup>3</sup>.

**Figure 6: Envelope of Cessna Citation 525B with Winglet Departure Point**
