# National Transportation Safety Board

ERA23FA185

**EXAM**

Location: Sebastian, Florida (X26)  
Date: April 7, 2023  
Time: 1443  
1843 (UTC)  
Airplane: PA-32-260 Reg# N44488

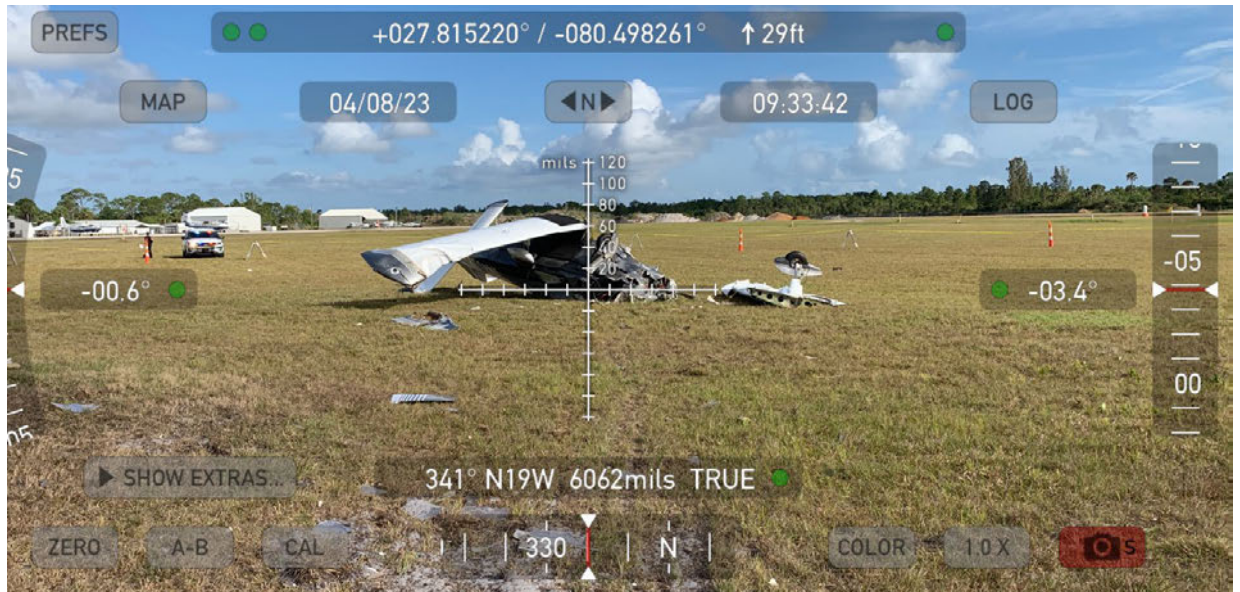
Sebastian Municipal Airport (X26) Sebastian, Florida, USA adjacent to runway 10 approach end. Level terrain grass. Accident site was compact with a ground impact gouge about 40 feet from the main wreckage. Initial ground impact contained red position light glass indicating the right wing struck the ground first, before cartwheeling and coming to rest on its left low side of the fuselage. Elevation was 21.5 feet. Lat/log 27.815221° / -80.498269° (figure 1)

**Figure 1 Accident site with location/ direction details**

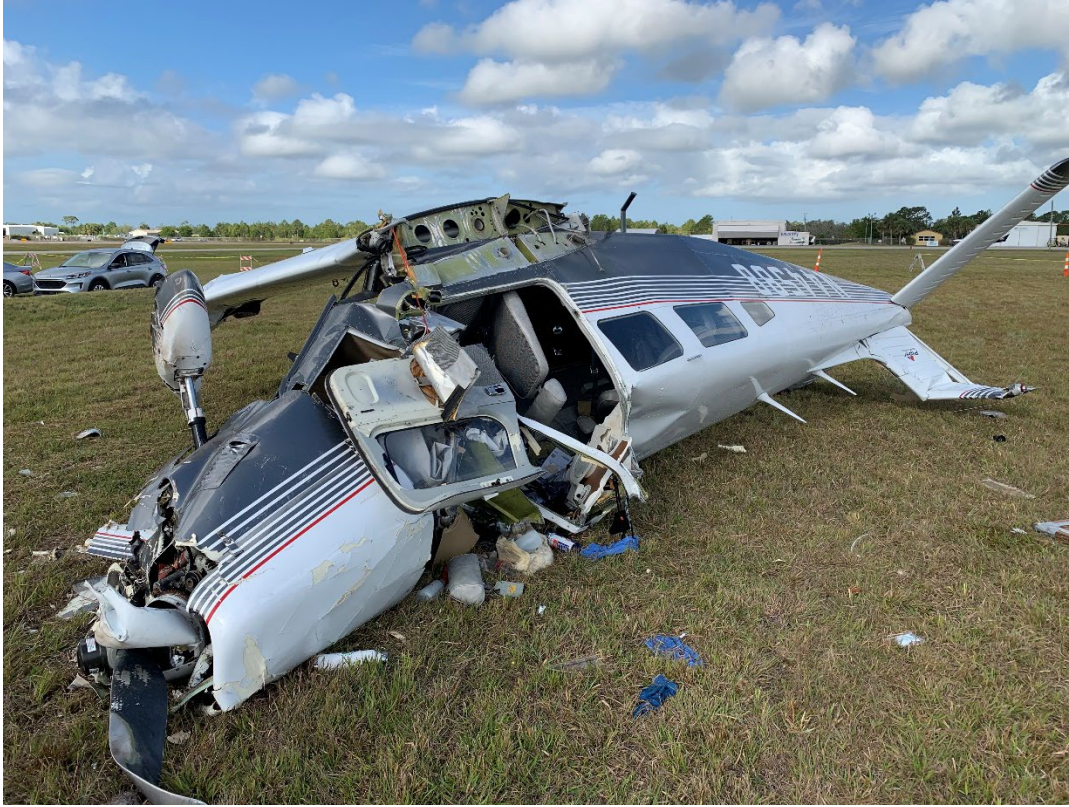
Fuselage buckled and crumpled in several areas but mostly intact from right side of the cockpit and aft to the empennage. Most severe damage was to the left (pilots) side of the forward cockpit. The engine compartment was significantly compromised by impact forces, displacing the engine and propeller slightly.

All tail control surfaces were intact and installed in their respective locations and moved manually with corresponding cable movement. A hole was cut into the fuselage to observe all cables and turnbuckles. No anomalies or other irregularities were discovered. Rudder continuity was established from the rudder-to-rudder pedals. Stabilator continuity was established from the stabilator to the main cabin area. Stabilator trim jackscrew measured 1 inch (8 threads) consistent with a neutral to nose up trim position.

**Figure 2 View of entire airplane wreckage looking aft.**

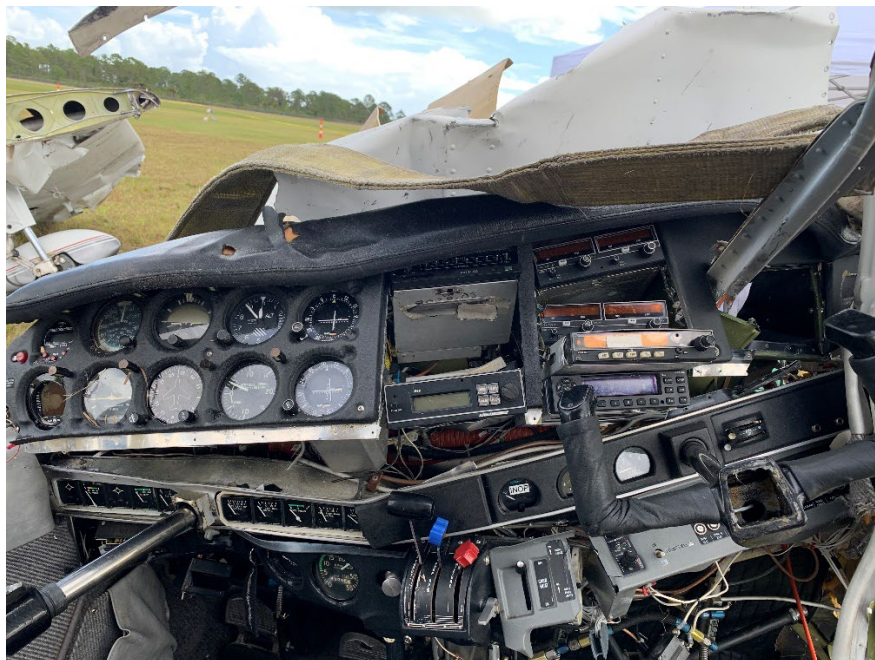
The fuel selector valve selected to the right main fuel tank. When manually operated, the selector moved freely, and resistance was felt at each of the detents. The electric fuel pump remained operative when switched in the on position. The flap handle was in the full flap configuration and matched the flap control surfaces. The stabilator trim jackscrew measured 1 inch (8 threads) consistent with a neutral to nose up trim position and matched the trim wheel in the cockpit. The tachometer was frozen in the 2500 RPM position and indicated 4,309.27 hours. The Hobbs meter indicated 1,250.9 hours. The throttle, mixture and propeller controls were located in the full forward position but note that the engine mounts had broken, and the engine was canted to the right and partially separated from the firewall.

- The airspeed indicator was intact and indicated 20 mph.
- The attitude indicator was operable and indicated about 15 degrees nose up.
- The heading indicator was functional and intact and indicated 264 degrees.
- The altimeter was intact and functional and indicated -100 ft and showed 30.10 hg in the window.
- The VSI was intact and indicated +400 fpm. The remaining gauges were intact and showed 0 fuel, 0 psi, 0 temps, and 0 AMPs across all systems.
- The master switch was on both.
- The fuel pump was off.
- The primer was in and locked. The carb heat was in the off position. Both left (pilot) and right control yokes were detached. The control chain failed during impact and engine displacement.

**Figure 3 Cockpit instrument panel and controls.**

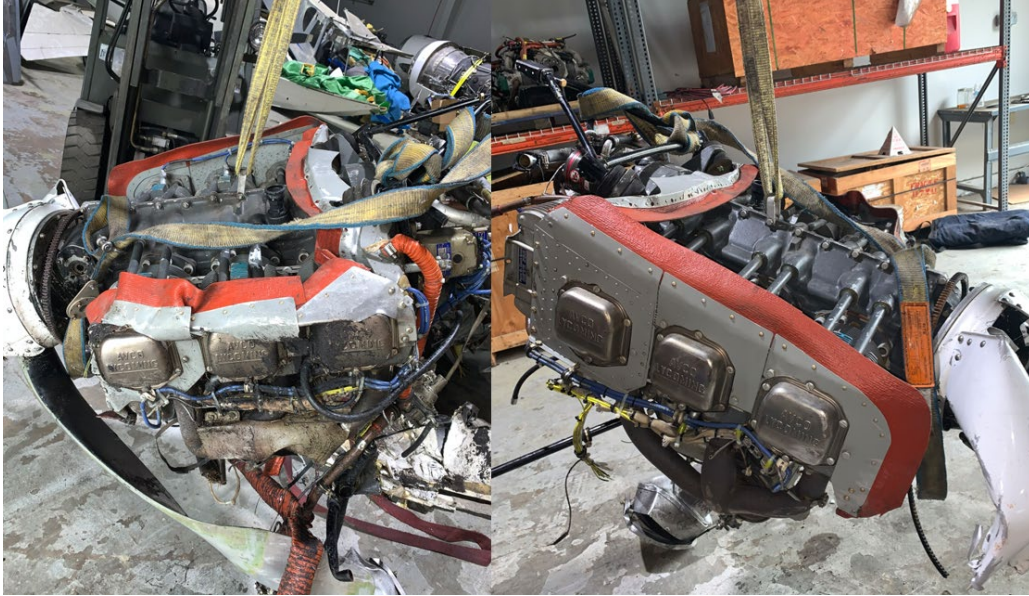
The powerplant is a six-cylinder, air cooled, direct drive, horizontally opposed, carbureted, naturally aspirated engine with a rating of 260HP @ 2700RPM. The Lycoming O-540-L4B5, Serial Number L-16650-40 was slightly impact damaged but was relatively free of serious damage that allowed for full functional testing and examination.

The carburetor was impact separated but remained with the engine via the control cables. The fuel line from the engine driven fuel pump to the carburetor was intact and undamaged. The line was removed, and no fuel was present. The engine drive fuel pump was fractured at the mounting flange and remained with the engine via the connecting fuel lines.

**Figure 4 View of left and right side of engine prior to examination.**

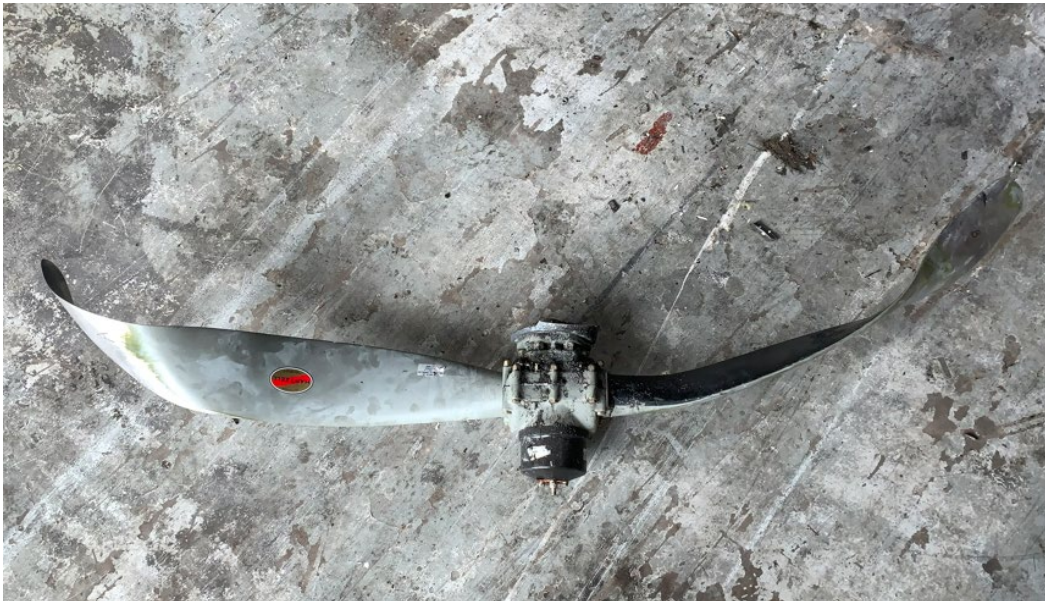
The propeller (Hartzell) hub remained attached to the flange and both blades were damaged. Both "A" and "B" propeller blades showed evidence of abrasive polishing on the outer 12 inches of blade tip. (The ground consisted of sandy soil) There were several clean propeller scalp marks in the ground near the wreckage. The A blade contained a compound bend and twist and bending in the opposite direction of rotation. There was also a buckling wave bend on the trailing edge. The propeller governor was impact separated from the front of the engine crankcase. (Figure 5)

**Figure 5 Hartzell propeller exhibiting signs of bending and polishing.**
