## **NATIONAL TRANSPORTATION SAFETY BOARD**

### **Attachment 1. Accidents with Lower Strength Restraint Failures**

## **SURVIVAL FACTORS**

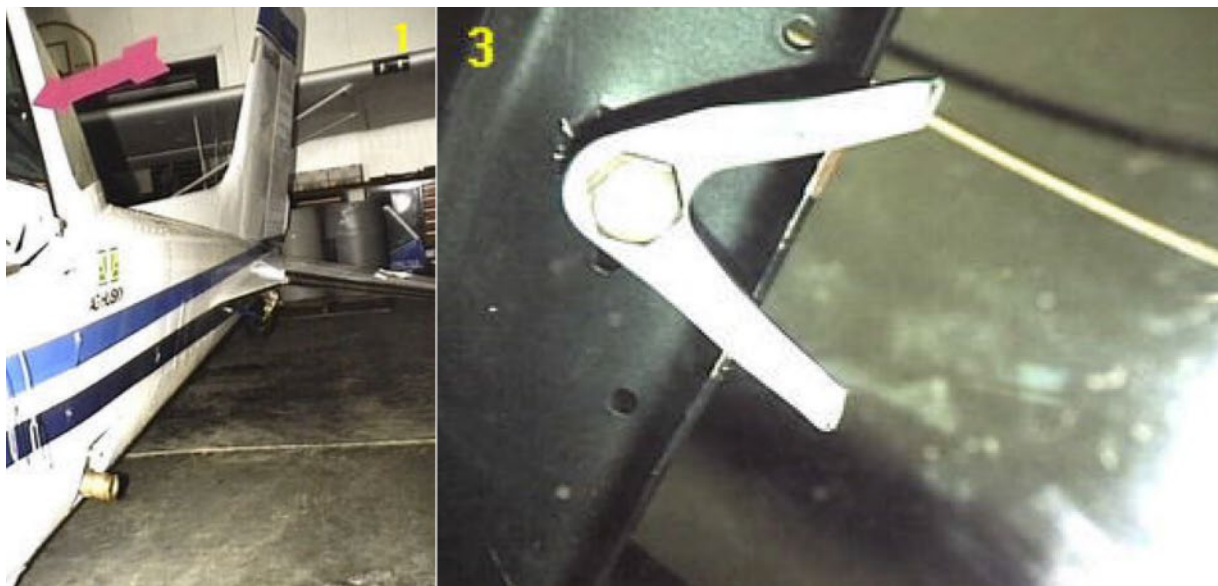
Postaccident examination of the airframe revealed that the pilot's upper torso harness attach ring broke during the accident sequence (see figure 1). The seat and seat belts were documented as being checked during the aircraft's last annual inspection, performed on April 5, 1996, at 1,226.7 hours AFTT. The operator reported an AFTT of 1,336 hours at the time of the accident. Photographs of the fractured part showed that the two fracture faces were on a 45-degree plane to the direction of load on the part. The fractures were through two legs of the triangle, along a line parallel to the third leg (which anchors the harness strap.) The attach ring bolts to the airframe at the apex of the triangle, opposite the third leg. A photograph of the manufacture tag sewn to the seat belt indicated that the belt assembly had a rated strength of 1,500 pounds and conformed to FAA Technical Standard Order (TSO) C22f. The tag indicated that the belt was manufactured by Aero Fabricators of Lyons, Wisconsin, on January 4, 1993. FAA Advisory Circular (AC) 20-36S indicates that Aero Fabricators holds a TSO-C22f authorization to manufacture safety belts.

**Figure 1.** Cessna T188C, N4970J, pilot seat upper torso harness attachment point and bracket.

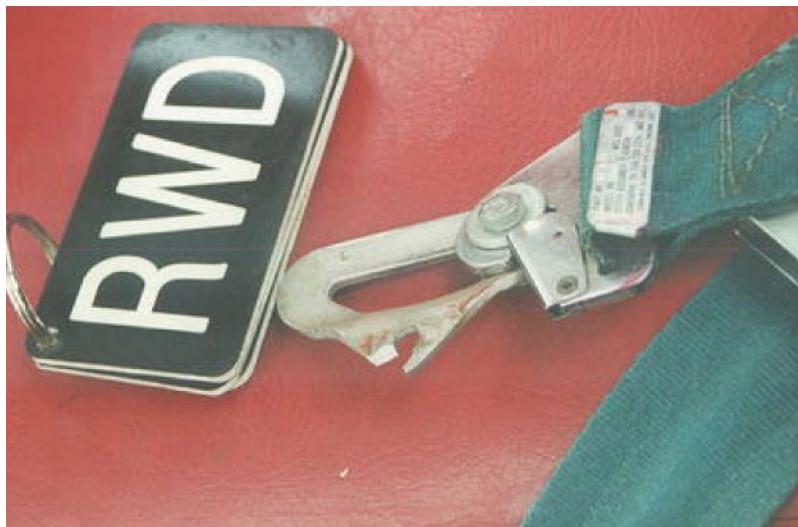
An aluminum-colored seat belt end from the rear seat was found detached from the fastener that secured it. That fitting's hole was found deformed and a section was torn in the radius area about that hole (see figure 3).

**Figure 3.** Photograph of rear seat belt attachment hardware failure.

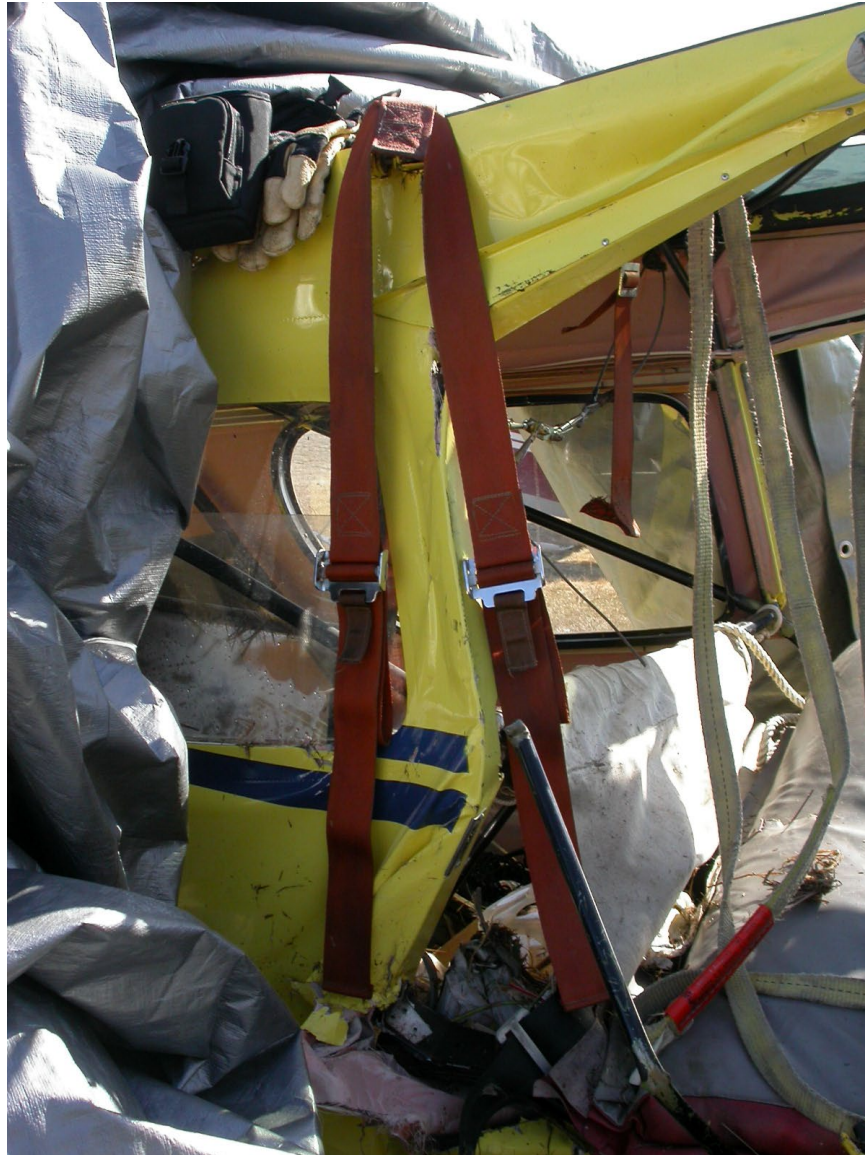
Postaccident examination of the airframe revealed that the pilot's TSOC22f upper torso harness failed at the point where the single anchor, or tail strap, attached to the V-shaped upper torso restraint straps (see figure 5). The passenger received serious injuries and was hospitalized for several weeks. Her upper torso restraint system did not fail.

**Figure 5.** Picture showing intact right side passenger harness, and left side pilot failed upper torso harness.

The pilot's and passenger's upper torso harnesses were sent to the NTSB Materials Laboratory for testing and failure analysis. The report notes, in part, that the pilot's harness failed at the stitching where the anchor strap was sewn to the junction of the upper torso restraints. The webbing material was tensile tested to failure, albeit without the ability to test the box stitching at the attachment point. The material was found to fail at 3,840 pounds, exceeding the minimum of 2,250 pounds as specified in Technical Service Order C22f for webbing material, which was applicable when the harnesses were reportedly purchased. A test was also performed on the passenger's harness. The webbing material again failed at a strength exceeding the minimum requirements, but the box stitching joint failed at 995 pounds, significantly below the minimum of 1,500 pounds.

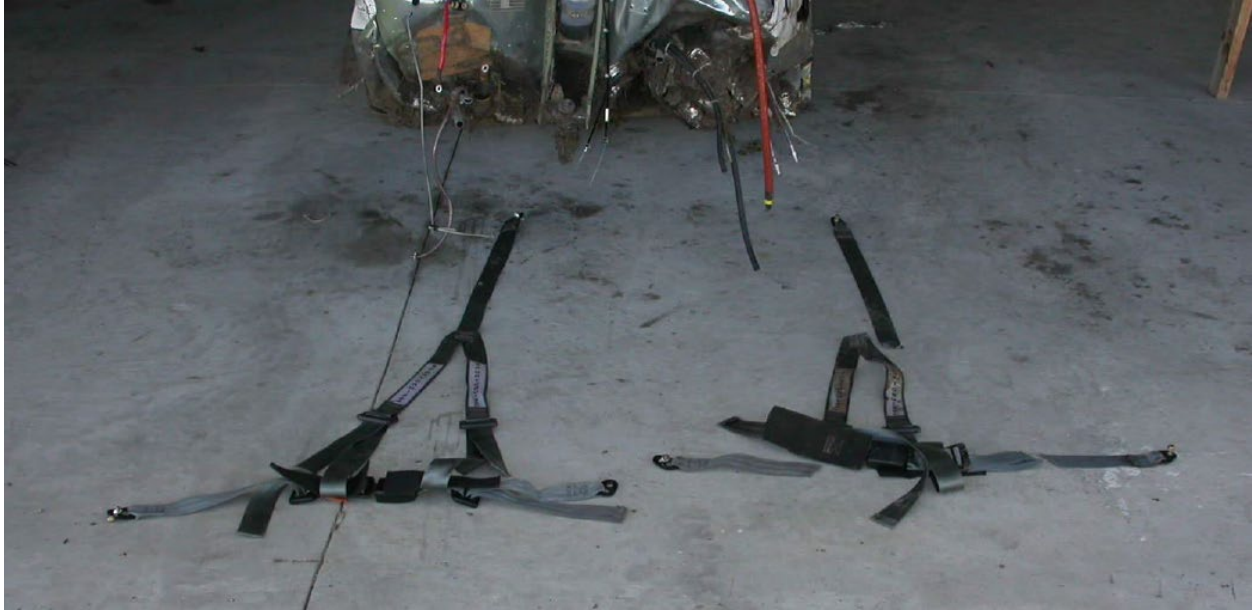
Postaccident examination of the airframe revealed that the pilot's TSO C22f upper torso harness revealed that the single strap of the upper torso harness that attached the harness to the rear cabin bulkhead was separated from the upper torso harness yoke where it was stitched to the right and left upper torso straps. The stitching had failed at the attach point (see figure 8). The pilot's and co-pilot's seat belt and upper torso harness assemblies were removed from the airplane and sent to the NTSB's Materials Laboratory for examination. The pilot's harness was in four pieces. The pilot's seat belt portion of the harness had been cut in two locations during the on-site recovery. The co-pilot's harness was intact.

Two exemplar harness sets (labeled EX1 and EX2) were obtained for the purpose of examination and destructive testing. In order to determine the strength of the sewing pattern at the yoke (where the pilot's harness failed) the exemplar harnesses EX1 and EX2 were subjected to tensile testing. For comparison, the sewing location at the rear fitting of the harness was also tested. The tensile test revealed that the EX1 harness yoke failure occurred at a load of 1,458 pounds, and the rear location failure occurred at a load of 3,384 pounds. The EX2 harness yoke failure occurred at a load of 1,456 pounds, and the rear location failure occurred at a load of 3,375 pounds.

**Figure 8.** Upper torso harnesses and seat belts.

Although there was intrusion into the cockpit and some buckling of the forward portions of the aircraft into the occupied space, the physical evidence appears to indicate that the deformation stopped forward of the base of the control stick. In addition, the upper torso harness failed at the stitching indicating that the harness was under load, which likely would not have been the case if the control stick were impacting the pilot's upper body. The control stick may have been displaced aft but likely not to the extent to impact the pilot if his restraint system were intact. The severity of the crash, the intrusion into the cockpit and the pilot's age may still have resulted in injuries severe enough to result in a fatality.

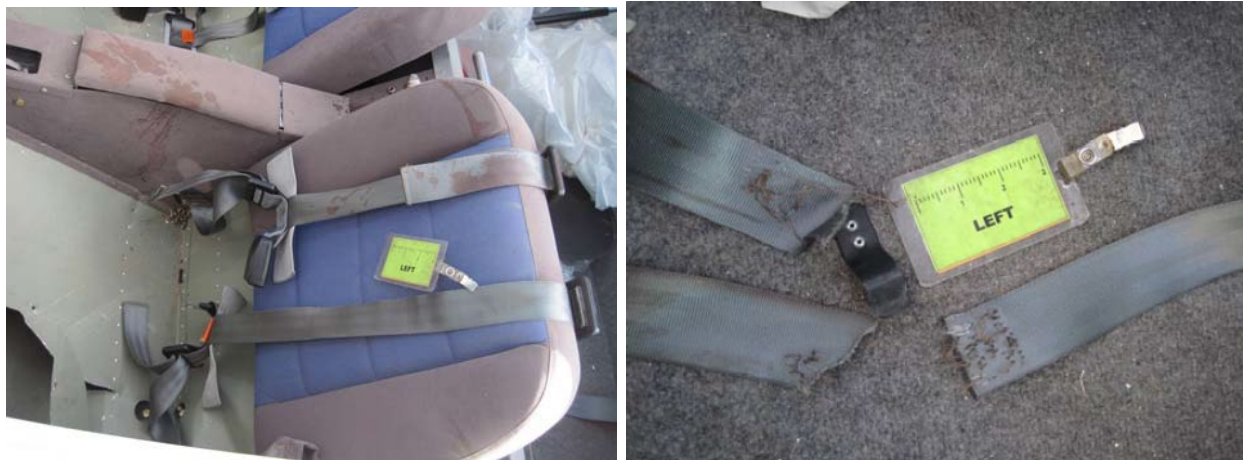
Postaccident examination of the airframe revealed that the left seat restraints remained attached to the airframe via all mounts. However, the left and right upper torso restraints were found separated from the single strap that originated from the aft mount (see figure 9). The area of separation appeared was reportedly not cut by first responders or aircraft recovery personnel. The separation of the left and right upper torso straps appeared to be pulled away from the aft strap. Remains of threads and stitching patterns remained in all three straps. The right seat restraint was intact and remained attached to the airframe via all mounts. The left and right upper torso straps remained attached to the aft strap. The area of where all three straps were stitched together exhibited a slight amount of separation.

**Figure 10.** Left seat place with restraints, (right) view of separation point for the restraints.

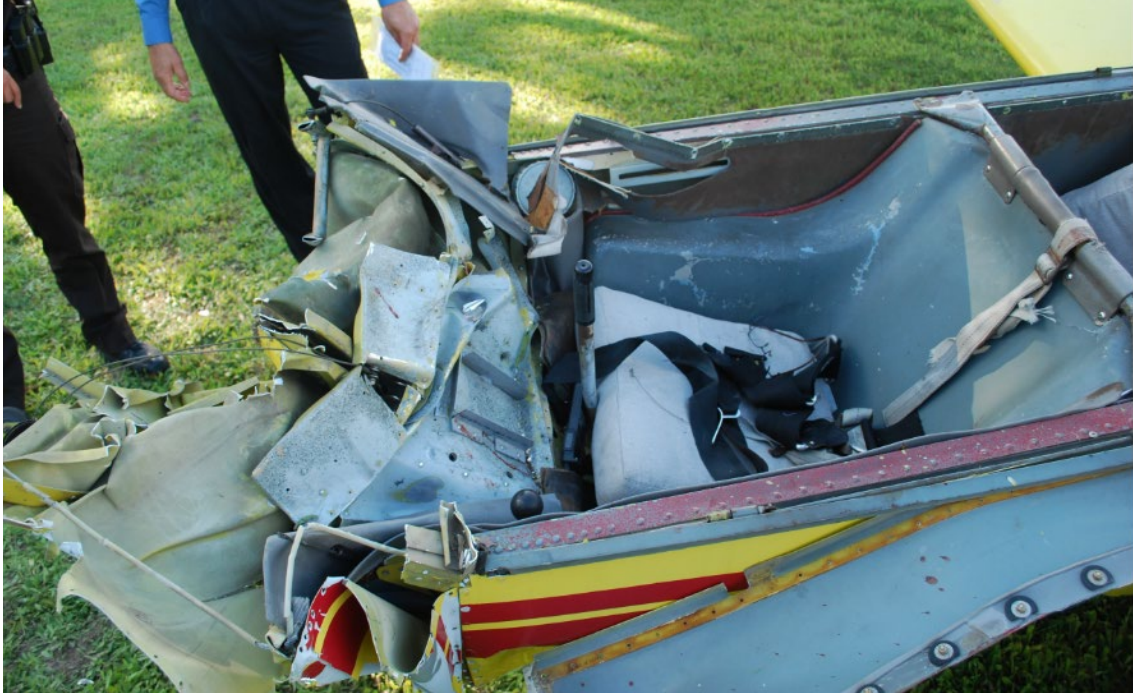
Postaccident examination of the airframe revealed that both TSO C22f upper torso restraints were separated. The front seat upper torso restraint was found separated through the fabric webbings above the chest adjusters (see figure 12) with no stitching or fitting attachments were apparent in the area. The rear upper torso restraint was found separated at the stitched webbing where the upper torso restraint straps connected to two straps which connected to the tubular metal support beam. The inside edges of the straps were slightly frayed. The separations were consistent with tensile overstress of both sides with no indications of cutting or sharp edges at the separation locations.

**Figure 12.** Schweitzer N591CC front seat upper torso harness and attachment point.

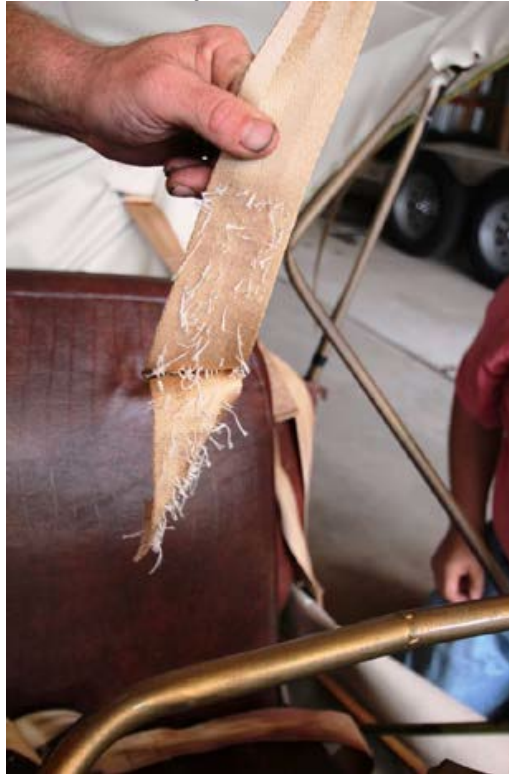
Postaccident examination of the airframe revealed that the pilot's upper torso harness failed during the accident (see figure 14). Material examination of the upper torso harness webbing and stitching showed that they failed due to an overload event. The occupants' injuries suggest that both occupants were using the four-point upper torso harnesses at the time of the accident and were exposed to strong deceleration forces. If the pilot's upper torso harness had not failed, he likely would not have suffered the brain injury he received, which caused permanent disability. However, it is possible that an intact upper torso harness could have led to more severe chest, abdominal, or cervical injuries.

**Figure 14.** Aeronca N82383 pilot's upper torso harness as found in airplane.

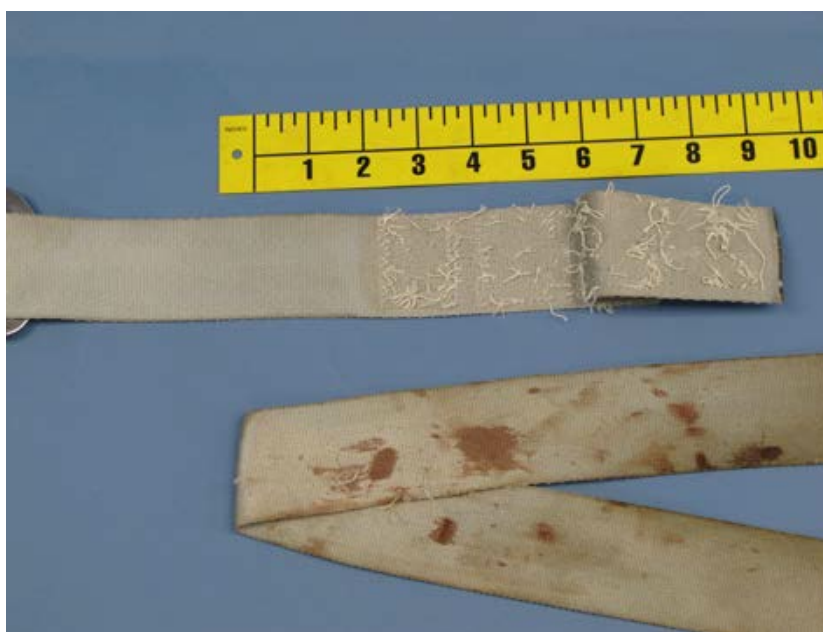
During the on-scene wreckage documentation, the NTSB observed that the pilot's TSO C22f upper torso harness had failed during the accident, with failure of the threading at the 'Y' junction (see figure 16). The pilot restraint was manufactured by Aero Fabricators (Model number H-702) and installed on the accident airplane on February 9, 2003. The date of manufacturing stamp on the upper torso harness restraint was smeared and was illegible. The upper torso harness label stated the restraint system had a "rated strength of assembly [of] 1500 pounds."

**Figure 16.** Cessna 172 N5129R pilot's upper torso harness.

In this case, the upper torso portion of the pilot's safety harness failed during the crash sequence, allowing his chest significant additional forward excursion. As a result, his chest interacted with the yoke and caused the overload failure of the control column. This interaction is most likely the cause of his sternal fracture, as well as his lung, mediastinal, and cardiac contusions. In addition, it allowed his face to impact either the yoke or the dashboard. If the upper torso harness had not failed, the pilot may have suffered superficial contusions to his chest wall (safety belt marks) and perhaps some rib fractures, but it is unlikely that he would have significantly impacted the yoke or suffered significant internal chest injuries.

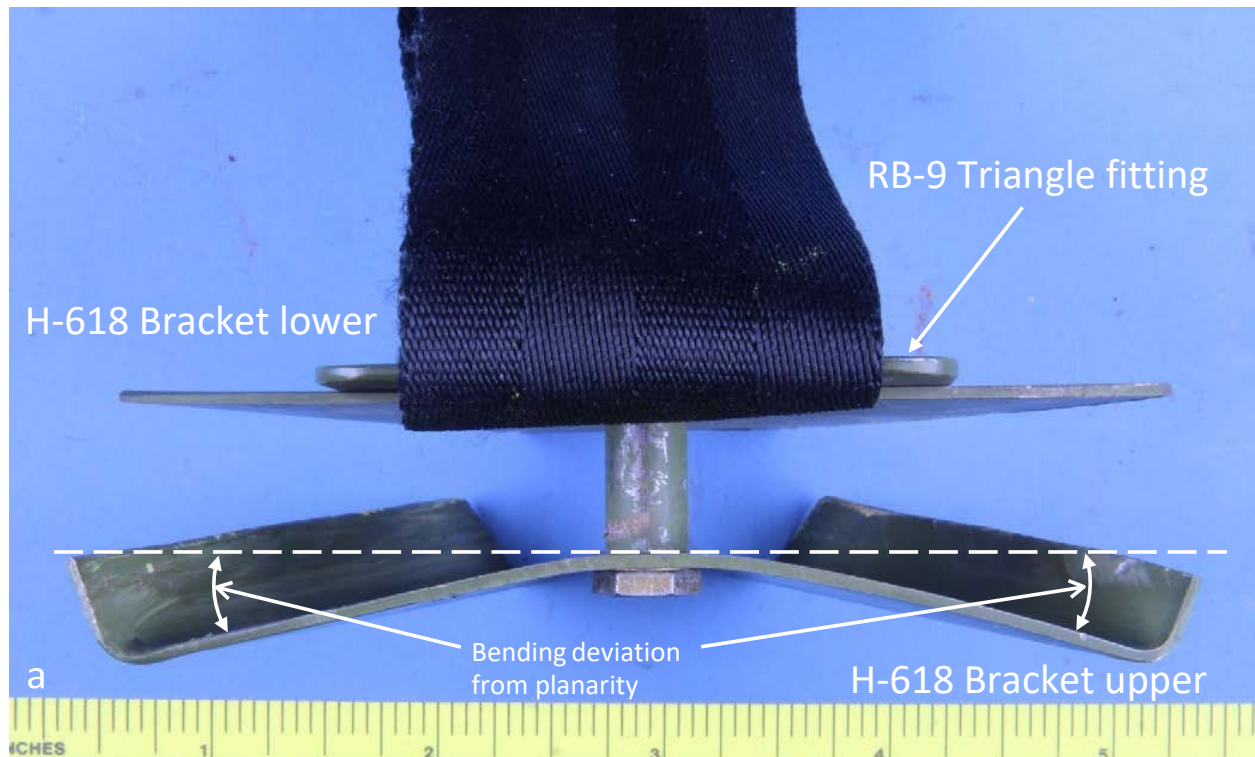
During the on-scene wreckage documentation, the NTSB observed that the rear seat upper torso harness assembly pulled loose from its mounting location. Examination of the rear seat upper torso harness assembly revealed that it was not bolted, fastened, or positively secured to the airplane's tubular structure but was instead clamped over two, 5/8-inch-diameter tubes with upper and lower triangular attachment brackets just forward of where the tubes intersected with the top longeron. Examination of the attachment brackets revealed that, during the impact sequence, the bracket assembly likely either mechanically pulled or slid over the airplane's structural tubing. It was noted that the back seat occupant was more seriously injured than the front seat occupant, whose upper torso harness did not separate from the structure. On the basis of this evidence, it is likely that the detachment of the rear upper torso harness assembly contributed to the instructor's injuries because it allowed him to strike the front seatback and his control stick.

**Figure 18.** Edge views of the rear attach hardware assembly showing permanent bending deformation in the upper bracket.

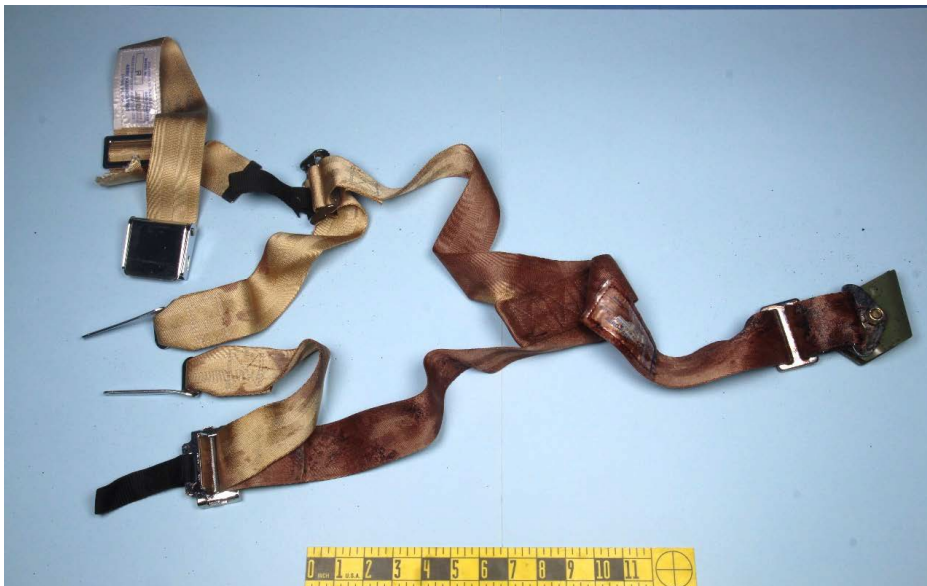
The front seat left-side lap belt webbing was separated in two places near its attach point (see figure 21). Examination of the fracture surfaces revealed damage consistent with overload.

**Figure 21.** Rear seat belt assembly

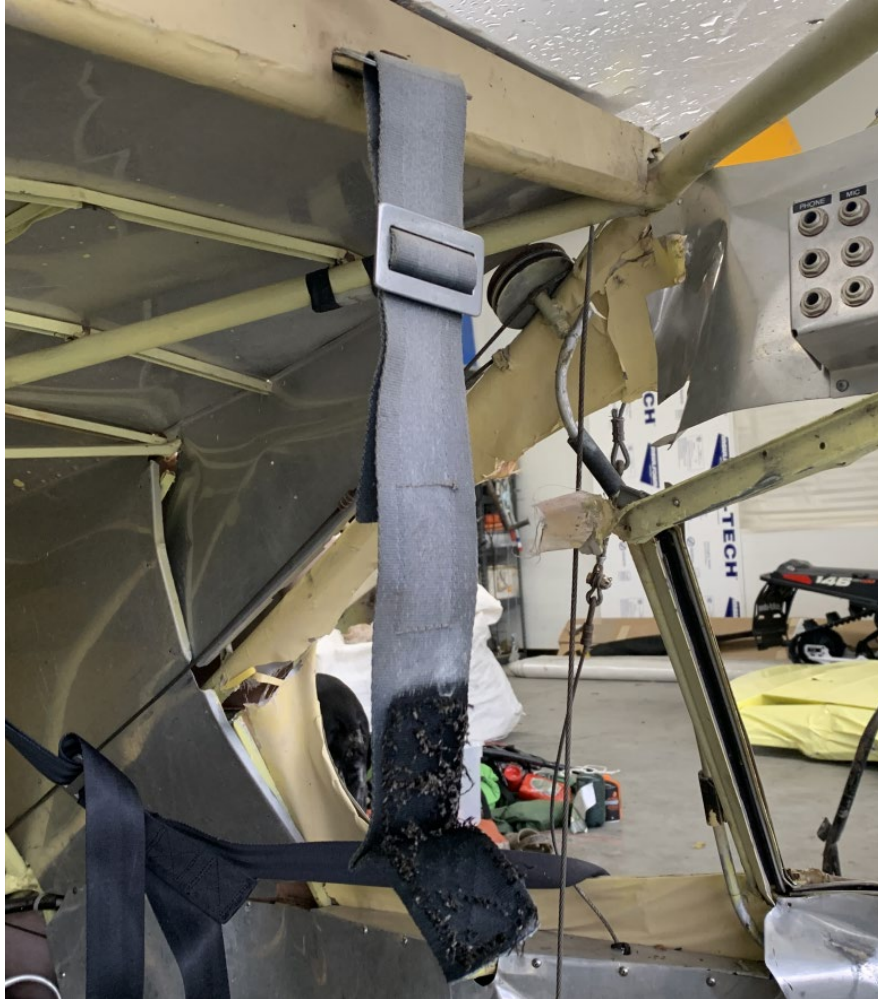
During the on-scene wreckage documentation, the NTSB observed that the pilot's upper torso harness had failed during the accident, with failure of the threading at the 'Y' junction (see figure 23).

**Figure 23.** Piper PA-12 N3937M pilot's upper torso harness.

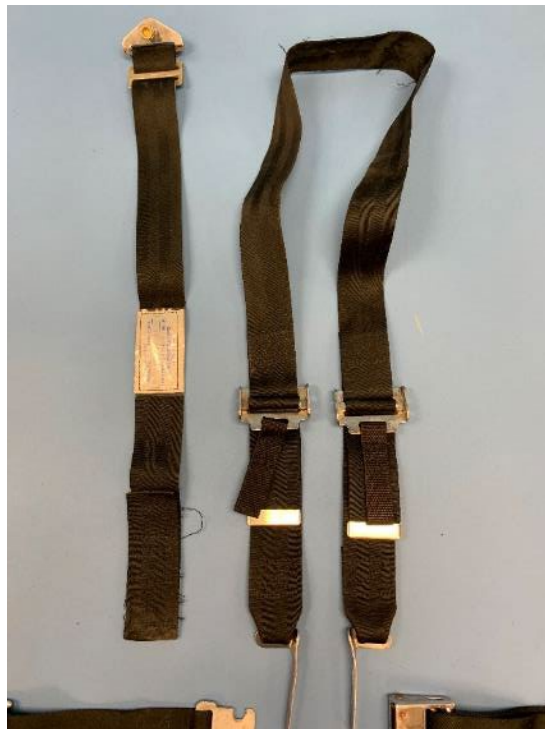
During the on-scene wreckage documentation, with separation of the threading at the 'Y' junction (see figure 25). The pilot seat had a label that read Model number 11-702-300, date of manufacture of December 15, 2017. The upper torso harness label stated the restraint system was an FAA-Parts Manufacturer Approval (PMA) part with a "rated strength of assembly [of] 1500 pounds."

**Figure 25.** Bellanca Aircraft 7ACA, N9111L, pilot's upper torso harness.

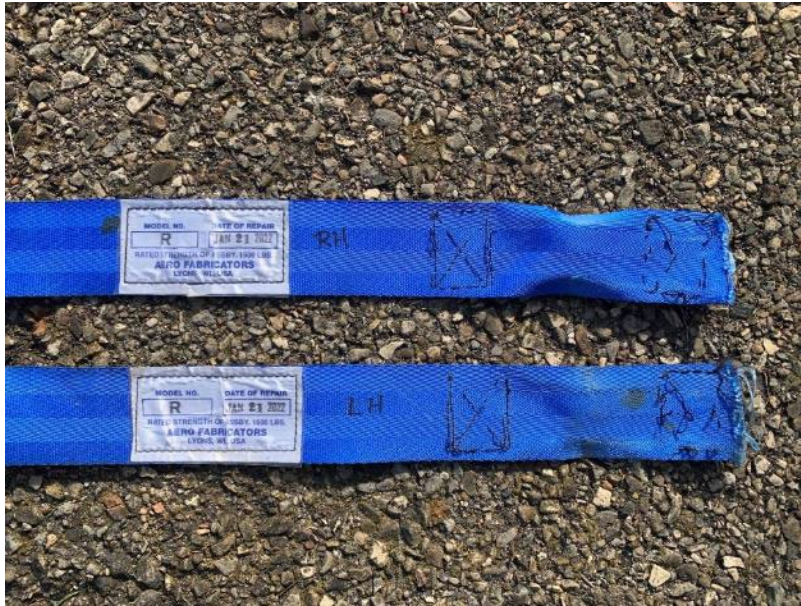
During the on-scene wreckage documentation, separation of the threading at the connection to the airframe of the upper torso restraint was noted (see figure 27). Both restraints had labels that read Model number R, date of repair of January 21, 2022. They further read "rated strength of assembly [of] 1500 pounds, Aero Fabricators, Lyons, WI, USA."

**Figure 27.** Cessna 172 Skyhawk, N734GB, front seat upper torso harnesses failed stitching.

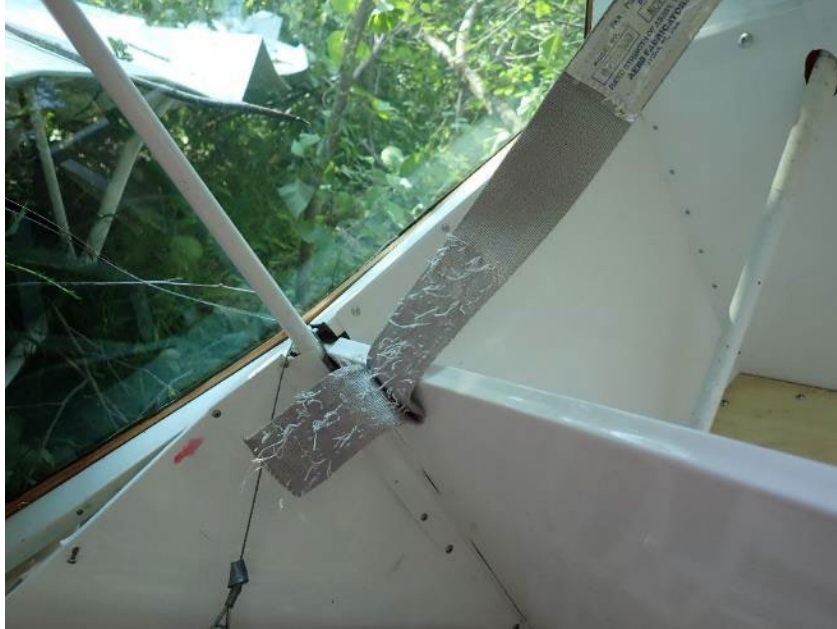
During the on-scene wreckage documentation, separation of the threading at the connection to the airframe of the upper torso restraint was noted (see figure 29). The pilot and passenger's restraints had a label on the upper torso restraint that read "Model Number H-702-300, Date of Manufacturing Nov 13, 2009." They both further read "rated strength of assembly [of] 1500 pounds, Aero Fabricators, Lyons, WI, USA."

**Figure 29.** Photograph of the upper torso restraint failure.
