ERA23FA209

## INVESTIGATION PHOTOGRAPHS

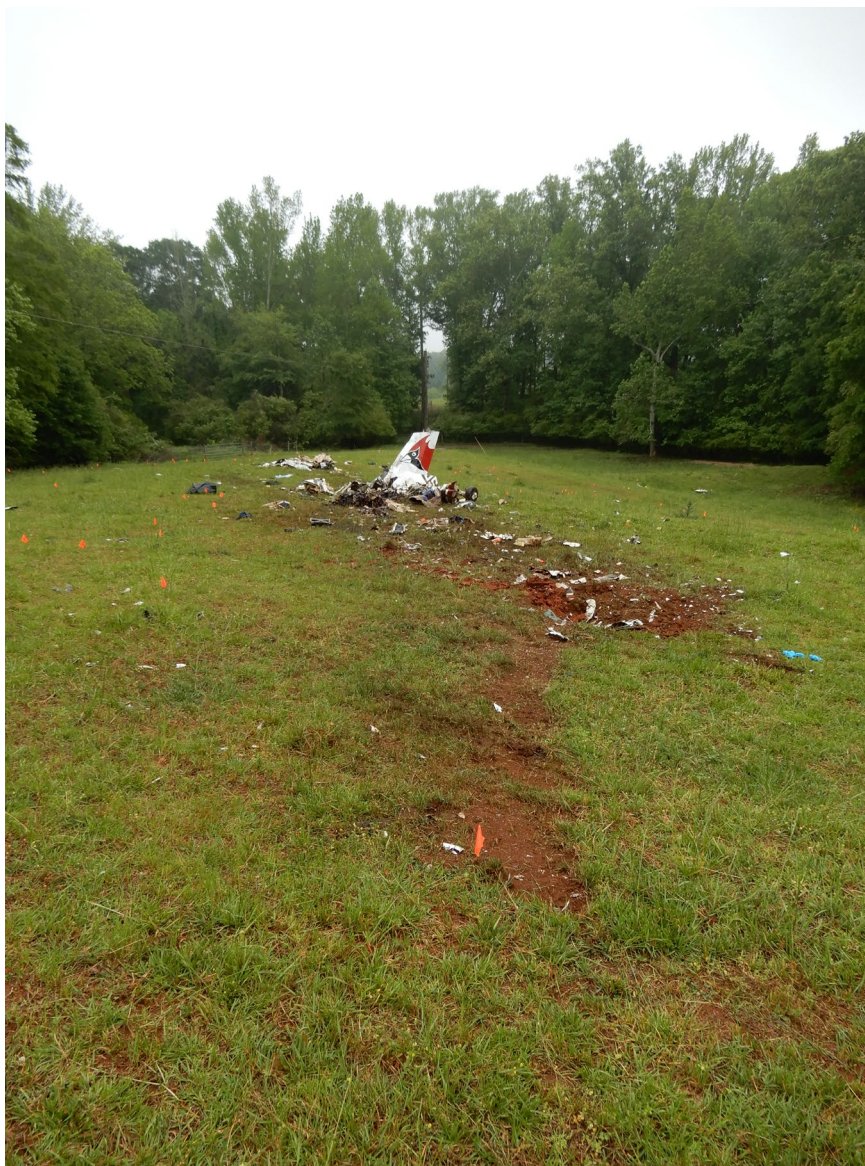
**Photograph 1 - Main Wreckage Site (NTSB Photo)**

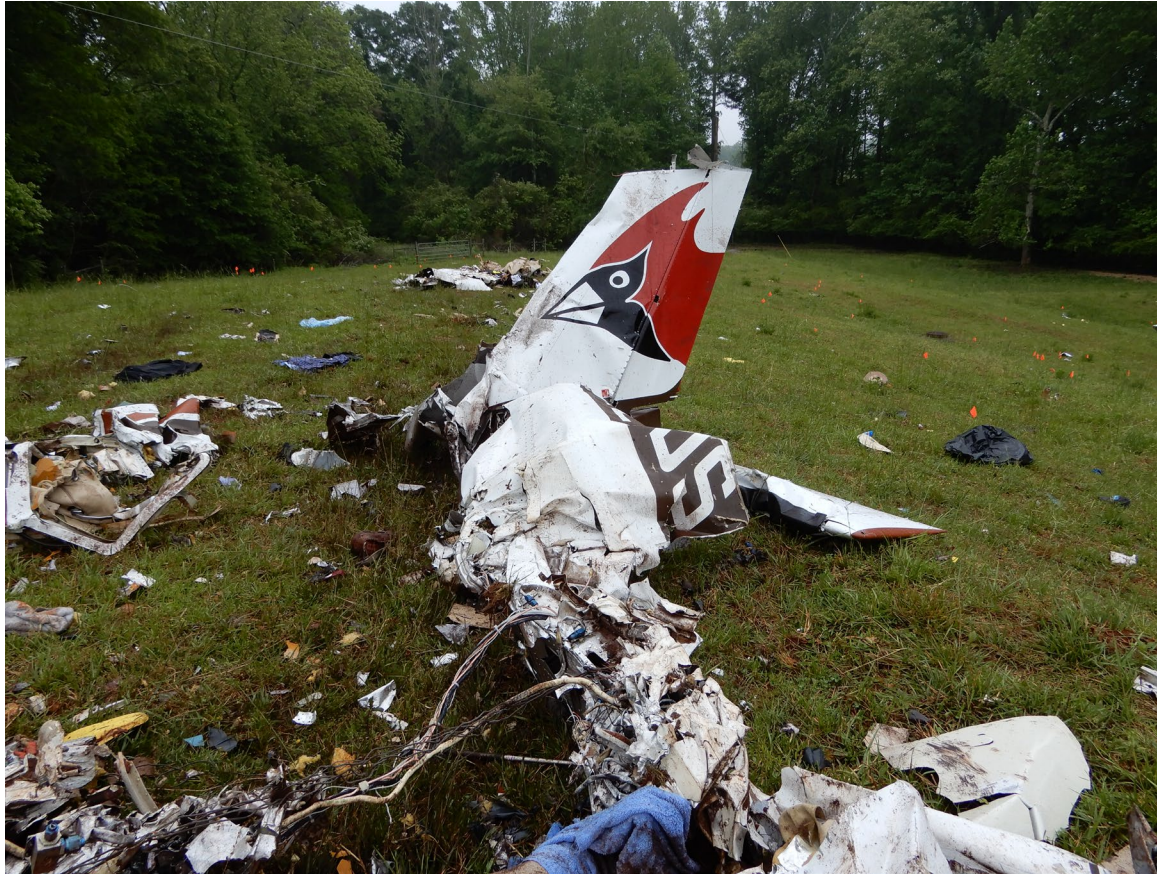
**Photograph 2 - Main Wreckage (NTSB Photo)**

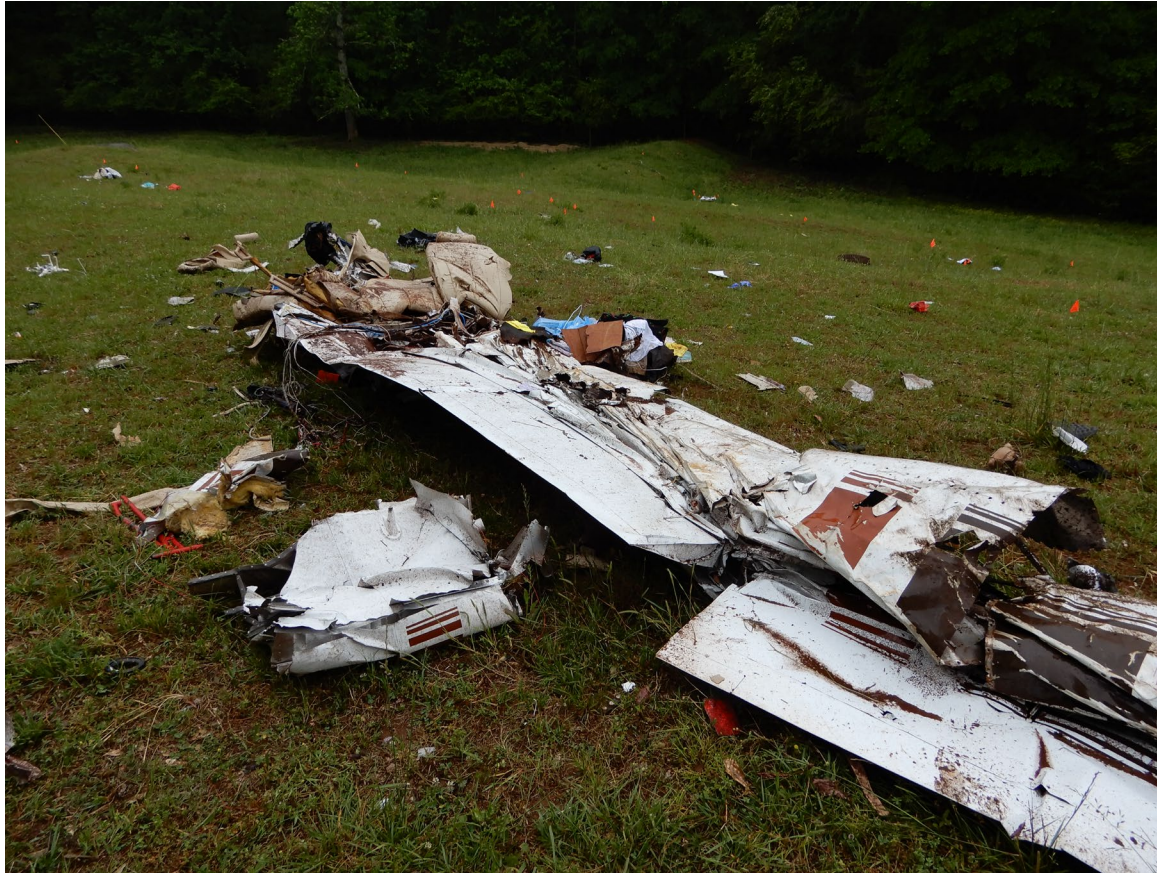
**Photograph 3 - Left Wing and Carry Through (NTSB Photo)**

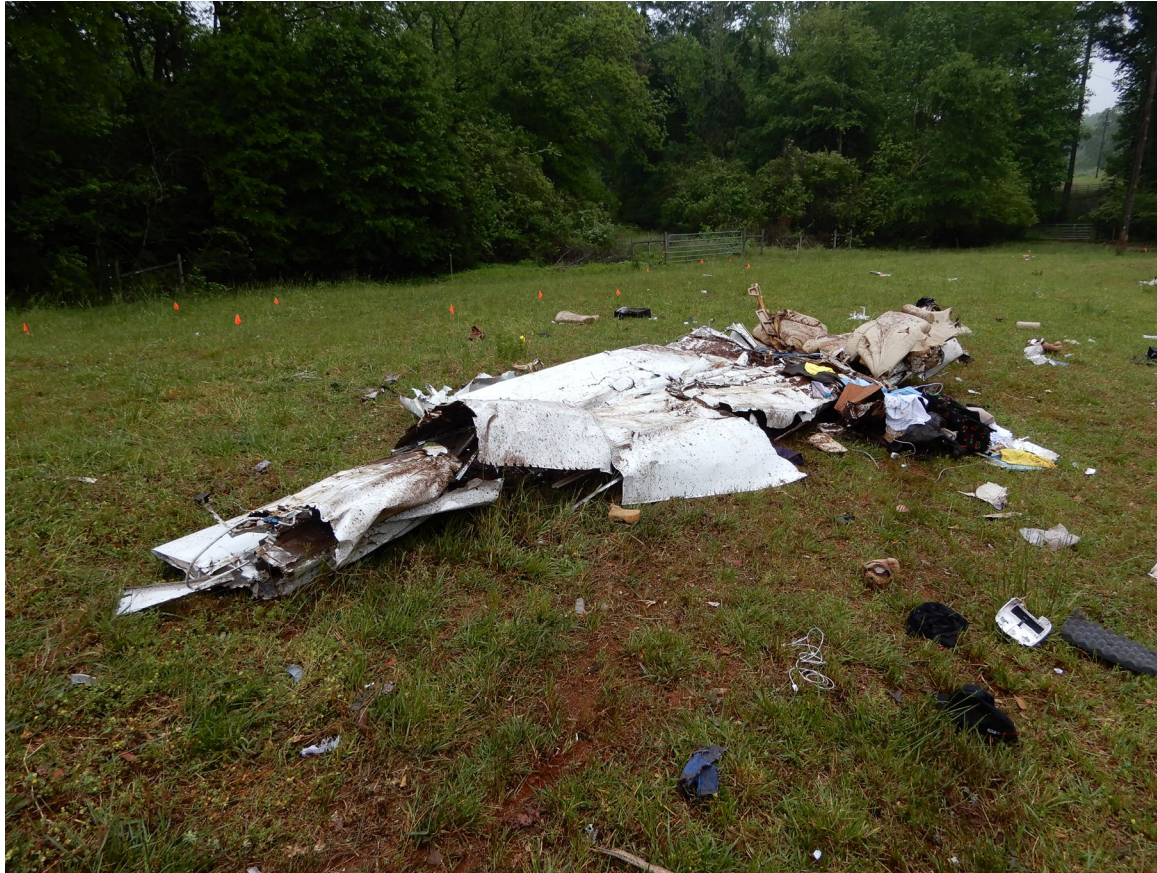
**Photograph 4 - Left Wing and Carry Through (NTSB Photo)**

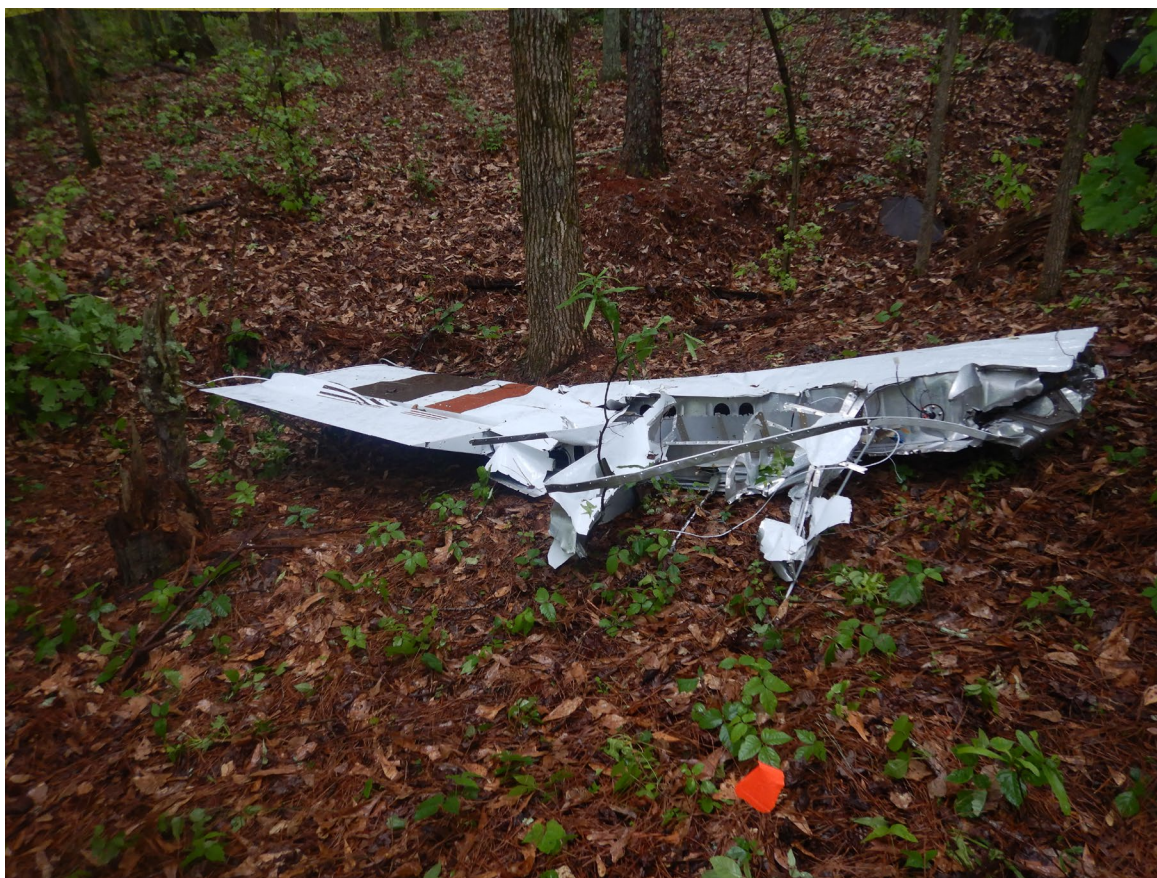
**Photograph 5 - Separated Right Wing Section (Courtesy of Textron)**

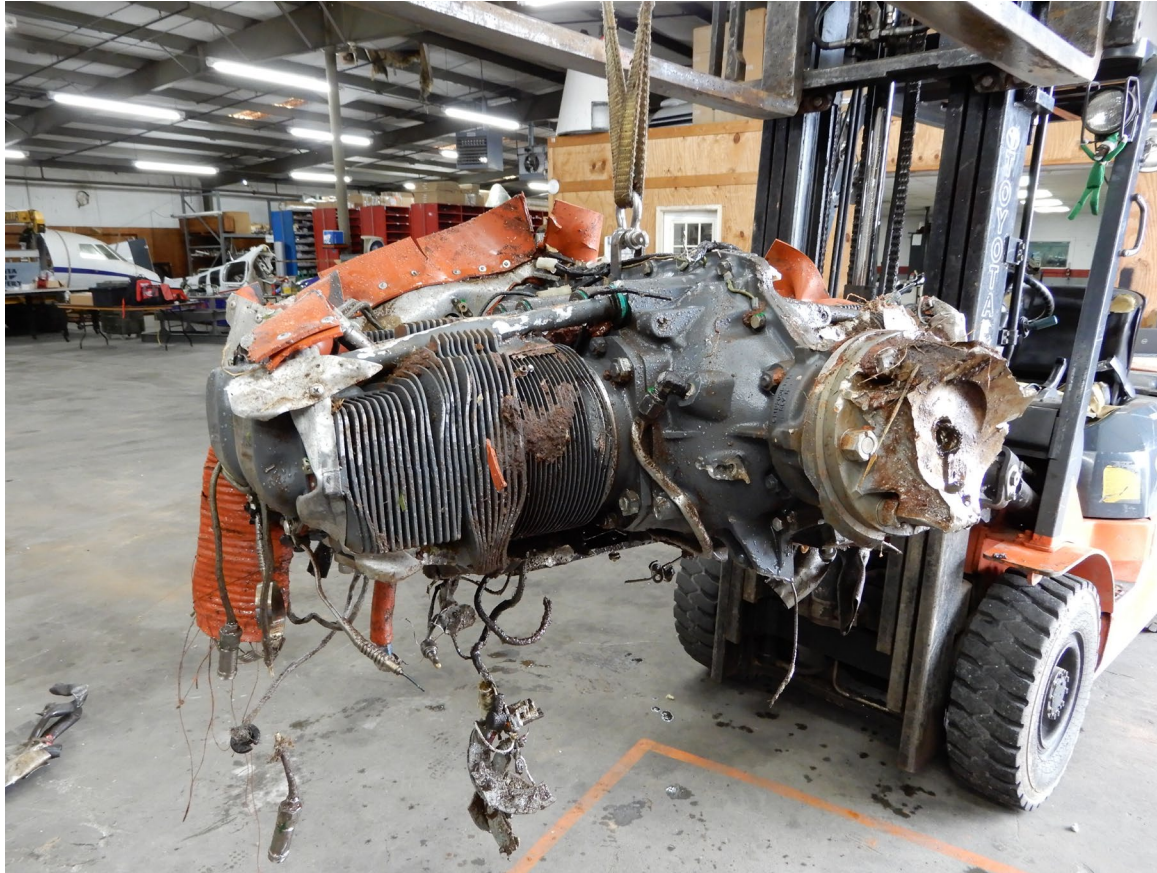
**Photograph 6 - Engine (NTSB Photo)**

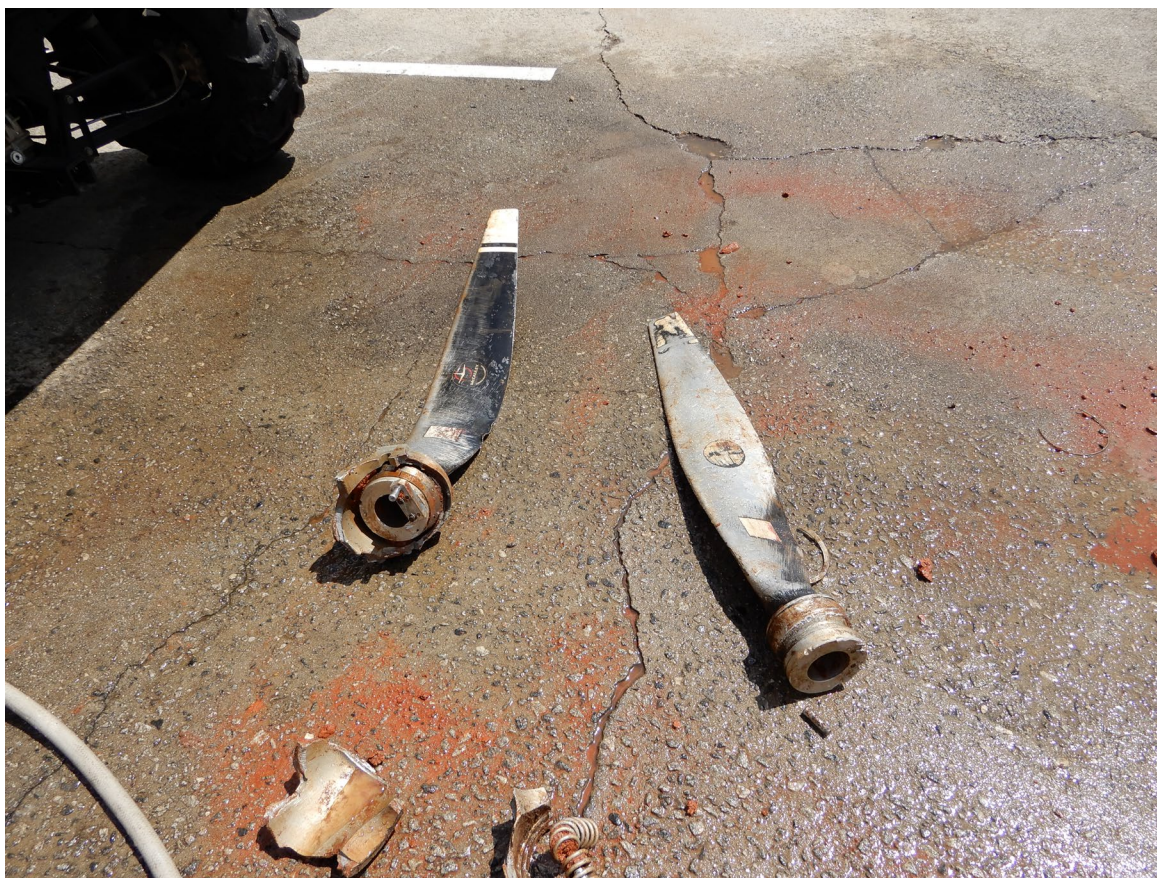
**Photograph 7 - Propeller Assembly (NTSB Photo)**
