**From:** [Charles Cates](#)  
**To:** [Ralph Hicks](#)  
**Cc:** [Sean Payne](#)  
**Subject:** ERA23FA209 (Watkinsville, GA) Garmin Area 796 SD Card  
**Date:** Wednesday, November 15, 2023 4:38:59 PM  
**Attachments:** [IMG\\_0431.jpg](#)  
[IMG\\_0432.jpg](#)  
[era23fa209.jpg](#)

### **Email Report**

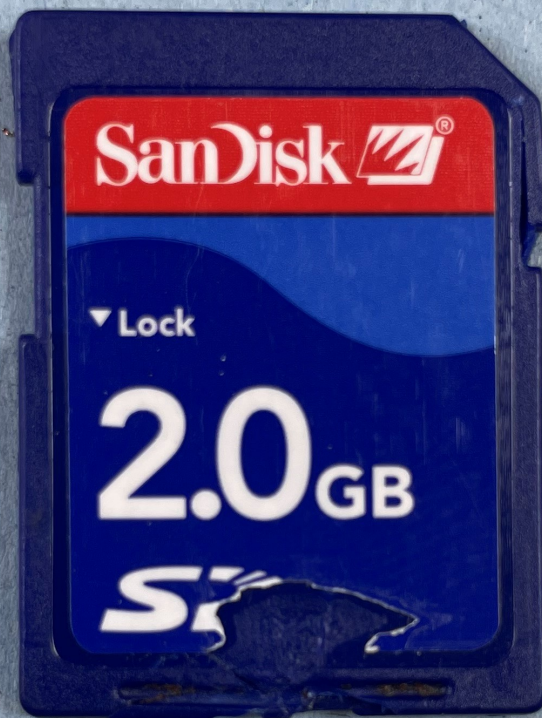
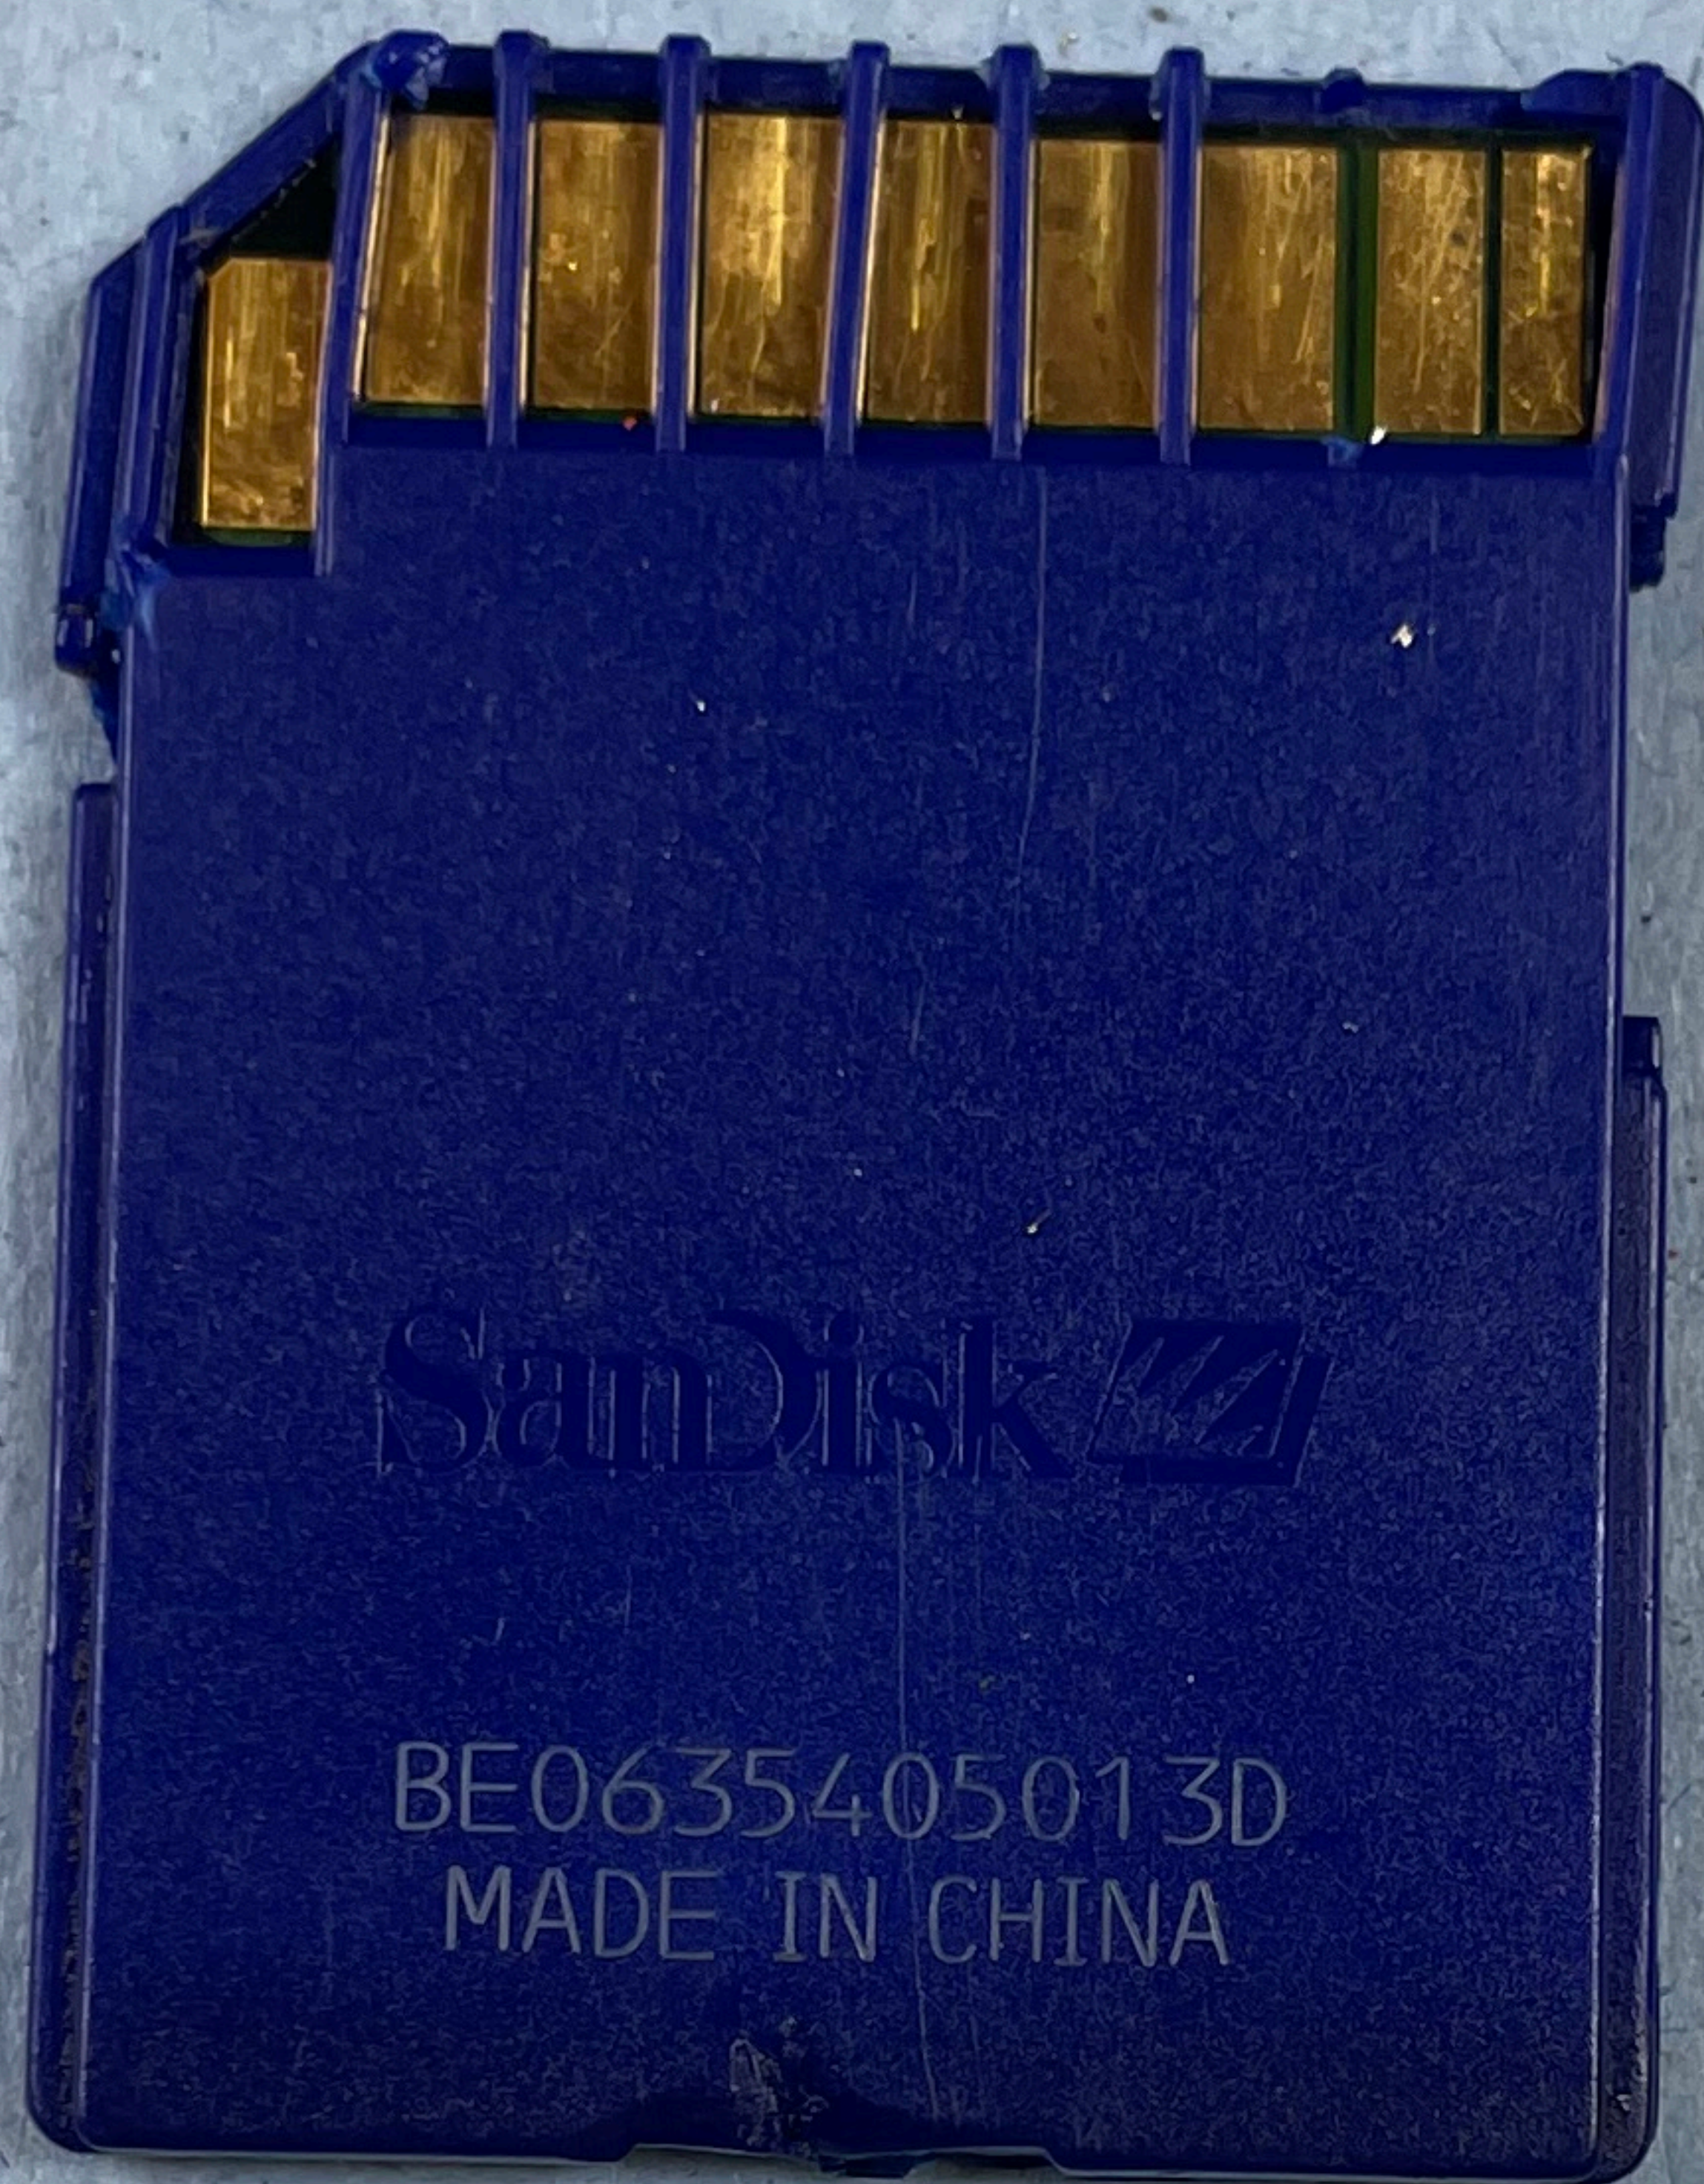
The Vehicle Recorder Division received the SD card from a Garmin Area 796 GPS. Upon receipt the card appeared to have suffered some mechanical impact damage including a gouge in the casing at the back edge of the card and damage to the contactor portion of the case (IMG\_0431.jpg and IMG\_0432.jpg). Readout of the card in a forensic card reader was unsuccessful. The case was removed to attempt a direct read of the memory. The device was found to have a crack spanning the full width of the memory package (era23fa209.jpg). Using an alternate direct reader showed that the card was unable to be powered and readout was unsuccessful. Due to the damage, no data could be recovered from the device.
