# National Transportation Safety Board

ERA23FA219

## **AIRPLANE INFORMATION AND BRS SYSTEM DESCRIPTION AND EXAMINATION SUMMARY**

Location: Reliance, Tennessee  
Date: May 7, 2023  
Time: 1849 Eastern Daylight Time  
2249 Coordinated Universal Time (UTC)  
Airplane: N725AS, Cessna 182Q

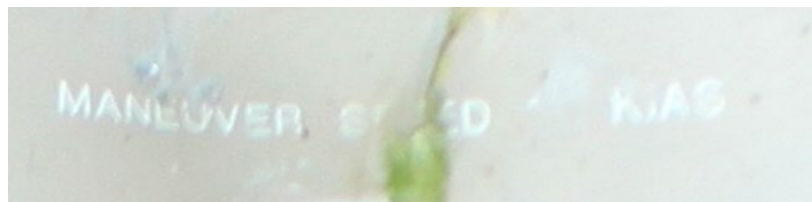
**Figure 1 Placard on Instrument Panel**

The instrument panel contained a placard documenting the maneuvering speed, but the value was damaged and unreadable (Figure 1).

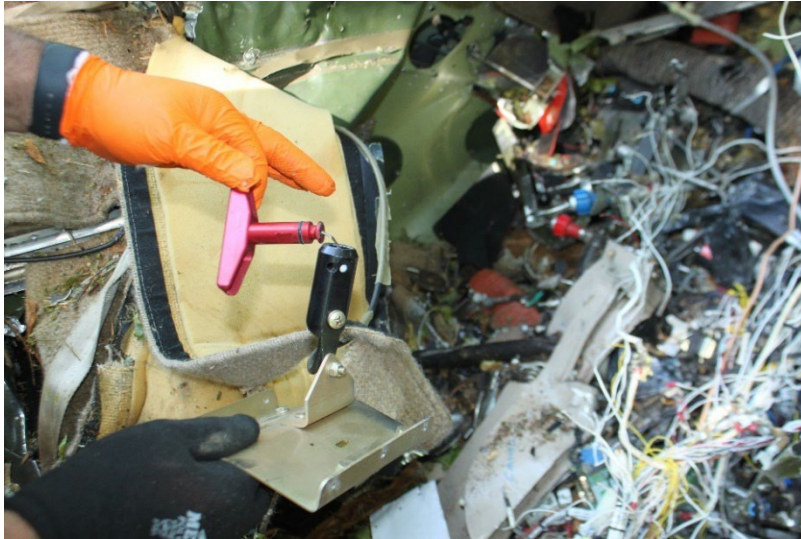
**Figure 10 View of the BRS Activation Handle**

The safety pin was not in position, the handle was outside the handle housing and the cable had a slight kink near the handle (Figure 10).

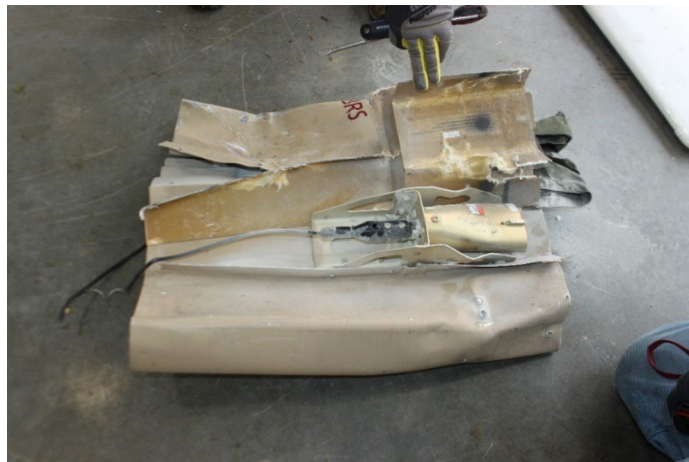
**Figure 11 View of the BRS-182 Canister and the remaining parts of the activated rocket**

The parachute canister and rocket support and the rocket fairing exhibited extensive impact damage (Figure 11).

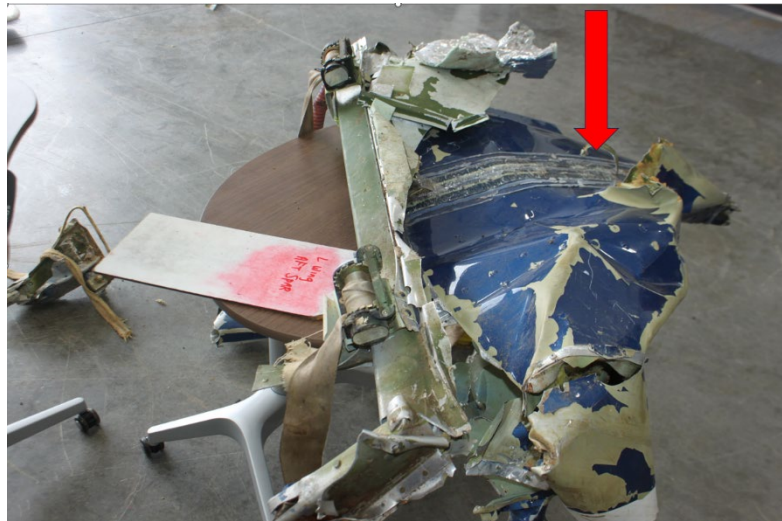
**Figure 12 Upper Skin Aft of Aft Spar Arrow Points to Area of Separated Fiberglass Cover For Front Harness**

Inspection of the upper skin aft of the aft spar revealed the fiberglass protective cover which would normally cover the front harness was separated (Figure 12).

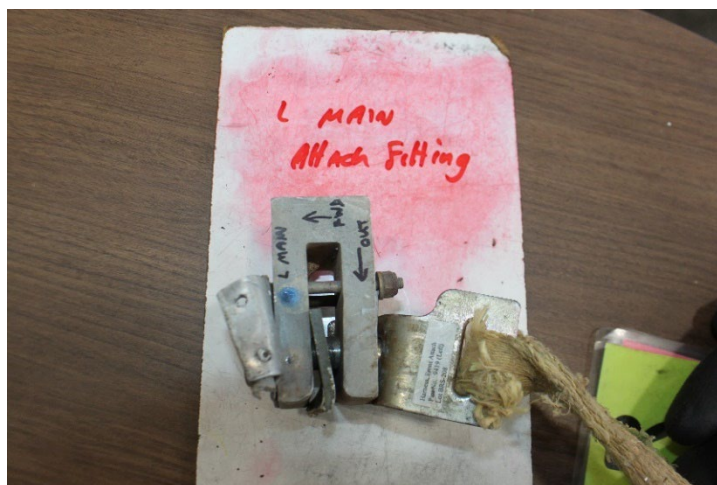
**Figure 13 View of the Left Main Spar With Attached BRS Harness**

The attachment bracket, securing hardware, and harness remained attached to the attachment bracket but the left wing forward spar main attach fitting (spar block) was structurally separated. The harness was continuous to the 3 Pt. shackle but exhibited fraying near the attachment bracket (Figure 13).

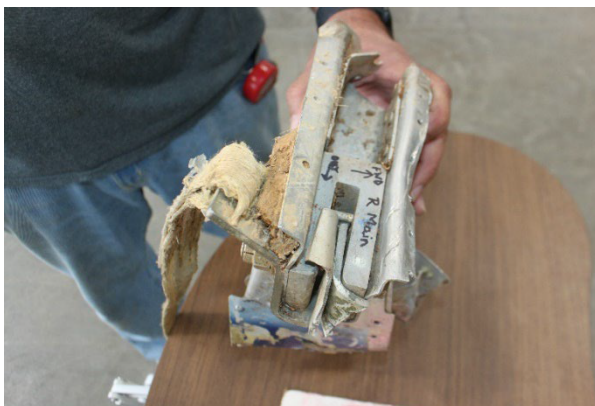
**Figure 14 Figure 10 Right Main Spar With Attached BRS Harness**

The attachment bracket, securing hardware, and harness remained attached to the attachment bracket but the right wing forward spar main attach fitting (spar block) was structurally separated (Figure 14). The harness was fractured about 54 inches from the spar attach point (Figure 15).

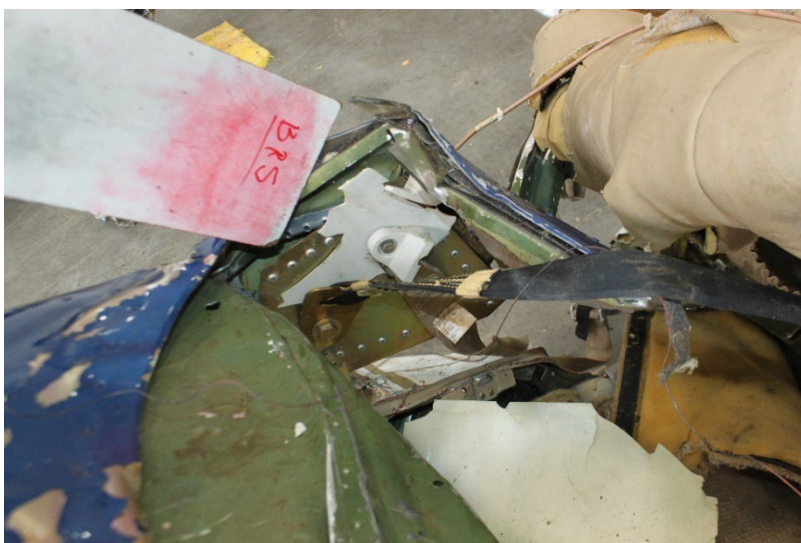
**Figure 16 View of Left Rear BRS Strap Structural Attach**

The left rear attach plate remained structurally attached and the tang remained attached to the rear attach plate. The harness remained attached to the tang (Figure 16) and was continuous to the 3-Pt. shackle.

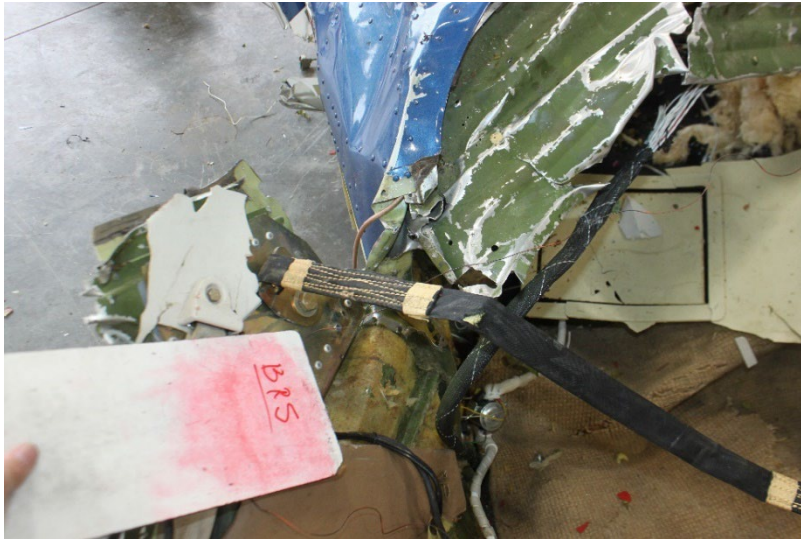
**Figure 17 View of Right Rear BRS Strap Structural Attach**

The left rear attach plate remained structurally attached and the tang remained attached to the rear attach plate. The harness remained attached to the tang (Figure 17) and was continuous to the 3-Pt. shackle.

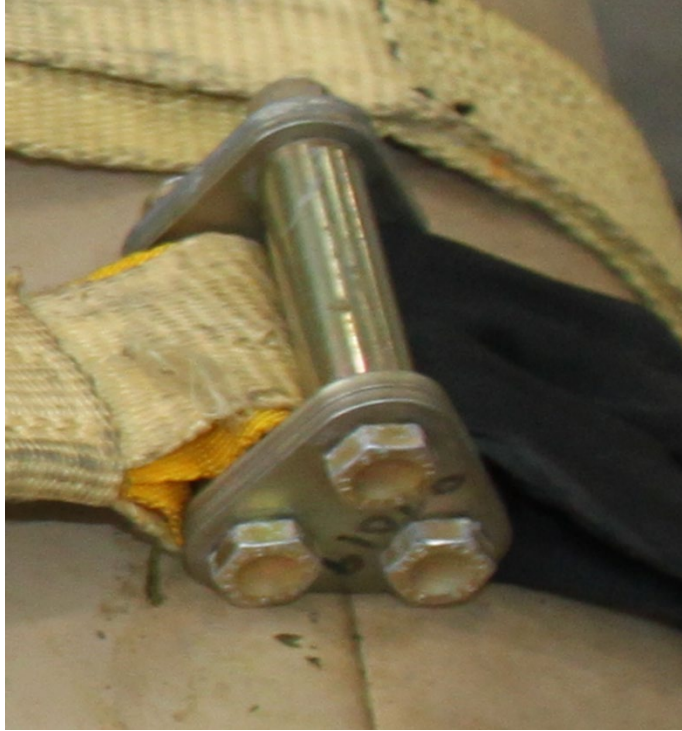
**Figure 18 View of the 3 Pt. Shackle The bolt/bushing on top is Where the Parachute Riser Would Attach**

The 3-Pt. shackle still had the front and rear harnesses attached but the parachute riser was not attached (Figure 18). The bolt/bushing for the riser attachment was not visibly deformed or damaged. Additionally, the bolts/bushings of the front and rear harness attachments were not visibly deformed or damaged.

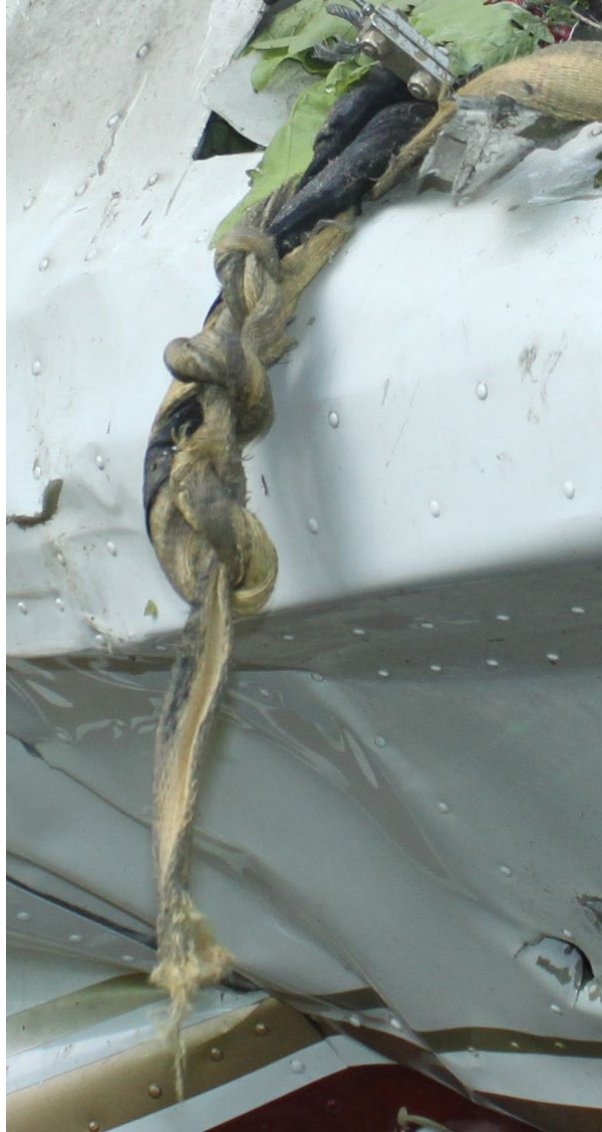
**Figure 19 View of the Entanglement of the Front Harness and Fractured Right Forward Harness**

Exiting the aft portion of the fuselage were black (front) and yellow webbing (rear) associated with the front harnesses connecting through the 3-Pt. shackle to the rear harness of the airframe ballistic parachute (Figure 21). The webbing of the front harness was wrapped tightly several times to the left. Entrapped with the twisted webbing were the elevator and rudder primary control cables, trim cables, and red rope which was the same kind of rope found in the cabin section of the wreckage.

Examination of the front harness revealed it exhibited entanglement and tightening (Figure 19).

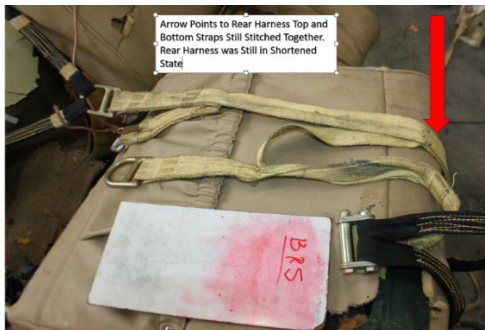
**Figure 20 View of Harnesses and 3-Pt. Shackle of BRS System Arrow Points to Section of Rear Harness Still Sewed Together**

Examination of the rear harness revealed that the shock absorption stitching pattern was not peeling/torn indicating that there was no force applied to the rear harness at the 3-point shackle level. Forces which would occur during parachute opening and steady state phases would peel/tear the stitching which would lengthen the rear harness, provide shock absorption and adjust the aircraft attitude (Figures 20 and 21).

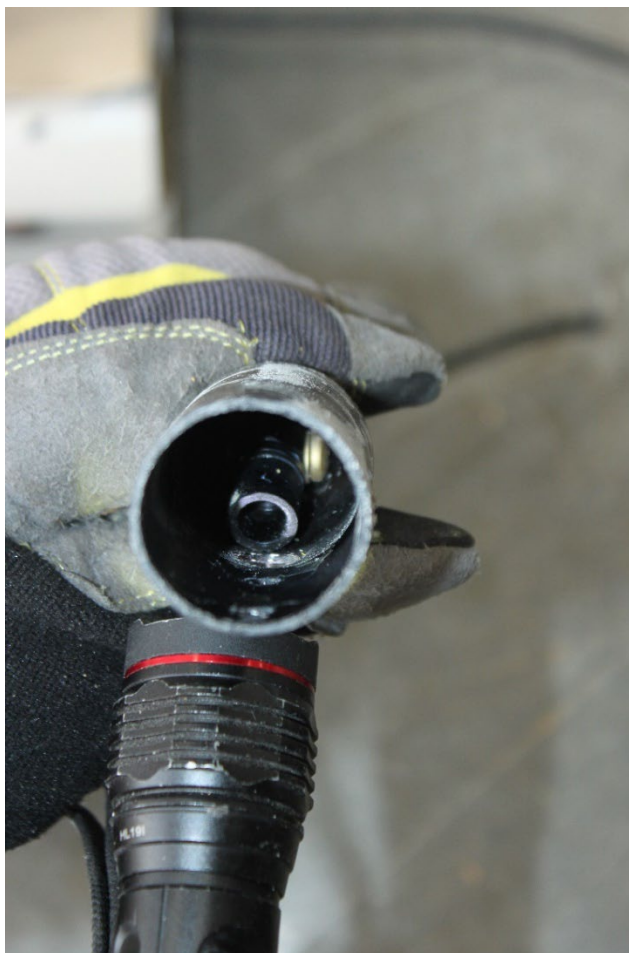
**Figure 22 View of the Rocket Cone and Fire Pin Actuator Inside Rocket Cone**

The fire pin actuator was found inside the rocket cone with the activation cable still attached consistent with normal activation (Figure 22).
