# National Transportation Safety Board

ERA23FA219

## **RADAR STUDY**

Location: Reliance, Tennessee  
Date: May 7, 2023  
Time: 1849 eastern daylight time (EDT)  
Airplane: Cessna 182Q, N725AS

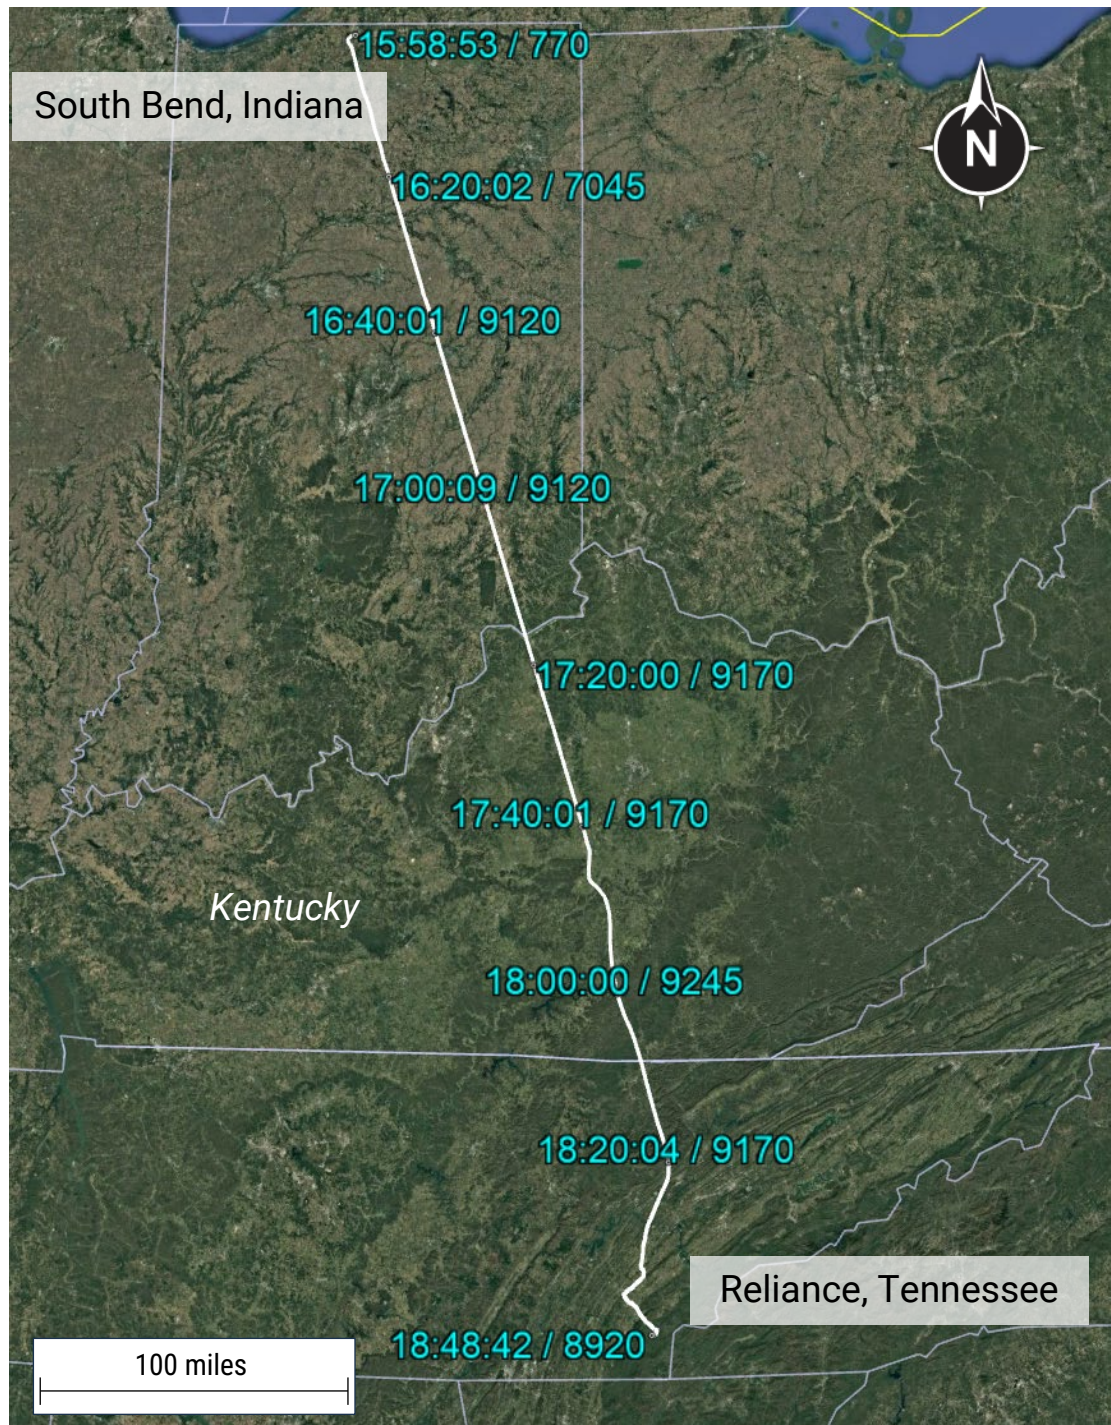
The airplane departed South Bend International Airport about 1559 destined for Jackson County Airport, Jefferson, Georgia. The airplane climbed to over 9,100 ft while on a southeasterly heading.

**Figure 2.** Airplane flight path with selected times and altitudes shown.

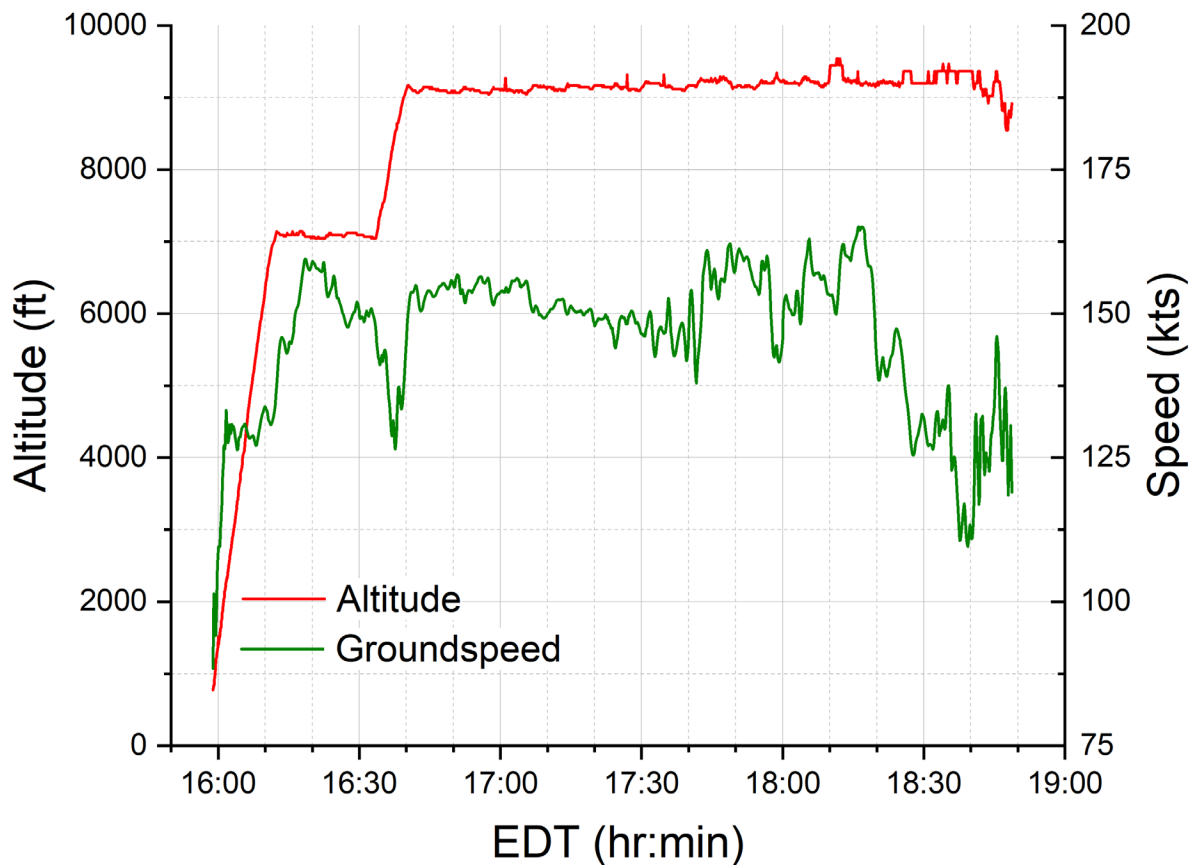
**Figure 3.** Radar recorded altitude and groundspeed.

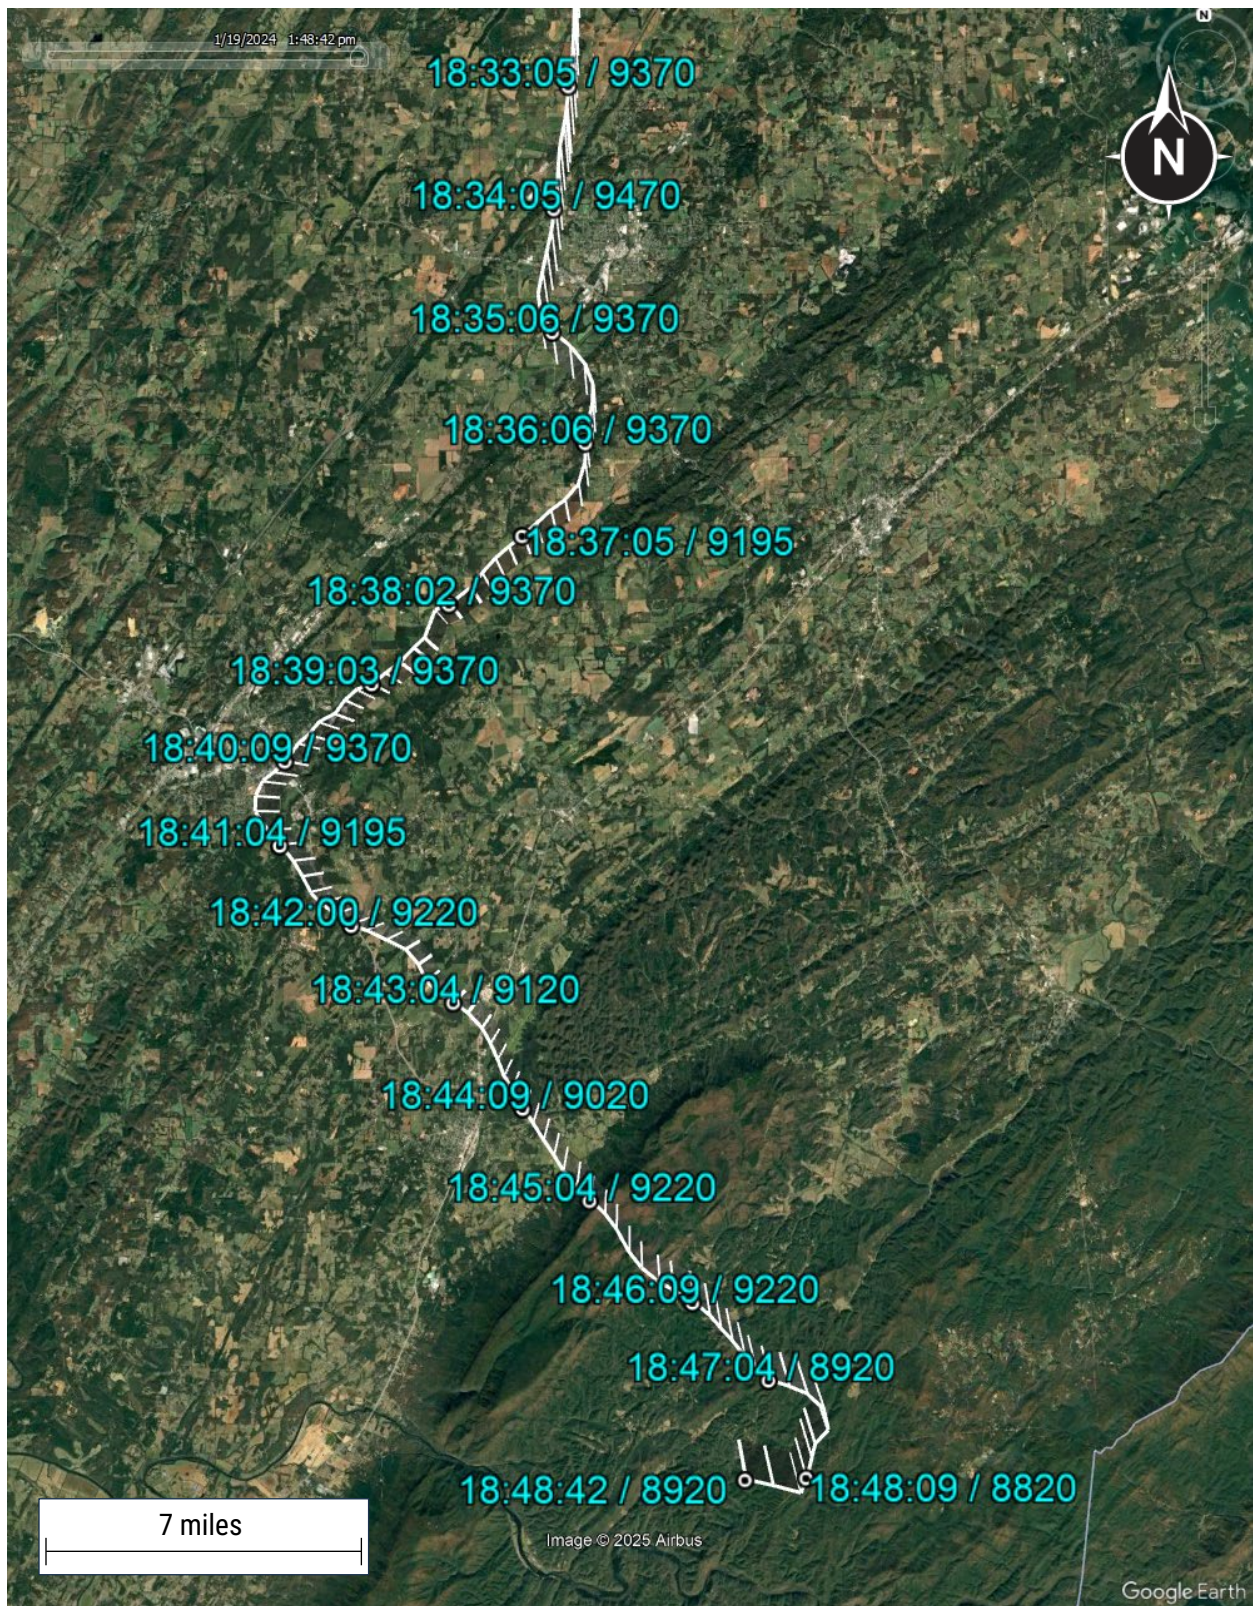
After 1830, the flight path track became irregular and the airplane made a series of turns. Local meteorological conditions and winds aloft were used to calculate the airplane's calibrated airspeed. During these turns, the airspeed was above the listed maneuvering speed,  $V_a$ , for 2,450 lbs gross weight (99 kts, calibrated airspeed) [1]. As discussed earlier, the airplane's weight at the time of the accident was estimated to be 2,400 lbs.

**Figure 4.** End of airplane flight path with selected times and altitudes shown.

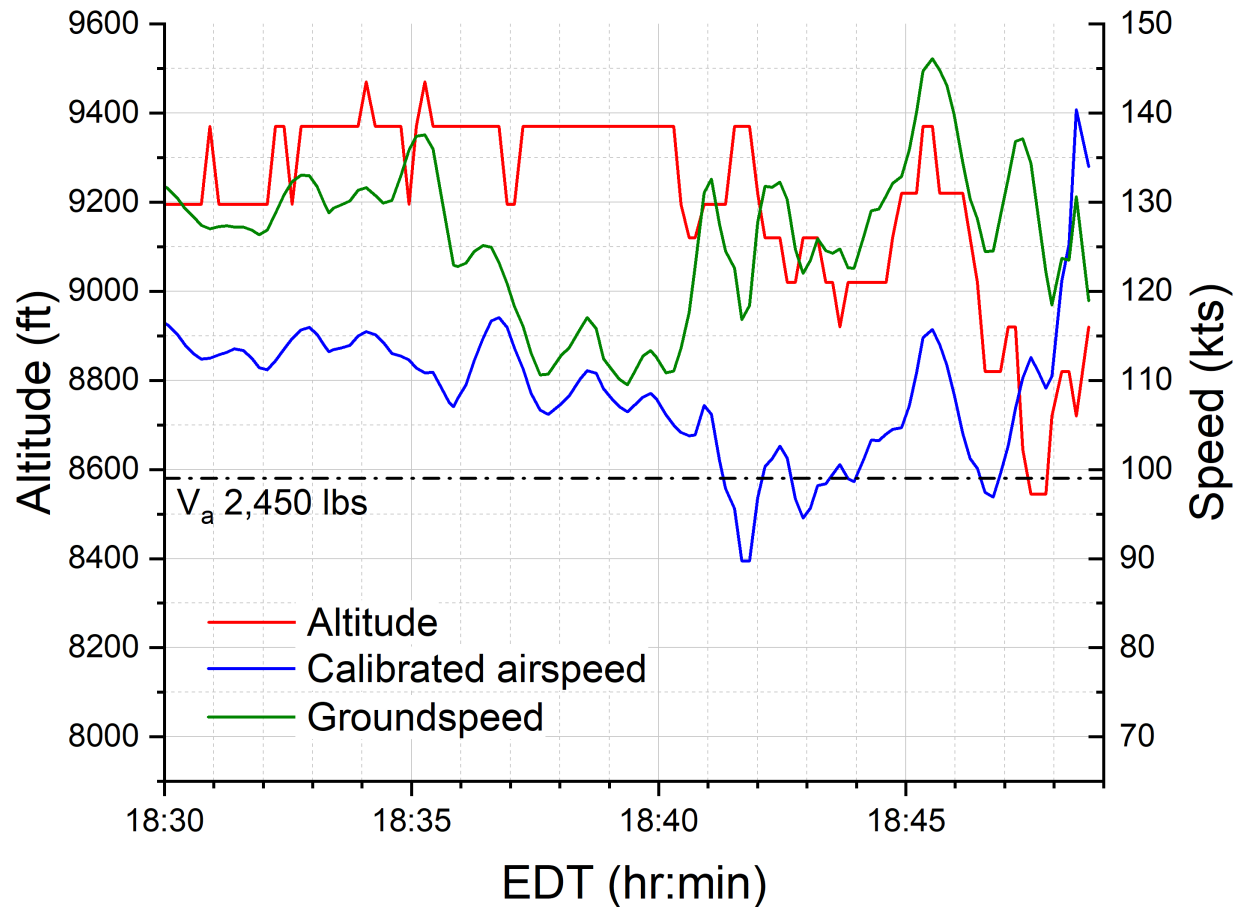
**Figure 5.** Radar recorded altitude, groundspeed, and calculated airspeed. The Va for 2,450 lbs is shown.

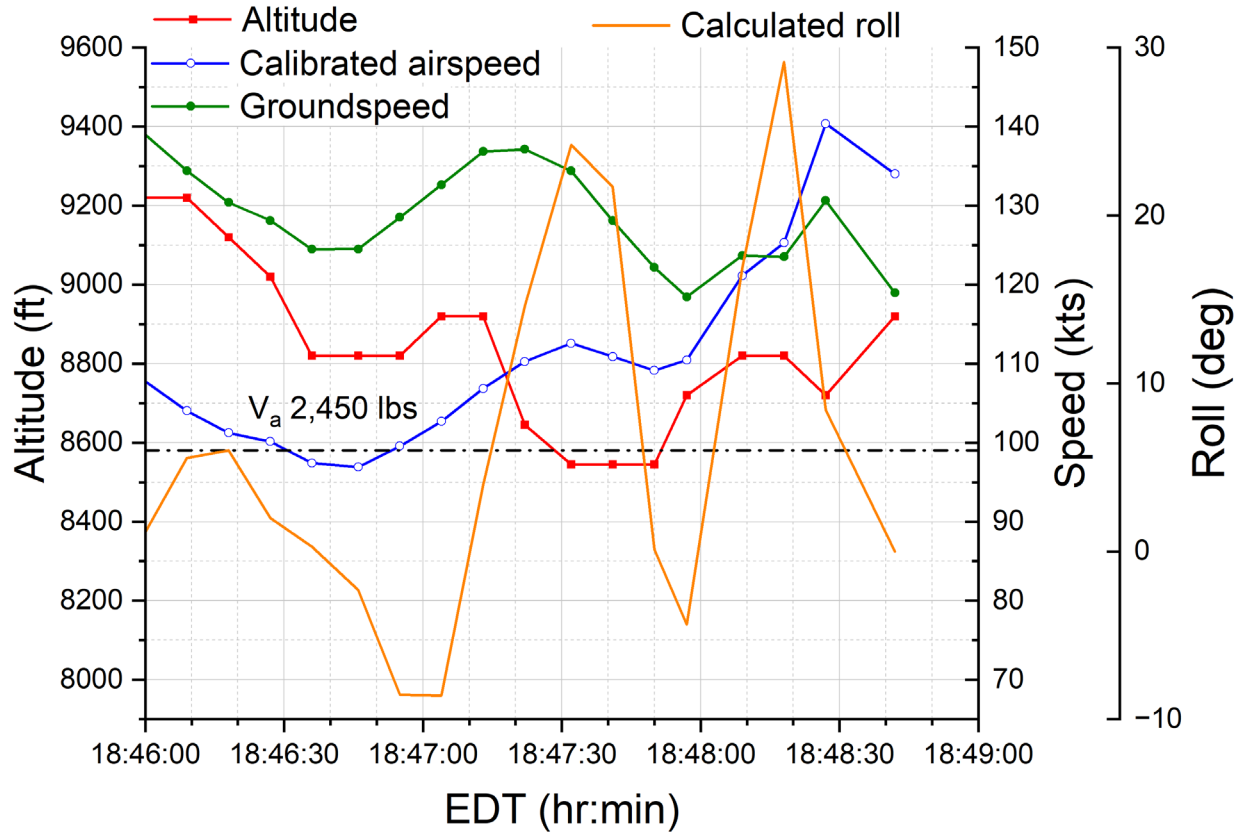
During the final minutes of flight, the airplane remained above the maneuvering speed while in a right turn that, according to aerodynamic calculations, would have required a roll angle of at least 20°. The airplane was generally descending, but the last few data points indicate a climb. However, due to the loss of radar data, the airplane likely again descended below radar coverage.

**Figure 6.** Radar recorded altitude, groundspeed, calculated airspeed, and calculated roll angle. The V<sub>a</sub> for 2,450 lbs is shown.

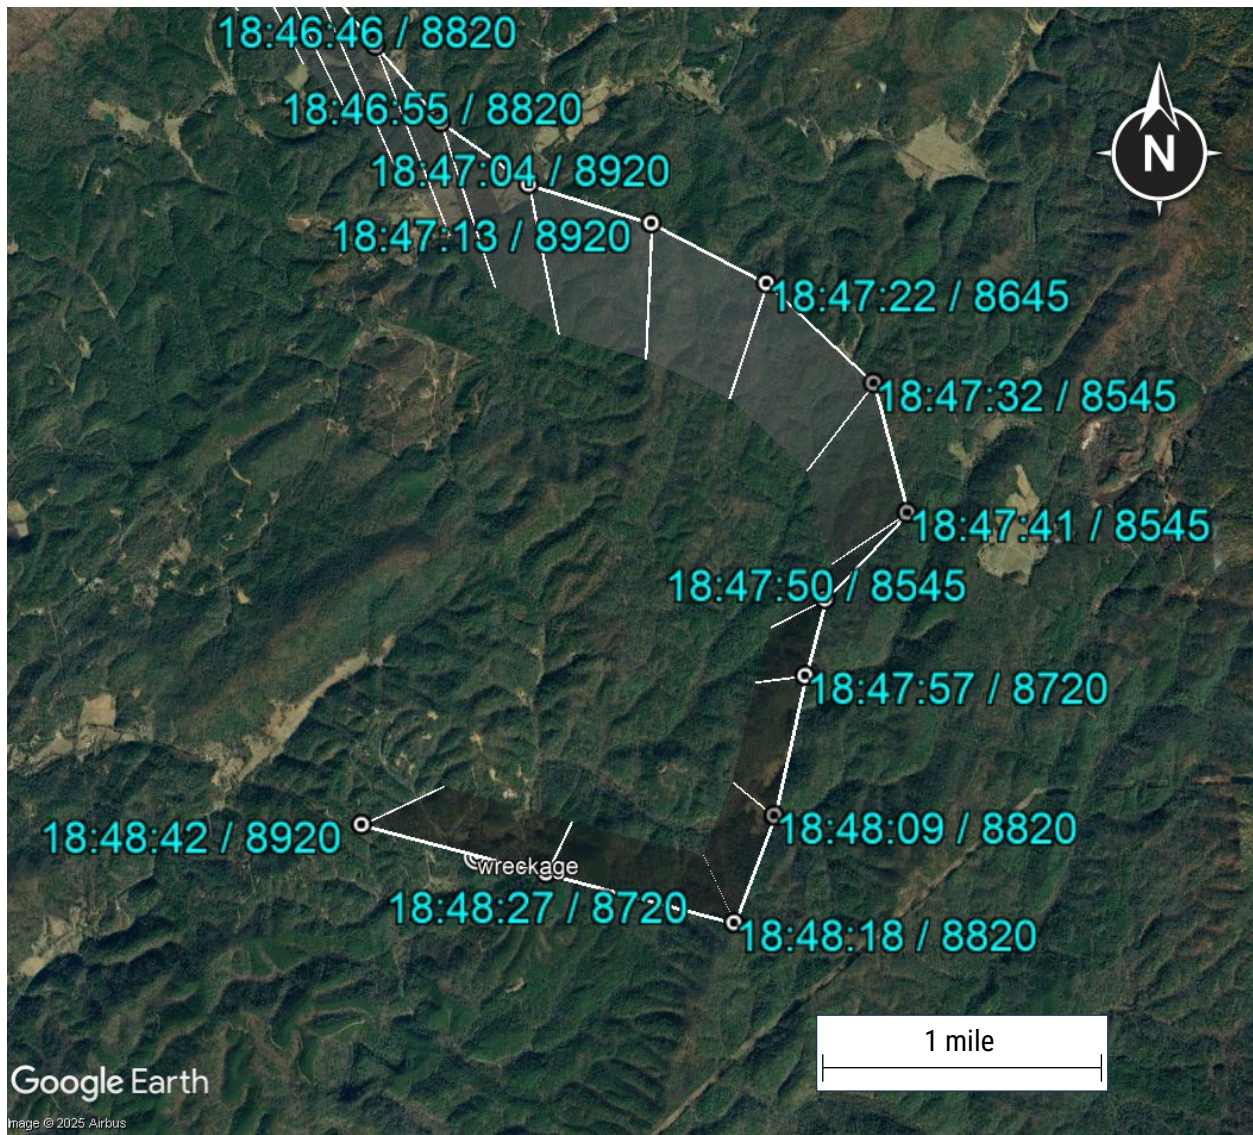
**Figure 7.** End of airplane flight path with selected times and altitudes shown.

After 1830, the airplane began a series of deviations from its earlier straight path. After 1847 the airplane began a right turn at a speed above its maneuvering speed. The last few data points show the airplane slowing and climbing, but the airplane likely entered a descent and was lost to further radar coverage. The low resolution of the ARSR data and the absence of ADS-B data did not allow for more in-depth investigation of the flight path.
