# National Transportation Safety Board

ERA23FA219

## WING EXAMINATION SUMMARY

Location: Reliance, TN  
Date: May 7, 2023  
Time: 1849 Eastern Daylight Time  
2249 COORDINATED UNIVERSAL TIME (UTC)  
Airplane: N725AS, Cessna 182Q

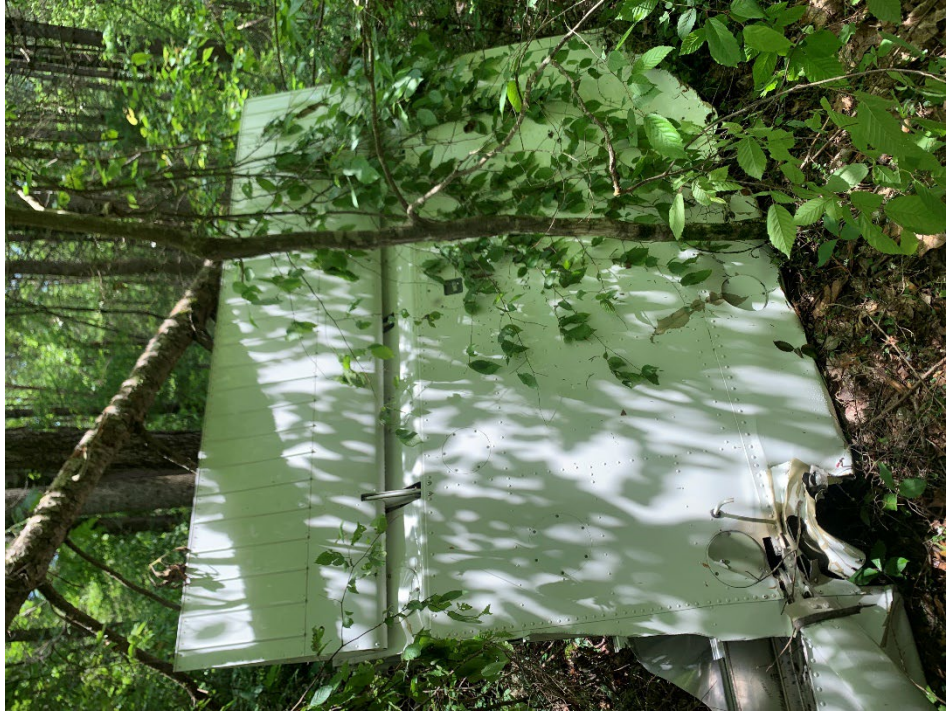
A local individual found the left wing on or about May 16, 2023 in a wooded area at 35.216771° north latitude and -084.419110° west longitude. That location when plotted on Google Earth was located about 0.56 nautical mile and 166° from the location of the main wreckage. The wing was retained and transported to the wreckage storage facility for further examination.

**Figure 1: View of the Left Wing at the As-Found Location.**

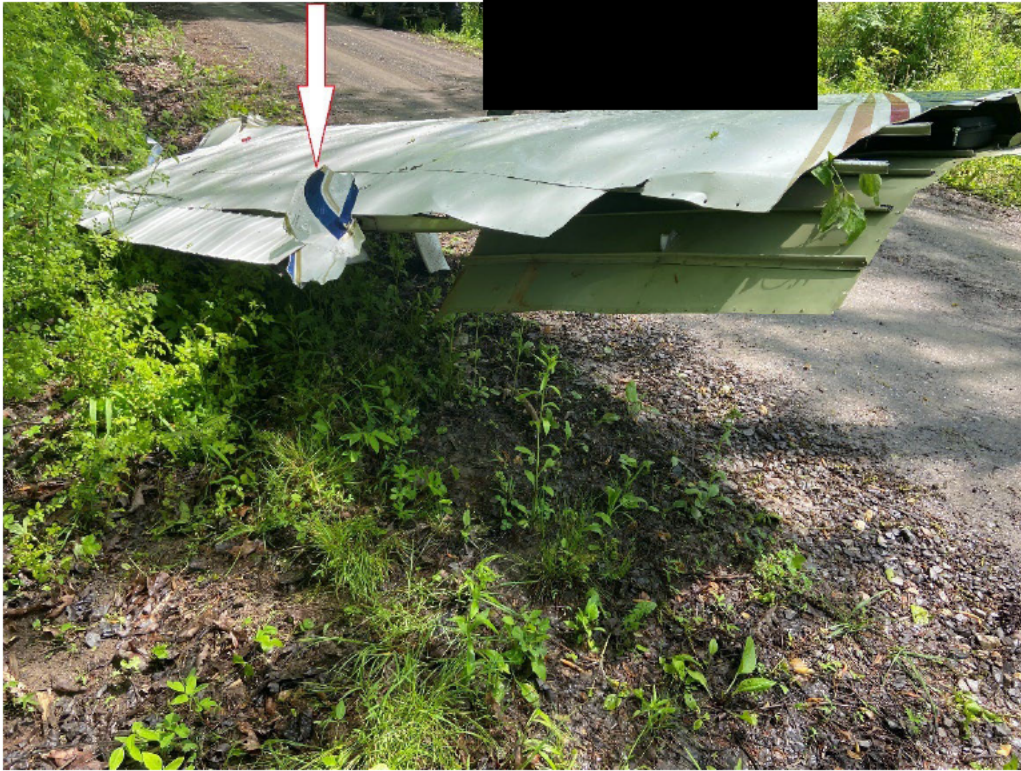
**Figure 2: View of the Right Wing On a Logging Road As Observed By FAA Before the Wing was Stolen. Arrow Points to Left Side Fuselage Skin Normally Located Between Fuselage Stations 156.0 and 172.0.**

Examination of photographs of the right wing provided by FAA inspectors revealed a section of the left side of fuselage skin was found embedded into the fractured right aileron at approximately wing station 154.0 (Figure 2). The skin was associated with the left side of the fuselage between fuselage stations (FS) 156.0 and 172.0.

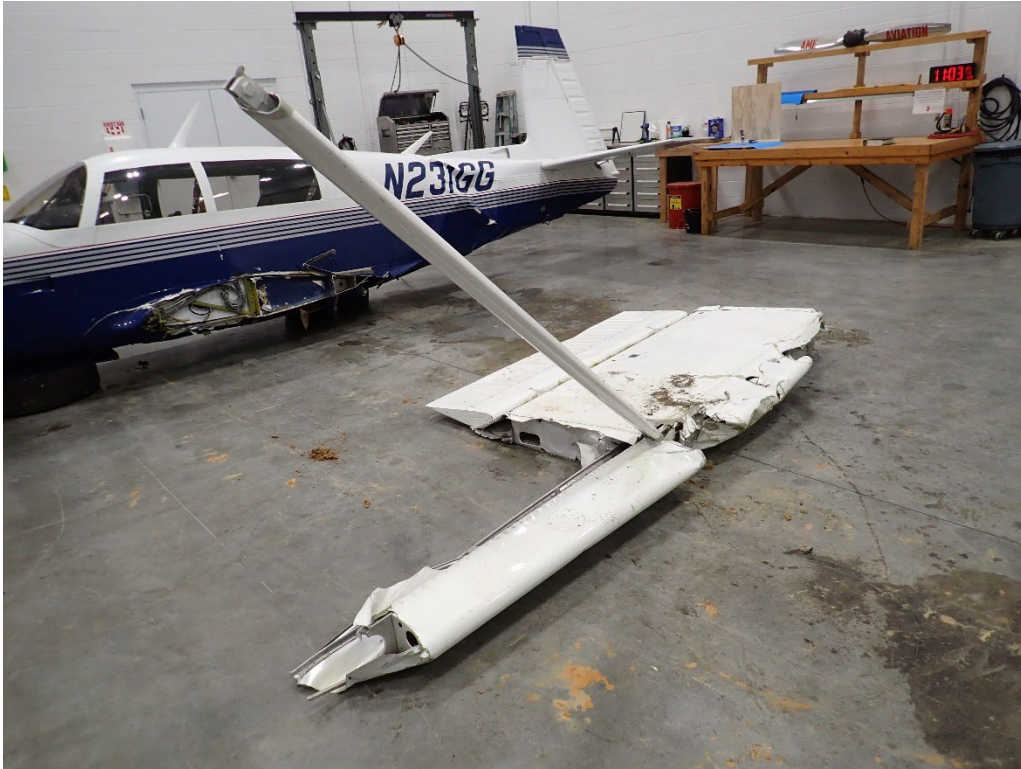
**Figure 3: View of Left Wing.**

The recovered left wing consisted of the nearly the full chord of the wing from the wing root to wing station (WS) 100<sup>2</sup>, full span of attached flap, full length of wing lift strut, and a total length of about 155 inches of main spar with attached sections of leading edge skin, and 1 flap cable. The inboard 31 inches of leading edge skin was separated, and the leading edge skin was also separated from WS 155 to WS 208. The wing was missing 108 inches of structure behind the main spar from WS 100 to the WS 208, which included the aileron. At WS 100 a semi-circular indentation was noted on the leading edge. The indentation was 14 inches in diameter. The main spar at WS 100 exhibited overload fractured and the spar was displaced forward.

The leading edge at WS 155 exhibited an impact damage. Black transfer with sharp metal transfer was noted on the upper wing skin at WS 159, or about 2 inches forward of the main spar rivet line.

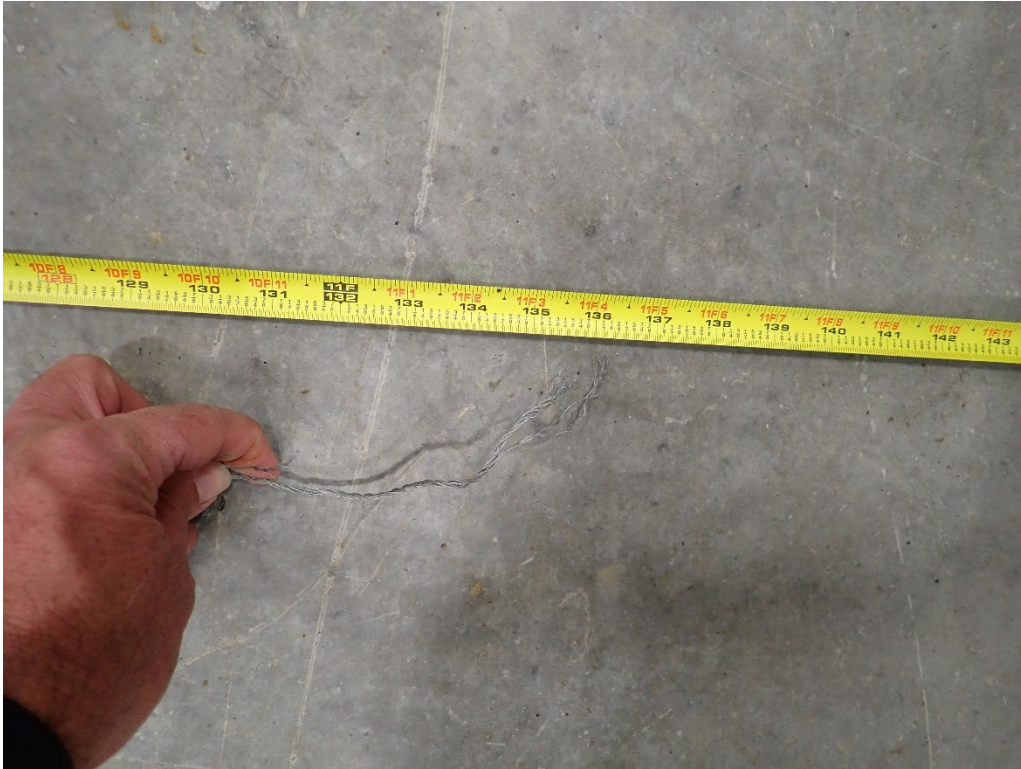
The flap remained attached at all hinges and the flap rod was bent 90° and fractured due to overload. One flap cable remained attached at the bellcrank and exhibited overload fracture about 137 inches from the bellcrank (Figure 4). The missing flap cable still had the pin in place at the bellcrank.

**Figure 4: View of Overload Fractured Flap Cable.**

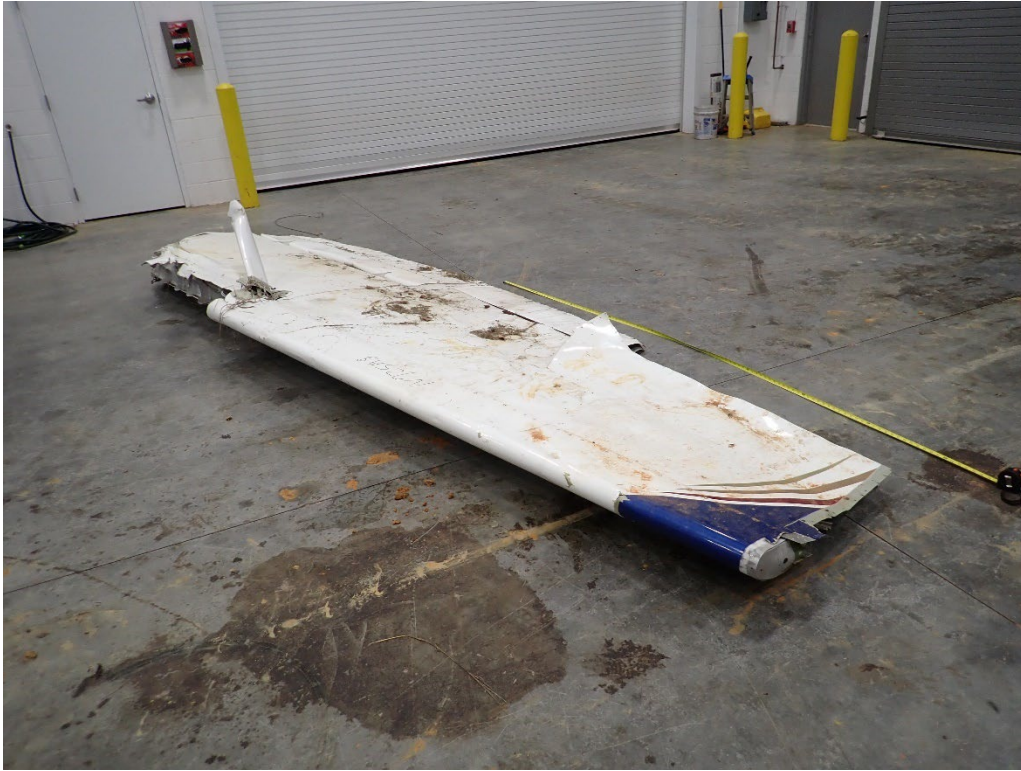
The recovered right wing was nearly full span and chord except for missing: inboard section of leading edge skin, outboard section of aileron, aileron cable, flap cable, wingtip, and fractured lift strut (Figure 5).

**Figure 5: View of the Bottom of the Right Wing.**

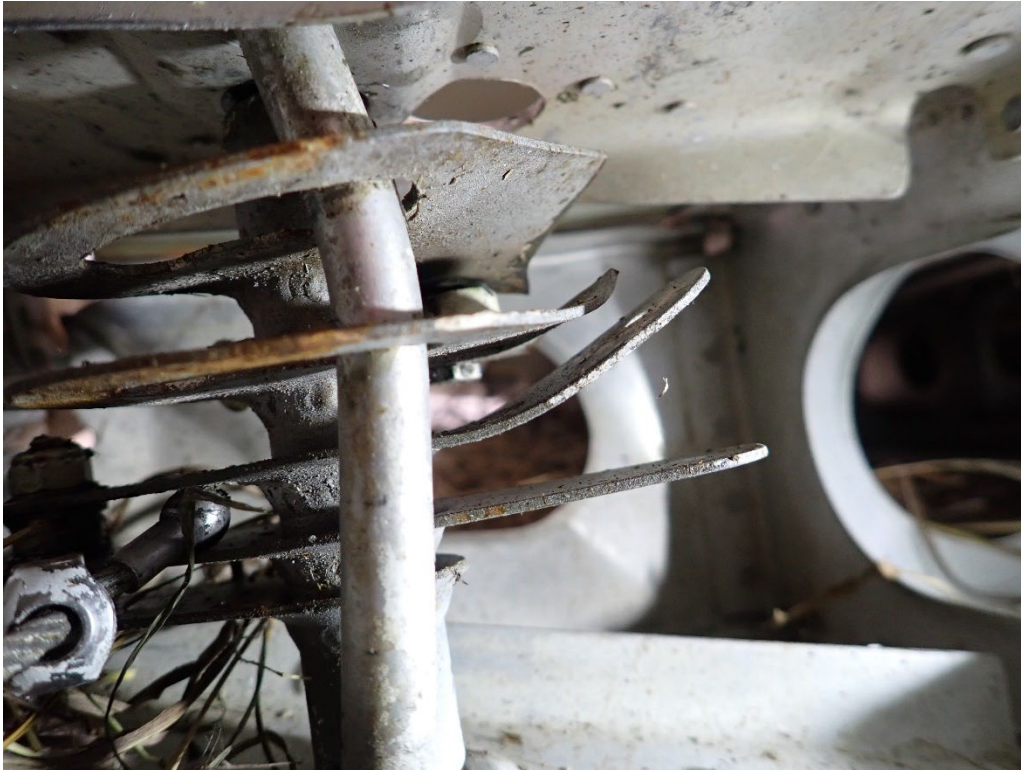
Further examination of the right wing revealed the outer approximately 52 inches of the aileron was separated. The separated section of aileron was missing from the 2<sup>nd</sup> hinge outboard. The installed portion of the aileron and full span of flap remained attached at all hinges. One aileron control cable remained attached to the aft connection of the aileron bellcrank and the cable was fractured due to tension overload at the wing root. The other aileron cable was not attached to the forward bellcrank which was deformed (Figure 6).

**Figure 6: View of Deformed Forward Aileron Bellcrank.**

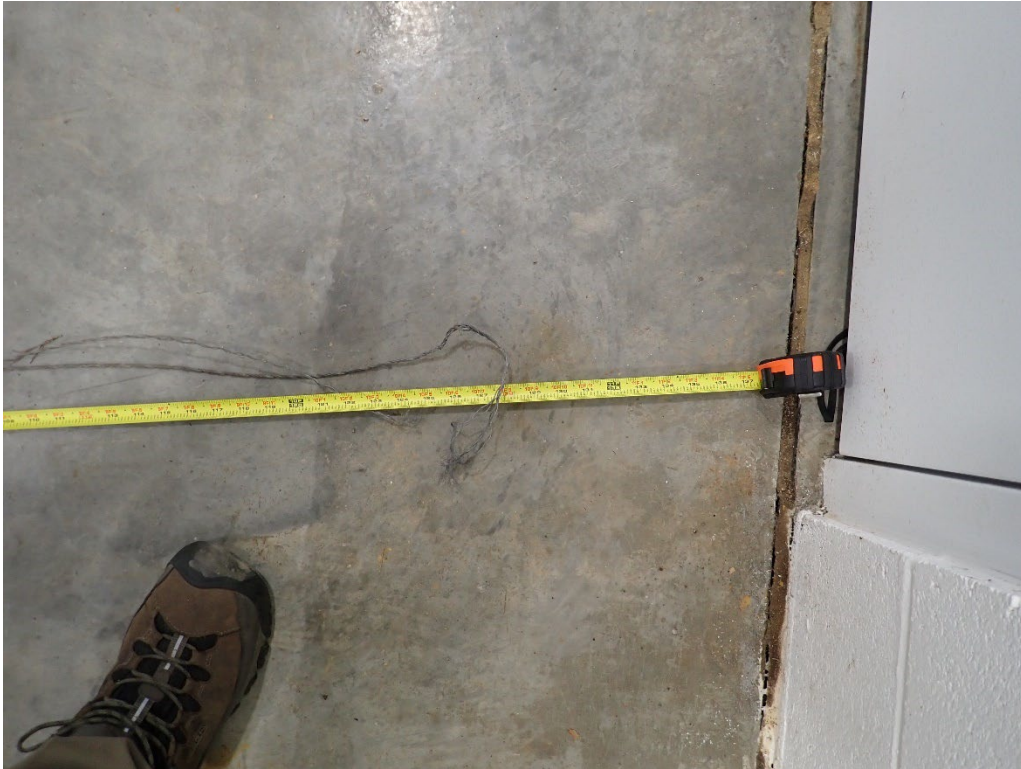
One flap cable remained attached to the flap bellcrank and exhibited tension overload failure about 134 inches from the bellcrank (Figure 7). The other flap cable was not attached to the intact bellcrank; the cable was not in place. There was no extension of the flap actuator (Figure 8), which equates to flaps retracted. The rod remained attached to the flap actuator and the flap.

**Figure 7: View of the Overload Fractured Flap Cable.**

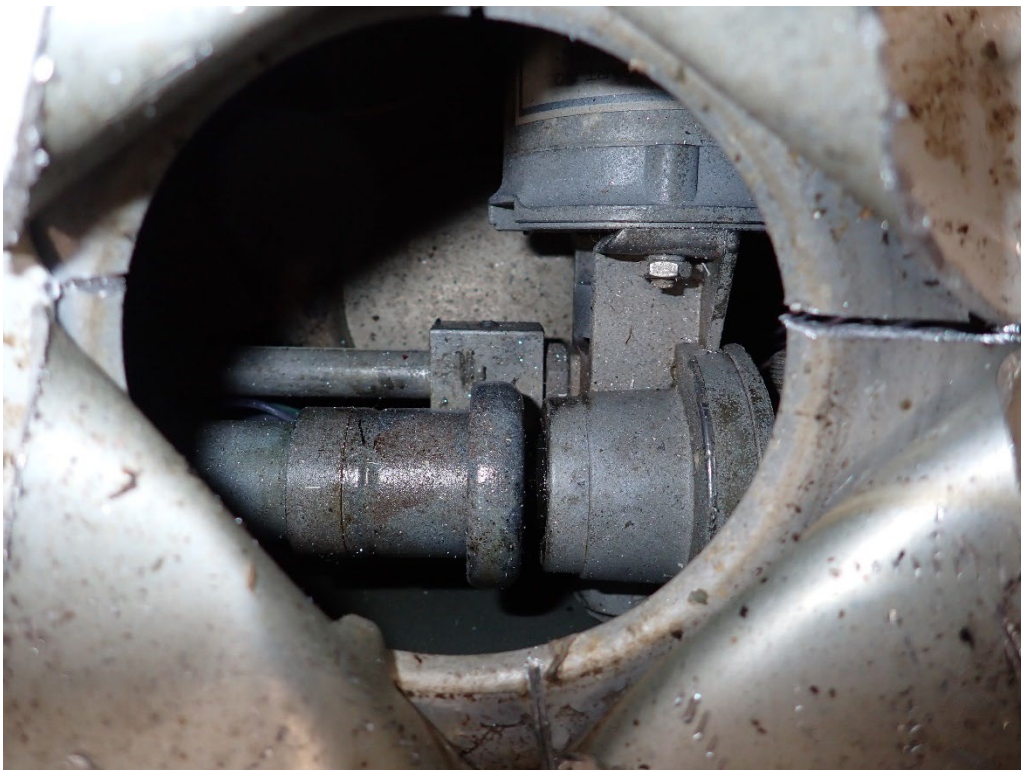
**Figure 8: View of the Flap Actuator Showing No Extension or Flaps Retracted.**

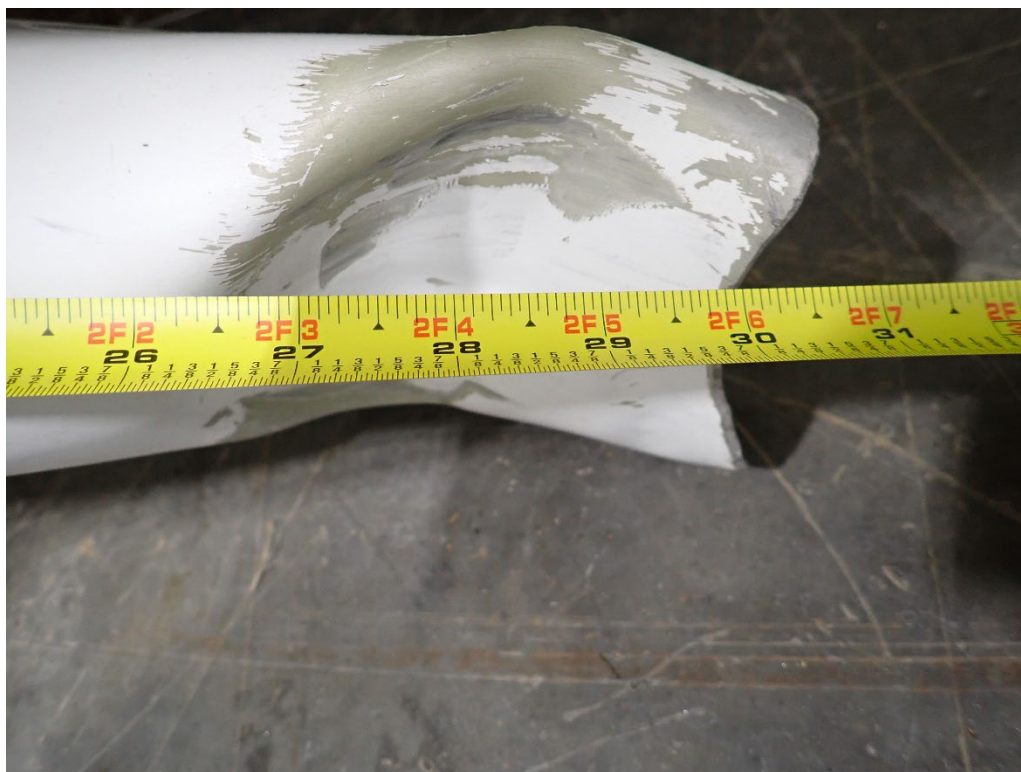
The lift strut<sup>3</sup> exhibited impact damage and was fractured about 31 inches from the upper attach point (Figure 9); thus, 61 inches of the lift strut were missing. The impact was semi-circular with a dark deposit with paint cracking.

**Figure 9: View of the Impact Damage on the Leading Edge of the Left Strut.**

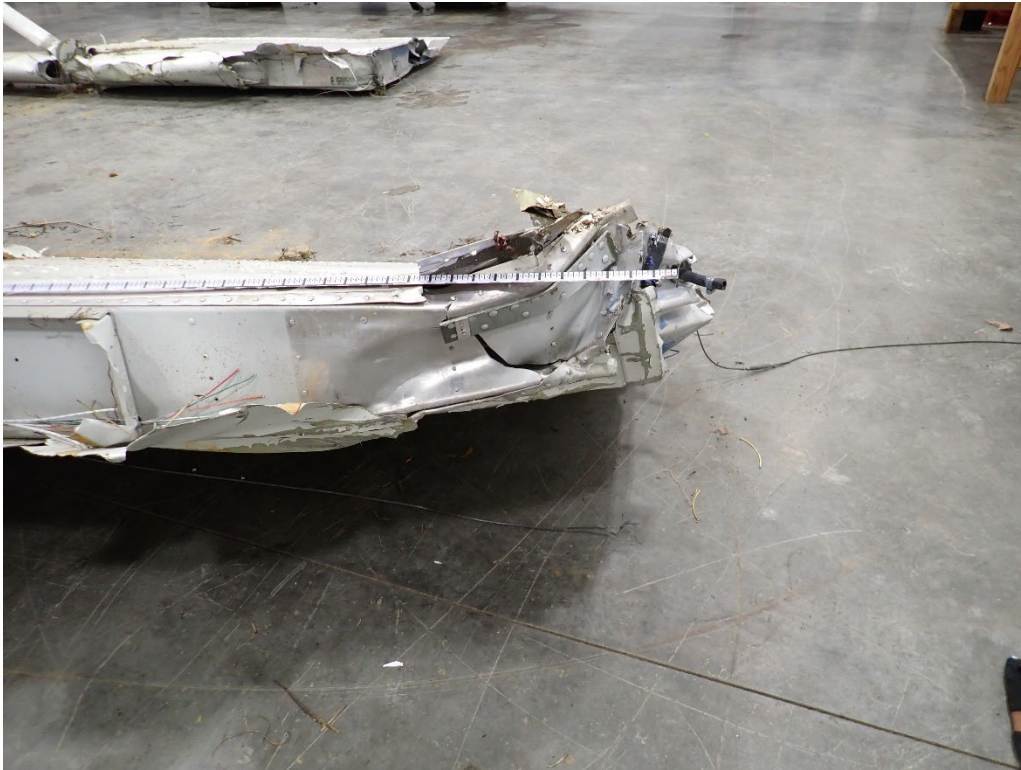
The leading edge main spar at the wing root was displaced up and aft (Figure 10), while the aft spar was displaced forward and slightly down. Further examination of the wing revealed the aft spar fitting and portion of fractured rear fuselage spar remained attached by the securing hardware (Figure 11). The fracture surfaces exhibited evidence of overload fracture with no evidence of preexisting cracking.

**Figure 10: View Showing the Up and Aft Deformation of the Main Spar at The Wing Root.**

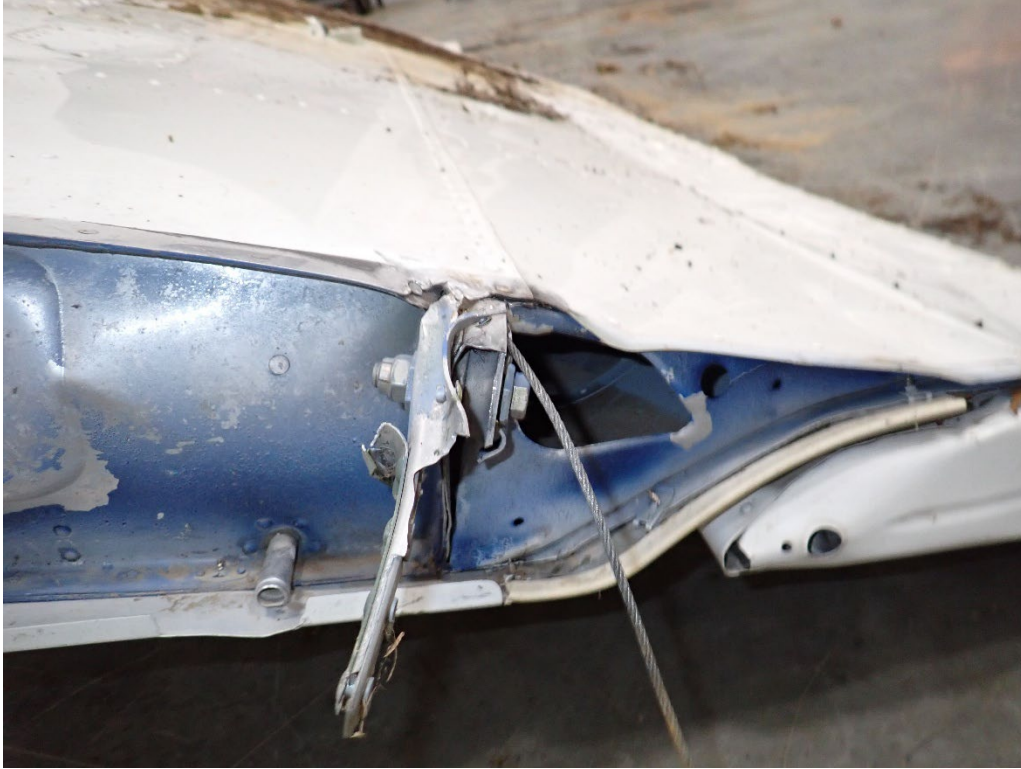
**Figure 11 View Showing the Aft Spar of the Right Wing with Attached Fractured Section of Rear Fuselage Spar**
