# National Transportation Safety Board

ERA23FA235

## **SYSTEMS**

Group Chair's Factual Report

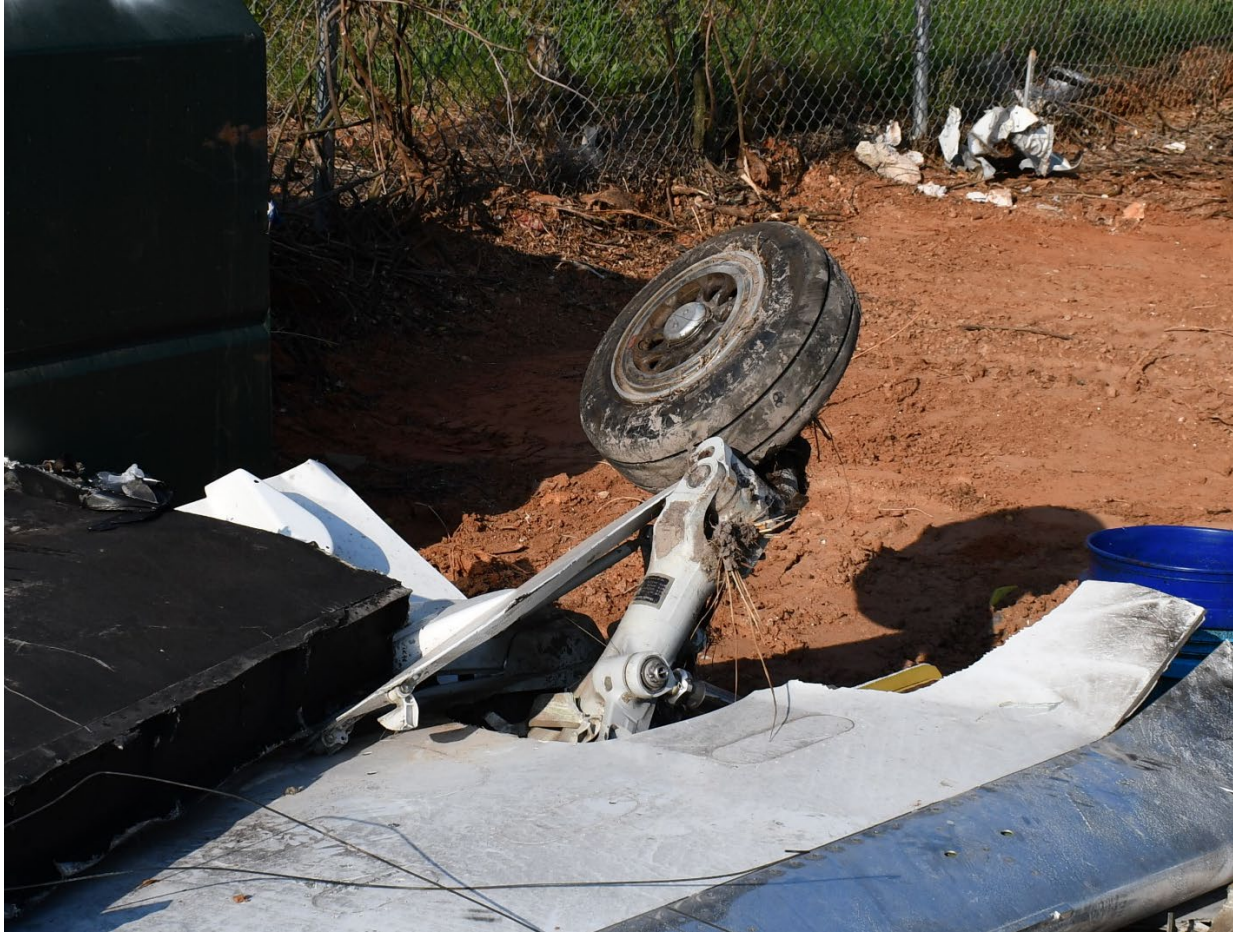
**Figure 1:** Left tire and gear assembly

The left brake assembly had a layer of dirt on it. The left brake was P/N 9006366, S/N "OCT 16-0242". The top brake wear pin measured approximately  $\frac{3}{4}$  inch extension with no pressure applied to the brake. The bottom brake wear pin measured approximately  $\frac{11}{16}$  inch extension with no pressure applied to the brake.

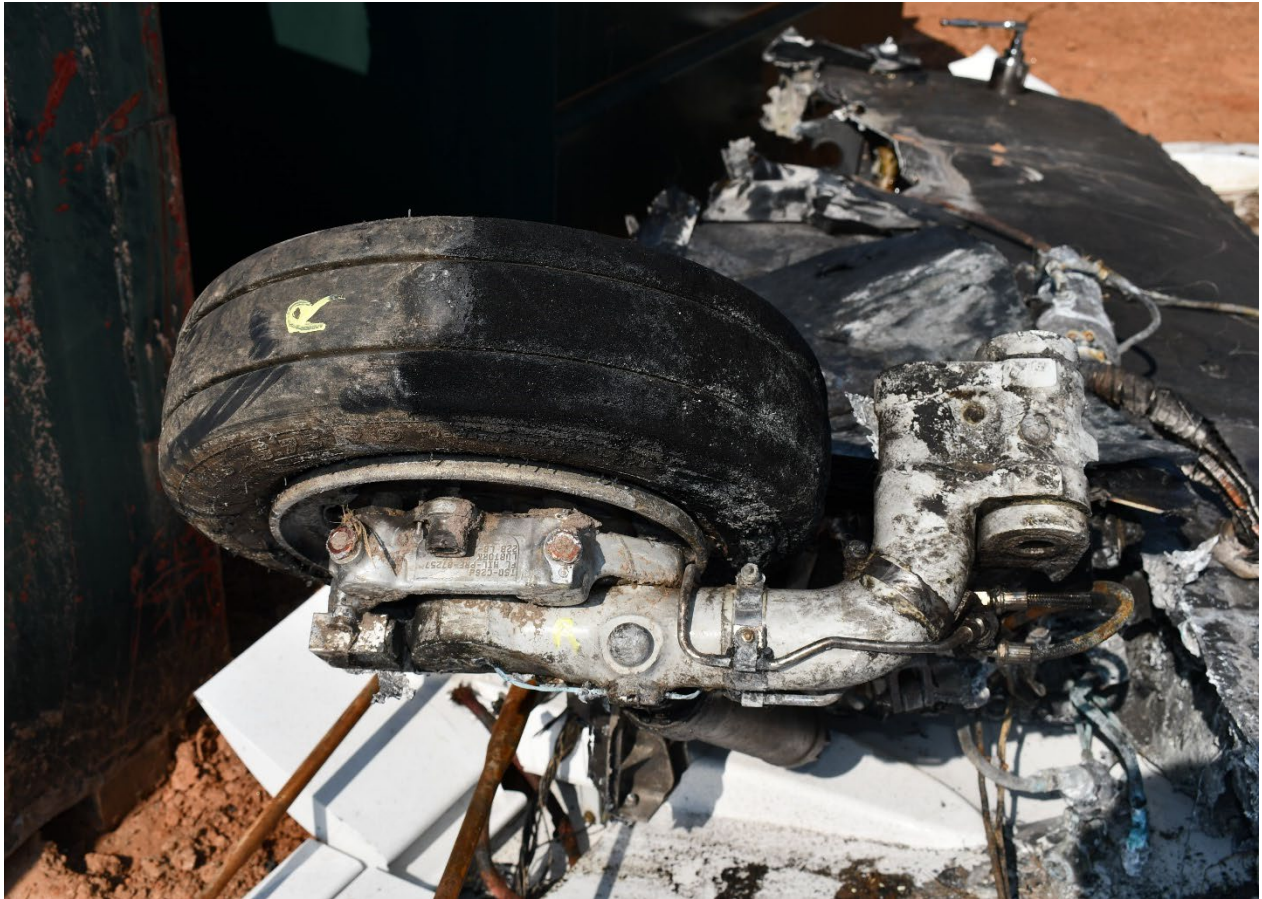
The right tire was inspected. Half of the tire was fire damaged and the rubber reversion spread down the side walls of the tire. The other half of the tire was intact, and there were no indications of rubber reversion and no signatures of locked or

skidding tires (see Figure 2). The tire was P/N M19402, size 17.5 x 5.75 R9. There was a hole in the sidewall of the tire and therefore no pressure was in the tire. The right tire inboard and outboard grooves measured a depth of 8/32 inch.<sup>3</sup>

**Figure 2:** Right side tire and landing gear

The right brake assembly was sooted. The right brake was P/N 9006366, S/N "APR 17-0269". Both brake wear pins measured approximately 1/4 inch extension with no pressure applied to the brake.

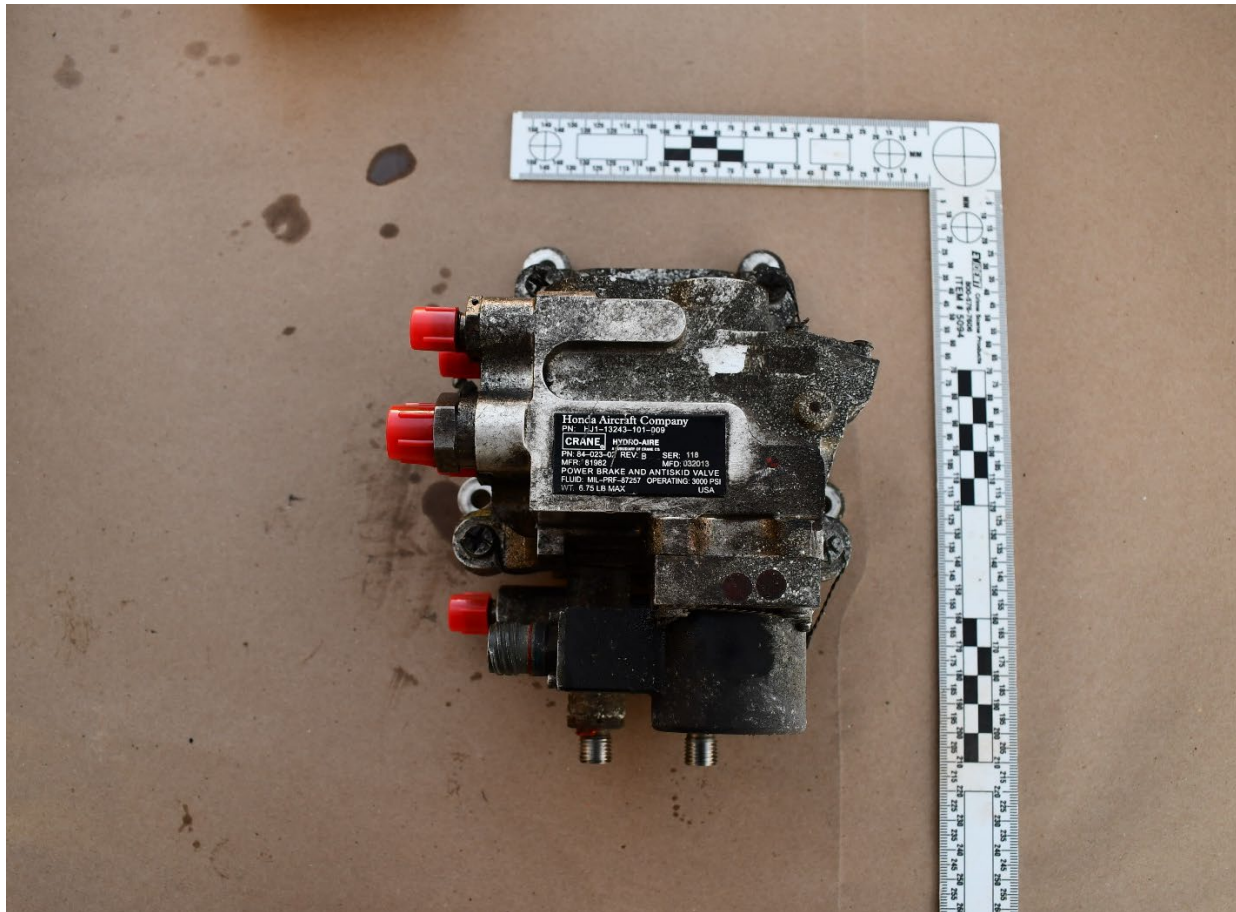
The power brake and antiskid valve was P/N 84-023-02 Rev B, S/N 118. The unit was sooted (see Figure 3). The unit was removed and retained by Honda for future testing.

**Figure 3:** Power brake and antiskid valve

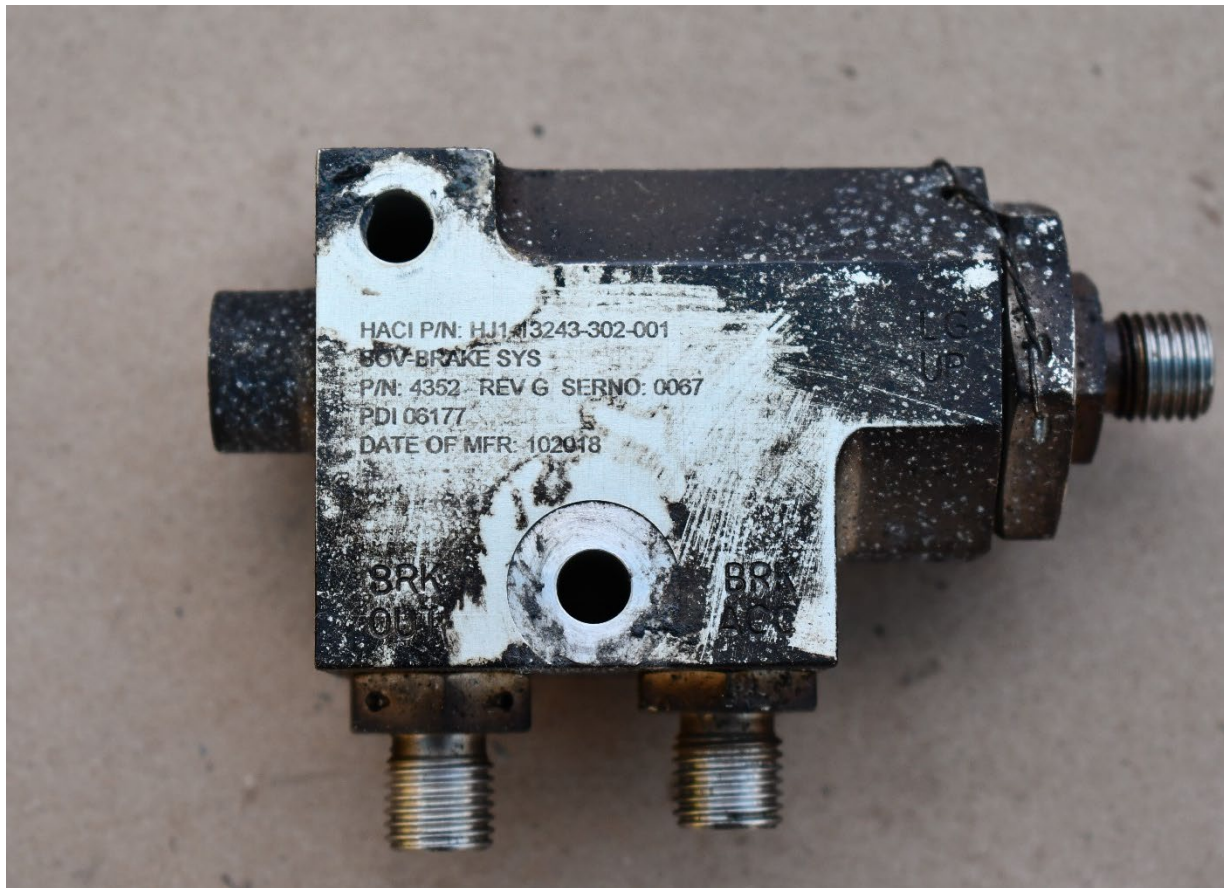
The brake shutoff valve was sooted (see Figure 4). The unit was P/N 4352, S/N 0067. The unit was removed and retained by Honda for future testing.

**Figure 4:** Brake shutoff valve

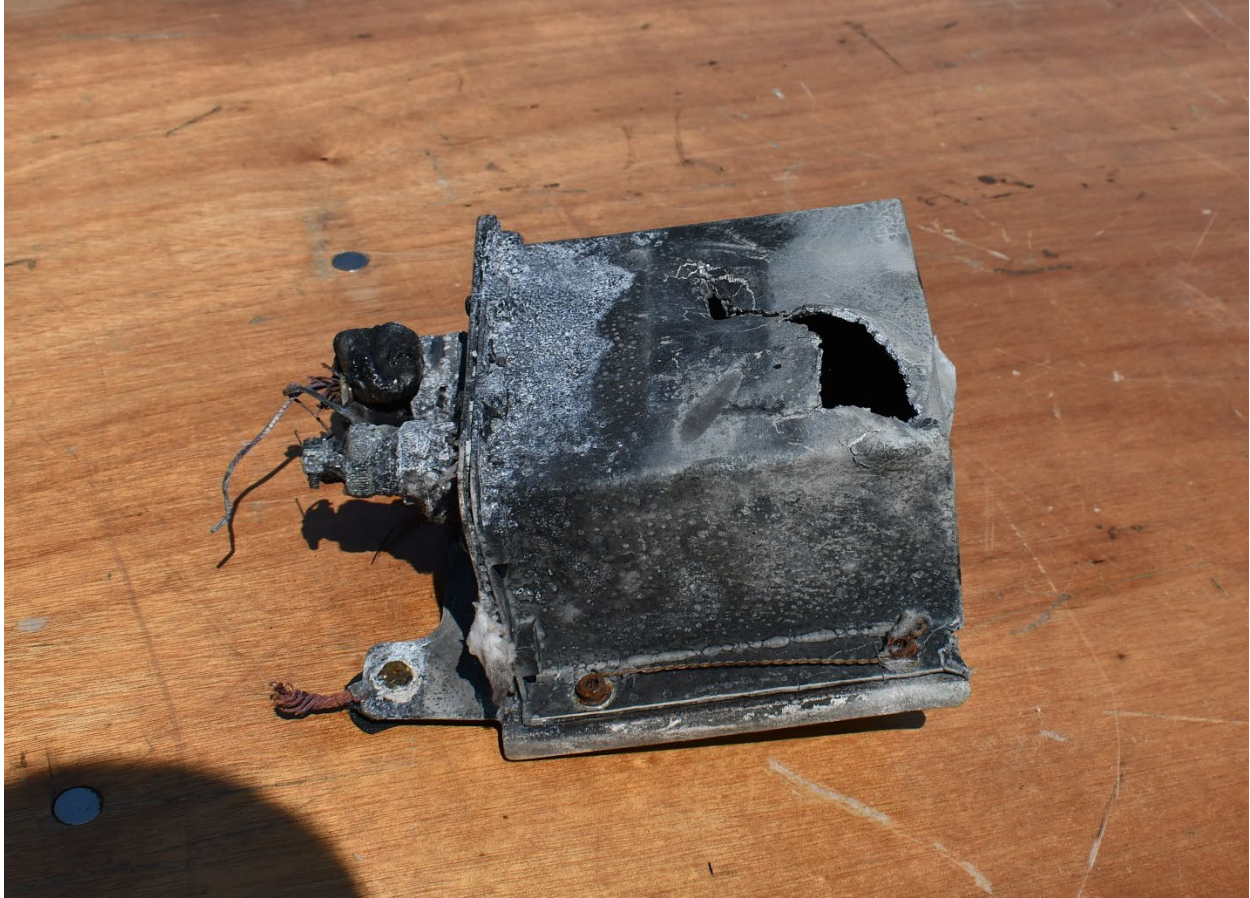
The antiskid control unit was severely thermally damaged. Through a hole in the case it was observed that the internal circuit card was thermally damaged and the unit was not testable. The unit was not retained for this reason. According to Honda there is no NVM within this unit. The label containing the part number and serial number was either missing or damaged beyond recognition. See Figure 5.

**Figure 5:** Antiskid control unit

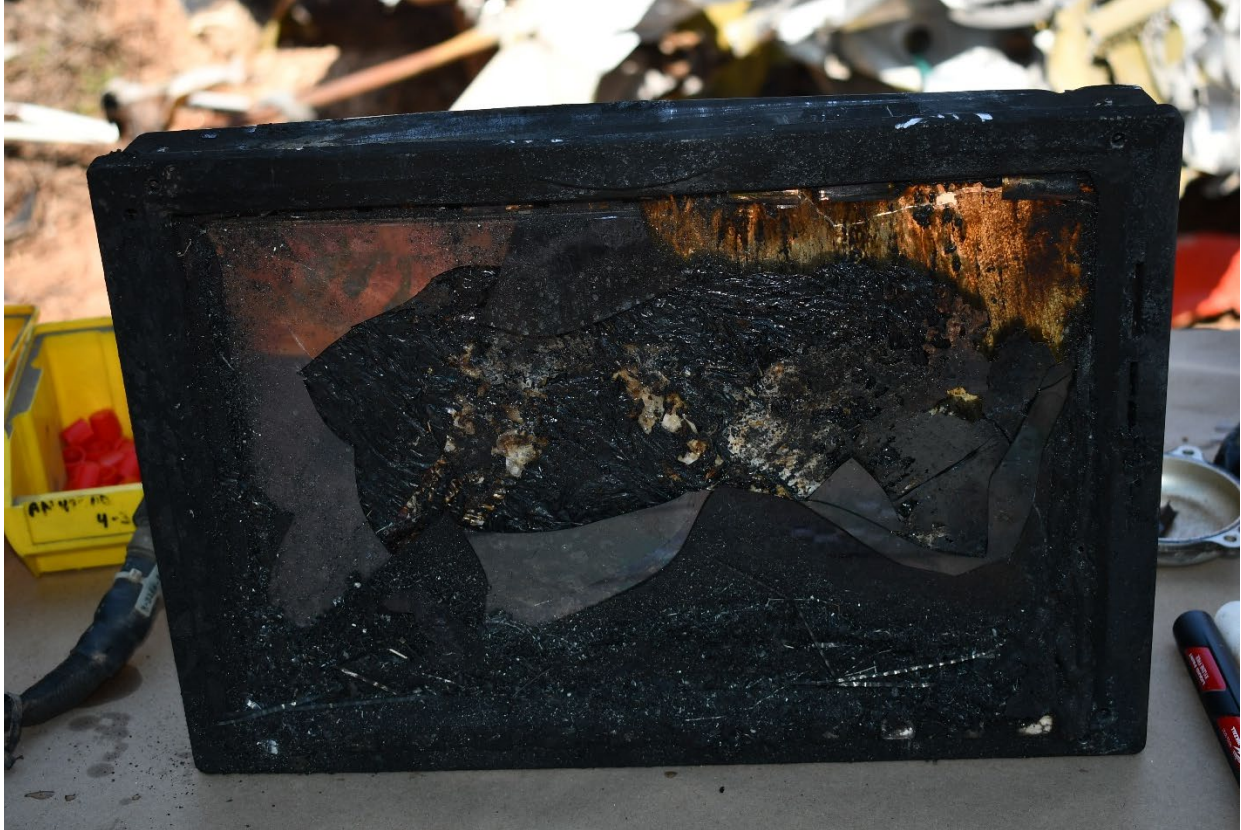
The left primary flight display was severely thermally damaged (see Figure 6). The unit was opened. The internal SD card was missing or was unrecognizable due to the thermal damage. All loose chips were bagged and sent to the NTSB recorders laboratory to attempt to extract non-volatile memory (NVM). See the Cockpit Display Specialist's Factual Report found in the public docket for this accident.

**Figure 6:** Left side primary flight display

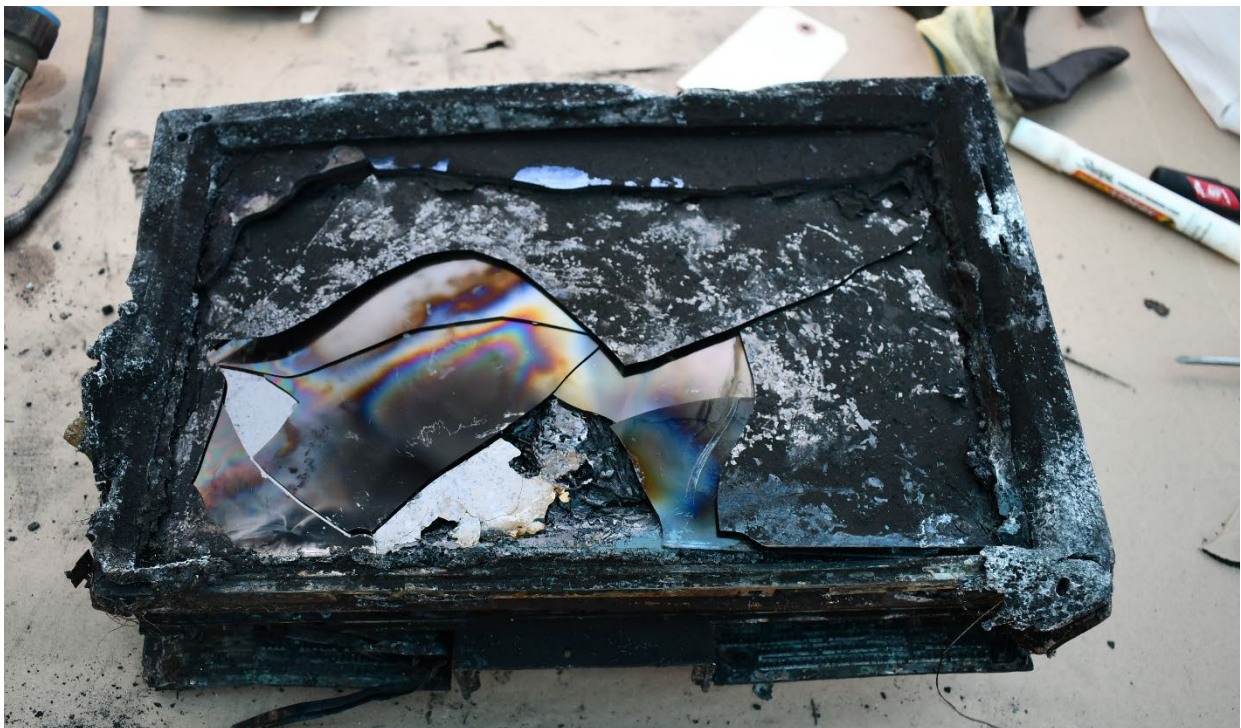
The right primary flight display was severely thermally damaged (see Figure 7). The remnants of a possible SD card was located in the internal SD housing. The SD card was bagged and sent to the NTSB recorders laboratory to attempt to extract NVM. See the Cockpit Display Specialist's Factual Report found in the public docket for this accident.

**Figure 7:** Right side primary flight display

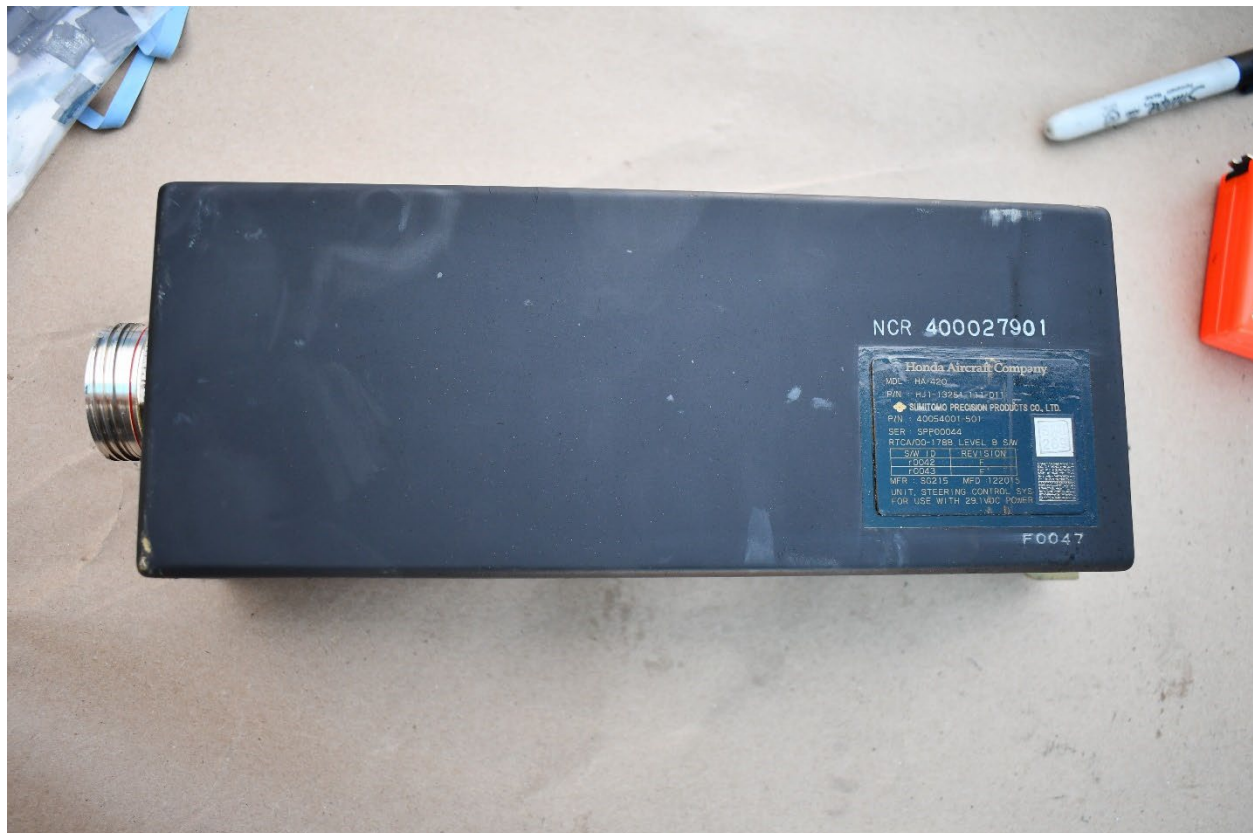
The nose wheel steering control unit was removed because it contains NVM related to nose wheel steering faults. The unit was in good condition (see Figure 8). The unit was P/N 40054001-501, S/N SPP000044. The connector pins were straight and clean. The unit was sent to NTSB headquarters for storage, and then later sent to Honda to attempt to extract NVM.

**Figure 8:** Nose wheel steering control unit

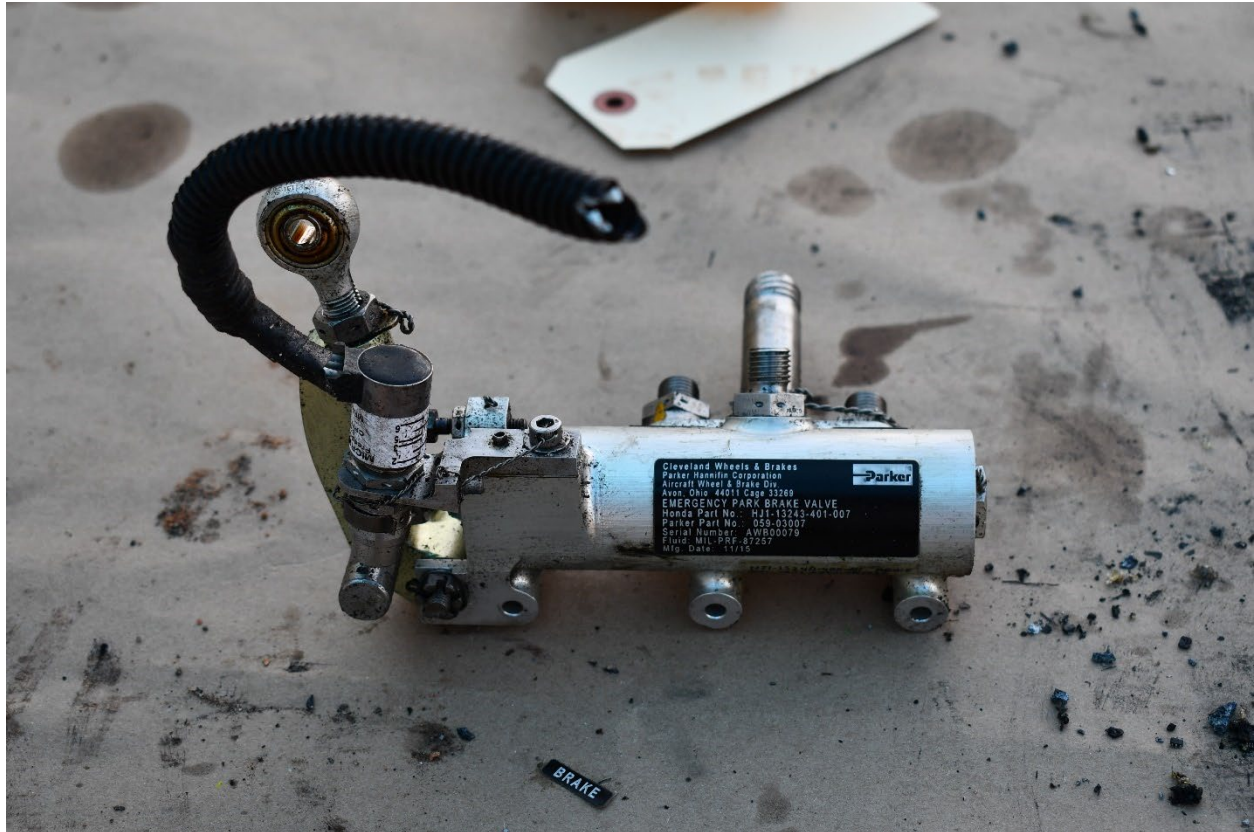
The emergency park brake valve was in good condition (see Figure 9). The unit was P/N 059-03007, S/N AWB0079. The unit was removed and retained by Honda for future testing.

**Figure 9:** Emergency park brake valve

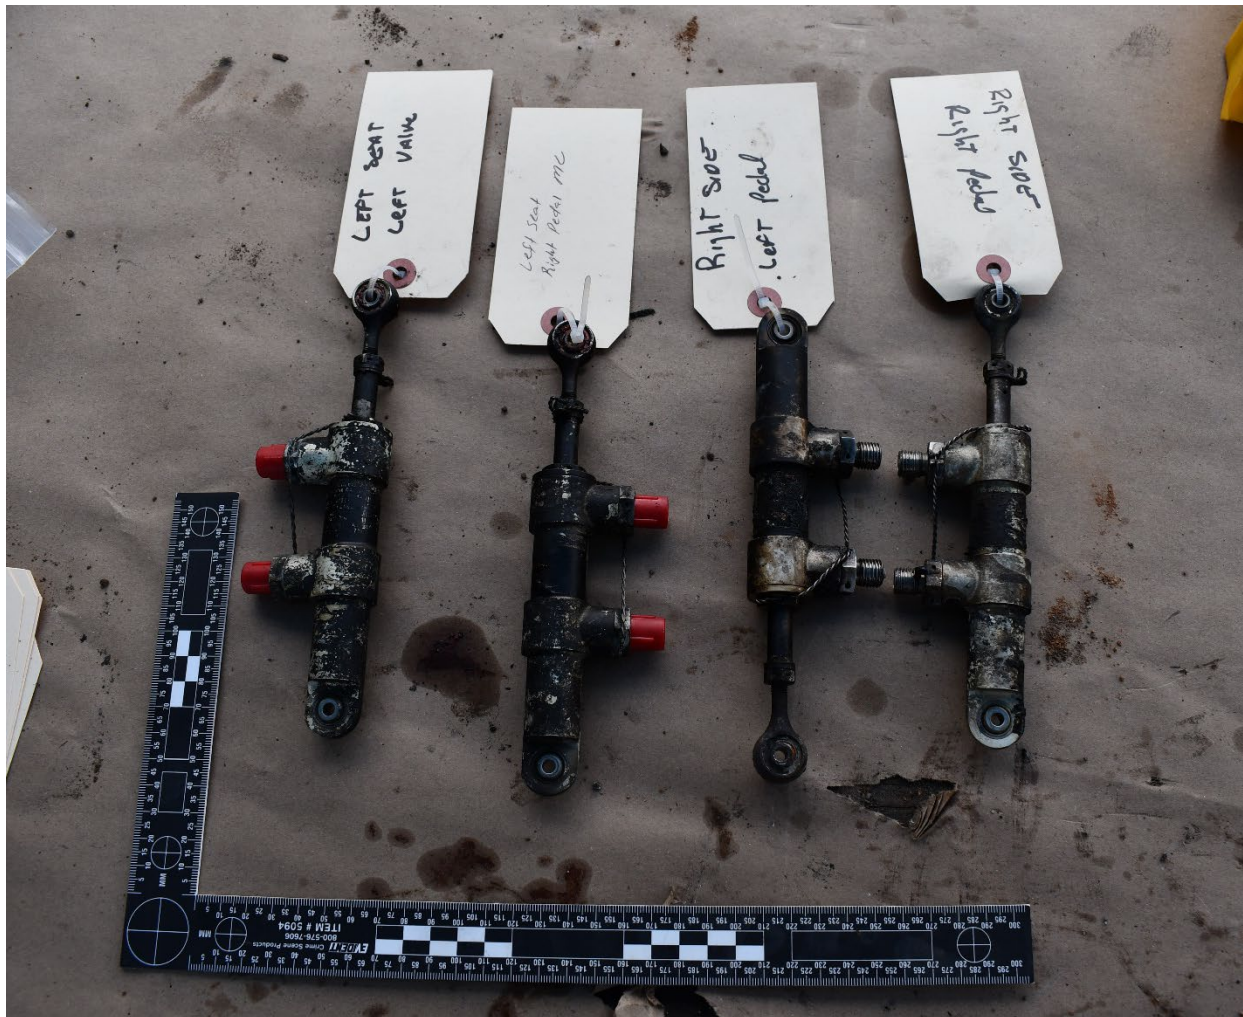
All four master cylinders were removed from the aircraft and tagged with their location. All were thermally damaged and the labels could not be read on scene (see Figure 10). The right side left pedal master cylinder was blocked with material consistent with melted and extruded piston in the port closest to the piston side. All four master cylinders were retained by Honda for future testing.

**Figure 10:** Brake master cylinders

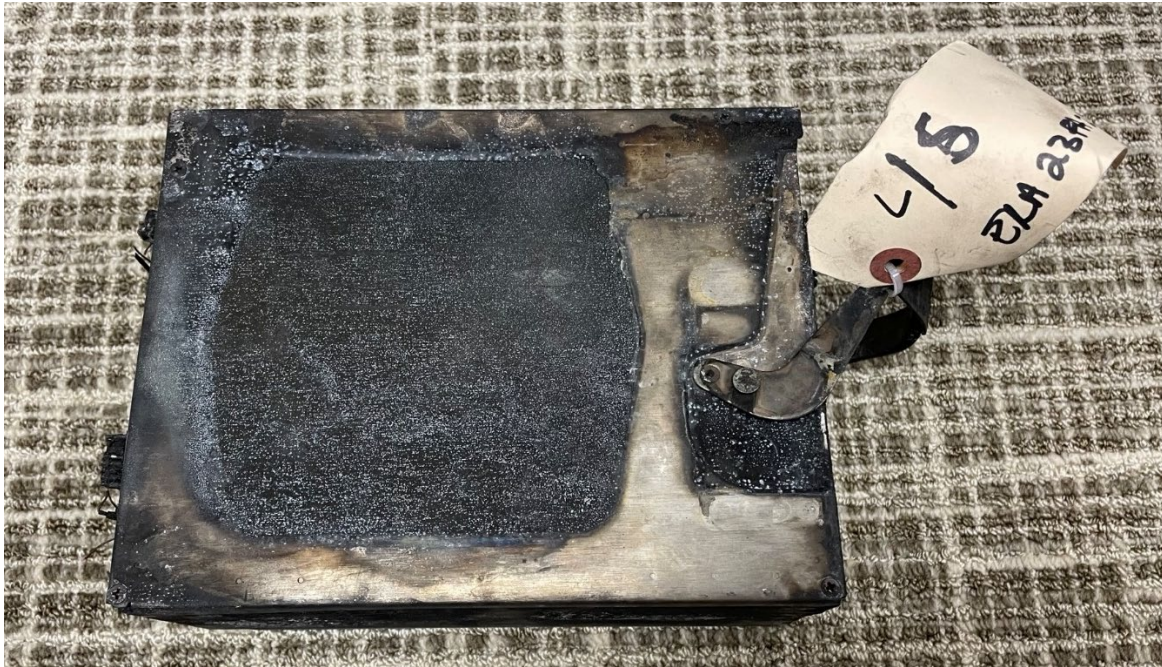
The Garmin integrated avionics computers were removed because they contain NVM. Both left and right integrated avionics computers were externally thermally damaged and the labels containing the part number and serial number were either missing or damaged beyond recognition (see Figures 11 and 12). Both units were tagged with their location. Both units were removed from the wreckage and sent to the NTSB recorder's laboratory to attempt to extract NVM. See "Cockpit Display Specialist's Factual Report" found in the public docket for this accident for information related to the NVM download attempt.

**Figure 11:** Left side integrated avionics computer

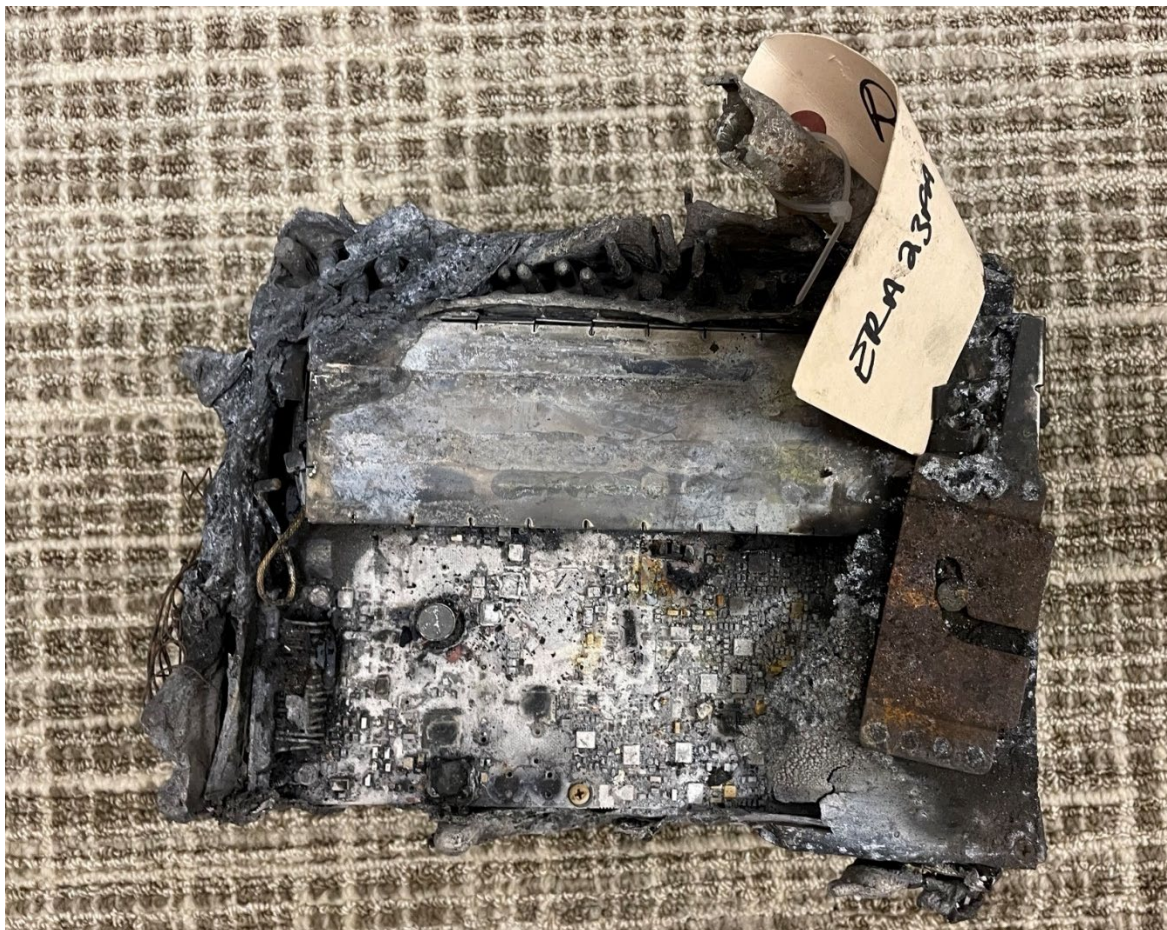
**Figure 12:** Right side integrated avionics computer

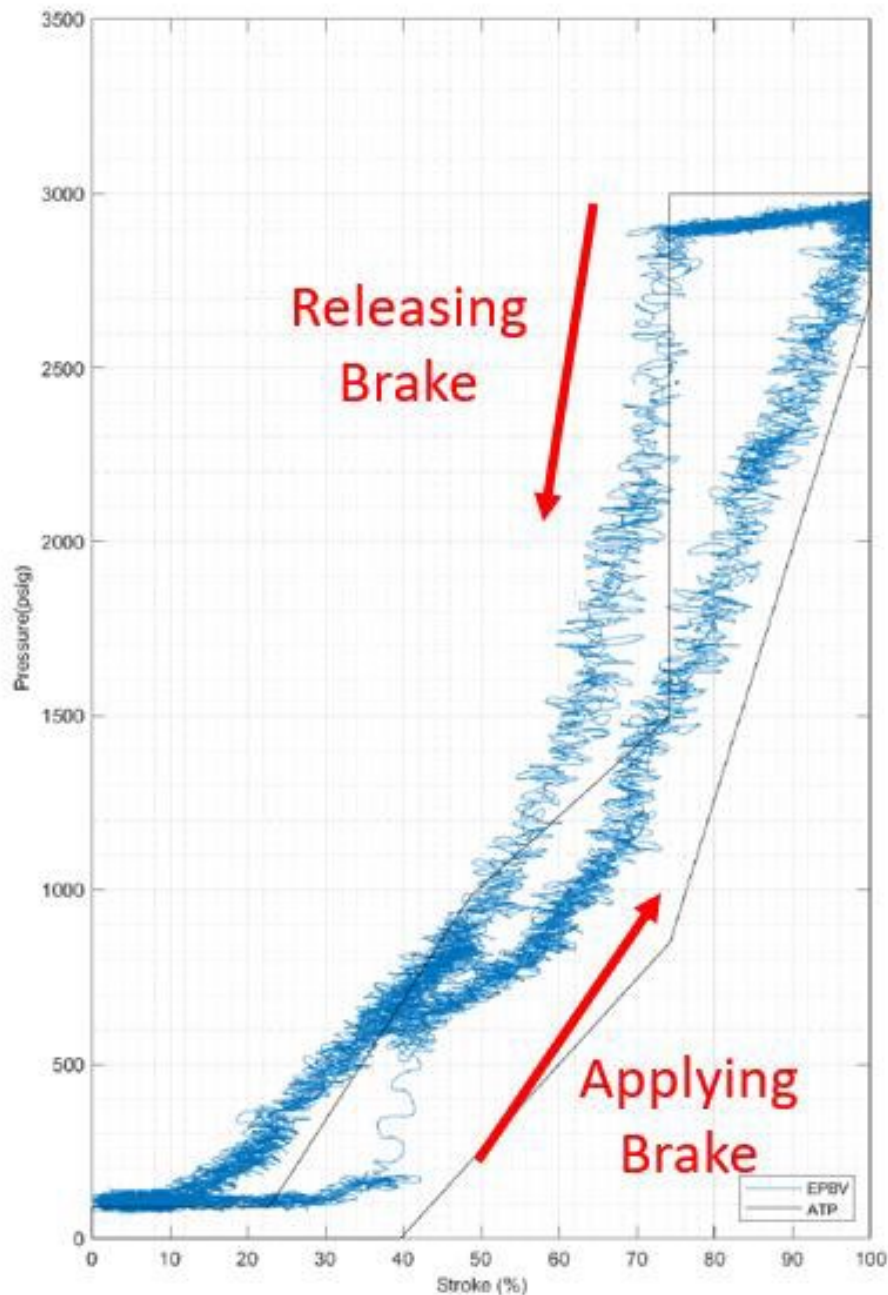
The emergency park brake valve was P/N 059-03007 (Honda P/N HJ1-13243-401-007), S/N AWB00079. Date of manufacture was 11-2015. The unit was in good condition with no damage or sooting observed. All safety wire was present. The unit was connected to an oscilloscope and system pressure, brake pressure, and valve input lever position were recorded. With 3000 psi input pressure, there was no output pressure when the valve was closed, and 3000 psi output pressure when the valve was fully open. The valve lever was then manually actuated through its full stroke and the output pressure was recorded and compared to the ATP (ATP6158, Rev C) requirement envelope. The data is plotted in Figure 13. The ATP requirement

envelope for the lever stroke vs output pressure curve is only applicable while applying brakes. Deviations are acceptable during the release of the brakes.

**Figure 13:** Emergency park brake valve lever Stroke vs. Output pressure. The grey box represents the ATP requirement envelope while applying brake pressure only. Figure used with permission from Honda and Crane.

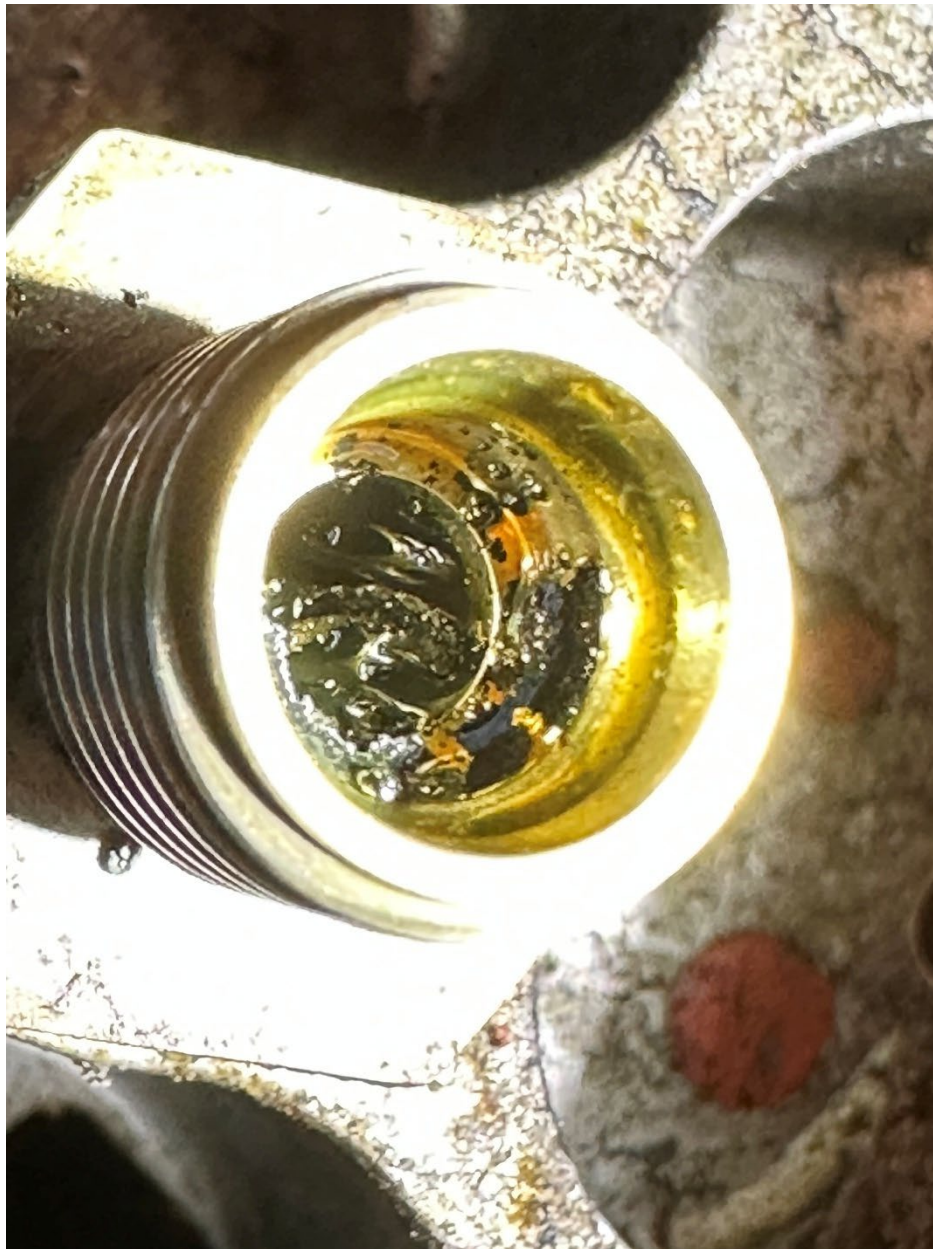
Connector pins were straight and clean. The unit was shipped with dust caps. The caps were removed and all fluid was poured out. The ports were cleaned with alcohol and some small FOD specs were observed. Significant FOD was observed in the brake right port fitting, which provides output pressure to the brake assembly (see Figure 14). When the FOD was flushed out during testing (see next paragraph) it broke into small pieces in the hydraulic fluid. It is noted that the FOD is on the downstream side of a 10 micron filter in this port fitting. Computed tomography scans (described later in this section) revealed that the screen was intact.

**Figure 14:** FOD observed in the brake right port fitting of the power brake and antiskid valve. Photo courtesy of Honda.

To understand the effects of the material observed in the brake right port fitting, the power brake valve was connected to the test bench. With only return pressure applied to the brake right port (40 psi), the port dripped fluid and some material came out with the fluid. With 200 psi input pressure, a steady stream of hydraulic fluid was coming from the right brake port, and a lot of the material came out with the fluid. The port was again observed and now looked clean.

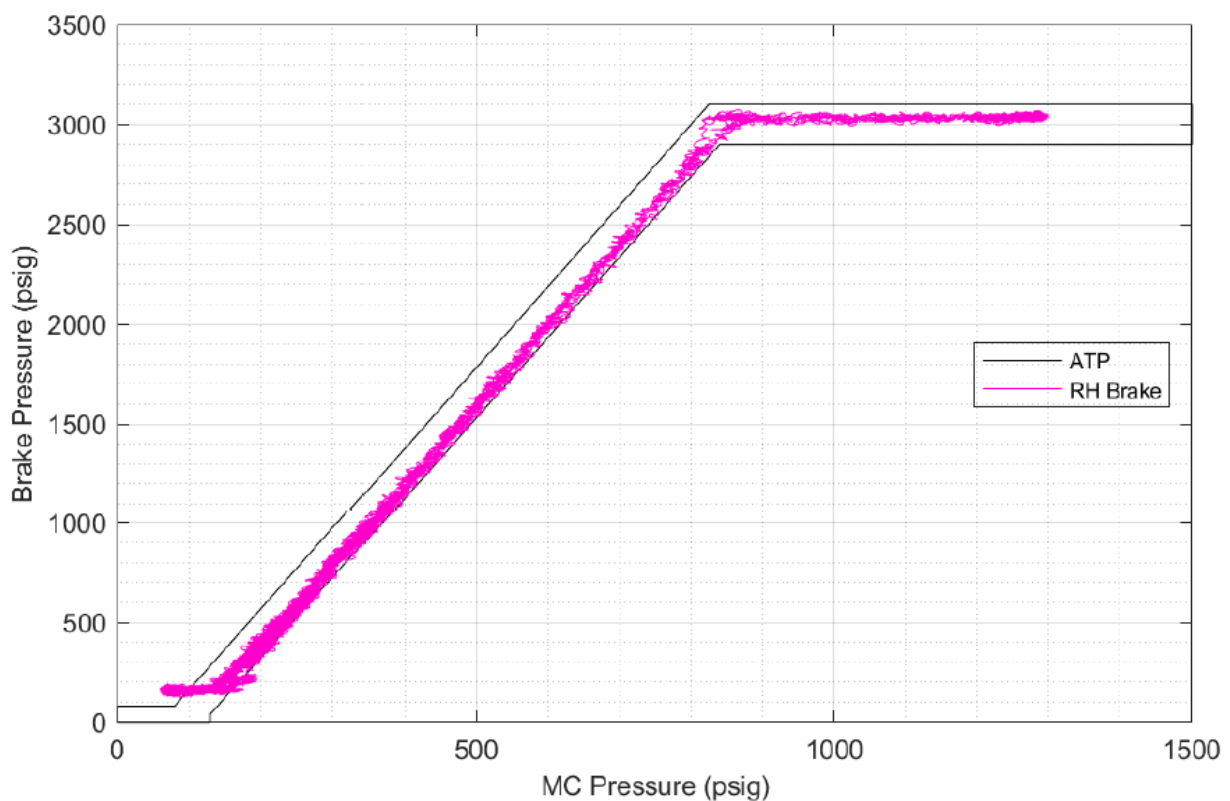
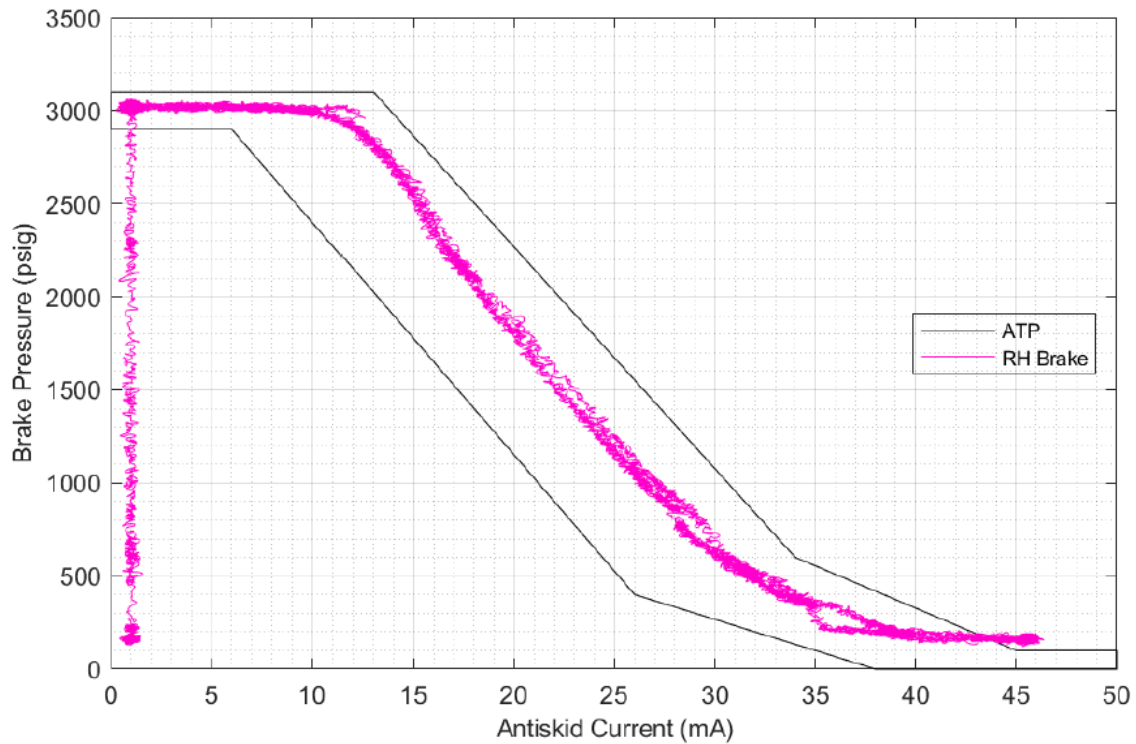
The valve test was set up to test the right brake functionality first. The valve was supplied with an input pressure of 3000 psig. The master cylinder in the test stand was actuated to provide an input pressure to the master cylinder right port. The master cylinder pressure vs brake pressure and antiskid current vs brake pressure were plotted and compared to the ATP requirement envelopes. A sample of the data plots can be found in Figures 15 and 16.

**Figure 15:** Power brake and antiskid valve master cylinder Pressure vs. Brake pressure for right brake. Figure used with permission from Honda and Crane.

**Figure 16:** Power brake and antiskid valve Antiskid Current vs. Brake Pressure for right brake. Figure used with permission from Honda and Crane.

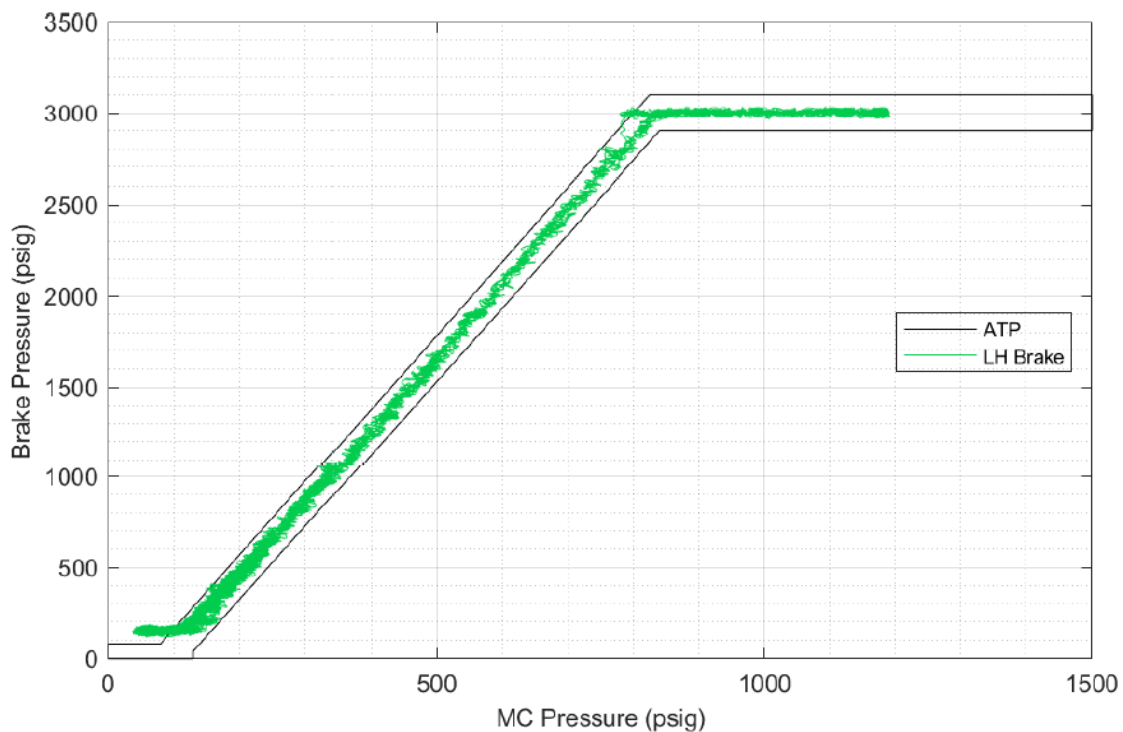
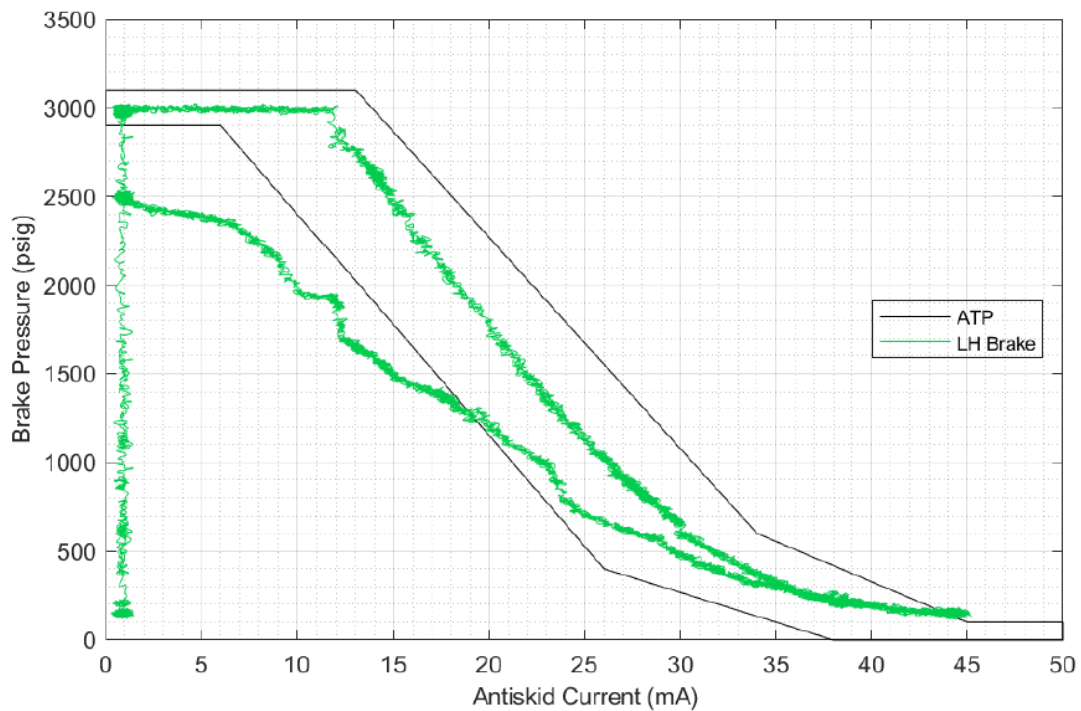
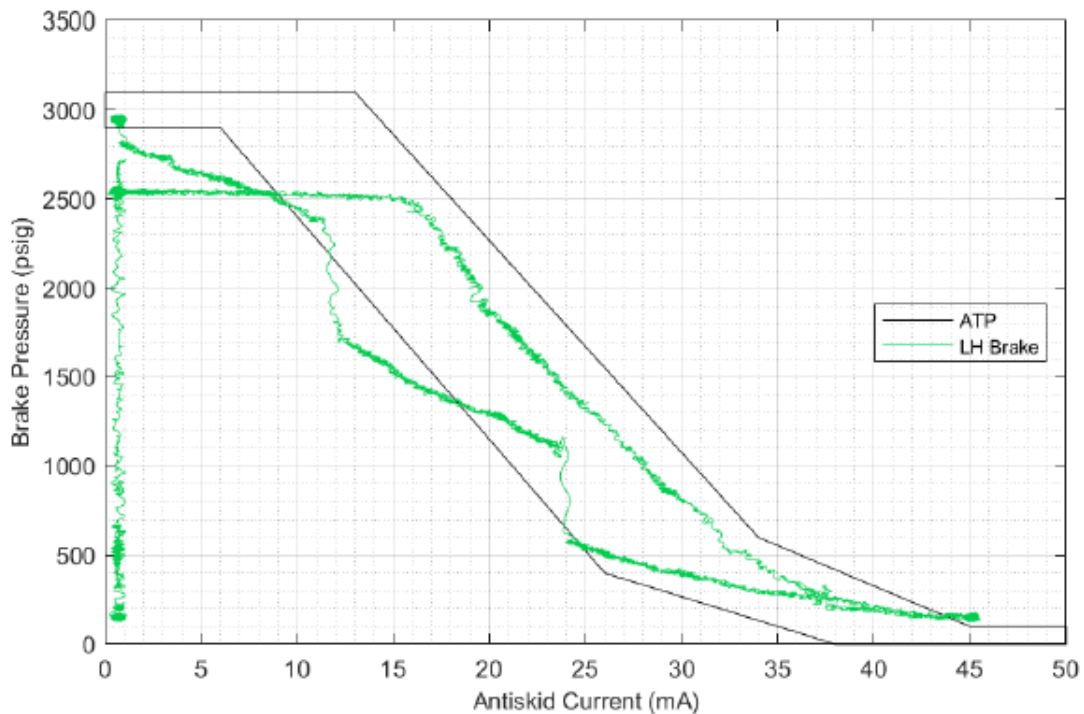
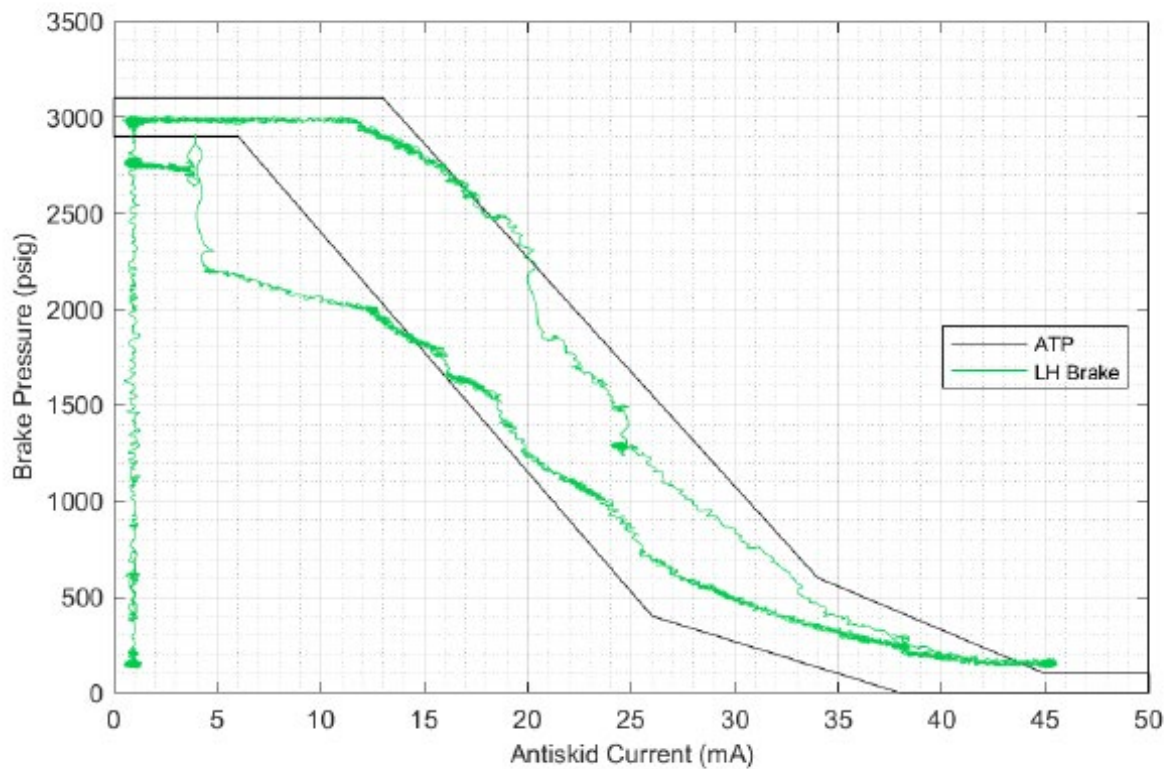
**Figure 17:** Power brake and antiskid valve Master Cylinder Pressure vs. Brake Pressure for left brake. Figure used with permission from Honda and Crane.

**Figure 18:** Power brake and antiskid valve Antiskid Current vs. Brake Pressure for left brake (example 1 of 3). Figure used with permission from Honda and Crane.

**Figure 19:** Power brake and antiskid valve Antiskid Current vs. Brake Pressure for left brake (example 2 of 3). Figure used with permission from Honda and Crane.

**Figure 20:** Power brake and antiskid valve Antiskid Current vs. Brake Pressure for left brake (example 3 of 3). Figure used with permission from Honda and Crane.
