# National Transportation Safety Board

ERA23FA235

## **SYSTEMS**

Group Chair's Factual Report

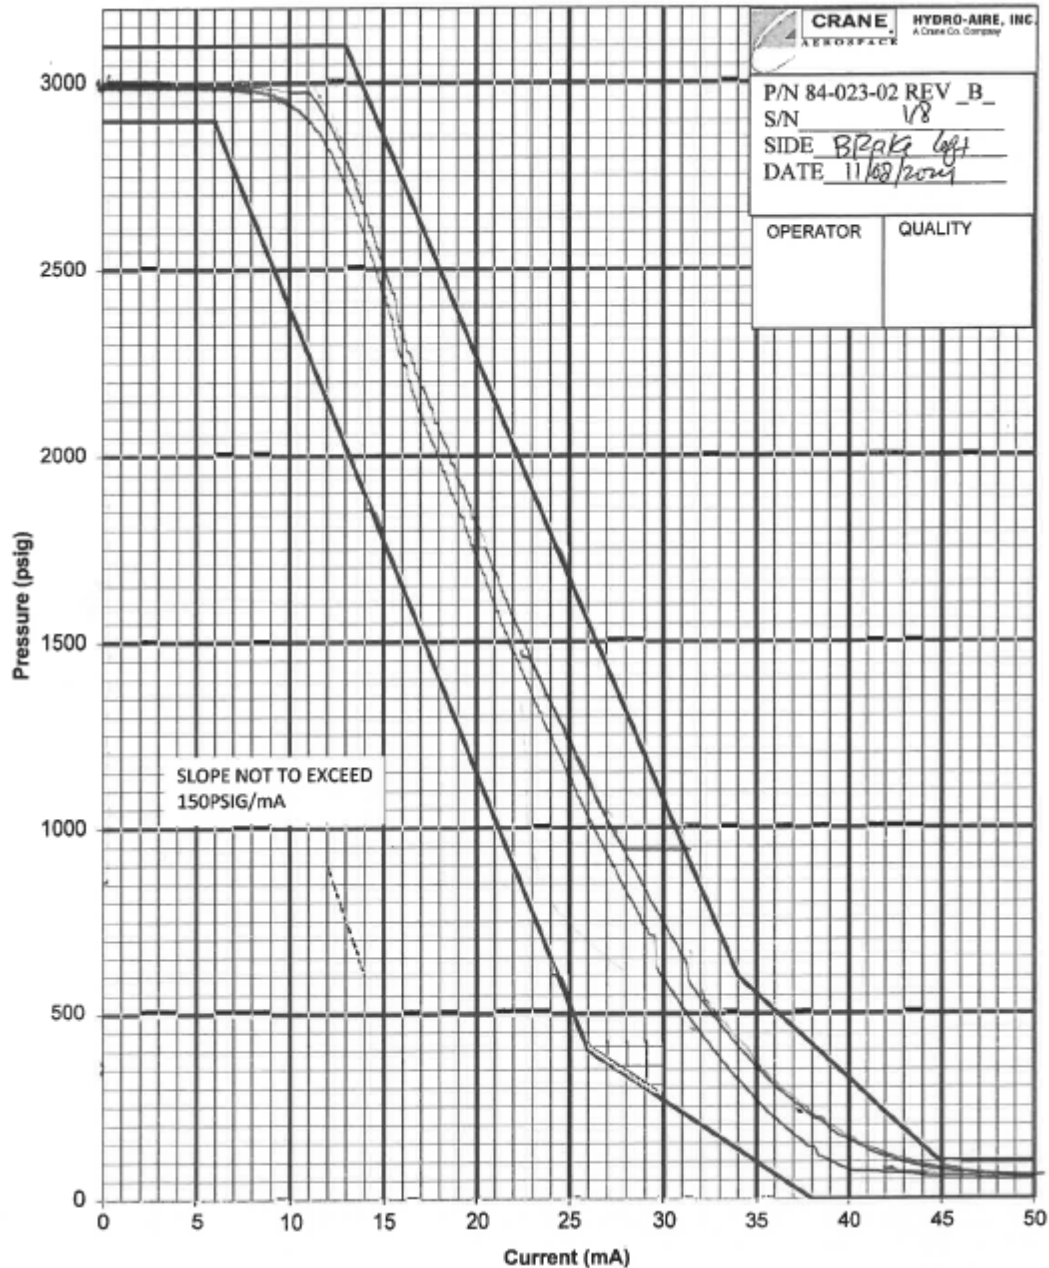
It was unknown if the test setup or equipment used during the testing at Honda contributed to the unexpected test results, so the valve was sent to Crane to be tested per ATP TP140-329 on the manufacturer's test equipment.<sup>4</sup> On 11/08/2024 the unit passed all portions of the ATP. A Current vs Pressure plot was made prior to the ATP and after the ATP. All plots were within limits both times. The initial Current vs Pressure plot (created prior to starting the ATP) can be found in Figure 21.

**Figure 21:** Power brake and antiskid valve Antiskid Current vs. Brake Pressure for left brake. Plot made at Crane prior to the ATP test. Figure used with permission from Crane.

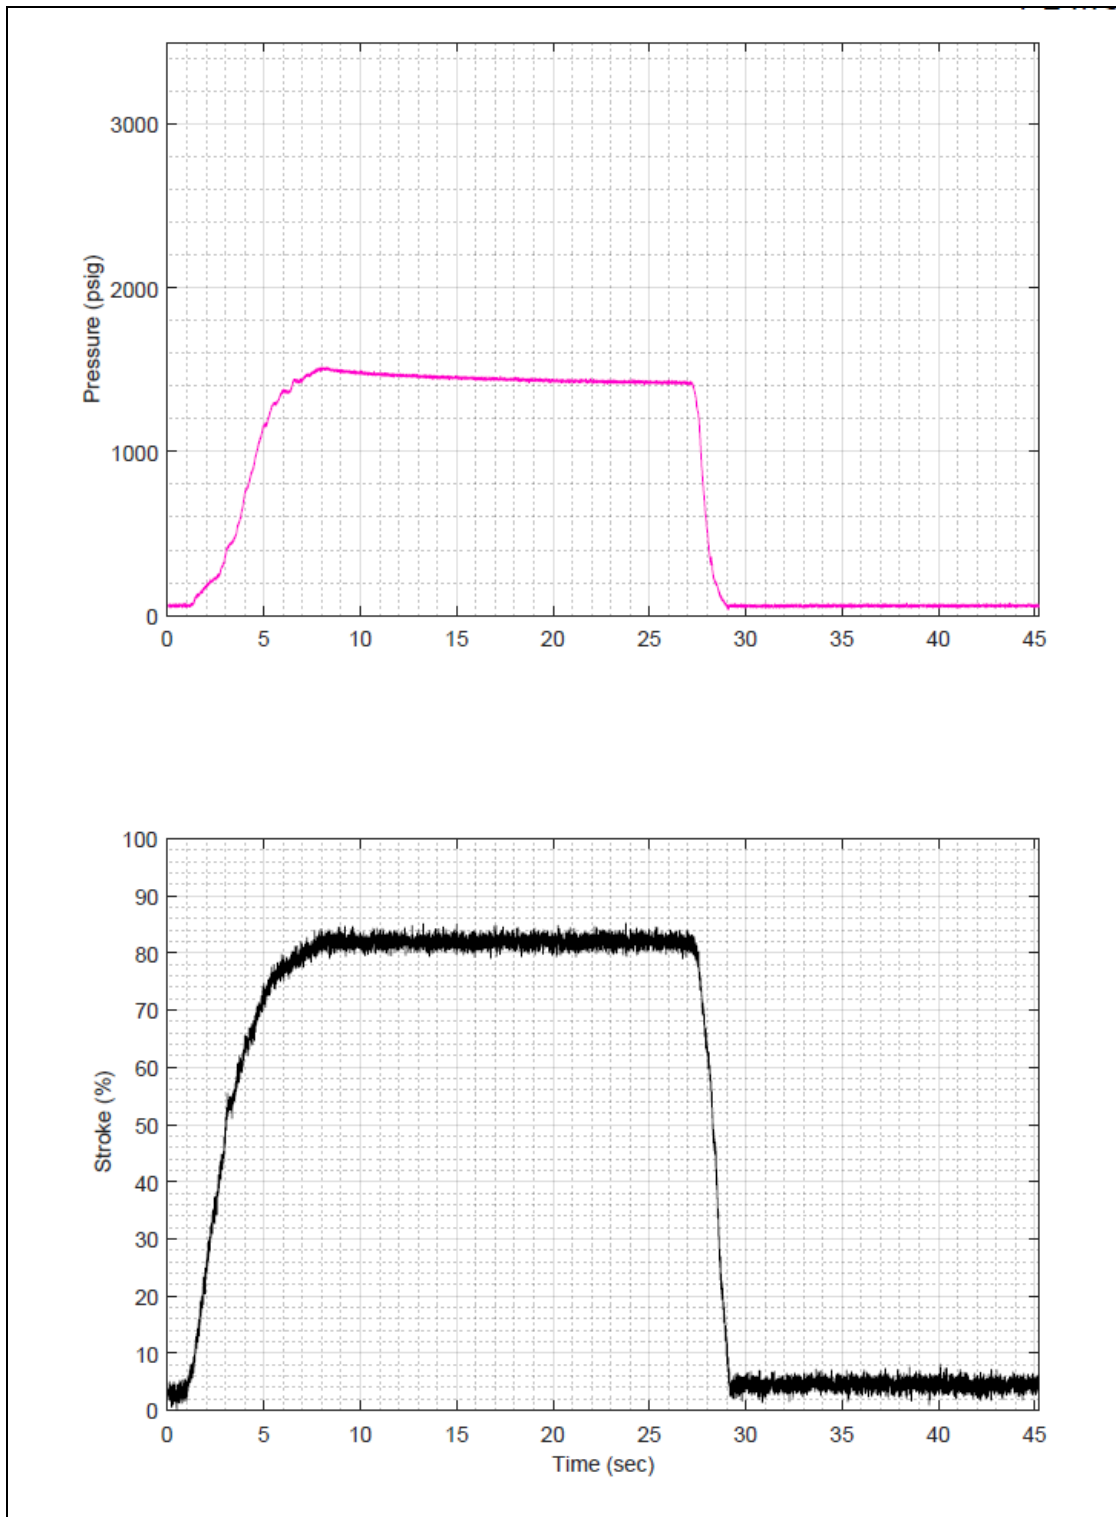
The unit was connected to the test bench and flushed. Some small specs of FOD came out during the flush.

The master cylinder was supplied with inlet pressure at 40 psig. The master cylinder was manually actuated to varying targeted pressure outputs (approximately 350, 750, and 1500 psi) and held steady for a short duration. The intention of the test was to hold the master cylinder in a steady position and monitor the pressure to ensure it was not dropping, as that would be indicative of a leak within the master cylinder. A sample of the master cylinder stroke and output pressure time history can be found in Figure 22.

**Figure 22:** Pilot left master cylinder Time vs Stroke at approximately 1500psi target pressure. Figure used with permission from Honda and Crane.

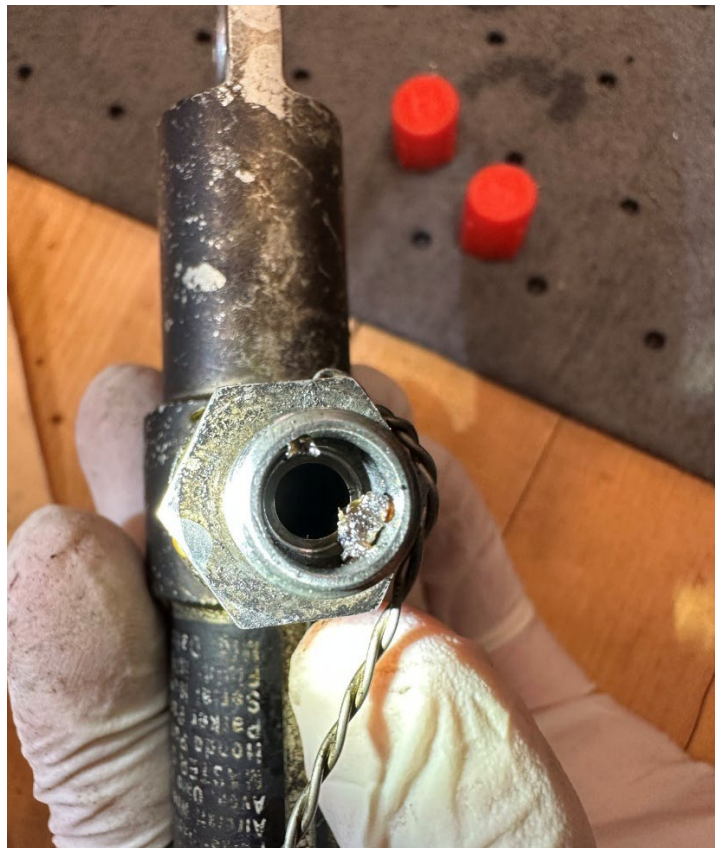
The master cylinder was P/N HJ1-13243-201-005, S/N AWB00294. The unit was heavily sooted. All safety wire was intact. Dust covers were installed on the hydraulic ports. The ports were dry. FOD was identified in the top of the outlet port (see Figure 23). The piston chamber was cleaned with alcohol prior to testing and significant amounts of fine dark colored specs of FOD were observed. The FOD had some shiny features and did not visually appear to be consistent with an o-ring material. It is noted that possible contaminants from the surrounding heat damaged area could have been introduced during the component removal and capping process.

**Figure 23:** FOD in outlet port fitting of the pilot right master cylinder. Picture courtesy of Honda.

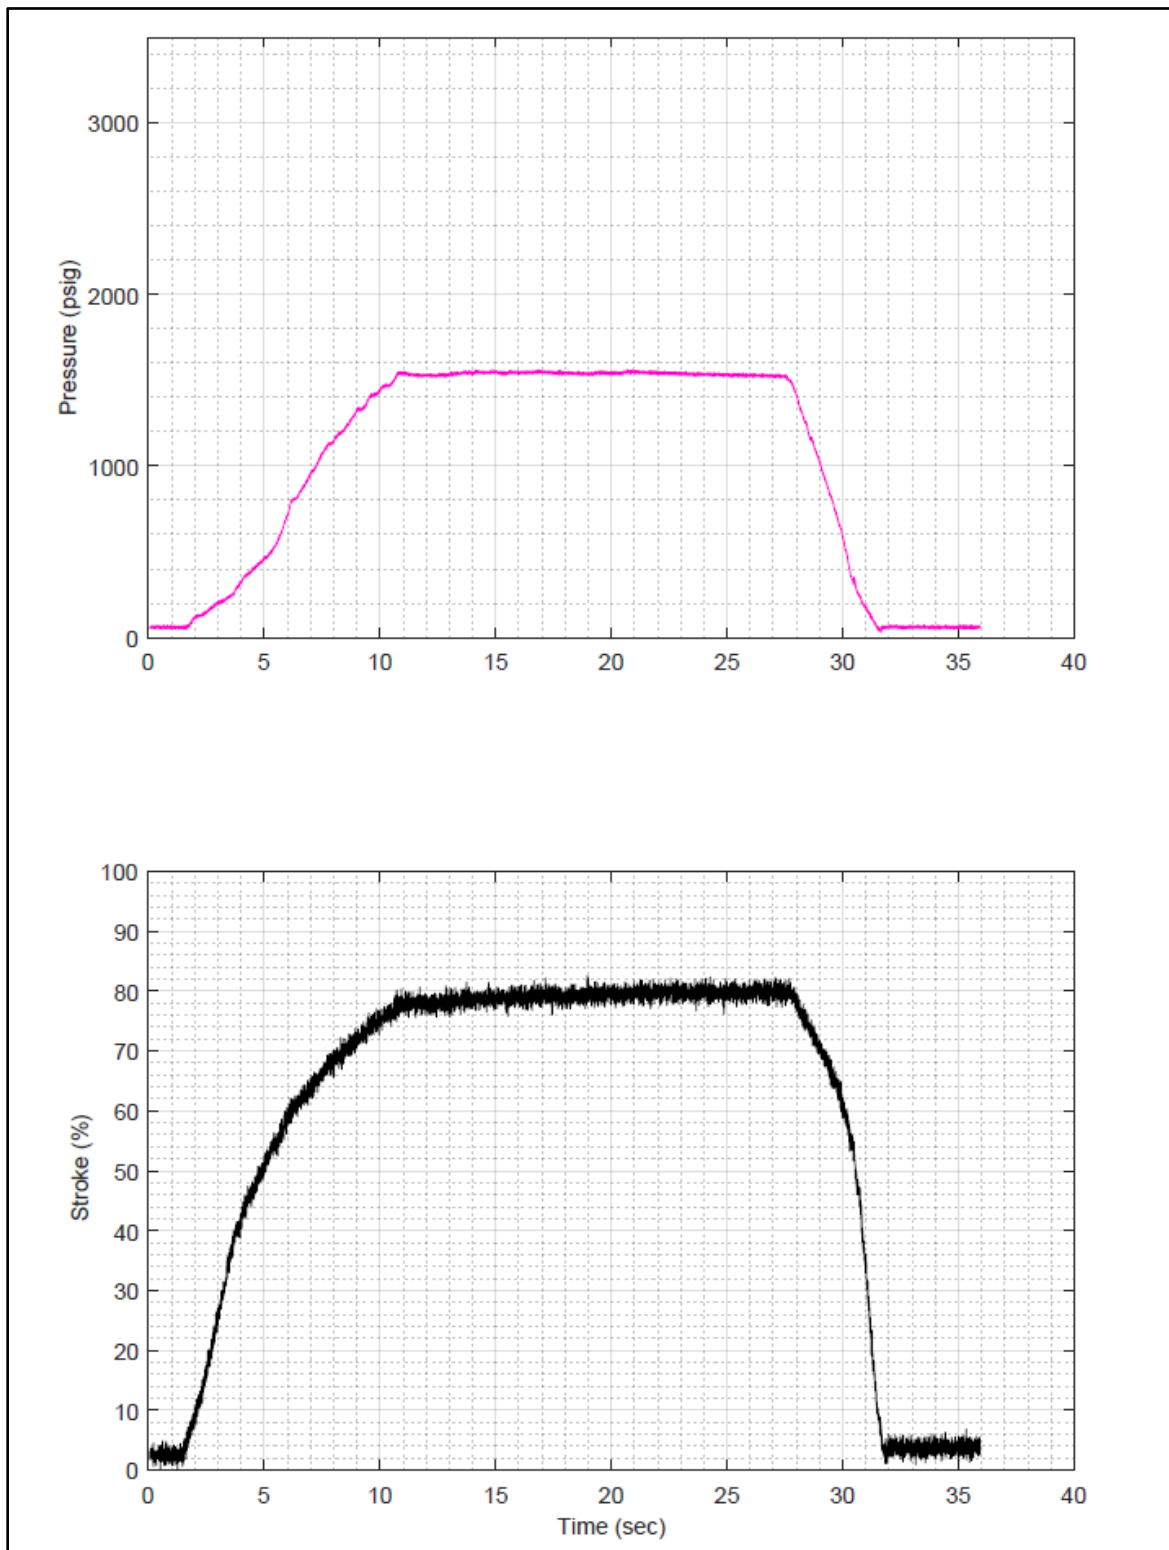
The master cylinder was supplied with inlet pressure at 40 psig. The master cylinder was manually actuated to varying targeted pressure outputs (approximately 350, 750, and 1500 psi) and held steady for a short duration. The intention of the test was to hold the master cylinder in a steady position and monitor the pressure to ensure it was not dropping, as that would be indicative of a leak within the master cylinder. A sample of the master cylinder stroke and output pressure time history can be found in Figure 24.

**Figure 24:** Pilot right master cylinder Time vs Stroke at approximately 1500psi target pressure. Figure used with permission from Honda and Crane.

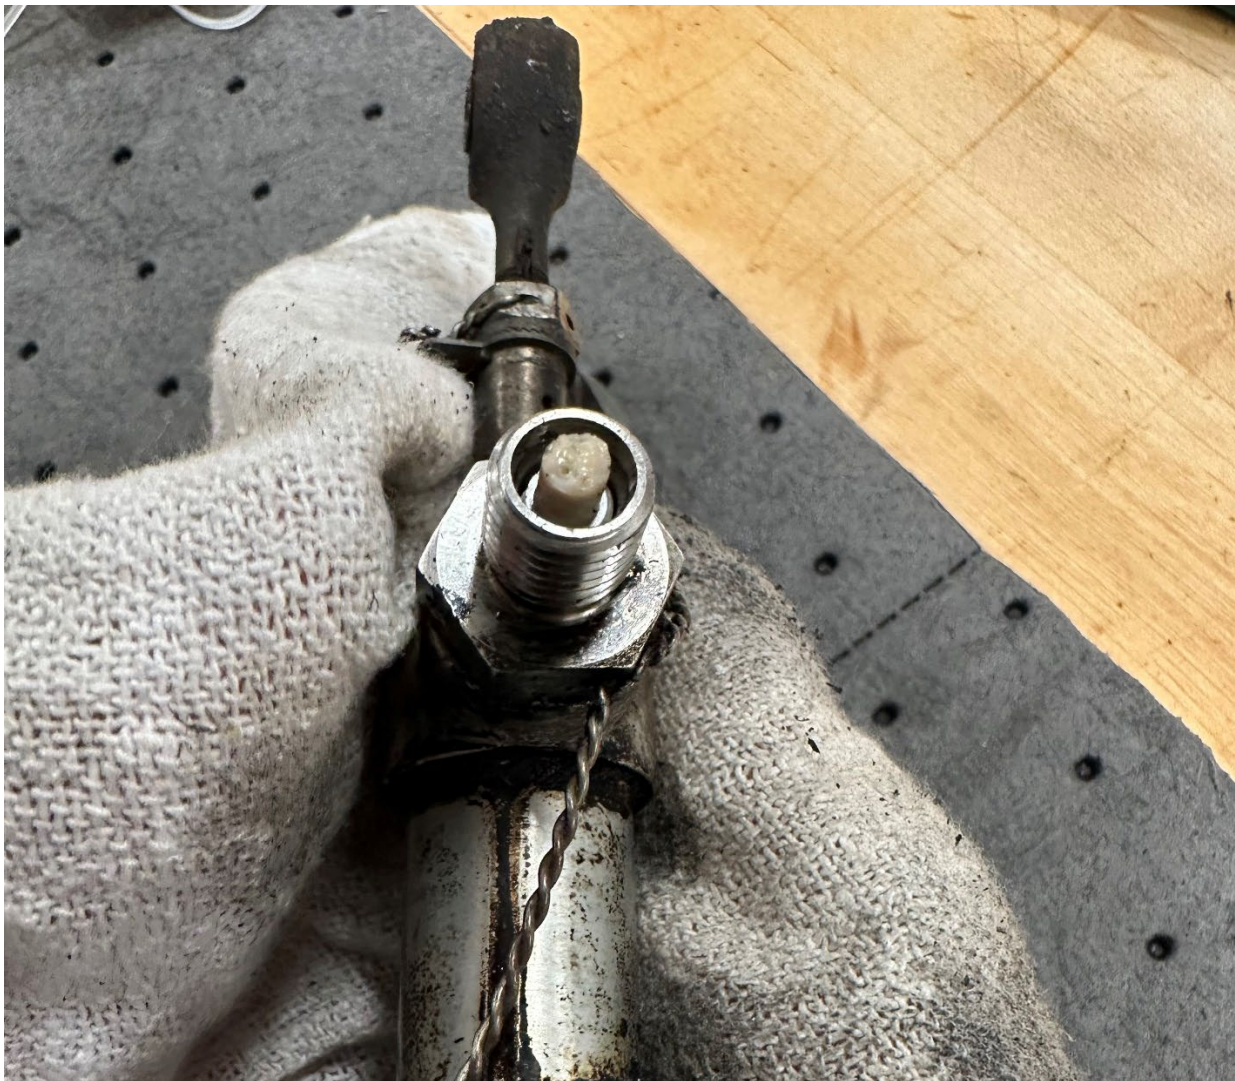
The label was missing from this master cylinder. The unit was heavily sooted. All safety wire was intact. Dust covers were installed on the hydraulic ports. A white material, consistent with hardened plastic, was extruding out the inlet port fitting (see Figure 25). This FOD could not be removed, and the piston was incapable of being actuated by hand. The unit could not be tested and the decision was made to perform a teardown inspection. Disassembly of the master cylinder revealed that the FOD material was the melted piston, P/N 148-09500, of the master cylinder. According to the manufacturer, the material is PEEK per MIL-P-46183 Type 1.<sup>5</sup> Aside from the melted material, no other anomalies were identified during the teardown.

**Figure 25:** Piston extrusion from the first officer left brake master cylinder inlet port fitting. Picture courtesy of Honda.

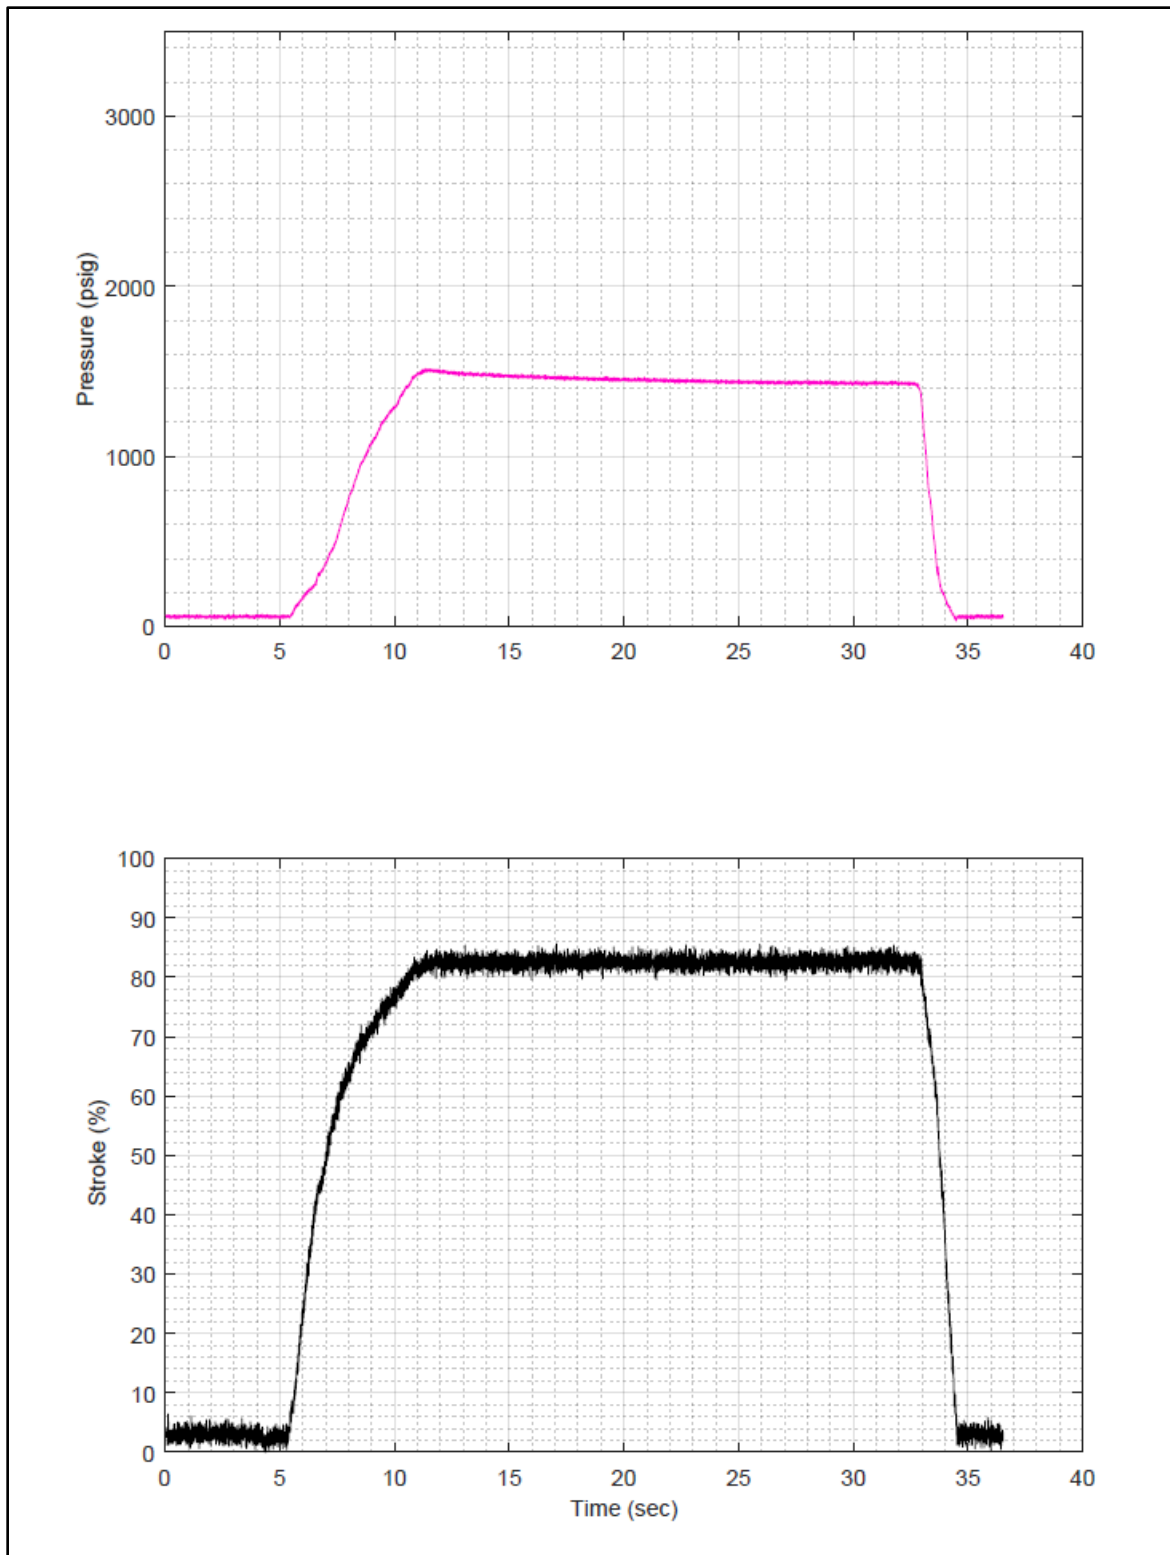
The master cylinder part number and serial number could not be read due to damage to the label. The unit was heavily sooted. All safety wire was intact. Dust covers were installed on the hydraulic ports. The ports were dry. The ports were flushed with alcohol with a few small specs of FOD were observed. The piston chamber was cleaned with alcohol prior to testing. The unit was connected to the test bench and flushed. No FOD was observed during the flush.

The master cylinder was supplied with inlet pressure at 40 psig. The master cylinder was manually actuated to varying targeted pressure outputs (approximately 350, 750, and 1500 psi) and held steady for a short duration. The intention of the test was to hold the master cylinder in a steady position and monitor the pressure to ensure it was not dropping, as that would be indicative of a leak within the master cylinder. A sample of the master cylinder stroke and output pressure time history can be found in Figure 26.

**Figure 26:** Co-pilot right master cylinder Time vs Stroke at approximately 1500psi target pressure. Figure used with permission from Honda and Crane.
