Office of Aviation Safety  
Eastern Region

**Photo Array**

**ERA23FA238**

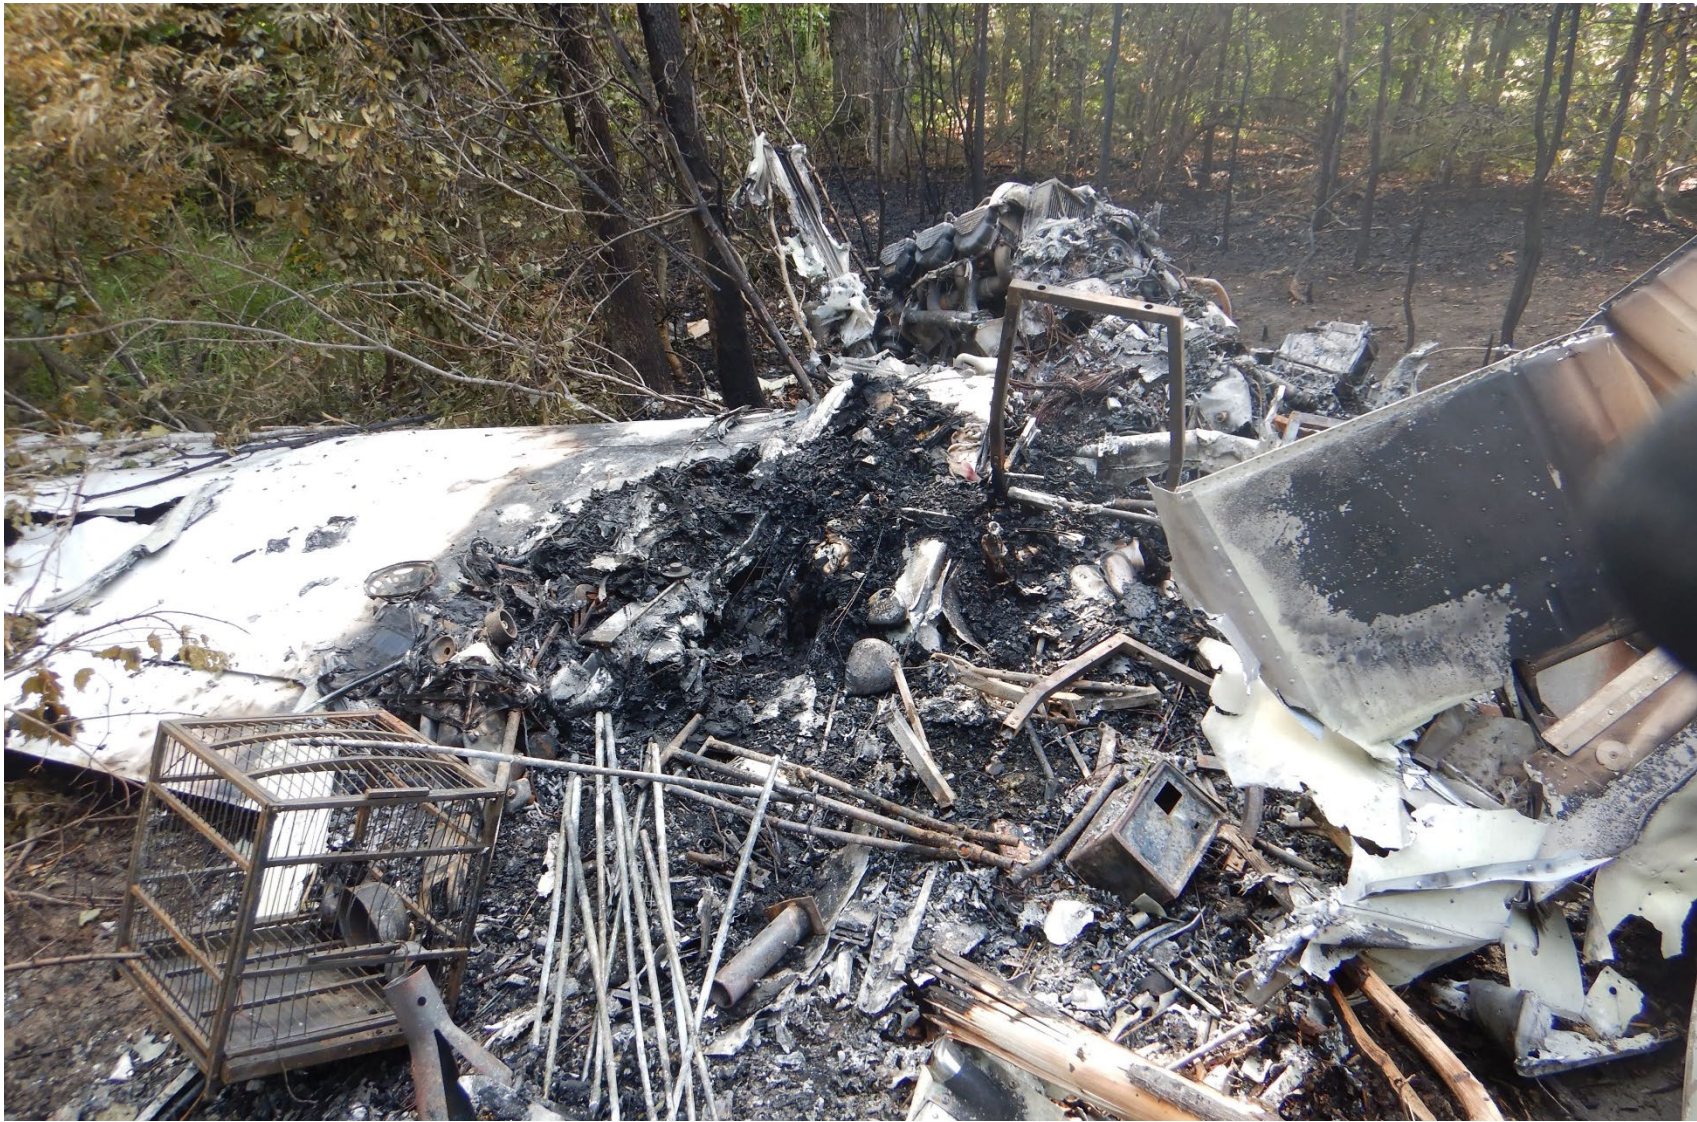
**Photo 1 – View of burned airplane wreckage from rear.**

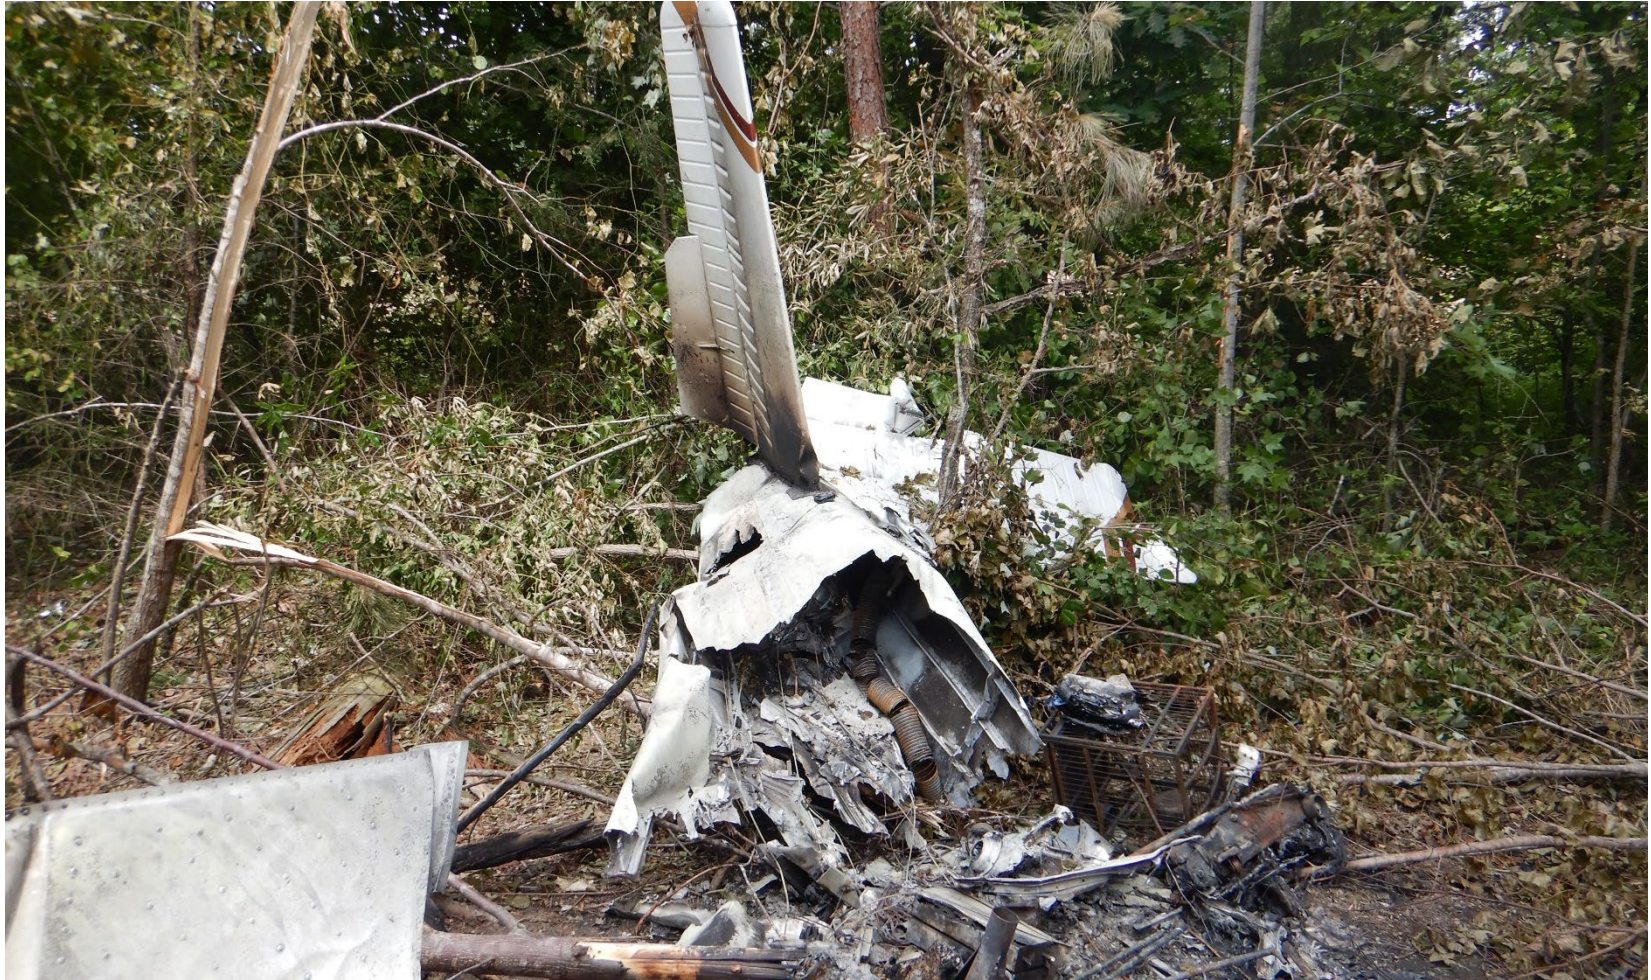
**Photo 2 – View of empennage.**

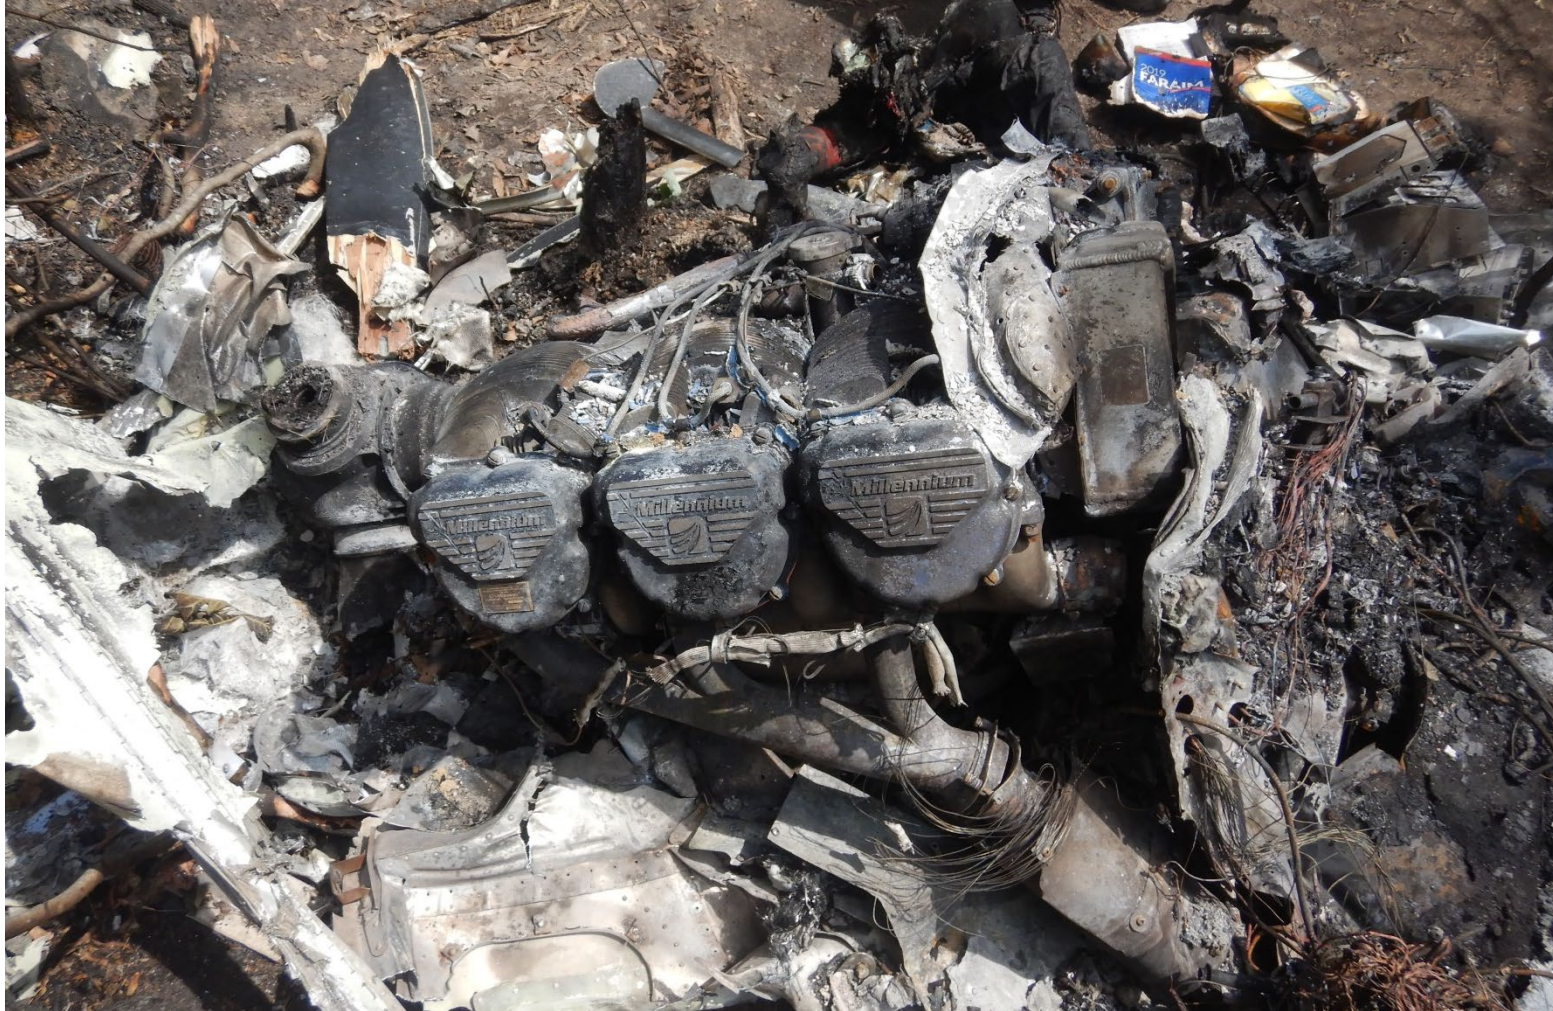
**Photo 3 – View of airplane engine.**

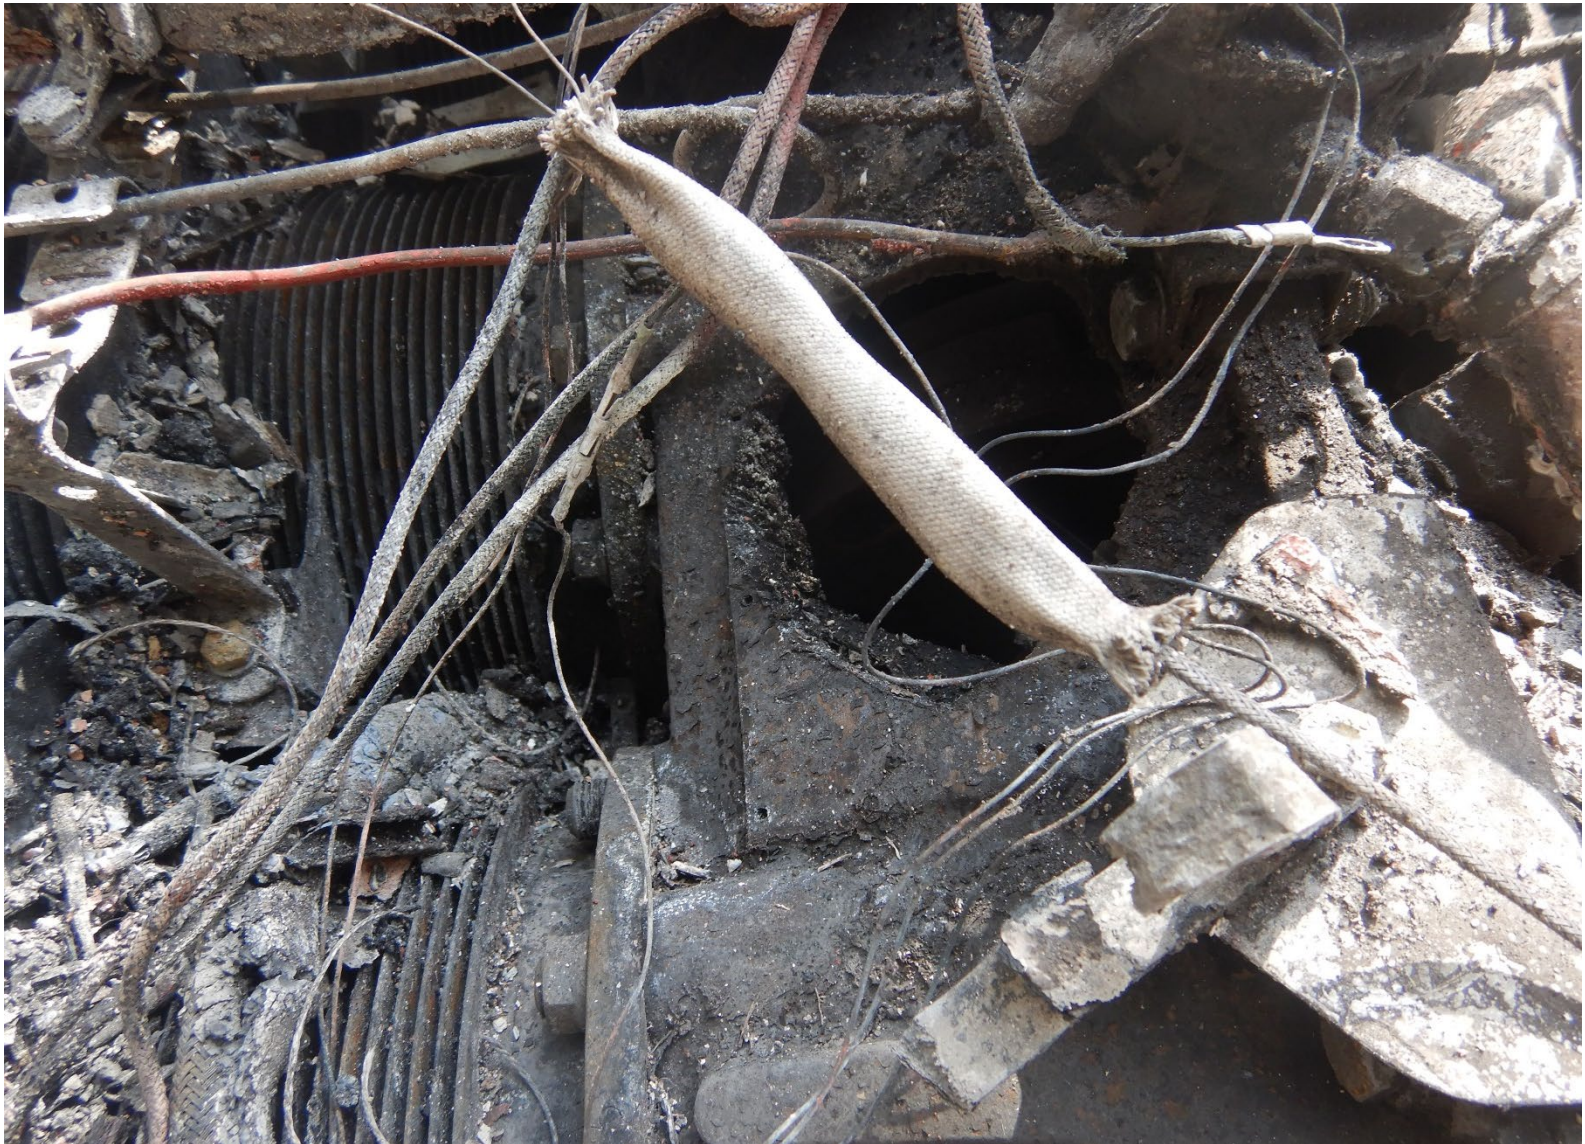
**Photo 4 – View of hole in engine crankcase.**
