# National Transportation Safety Board

ERA23FA238

## **ENGINE EXAMINATION**

Location: Rougemont, NC  
Date: May 21, 2023  
Time: 1115 EDT  
1515 UTC  
Airplane: Beech V-35, N272S

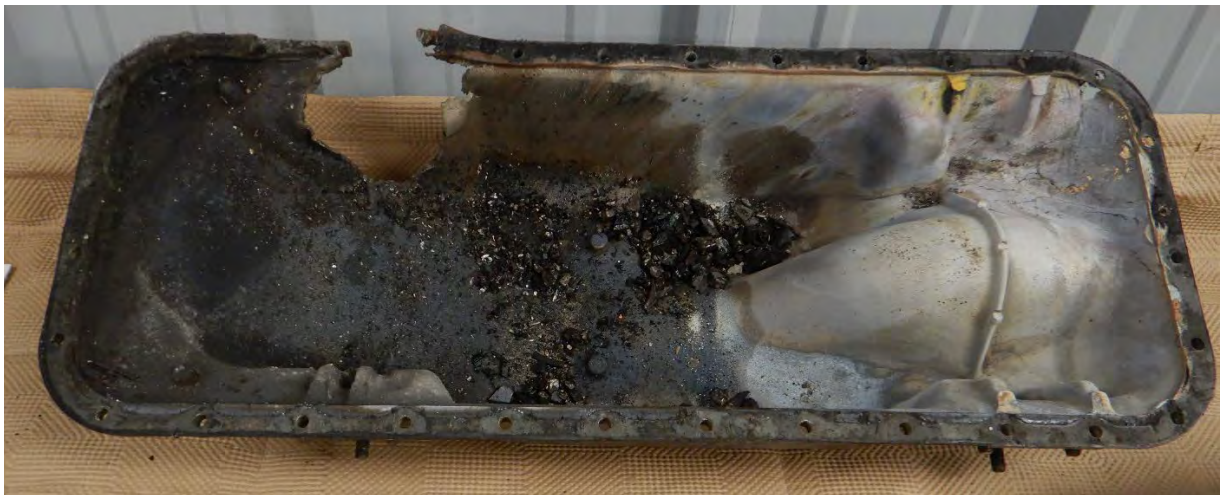
The camshaft was intact, and the lobes exhibited normal wear. The crankshaft was intact, and all main bearings exhibited no evidence of bearing movement or lock slot elongation. Scoring and darkening of the crankshaft main bearings were consistent with lubrication distress. The connecting rod bearings showed heat signatures and oil starvation in varying degrees. The No. 2 connecting rod bearing was partially extruded, smeared, scratched, and torn. The Nos. 3 and 4 connecting rod bearings and rod caps were released from the crankshaft and their remnants found within the engine casing and oil sump pan. The crankshaft counterweight pins were of the incorrect sizes.

Photo 4 - Metal debris in impact damaged oil sump pan.

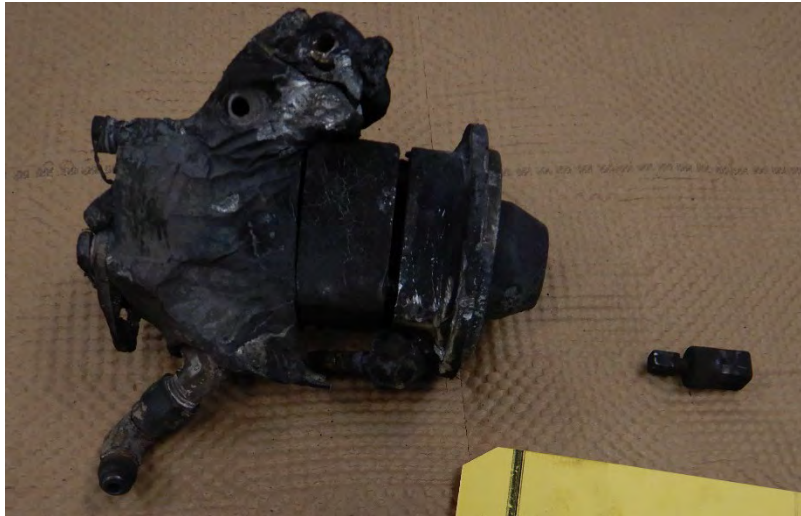
All accessories were thermally and heat damaged and removed. The drive coupling of the engine driven fuel pump remained intact. The fuel pump would not rotate by hand force. The starter adapter would not rotate by hand force. The oil pump was disassembled, and the shaft and gears were intact. The airframe throttle and mixture control cables remained attached to their respective attachment points on the throttle body. The propeller governor oil screen was clean and intact. The oil sump pan was disassembled, and examination revealed a significant amount of metal debris, some of which were identified as pieces of rod bearings, piston parts, and a connecting rod nut. Various installed seals, screws and nuts were unapproved parts. The pushrod housing seals for cylinder No. 4 were not approved parts and appeared to be field made. The lower crankcase splitline bolts were not approved parts and had spacers as they were too long, and the nuts were not approved parts. All but two of the six Seventh stud nuts were unapproved parts.

Photo 5 - Engine driven fuel pump and drive coupling.

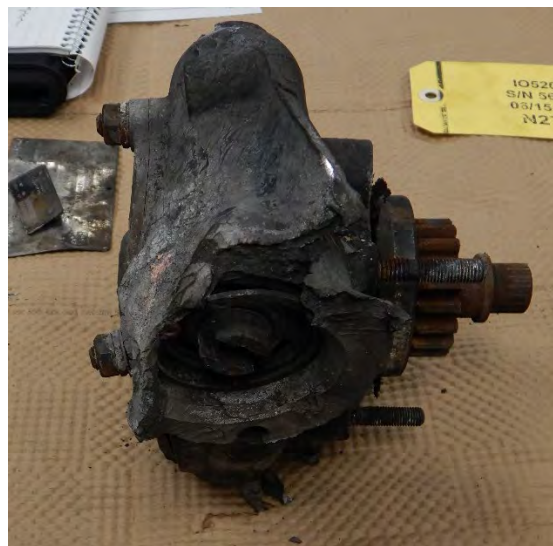
Photo 6 - Starter adapter.

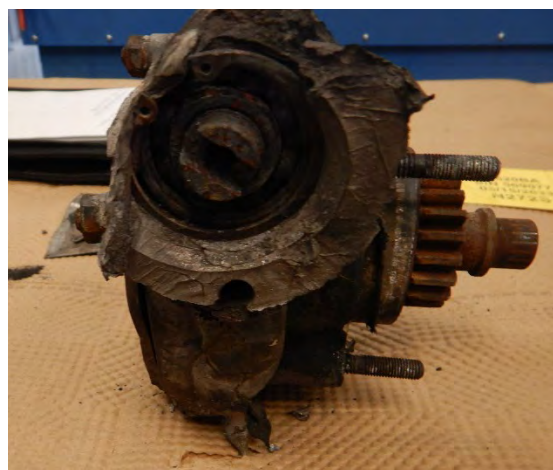
Photo 7 - Starter Adapter

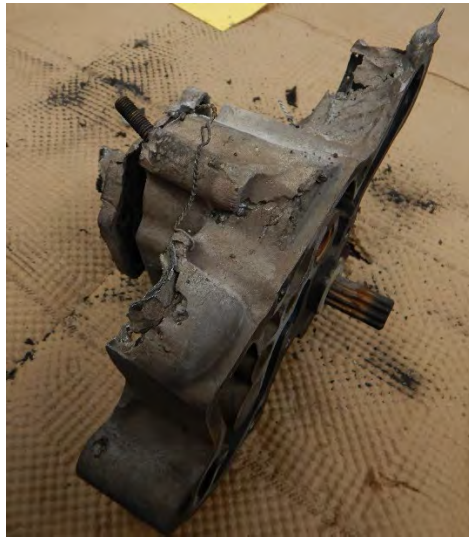
Photo 8 - Oil pump

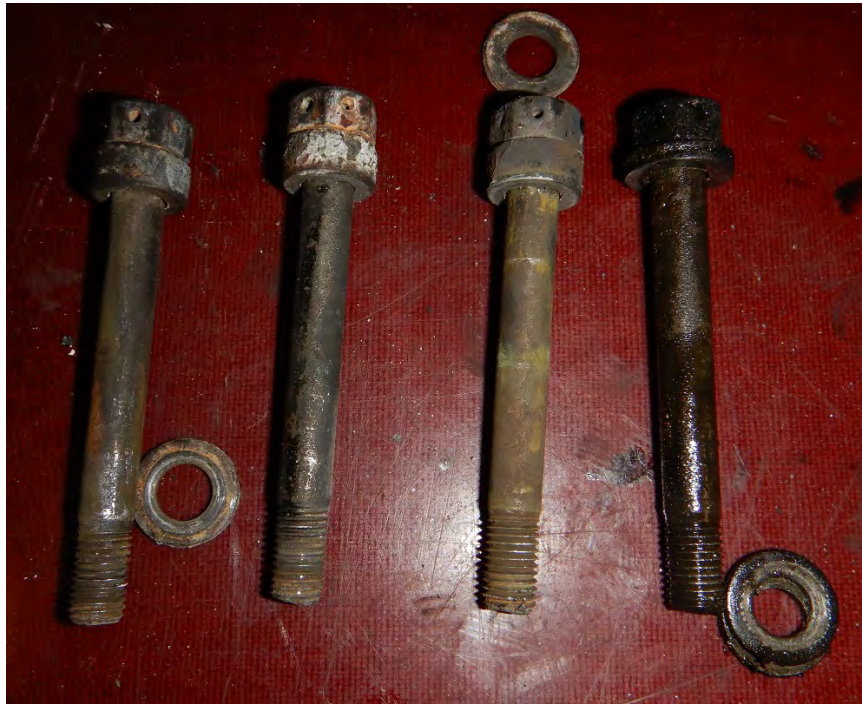
Photo 9 - Lower crankcase splitline bolts unapproved parts and spacers.

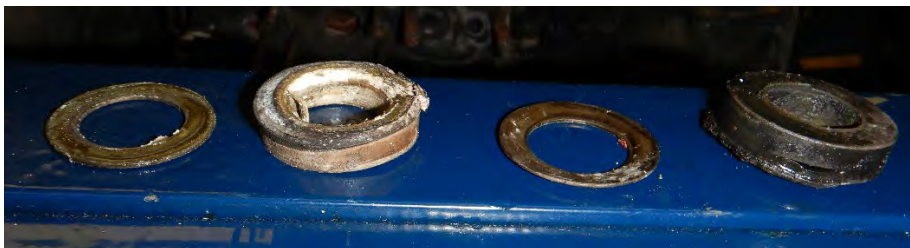
Photo 10 - Unapproved pushrod housing seals for cylinder No. 4

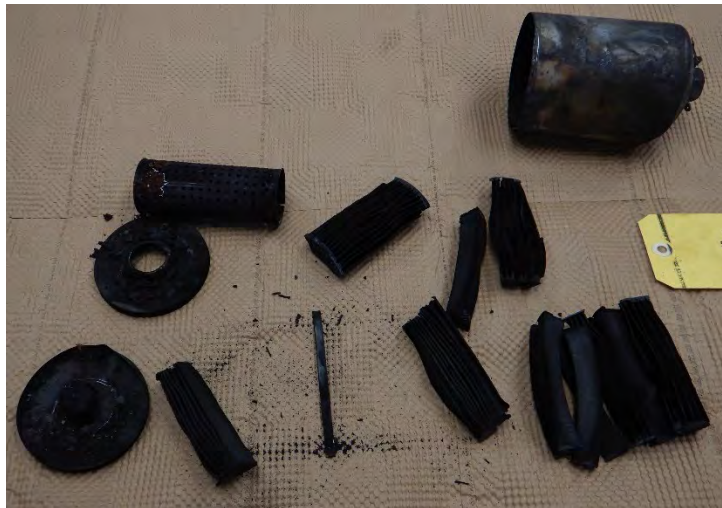
The oil filter was opened, and the paper element was charred, with no metallic particles noted.

Photo 12 - Disassembled thermally damaged oil filter.

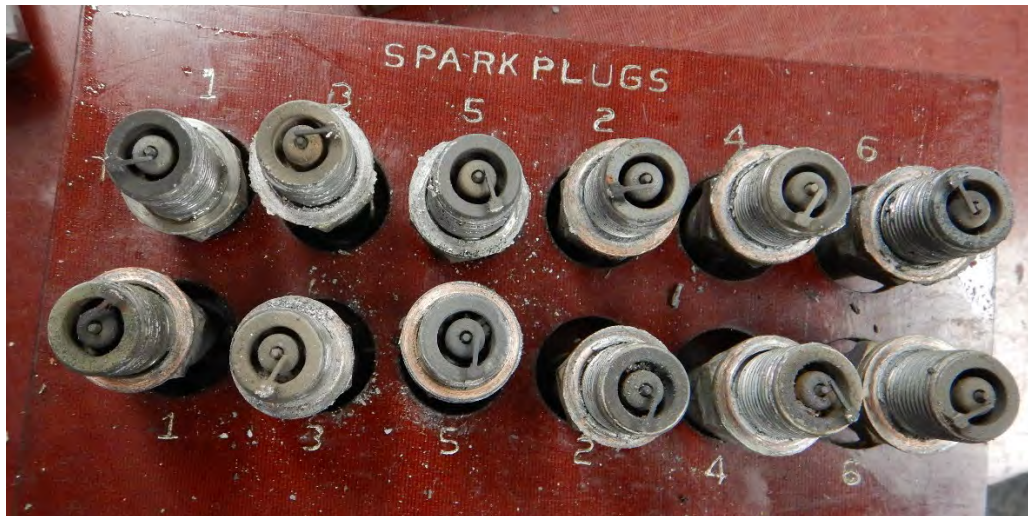
The cylinders were removed. Nos. 3 and 4 connecting rods were released from the crankshaft. Pistons of cylinder Nos. 3 and 4 were lodged inside their respective cylinders. All the pistons exhibited normal carbon deposits and no signs of detonation. Piston No. 4 had a fracture at the piston skirt, and examination of the piston face revealed impact gouging from exhaust and intake valve contact. All exhaust and intake valves appeared normal, although both No. 4 valves showed polishing at their edges consistent with piston contact. There was no evidence of detonation on the valves.

Photo 13 - Spark plugs with no evidence of detonation.

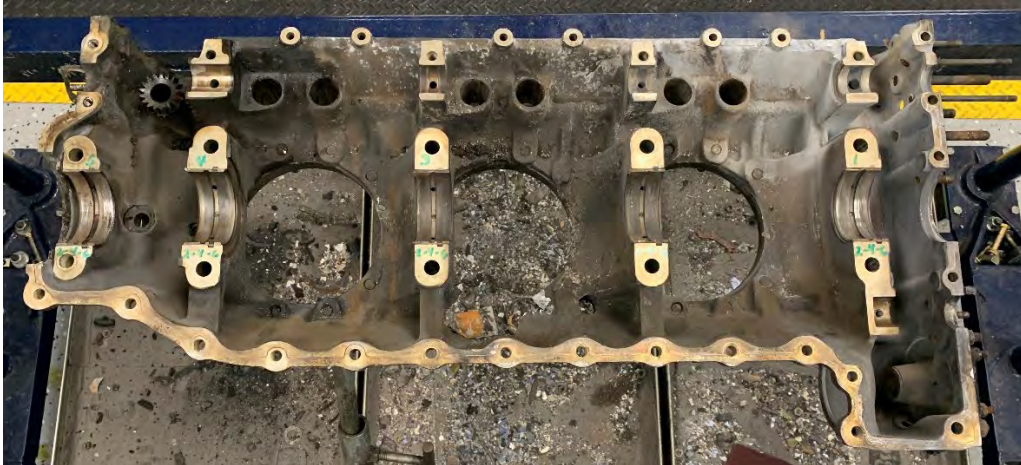
Photo 16 - View of open crankcase and main bearings for cylinder Nos. 6,4 and 2 (left to right).

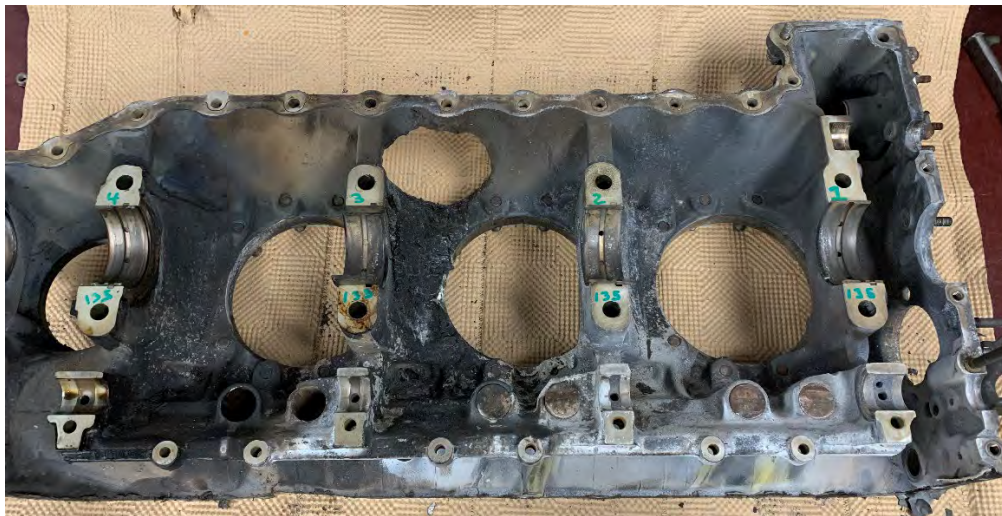
Photo 17 - View of open crankcase and main bearings for cylinder Nos. 5,3 and 1(left to right), note lifters that could not be removed.

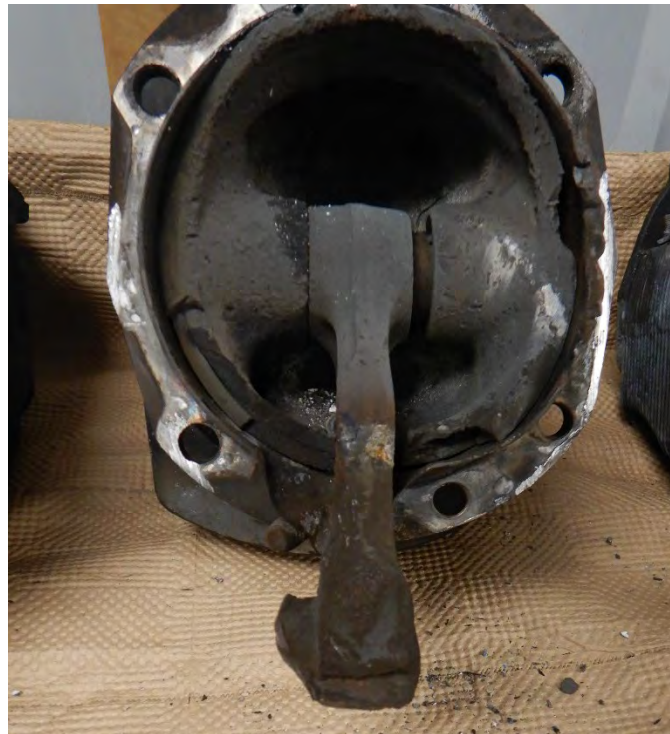
Photo 20 - Cylinder No. 4 with piston and connecting rod (note fracture at the piston skirt).

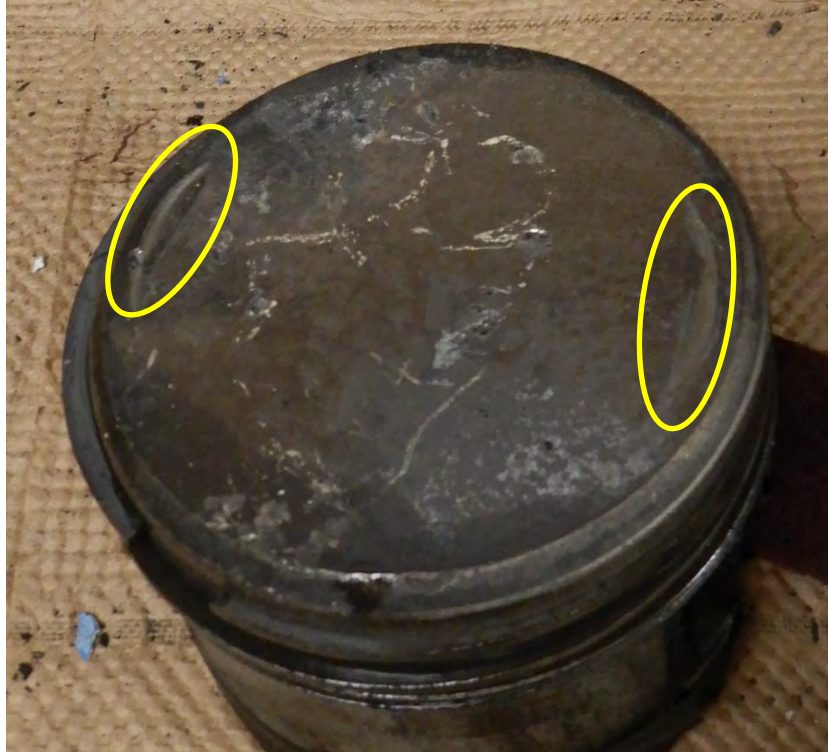
Photo 21 - Cylinder No. 4 piston with valve strike marks (circled in yellow).

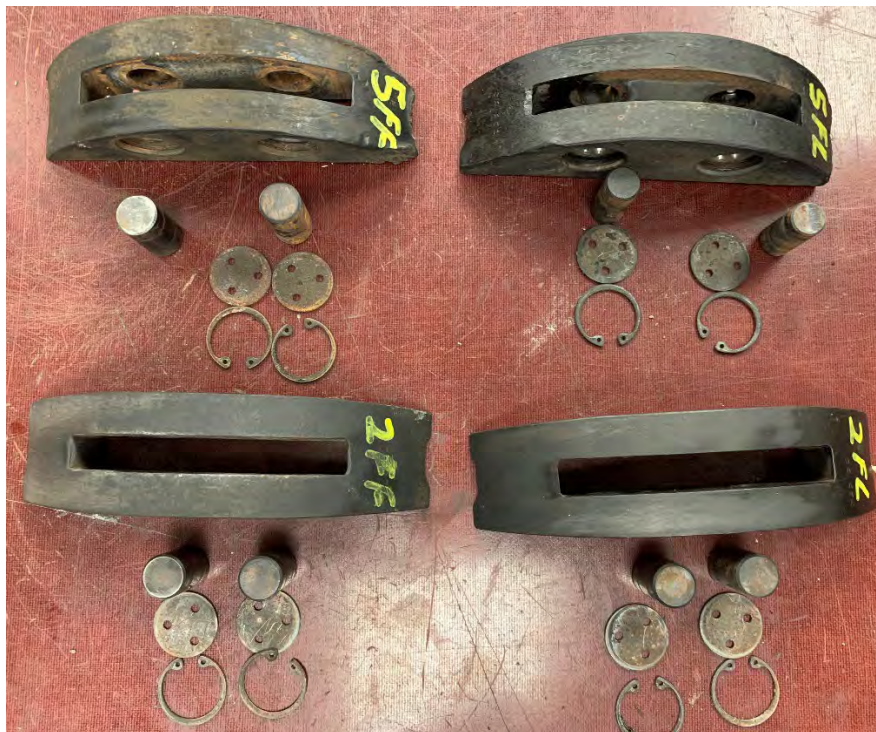
Photo 22 - Counterweights

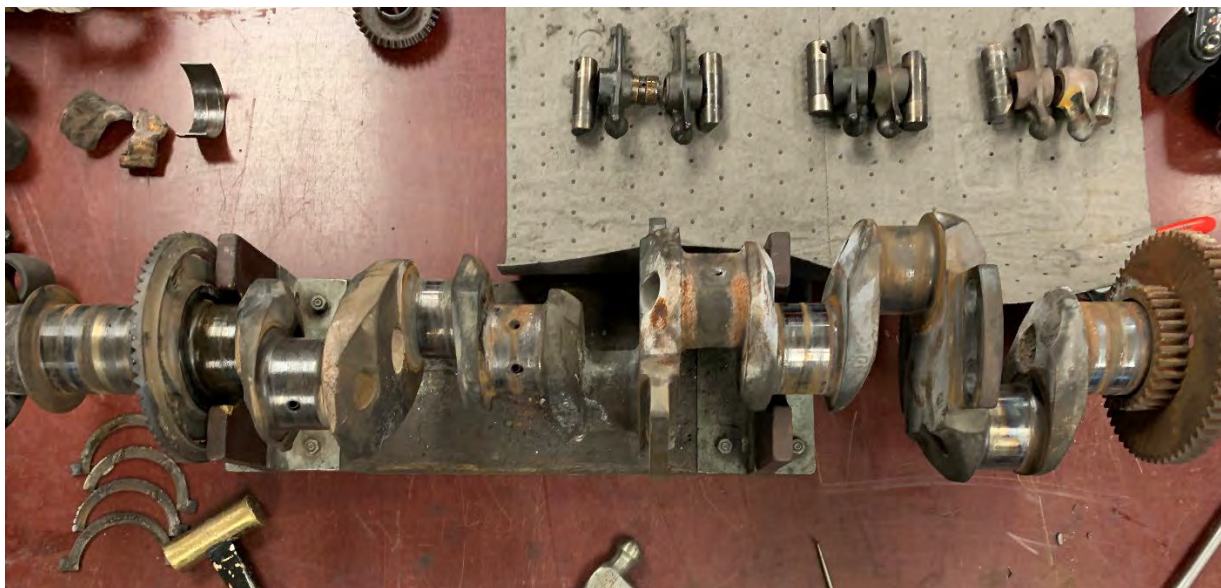
The engine damage was consistent with oil depletion. Due to the postcrash fire, no source of oil leakage could be determined.

Photo 23 - Crankshaft (Note scoring and darkening of the crankshaft main bearings).

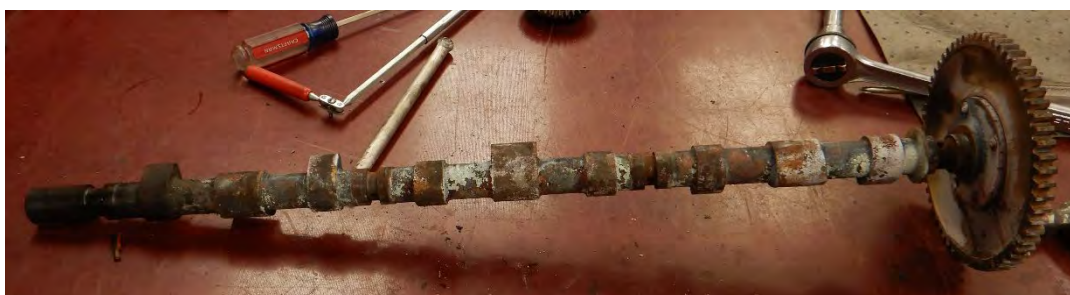
Photo 24 - Camshaft and camshaft gear with heat and thermal damage.
