# National Transportation Safety Board

ERA23FA238

## **AIRFRAME EXAMINATION**

Location: Rougemont, NC  
Date: May 21, 2023  
Time: 1115 EDT  
1515 UTC  
Airplane: Beech V-35, N272S

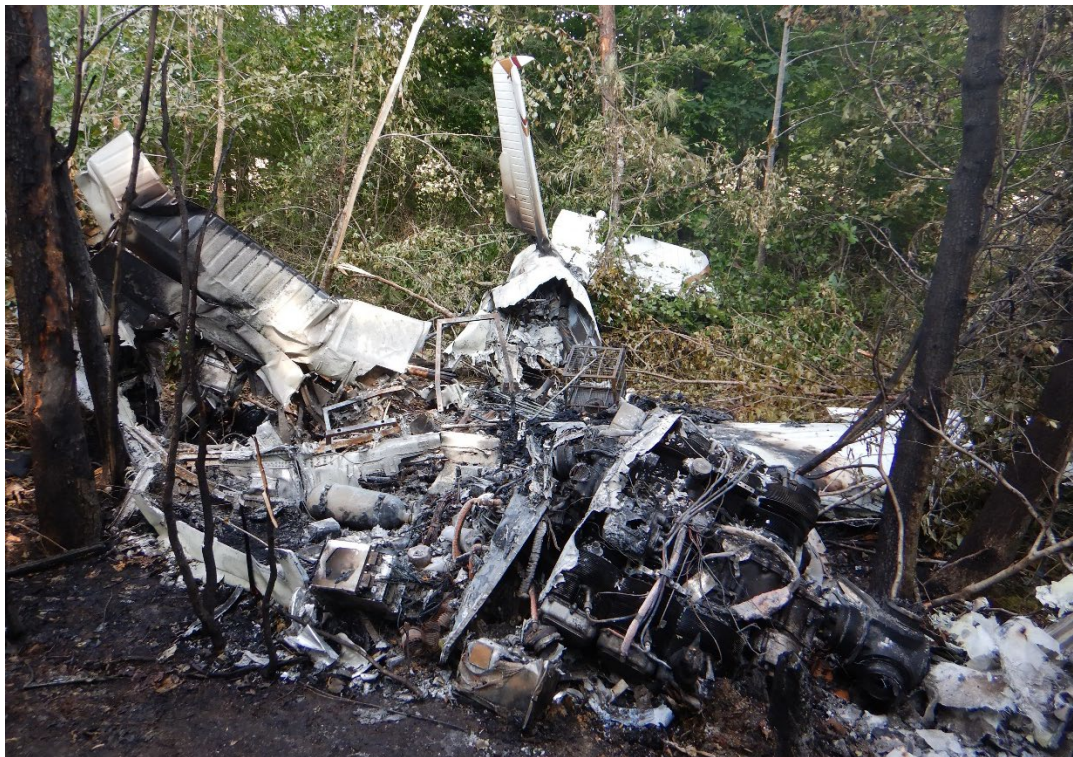
**Photo 1 - View of wreckage from front**

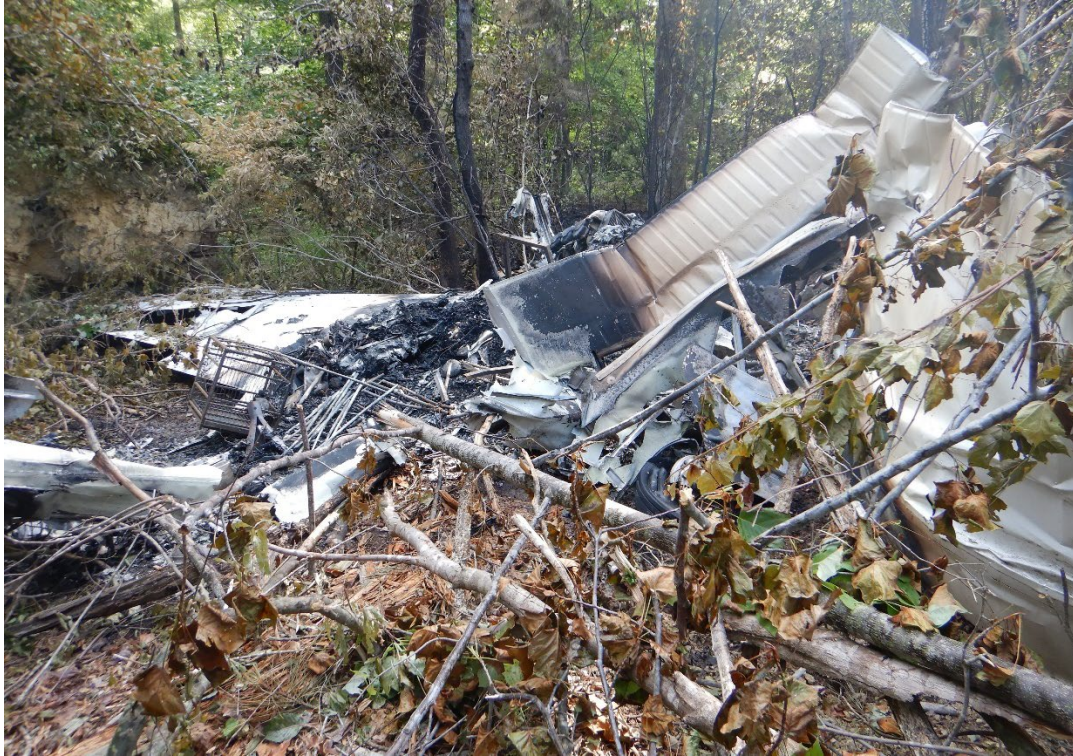
**Photo 2 - View of wreckage from right rear**

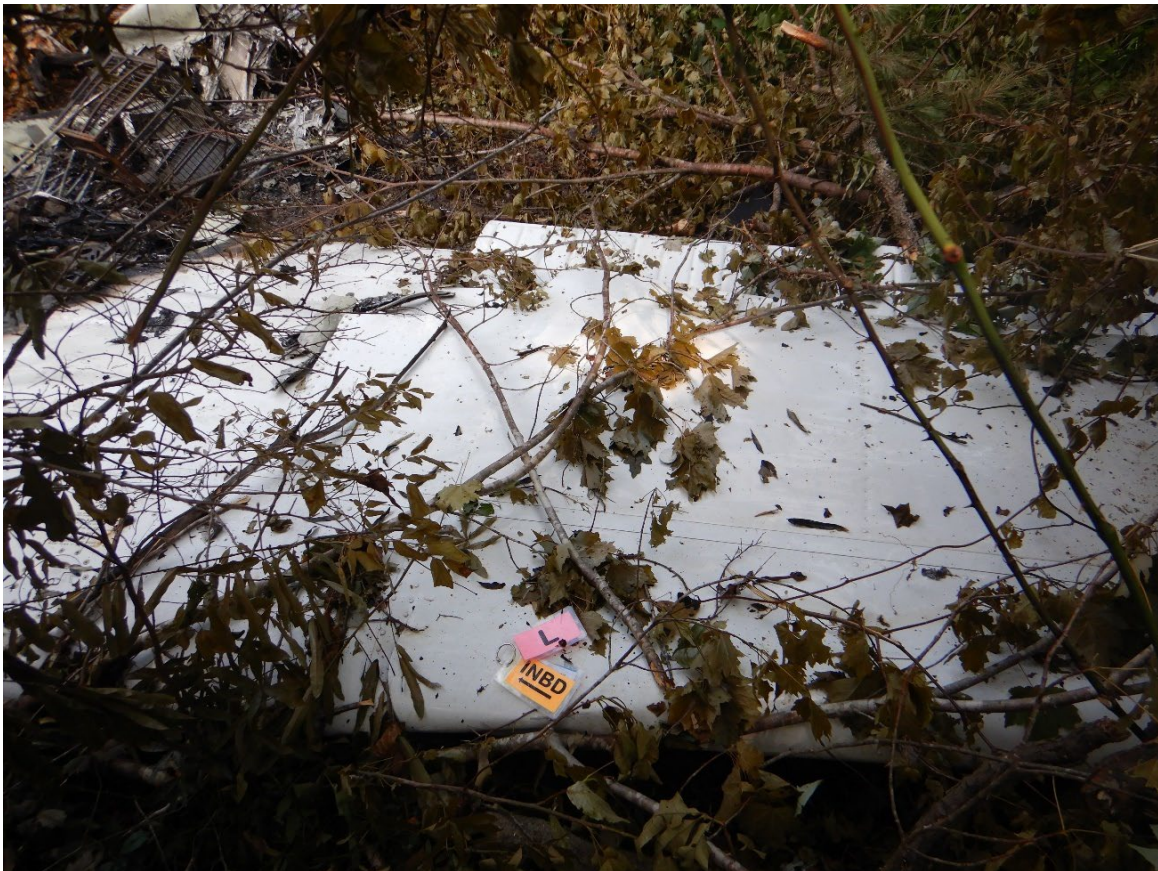
**Photo 3 - View of the left wing.**

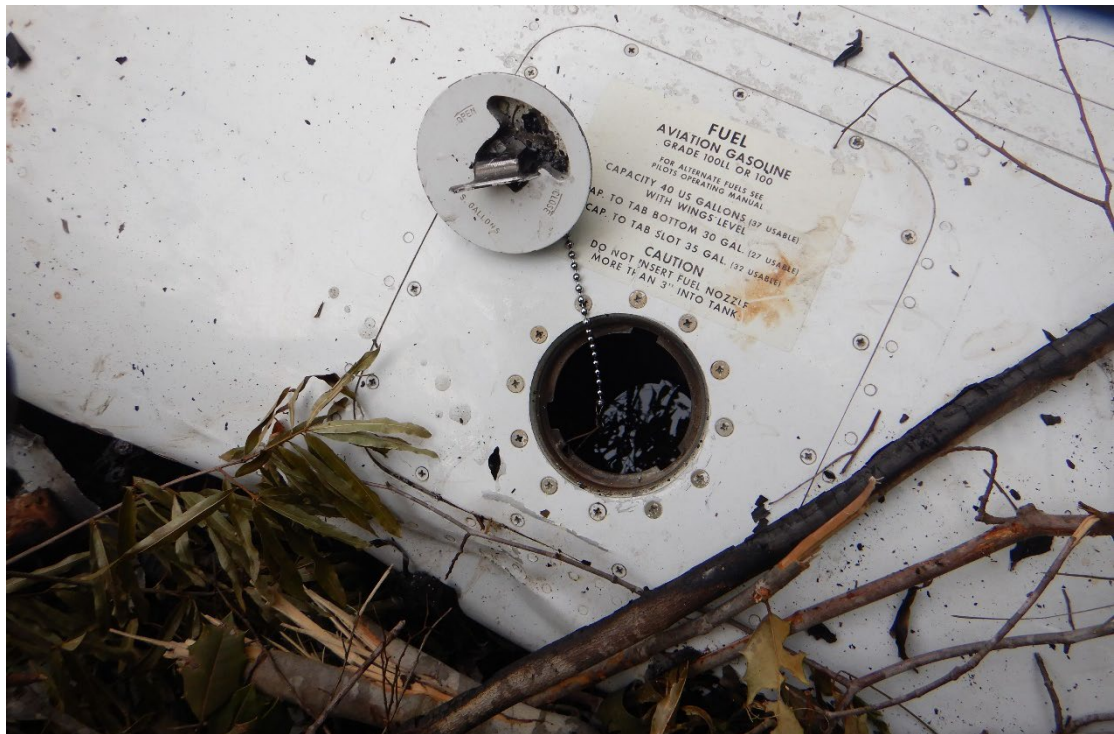
**Photo 4 - View of left wing fuel tank with fuel cap removed.**

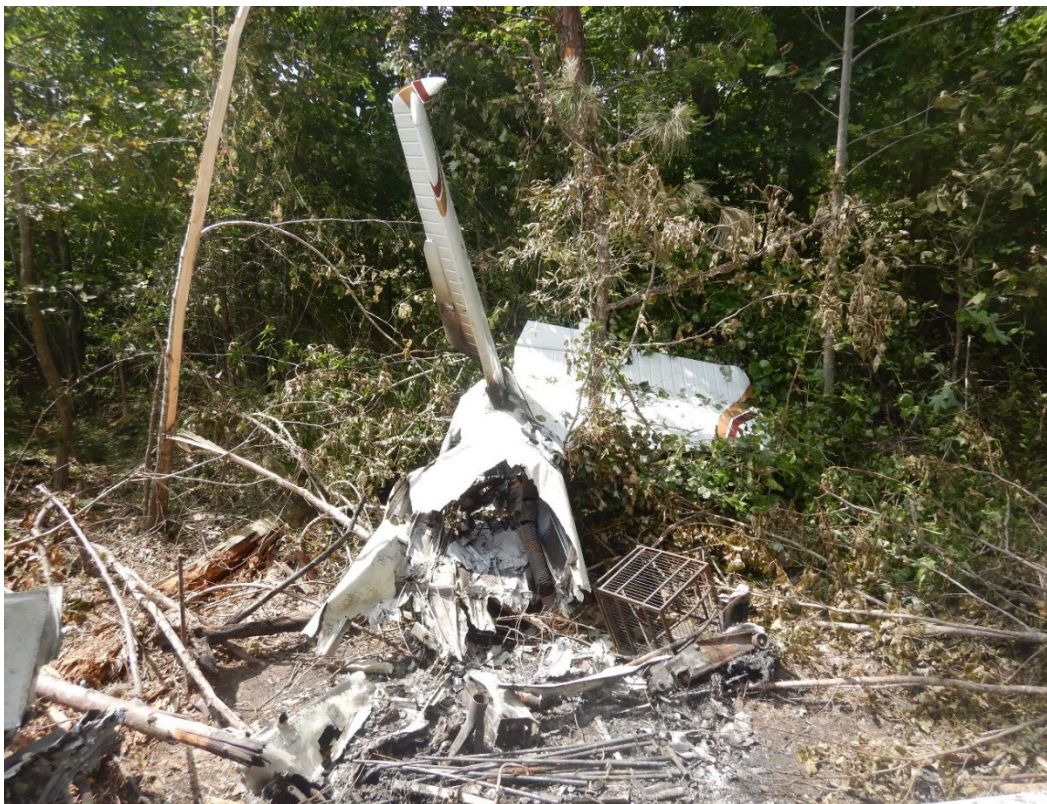
**Photo 5 - View of the empennage and burned fuselage.**

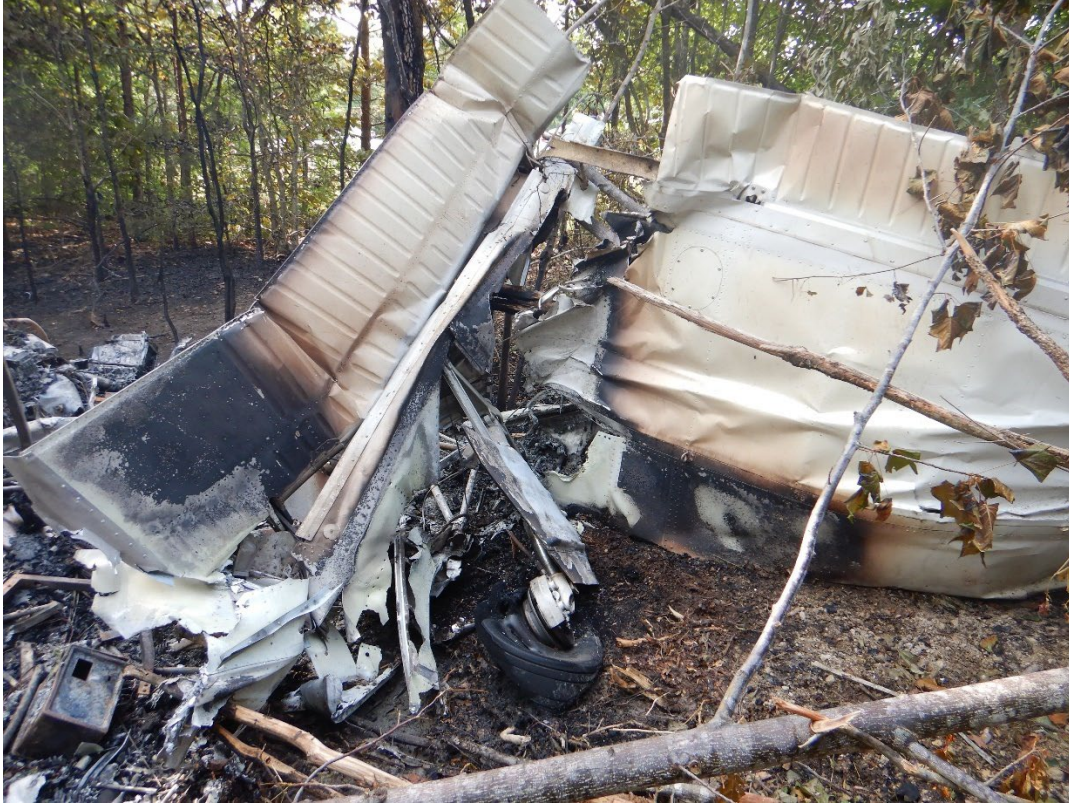
**Photo 6 - View of fractured right wing with thermal damage**

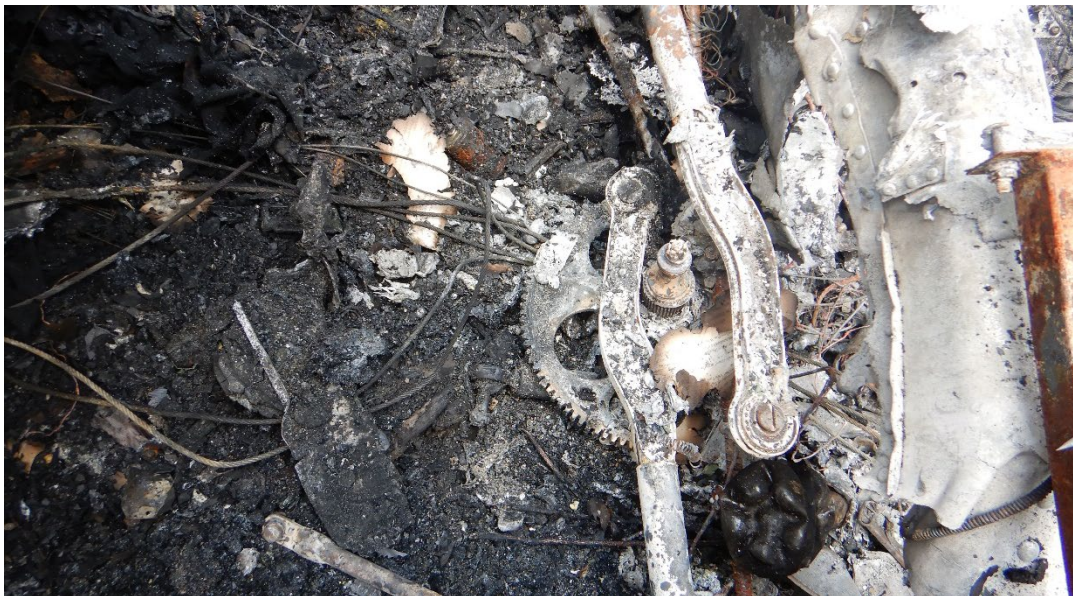
**Photo 7 - View of landing gear mechanism indicating that gear were in the UP position**

The landing gear motor/actuator was thermally damaged exposing the internal steel gears. The left main and nose landing gears remained in their stowed positions, and the right main landing gear was hanging in the wreckage.

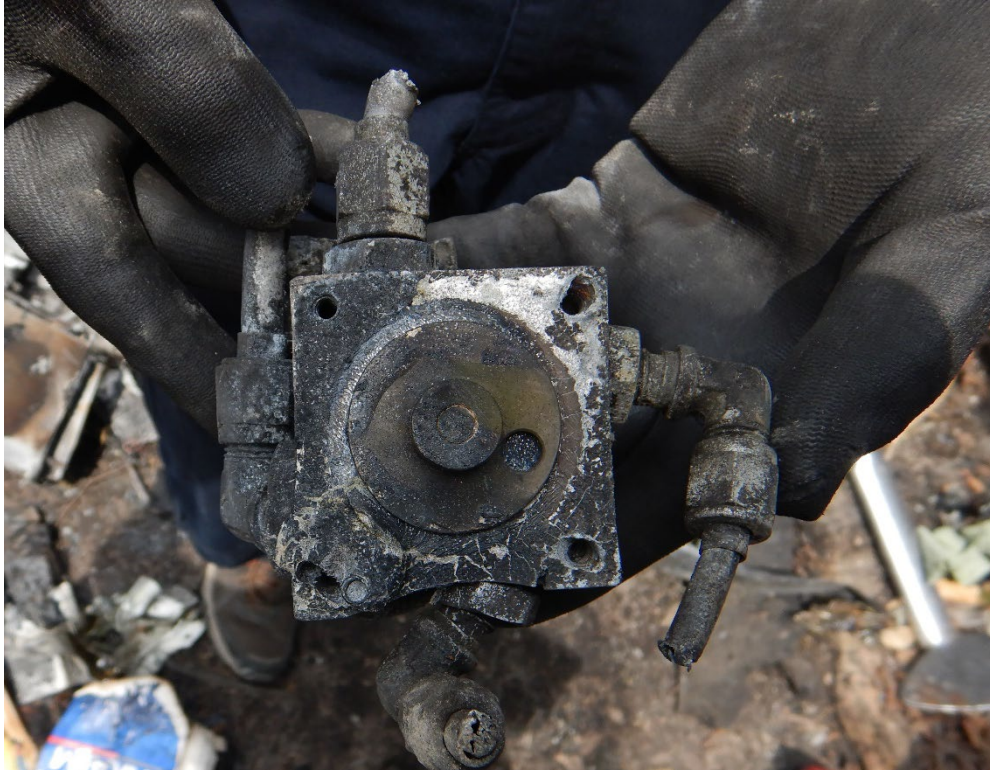
**Photo 8 - View of fuel selector valve in closed position**

The fuel selector handle was in the off position, and the fuel selector valve was in the off position. The fuel strainer screen, strainer bowl, and the boost pump switch were thermally damaged.

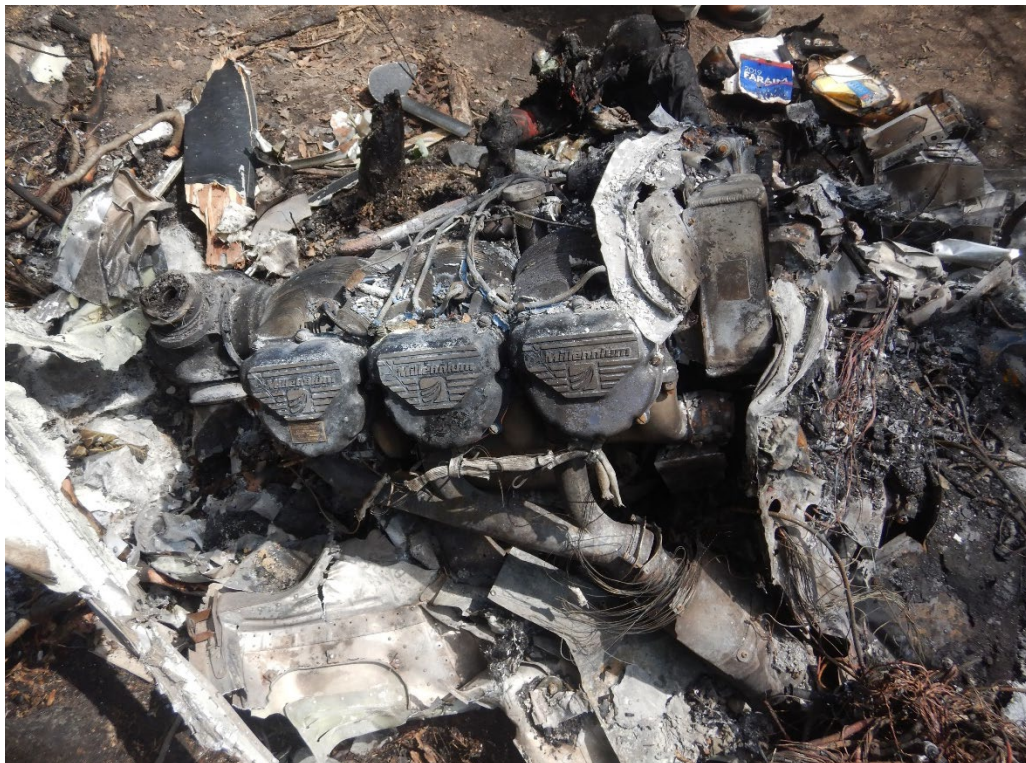
**Photo 9 - View of engine, propeller hub, and fractured propeller blade**

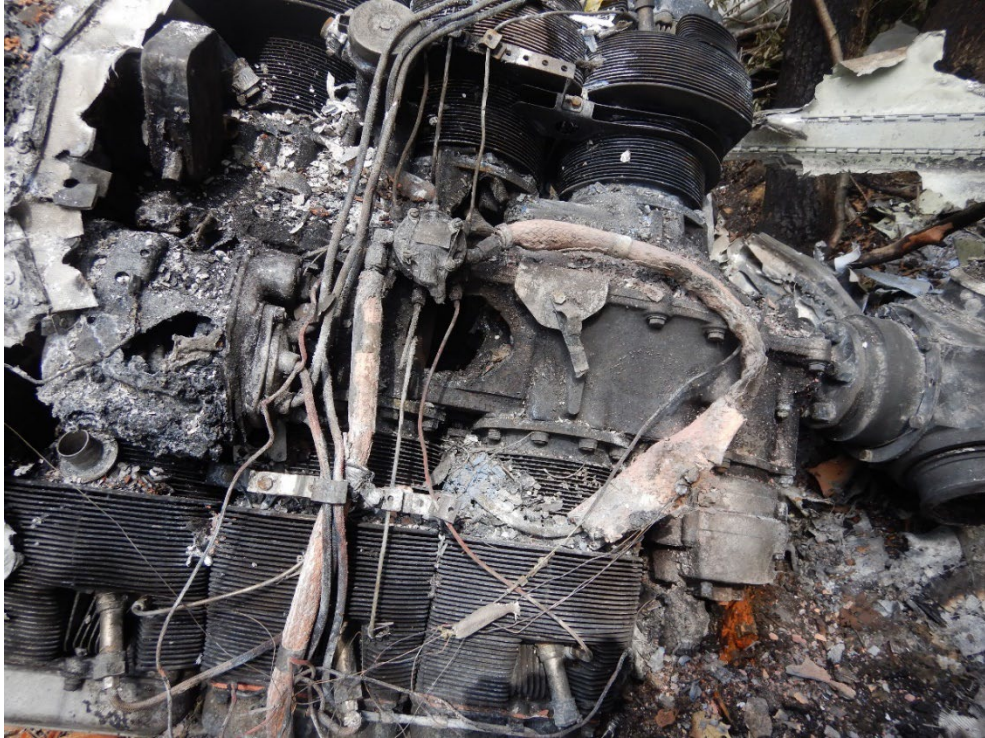
**Photo 10 - View of top of engine with holes in crankcase above cylinder Nos. 3 and 4**

The engine remained partially attached to the engine mounts. On top of the engine at cylinder Nos. 3 and 4 were two holes in the crankcase. There was a single magneto per an STC. The vacuum pump drive shaft was thermally damaged. The engine exhibited impact and thermal damage. The propeller hub remained attached to the engine at the engine crankshaft propeller flange. The STC 3-bladed wood/composite propeller blades were impact and thermally damaged.

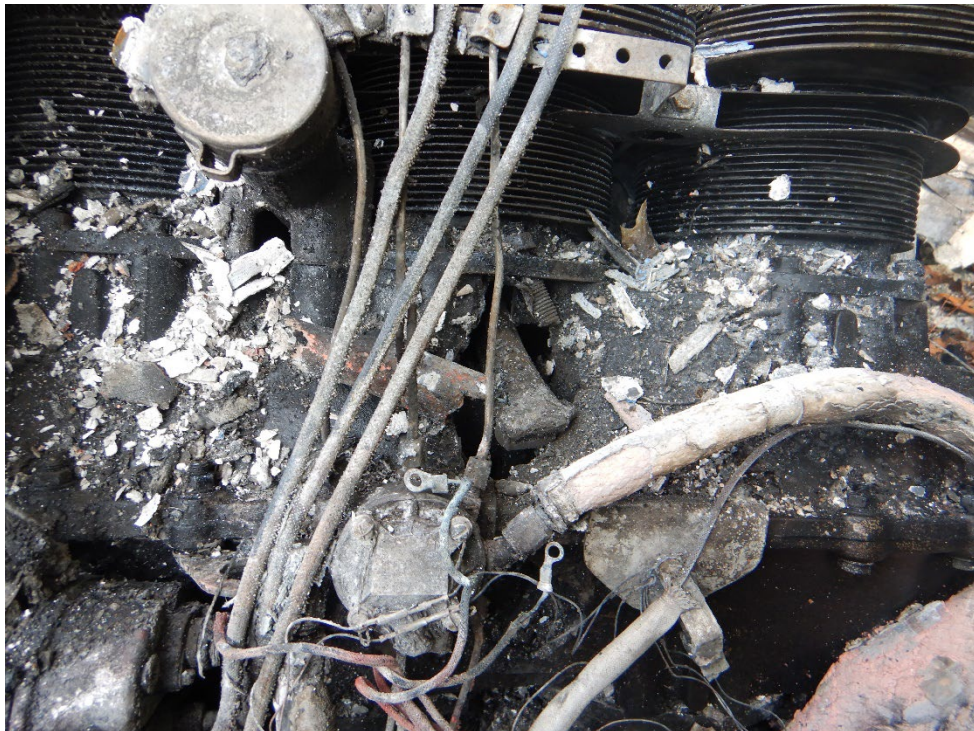
**Photo 11 - View of hole of crankcase at cylinder No. 4 with connecting rod exposed**

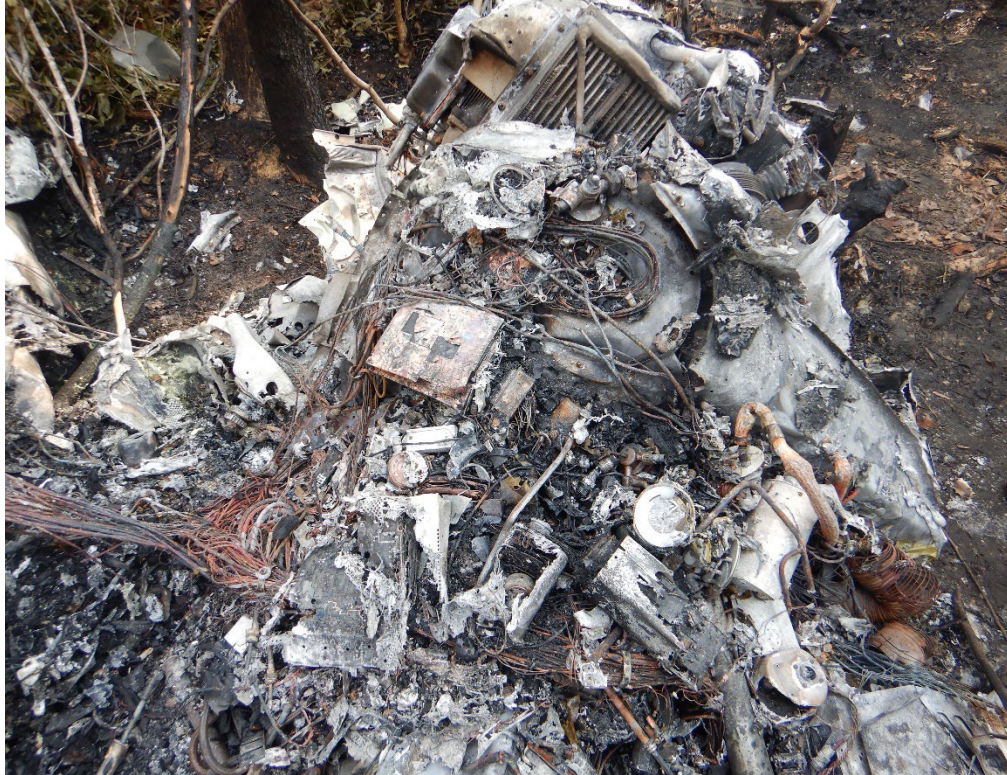
**Photo 12 - View of thermally damaged cockpit and instruments**

The cockpit was destroyed. The instrument panel, navigation instruments, communication, and navigation radios, and electrical, lighting, and ignition switches were thermally damaged. All engine instruments and controls were thermally damaged.

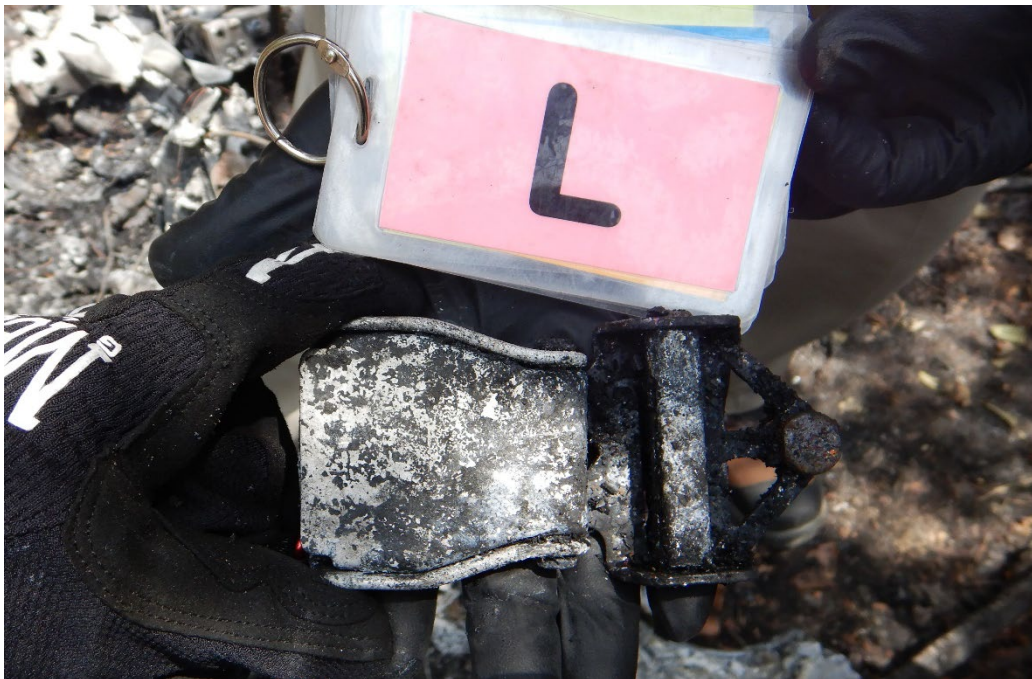
**Photo 13 - View of left front seatbelt latch**

The cockpit and cabin seats were thermally and impact damaged. The 3-pt seatbelts were burned in the postcrash fire; however, the pilot's seatbelt latch remained latched.
