# National Transportation Safety Board

ERA23FA247

## **WRECKAGE EXAMINATION SUMMARY**

Location: Lake Worth, Florida  
Date: May 26, 2023  
Time: 1118 EDT  
1518 UTC  
Airplane: Cessna 172P, N3KV

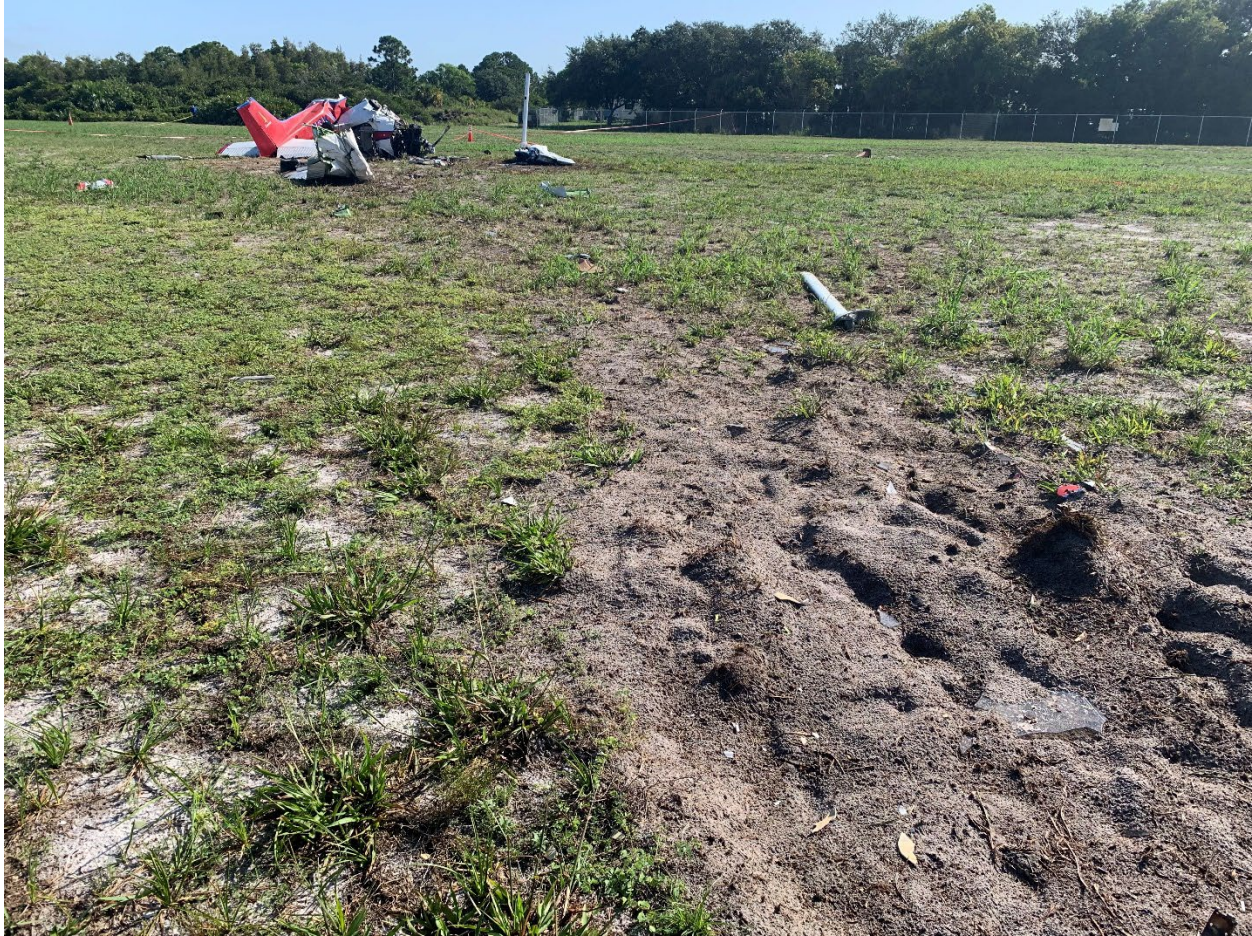
The fuselage came to rest in the vicinity of the runway and the engine remained attached to the fuselage. The empennage remained partially attached to the fuselage. All major components of the airplane were located within the vicinity of the main wreckage.

**Figure 2: View of wreckage debris path.**

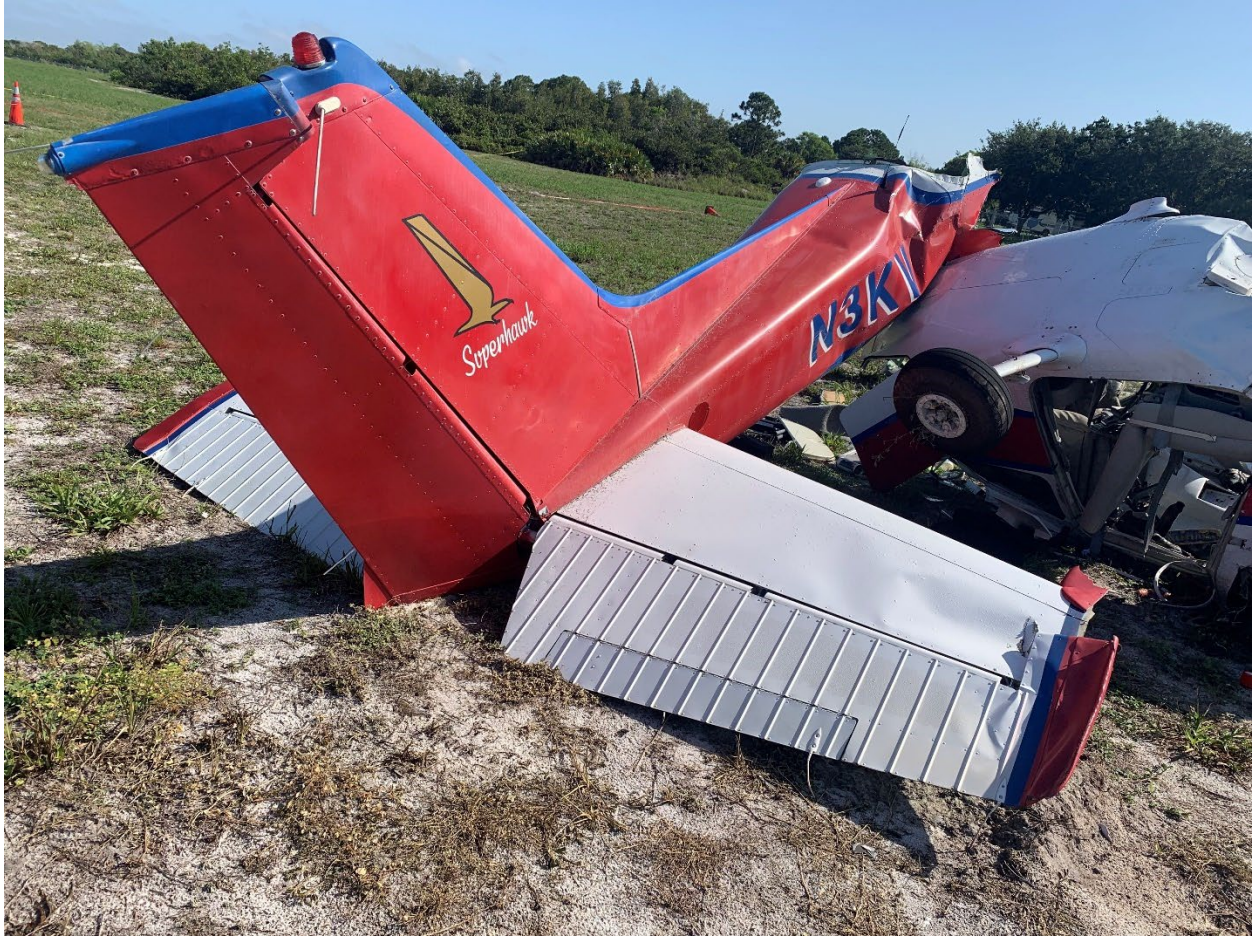
The empennage was wrinkled. The right horizontal stabilizer remained attached to the empennage. The right elevator remained attached to the right horizontal stabilizer. The trim tab remained attached to the right elevator and was measured to be in a 8° tab down position. However, the empennage cables were twisted and pulled during the impact. The right elevator cap remained attached to the right elevator and exhibited impact damage. The right elevator counterweight remained attached. Elevator and rudder control continuity was confirmed from the flight control surface to the flight control yoke in the cockpit.

**Figure 3. View of right horizontal stabilizer, right elevator, rudder, and vertical stabilizer.**

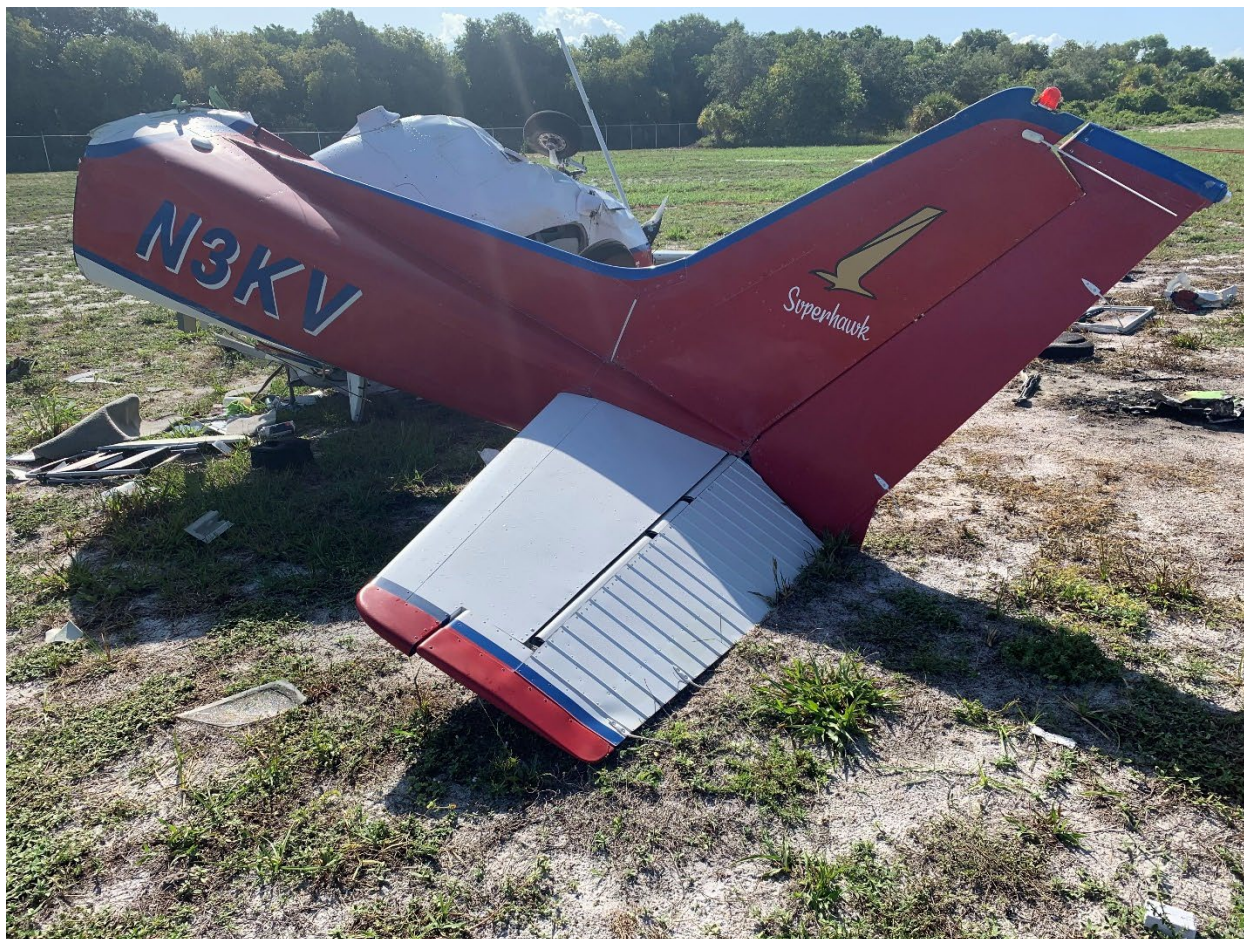
The left horizontal stabilizer remained attached to the empennage. The left elevator remained attached to the left horizontal stabilizer. The left elevator cap remained attached to the left elevators and the outboard trailing edge of the left elevator was slight bent in the positive direction.

**Figure 4. View of left horizontal stabilizer and left elevator along with the left side of the rudder and vertical stabilizer.**

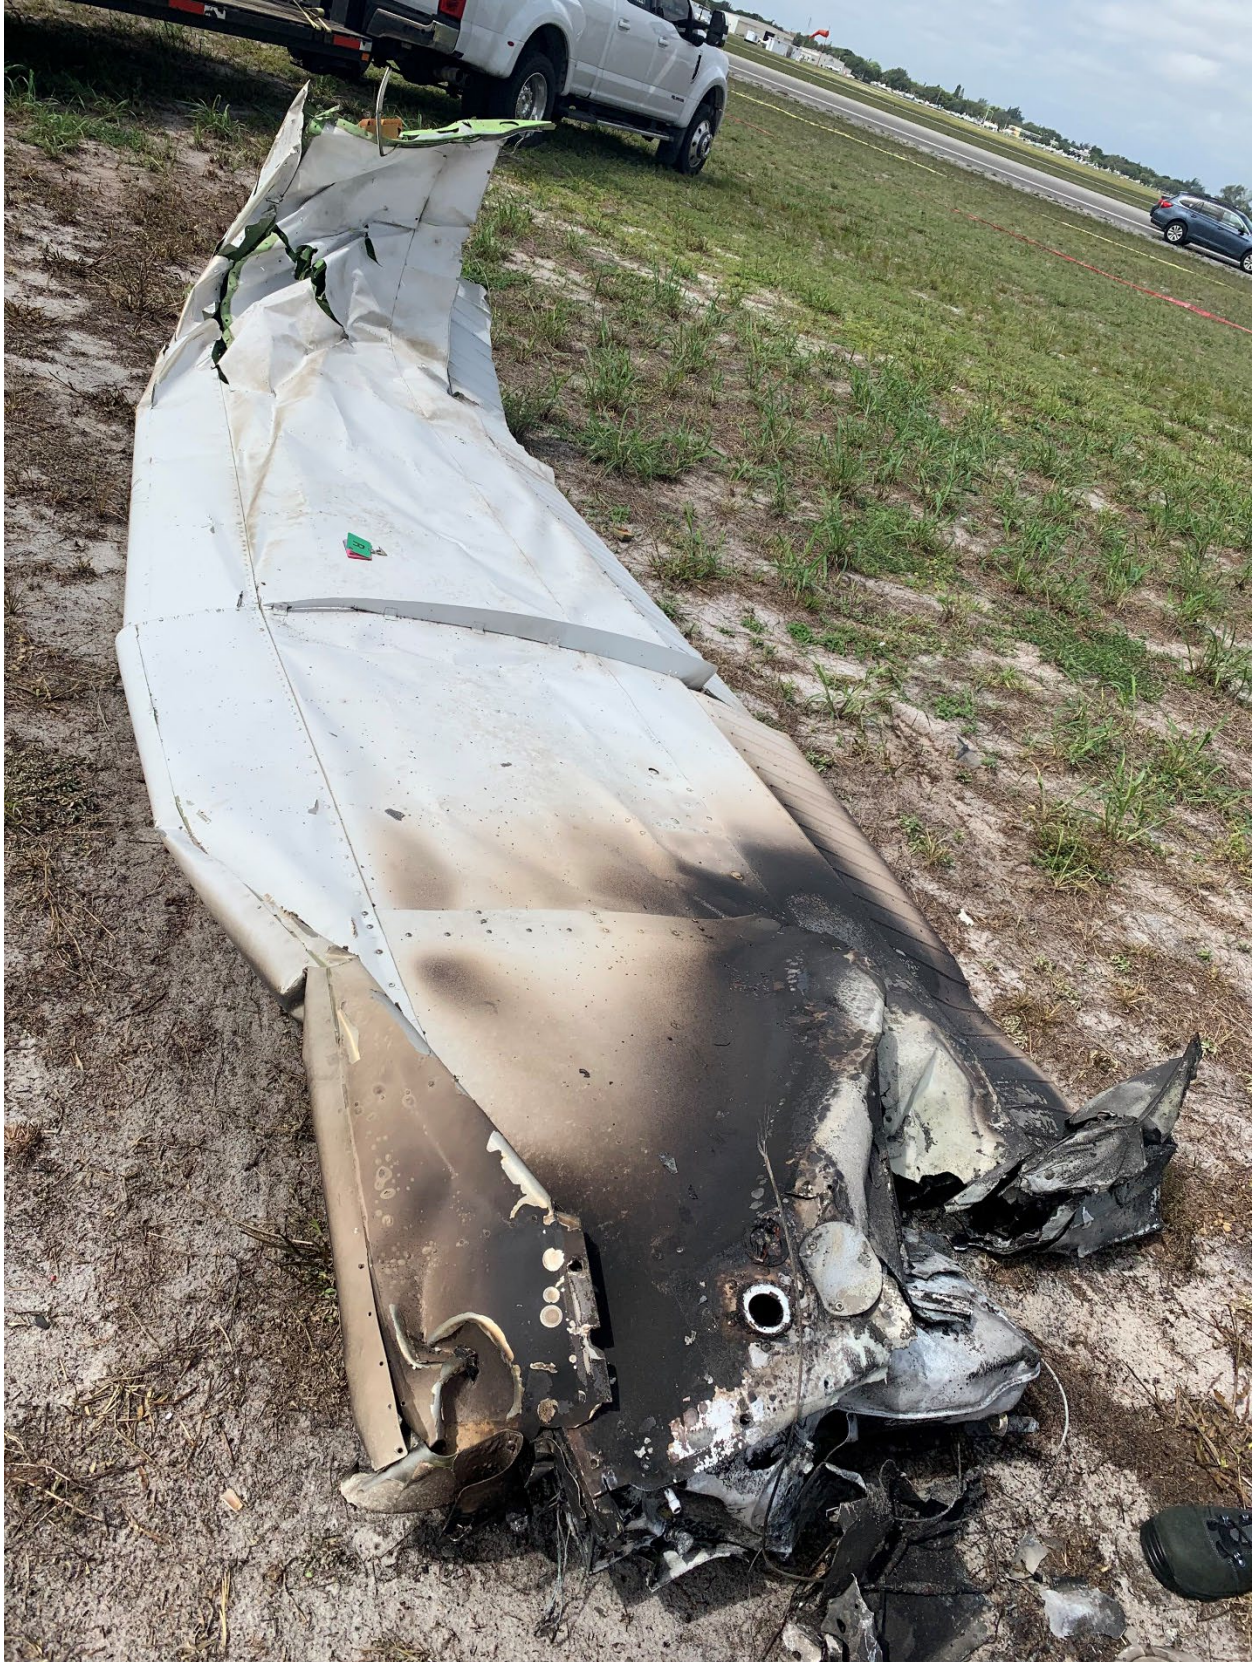
The right wing was impact separated from the fuselage. The wing tip was impact separated from the right wing and located along the debris path. The right-wing tip light lens cap was located at the initial impact point. The outboard 5 ft section of the wing tip was bent in the position direction and crushed aft. A 6-inch section of the right aileron was impact separated from the wing. The remaining portion of right aileron and right flap remained attached to the right wing. The inboard 4 ft section of the right wing exhibited thermal damage. The right-wing fuel tank was breached. When the right wing was moved by recovery personnel, an undetermined amount of fuel drained from the wing. The right strut was impact separated from the right wing and located on the debris path. The flap jack screw was measured and corresponded to the flaps in the retracted position.

**Figure 5. View of right wing.**

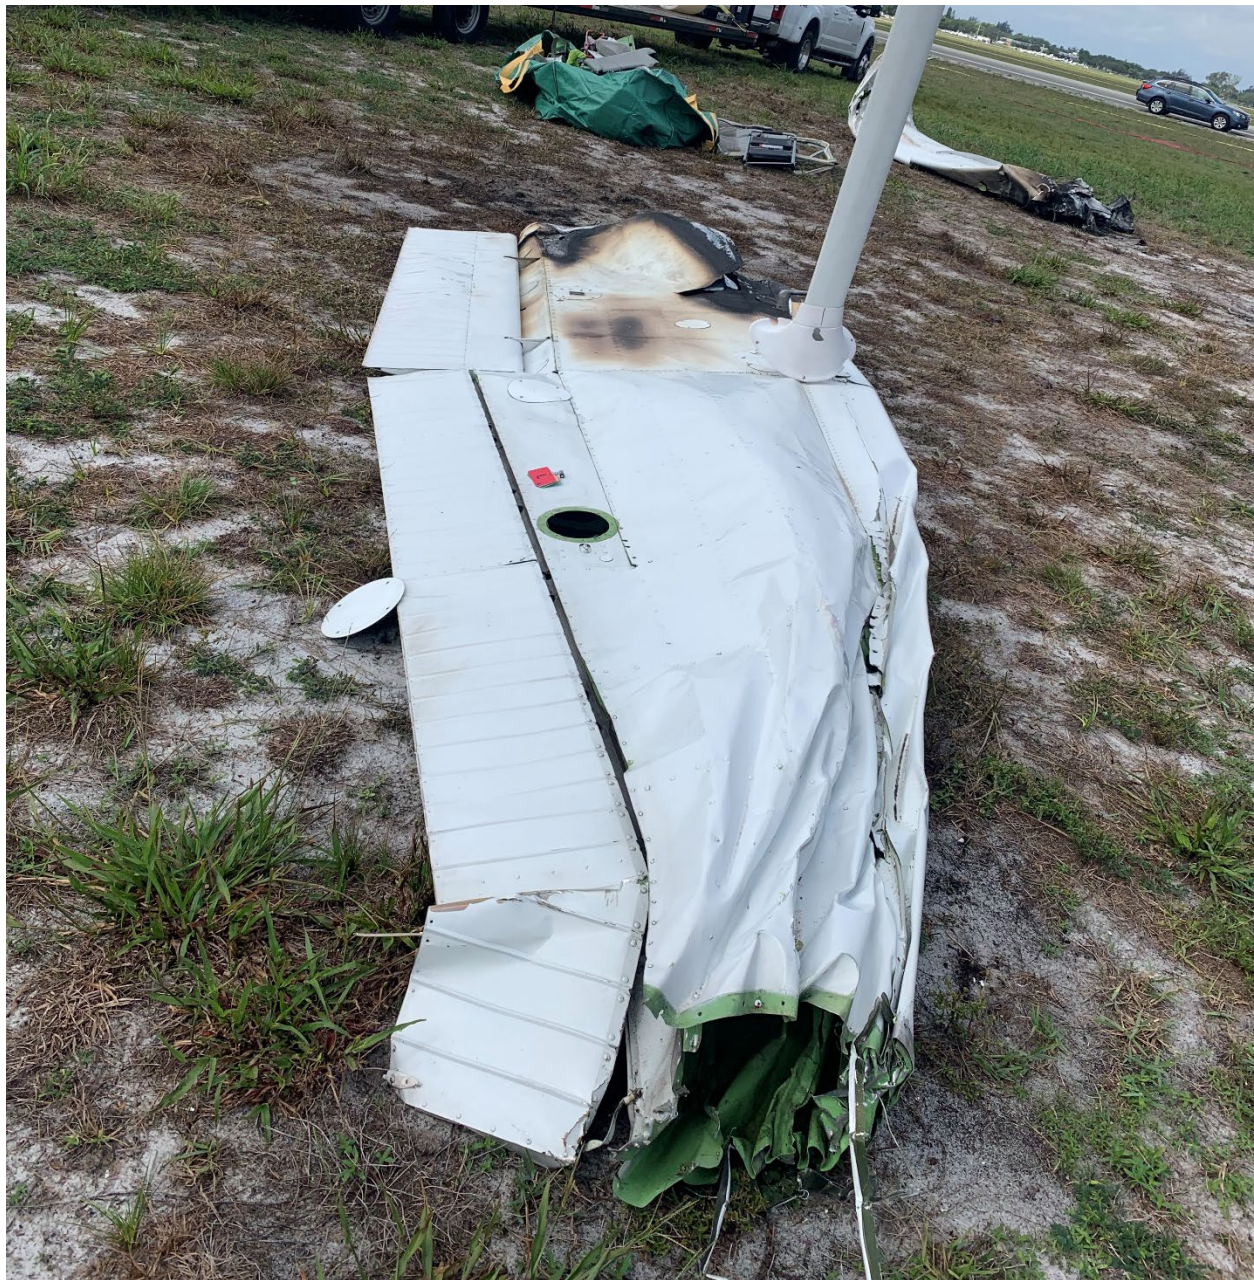
The left wing was impact separated from the fuselage. The outboard 6 ft section of the left wing was impact crushed aft and the wing tip was impact separated. However, it was located along the debris field. The left aileron and the left flap remained attached to the wing. The flap was free to move along the flap tracks. The inboard 4 ft section of the wing exhibited thermal damage. The pitot tube remained attached to the left wing. The left fuel tank was breached. The left strut remained attached to the left wing.

**Figure 6. View of left wing.**

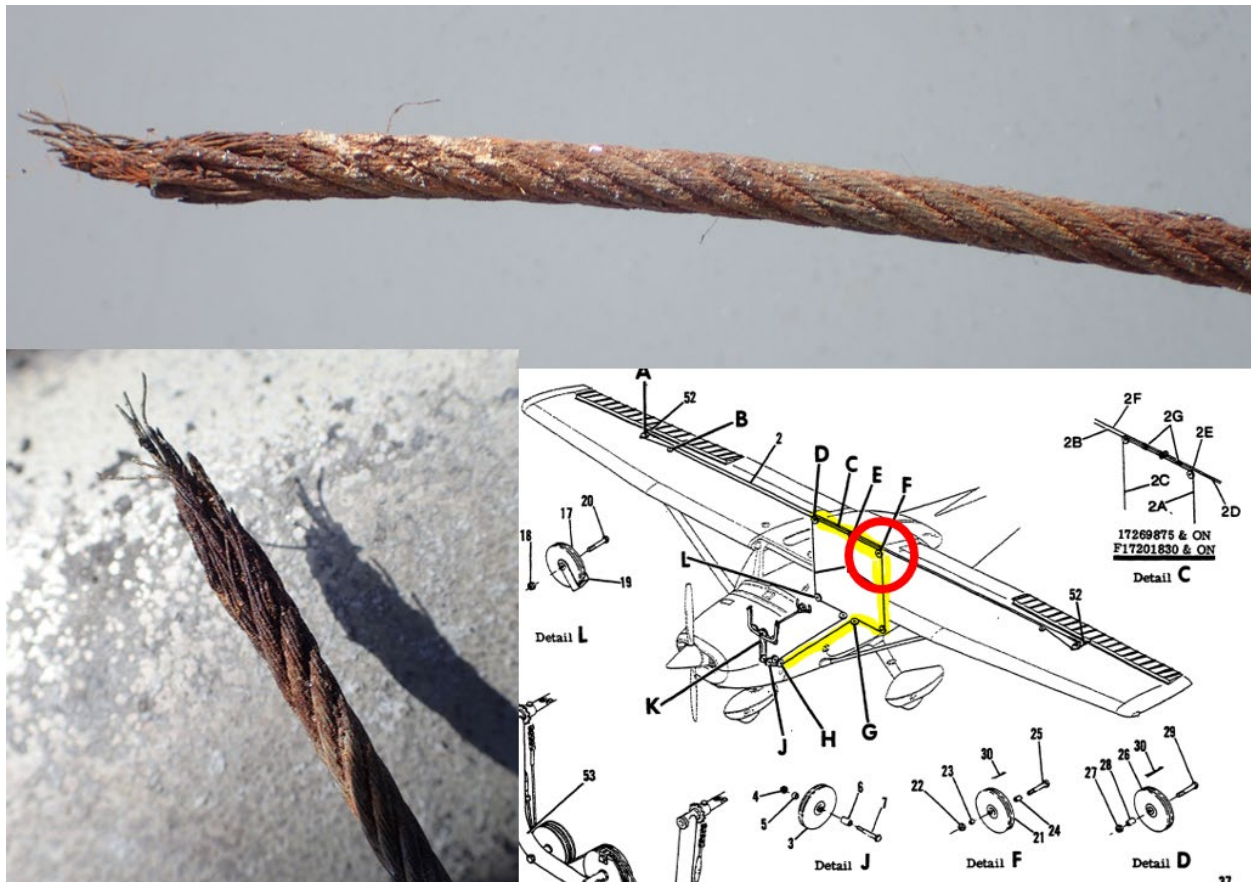
Aileron control continuity was not confirmed. A separation was noted in the aileron control systems in the vicinity of the left upper door post right direct aileron cable pulley. The pulley was removed, examined, and exhibited corrosion. Several other breaks were noted in the aileron control system consistent with tension overload failures. The pulley did not move freely. The right upper door post left direct aileron over pulley was removed and examined. The pulley did not rotate freely, and corrosion was noted.

**Figure 7. Close up view of the separated aileron cable sections. The red circle indicates the approximate location of the broken portion of cable. The highlight portion of aileron cable in the diagram indicates the section of cable sent to the NTSB Materials Laboratory.**

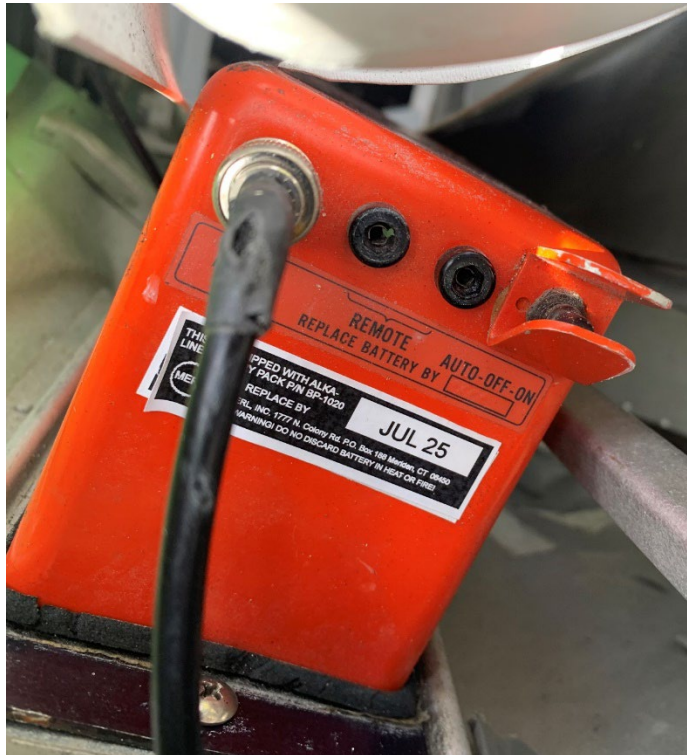
The emergency locator transmitter (ELT) was found secured in the airplane fuselage and it was in the armed position. The ELT battery expiration date was July 2025. An FAA inspector who responded to the accident site turned it to the OFF position.

**Figure 8: ELT in the off position**

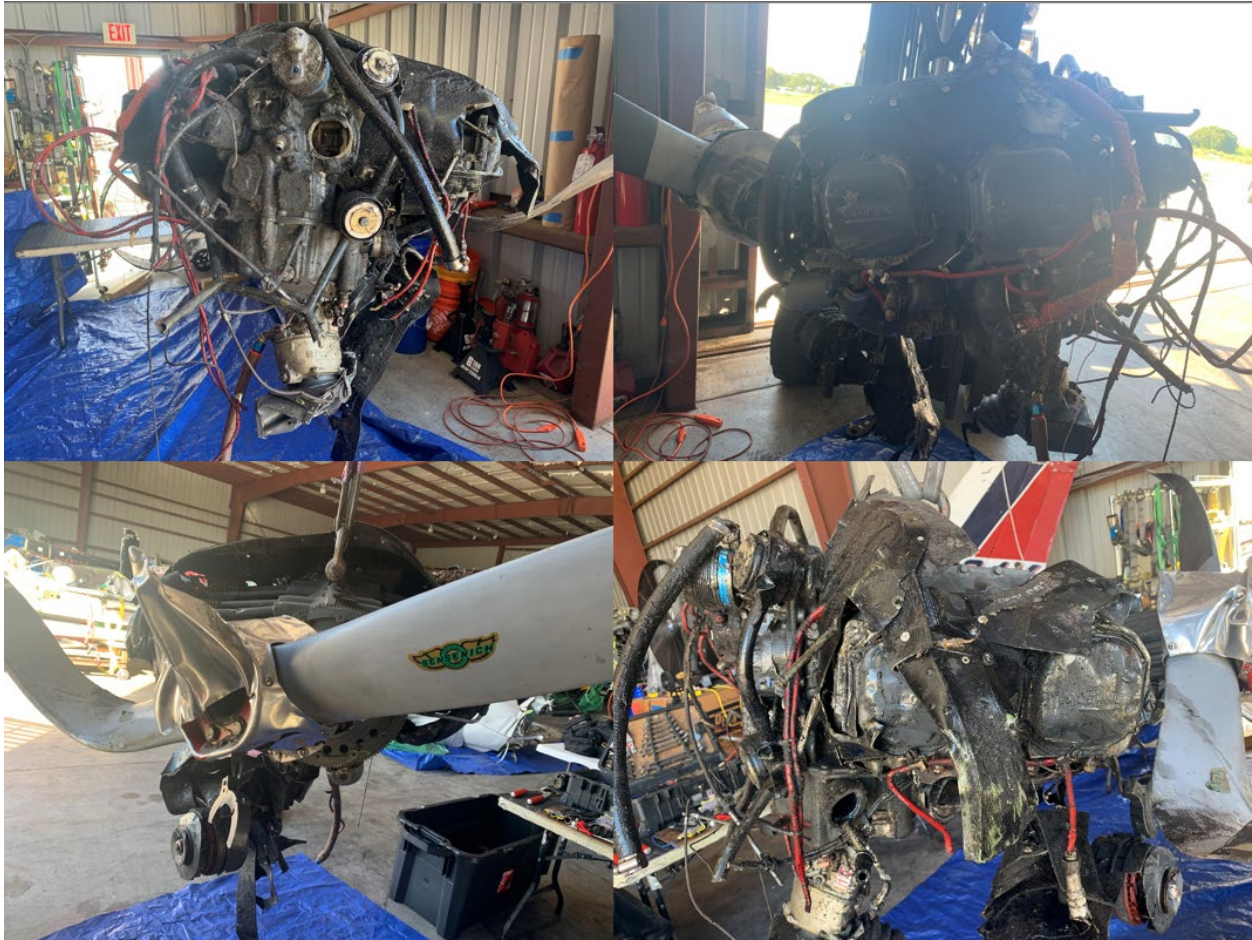
The crankcase was examined and did not have any holes except in the oil sump. The cylinders were examined with a lighted borescope and no anomalies were noted. Crankshaft continuity was confirmed by rotating it through the vacuum pump drive shaft through 720° of rotation. Compression was confirmed on all cylinders by rotating the propeller. The rocker covers were removed from the cylinders and valve train continuity was confirmed.

**Figure 9. Four side view of engine.**

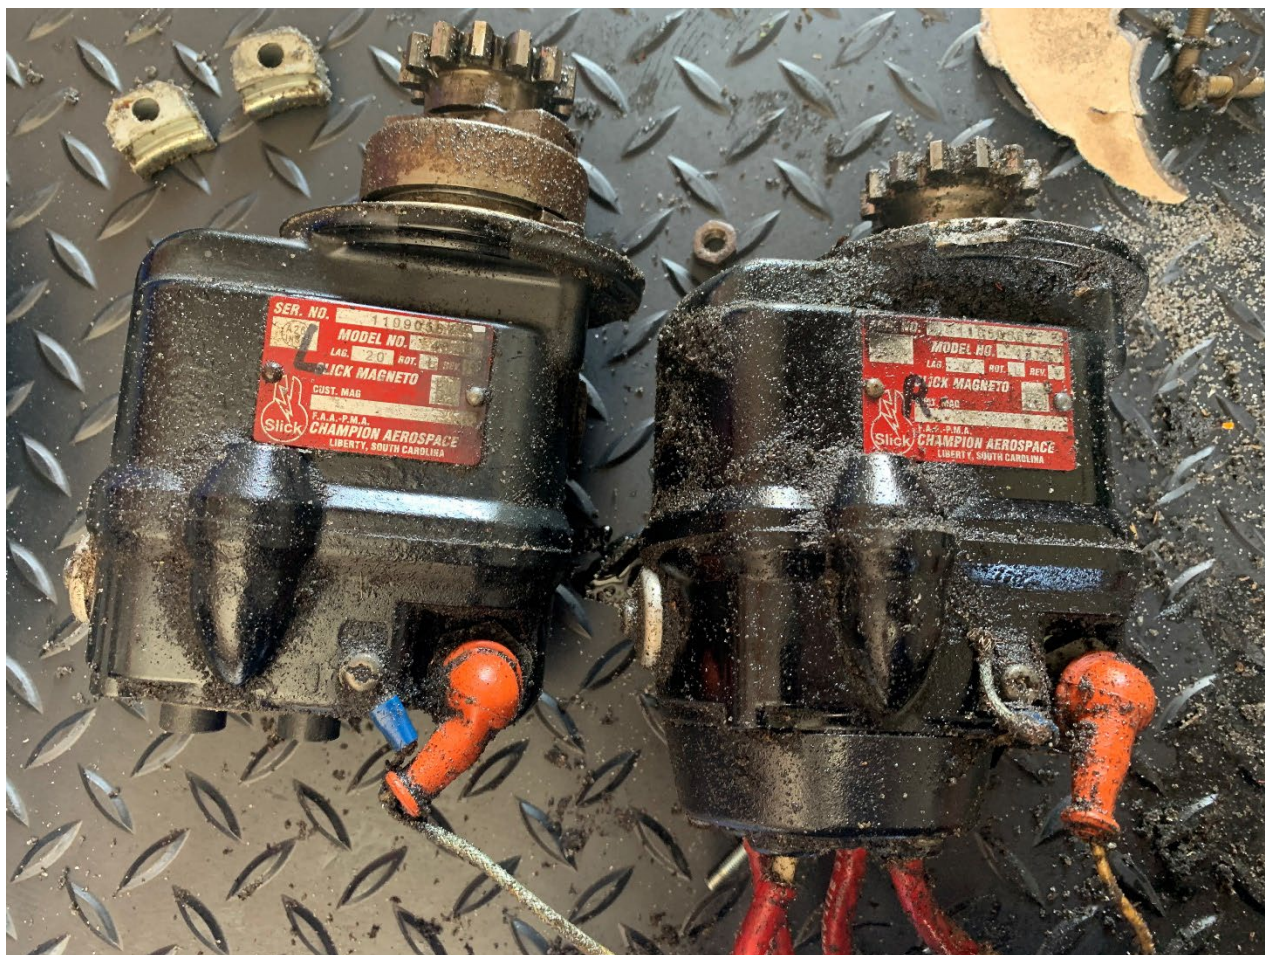
The left magneto was removed from the engine and sparked on all towers when turned by hand. The right magneto was impact separated from the engine and sparked on all towers when rotated by hand.

**Figure 10. Left and right magnetos.**

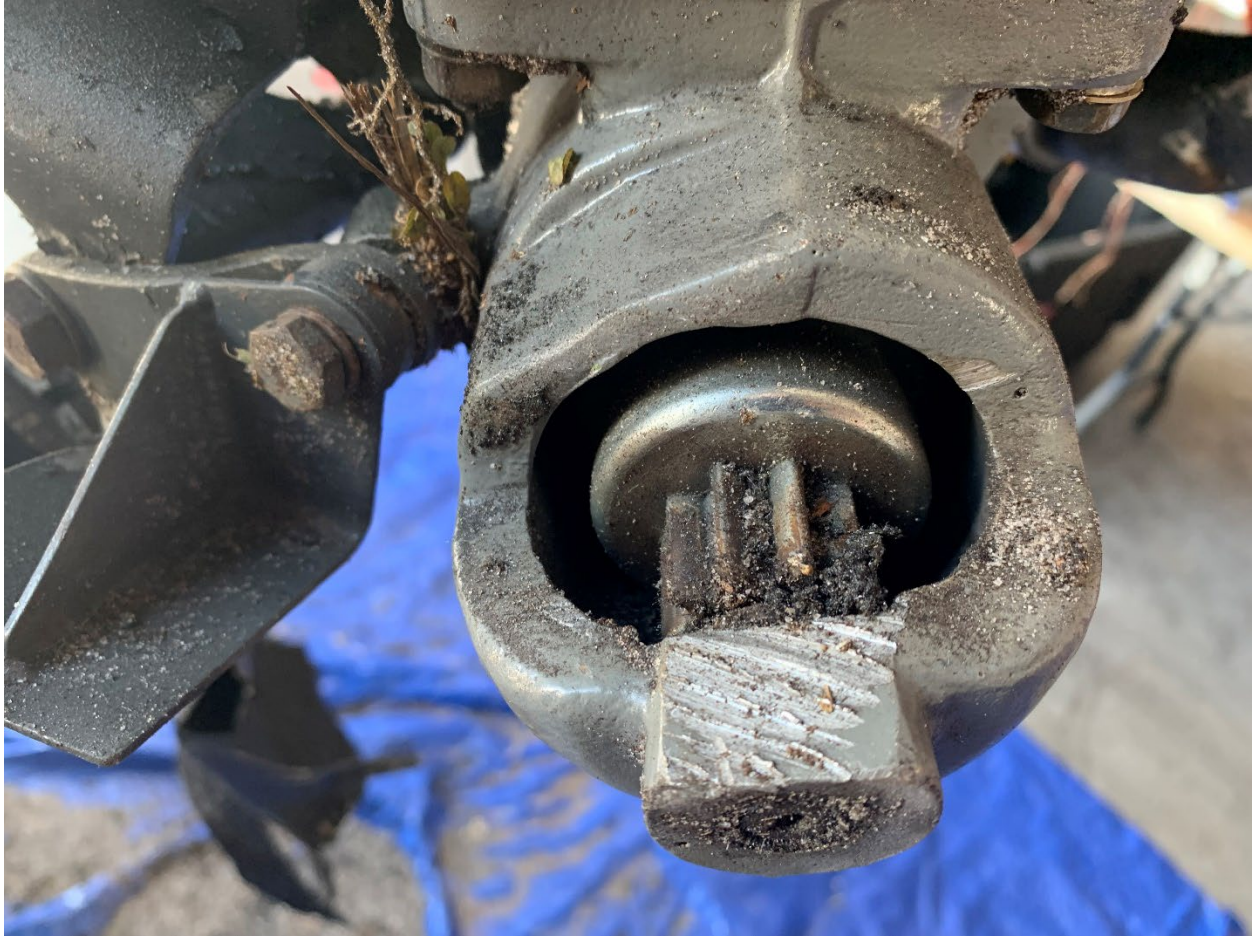
The airplane was equipped with a starter motor that remained attached to the engine. There were rotational scoring marks on the starter.

**Figure 11. Engine starter. Note rotational scoring.**

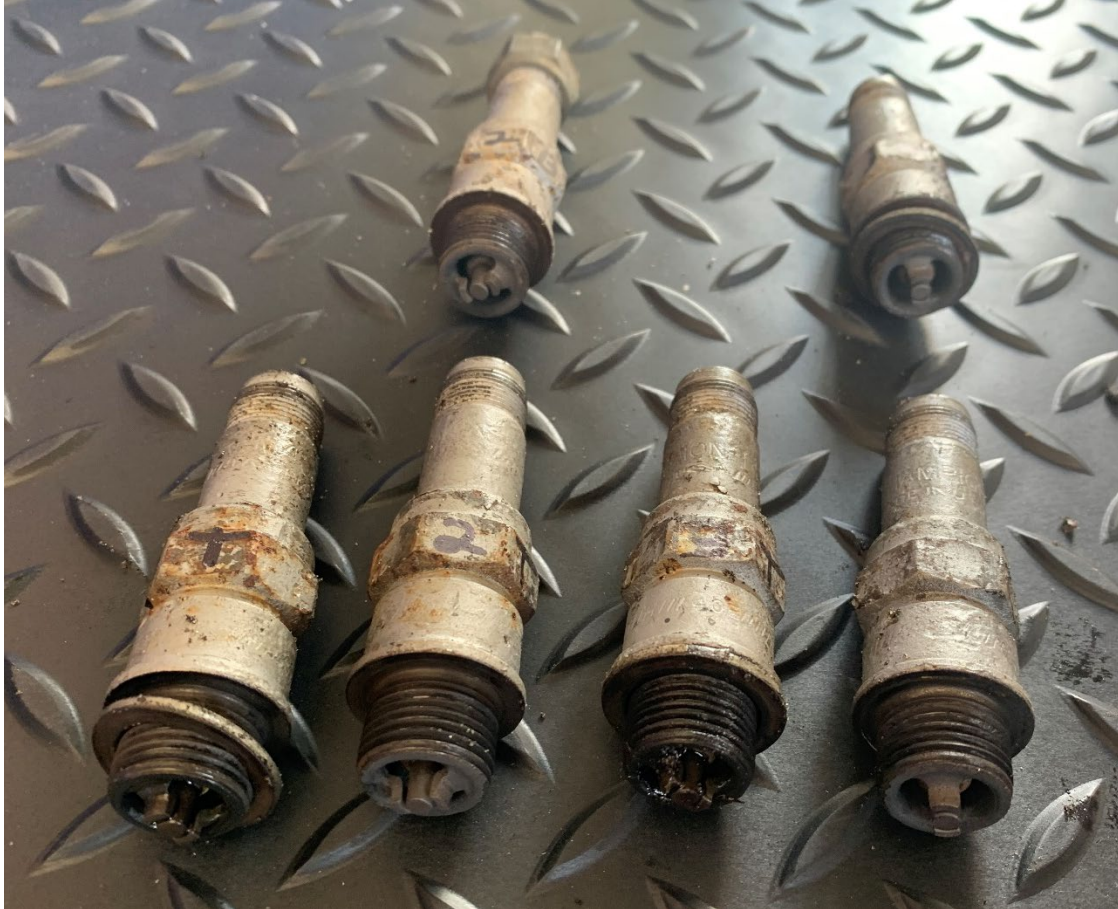
The spark plugs were removed and examined using the Champion Aerospace Aviation Check-A-Plug chart. The Nos. 1 and 3 top spark plugs were oily and the electrode was in normal condition. The Nos. 1 and 3 bottom spark plugs were damaged and could not be removed. However, they were examined using a lighted borescope and no anomalies were noted. The Nos. 2 and 4 top and bottoms spark plugs exhibited normal wear when compared to the Champion Aerospace Aviation Check-A-Plug chart.

**Figure 12. Spark plugs removed from engine.**

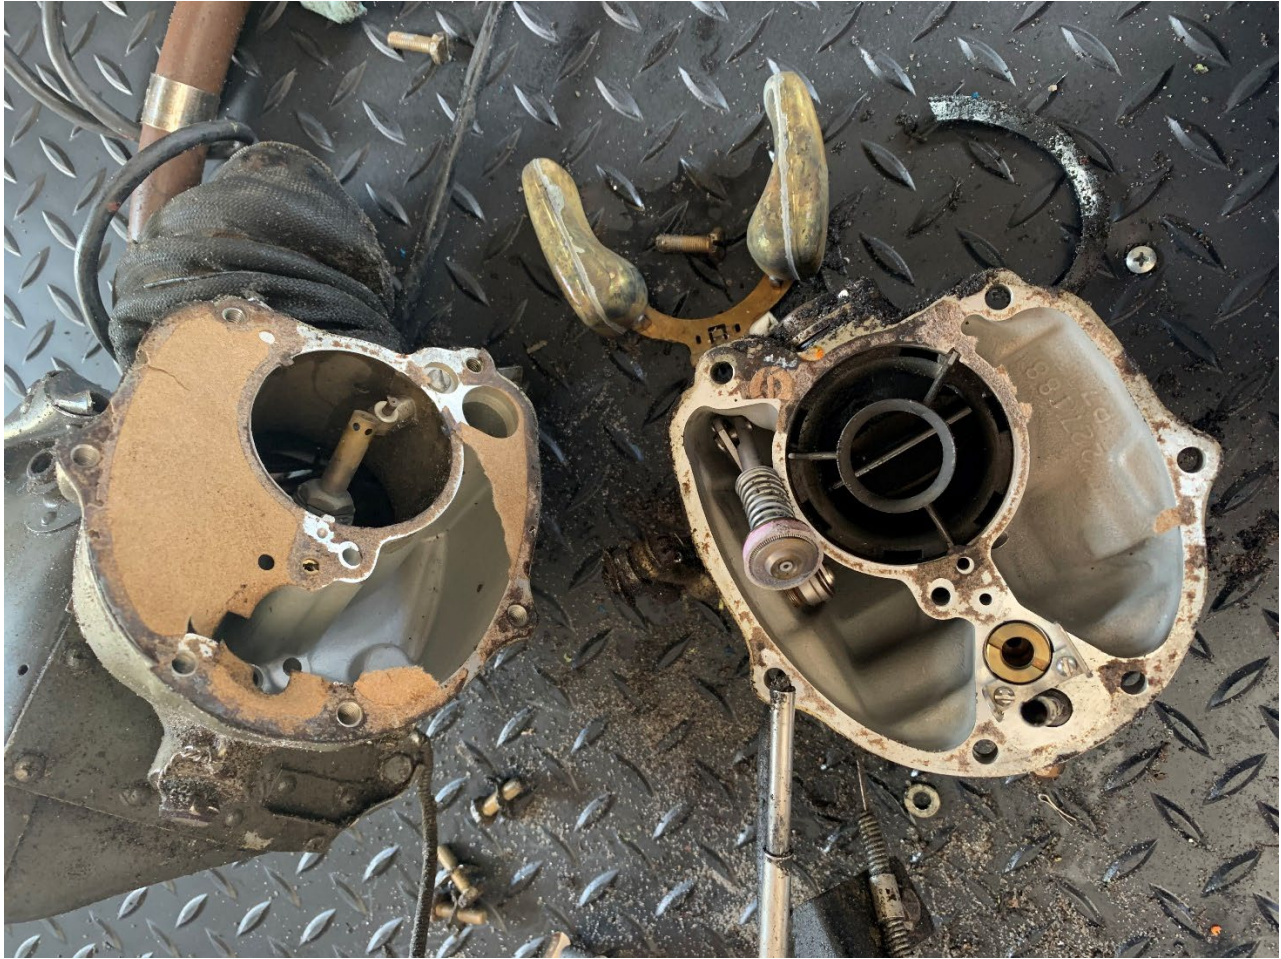
The carburetor was removed and disassembled. There was fuel in the carburetor bowl that drained out when the carburetor was removed from the engine. The floats were examined and were not damaged. The fuel inlet screen was examined, and no debris was noted. The float needle valve was examined and was without anomalies.

**Figure 13. View of disassembled carburetor.**

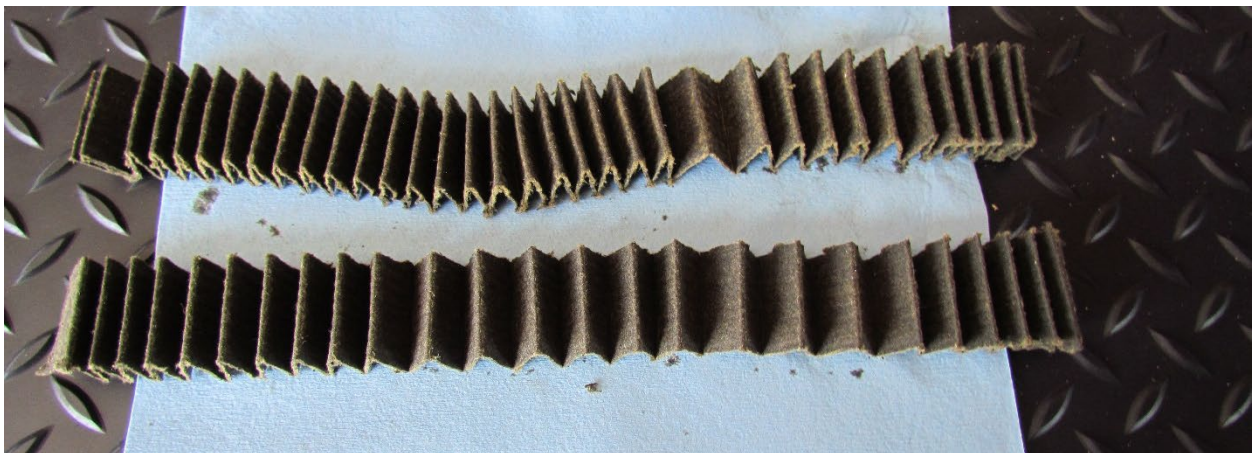
The oil filter was impact separated from the engine. It was disassembled and no metallic material was noted in the filter.

**Figure 14. View of oil filter element.**

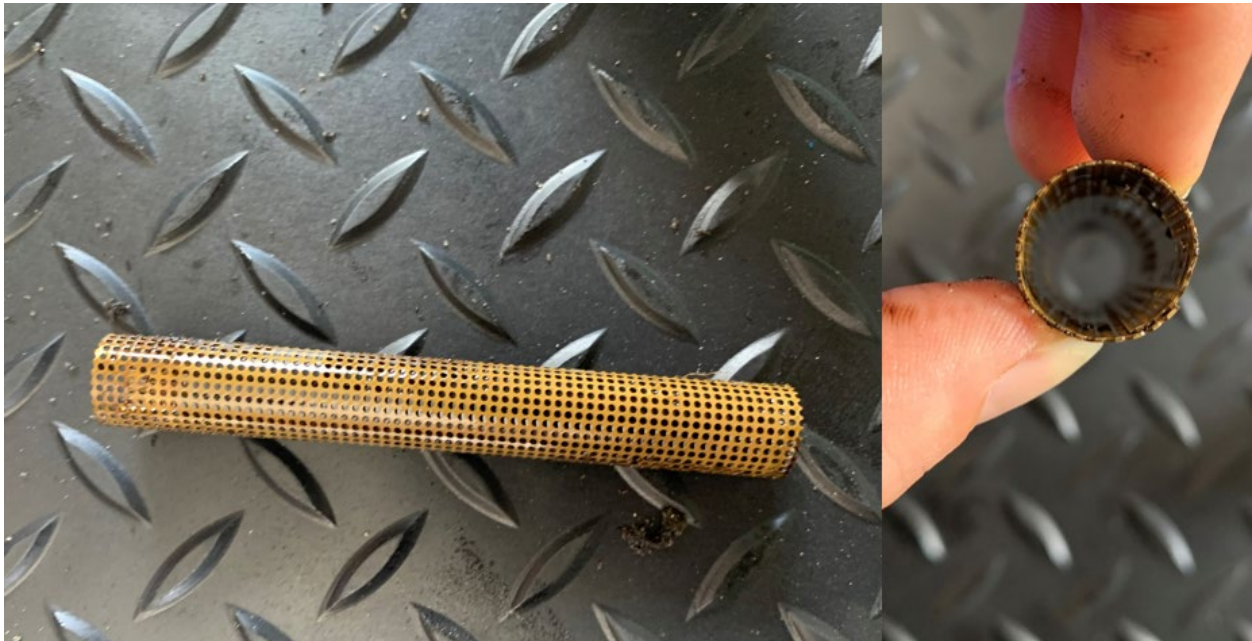
The oil pick up screen was removed from the oil sump and no debris was noted.

**Figure 15. View of oil pickup screen.**

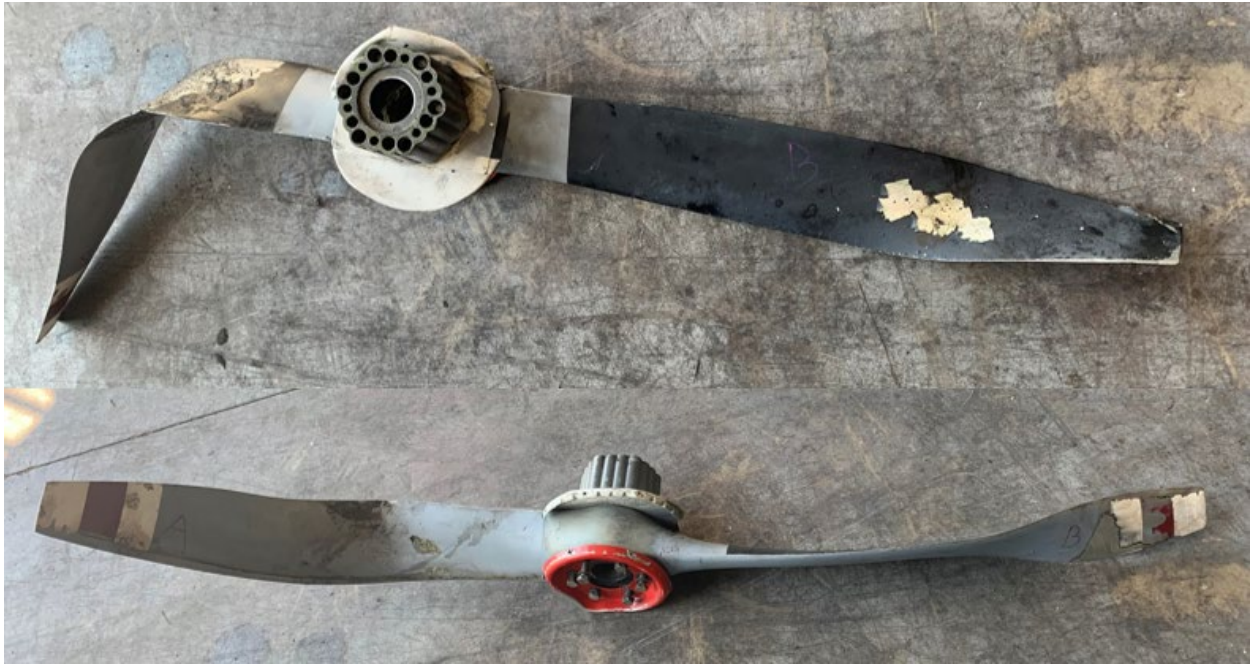
The fixed pitch propeller remained attached to the crankshaft flange and the two blades remained attached to the hub. Blade A was bent forward about mid-span and exhibited chordwise scratching. Blade B was twisted and exhibited chordwise scratching.

**Figure 16. Two-angle view of the propeller blade.**
